Subject: Semiannual Discharge Monitoring and Site Inspection Report – November 2018
Primoshield Incorporated Site, Site No. 633027
MACTEC Engineering & Consulting, P.C., Project No. 3612122251

Attachment 1 –Photographic Log

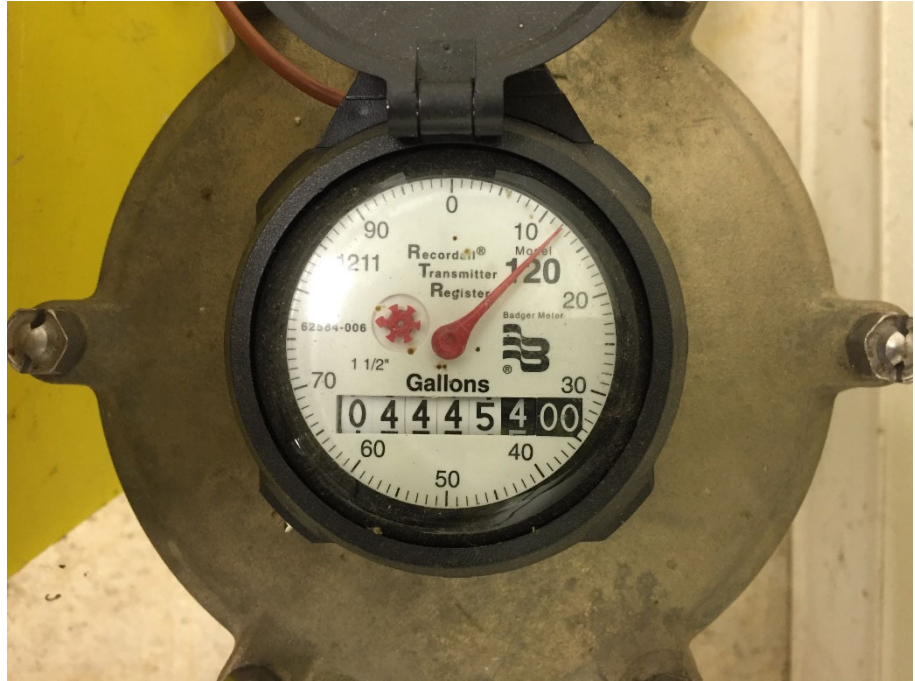
Photograph: 1

Flow meter/totalizer reading

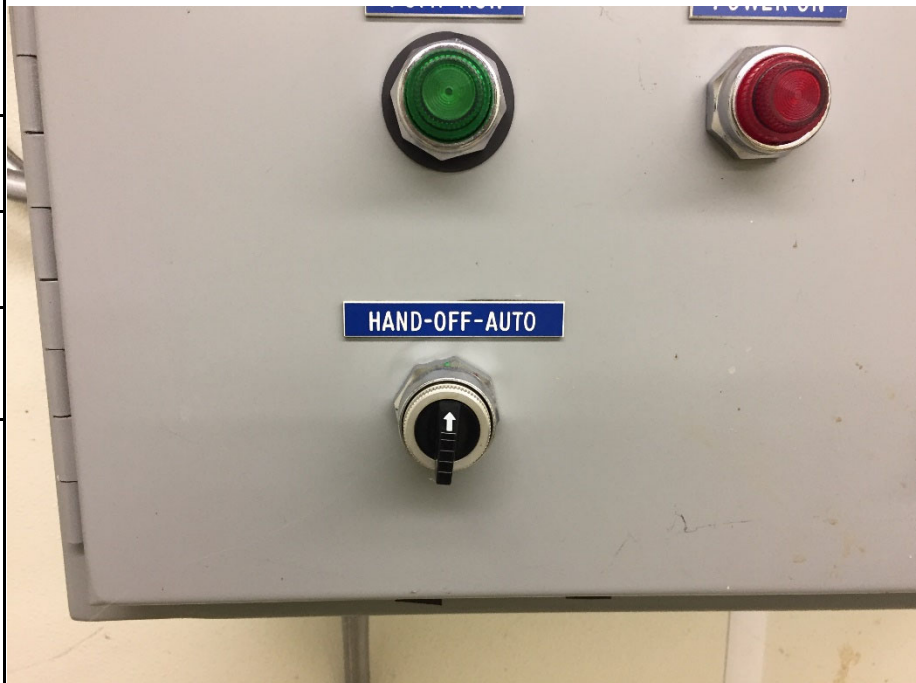
Photograph: 2

System was turned to "off" position upon arrival.

The treatment system was observed to be turned off upon arrival. The system was turned to autorun mode and allowed to run for one hour prior to discharge sampling. The system was left running for the duration of the inspection visit. However, during the Site visit silty water was observed upwelling near the Trench 1 cleanout on the southwest corner of the Site (see Attachment 1, photos 9 and 10). The cause of the upwelling was not apparent at the time of the inspection, therefore, the system was shut off prior to leaving the Site. The issue was further investigated in December 2018 and is discussed in the 2018 Annual Report. The flow meter/totalizer reading was recorded at 4,445,400 gallons (see Attachment 1 photo 1). The manhole was opened during the inspection and the pump assembly was visually examined and appears to be in good condition.

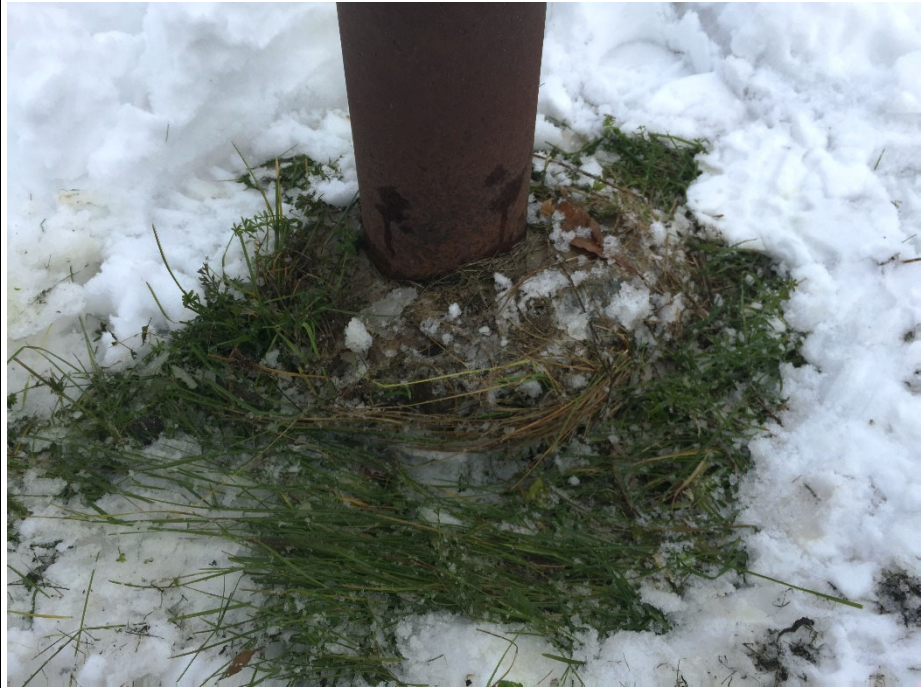
Photograph: 3

- The protective casings on P-106S, P-106D, and P-107S were observed to be loose and the well pad for P-107S was observed to have heaved (see Photo 3)
- The northernmost cleanout (Trench 2, Cleanout 5) will not close due to settlement of the protective road-box and surrounding concrete (see Photo 4)
- Young trees and other vegetation are encroaching on the fencing to the southeast of P-105, north of P-106, and a few other areas. Vegetation is encroaching on the perimeter fence in several locations (see Photos 6, 7, and 8).

Well pad heaved at P-107S and casing is loose.

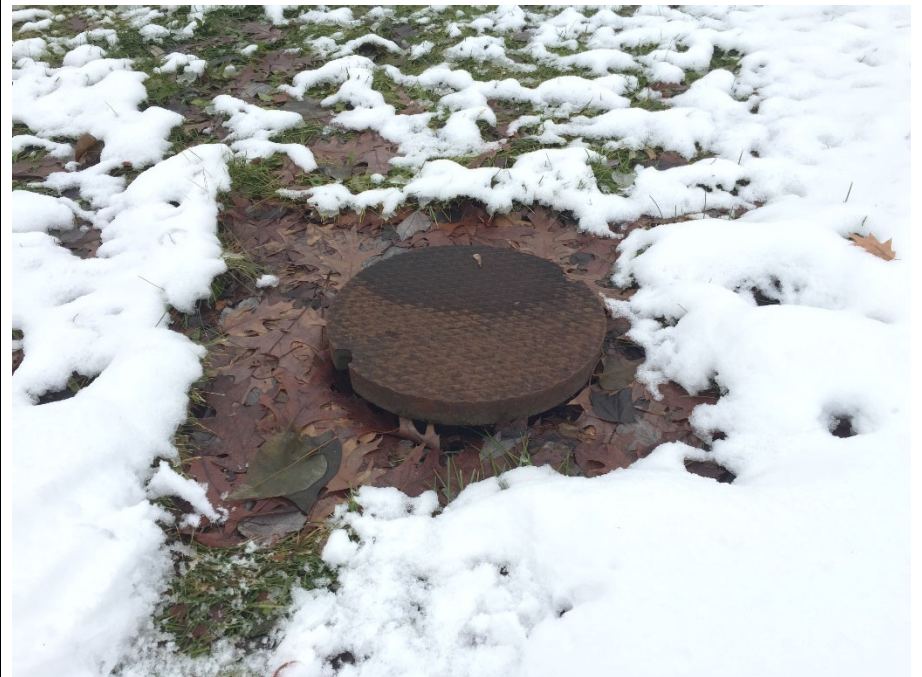
Photograph: 4

**TRENCH 2 NORTH CLEAN-OUT COVER NOT SITTING FLUSH.*

Northwest end collection trench #2 cleanout lid does not sit properly.

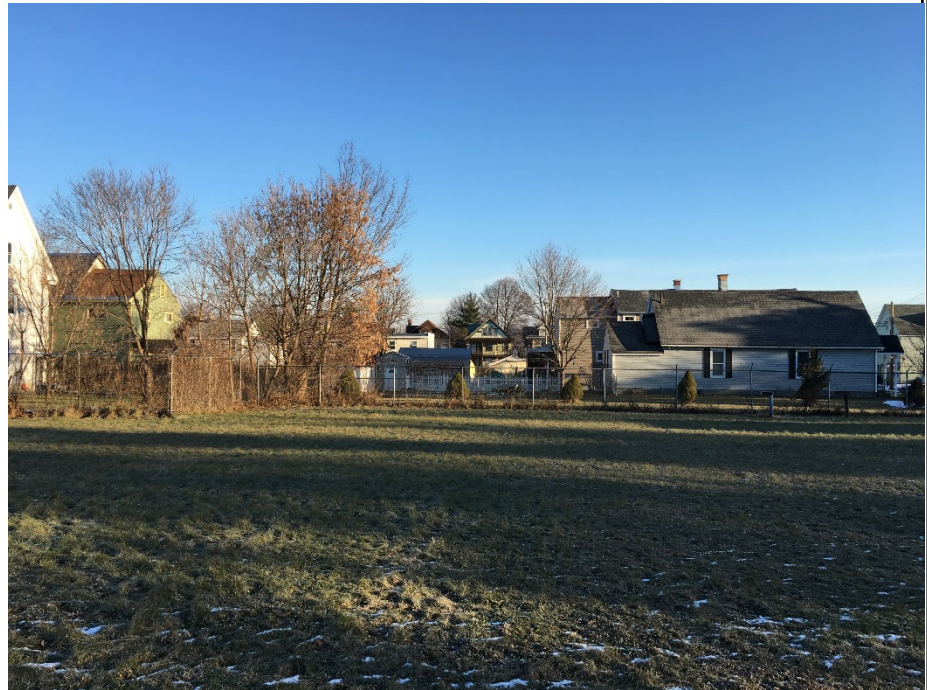
Photograph: 6

Overgrown fence portions along the northern property boundary.

The perimeter fence condition is consistent with past observations; some minor damage was noted that does not require immediate repair. Young trees impinging on the perimeter fences should be removed at the roots to prevent continued growth and potential fence damage. The well casings for P-106S, P-107S and P-107D should be regouted and the Trench 2 cleanout should be trimmed down to allow the cover to fit securely. Maintenance activities will be coordinated with the spring 2019 Site inspection.

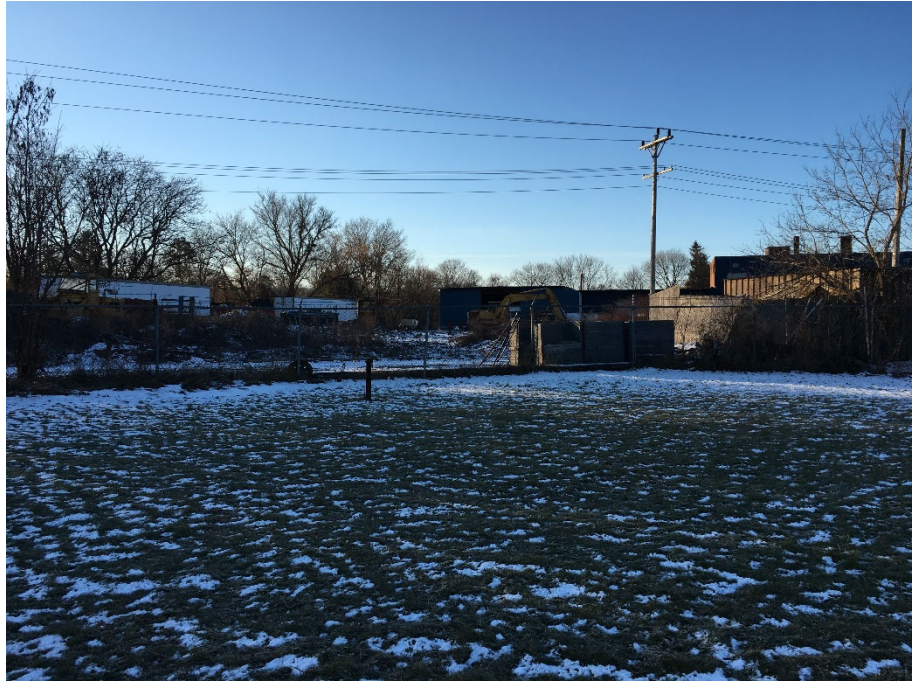
Photograph: 7

Previous fence repair at the northwestern property boundary, vegetation encroaching on the fenceline.

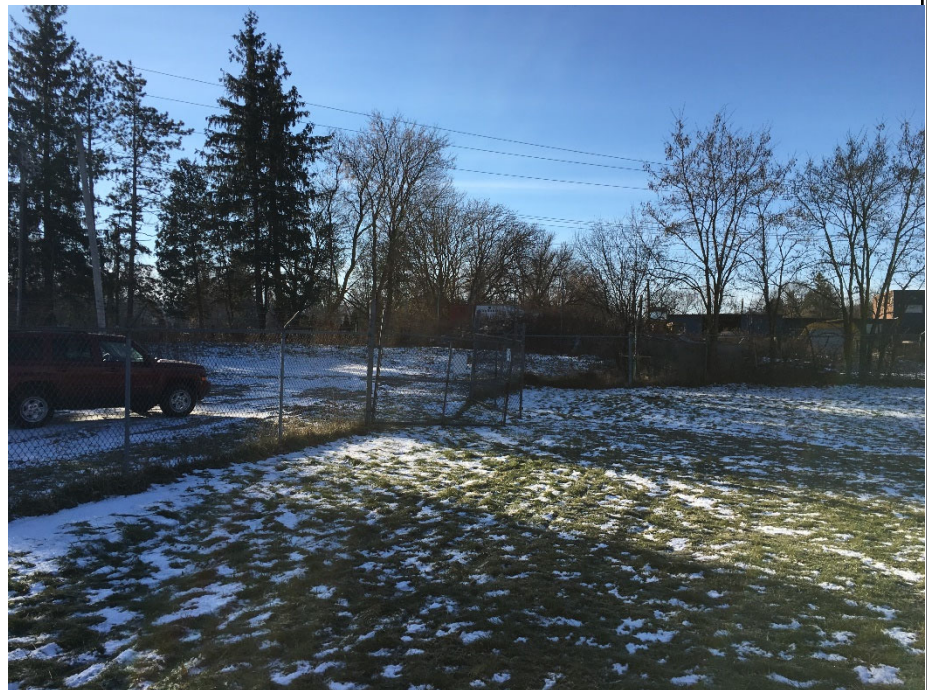
Photograph: 8

Overgrown fence portions along the southern property near P-105 and the St. Vincent Street gate.

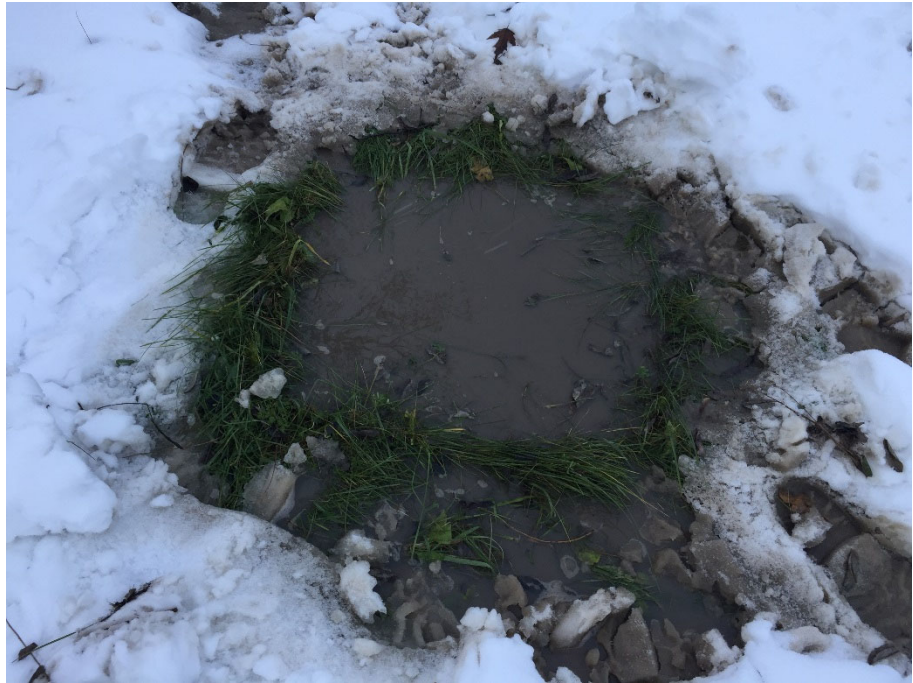
Photograph: 9

The Site's groundwater collection system near the Trench 1 clean-out was observed to be contributing to upwelling groundwater while the system was running at the time of the November 2018 inspection event. This issue was investigated further during a December 2018 Site visit and the same condition was not observed. This follow up investigation is discussed in the 2018 Annual Report. The system was set to the "autorun" position in December and should be inspected periodically before the Spring Inspection which is scheduled for April 2019.

Silty water observed at Trench 1 cleanout after the system was turned on.

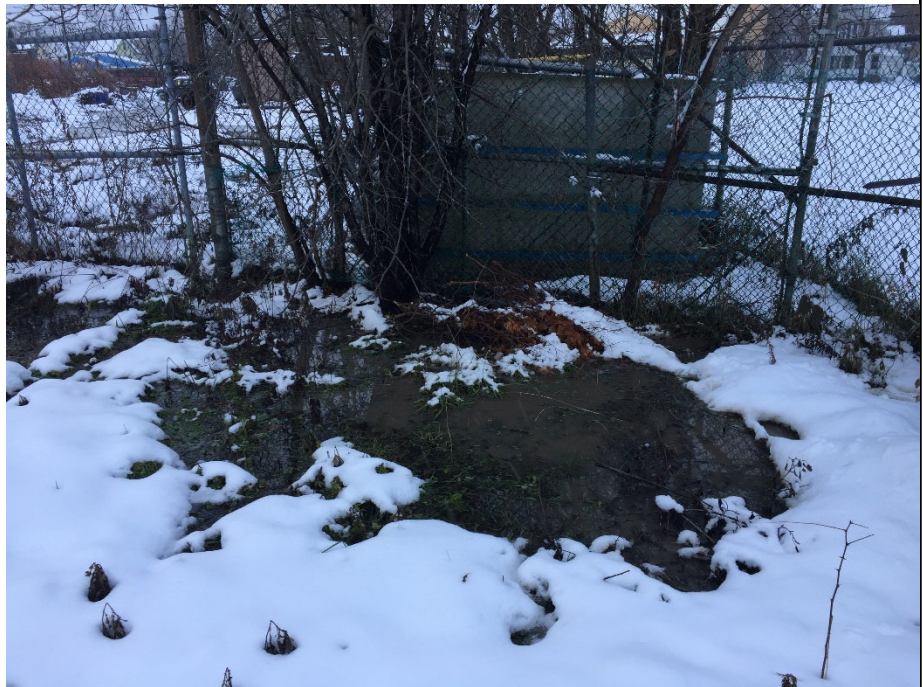
Photograph: 10

Silty water observed at the southern property boundary near the Trench 1 cleanout after the system was turned on.
