Subject: Semiannual Discharge Monitoring and Site Inspection Report – June 2019
Primoshield Incorporated Site, Site No. 633027
MACTEC Engineering & Consulting, P.C., Project No. 3612122251

MACTEC Engineering and Consulting, P.C., (MACTEC), under contract to the New York State Department of Environmental Conservation (NYSDEC) is submitting this letter report describing the June 2019 semiannual site management (SM) activities completed, and observations noted at the Primoshield Incorporated Site (Site), NYSDEC Site # 633027, located in Utica, New York.

The Primoshield site is a former metal electroplating facility located at 1212 St. Vincent Street. The Site is approximately 2.4 acres in size and is bordered by Conkling Avenue on the Northwest and St. Vincent Street on the South and East, and has a Classification Code of 4 (SM). Figure 1 shows the Site location and Figure 2 depicts the Site features.

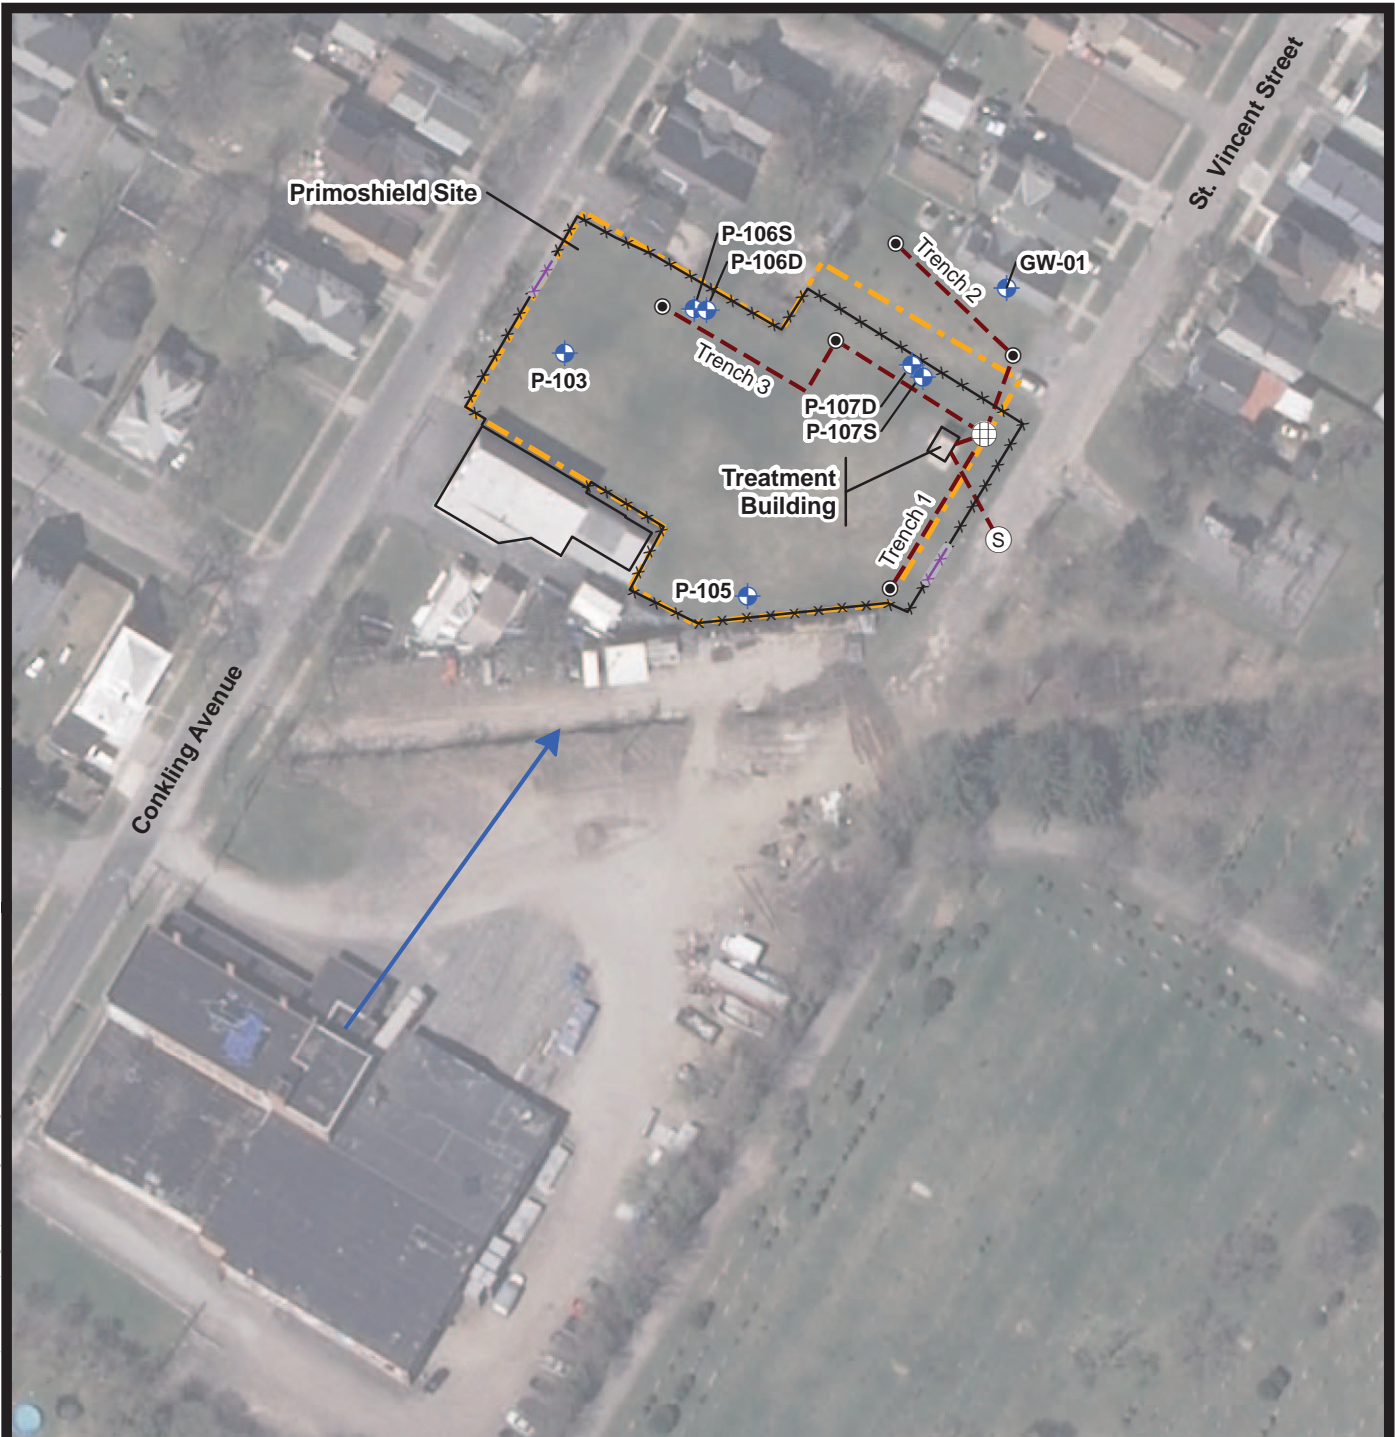
Figure 2

SITE FEATURES

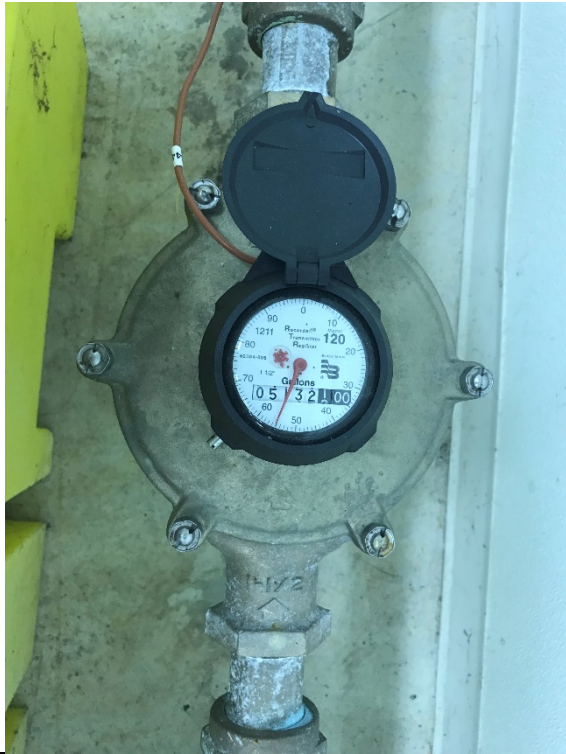
Photograph: 1

Flow meters / totalizer in treatment building

Flow meter/totalizer reading

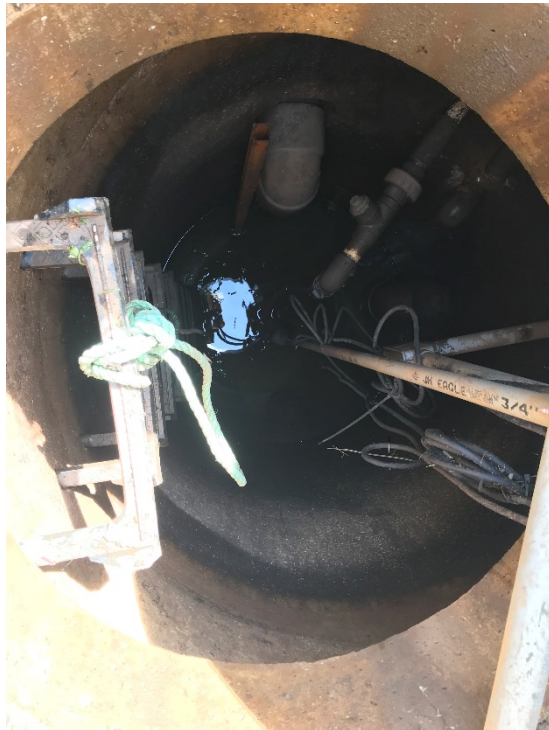
Photograph: 2

The treatment system was observed to be set in automatic (standby) mode upon arrival and was pumping intermittently in response to the float switch in the collection manhole. The pump was switched to manual (hand) mode to perform discharge sampling. The flow meter/totalizer reading was 5,132,155 gallons (see Attachment 1 Photo #1). The manhole was opened during the inspection and, although the high water and light contrast made visual examination difficult, the pump assembly appeared to be in good condition (Photo #2).

interior of manhole

View in Manhole

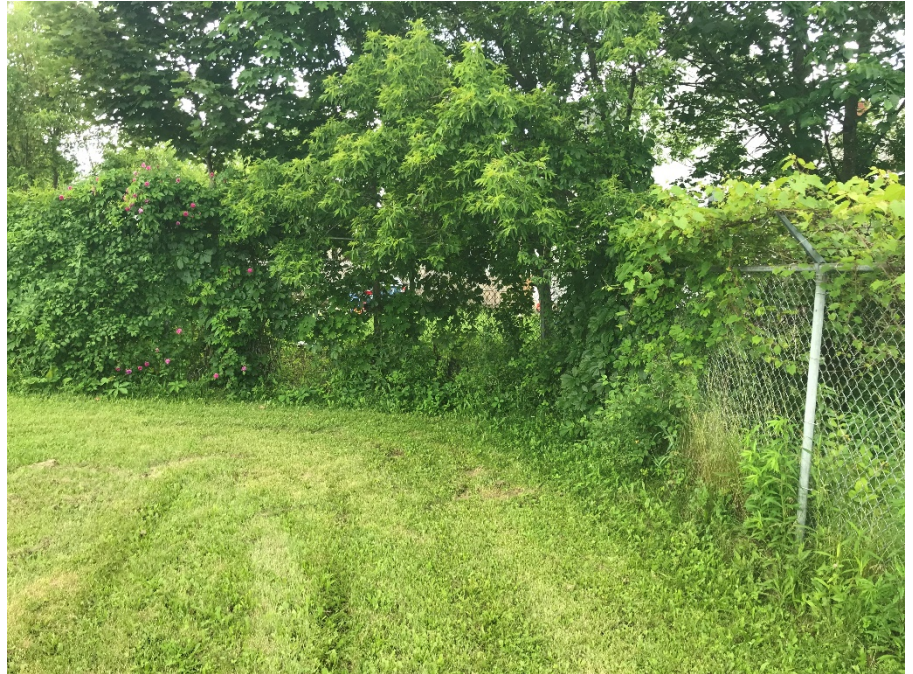
Photograph: 3

end of top rail where fence height changes (west of P-107 S/D)

End of top rail where fence height changes.

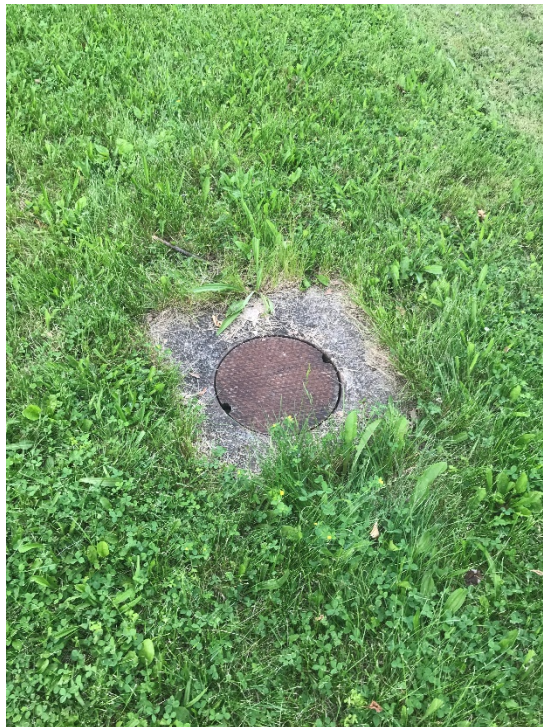
Photograph: 4

intake port was fixed at same time as P-107 S/D. yes

NW end of Trench 2, sits flush after being fixed by driller.

Northwest end collection trench #2 cleanout lid repaired 6/17/19.

Repairs were made to the northernmost cleanout (Trench #2, Cleanout #5) and monitoring wells P-107S, P-107D, P-106S, and P-106D. No other repairs were made during the June 2019 Inspection.

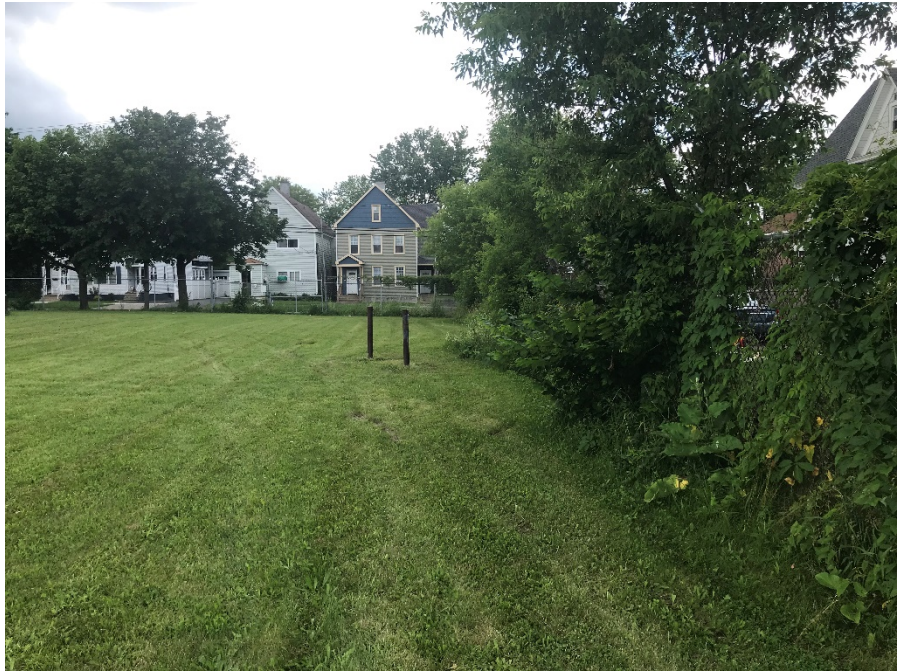
Photograph: 5

yes, vegetation has infringed in multiple locations. Power tools are required at this point for removal.

North fence near P-106 S/D new tree growth, requires power tools

Trees, vines, and other vegetation growing on north fence near P-106 well pair.

The perimeter fence and gate condition is consistent with past observations, minor damage was noted that does not require immediate repair. Repairs were made to the northernmost cleanout (Trench #2, Cleanout #5) and monitoring wells P-107S, P-107D, P-106S, and P-106D. MACTEC will continue to monitor the perimeter fence damage and vegetation growth during future inspections.

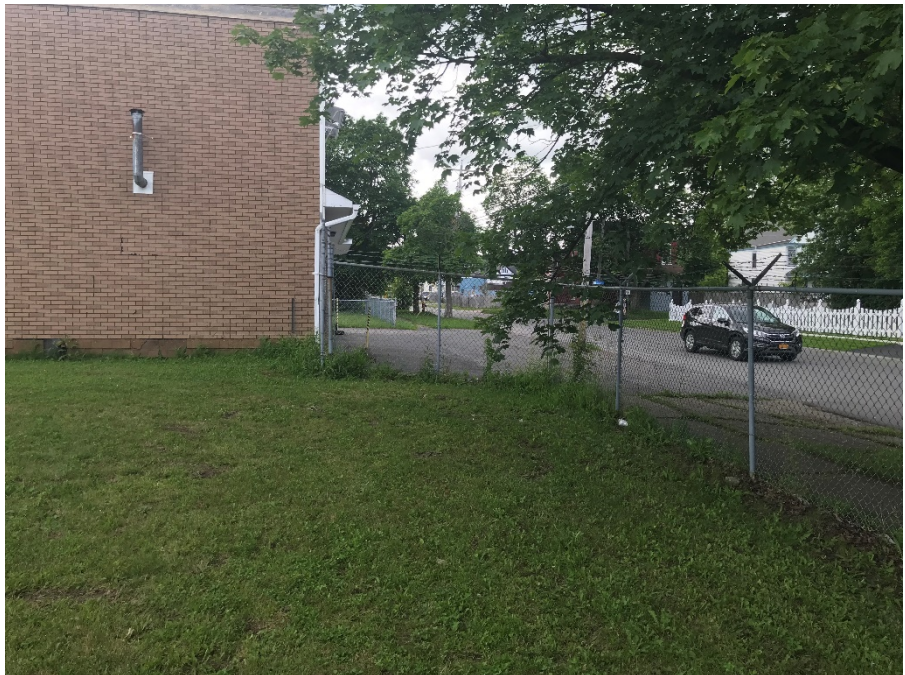
Photograph: 6

SW corner of Conting Ave tree branch pulled away.

Southwest corner, slightly damaged barbed wire.

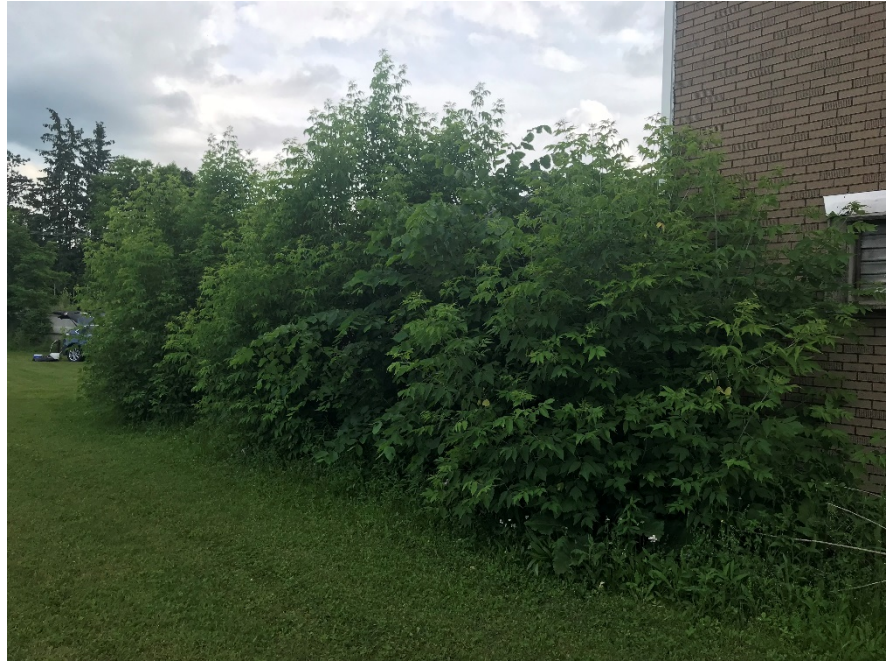
Photograph: 7

not visible due to tree and plant growth damaged barbed wire.

Heavy vegetation on south fence line near adjacent building.

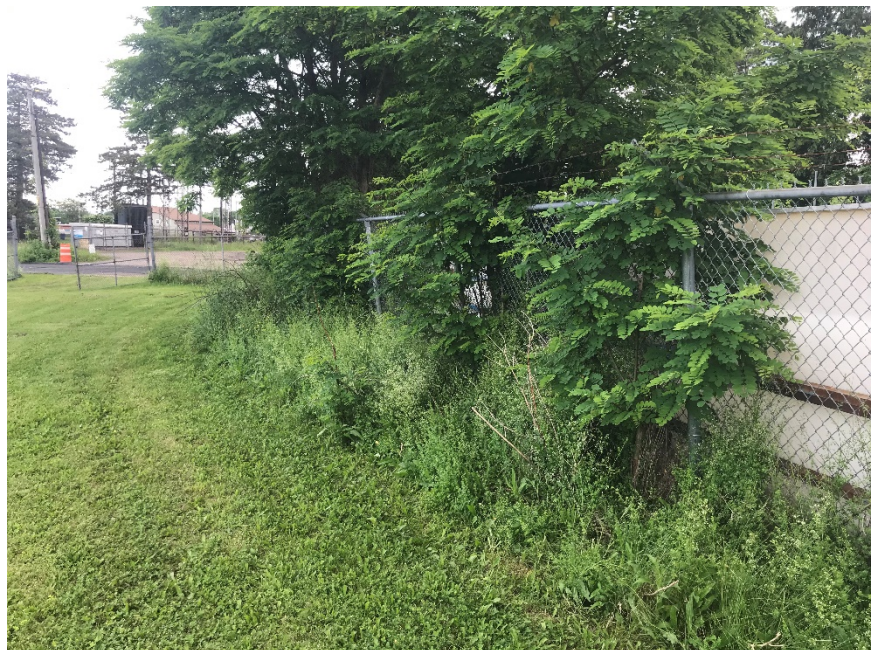
Photograph: 8

new tree growth near P-105

Vegetation along fence east of P-105.

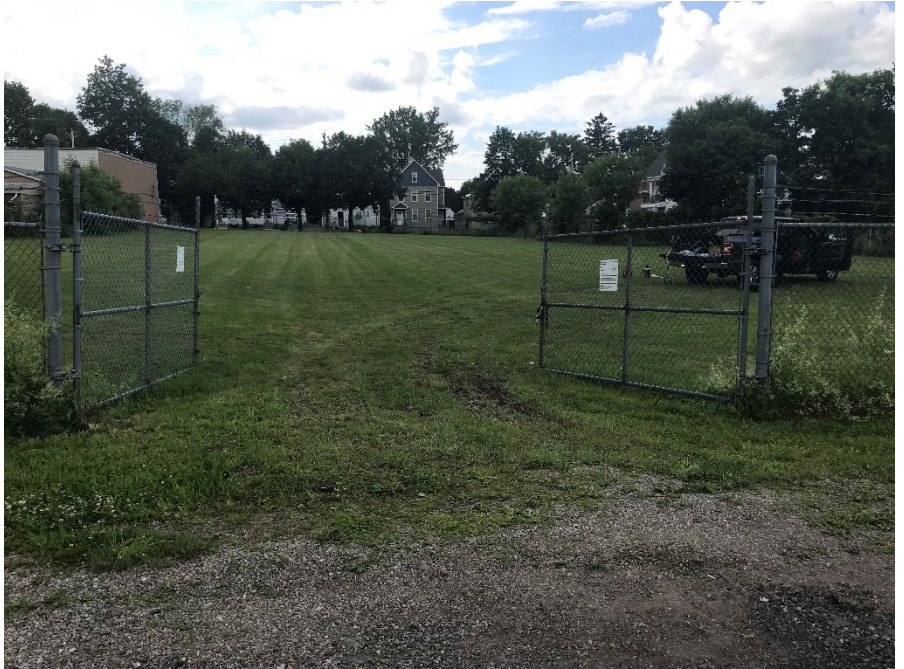
Photograph: 9

no pad lock on gate when arrived. lawn care company opened gate. gates at both sides of site are saggy somewhat no post to keep from swinging.

St Vincent Street gate entrance.

St Vincent Street gate. Gate posts are tilting slightly, but the gate is functional.

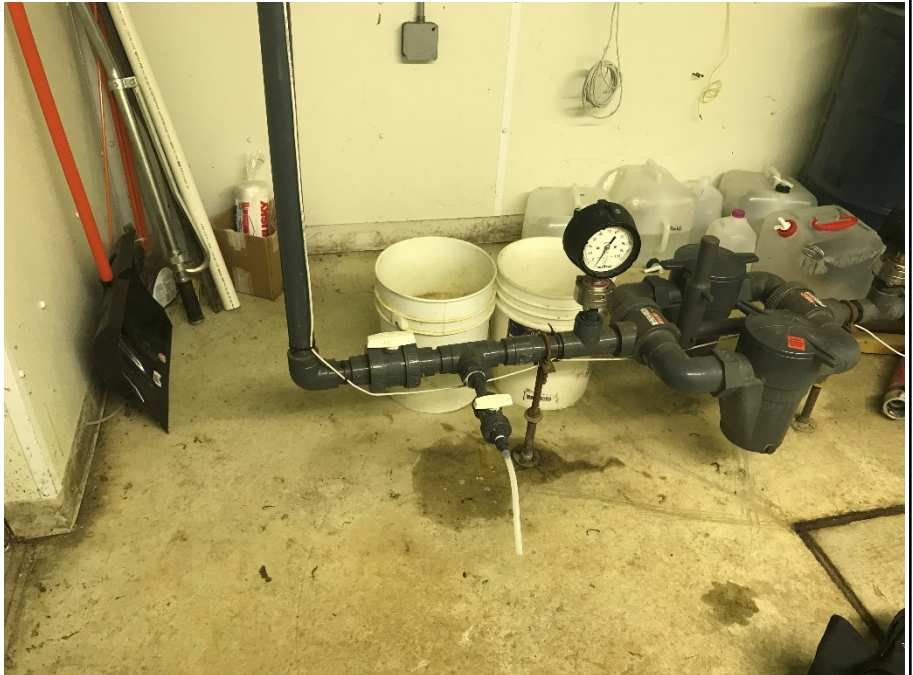
Photograph: 10

Effluent sample port.

Effluent sample port inside treatment building.
