Reference: Former Lockheed Martin French Road Facility, Utica, NY

Copies	Doc Date	Pages	Description
1	January 10, 2017	209 (pdf)	Final Document entitled "Excavation Initial Design Investigation Report, Former Lockheed Martin French Road Facility, Utica, New York"
		7,578 (pdf)	Appendix C – Analytical Laboratory Reports

**EXCAVATION INITIAL DESIGN
INVESTIGATION REPORT
FORMER LOCKHEED MARTIN FRENCH ROAD FACILITY
UTICA, NEW YORK**

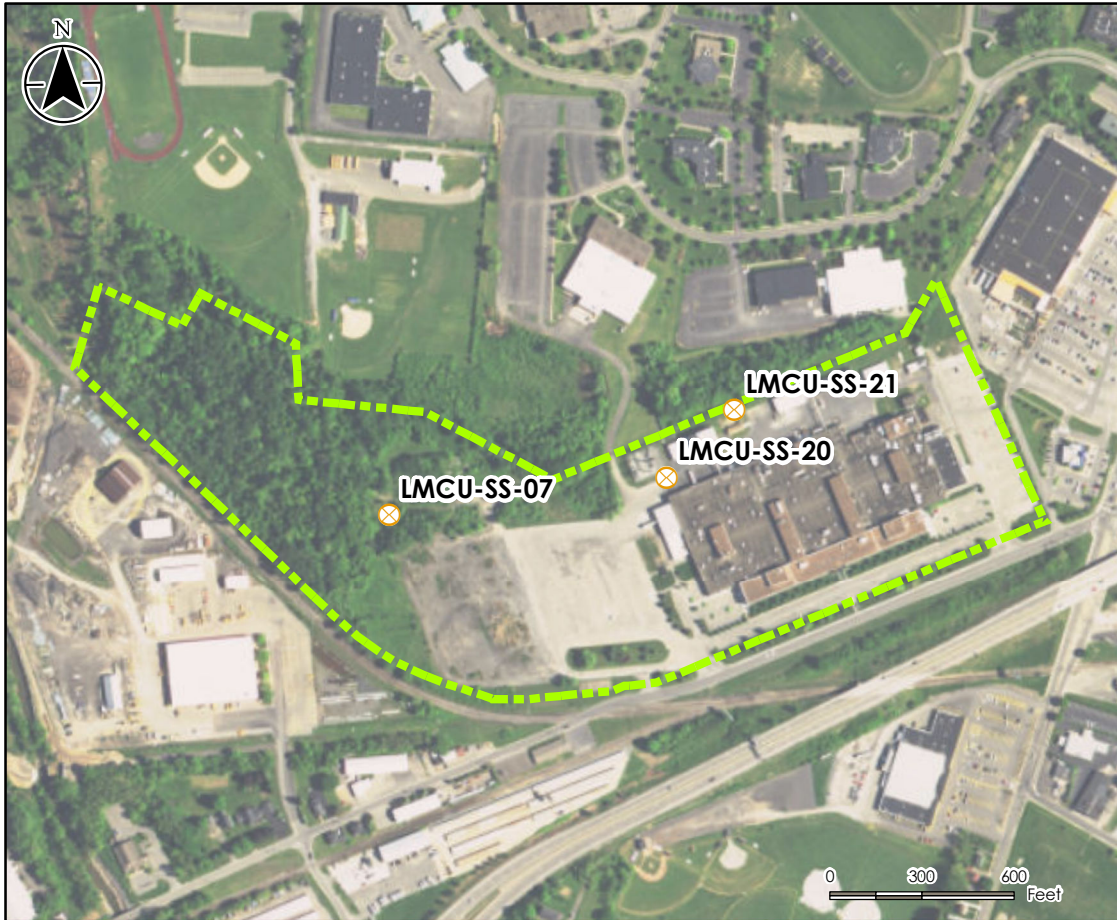
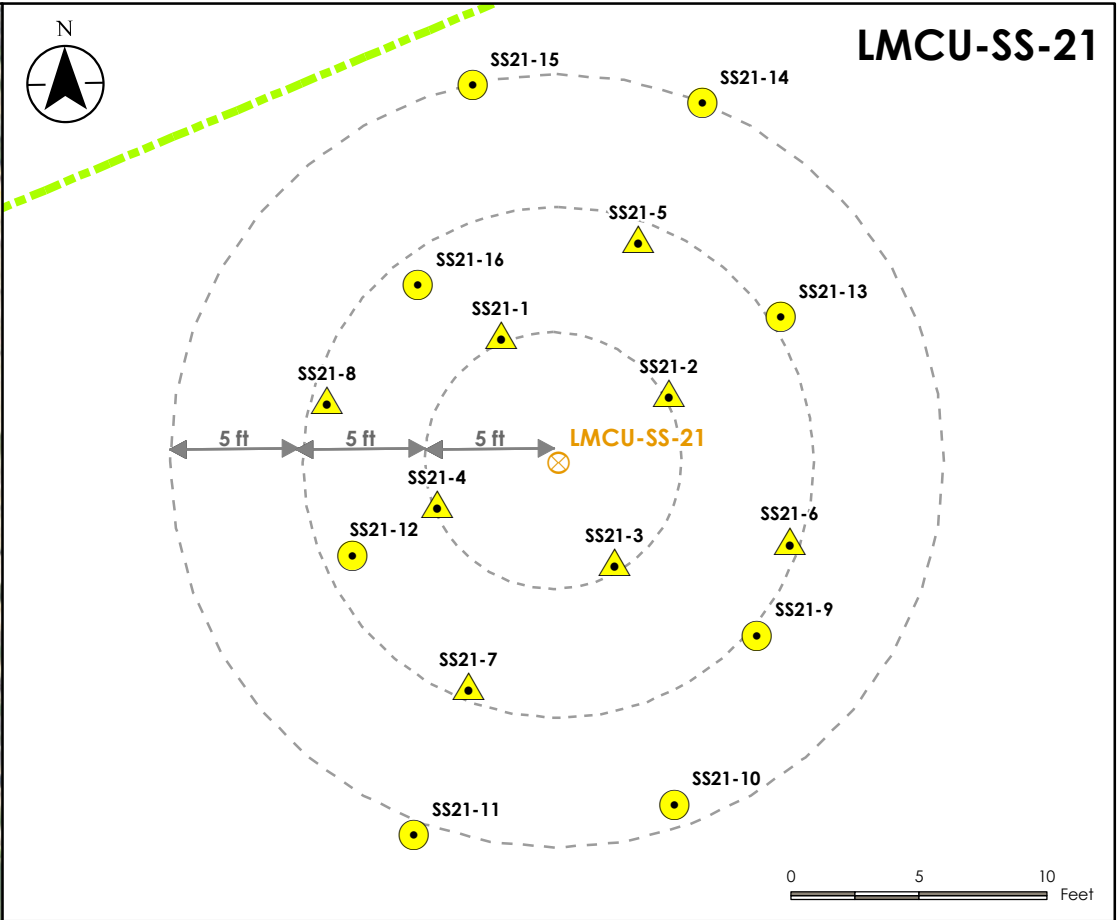
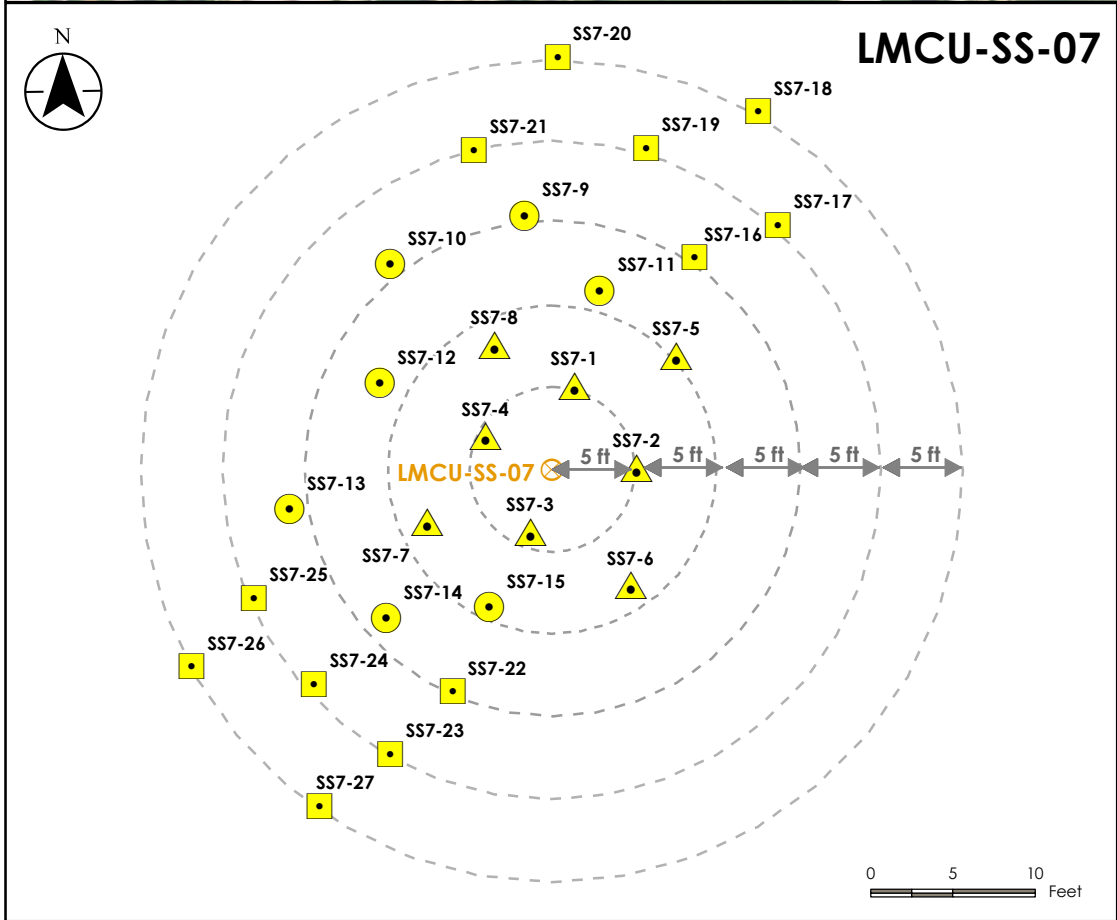
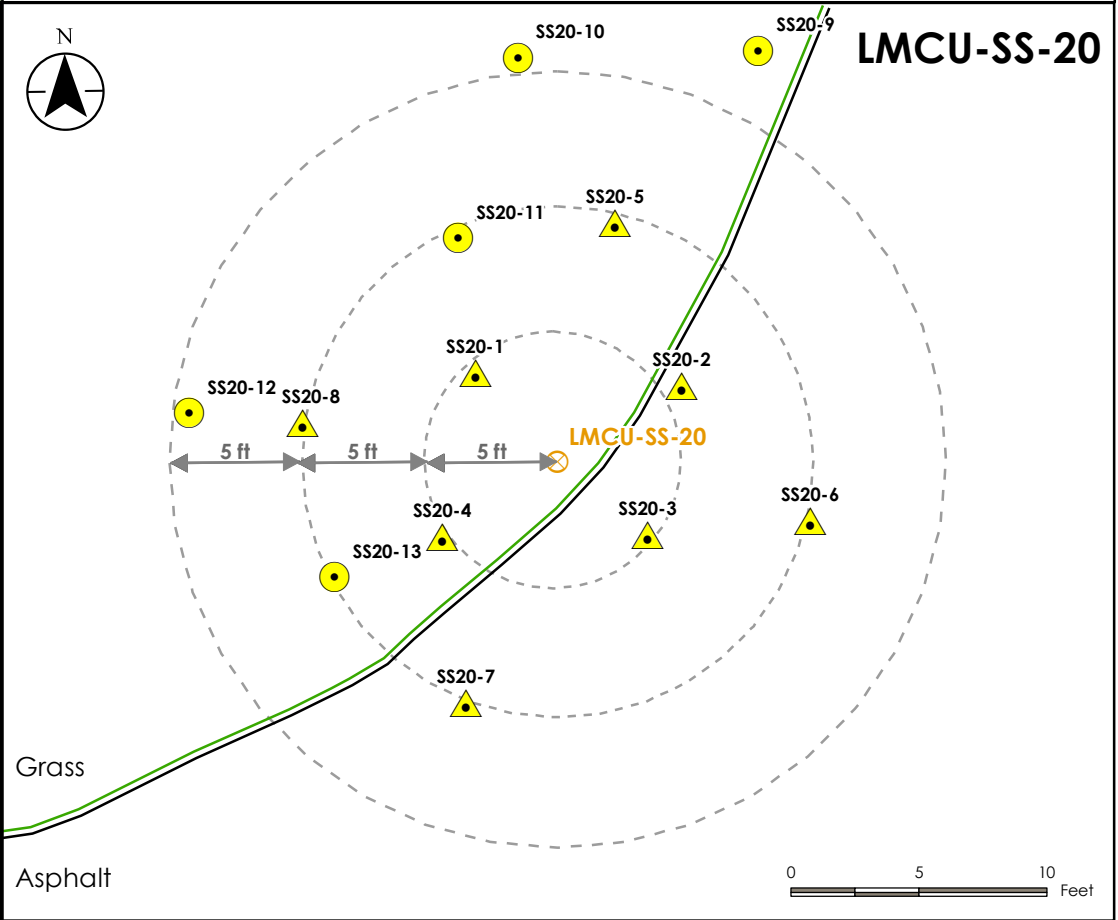
Surface Soil Sample Locations

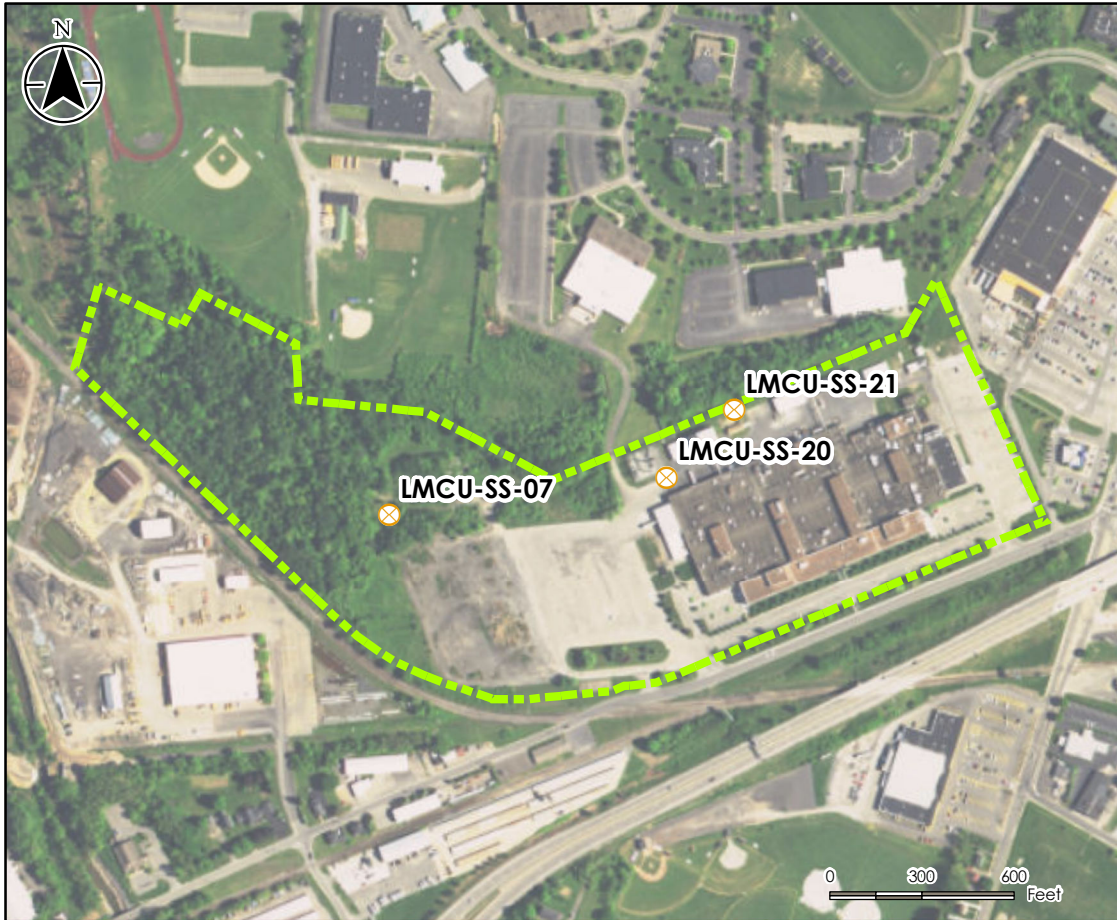
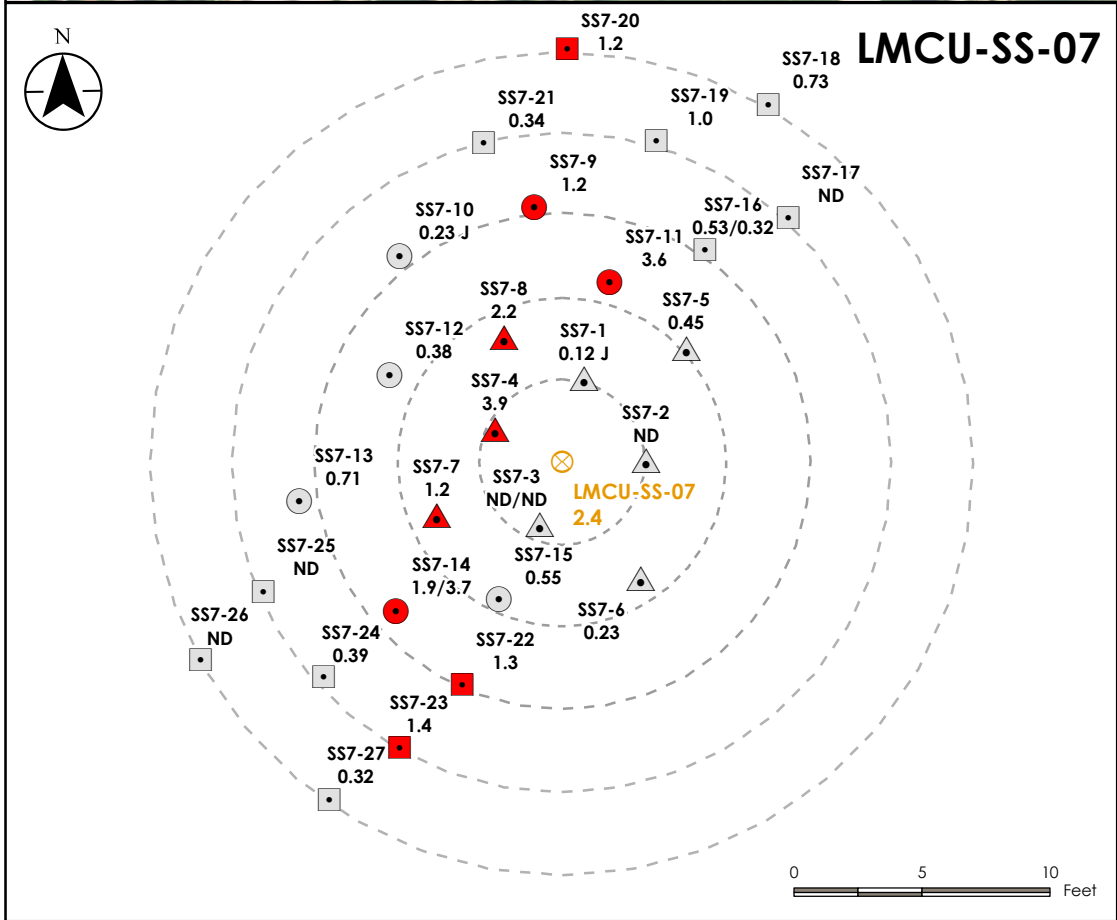
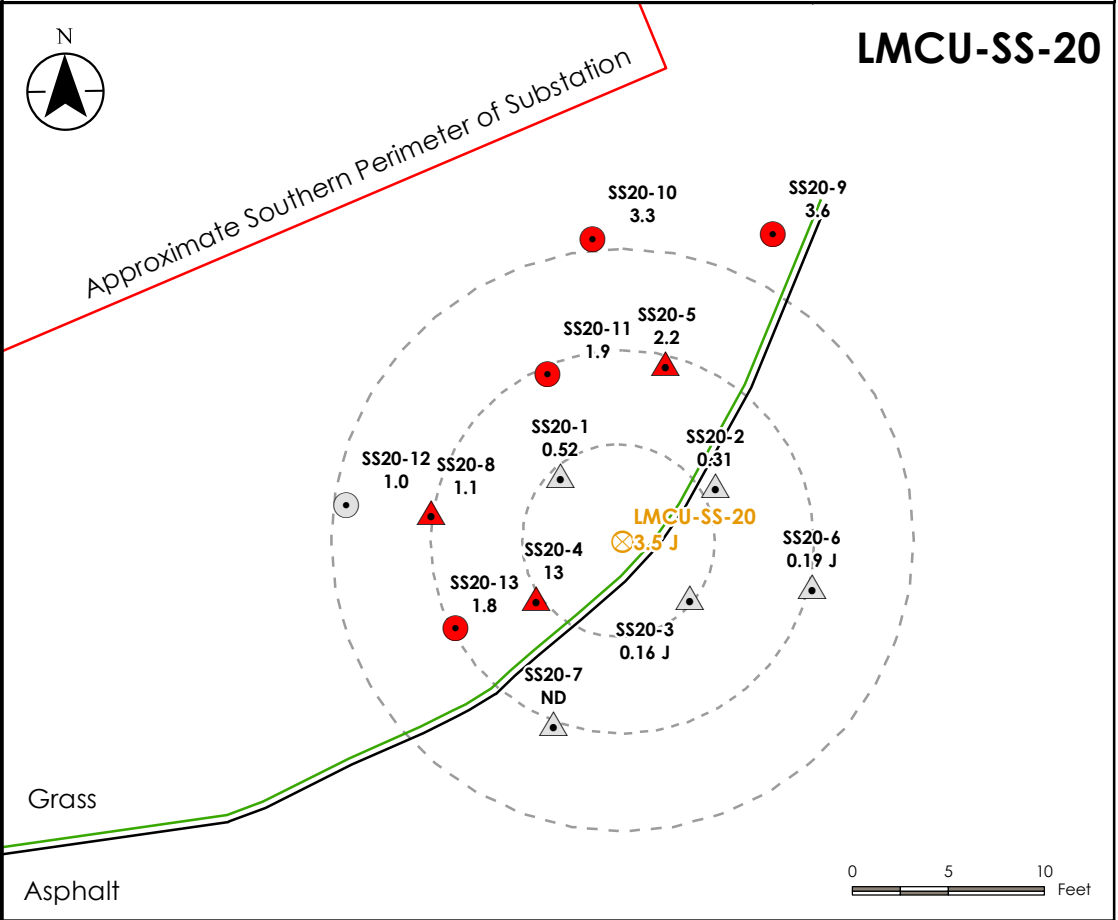
Excavation Initial Design Investigation Report
Former Lockheed Martin French Road Facility
Utica, New York
Figure No.
6
Title

Surface Soil Analytical Results

Exceedances of the CU SCO for PCBs (1 mg/kg) are depicted both on Figure 6 and in Table 8. Of the 24 surface soil samples collected during the initial sampling in November 2015, ten samples exhibited PCB concentrations exceeding the CU SCO (1 mg/kg). The highest concentration (13 mg/kg) was observed in the vicinity of LMCU-SS-20, located near the substation. The other locations exhibited only slight exceedances of this SCO.

The supplemental (June 2016) sampling locations were selected to further delineate the impacts surrounding the newly-identified exceedances. Of the 20 supplemental surface soil samples collected, ten samples exhibited PCB concentrations exceeding the CU SCO. The highest concentration (3.6 mg/kg) reported in the supplemental round of sampling was observed at two locations: one in the vicinity of LMCU-SS-07 and one in the vicinity of LMCU-SS-20.

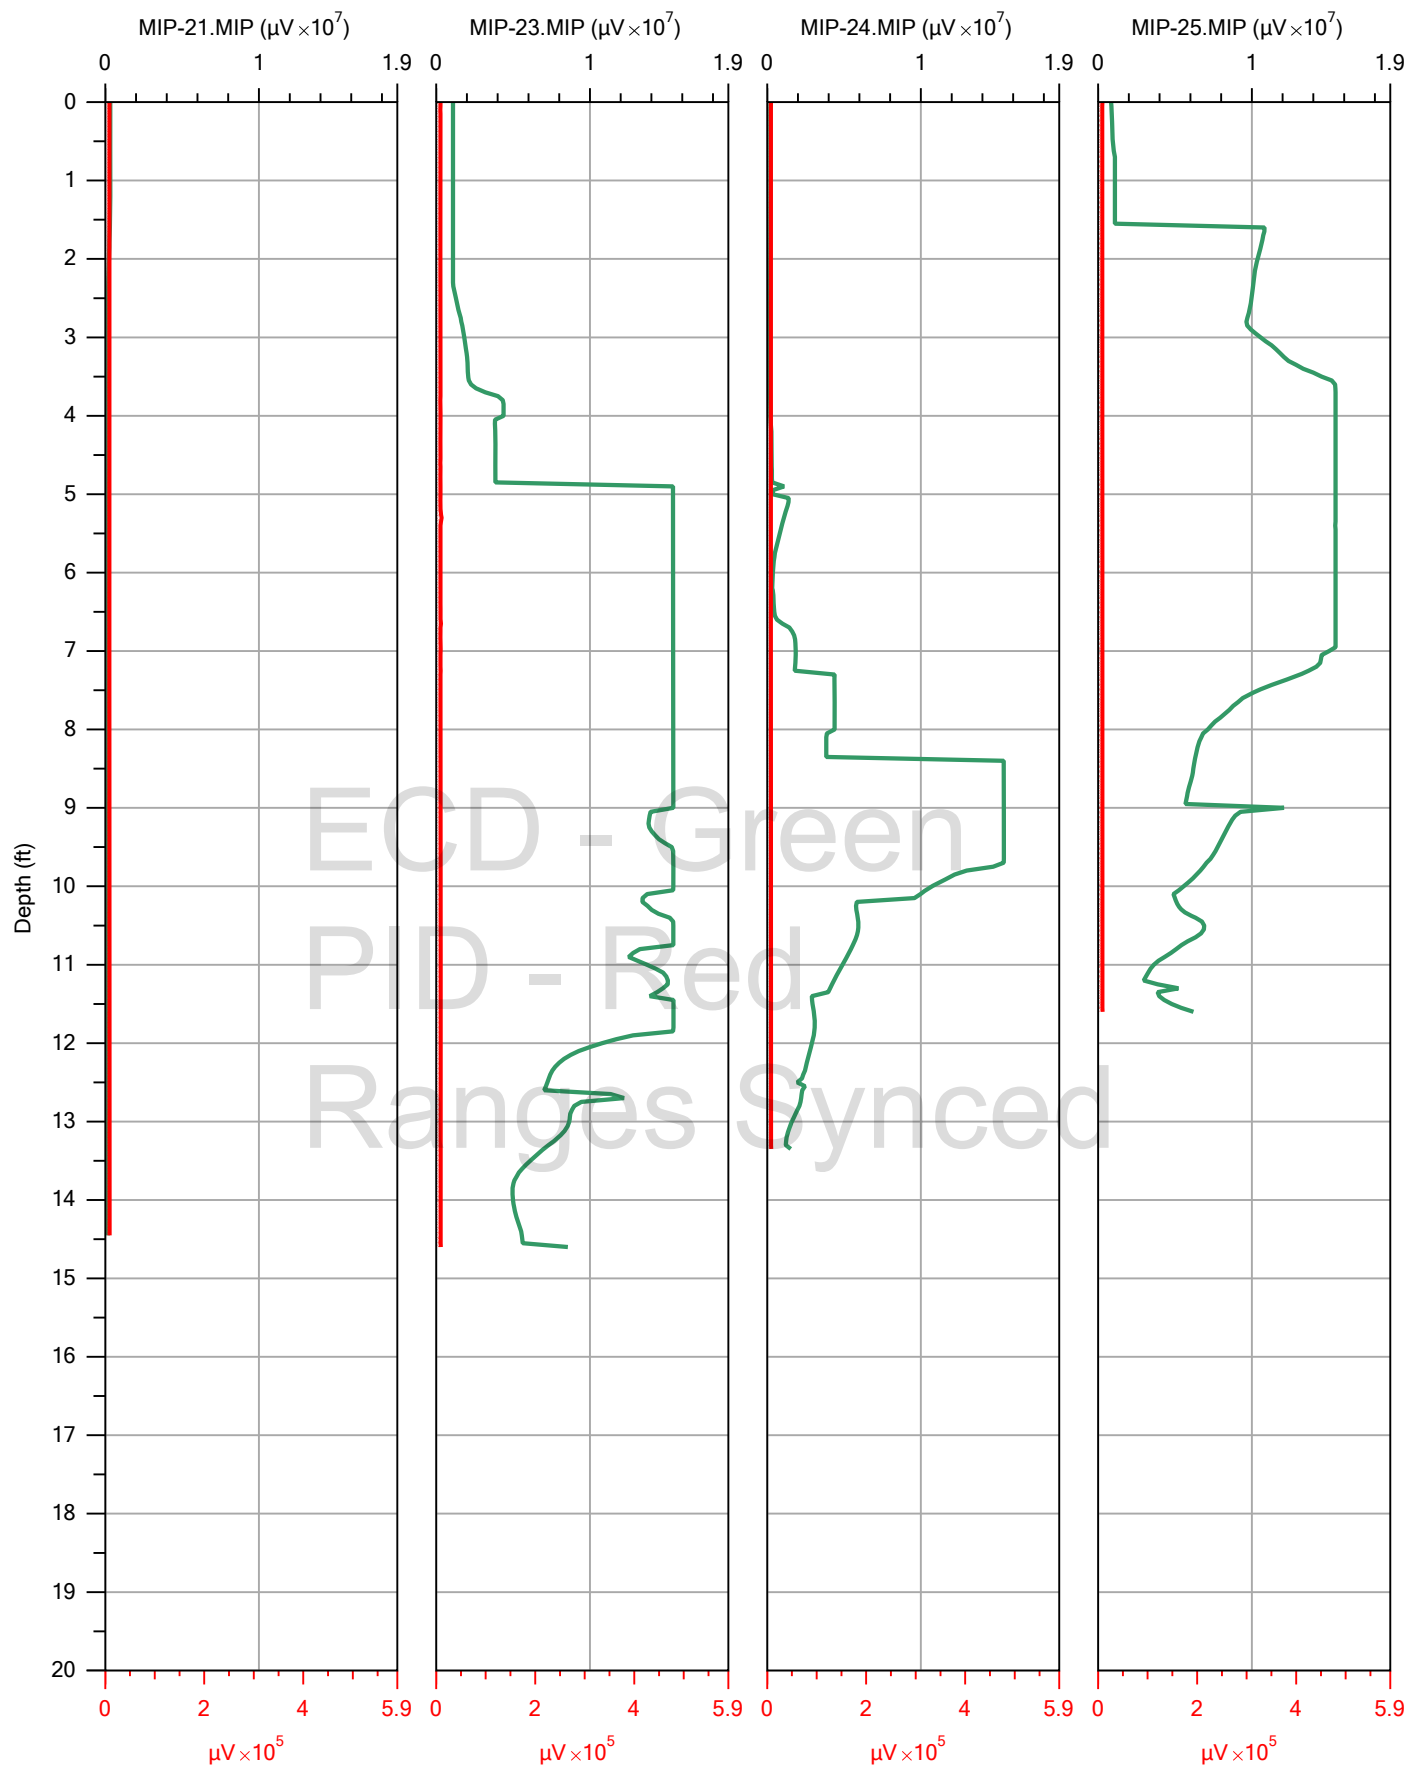
ECD Max / PID Max

Company:	Zebra	Operator:	Zach
Project ID:		Client:	Stantec
		MIP-21.MIP	11/19/2015
		MIP-23.MIP	11/19/2015
		MIP-24.MIP	11/19/2015
		MIP-25.MIP	11/19/2015

To determine whether a step-out location was warranted, the ECD, PID, and FID responses were evaluated. A peak in the ECD plot indicated presence of CVOCs. If a peak was also seen at a similar depth in the PID/FID profiles, the magnitude of VOC impact was considered significant. If no peaks were observed at a given location, the location was assumed to be at or beyond the lateral extent of VOC impacts, thus not warranting additional MIP borings. A total of thirteen step-out MIP locations were investigated beyond the original locations in the work plan. Note that during the MIP program, the final lateral extent of the step-out locations (and delineation of potential impact boundaries) was limited by the areal extent of the preclearance GPR survey and/or the anticipated practicable excavation restrictions.
