CONSTRUCTION COMPLETION REPORT PCB-IMPACTED SOIL REMOVAL AT FORMER LOCKHEED MARTIN CORPORATION FRENCH ROAD FACILITY, UTICA, NEW YORK

Brown and Caldwell Associates

May 2020

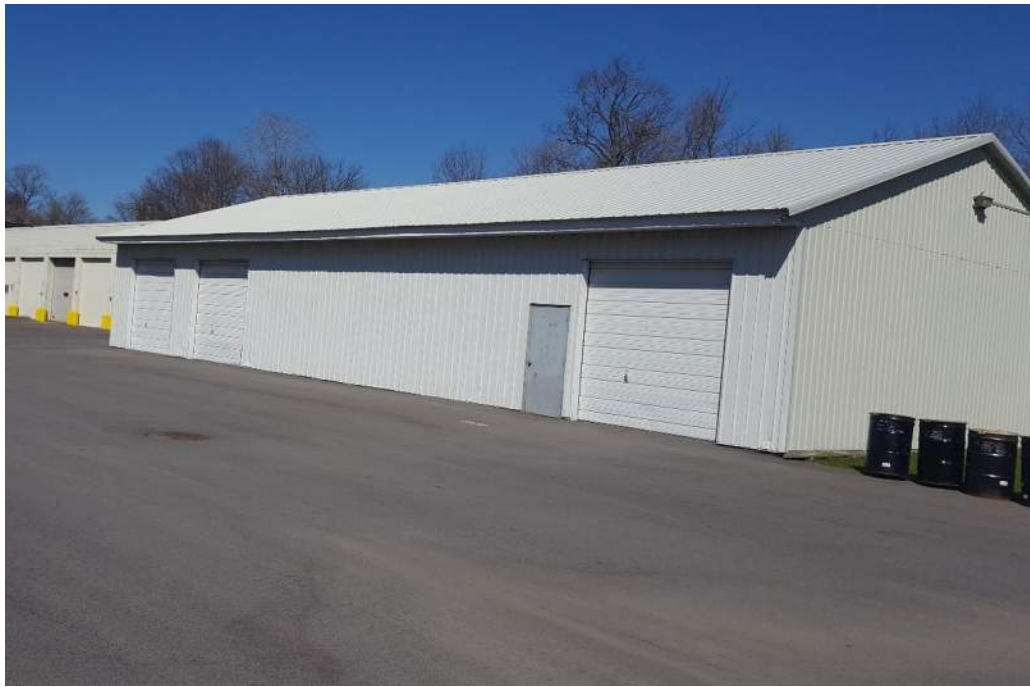
Date: 04/20/2016 Site Name: Former Lockheed Martin Corporation French Road Facility
Photographer's Initials: KT
Description: Photograph #1 facing the south side of the pole barn building.

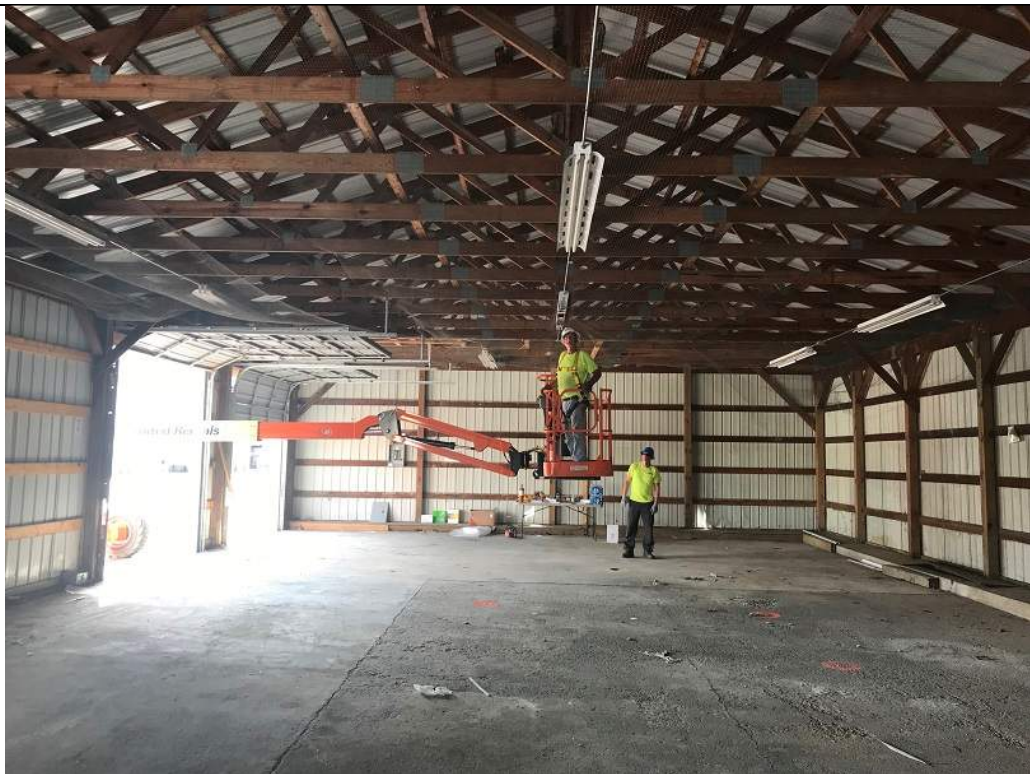
Date: 09/18/2018 Site Name: Former Lockheed Martin Corporation French Road Facility
Photographer's Initials: AG
Description: Photograph #2 from inside the eastern portion of the pole barn building facing west showing removal of internal pole barn fixtures.

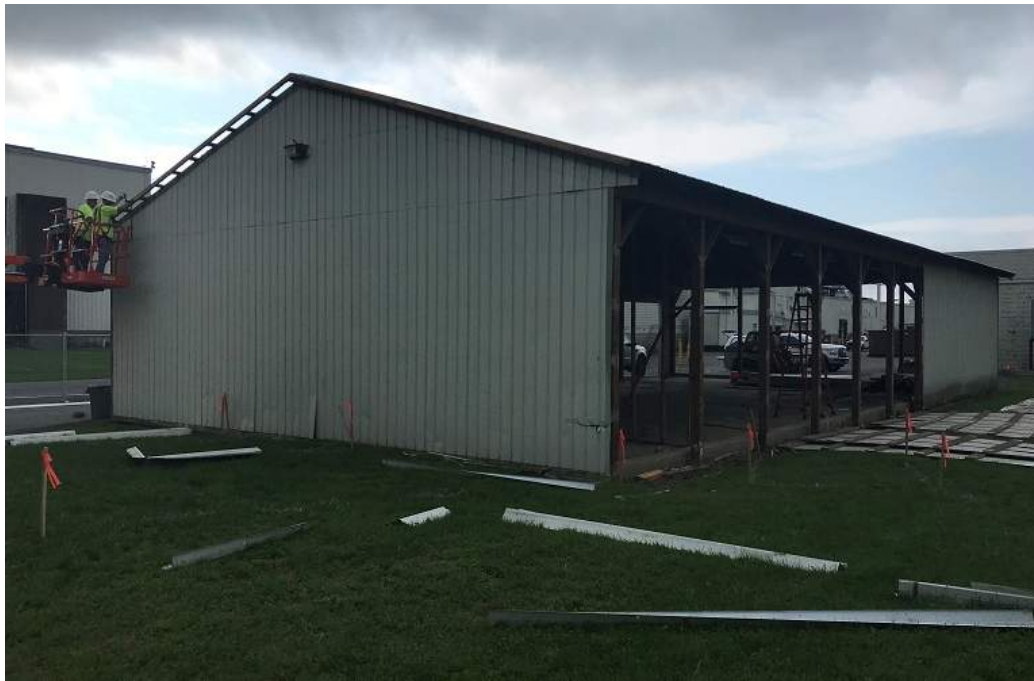
Date: 09/21/2018 Site Name: Former Lockheed Martin Corporation French Road Facility
Photographer's Initials: AG
Description: Photograph #4 from the northeast corner of the pole barn building showing siding removed from the northern side of the building.

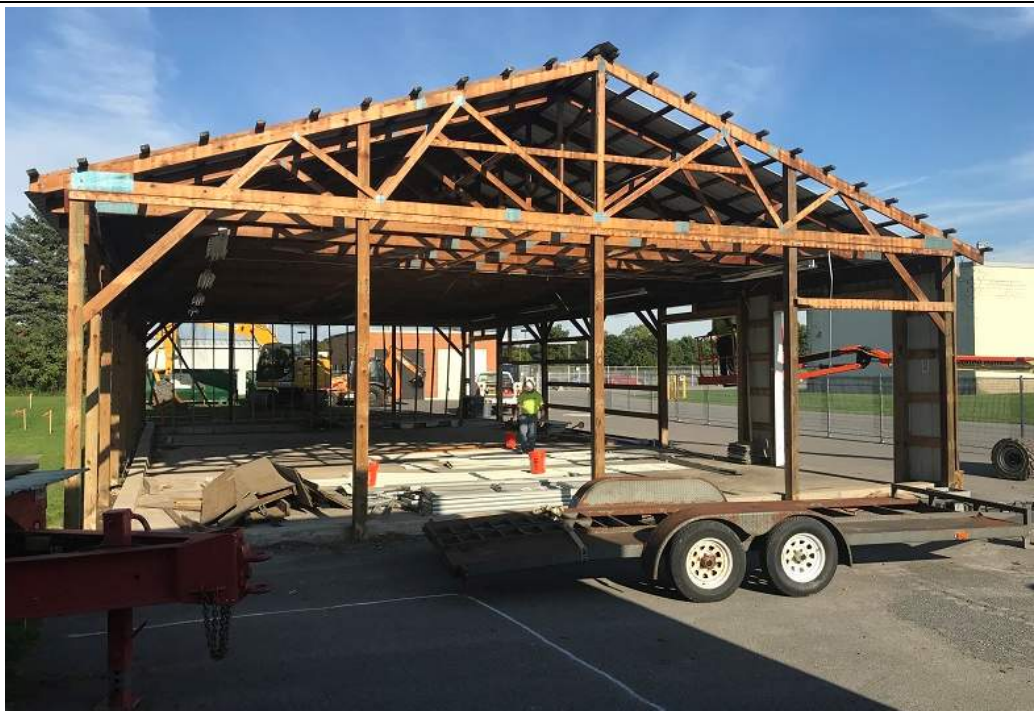
Date: 09/24/2018 Site Name: Former Lockheed Martin Corporation French Road Facility
Photographer's Initials: AG
Description: Photograph #5 from the western side of the pole barn building showing removal of siding from the building.

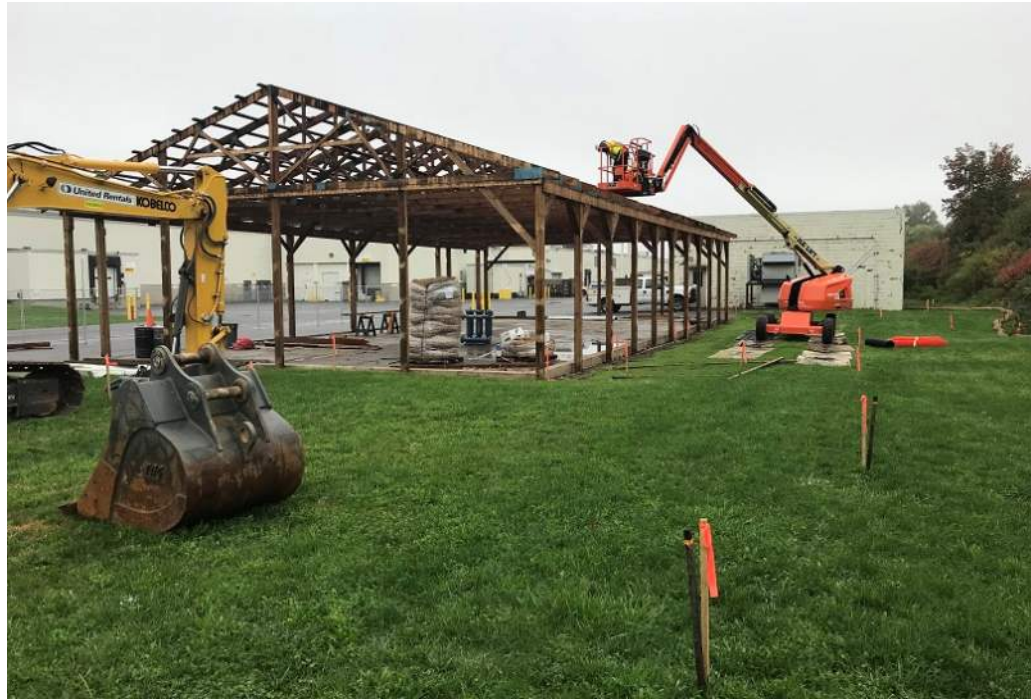
Date: 10/03/2018 Site Name: Former Lockheed Martin Corporation French Road Facility
Photographer's Initials: AG
Description: Photograph #6 from the northwestern side of the pole barn building facing east showing removal of roofing from the building.

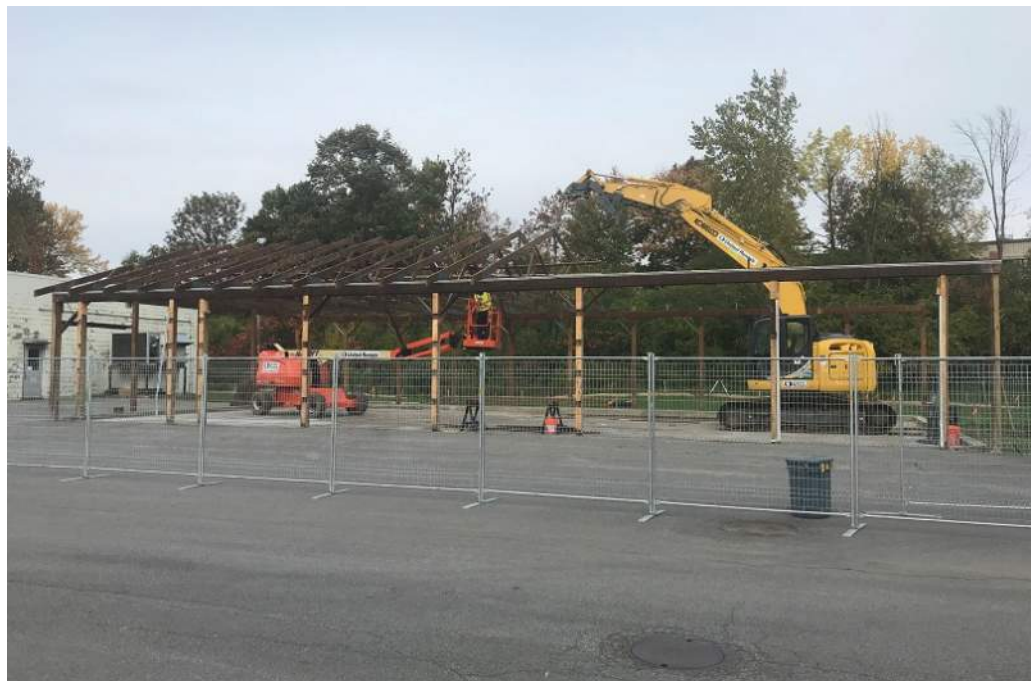
Date: 10/08/2018 Site Name: Former Lockheed Martin Corporation French Road Facility
Photographer's Initials: AG
Description: Photograph #7 from the southern side of the pole barn building facing north showing removal of pole barn roof trusses.

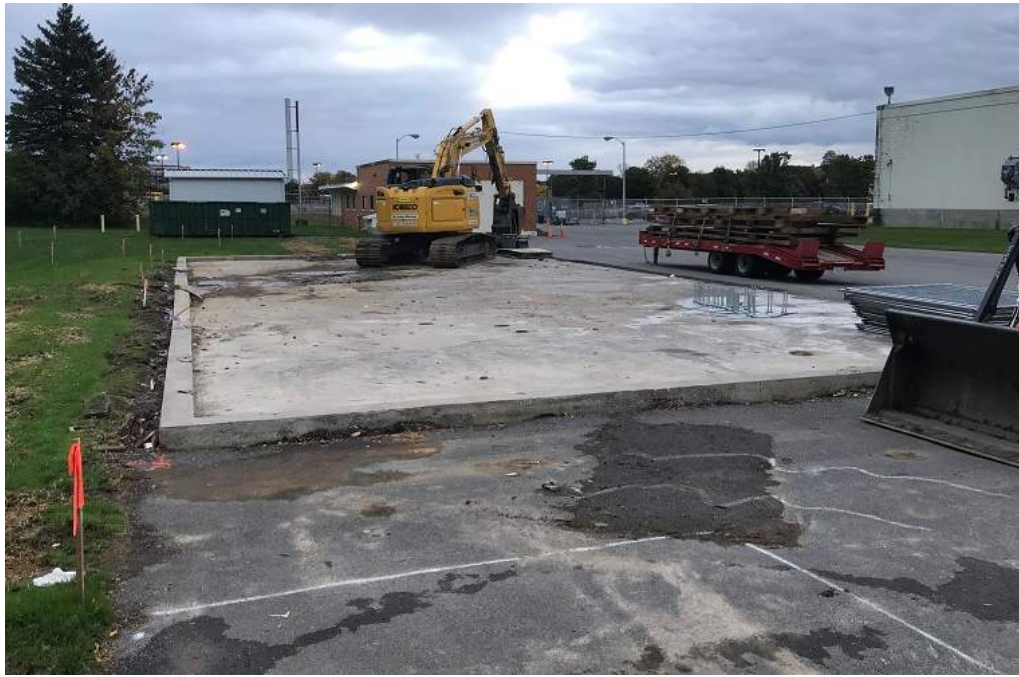
Date: 10/12/2019 Site Name: Former Lockheed Martin Corporation French Road Facility
Photographer's Initials: AG
Description: Photograph #8 from the western side of the former pole barn foundation facing east showing the building superstructure removed and the foundation left in-place.

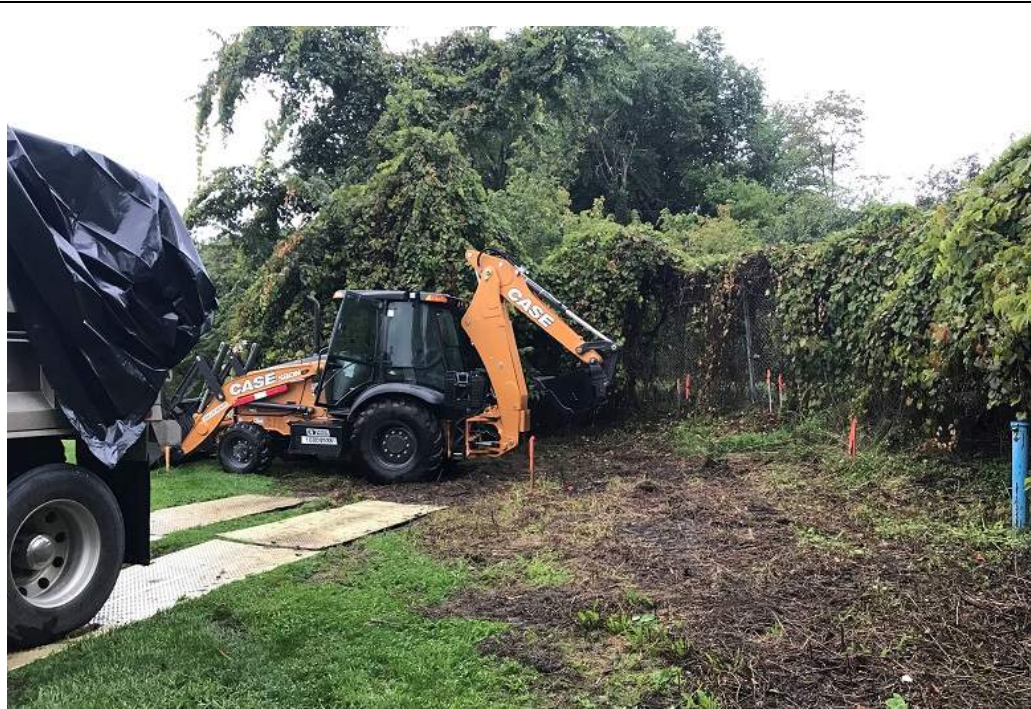
Date: 09/28/2018 Site Name: Former Lockheed Martin Corporation French Road Facility
Photographer's Initials: AG
Description: Photograph #9 from the eastern side of Excavation Area LMCU-SS-21 facing west showing set before soil removal from this area.

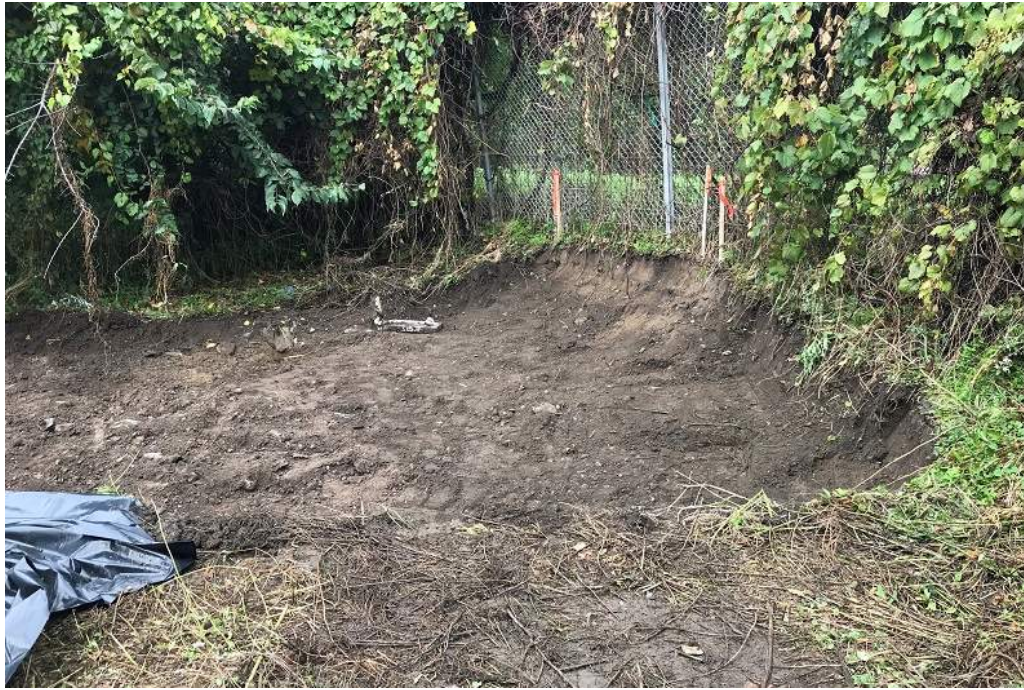
Date: 09/28/2018 Site Name: Former Lockheed Martin Corporation French Road Facility
Photographer's Initials: AG
Description: Photograph 10 from the eastern portion of Excavation Area LMCU-SS-21 facing west showing soil removed to target depth from the northern portion of this area.

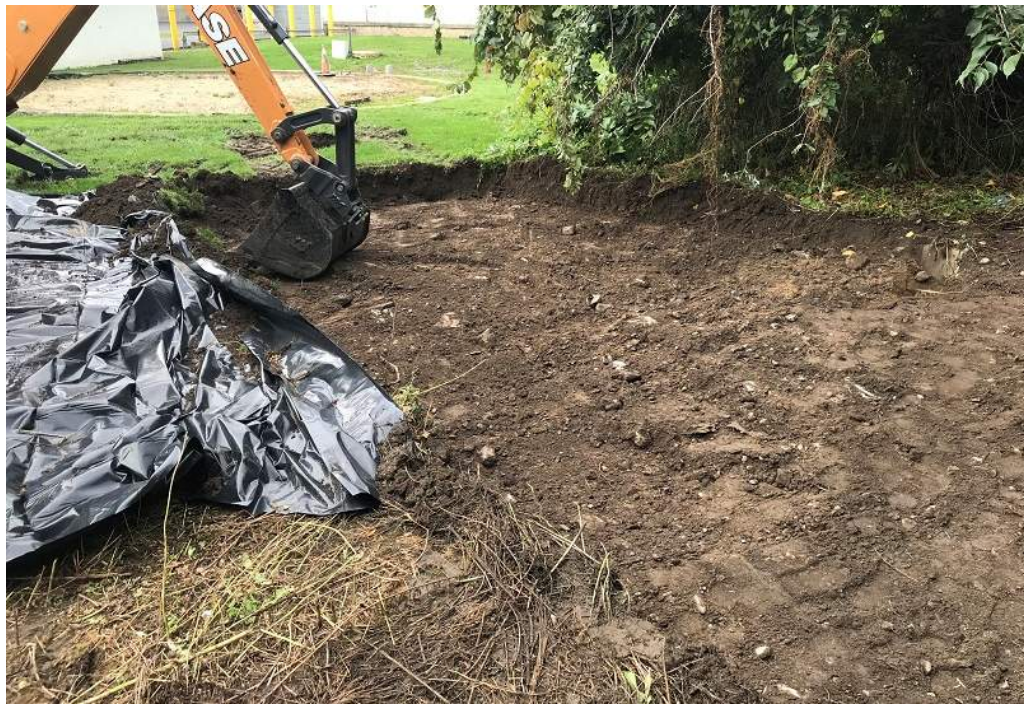
Date: 09/28/2018 Site Name: Former Lockheed Martin Corporation French Road Facility
Photographer's Initials: AG
Description: Photograph #11 from the eastern portion of Excavation Area LMCU-SS-21 facing south showing soil removed to target depth from the northern portion of this area.

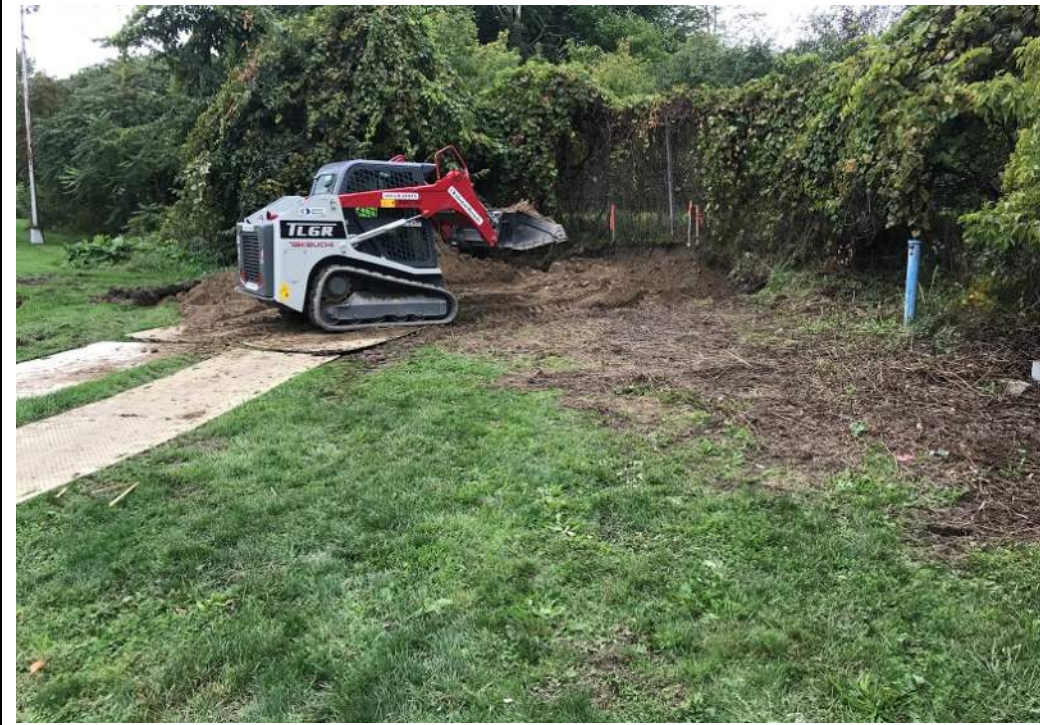
Date: 09/28/2018 Site Name: Former Lockheed Martin Corporation French Road Facility
Photographer's Initials: AG
Description: Photograph #12 from the eastern portion of Excavation Area LMCU-SS-21 facing west showing placement of backfill in this area.

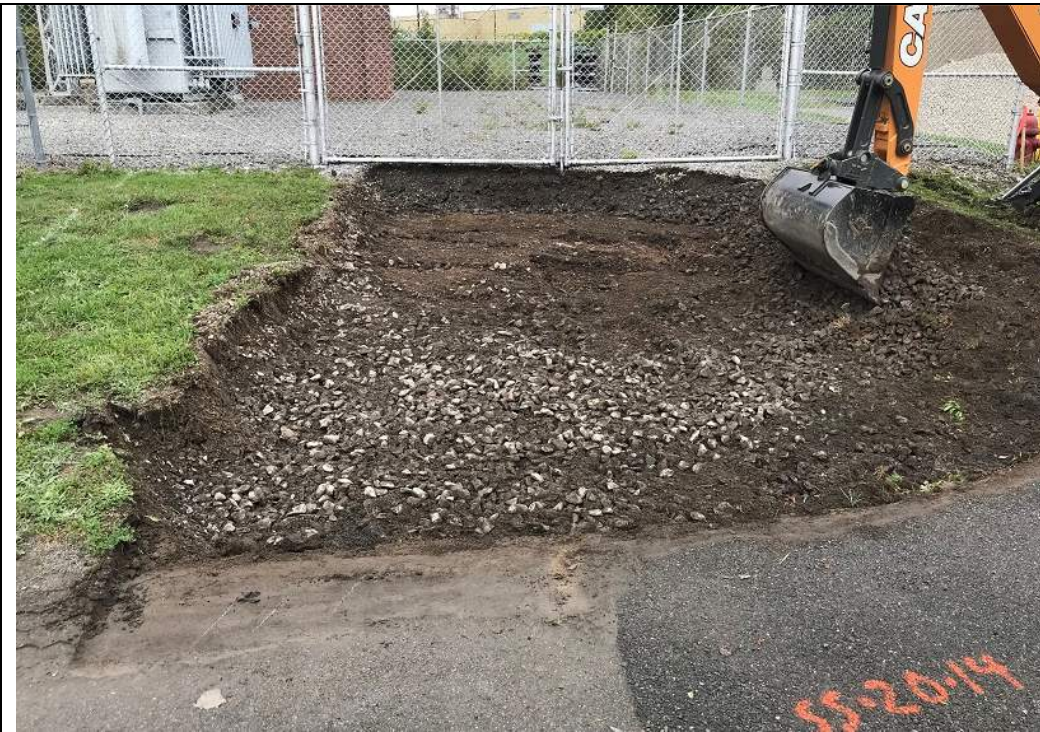
Date: 09/28/2018 Site Name: Former Lockheed Martin Corporation French Road Facility
Photographer's Initials: AG
Description: Photograph #13 from the southern portion of Excavation Area LMCU-SS-20 facing north showing soil removed to target depth in the western portion of this area.

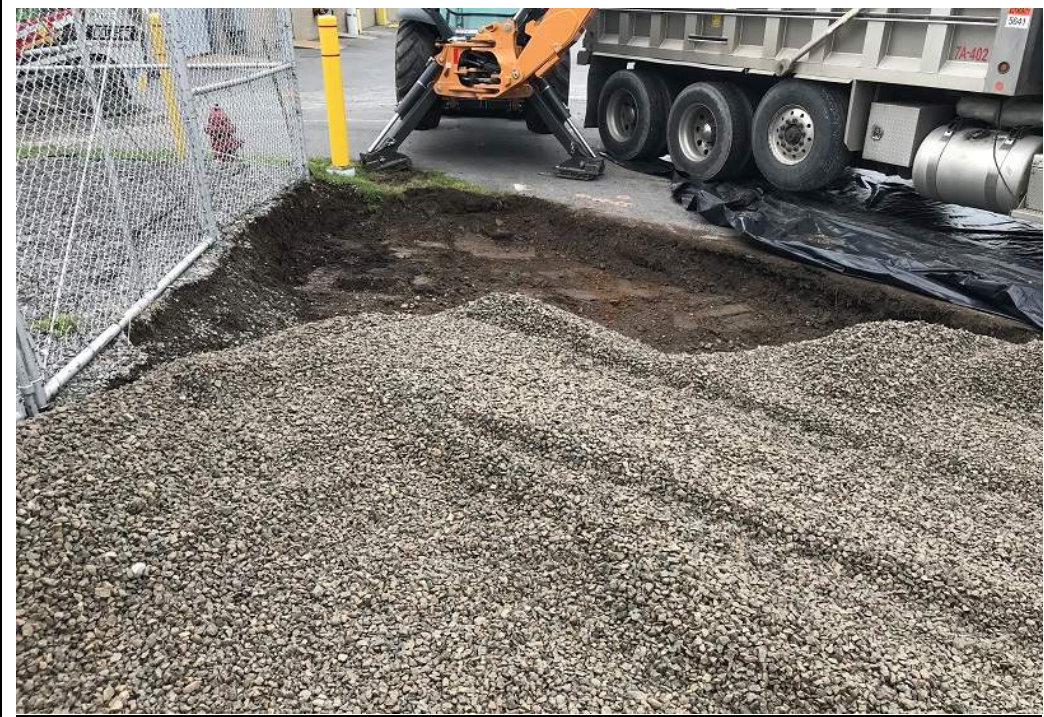
Date: 09/28/2018 Site Name: Former Lockheed Martin Corporation French Road Facility
Photographer's Initials: AG
Description: Photograph #14 from the central portion of Excavation Area LMCU-SS-20 facing east showing crushed stone backfill placed in the western and central portions of this area (foreground) and soil removed to target depth in the eastern portion of this area (background).

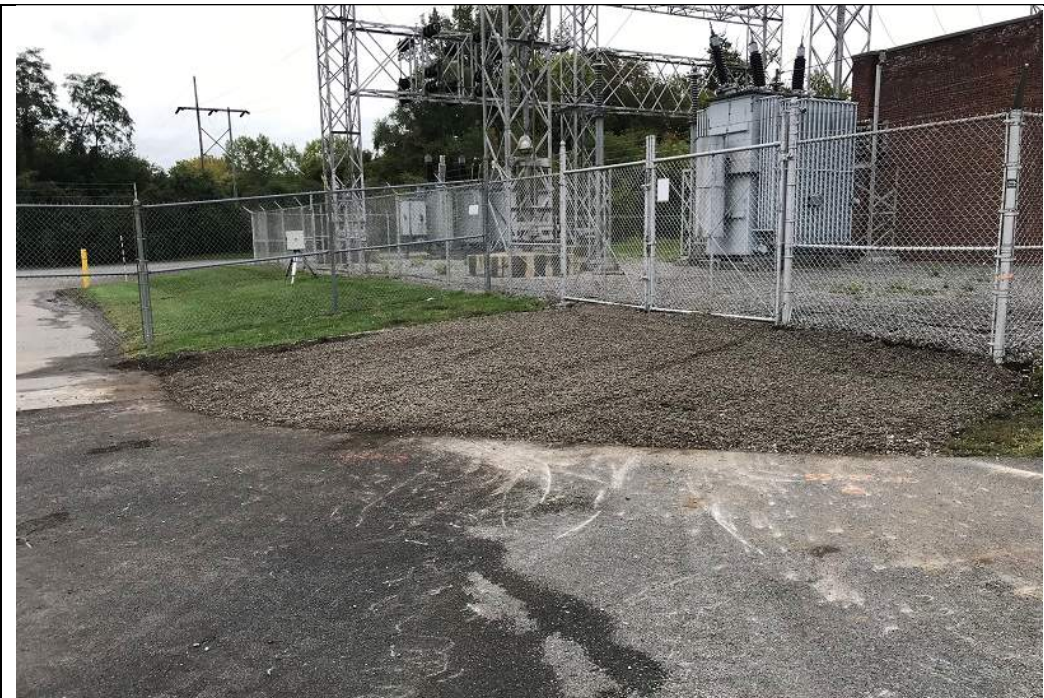
Date: 09/28/2018 Site Name: Former Lockheed Martin Corporation French Road Facility
Photographer's Initials: AG
Description: Photograph #15 from the southeastern portion of Excavation Area LMCU-SS-20 facing northwest showing this area backfill and restored with crushed stone..

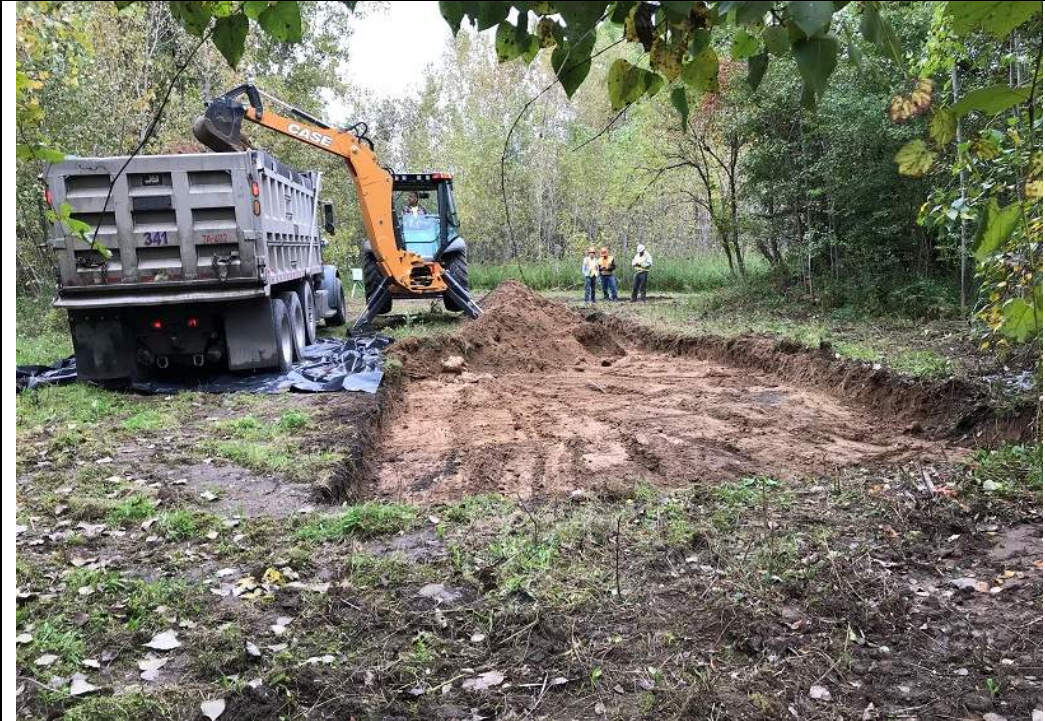
Date: 10/01/2018 Site Name: Former Lockheed Martin Corporation French Road Facility
Photographer's Initials: AG
Description: Photograph #16 from the southern portion of Excavation Area LMCU-SS-07 facing north showing soil removed to target depth in the southern portion of this area.

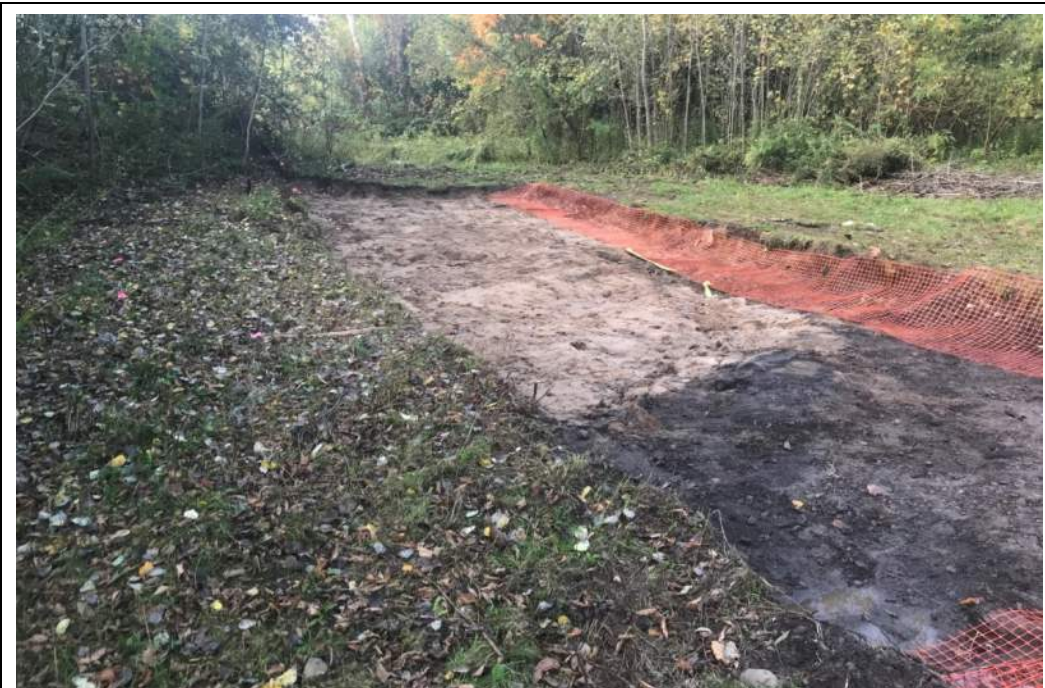
Date: 10/10/2018 Site Name: Former Lockheed Martin Corporation French Road Facility
Photographer's Initials: AG
Description: Photograph #17 from the northeastern portion of Excavation Area LMCU-SS-07 facing south showing soil removed from the southern portion of this area to target depth. Photograph also shows orange snow fence placed on the western sidewall of this area.

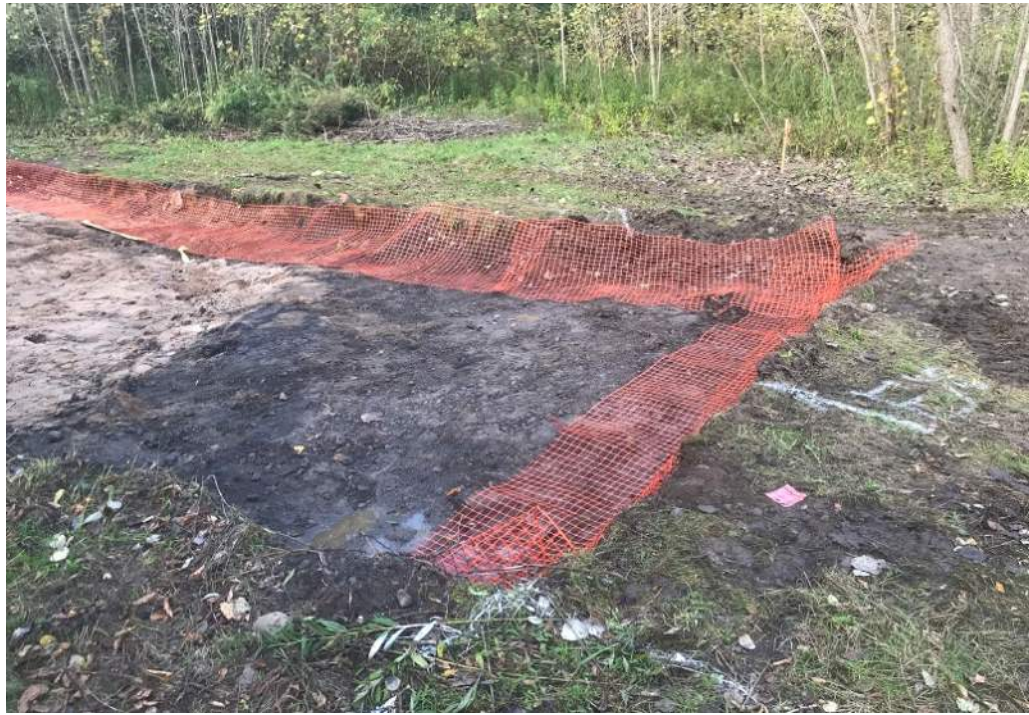
Date: 10/10/2018 Site Name: Former Lockheed Martin Corporation French Road Facility
Photographer's Initials: AG
Description: Photograph #18 from the northeastern portion of Excavation Area LMCU-SS-07 facing west showing soil removed from the northern portion of this area to target depth. Photograph also shows orange snow fence placed on the northern and western sidewalls of this area.

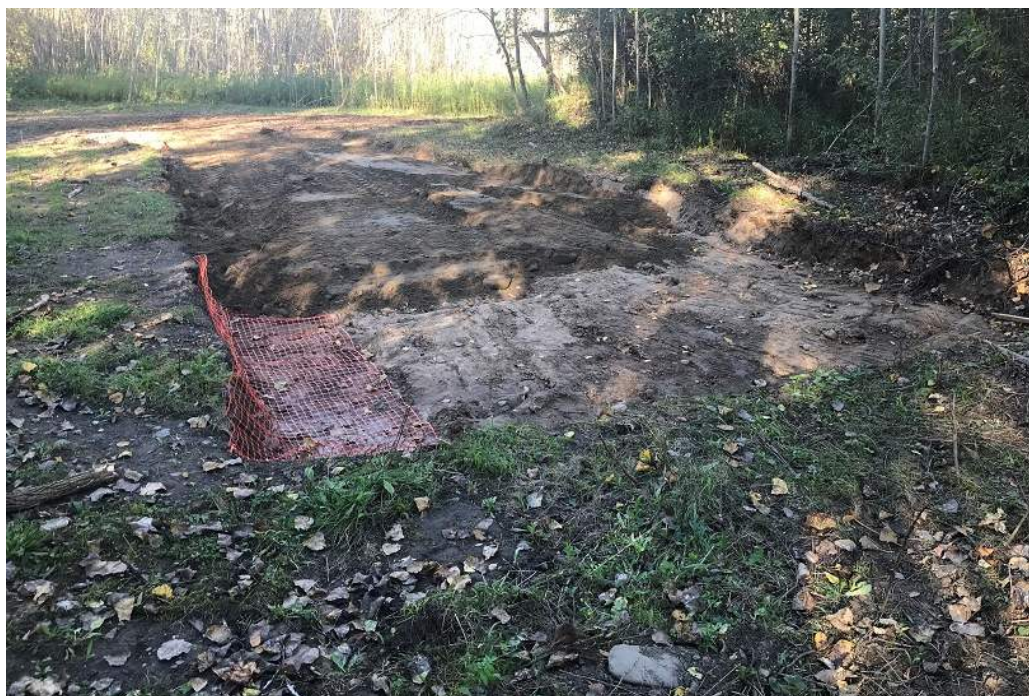
Date: 10/10/2019 Site Name: Former Lockheed Martin Corporation French Road Facility
Photographer's Initials: AG
Description: Photograph #19 from the southern portion of Excavation Area LMCU-SS-07 facing north showing backfill placed in this area.

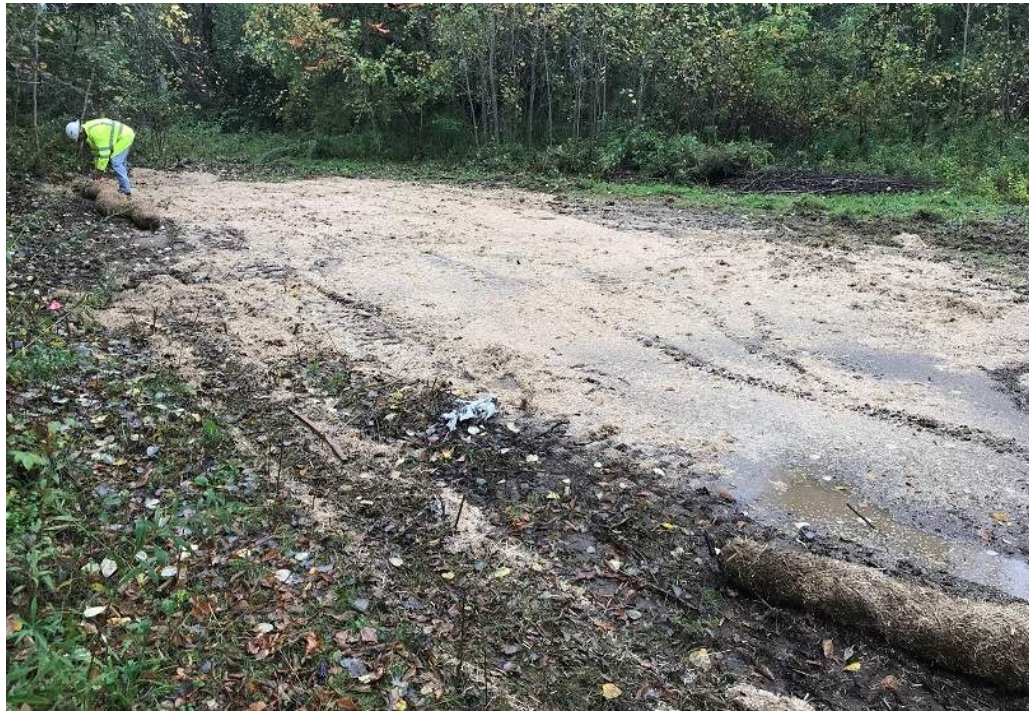
Date: 10/11/2018 Site Name: Former Lockheed Martin Corporation French Road Facility
Photographer's Initials: AG
Description: Photograph #20 from the northeastern portion of Excavation Area LMCU-SS-07 facing south showing seed and straw being spread at this location.

Areas which were disturbed by RAWP implementation activities including areas outside of soil removal areas were restored to prior conditions. Areas around LMCU-SS-07 and LMCU-SS-21 were seeded and covered with straw. Areas where equipment had impacted grassed areas on-site were also seeded and covered with straw. The area around LMCU-SS-20, which is located in an access ramp to the transformer station, was restored with stone.

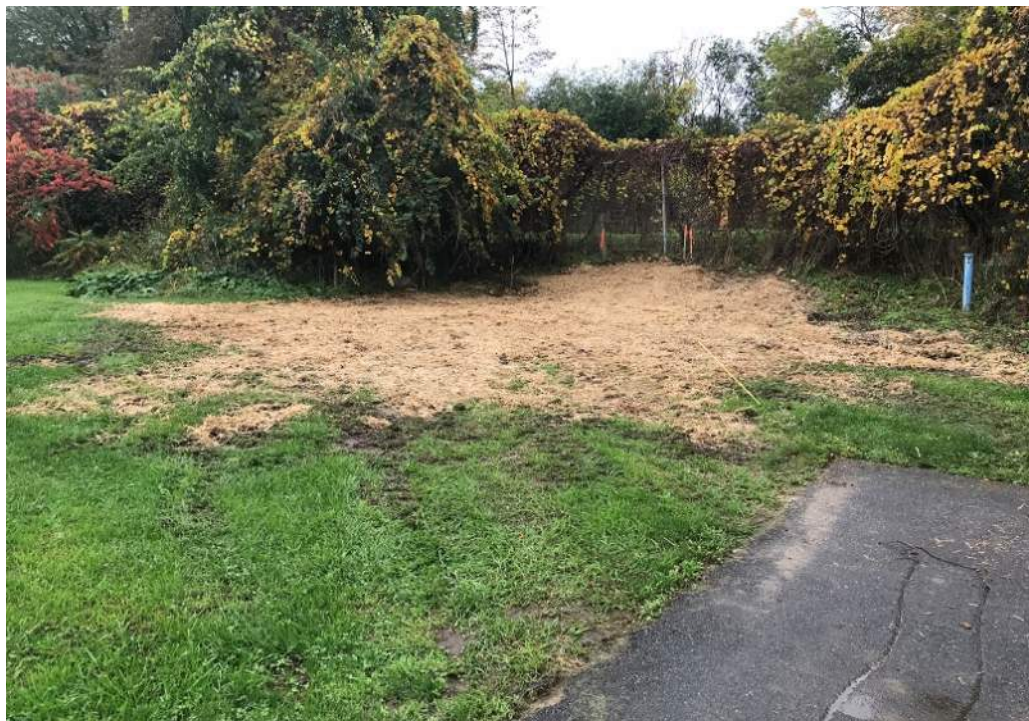
Date: 10/11/2018 Site Name: Former Lockheed Martin Corporation French Road Facility
Photographer's Initials: AG
Description: Photograph #21 from the southern portion of Excavation Area LMCU-SS-20 facing north showing seed and straw spread at this location.

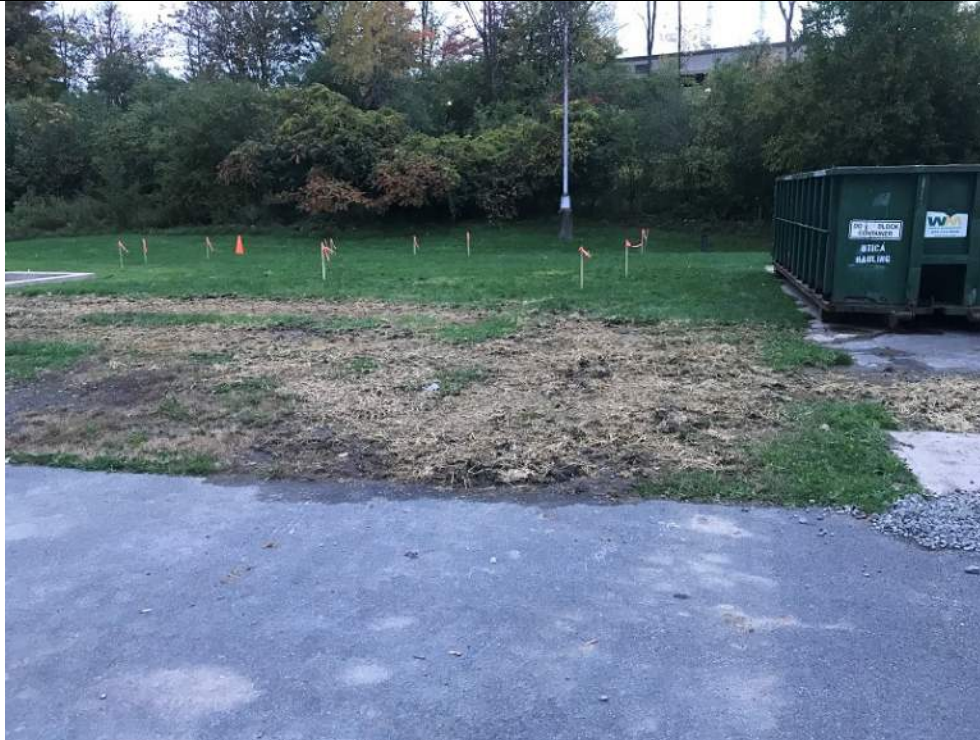
Date: 10/12/2018 Site Name: Former Lockheed Martin Corporation French Road Facility
Photographer's Initials: AG
Description: Photograph #22 from the from the southeastern side of the former pole barn building facing north showing seed and straw spread at this location.

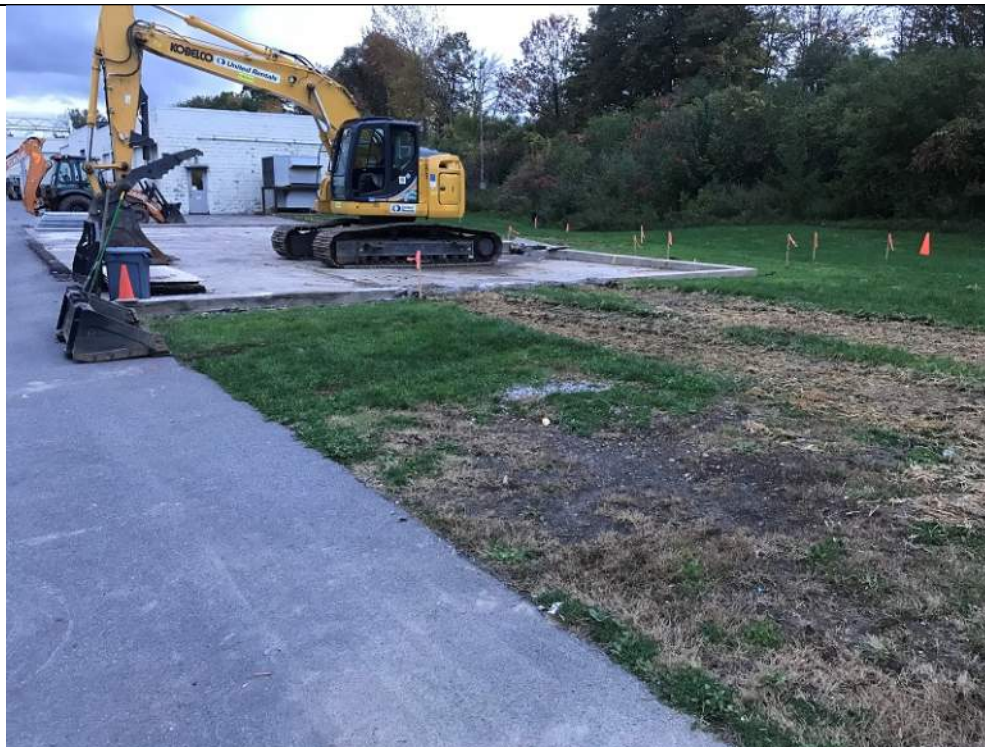
Date: 10/11/2018 Site Name: Former Lockheed Martin Corporation French Road Facility
Photographer's Initials: AG
Description: Photograph #21 from the eastern side of the former pole barn building facing northwest showing seed and straw spread at this location.
