Subject:
2016 Groundwater Sampling & Soil Cover Inspection Report
Waterville Former MGP Site
Waterville, New York

On behalf of NYSEG, Arcadis is pleased to present this annual report summarizing the results of groundwater sampling and soil cover inspection activities conducted in 2016 at the Waterville manufactured gas plant (MGP) site. Relevant background information is provided below, followed by a discussion of the 2016 results and recommendations for the site.

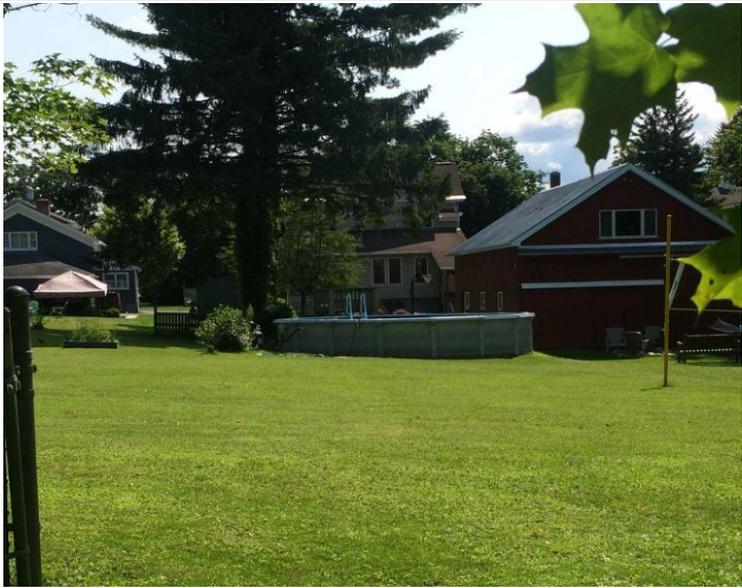
CLIENT: NYSEG	SITE NAME: Waterville Former MGP Site
PROJECT#: B0013053.0001	SITE LOCATION: Waterville, New York
PHOTOGRAPH #: 1

On July 20, 2016, Arcadis also performed the annual reconnaissance of the soil cover portion of the site, as required by the site's ROD. Unlike previous years, the area of soft wet soil typically observed in the southwest corner of the property, near the fence corner and just north of the MW98-7S/7D, was not present (Photo #1). This was likely due to the unusually dry summer in 2016. As reported in previous inspection reports, the above-ground pool installed at the 139 Babbott Avenue property, and raised-bed vegetable garden at 145 Babbott Avenue were still present during the 2016 inspection event (Photo #2). The pool appears to be located within the soil cover area and approximately 0.5 feet to 1.5 feet of material appears to have been excavated to facilitate the installation. No additional disturbances to the soil cover area were observed during the 2016 inspection.

PHOTOGRAPHER: LT	
DATE: 07/20/16	
DIRECTION: E	
COMMENT: Raised bed garden and above ground swimming pool behind 139 and 145 Babbott Avenue.

Aside from the disturbances caused by the installation of the above-ground pool and raised garden, the soil cover appeared to be in good condition with no obvious damage.
