Subject:
2017 Groundwater Sampling & Soil Cover Inspection Report
Waterville Former MGP Site
Waterville, New York

NYSEG WATERVILLE MGP SITE WATERVILLE, NEW YORK	
SITE MAP	
Design & Consultancy for natural and built assets	FIGURE 1

SOIL COVER INSPECTION PHOTOGRAPH LOG

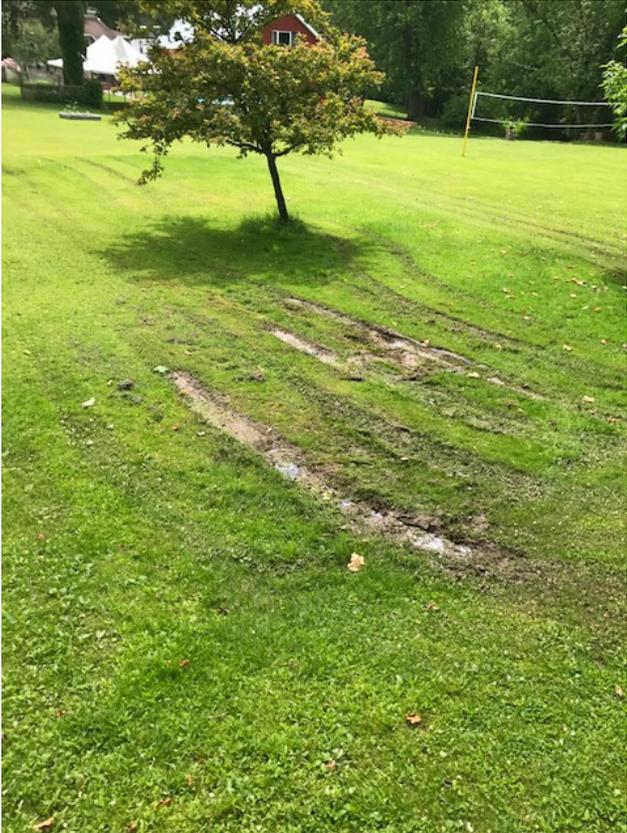
CLIENT: NYSEG	SITE NAME: Waterville Former MGP Site
PROJECT#: B0013053.0005	SITE LOCATION: Waterville, New York
PHOTOGRAPH #: 1

Aside from the disturbances caused by the installation of the above-ground pool and raised garden in 2014, and the shallow tire ruts near the MW98-7 well pair, the soil cover appeared to be in good condition with no obvious damage.

PHOTOGRAPHER: LGT	
DATE: 06/15/17	
DIRECTION: E-SE	
COMMENT: Location where soft wet soil and tire ruts were observed.

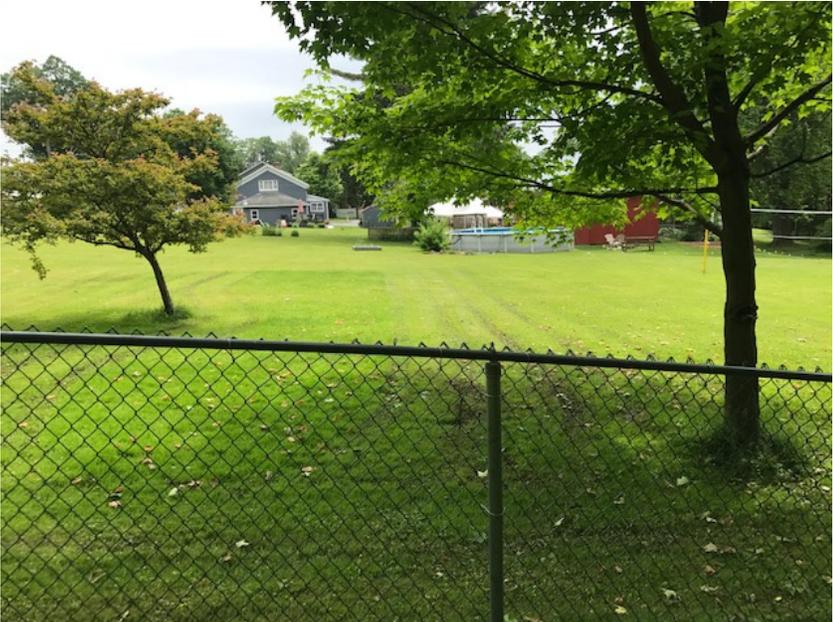
CLIENT: NYSEG	SITE NAME: Waterville Former MGP Site
PROJECT#: B0013053.0001	SITE LOCATION: Waterville, New York
PHOTOGRAPH #: 2

On June 15, 2017, Arcadis also performed the annual reconnaissance of the soil cover portion of the site, as required by the site's ROD. Findings of the reconnaissance were generally consistent with those found during previous years. Please refer to the attached photographic log for pictures of relevant features of the soil cover. As observed in the past, soft wet soil was observed in the southwest corner of the property, near the fence corner and just north of the MW98-7S/7D well pair. Tire ruts from apparent lawn mowing were present in the soft soil area (Photo #1). The ruts appeared to be shallow with no obvious damage to the cover. As reported in the 2014 inspection report, the above-ground pool installed at the 139 Babbott Avenue property and raised-bed vegetable garden at 145 Babbott Avenue are still present (Photo #2). No additional disturbances were observed during the 2017 inspection.

PHOTOGRAPHER: LGT	
DATE: 06/15/17	
DIRECTION: E	
COMMENT: Raised bed garden and above ground swimming pool behind 139 and 145 Babbott Avenue.
