Subject:
2018 Groundwater Sampling & Soil Cover Inspection Report
Waterville Former MGP Site
Waterville, New York

On behalf of NYSEG, Arcadis is pleased to present this annual report summarizing the results of groundwater sampling and soil cover inspection activities conducted in 2018 at the Waterville manufactured gas plant (MGP) site. Relevant background information is provided below, followed by a discussion of the 2018 results and recommendations for the site.

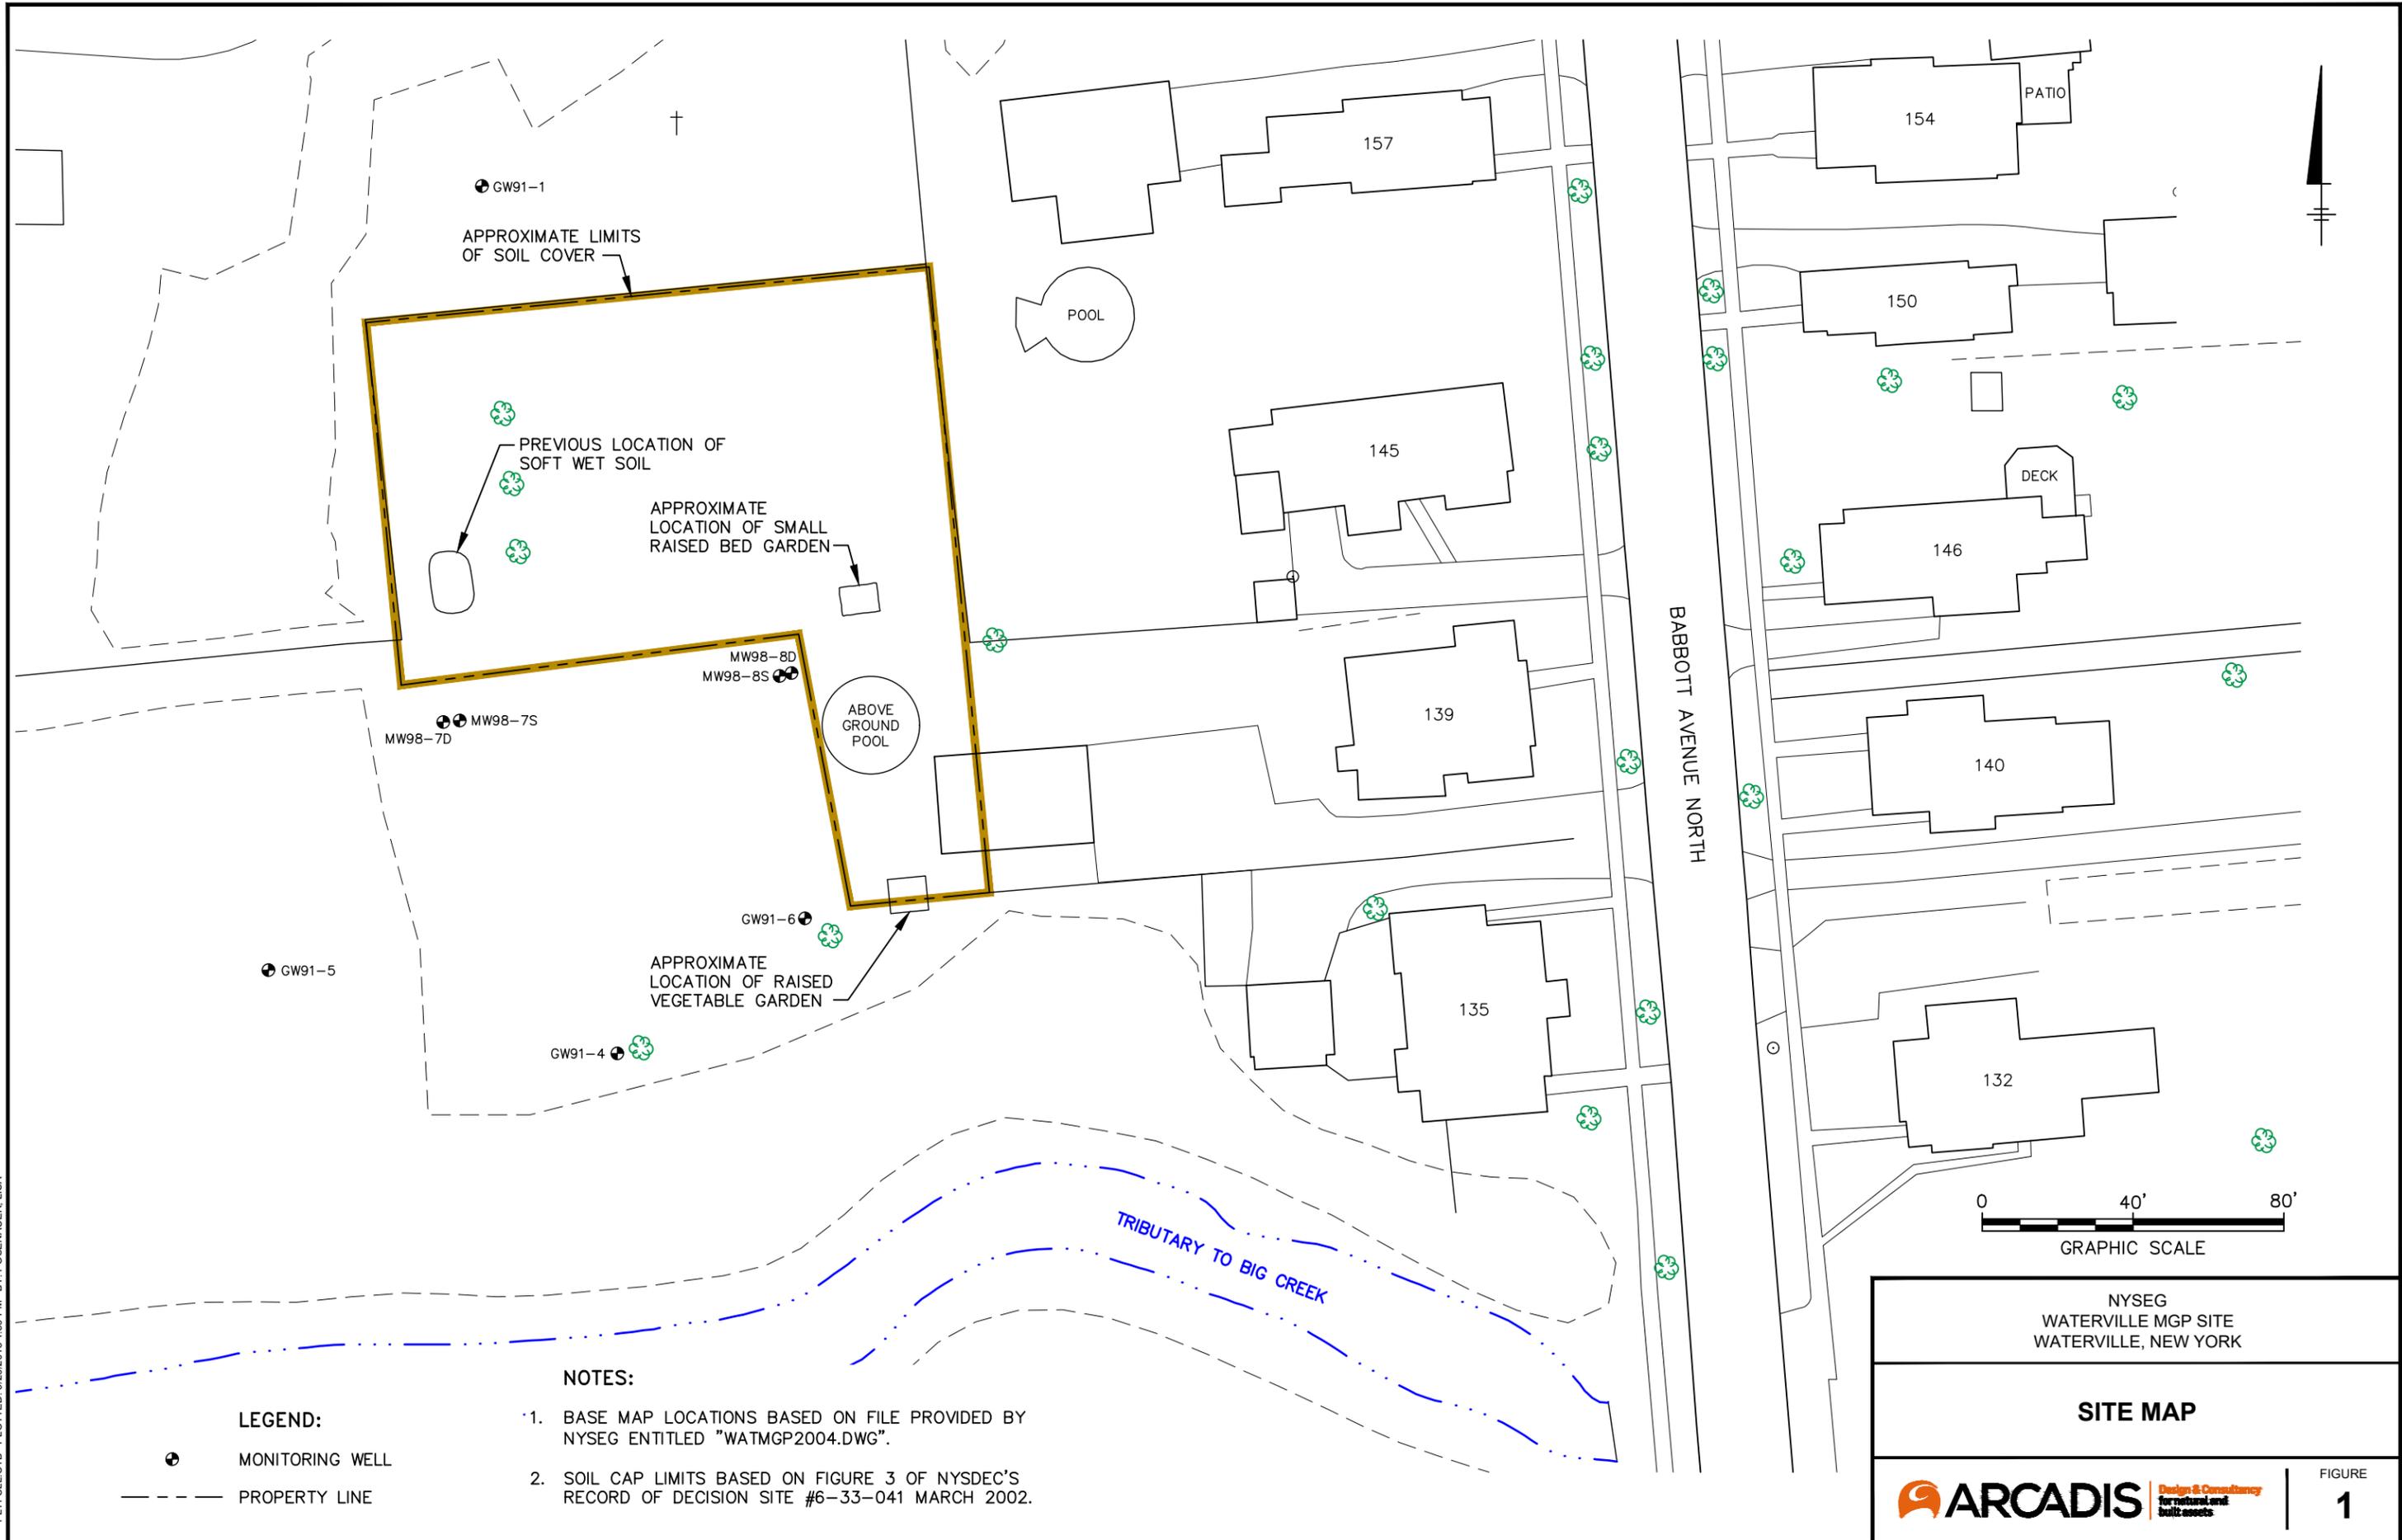
NYSEG WATERVILLE MGP SITE WATERVILLE, NEW YORK	
SITE MAP	
ARCADIS Design & Consultancy for natural and built assets 	FIGURE 1

Arcadis sampled groundwater from monitoring well MW98-7D on June 26, 2018. The location of the well and other pertinent site features can be found on Figure 1. Consistent with the sampling events completed since 2004, the sampling from

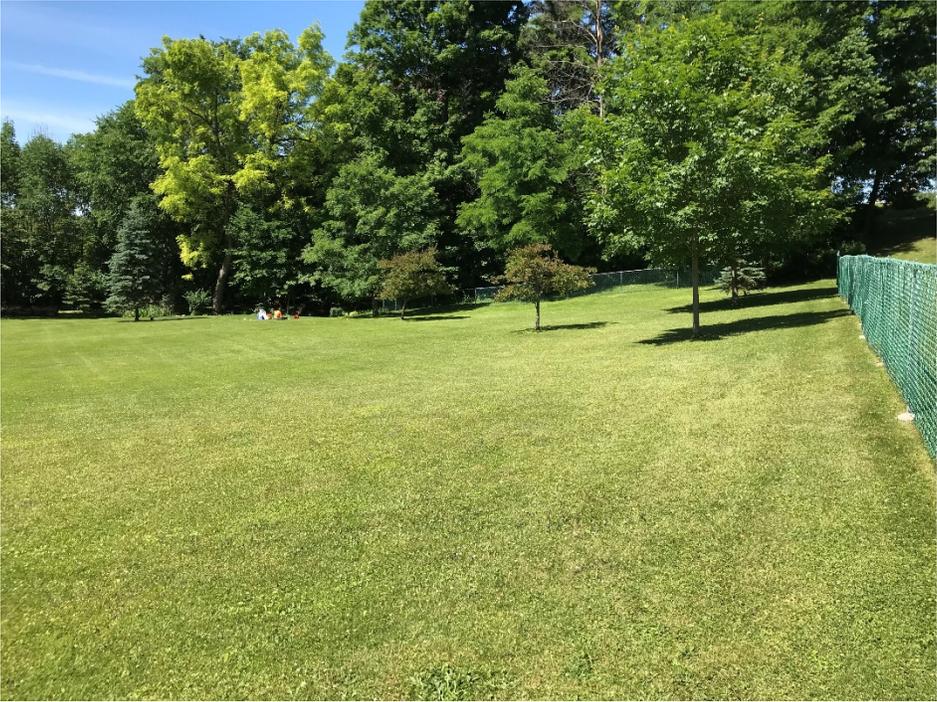
CLIENT: NYSEG	SITE NAME: Waterville Former MGP Site
PROJECT#: B0013053.0006	SITE LOCATION: Waterville, New York
PHOTOGRAPH #: 3

installed at the 139 Babbott Avenue property and small raised-bed vegetable garden at 145 Babbott Avenue are still present (Photo #2). No additional disturbances were observed during the 2018 inspection and the soil cover appeared in good condition (Photos #3 &4).

PHOTOGRAPHER: LGT	
DATE: 06/26/18	
DIRECTION: West	
COMMENT: View of the soil cover looking west along the cemetery fence line behind 145 Babbott Avenue.

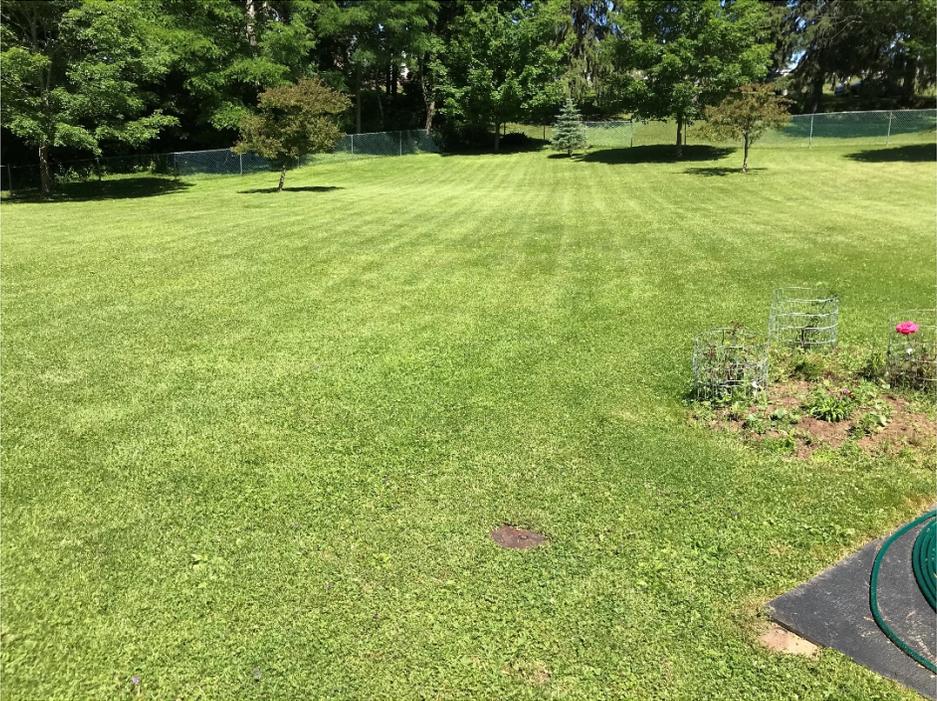
CLIENT: NYSEG	SITE NAME: Waterville Former MGP Site
PROJECT#: B0013053.0006	SITE LOCATION: Waterville, New York
PHOTOGRAPH #: 4

PHOTOGRAPHER: LGT	
DATE: 06/26/18	
DIRECTION: Northwest	
COMMENT: View of the soil cover looking northwest from behind 139 Babbott Avenue.
