Subject:
2020 Groundwater Sampling & Soil Cover Inspection Report
Waterville Former MGP Site
Waterville, New York

On behalf of NYSEG, Arcadis of New York, Inc. (Arcadis) is pleased to present this annual report summarizing the results of groundwater sampling and soil cover inspection activities conducted in 2020 at the Waterville manufactured gas plant (MGP) site. Relevant background information is provided below, followed by a discussion of the 2020 results and recommendations for the site.

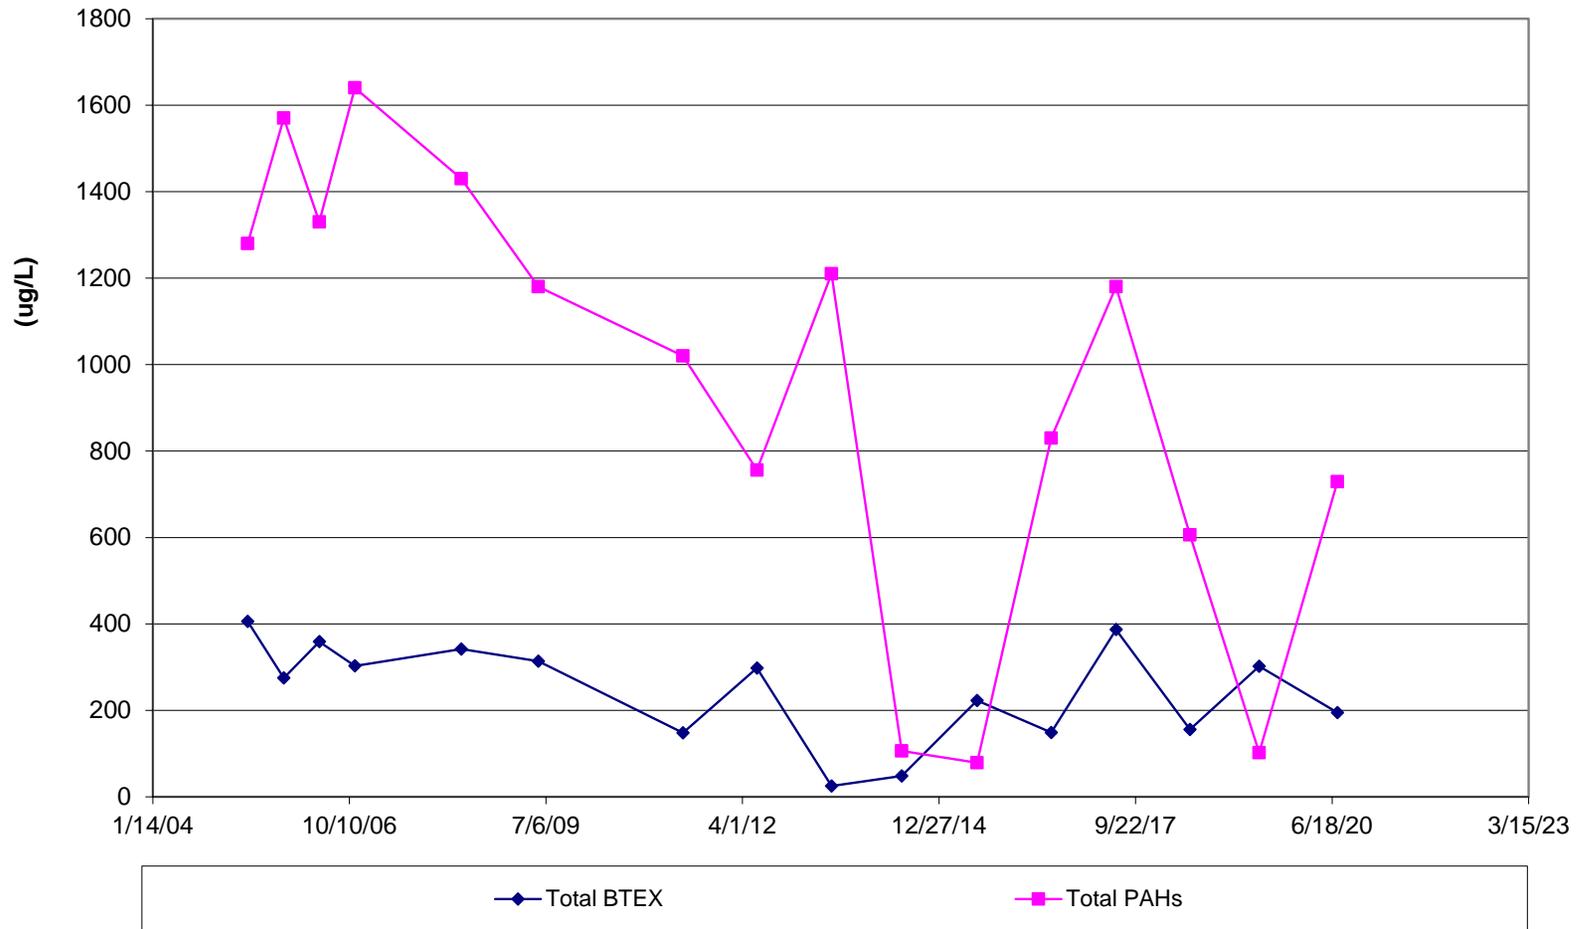
**TOTAL BTEX & PAH CONCENTRATION OVER TIME
MONITORING WELL - MW98-7D**

Historical analytical results for MW98-7D are summarized in Table 1 in comparison to NYSDEC Class GA Standards and Guidance Values¹. Consistent with previous sampling events, groundwater sampled from MW98-7D exceeded the NYSDEC Class GA Standards for all of the BTEX compounds. Also consistent with previous events, several PAHs continue to be detected in the sample collected from well MW98-7D. While trace amounts of individual PAHs continue to be detected, only acenaphthene and naphthalene were detected at concentrations above the NYSDEC Class GA Guidance Value for these compounds. The levels for both BTEX and PAHs were within the range of concentrations detected during the previous sampling rounds. As shown on the time-series graph provided in Attachment 2, there is no discernable trend in dissolved-phase BTEX concentrations at MW98-7D since sampling began in 2004; however, there does appear to be an overall slow downward trend in the concentration of dissolved phase PAHs.

The 2020 PAH analytical results for the groundwater sample collected from MW98-7D are higher than the 2019 results but are within the range of concentrations historically detected at this well. Only acenaphthene and naphthalene were found to exceed Class GA Guidance Values for these compounds. BTEX concentrations decreased slightly in 2020 compared to analytical results from 2019, but remained within the range of historical BTEX concentrations observed in groundwater from this well. Consistent with previous years, BTEX concentrations exceeded Class GA Standards for each respective compound. Analytical data from the 2021 BTEX and PAH results will be evaluated to determine if any concentration trends become apparent.

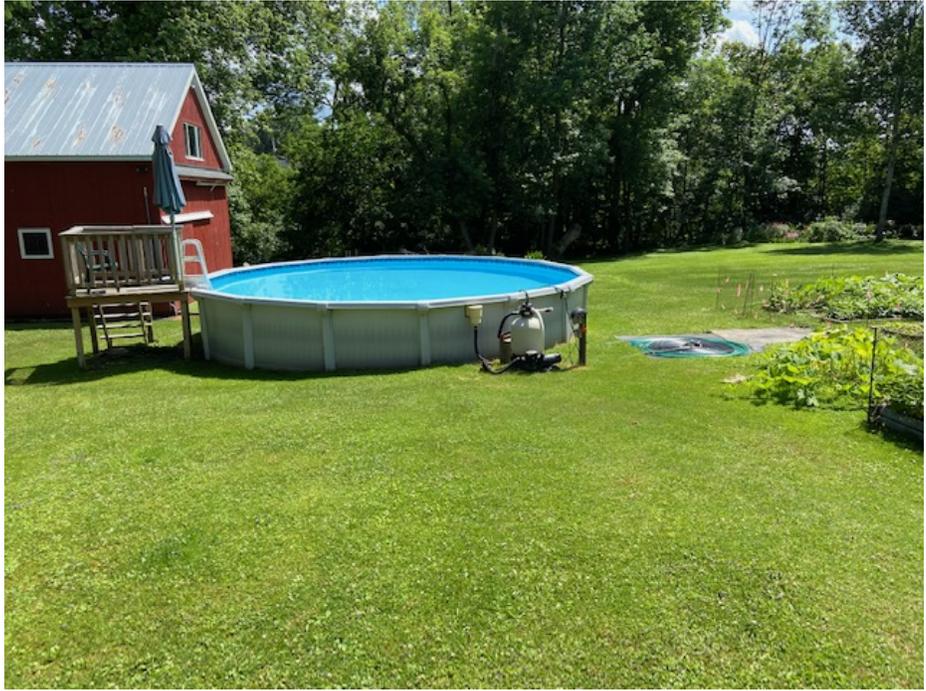
CLIENT: NYSEG	SITE NAME: Waterville Former MGP Site
PROJECT#: 30056393	SITE LOCATION: Waterville, New York
PHOTOGRAPH #: 1

As reported since the 2014 inspection report, the above-ground pool (Photo #1) installed behind the 139 Babbott Avenue property and small raised-bed vegetable garden (Photo #2) behind 145 Babbott Avenue are all still present on-site. The vegetable garden behind 139 Babbott Avenue observed since 2018 is also still present east of monitoring well CW91-6 (Photo #3), however, it no longer appears to be a raised-bed garden. New in 2020 is the appearance on a small vegetable garden immediately south of the small

PHOTOGRAPHER: JES	
DATE: 07/15/2020	
DIRECTION: South	
COMMENT: View of above-ground swimming pool behind 139 Babbott Ave.

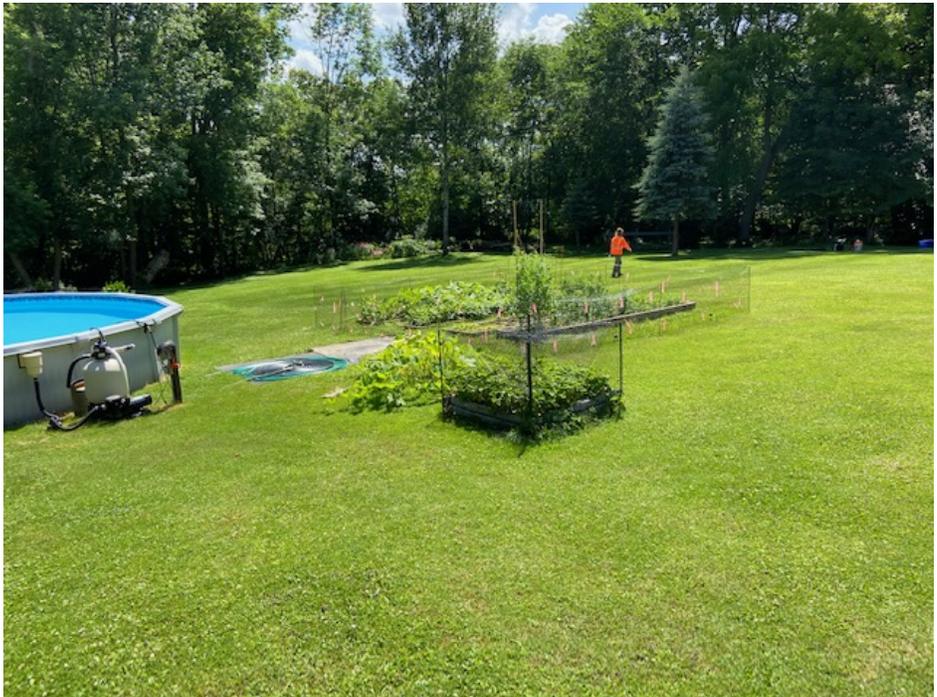
CLIENT: NYSEG	SITE NAME: Waterville Former MGP Site
PROJECT#: 30056393	SITE LOCATION: Waterville, New York
PHOTOGRAPH #: 2

PHOTOGRAPHER: JES	
DATE: 07/15/2020	
DIRECTION: Southwest	
COMMENT: View of small raised-bed vegetable garden behind 145 Babbott Avenue property.

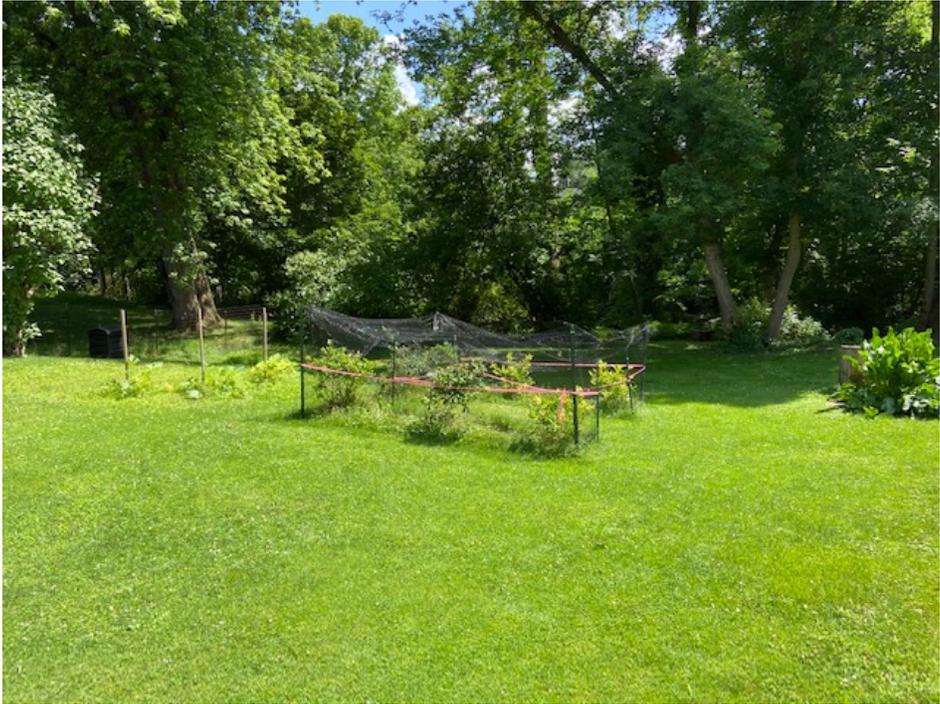
CLIENT: NYSEG	SITE NAME: Waterville Former MGP Site
PROJECT#: 30056393	SITE LOCATION: Waterville, New York
PHOTOGRAPH #: 3

PHOTOGRAPHER: JES	
DATE: 07/15/2020	
DIRECTION: South	
COMMENT: View of vegetable garden behind 139 Babbott Avenue property.

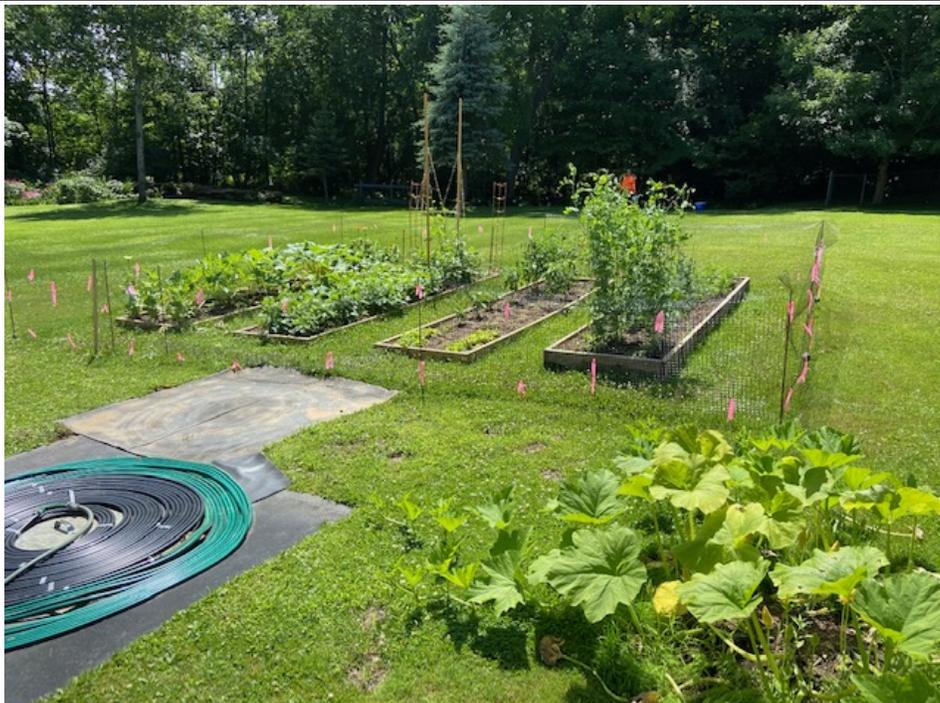
CLIENT: NYSEG	SITE NAME: Waterville Former MGP Site
PROJECT#: 30056393	SITE LOCATION: Waterville, New York
PHOTOGRAPH #: 4

raised-bed vegetable garden at 145 Babbott Avenue and immediately north of the MW98-8 well cluster (Photo #4). Also new in 2020 is the appearance to four rectangular raised-bed vegetable gardens west of the aboveground pool behind 139 Babbott Avenue (Photo #4). Both of the new gardens appear to be immediately outside of the soil cover footprint. No additional disturbances were observed during the 2020 inspection and the soil cover appeared in good condition (Photos #5 & 6).

PHOTOGRAPHER: JES	
DATE: 07/15/2020	
DIRECTION: West	
COMMENT: View of new small vegetable garden (foreground) and four new rectangular raised-bed vegetable gardens (fenced in background) behind 139 Babbott Avenue property.

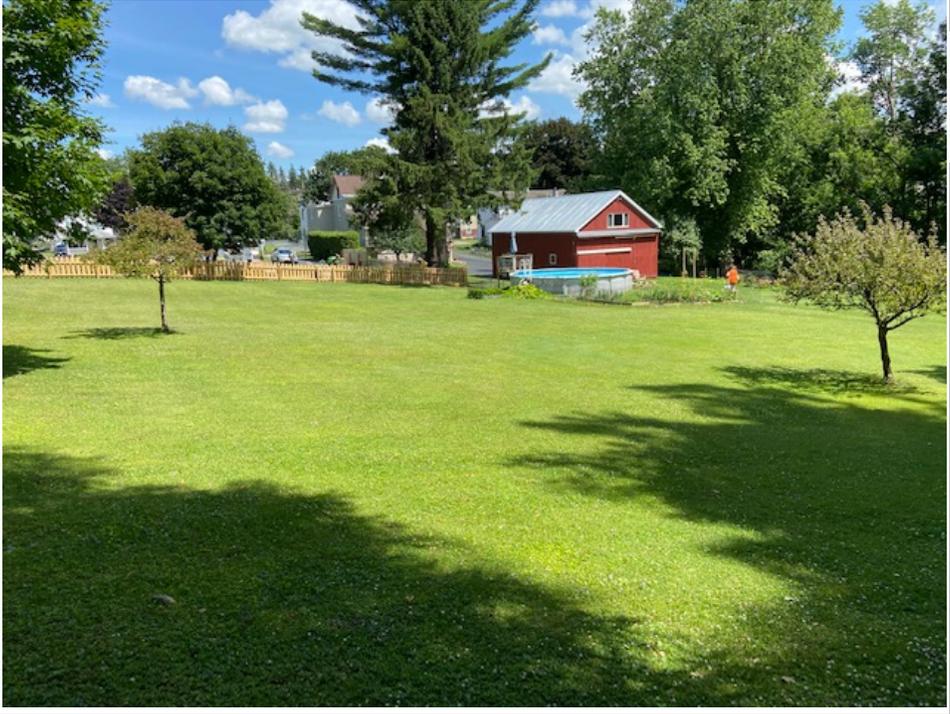
CLIENT: NYSEG	SITE NAME: Waterville Former MGP Site
PROJECT#: 30056393	SITE LOCATION: Waterville, New York
PHOTOGRAPH #: 5

PHOTOGRAPHER: JES	
DATE: 07/15/2020	
DIRECTION: Southeast	
COMMENT: View of soil cover looking southeast.

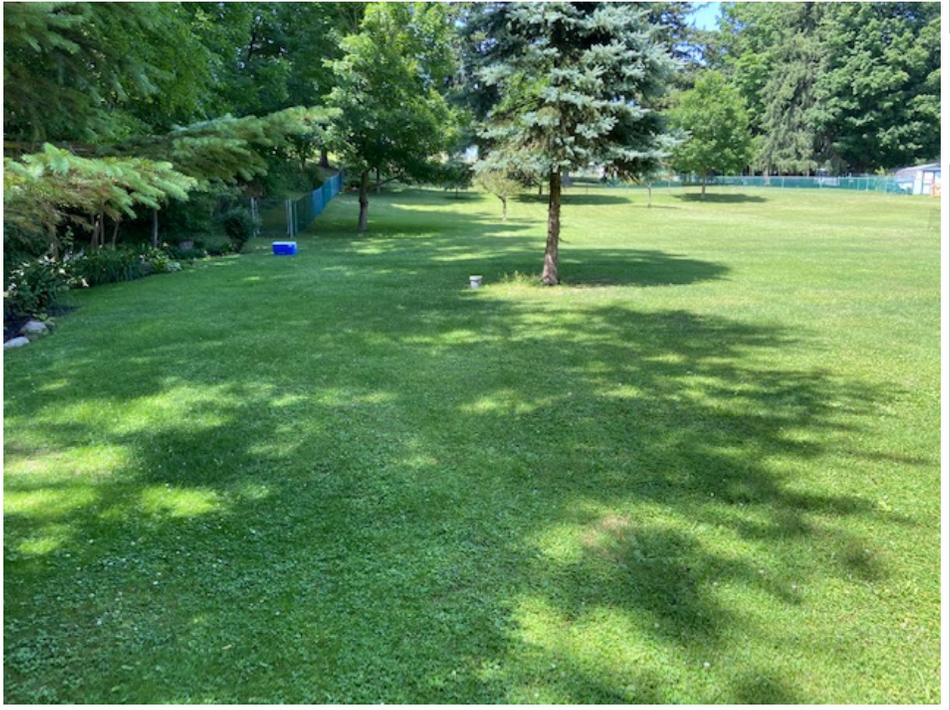
CLIENT: NYSEG	SITE NAME: Waterville Former MGP Site
PROJECT#: 30056393	SITE LOCATION: Waterville, New York
PHOTOGRAPH #: 6

PHOTOGRAPHER: JES	
DATE: 07/15/2020	
DIRECTION: North	
COMMENT: View of soil cover looking north.
