Date: November 19, 2021  
Our Ref: 30076500  
Subject: **2021 Groundwater Sampling & Soil Cover Inspection Report**  
NYSEG Waterville Former MGP Site  
Waterville, New York

On behalf of NYSEG, Arcadis of New York, Inc. (Arcadis) is pleased to present this annual report summarizing the results of groundwater sampling and soil cover inspection activities conducted in 2021 at the Waterville manufactured gas plant (MGP) site. Relevant background information is provided below, followed by a discussion of the 2021 results and recommendations for the site.

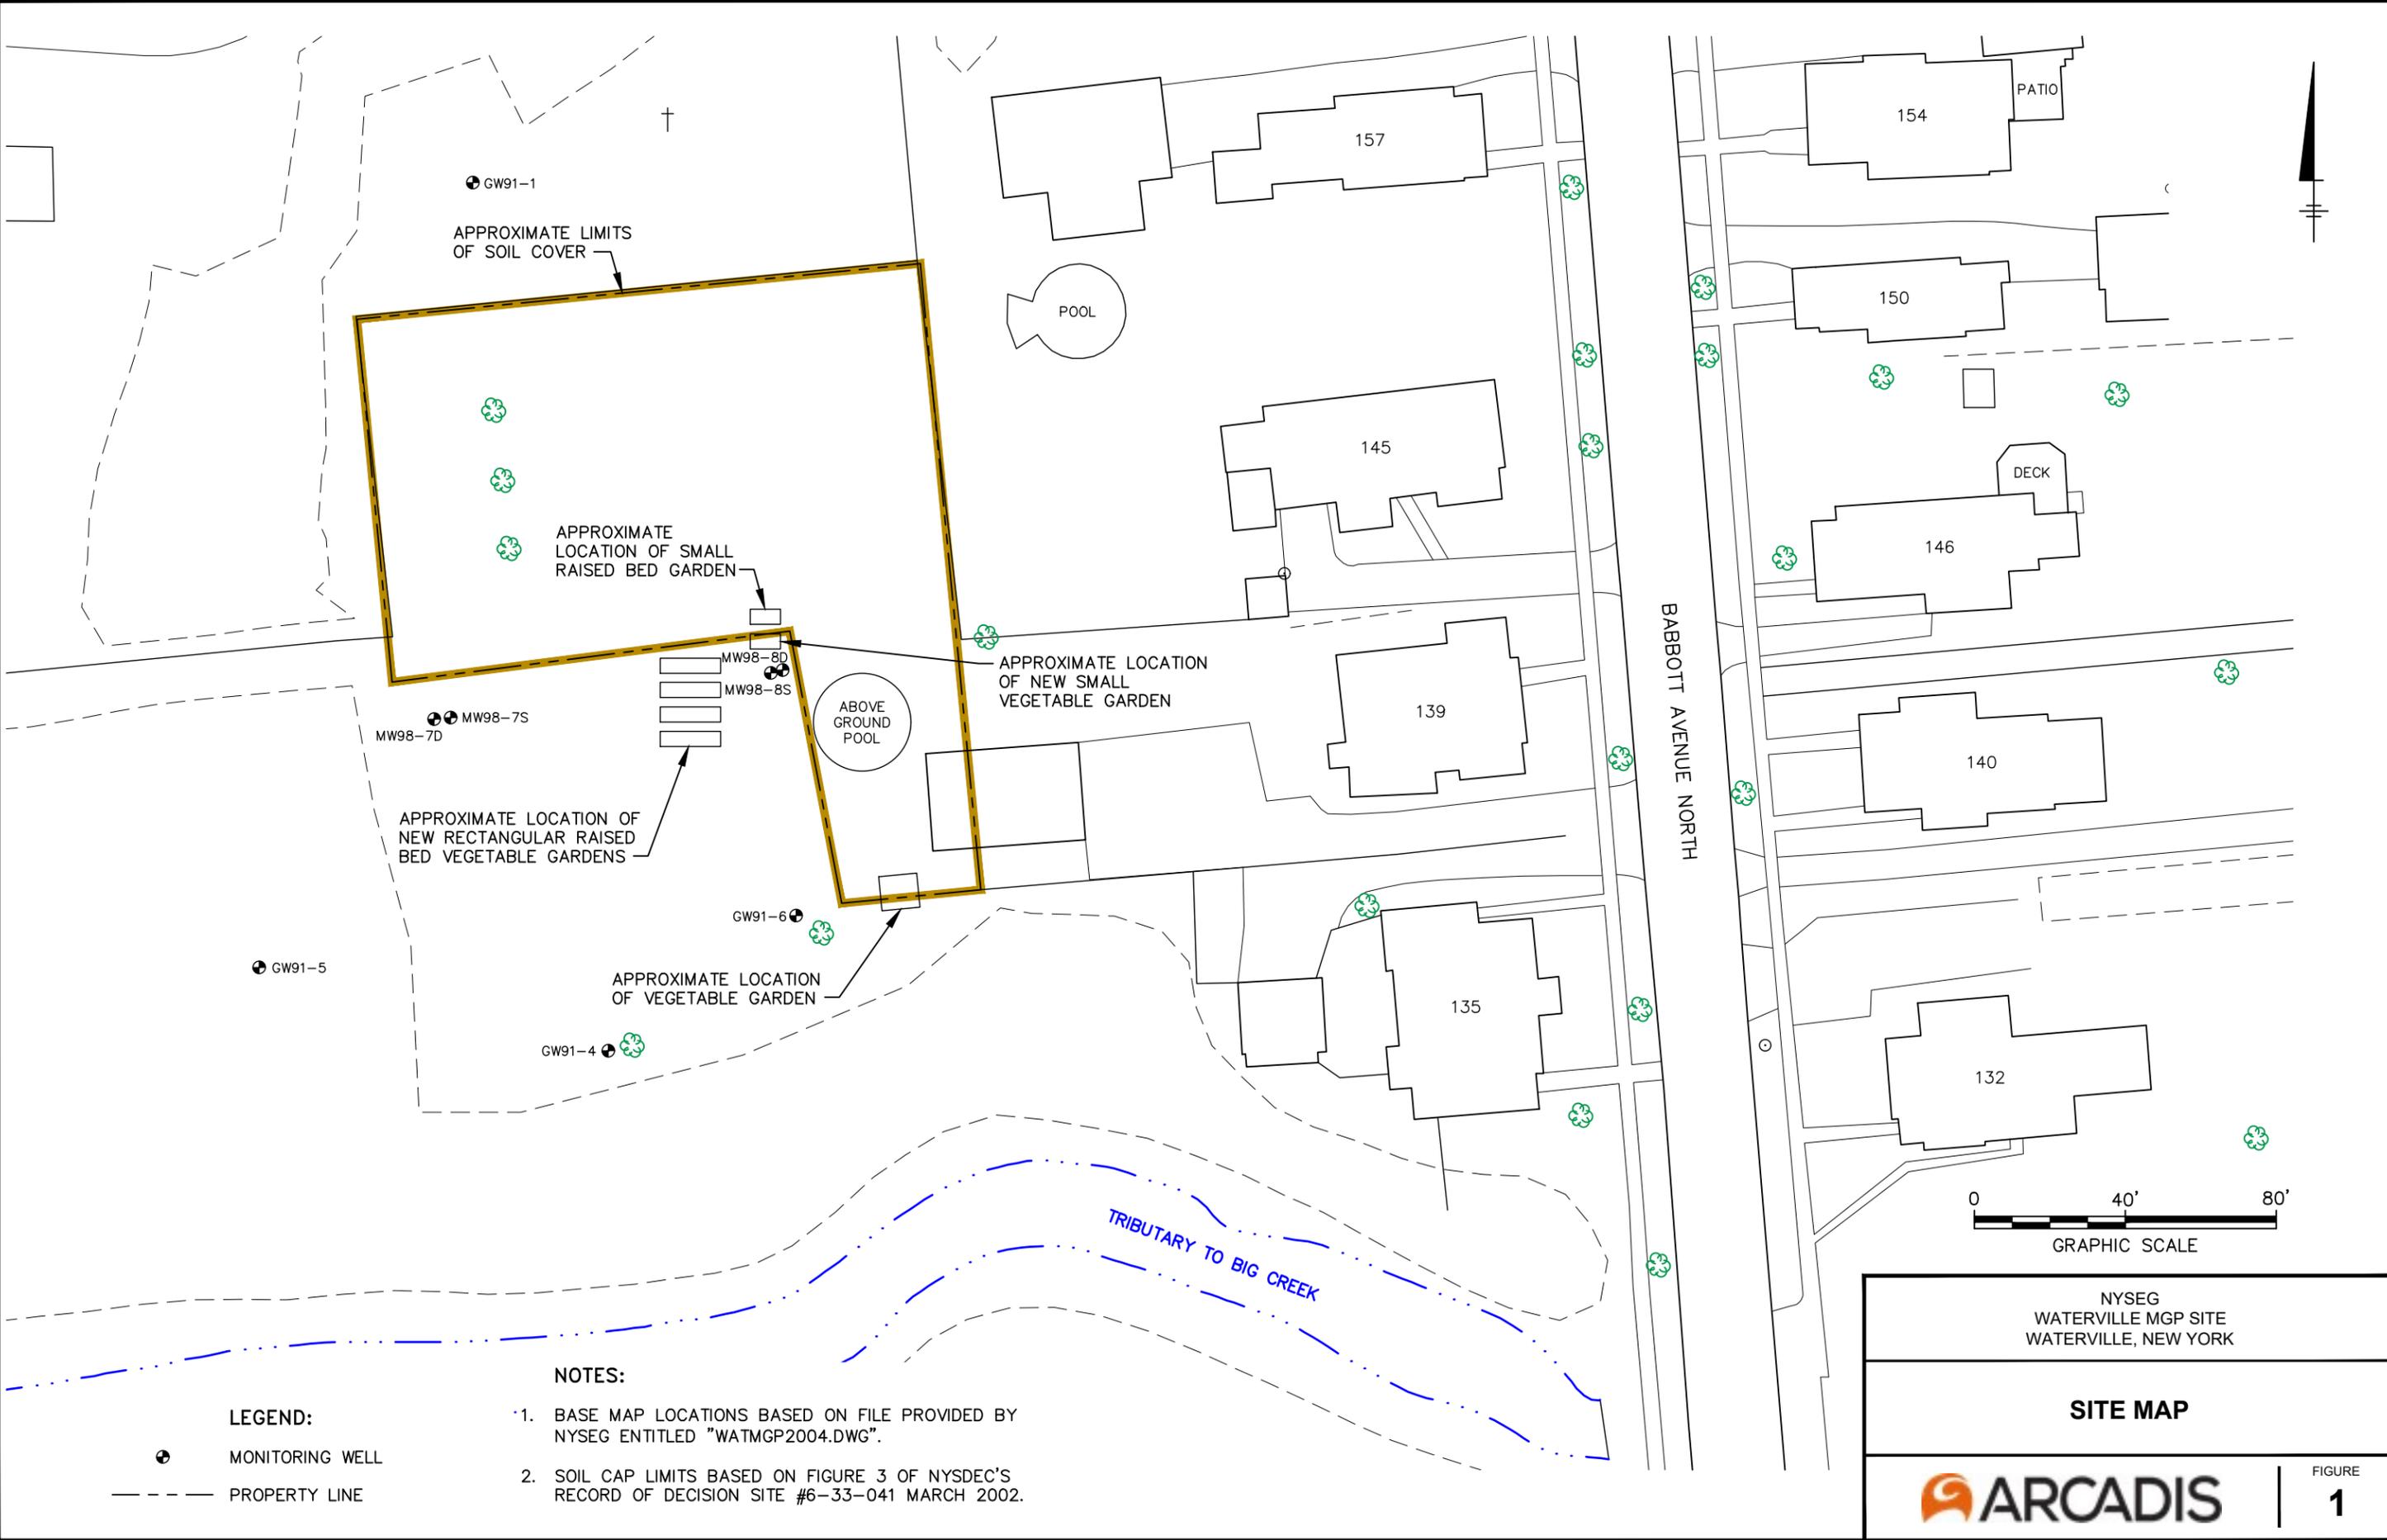
FIGURE  
**1**

Arcadis sampled groundwater from monitoring well MW98-7D and conducted site wide synoptic water-level gauging on July 1, 2021. The location of site monitoring wells and other pertinent site features can be found on Figure 1. Consistent with the previous sampling events, the sampling from MW98-7D was conducted using low-flow purging techniques. The low-flow method consists of slowly purging water from the well at a rate of approximately 100 to 200 milliliters per minute (mL/min) until readings of the following field parameters stabilize: pH, dissolved oxygen, oxidation-reduction potential (ORP), turbidity and conductivity. The table below presents the values for these field parameters at the time of sampling:

**SITE MAP**

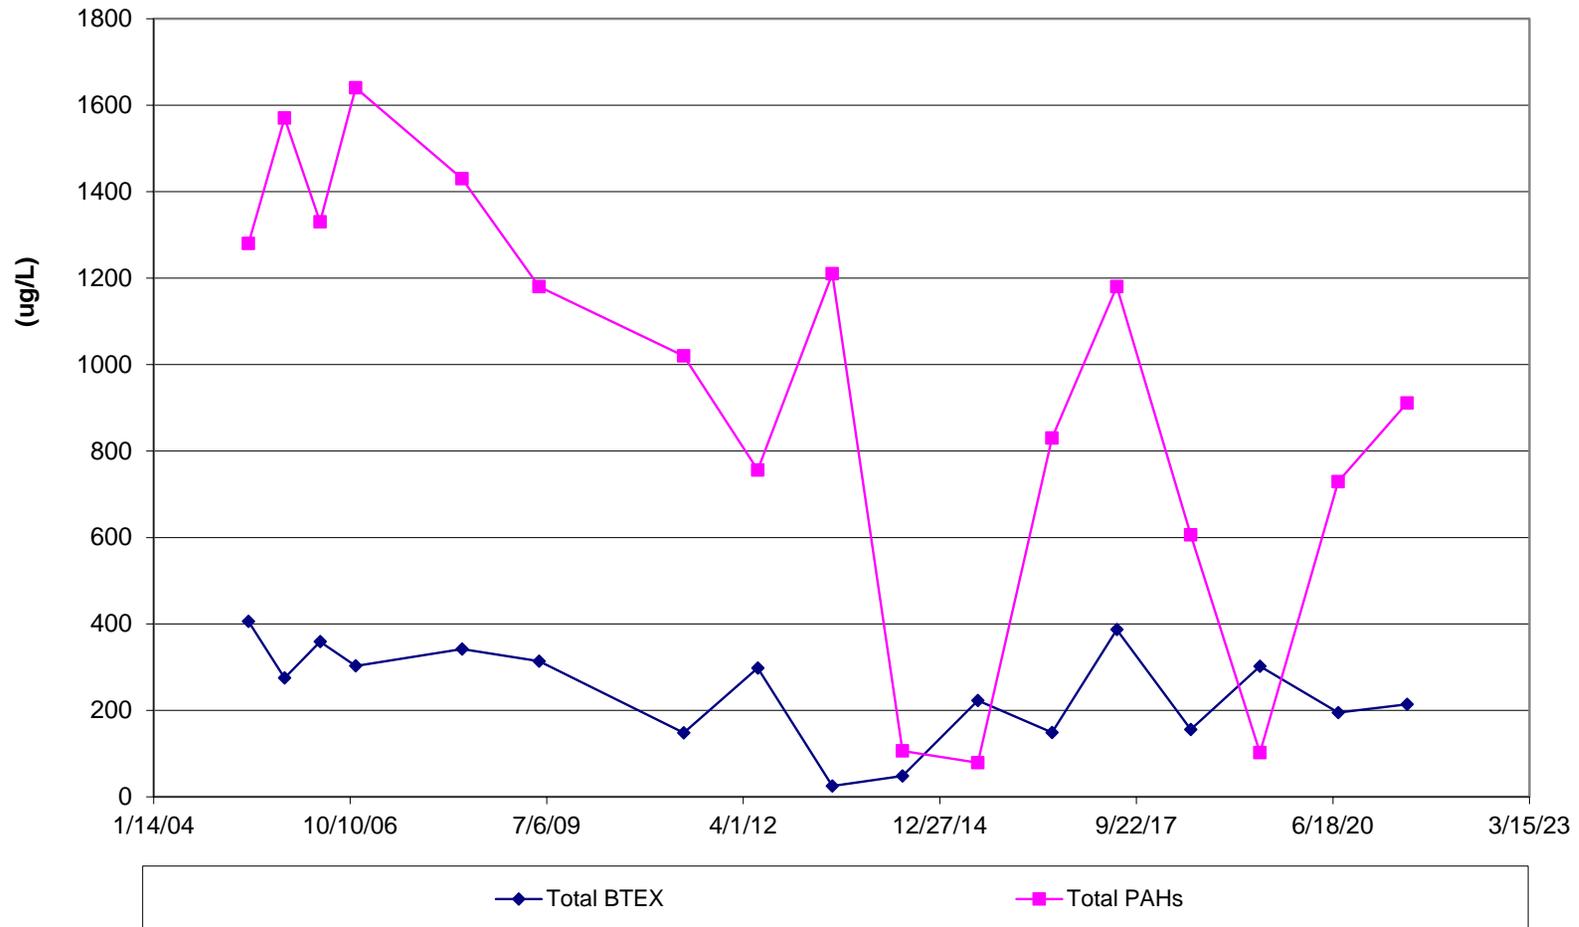
**MW98-7D Time-Series Graph**

Historical analytical results for MW98-7D are summarized in Table 1 in comparison to NYSDEC Class GA Standards and Guidance Values. Consistent with previous sampling events, groundwater sampled from MW98-7D exceeded the NYSDEC Class GA Standards for all of the BTEX compounds. Also consistent with previous events, several PAHs continue to be detected in the sample collected from well MW98-7D. While trace amounts of individual PAHs continue to be detected, only acenaphthene and naphthalene were detected at concentrations above the NYSDEC Class GA Guidance Value for these compounds. The levels for both BTEX and PAHs were within the range of concentrations detected during the previous sampling rounds. As shown on the time-series graph provided in Attachment 2, there is no discernable trend in dissolved-phase BTEX concentrations at MW98-7D since sampling began in 2004; however, there does appear to be an overall slight downward trend in the concentration of dissolved phase BTEX and PAHs.

**TOTAL BTEX & PAH CONCENTRATION OVER TIME  
MONITORING WELL - MW98-7D**

concentrations exceeded Class GA Standards for each respective compound. There is a slightly downward overall trend for BTEX and PAHs when reviewing historical data. Analytical data from the 2022 sampling events will be evaluated to determine if the concentration trend remains downward.

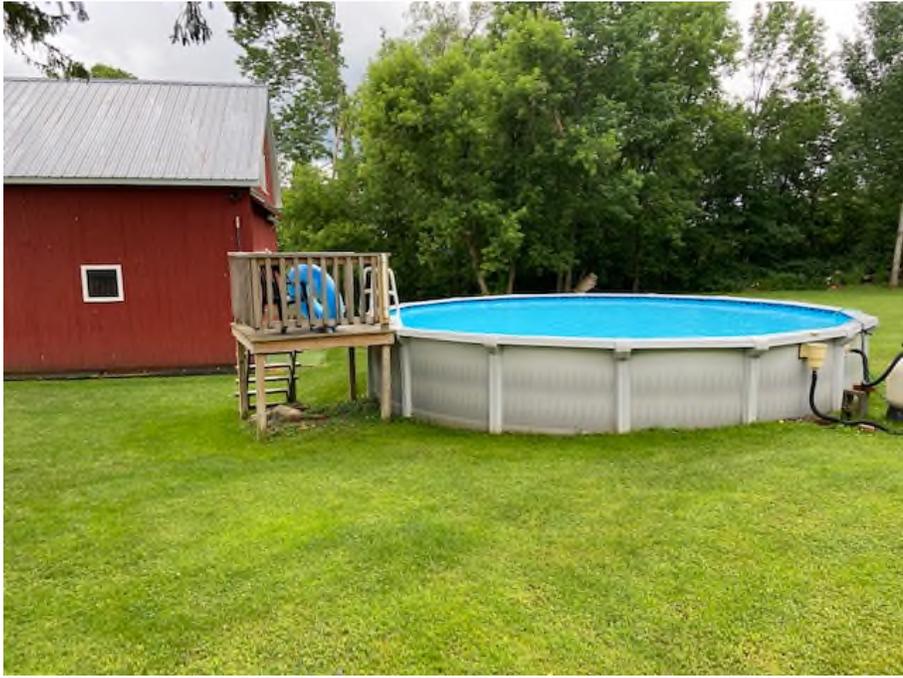
<b>CLIENT:</b> NYSEG	<b>SITE NAME:</b> Waterville Former MGP Site
<b>PROJECT#:</b> 30076500	<b>SITE LOCATION:</b> Waterville, New York
<b>PHOTOGRAPH #:</b> 1

On July 1, 2021, Arcadis also performed the annual reconnaissance of the soil cover portion of the site, as required by the site’s ROD. Findings of the reconnaissance were generally consistent with those found during previous years. Please refer to the photographic log in Attachment 3 for pictures of relevant features of the soil cover. As reported since the 2014 inspection report, the above-ground pool (Photo #1) installed behind the 139 Babbott Avenue property and the vegetable gardens (Photo #2) behind 145 Babbott Avenue are all still present on-site. The vegetable garden behind 139 Babbott Avenue observed since 2018 is also still present east of monitoring well CW91-6 (Photo #3). No additional disturbances were observed during the 2021 inspection and the soil cover appeared in good condition (Photos #4, 5 & 6).

Aside from the disturbances caused by the installation of the above-ground pool and vegetable gardens in 2014, the soil cover appeared to be in good condition with no obvious damage.

<b>PHOTOGRAPHER:</b> JES	
<b>DATE:</b> 07/1/2021	
<b>DIRECTION:</b> South	
<b>COMMENT:</b> View of above-ground swimming pool behind 139 Babbott Avenue property.

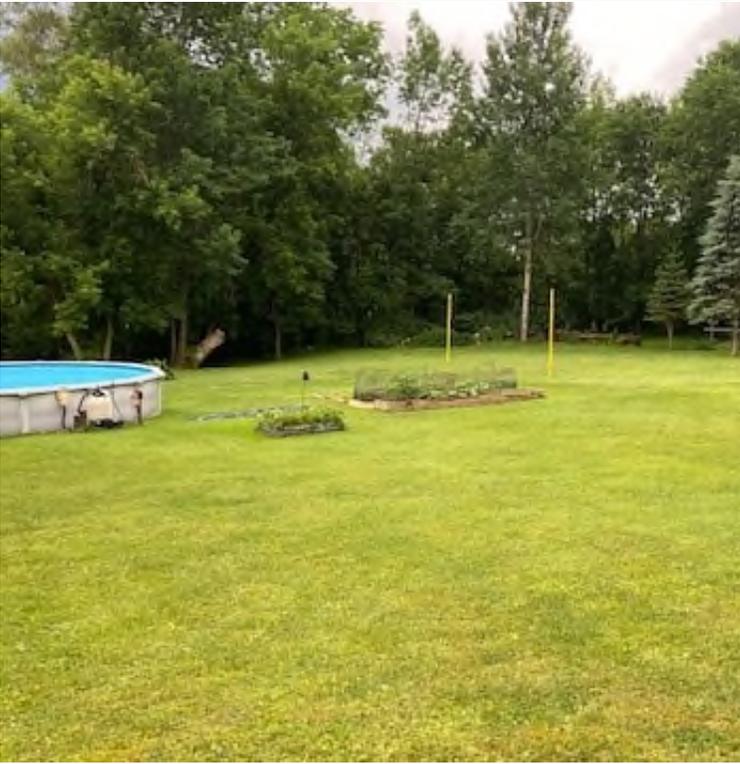
<b>CLIENT:</b> NYSEG	<b>SITE NAME:</b> Waterville Former MGP Site
<b>PROJECT#:</b> 30076500	<b>SITE LOCATION:</b> Waterville, New York
<b>PHOTOGRAPH #:</b> 2

<b>PHOTOGRAPHER:</b> JES	
<b>DATE:</b> 07/1/2021	
<b>DIRECTION:</b> Southwest	
<b>COMMENT:</b> View of raised-bed vegetable gardens behind 145 Babbott Avenue property.

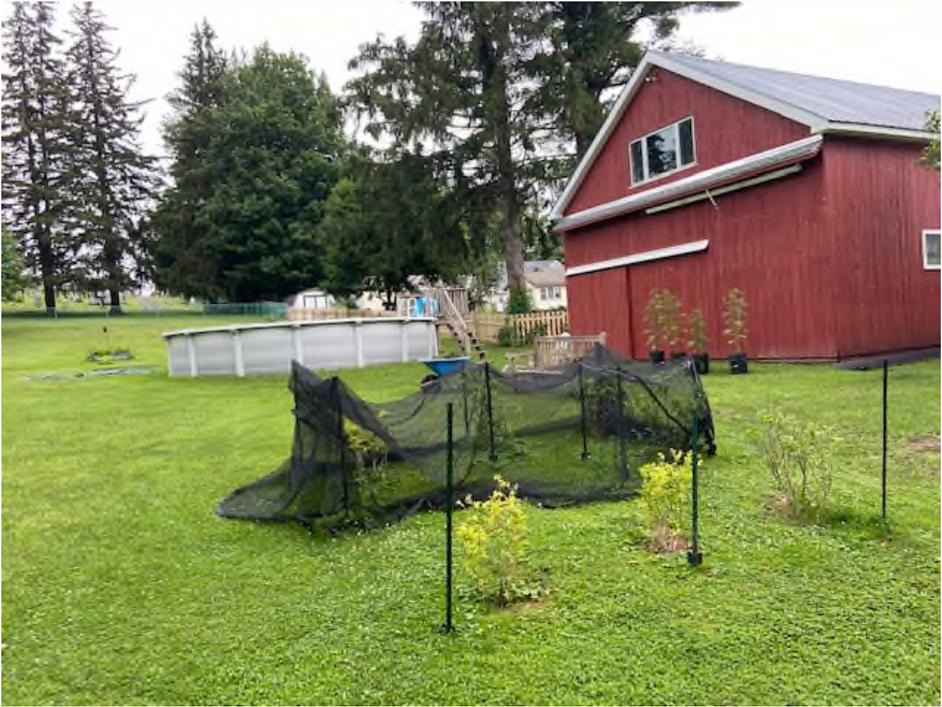
<b>CLIENT:</b> NYSEG	<b>SITE NAME:</b> Waterville Former MGP Site
<b>PROJECT#:</b> 30076500	<b>SITE LOCATION:</b> Waterville, New York
<b>PHOTOGRAPH #:</b> 3

<b>PHOTOGRAPHER:</b> JES	
<b>DATE:</b> 07/1/2021	
<b>DIRECTION:</b> North	
<b>COMMENT:</b> View of vegetable garden behind 139 Babbott Avenue property.

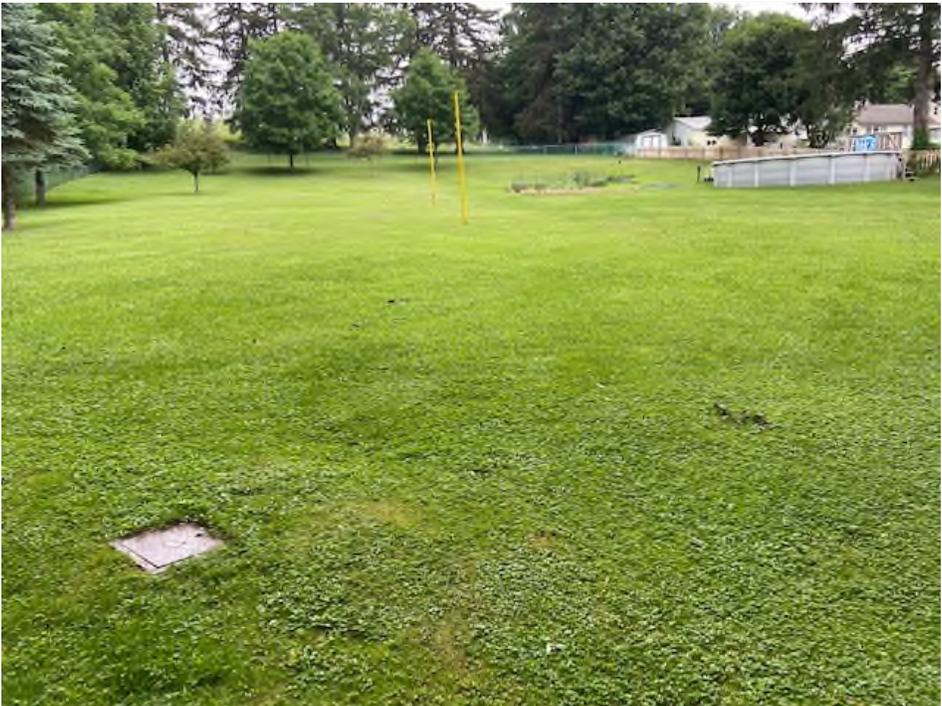
<b>CLIENT:</b> NYSEG	<b>SITE NAME:</b> Waterville Former MGP Site
<b>PROJECT#:</b> 30076500	<b>SITE LOCATION:</b> Waterville, New York
<b>PHOTOGRAPH #:</b> 4

<b>PHOTOGRAPHER:</b> JES	
<b>DATE:</b> 07/1/2021	
<b>DIRECTION:</b> North	
<b>COMMENT:</b> View of soil cover looking north.

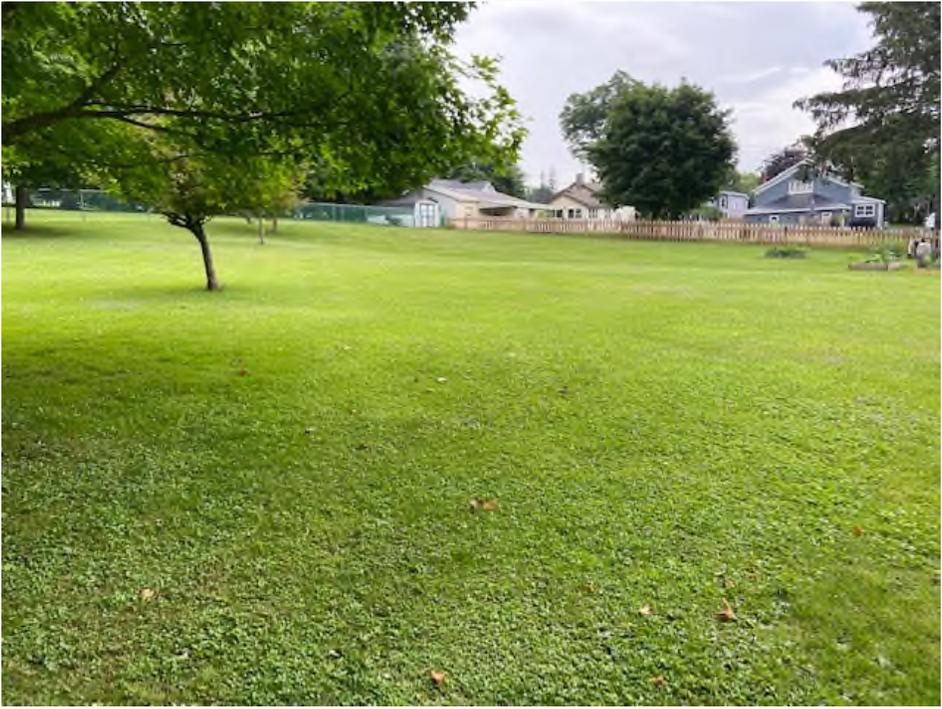
<b>CLIENT:</b> NYSEG	<b>SITE NAME:</b> Waterville Former MGP Site
<b>PROJECT#:</b> 30076500	<b>SITE LOCATION:</b> Waterville, New York
<b>PHOTOGRAPH #:</b> 5

<b>PHOTOGRAPHER:</b> JES	
<b>DATE:</b> 07/1/2021	
<b>DIRECTION:</b> East	
<b>COMMENT:</b> View of soil cover looking east.

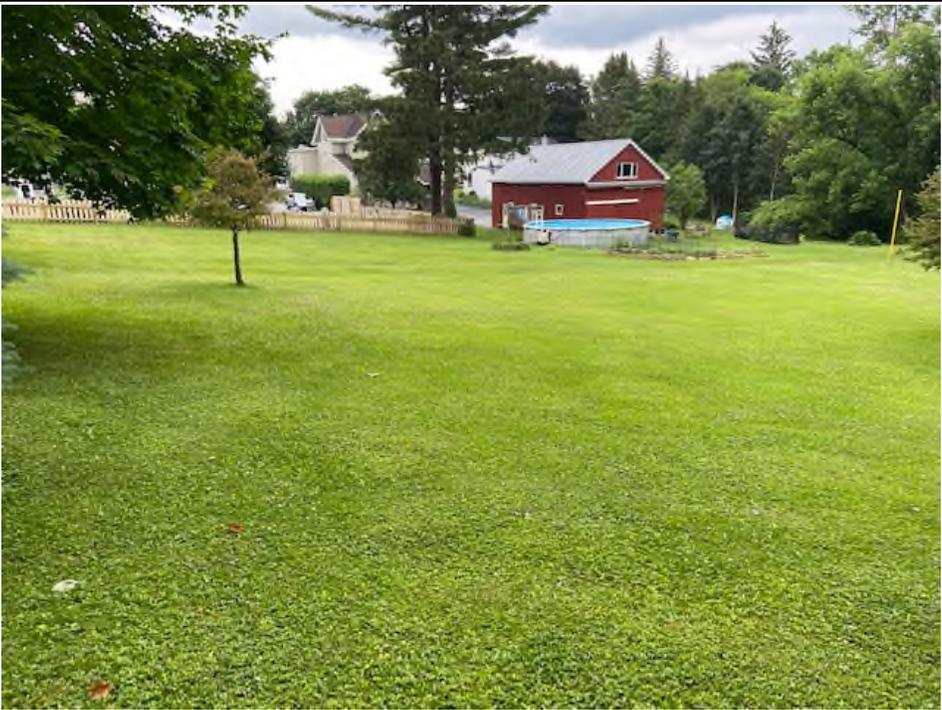
<b>CLIENT:</b> NYSEG	<b>SITE NAME:</b> Waterville Former MGP Site
<b>PROJECT#:</b> 30076500	<b>SITE LOCATION:</b> Waterville, New York
<b>PHOTOGRAPH #:</b> 6

<b>PHOTOGRAPHER:</b> JES	
<b>DATE:</b> 07/1/2021	
<b>DIRECTION:</b> Southeast	
<b>COMMENT:</b> View of soil cover looking southeast.
