Date: December 2, 2024
Our Ref: 30230453
Subject: **2024 Groundwater Sampling and Soil Cover Inspection Report**
New York State Electric and Gas
Waterville Former Manufactured Gas Plant Site
Waterville, New York

2024 Groundwater Sampling and Soil Cover Inspection Report
Waterville Former MGP Site
Waterville, New York

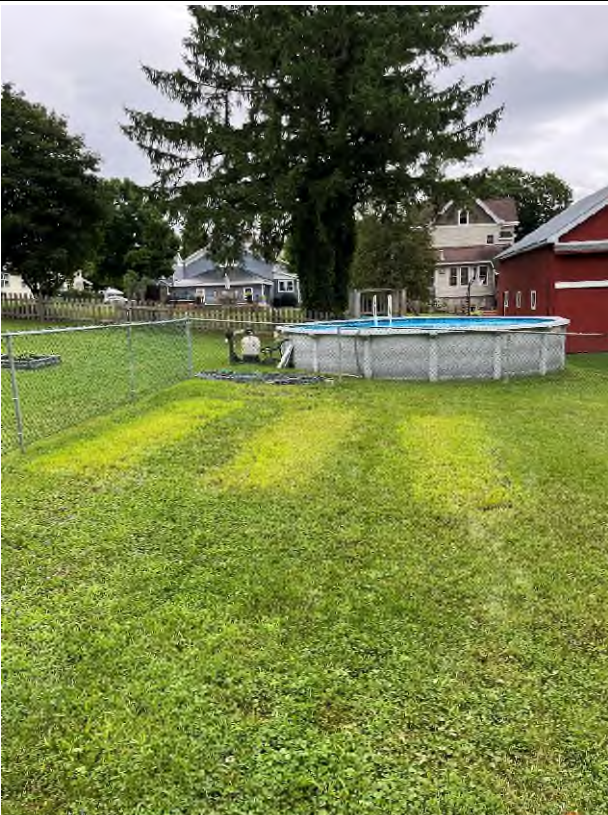
CLIENT: NYSEG	SITE NAME: Waterville Former MGP Site
PROJECT #: 30230453	SITE LOCATION: Waterville, New York
PHOTOGRAPH #: 2

On August 8, 2024, Arcadis also performed the annual inspection of the soil cover portion of the site, as required by the site's Record of Decision. Please refer to the photograph log in Attachment 3 for pictures of relevant features of the soil cover. As observed in previous years, the above-ground pool and small raised-bed garden (Photographs 1 and 2) behind 139 Babbott Avenue North are still present at the site. The rectangular gardens previously observed behind 139 Babbott Avenue North are no longer present (Photograph 2). A new metal chain-link fence has been installed along the south/southeast edge of the soil cover, as depicted on Figure 1 (Photographs 1, 2, 3, 4, and 5). Based on visual observations during the fieldwork, it appeared that the fence was installed by the cemetery. There were no visible gates for entering through the fence onto the 139 or the 145 Babbott Avenue North properties, and there is now an opening along the previously existing western fence leading up to the cemetery where there was once a gate. During a call on November 7, 2024, the Waterville Cemetery Association confirmed that the fence was installed by the cemetery. The Cemetery Association indicated that they were having a problem with motorized vehicles (All Terrain Vehicles) traversing the property and continuing up onto the main cemetery property and decided that a fence was necessary. The new fence appears to be located just outside the soil cover perimeter and not within the soil cover footprint. No additional

Aside from the disturbances caused by installation of the above-ground pool and the small rectangular garden observed since 2014, the soil cover appeared to be in good condition with no obvious damage. A new chain-link fence was installed along the southern boundary of the soil cover by the Waterville Cemetery Association.

PHOTOGRAPHER: DM	
DATE: 08/8/2024	
DIRECTION: East	
COMMENT: View of swimming pool, small vegetable garden, and new fence behind 139 Babbott Avenue North. Location of former rectangular gardens behind 139 Babbott Avenue North property in the foreground.

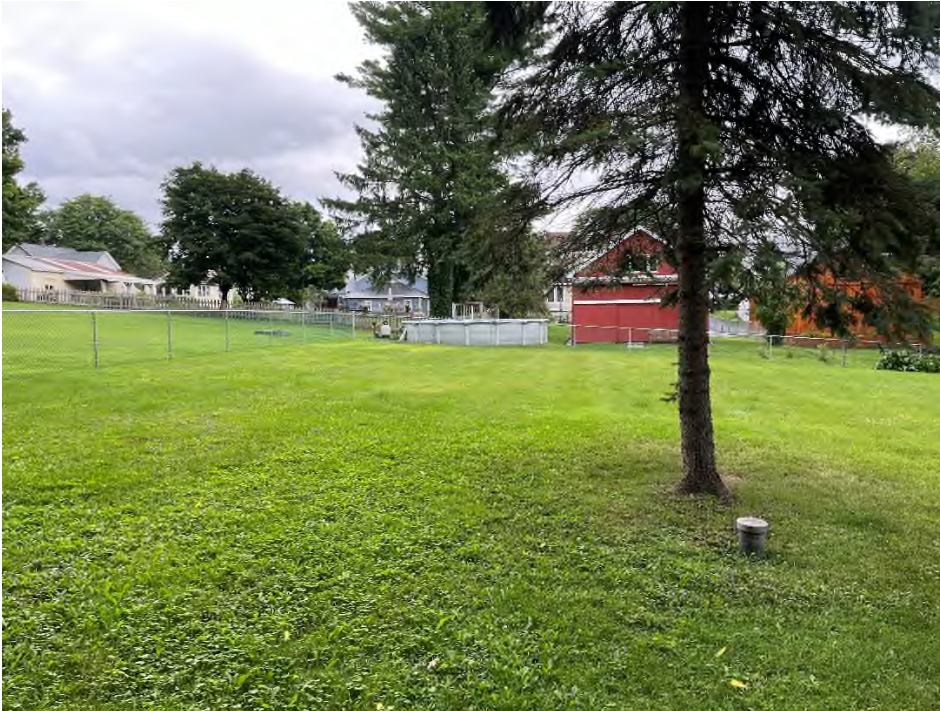
CLIENT: NYSEG	SITE NAME: Waterville Former MGP Site
PROJECT #: 30230453	SITE LOCATION: Waterville, New York
PHOTOGRAPH #: 4

PHOTOGRAPHER: DM	
DATE: 08/8/2024	
DIRECTION: East	
COMMENT: View of new fence behind 139 Babbott Avenue North property.
