SEPTEMBER 2021 SITE SUMMARY REPORT

FORMER J&L STEEL SPILL SITE 4669 STATE HIGHWAY 3 STAR LAKE, NEW YORK

NRC NY ENVIRONMENTAL SERVICES, INC. / US Ecology 63 TRADE ROAD, BLDG 4 MASSENA, NY 13662

123065

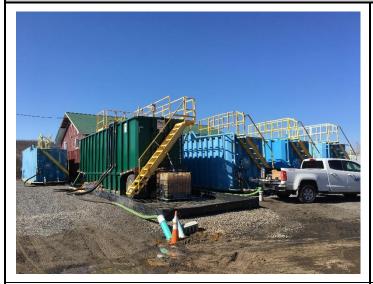
PHOTOGRAPH 1: Southerly view of weir tank and frac tanks (foreground), with the "clean water" frac tank and Remediation Building visible in the background.

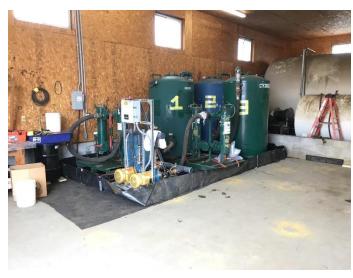
PHOTOGRAPH 2: View of groundwater treatment system components inside the Remediation Building, including water treatment pumps and control box, bag filter units, and activated carbon vessels. The 4,000-gallon oil storage AST and 18,000-gallon AST are visible.

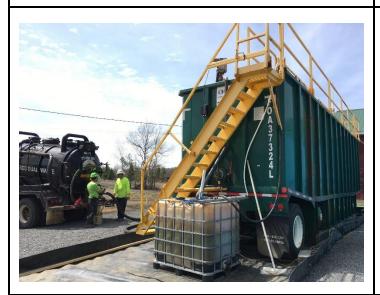
PHOTOGRAPH 3: View of vacuum truck recovery trench oil/water offloading operations. The weir tank oil recovery tote is in the foreground.

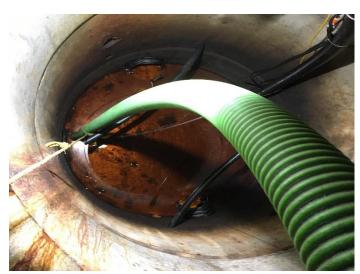
PHOTOGRAPH 4: View down the RTM-2 manhole, depicting vacuum truck oil skimming using a 2-inch vac hose.

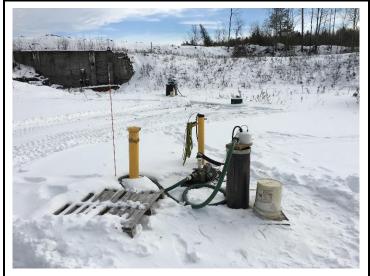
PHOTOGRAPH 5: Southern view of winter jet pump recovery well water depression operations. RW-2 in the foreground and RW-6 in the background.

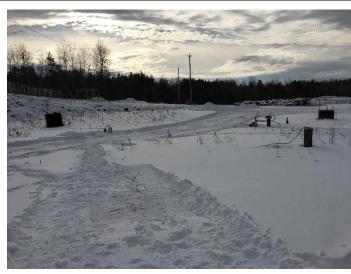
PHOTOGRAPH 6: Southwest view of winter peristaltic pump oil recovery operations. RW-3, RW-4, and RW-8 are visible in the photo.

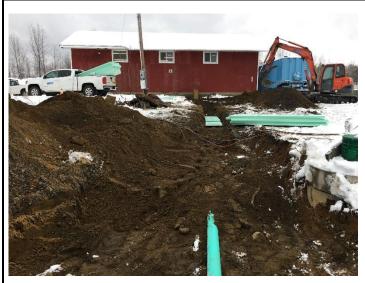
PHOTOGRAPH 7: Northerly view of new treated water discharge line from Remediation building to the Little River, during insulating and backfilling of excavated trench.

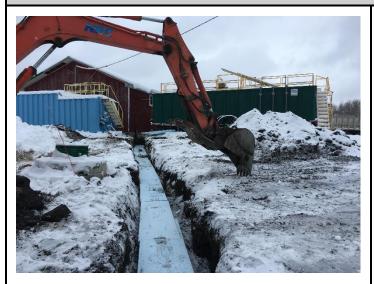
PHOTOGRAPH 9: Northeast view from pump controls conex to Remediation Building, showing installation of two layers of rigid insulation over the recovery well water transfer pipe.

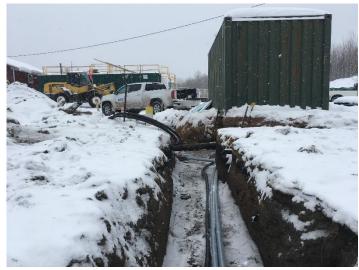
PHOTOGRAPH 10: East view of installation of RW-4 waterline and submersible pump power and AC Sipper air and oil line conduits.

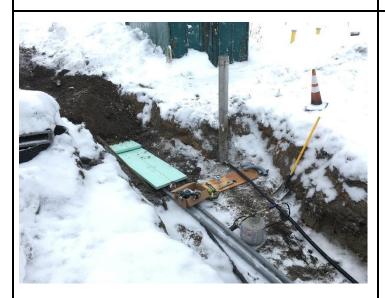
PHOTOGRAPH 11: RW-5 pitless adapter and water line installation. Waterline and conduits for RW-6 are also visible, coming from the left.

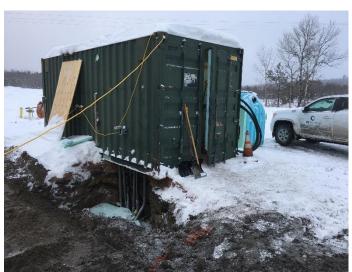
PHOTOGRAPH 12: Westerly view of pump controls conex, depicting waterlines and electrical supply and Sipper air and oil line conduits.

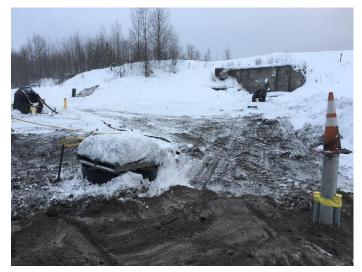
PHOTOGRAPH 13: Northwest view of backfilled trenches for recovery wells RW-2, RW-6, and RW-6 waterlines and conduits.

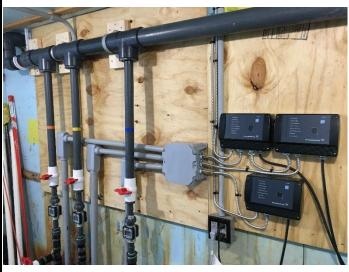
PHOTOGRAPH 14: Interior view of conex, showing submersible pump controllers, electrical conduits and incoming waterlines.

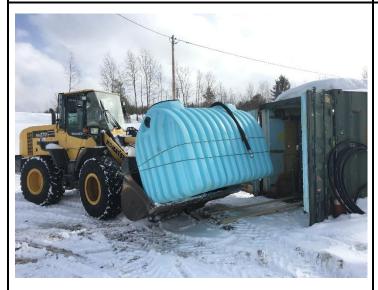
PHOTOGRAPH 15: Loading the new 1,150-gallon recovery well water transfer tank into the conex.

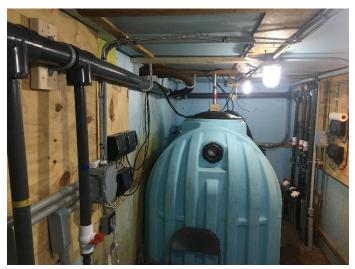
PHOTOGRAPH 16: View inside conex showing (left and right) recovery well waterlines, electrical conduits and pump control boxes.

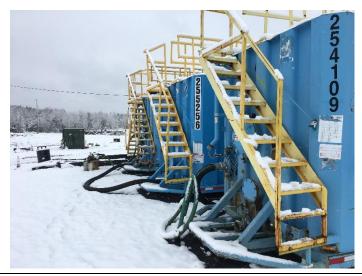
PHOTOGRAPH 17: Westerly view of newly reconnected hoses and initiation of frac tanks for oil/water and iron separation for the 2021 season. The Groundwater depression system pump controls conex building is visible in the background.

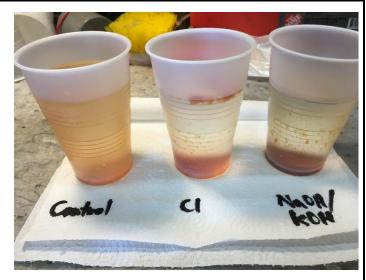
PHOTOGRAPH 18: Photograph of recovery well water iron separation bench testing, taken moments after the test was initiated, with control sample and chlorine solution added and sodium hydroxide/potassium hydroxide solution added samples. Note slow oxidation in the control sample and fast settlement of ferric iron in the treated samples.

These results show similar concentrations of total iron in the recovery trench and recovery well samples. The results also indicate significant iron reduction occurs as the water passes through the weir and frac tanks, and that iron continues to be removed within the carbon treatment system, which explains the fouling of the bag filters and carbon vessels by iron. The iron fouling in the activated carbon vessels causes flow to be reduced, which has hampered water processing operations at the site.

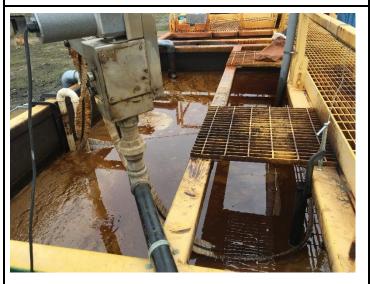
PHOTOGRAPH 19: April 28, 2021 view of water inlet chamber of weir, showing floating oil and emulsified oil. Ambar belt skimmer is operating in foreground.

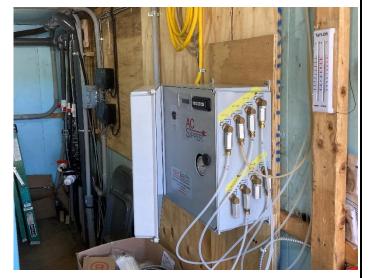
PHOTOGRAPH 21: AC Sipper Controller 2 installed in the groundwater depression pump controls conex building.

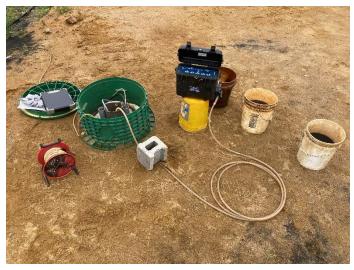
PHOTOGRAPH 22: Peristaltic pump oil recovery operations at RW-6.

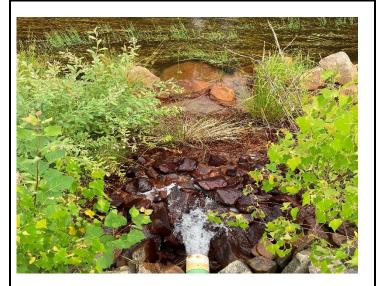
PHOTOGRAPH 23: North view of treated water discharge point at the Little River.

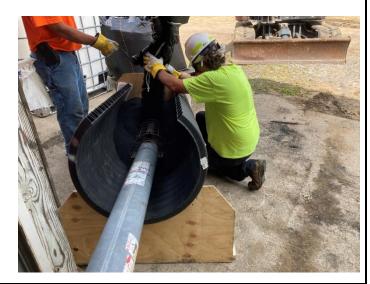
PHOTOGRAPH 24: NRC workers loading carbon from a super sack suspended by an excavator, into a tube auger for elevation of the carbon into the carbon vessel.

After incidents of breakthrough in VOC sample results in post-treatment water samples, and after exhausting reasonable alterations in the system to improve discharge water quality, NYSDEC directed NRC to replace all the carbon in the GWT system. During the period of August 11 to 18, 2021, NRC removed the spent carbon from the four (4) activated carbon vessels and replaced it with fresh virgin coal activated carbon. The carbon replacement was conducted without interruption of the water treatment process. The carbon was removed using the NRC vacuum truck and piled in a bermed area located east of the Remediation Building, on two (2) layers of 6-mil polyethylene sheeting. After overnight hydration of the new carbon in each vessel after filling, each carbon was placed back on-line. Per the NYSDEC, pre and post treatment samples were collected on September 7, 2021, and "clean" post treatment results were reported. The results of the GWT system sampling are presented in **Exhibit** Laboratory Analytical Reports and Sample Custody Documentation.

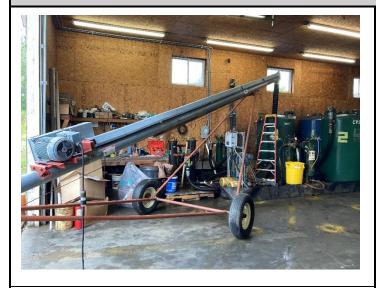
PHOTOGRAPH 25: Inside view of the tube auger loading activated carbon into carbon vessel number 4.

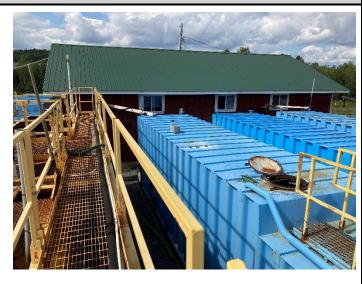
PHOTOGRAPH 26: view atop weir tank, showing adjacent frac tanks and remediation building.

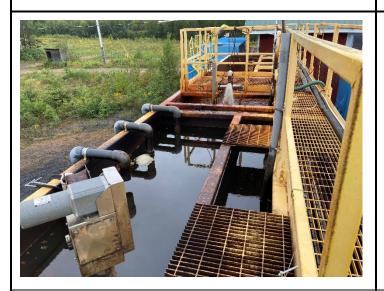
PHOTOGRAPH 27: September 8, 2021 photo of inlet chamber of weir. The photo shows dark free product introduced primarily by recovery trench pumping and vacuum truck skimming operations.

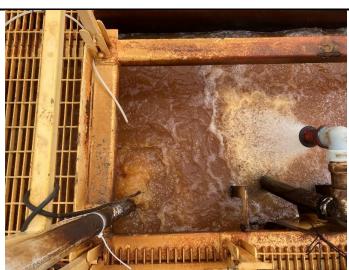
PHOTOGRAPH 4: Top view of central chamber of the weir tank, depicting the aeration blower/diffuser action, the pump sprayer nozzle, and chlorine injection tube.

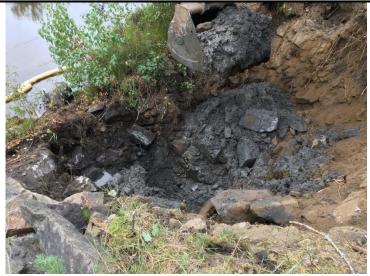
PHOTOGRAPH 2: Southwest view of TP-1 depicting its proximity to the Little River at the location of the Benson Seep.

The September 19, 2018 test pit investigation was conducted using typical field soil screening methods, consisting of examining excavated soil samples for characteristic petroleum staining and odors and screening the soil samples for measurable VOC, using a photoionization detector (PID), equipped with a 10.6 eV lamp. The soil encountered in the test pits, identified as TP-1 and TP-2, included gravel and sand, intermingled with small angular cobbles, and large pieces of fragmented rock, up to four (4) feet in dimension. Test Pit TP-1, located adjacent to the main seep, was excavated approximately two (2) feet from the shoreline and extended approximately 15 feet north, into the bank. Soil samples recovered form TP-1 revealed significant petroleum staining, odors, and PID readings over 400 ppm VOC, at approximately 11 feet below grade (fbg), which was approximately one (1) foot above the stream surface elevation at the time. TP-2 was excavated approximately 25 feet west of TP-1. The marsh mat was encountered in TP-2 at 10.5 to 11.5 fbg, at approximate stream surface elevation. The marsh mat material exhibited moderate petroleum odors and 50 ppm VOC with the PID. Coarse to fine sand and fine gravel was present under the marsh mat, with trace petroleum odors and <10 ppm VOC.

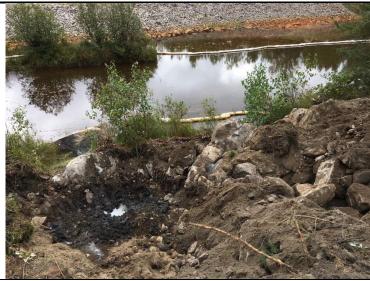
PHOTOGRAPH 1: Westerly view of Benson Seep test pit TP-1, depicting gravelly soil with large, angular rock fragments and grey, petroleumstained soil at the bottom of the excavation. The Little River is immediately south (left) of the excavation.

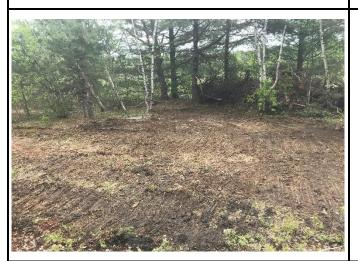
PHOTOGRAPH 3: Southwest view of the TP-4 restoration area.
