SUBJECT: March 2015 Operating Report for the Vestal Well field 1-1 Superfund Site, Area 4,  
Vestal, New York

SUBJECT: March 2014 Monthly Report on Activities at the Vestal Well field 1-1 Superfund Site, Area 4, Vestal, New York

**LATA Project # 11202**  
**Contract # W912DQ-09-D-3003,**  
**Task Order # 008**

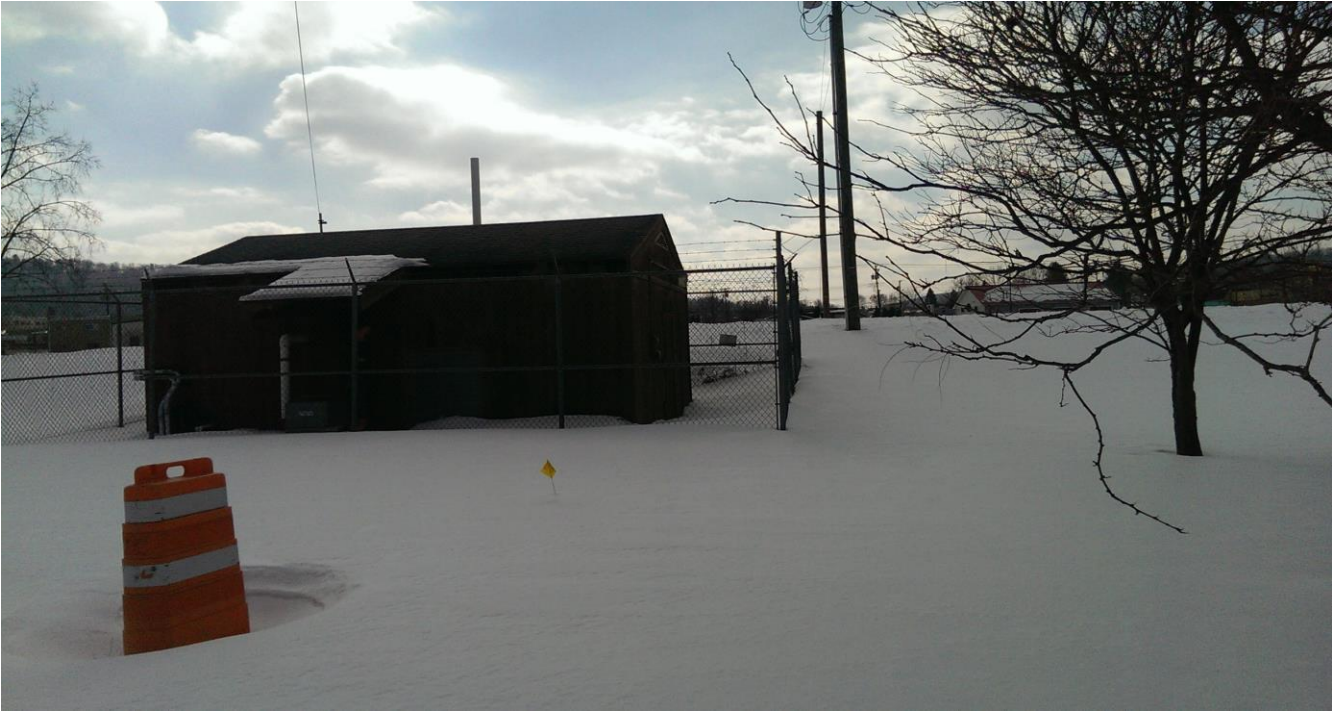
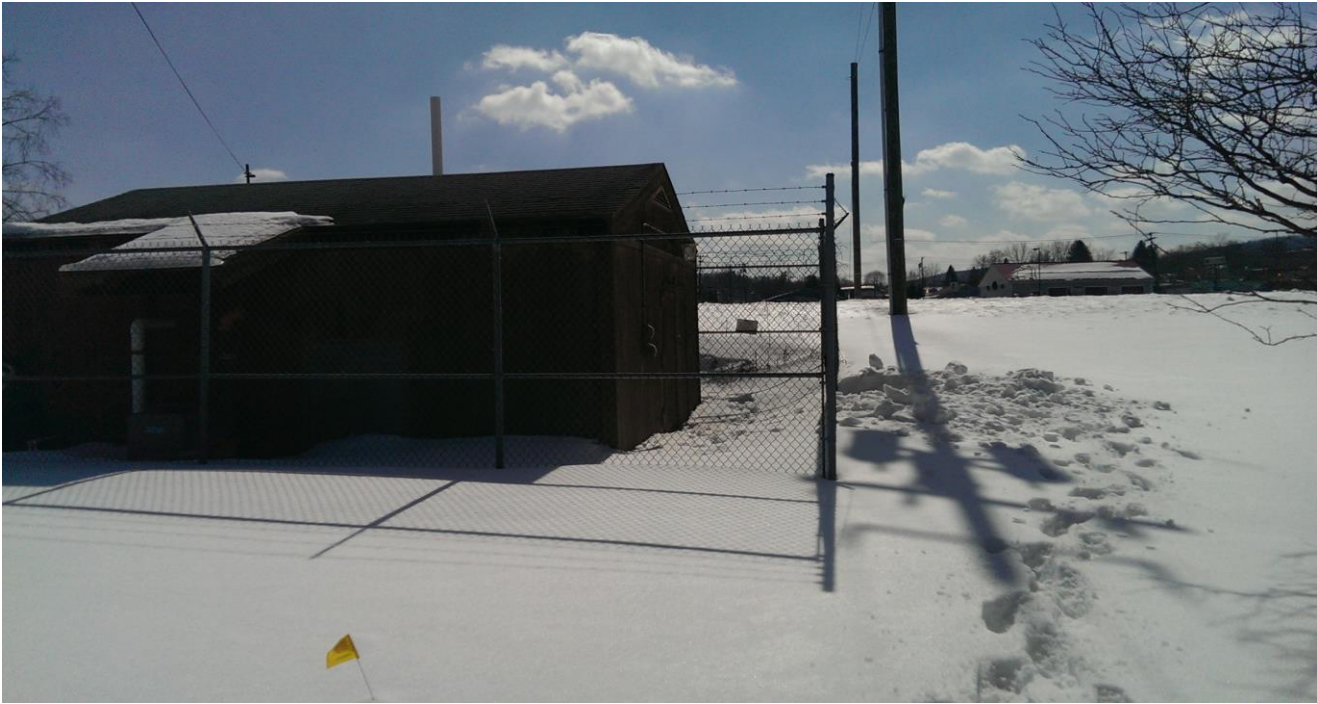
**Main Building**

**Comments**  
Heavy snow (~2 ft.) and layer of ice around main building and cells one and two was removed to access buildings.
