SUBJECT: October 2015 Operating Report for the Vestal Well Field 1-1 Superfund Site, Area 4, Vestal, New York

SUBJECT: October 2015 Monthly Report on Activities at the Vestal Well field 1-1 Superfund Site, Area 4,  
Vestal, New York

**LATA Project # 11202**  
**Contract # W912DQ-09-D-3003,**  
**Task Order # 008**

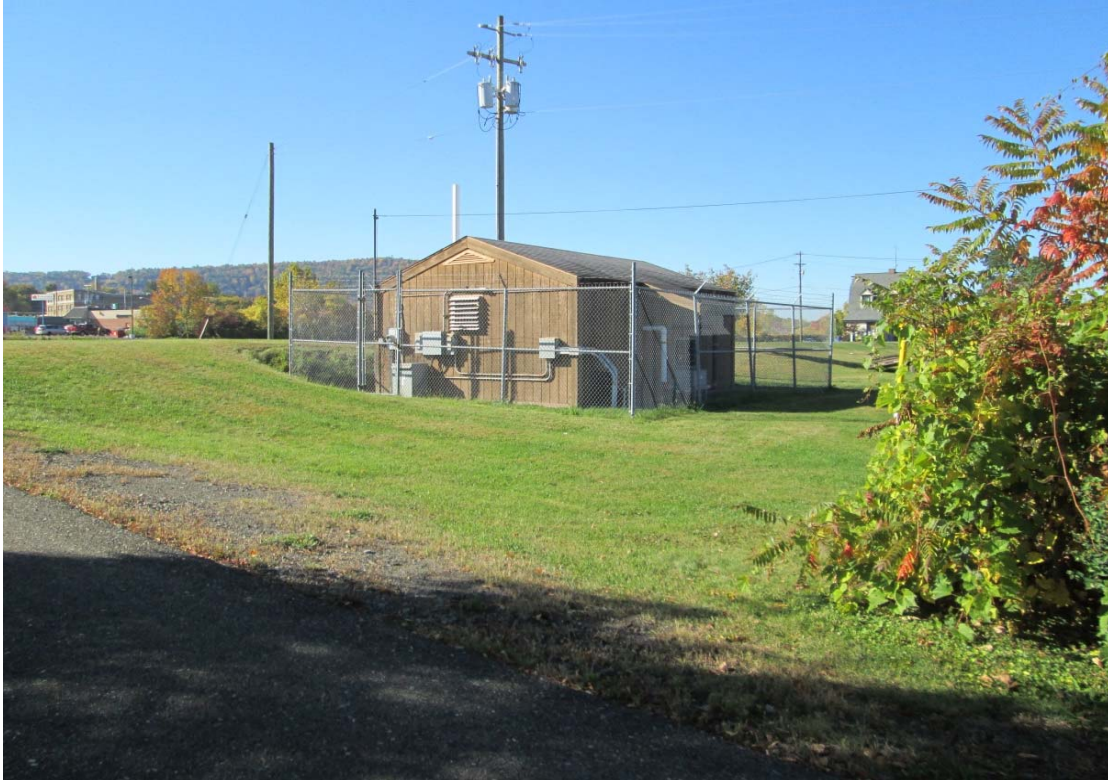
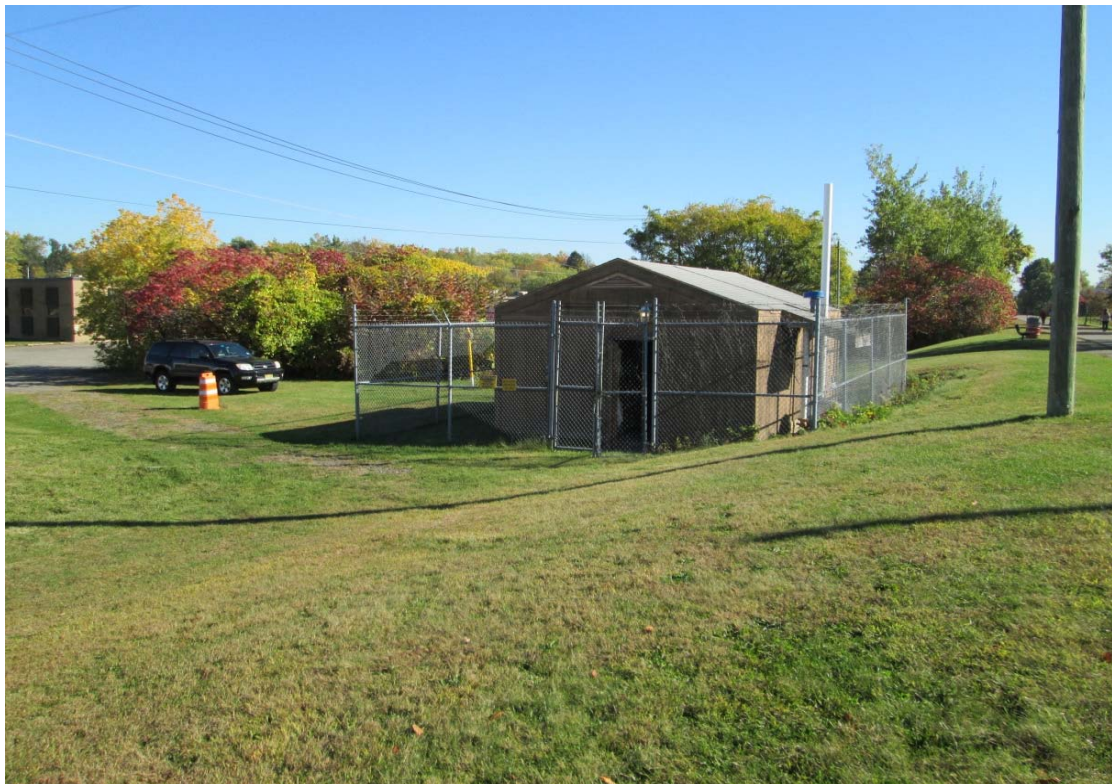
**Main Building**

No other operational issues were noted during the inspection. Both the distribution buildings and the adjacent parking lot area were inspected and no issues were noted.
