SUBJECT: August 2016 Operating Report for the Vestal Well Field 1-1 Superfund Site, Area 4,  
Vestal, New York

SUBJECT: August 2016 Monthly Report on Activities at the Vestal Well field 1-1 Superfund Site, Area 4, Vestal, New York

**LATA Project # 11202**  
**Contract # W912DQ-09-D-3003,**  
**Task Order # 008**

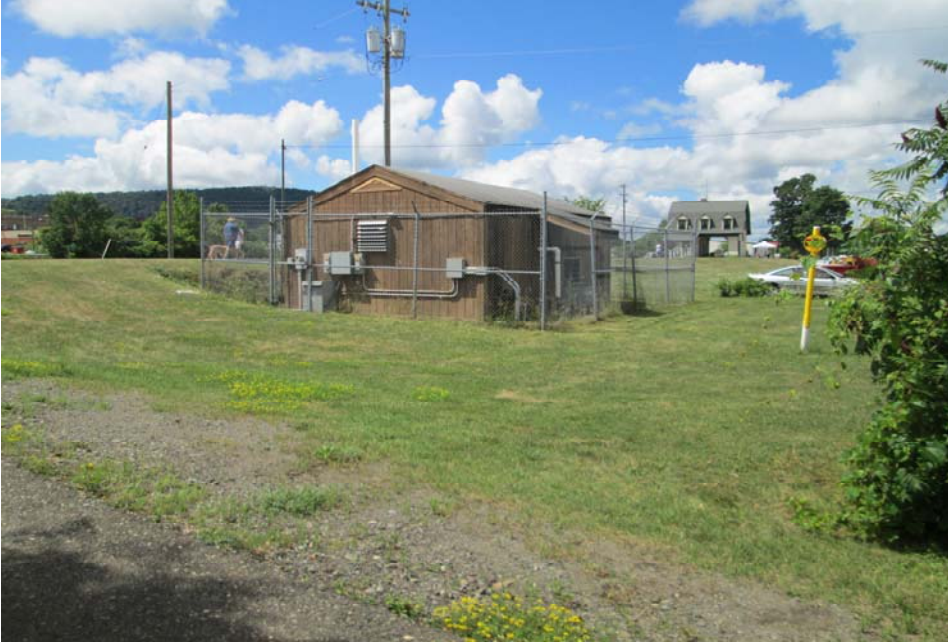
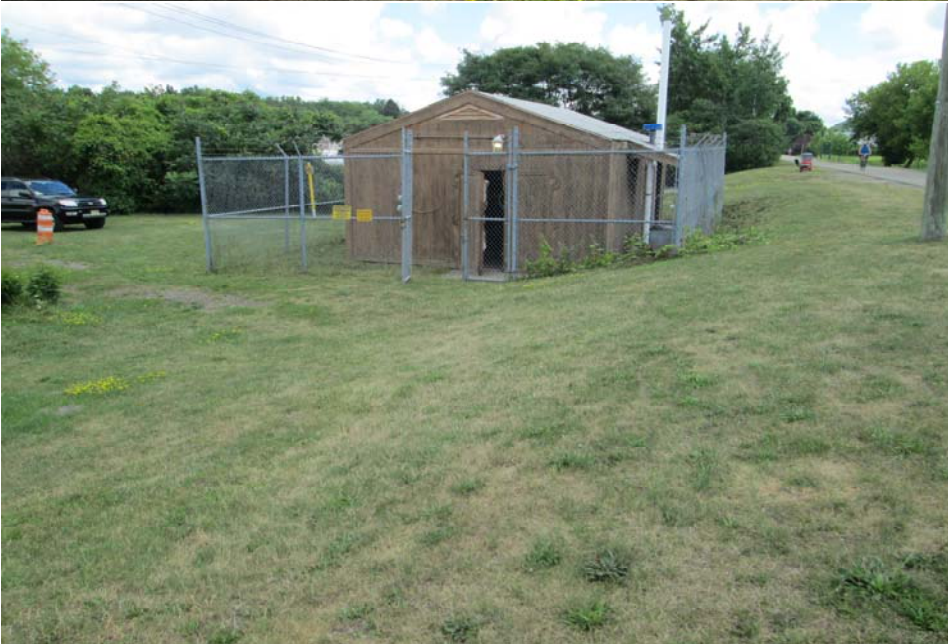
**Main Building**

No other operational issues were noted during the inspection. Both the distribution buildings and the adjacent parking lot area were inspected and no issues were noted.
