SUBJECT: June 2017 Operating Report for the Vestal Well Field 1-1 Superfund Site, Area 4,
Vestal, New York

SUBJECT: June 2017 Monthly Report on Activities at the Vestal Well field 1-1 Superfund Site, Area 4, Vestal,
New York

LATA Project # 11202
Contract # W912DQ-09-D-3003,
Task Order # 008

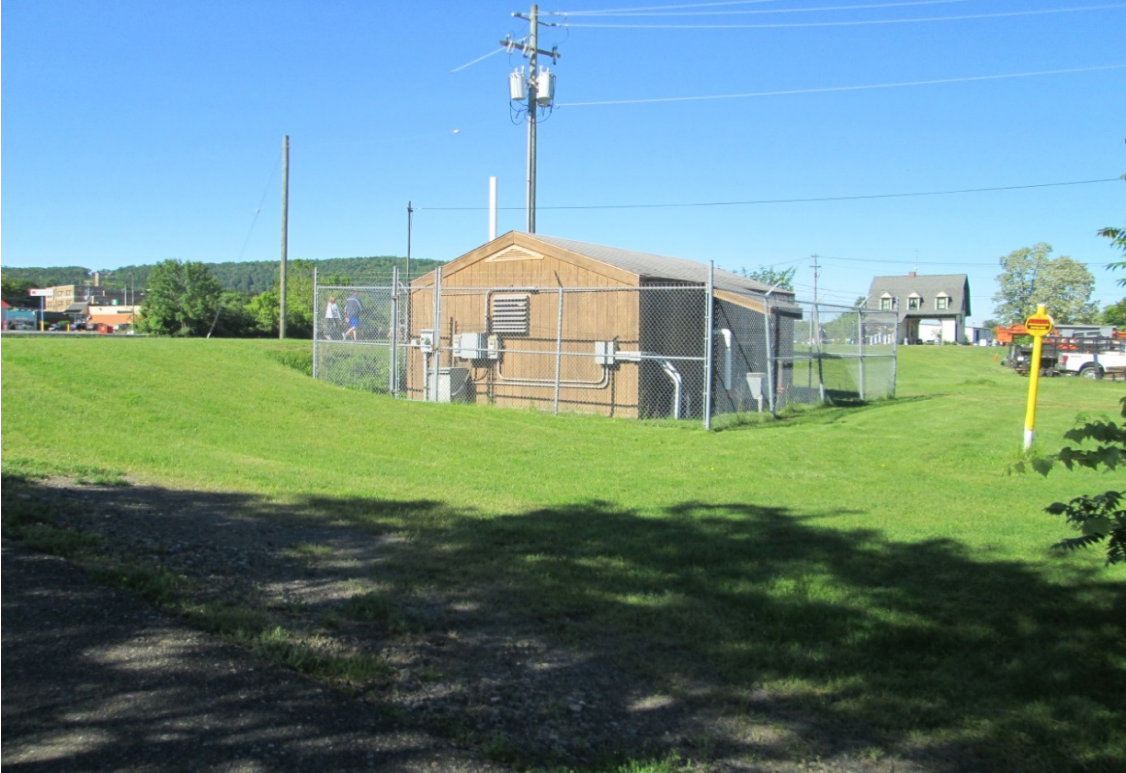
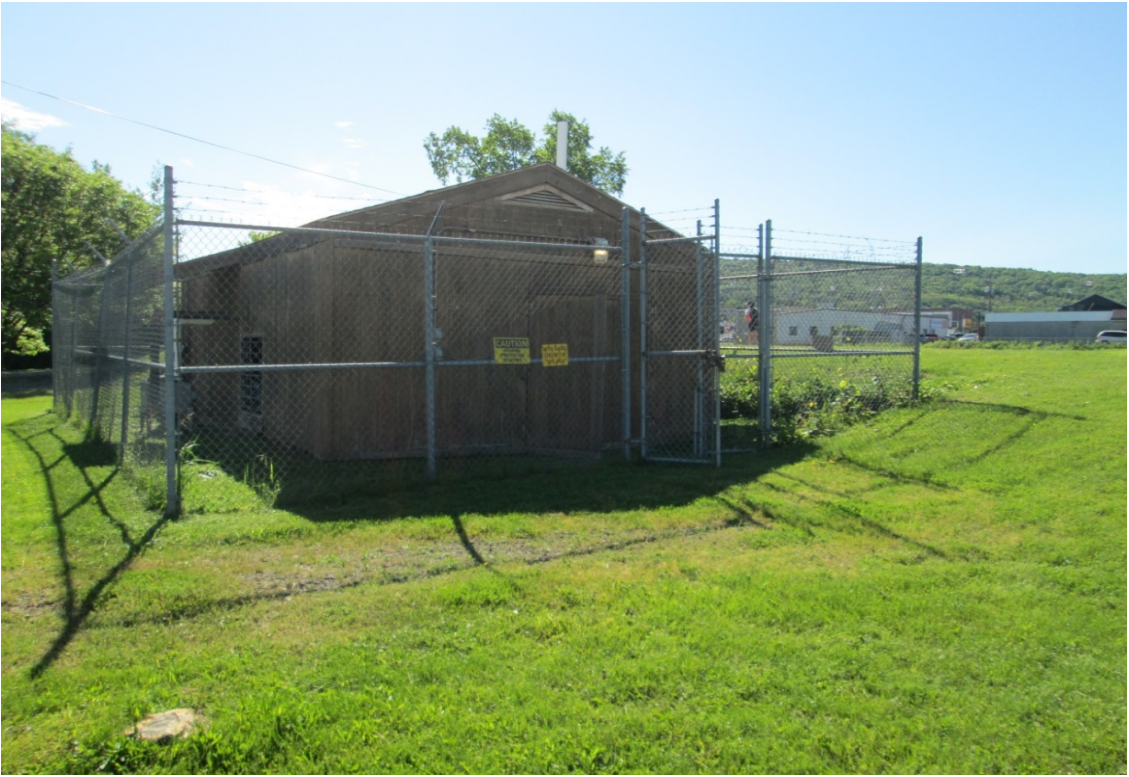
Main Building

No other operational issues were noted during the inspection. Both the distribution buildings and the adjacent parking lot area were inspected and no issues were noted.

Quality control activities (including field calibrations):
N/A
Health and safety levels and activities:
Problems encountered/corrective actions taken:
Small animal was able to get into the main building through small holes and a hornets nest was observed on the ceiling inside the main building. The holes were patched with wood from inside the main building, the hornets' nest was sprayed with Raid wasp/ hornet killer, and rodent bait blocks were placed around the inside of the main building.
Special notes:
Tomorrow's expectations:
