Re: Colesville Landfill Settlement Remediation

Investigation Report

COLESVILLE LANDFILL SETTLEMENT INVESTIGATION

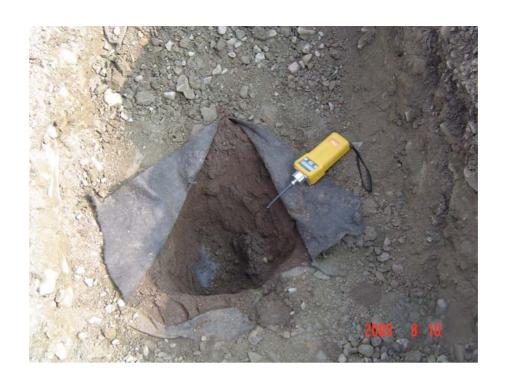
- a) The exposed liner in all seven locations appeared relaxed, and laid flat on the subgrade surface. There were no apparent signs of stress or tension, and no signs of undue wear or damage observed.

COLE-1 Investigation Location Liner Exposed

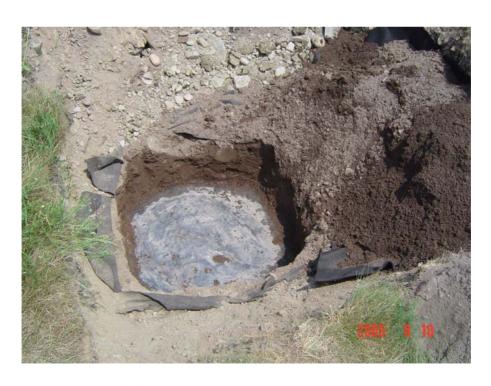
- d) While obtaining the samples for laboratory analysis, no stress was observed on the liner at any of the sample locations during the cutting of the liner.

COLE-1 Investigation Location Sample Preparation

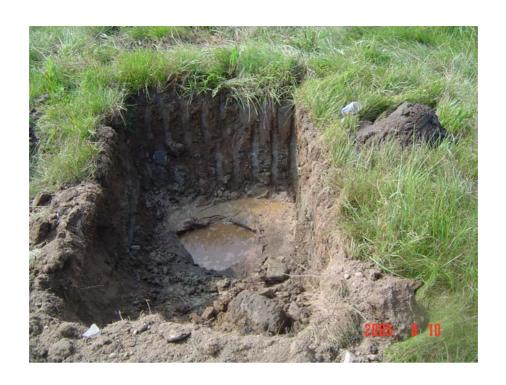
- b) At locations COLE-2, COLE-3, and COLE-5 (locations surrounding the basin of the depressed area) standing water was observed in the sand layer above the liner.

COLE-2 Investigation Location Standing Water in Drainage Layer Above Liner

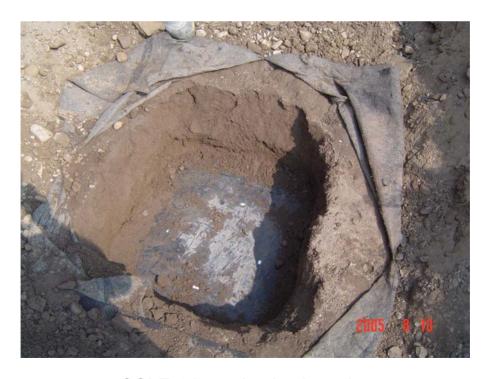
COLE-4 Investigation Location Liner Exposed

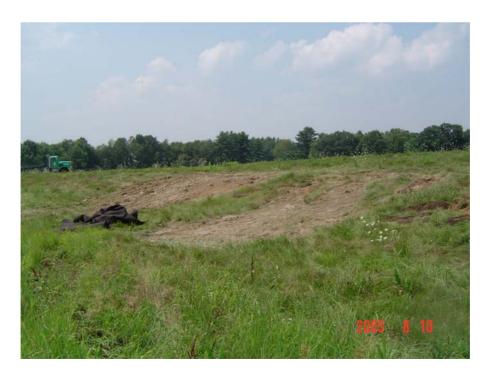
Backfilled Test Pits
