Broome County Division of Solid Waste Management

RE: Colesville Landfill Cap Regrading Report

Colesville Landfill
Cap Maintenance Report – Regrading for Drainage
October 2010

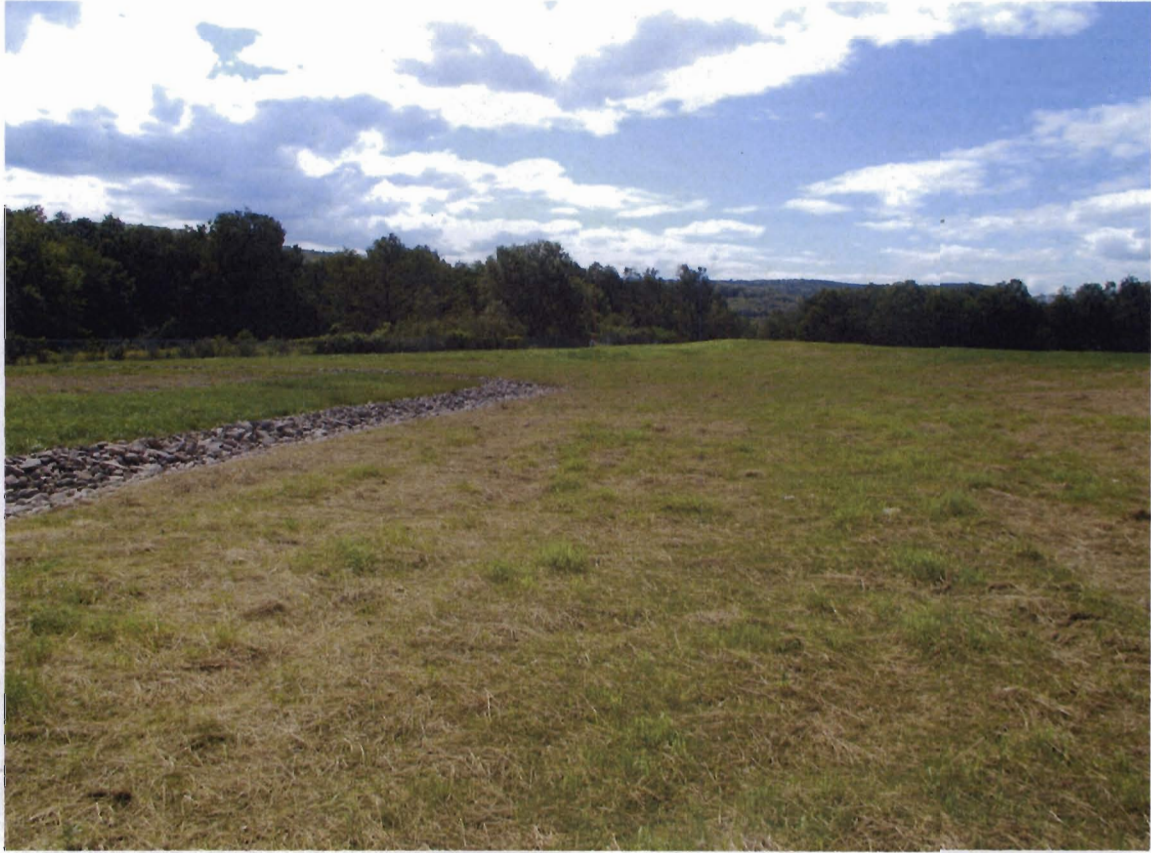
Repaired Settlement, picture taken on 8/26/10

In accordance with the NYSDEC approved Work Plan, Broome County successfully conducted landfill cap maintenance in the settlement area at the Colesville Landfill in August of 2010. On August 5, 2010 Broome County Landfill employees mobilized equipment to the site and installed silt fencing. From August 9th through August 12th the drainage channel was installed, the area around it was re-graded, then seeded and mulched. Heavy rain came through the area on August 23rd and the site was checked on August 26th. Everything was intact and there were no signs of erosion.

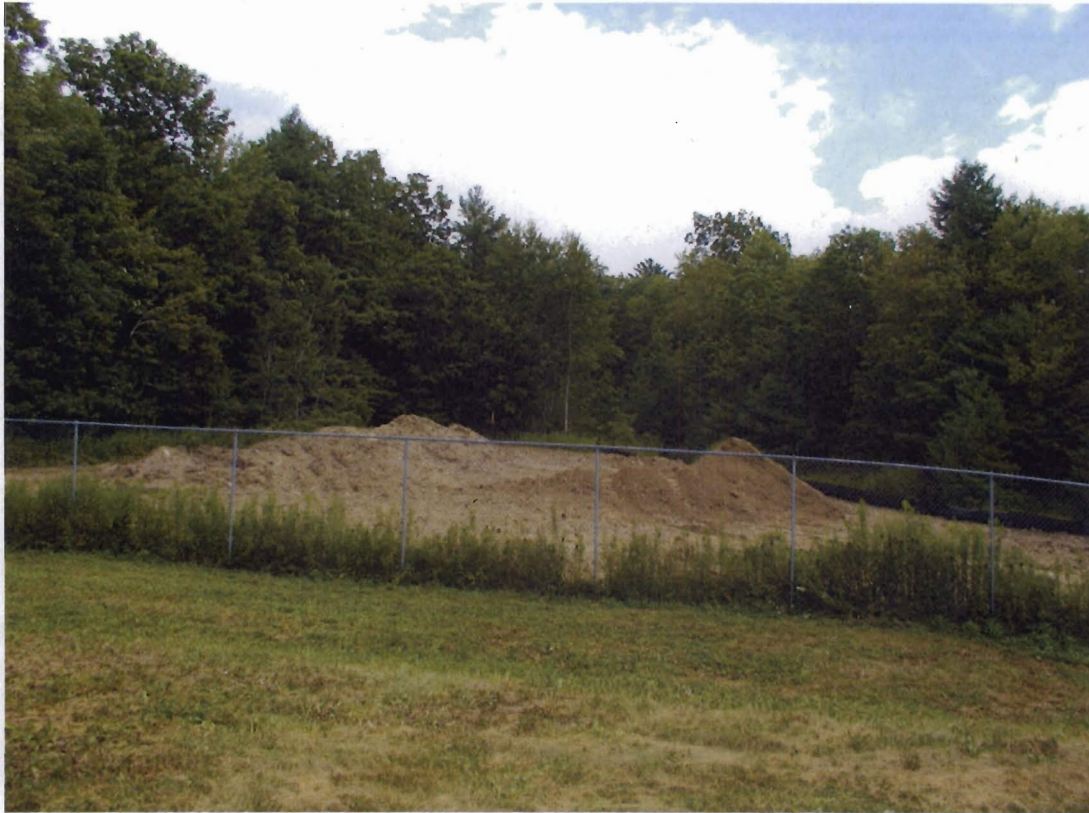
Borrow area

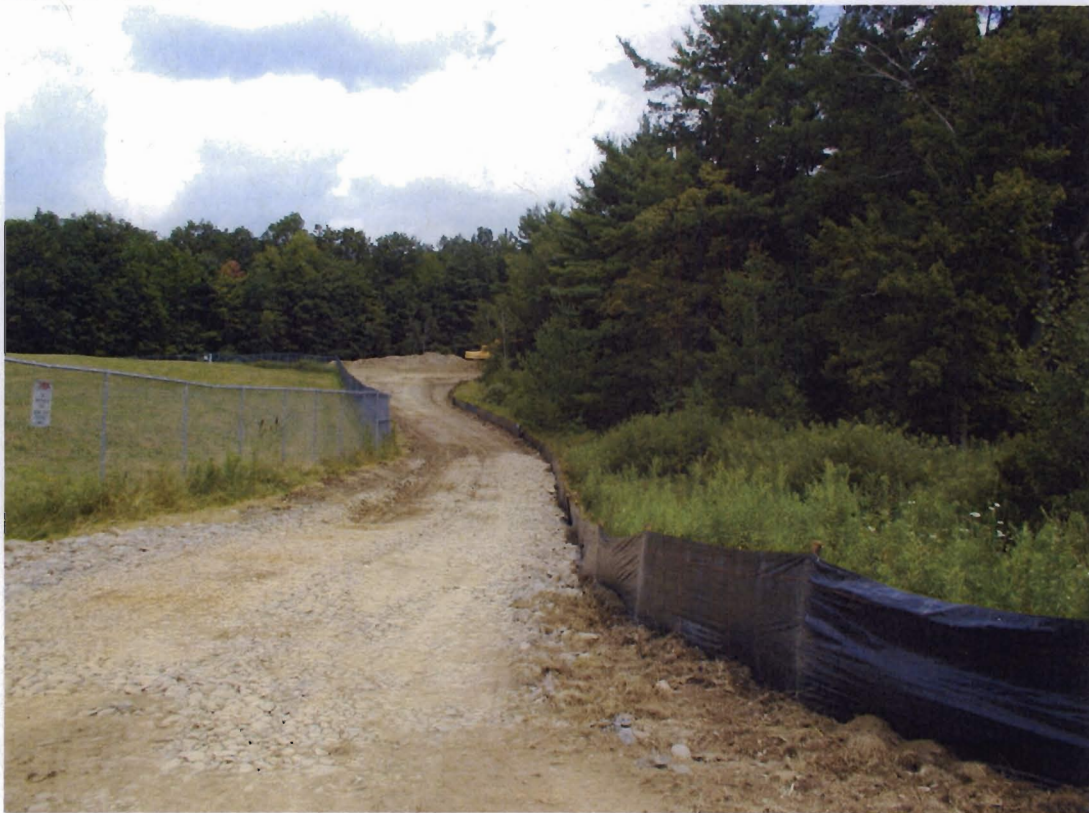
Temporary haul road to borrow area with silt fence

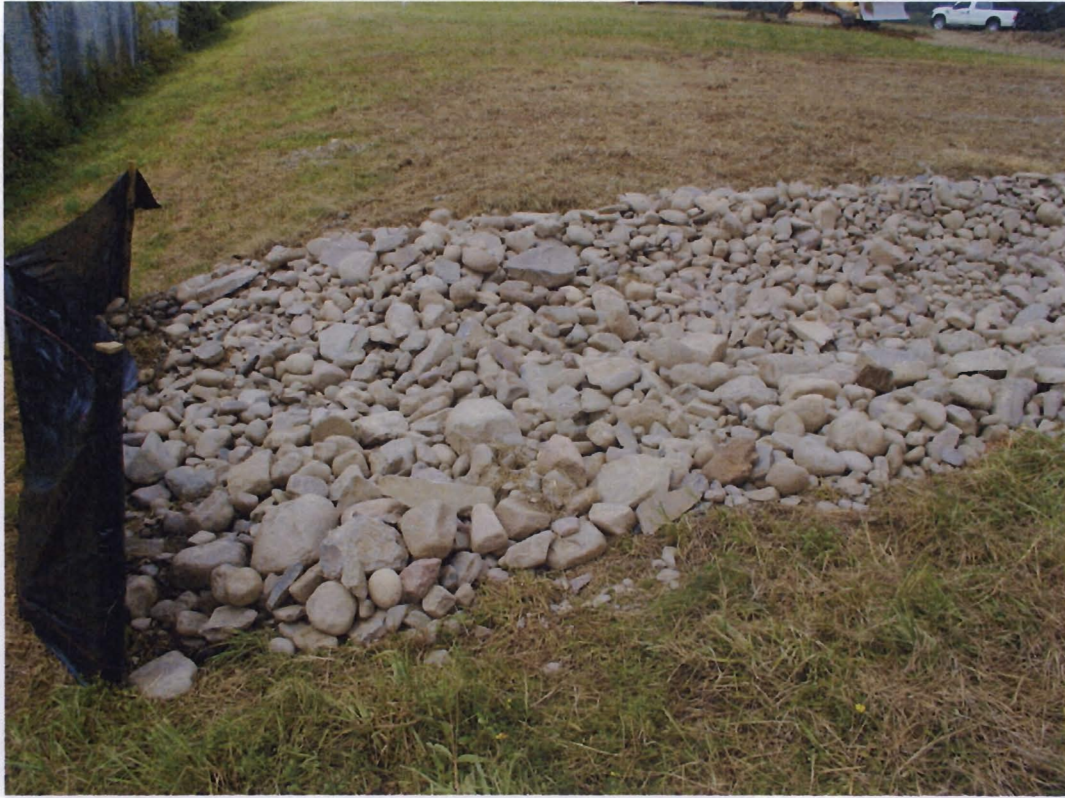
South End of Ditch

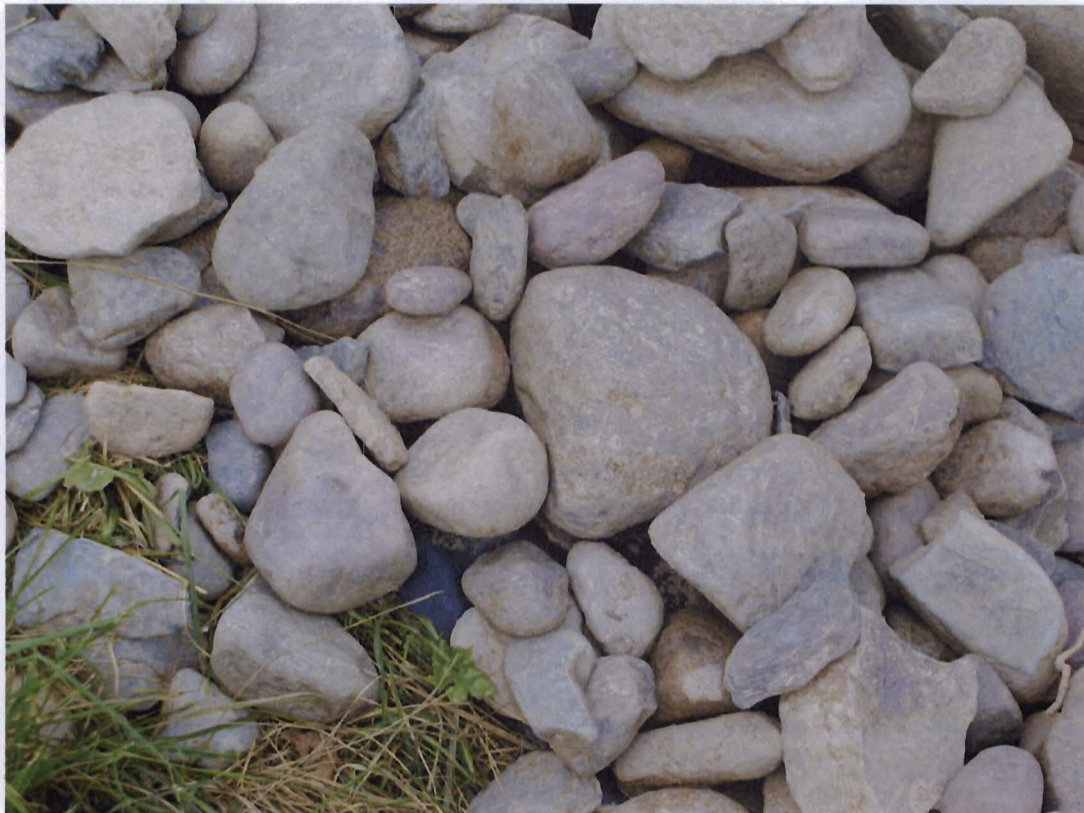
Rock over fabric in new ditch

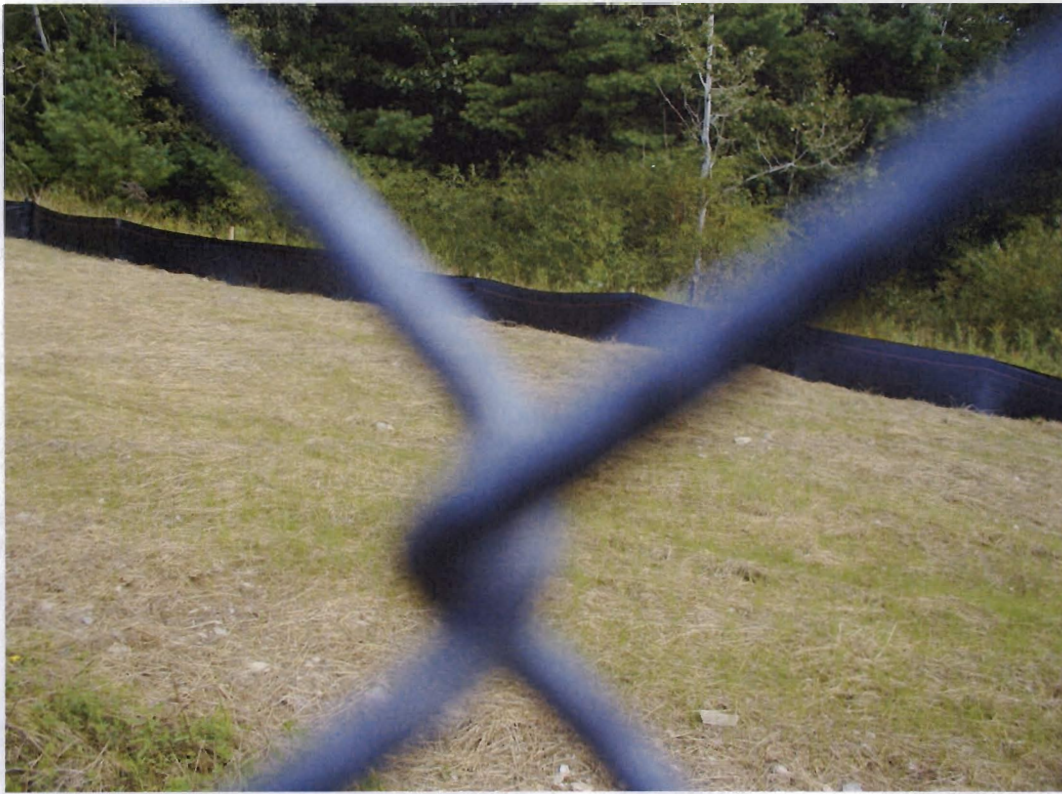
Haul road seeded and mulched, picture taken on 8/26/10

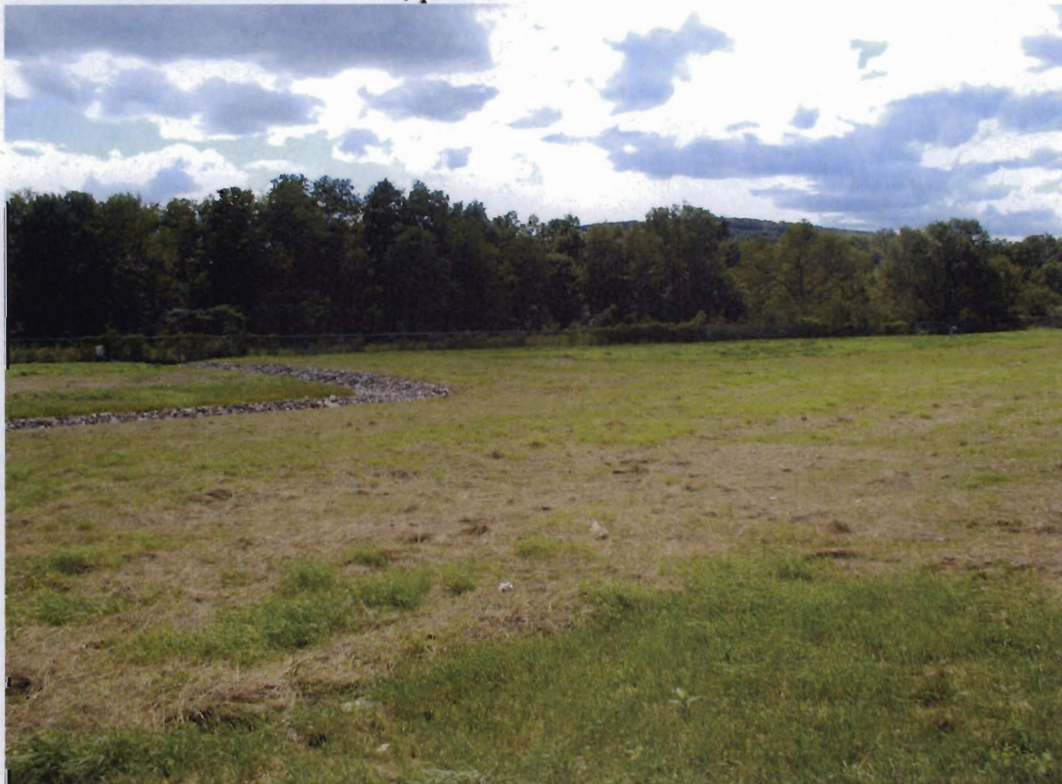
Ditch and graded area, pictured on 8/26/10
