Re: Colesville Landfill, Site No. 704010
Periodic Review Report 2016-2018

COLESVILLE LANDFILL
SITE NO. 704010
PERIODIC REVIEW REPORT
BROOME COUNTY
DIVISION OF SOLID WASTE MANAGEMENT
January 1, 2016 - December 31, 2018

Colesville Annual Inspection 2016

Colesville Landfill
2017 Inspection Pictures

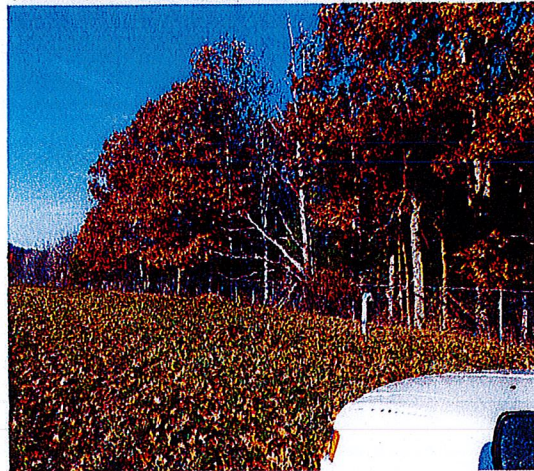
There is a tree down on the north fence that caused some slight bending of the fence. It will be removed and fixed.

Tree on north fence

- The landfill cap was mowed at least annually.
- Trees were removed from the perimeter fence of the landfill as needed and the fence was straightened.
- The surface sediment was removed in the areas of SP-3 and SP-4 at least annually and as needed. During the November 10, 2016 event sediment at SP-3 was removed to rock and a bucket of upstream sand was collected and placed there to facilitate future scrapings.
- SP-3 formed a channel along the streambank that was sampled at its midpoint in March and towards the end of the channel in December 2016. This extra sampling along the

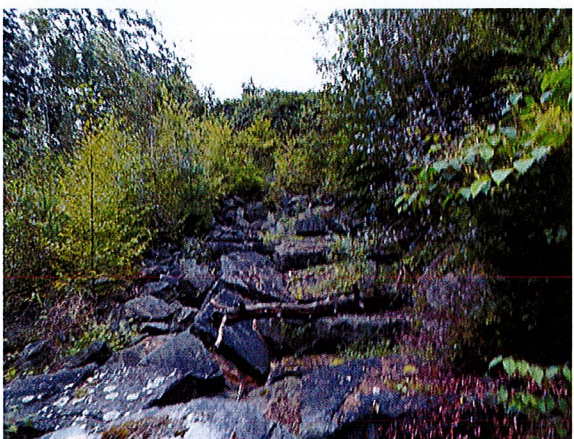
Downchute after storm inspection Date: 9/21/2018

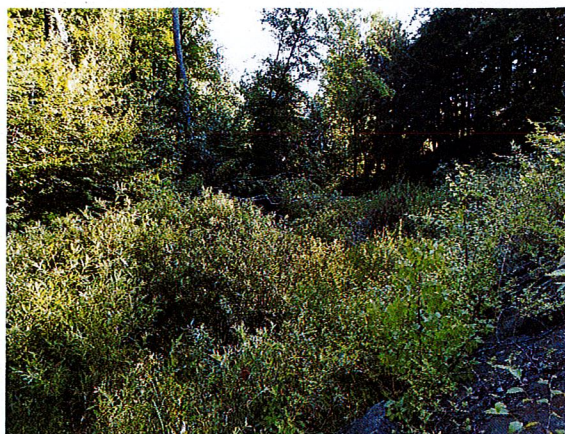
- The sediment results for SP-3-SED indicate that impacts are mostly limited to the surface and that limited excavation of the surficial sediment is a viable interim measure.

SP-3 before cleanup Date: 7/20/2018

- During the 2018 June/July events, samples were taken prior to and then following the cleanup to evaluate the effectiveness of the scraping.
- Deposited material was cleaned out of the SP-5 drainage pipe during monitoring.

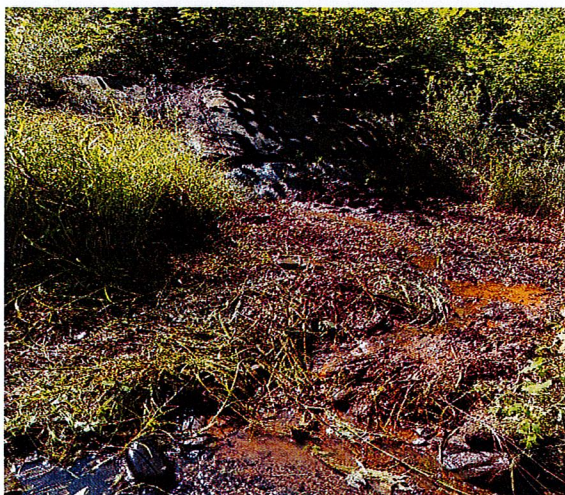
SP-3 after cleanup Date: 7/20/2018
