# REMEDIAL INVESTIGATION

## FEASIBILITY STUDY

### GORICK C & D LANDFILL

#### VOLUME I REMEDIAL INVESTIGATION

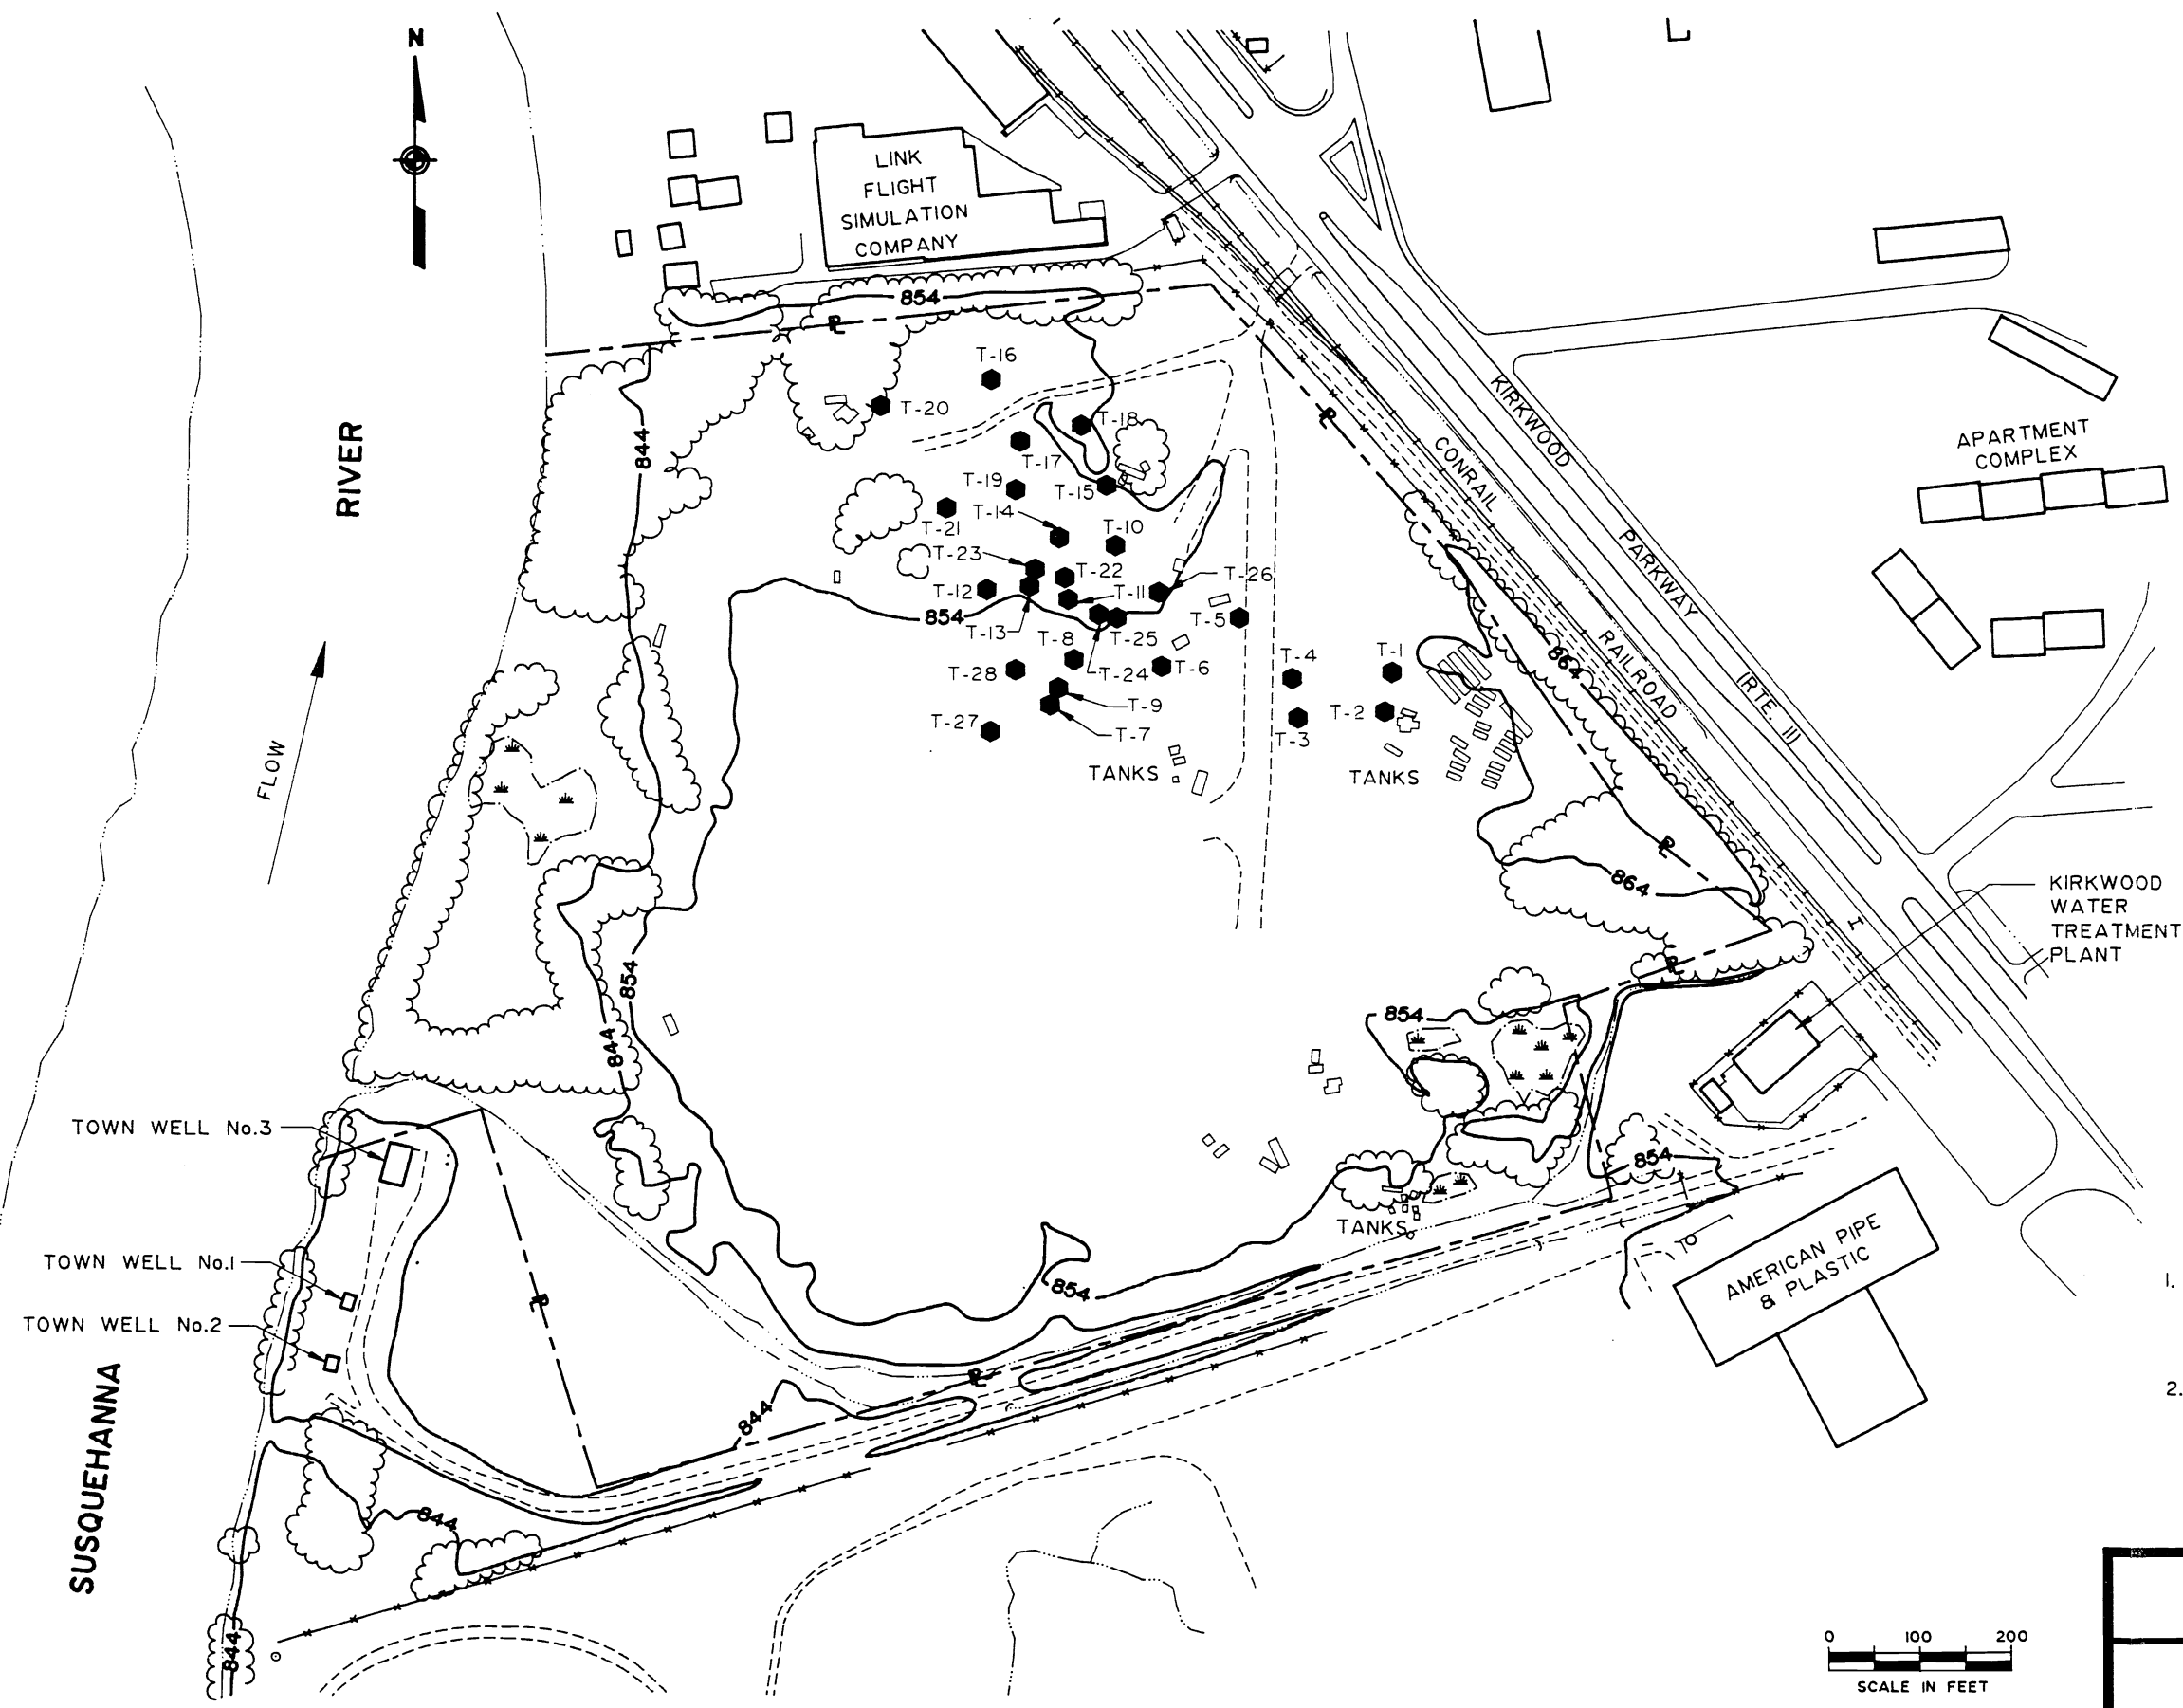
It was planned to excavate 3-5 pits in each of three areas at the site. Two of these areas are in the fill (upper and lower plateaus) and the third area was just east of the fill, downgradient of the railroad near the center of the eastern boundary of the site, where approximately 20 rusted storage tanks are lying on the ground. Some of these tanks have had their ends cut open or removed. During the second-phase field work, however, time allowed for the number of test pits and area covered to be expanded from what had been planned. Twenty eight (28) test pits/trenches were dug using a CAT-215 (or CAT-225) backhoe. Figure 2-1 shows the approximate locations of the test pits and trenches.

● TEST PIT/ TRENCH

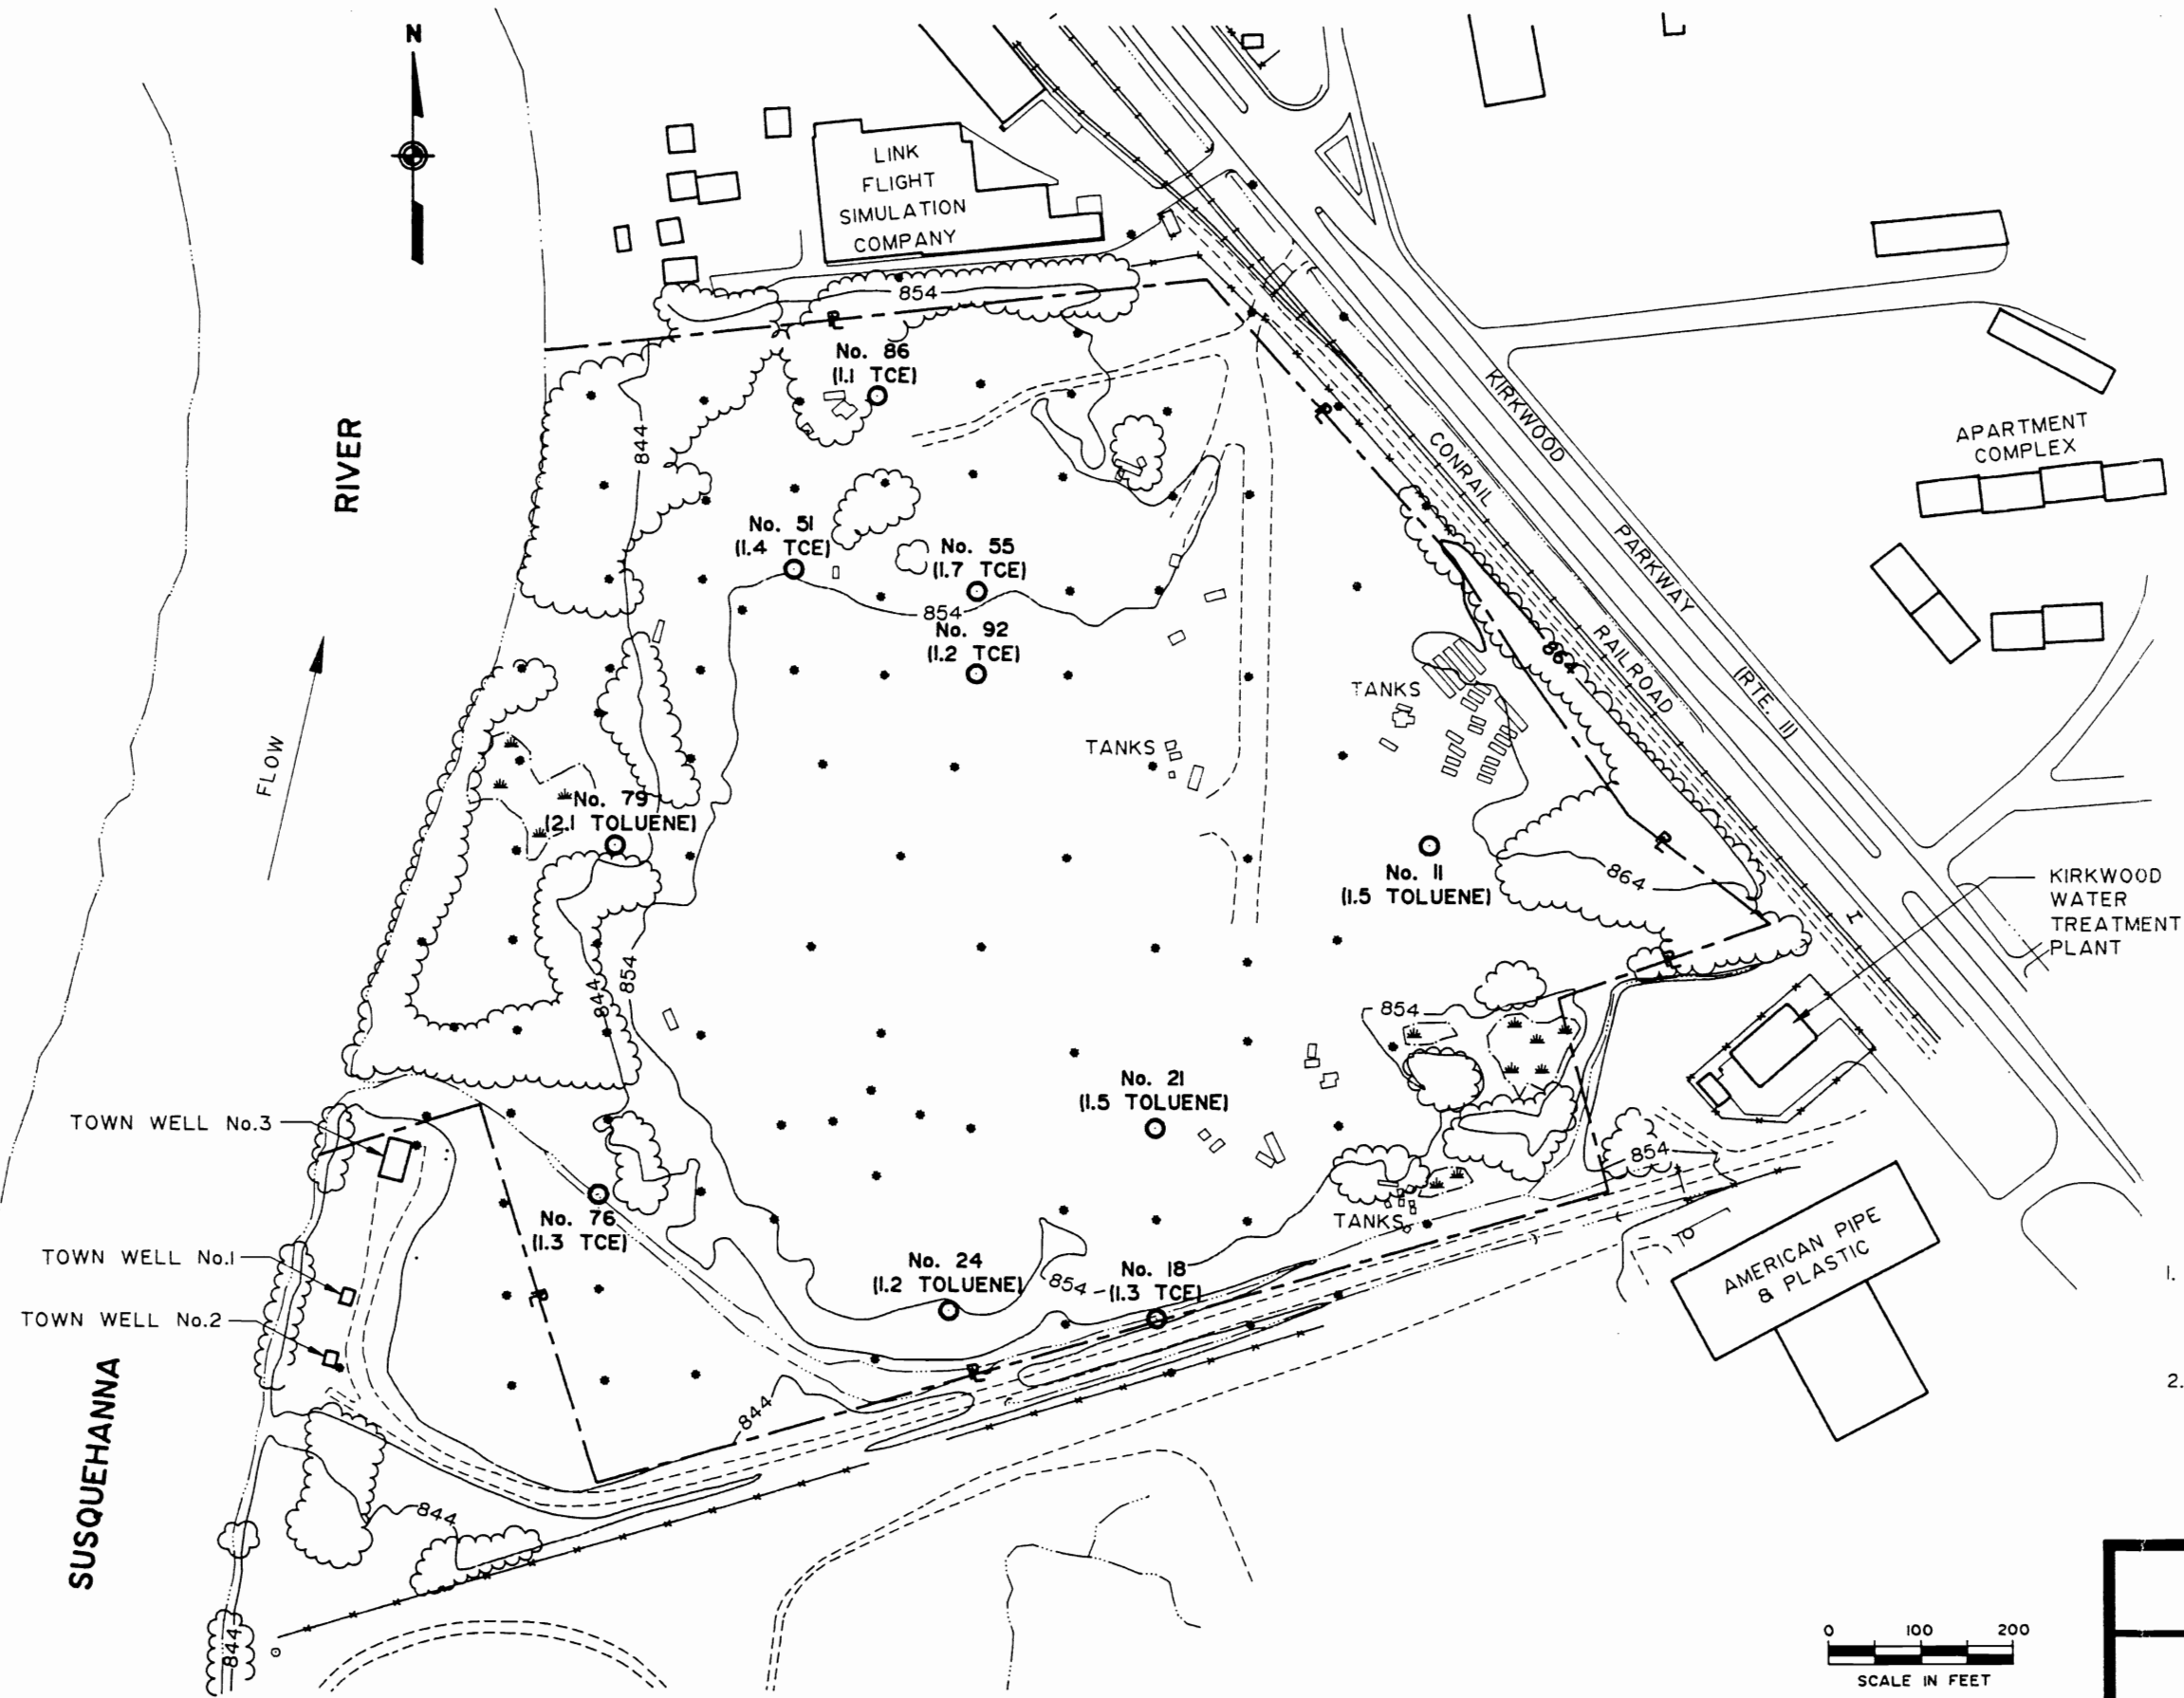
- SOIL GAS SAMPLE LOCATION; NO DETECTIONS
- SOIL GAS SAMPLE LOCATION; CONCENTRATION (ppb); COMPOUND DETECTED
