Reference: EPA Contract No. 68-W9-0040; Work Assignment
No. R02-10-01; Ashland Chemical, Inc.;
Binghamton, New York; EPA I.D. NYD049253719;
RCRA Facility Assessment; Visual Site
Inspection Summary Report; Final Deliverable

FINAL VSI SUMMARY REPORT

ASHLAND CHEMICAL, INC.
BINGHAMTON, NEW YORK
EPA. I.D. No. NYD049253719

I. INTRODUCTION

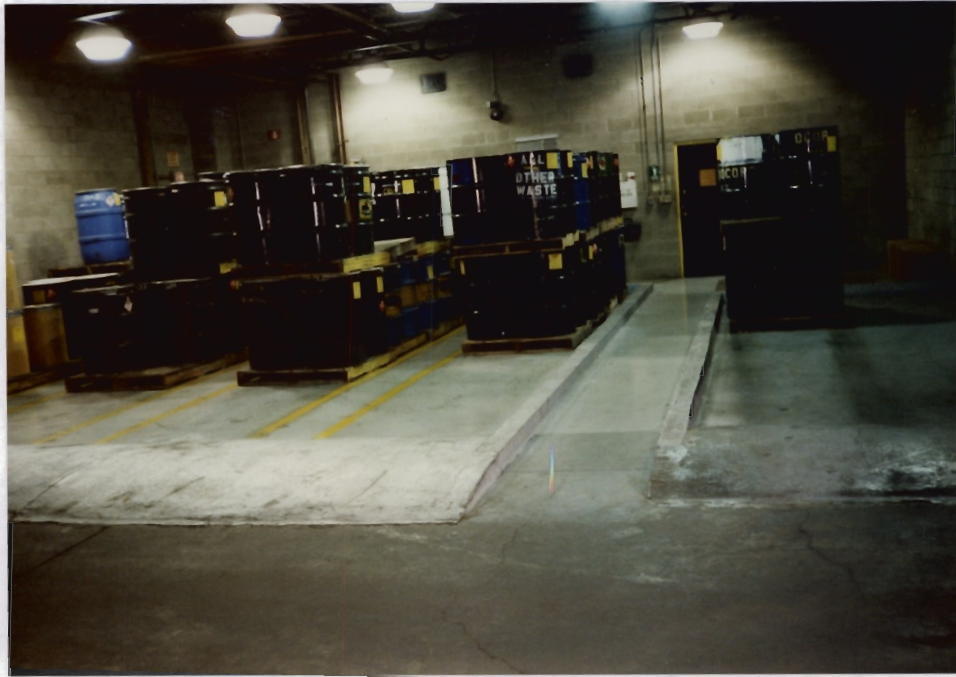
The unit is located inside Warehouse No. 1 in the northeast section of the facility. This active, interim status unit consists of three compartments utilized to segregate ignitable, corrosive, noncorrosive, and non-hazardous wastes. The unit has been active since 1985 and has a combined storage area of approximately 5,500 square feet. Wastes stored at the unit include Ignitable wastes, halogenated toxic wastes, EP toxic wastes, spent commercial solvents, corrosive wastes, toxic wastes, plating/metal wastes acutely toxic wastes, and New York Non-Hazardous Wastes. Approximately 98 percent of the wastes are stored in 55-gallon drums with the remaining two percent consisting of storage in fiber drums and five-gallon pails. Drums are stored on wooden pallets stacked two high. The concrete floor is coated with a polyester resin that is corrosive resistant. The wastes are received by the facility via trucks which are unloaded through two loading docks situated on the south side of Warehouse No. 1. There are no bulking or analytical activities conducted at this unit or at the facility. The VSI Team observed approximately 350 drums stored at this unit.

1. View inside Warehouse No. 1 showing the drum storage area for flammable (ignitable) wastes at the Hazardous Waste Container Storage and Staging Area (SWMU 1). The unit is located in the northeast section of the facility.

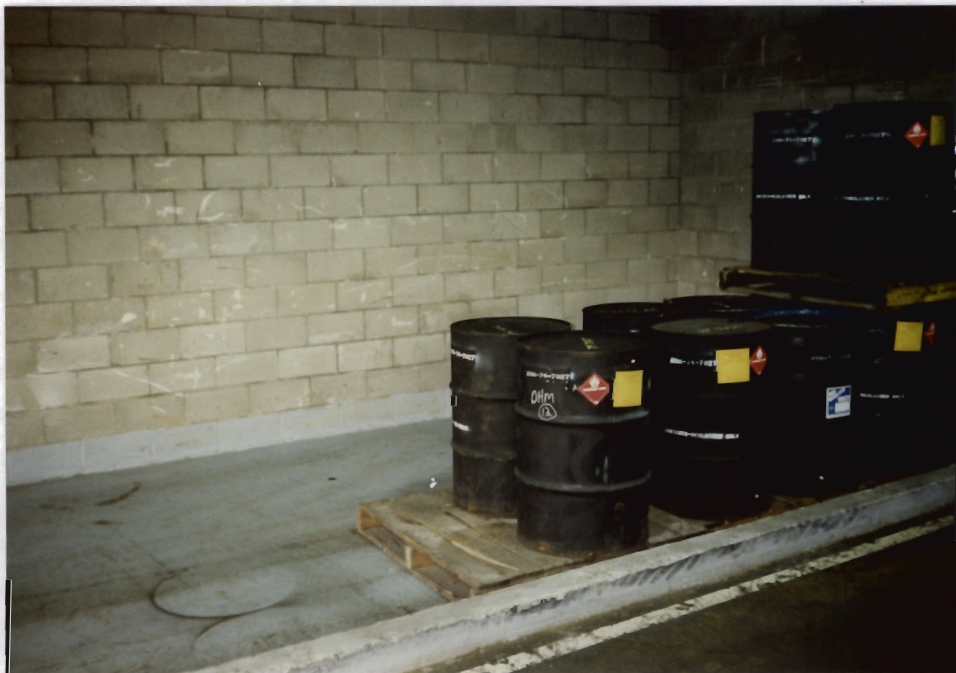
2. View of additional drum storage for flammable wastes at the Hazardous Waste Container Storage and Staging Area (SWMU 1).

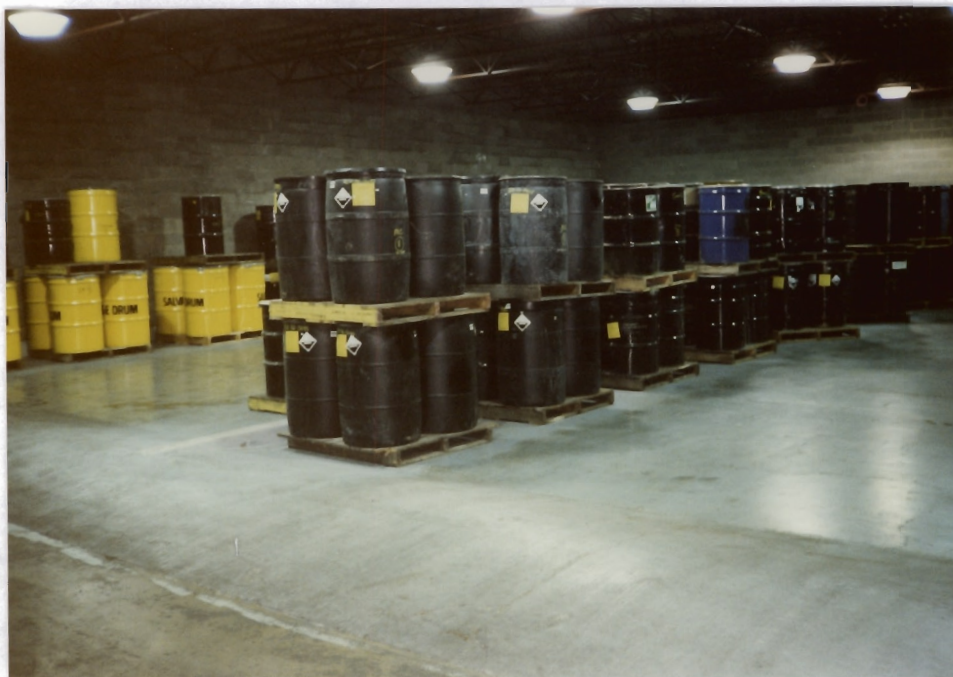
3. View of the corrosive waste storage area located at the Hazardous Waste Container Storage and Staging Area (SWMU 1). The non-ignitable and non-corrosive waste storage area for this unit is located to the immediate right of the photograph.

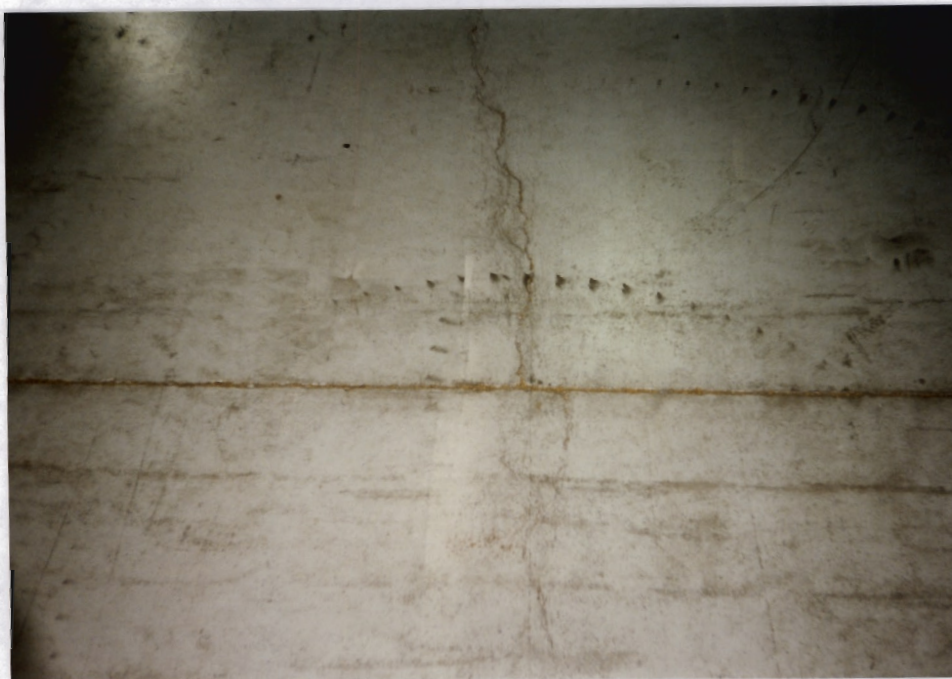
4. Close-up of the floor in the vicinity of the corrosive waste storage area at the Hazardous Waste Container Storage and Staging Area (SWMU 1). The floor is coated with a polyester resin that is corrosive resistant. The cracks are reportedly sealed and appeared to be filled with an absorbent.

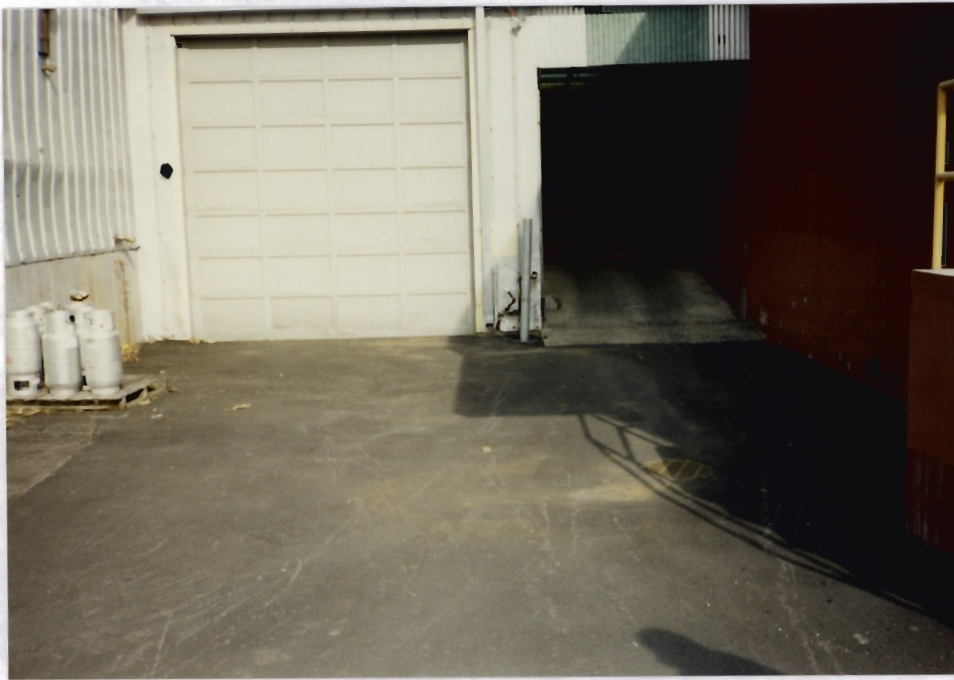
5. View of the ramp between Warehouse No. 1 and 2 showing the catch basin connected to the storm sewer. The red building on the right is Warehouse No. 1.

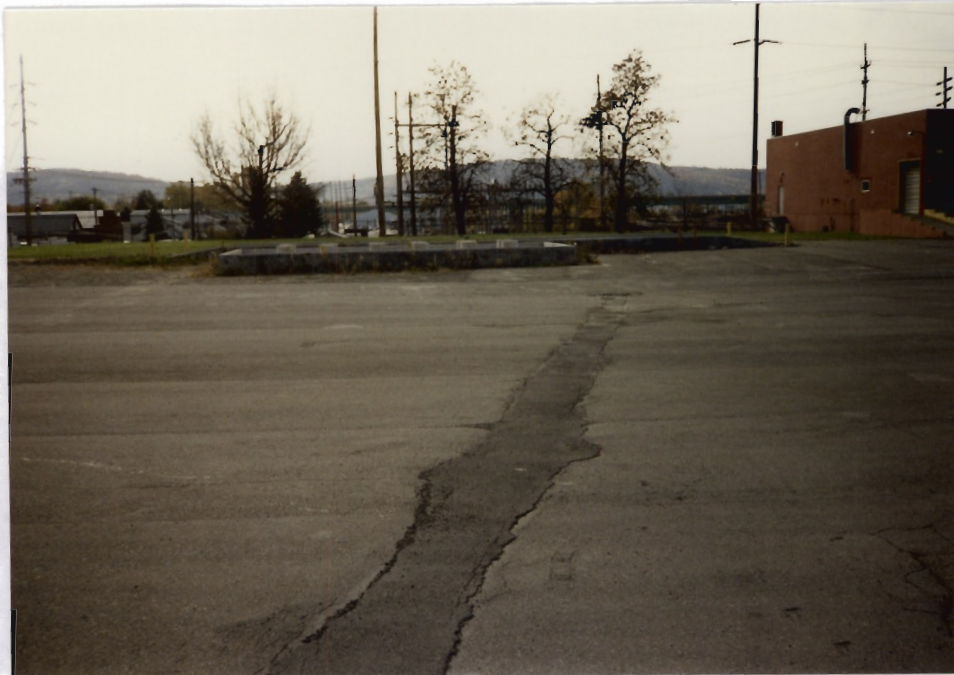
6. Overview of the south section of the facility facing south. The view shows Warehouse No. 4 on the right and the former location of the Solvent Blending Tanks 101, 102, and 103 in the center of the photograph. Another catch basin connected to the storm sewer is located at the end of the newer asphalt shown in the foreground.

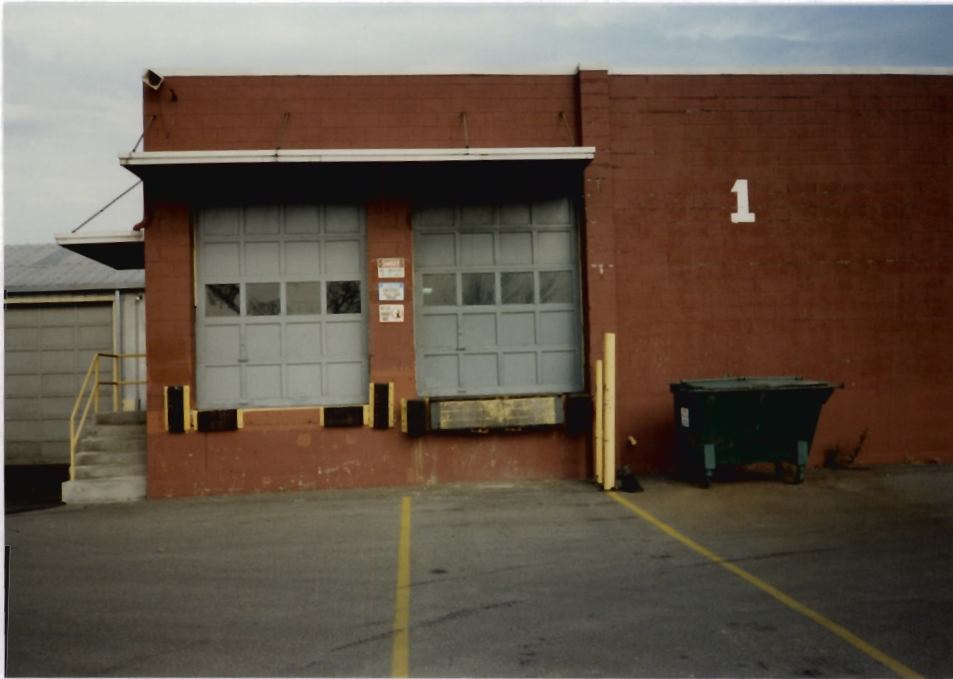
This active unit is a self-contained metal container located outside Warehouse No. 1 in the northeast section of the facility. Units of this type have been operating at the facility since at least 1976. The unit is approximately five feet long, four feet wide, and four feet tall. The unit is elevated above the asphalt via metal legs and wheels. The unit receives domestic refuse.

7. View of the loading docks for the Hazardous Waste Container Storage and Staging Area (SWMU 1) facing north. The general refuse Dumpster (SWMU 12) is shown on the right.

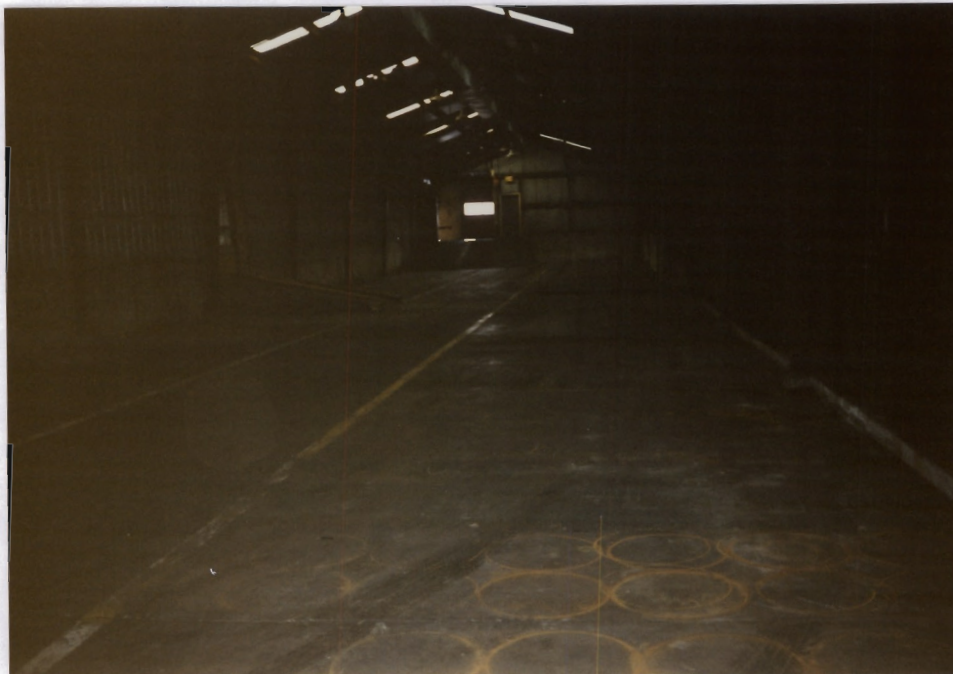
8. View inside Warehouse No. 2 located in the north section of the facility. The view shows the lower, product storage section of the warehouse. Note the rust stains in the foreground.

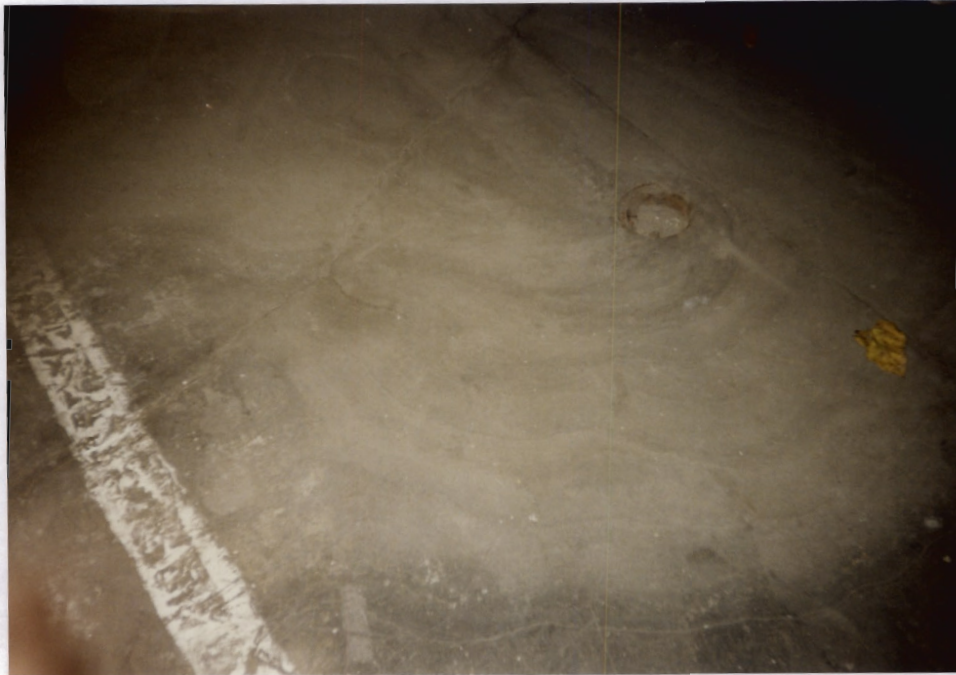
The unit consists of two drains observed during the VSI. One drain was identified inside Warehouse No. 2 and was reportedly designed to collect emergency sprinkler water in the event of a fire. The other drain was located in the immediate vicinity of an old paint booth inside Warehouse No. 4. The paint booth was reportedly used for drum reconditioning activities. Both drains appeared to have received building/equipment washdown that may have contained hazardous constituents. Facility representatives were unable to provide information pertaining to the disposition of the drains or wastes managed.

9. Close-up of the floor inside Warehouse No. 2 showing a Drain (SWMU 13). The drains inside Warehouse No. 2 were reportedly installed for drainage in the event the emergency fire sprinklers were used.

For the Drains (SWMU 13), it is suggested that the facility provide more detail on the composition of the washwaters regarding hazardous constituents. If it is determined that hazardous constituents were in the washwater, an integrity assessment of the drains and associated piping is suggested. Integrity testing of the Process Pipeline (SWMU 6) and the Post Treatment Sewer (SWMU 11) is also suggested.

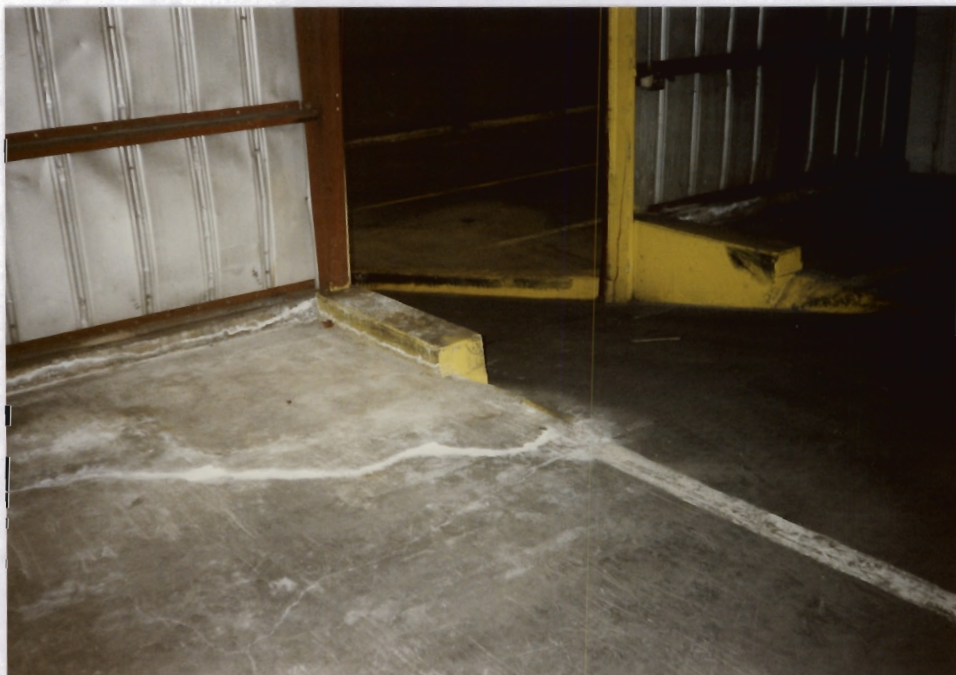
10. Interior view of Warehouse No. 2 showing a ramp connecting the upper and lower levels. The Drain (SWMU 13) that was featured in Photograph 9 is in the center of the photograph (indicated by an arrow).

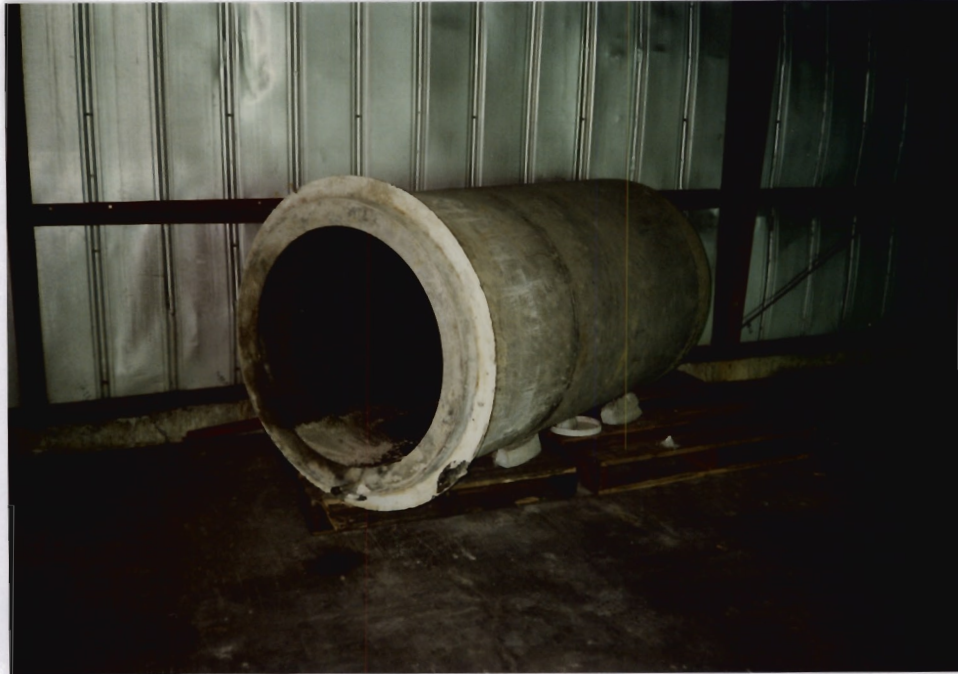
11. Interior view of Warehouse No. 2 showing the Solvent Recovery Sump identified as a SWMU in the PR. The sump was never used.

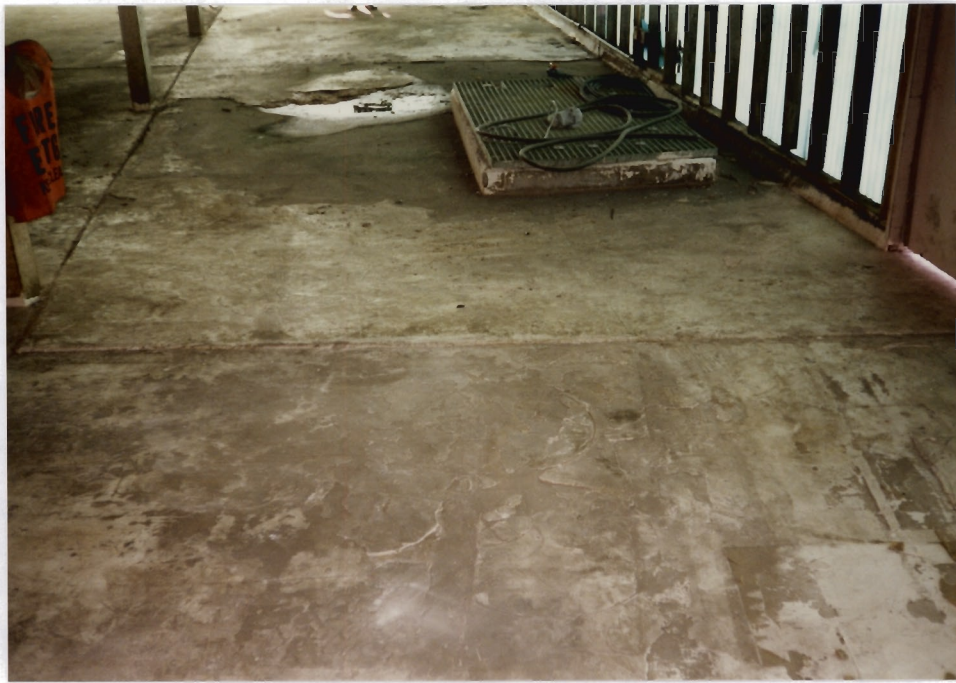
13. View of the Barrel Wash Station (SWMU 4). Note the eroded concrete filled with water in the top center of the photograph.

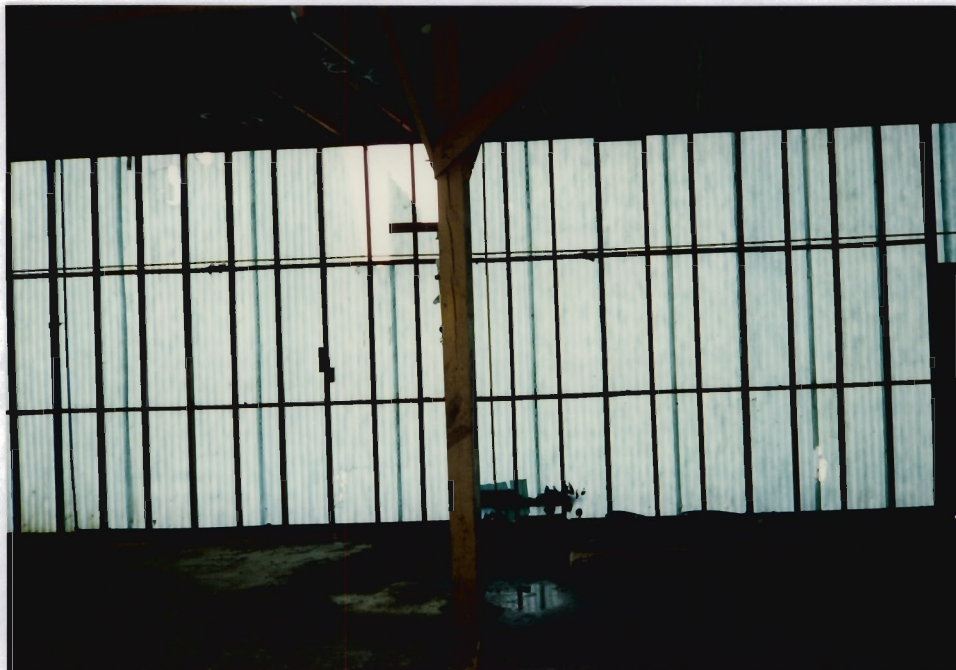
14. View of the Barrel Wash Station (SWMU 4) facing west. The current Neutralization Pit (SWMU 2) is located outside the green corrugated fiberglass wall shown in the center of the photograph.

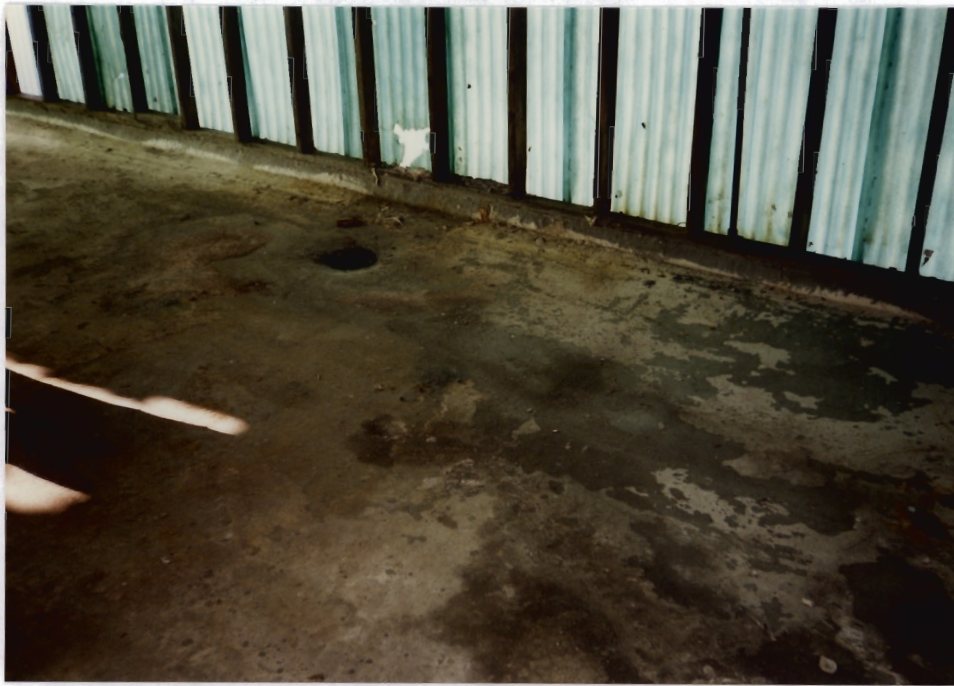
The inactive unit consists of pipes used to transfer wastewater from the Barrel Washing Station (SWMU 4) and the Fume Scrubber (SWMU 5) as well as spillage from the Acid Truck Unloading Pad (SWMU 10) to the Neutralization Pits (SWMUs 2 and 3). The pipes are located above and below-ground. The wastewater contained dilute amounts of caustic; muriatic, nitric, sulfuric, hydrochloric acid; and small amounts of formaldehyde. The unit is located throughout the immediate vicinity of Warehouse No. 3. There is approximately 150 feet of pipe. Some sections of pipe have been removed since some of the units, previously connected to the lines, have been dismantled. The unit operated from 1976 to 1990. Soil samples were taken from the vicinity of where the pipes connect to the Acid Truck Unloading Pad (SWMU 10) and where the pipes connect to the Neutralization Pit (SWMU 2). These samples were taken at the time the Neutralization Pit (SWMU 2) investigation was conducted. A pH of 7.2 was indicated for the soil sample taken near the pit and a pH of 4.7 was indicated for the soil sample taken near the unloading pad.

15. View of the immediate vicinity of the Barrel Wash Station (SWMU 4) showing a drain connected to the Process Sewer (SWMU 6). The view also shows the former location of the Fume Scrubber (SWMU 5).

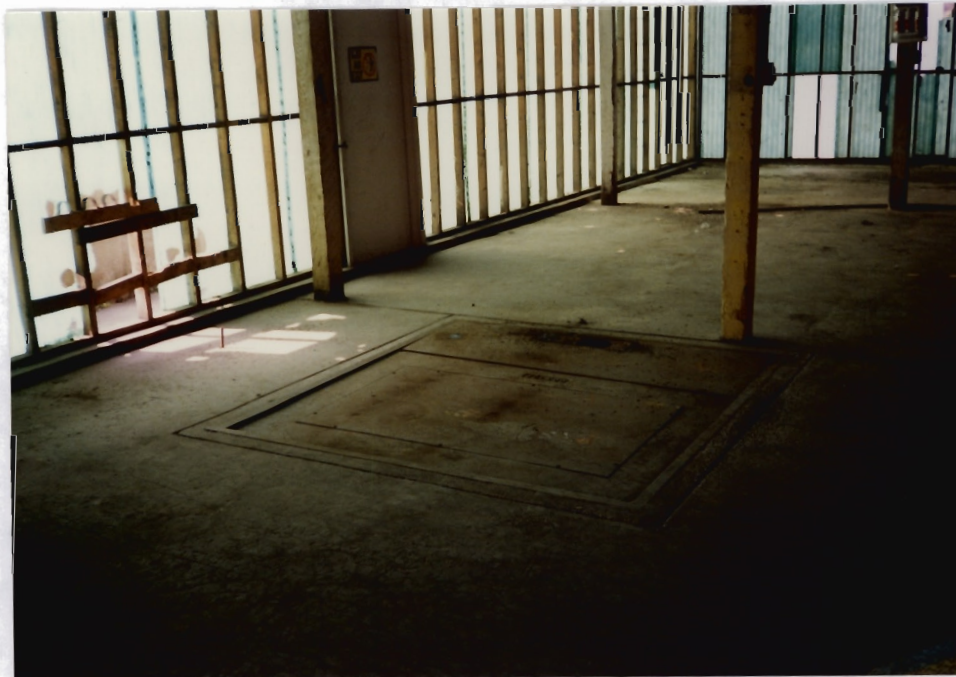
16 View inside Warehouse No. 3 showing a scale previously used at the Acid Drumming Station. The station was identified as a SWMU in the PR report. However the station was for product drumming activities.

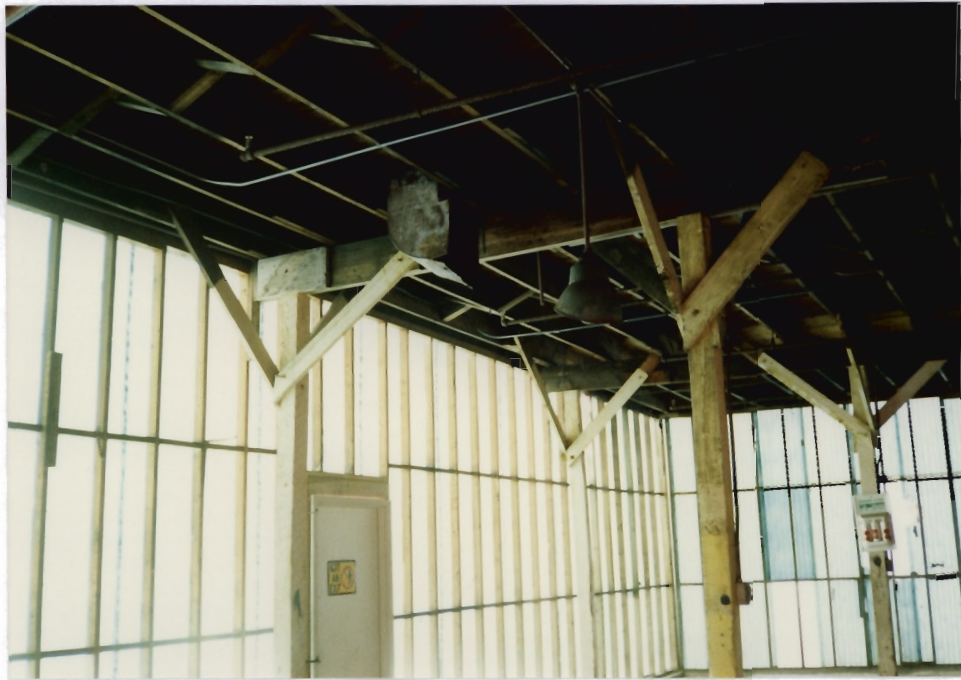
17. View inside Warehouse No, 3 showing a vent in the top of the photograph.

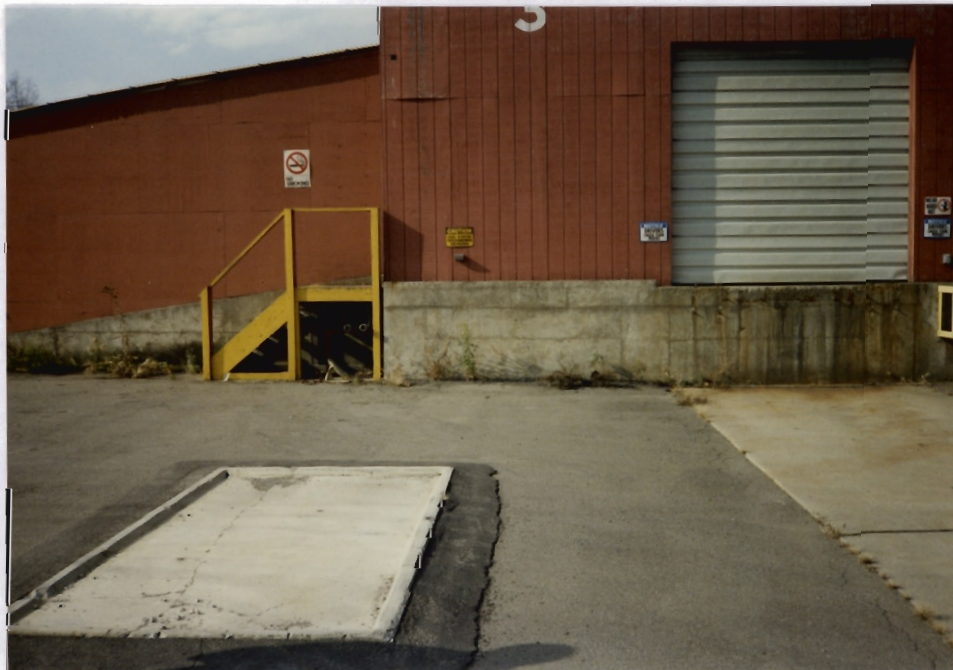
This inactive unit is located outdoors on the east side of Warehouse No. 3 in the northwest section of the facility. The unit consists of a small concrete pad approximately 10 feet long, five feet wide, surrounded by a concrete curb approximately six inches high. The pad was used to stage solvent transfer hoses during unloading operations. The unit had a belt of new asphalt around the outside of the curbing at the time of the VSI. Minor cracks were also observed. However, no stains were observed on the concrete. The unit operated from approximately 1987 to February 1990 and may have received small amounts of drippage consisting of various solvents including, but not limited to, acetone, toluene, and xylene.

18. View of Warehouse No. 3. showing Solvent Tank Truck Loading/Unloading Area (SWMU 9) identified by the small concrete pad shown in the foreground. The view is facing west.

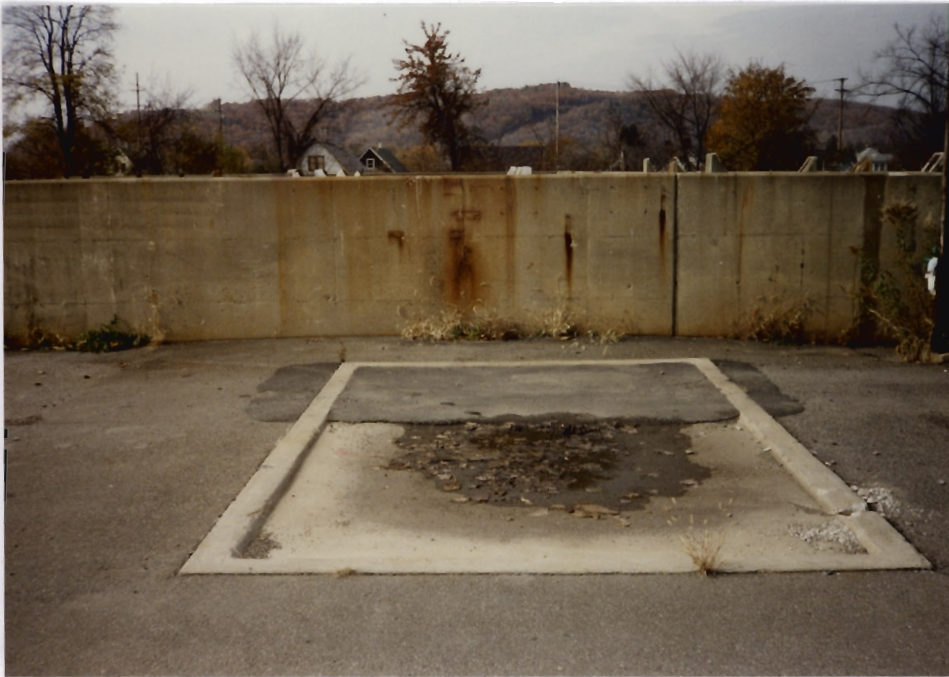
This unit is located outdoors on the southeast side of Warehouse No. 3 in the west section of the facility. The unit consists of a concrete pad approximately 12 feet long, six feet wide, and four inches deep. The pad is equipped with a small metal pipe drain connected to the Process Pipeline (SWMU 6). The drain was filled with water and leaves and the west end of the pad was covered with an asphalt patch, at the time of the VSI. The unit received nitric, sulfuric, and hydrochloric acid drippage from the truck unloading activities. The unit operated from 1976 to February 1990. Soil samples were collected from the immediate vicinity of the unit during 1988. Results of the analysis indicated a pH of 4.7.

19. View of the Acid Truck Unloading Pad (SWMU 10) located in the vicinity of the Solvent Tank Truck Loading/unloading Area (SWMU 9) in the west section of the facility. The view is facing west. The former Acid Tanks (Tks 4-6), identified as SWMUs in the PR, were supported by the concrete structure shown in the background of the photograph.

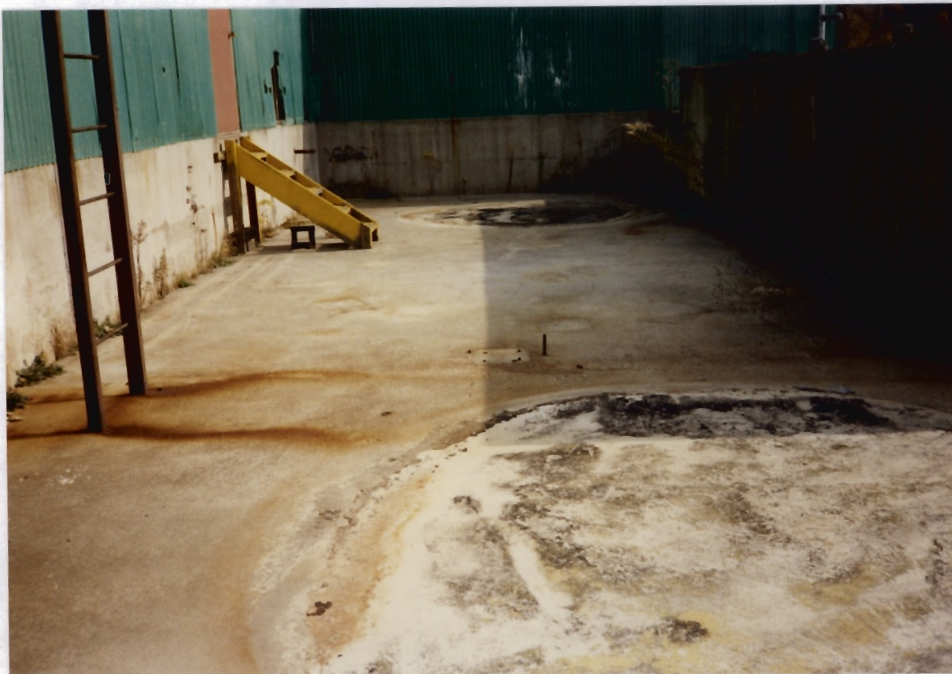
20. View outside Warehouse No. 3 showing the location of the former Solvent Tanks (Tks 1-3) facing east. These tanks were identified as SWMUs in the PR.

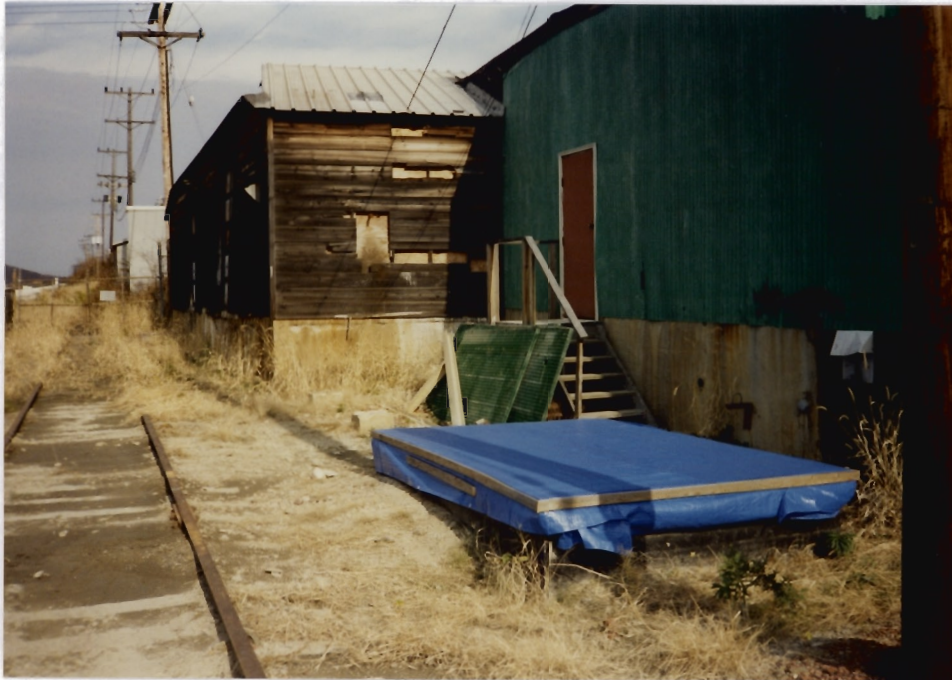
The inactive unit is located outdoors on the west side of Warehouse No. 3 in the northwest section of the facility. This unit replaced the Old Neutralization Pit (SWMU 3). Both neutralization pits occupied the same location and were used to neutralize wastewater and spillage generated at the Barrel Wash Station (SWMU 4), the Fume Scrubber (SWMU 5), the Acid Truck Unloading Pad (SWMU 10), and the acid drumming operations, which were conducted in Warehouse No. 3. The unit received the wastewaters and spillage via the Process Pipeline (SWMU 6). The inactive Neutralization Pit (SWMU 2) was installed during June 1987 and was used until February 1990. The pit was observed to be covered with a plastic tarp at the time of the VSI. The unit consists of an in-ground, precast concrete septic tank, with walls eight inches thick. The tank is 11 feet long, seven feet wide, and five feet deep and has been lined with a corrosive resistant polyester resin (Hetron). The capacity of the tank is 2000 gallons. The wastewaters previously received by the unit contained dilute amounts of muriatic, nitric, sulfuric, and hydrochloric acid; caustic rinseate from drum washing operations; and formaldehyde rinseate. Drums that had contained

formaldehyde were reportedly rinsed during one operation at the Barrel Wash Station (SWMU 4). Therefore at one time the wastewater contained dilute amounts of formaldehyde in addition to the acidic and alkaline wastewaters. The neutralization operations conducted at the pit consisted of adding caustics or acids to the wastewater to maintain a pH range of six to nine. Following neutralization, the contents of the pit were discharged to the Post Treatment Sewer (SWMU 11) via a portable pump and hoses. The Post Treatment Sewer (SWMU 11) intake point is located inside Warehouse No. 3. The Neutralization Pit (SWMU 2) developed a leak in 1988. After the unit was repaired, soil sampling was conducted by the facility. The samples were analyzed for formaldehyde, mineral salts, and pH. The results of the analysis indicated no concentrations of formaldehyde above the detection limit of 10 ppm. Up to 350 ppm nitrate, 95 ppm chloride, and 2000 ppm sulfate were detected. The pH range of the soil samples was 4.7 to 7.3.

21. View of the Neutralization Pit (SWMU 2) located outside Warehouse No. 3 in the northwest section of the facility. The view is facing northeast. The Old Neutralization Pit (SWMU 3) was also situated at this location.

During the VSI, facility representatives provided the results of soil analysis for soil sampling conducted at the Neutralization Pit (SWMU 2). The soil samples were analyzed for formaldehyde, mineral salts, m and pH. The results of analysis indicated formaldehyde below the detection limit. However, no specific quality assurance/quality control documentation was provided. Unless specific quality assurance/quality control procedures can be documented by the facility, it is suggested that additional soil sampling be conducted at this unit as part of the RFI. Additional samples should be analyzed for formaldehyde.

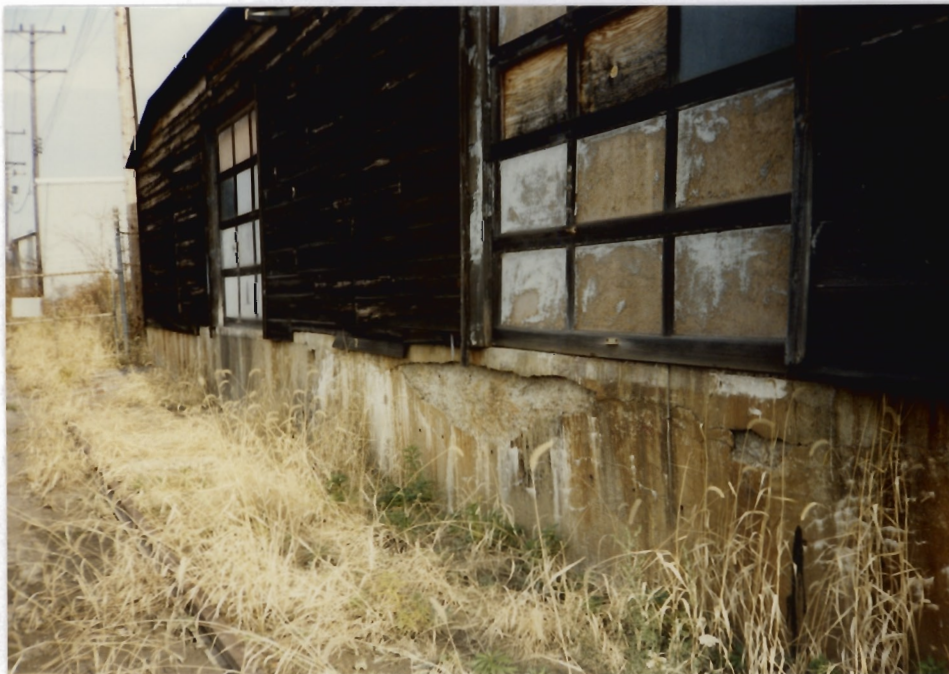
22. View of Warehouse No. 2 facing northeast showing what appeared to be railcar loading bays. According to facility representatives, Ashland only received materials via trucks.

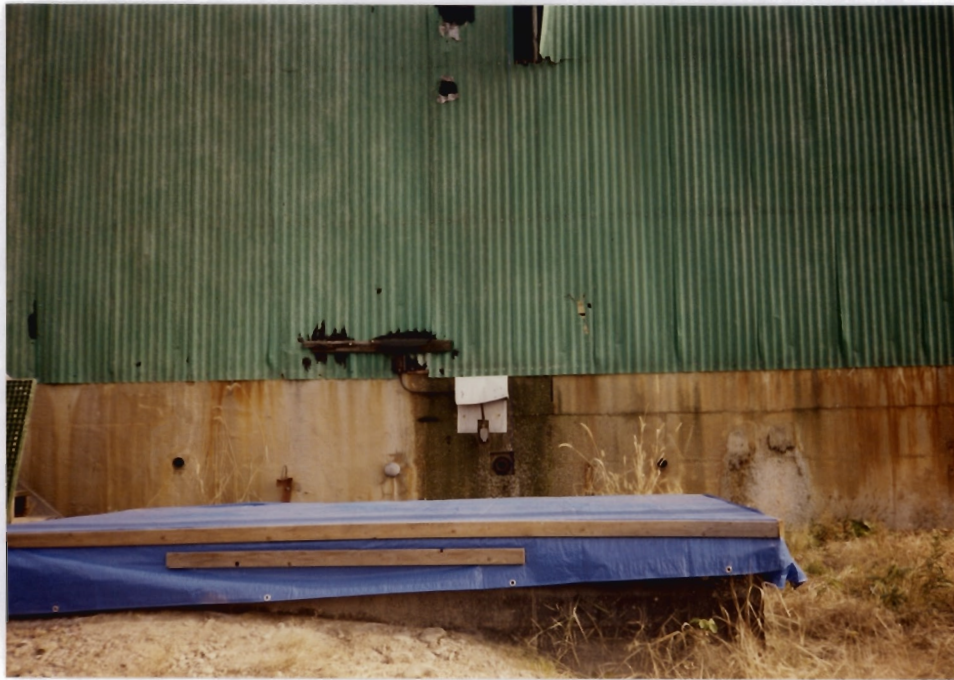
23. View of the Neutralization Pit (SWMU 2) facing east. The Fume Scrubber (SWMU 5) was located inside the wall shown in the center of the photograph.

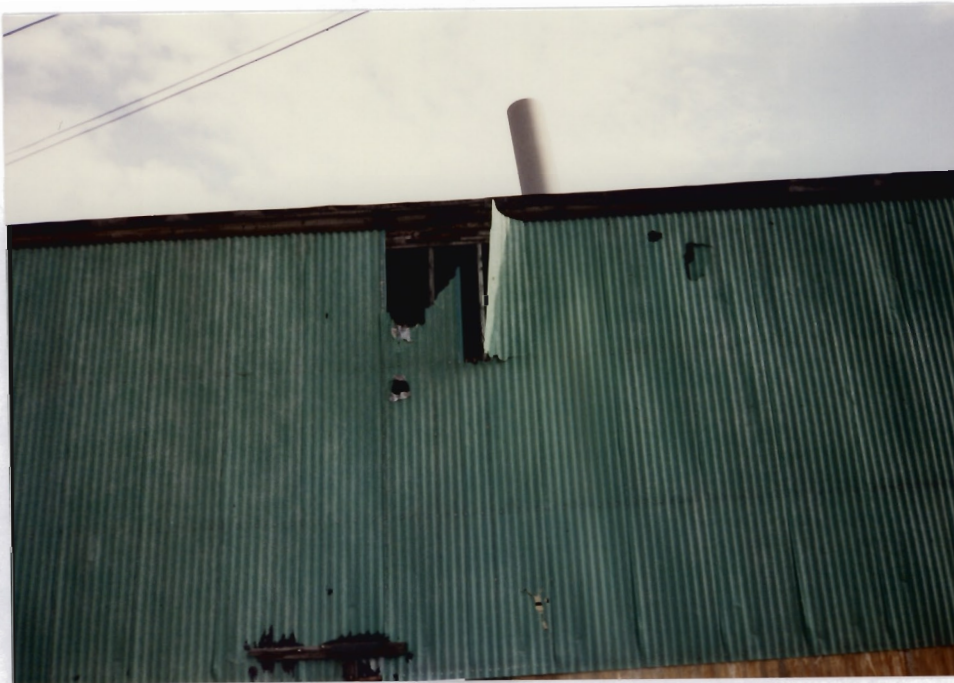
The inactive unit was located inside Warehouse No. 3 in the northwest section of the facility. The unit was used to treat the acid vapors generated by the acid drum filling operations, truck unloading operations, and the barrel washing operations. At the time of the VSI, all that remained of the unit was an exhaust pipe approximately 10 inches in diameter. Facility representatives could not provide operational details for the unit. The unit operated from 1976 to 1990. The unit discharged scrubber water into the Neutralization Pits (SWMUs 2 and 3) via the Process Pipeline (SWMU 6).

24. Continuation of photograph 23 showing the remains of the Fume Scrubber (SWMU 5). The view is facing east.

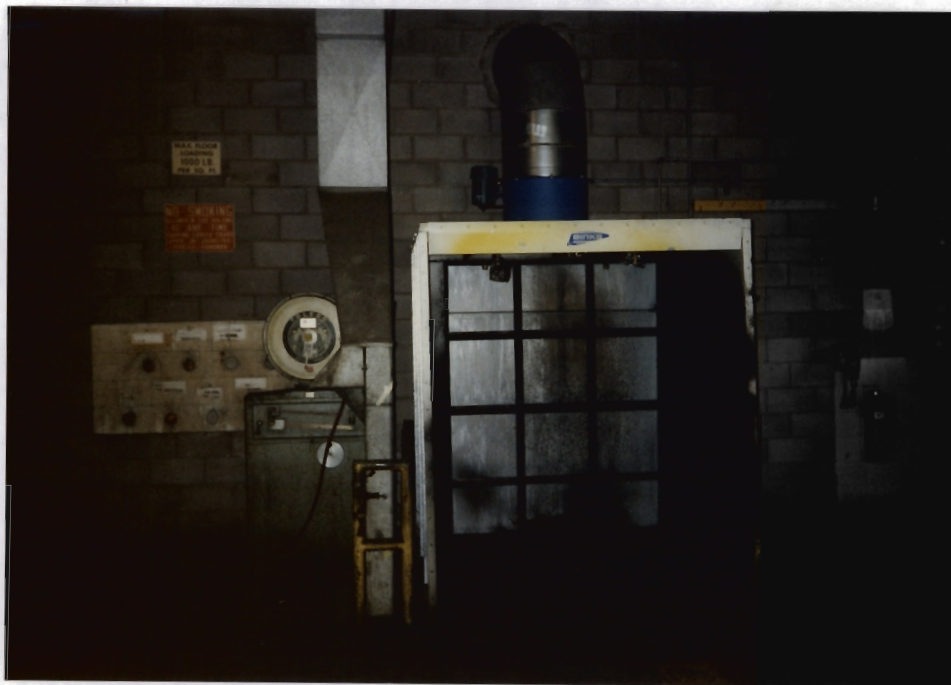
25. View inside Warehouse No. 4 showing an inactive paint booth previously used to paint drums. The former location of the intake pipes that were connected to the Old Tanks (Tks 7-14) is shown to the left of the booth (identified by the white square-- see next photograph).

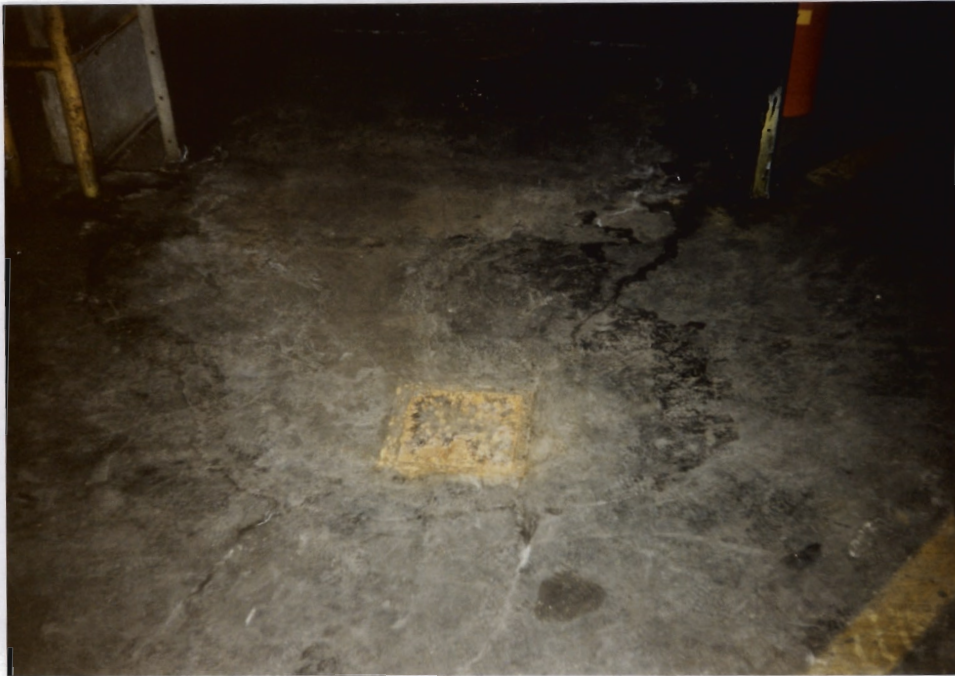
27. Close-up of a Drain (SWMU 13) in the vicinity of the paint booth shown in photograph 25. Note the stained floor.

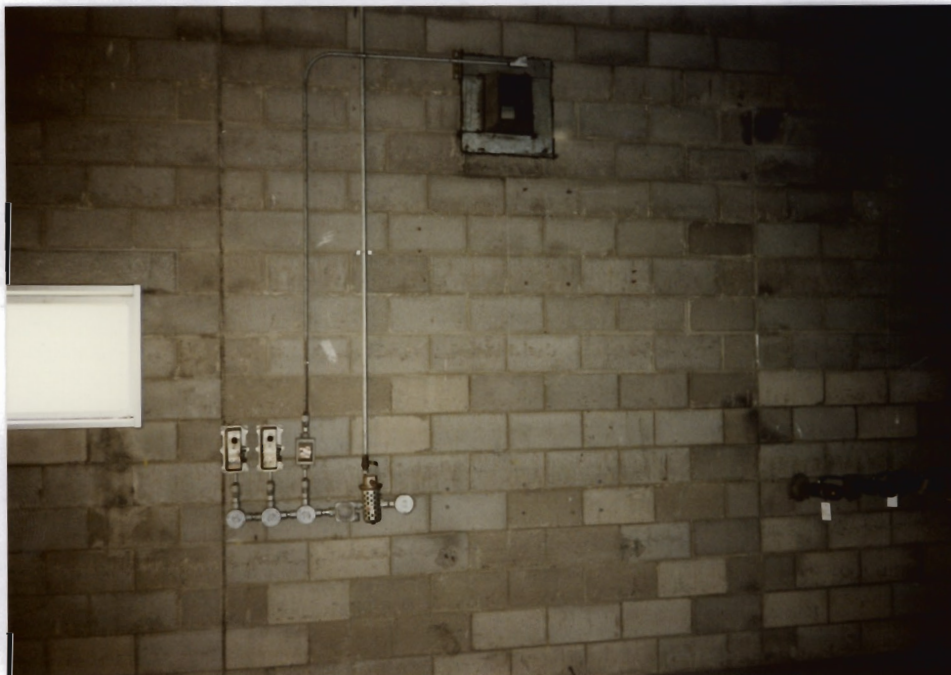
28. View of the east interior wall of Warehouse No. 4 showing the former intake pipes to the Solvent Blending Tanks in the lower right-hand corner of the photograph. According to facility representatives, the solvent tanks were never used. This area was designated to be the new solvent drumming station.

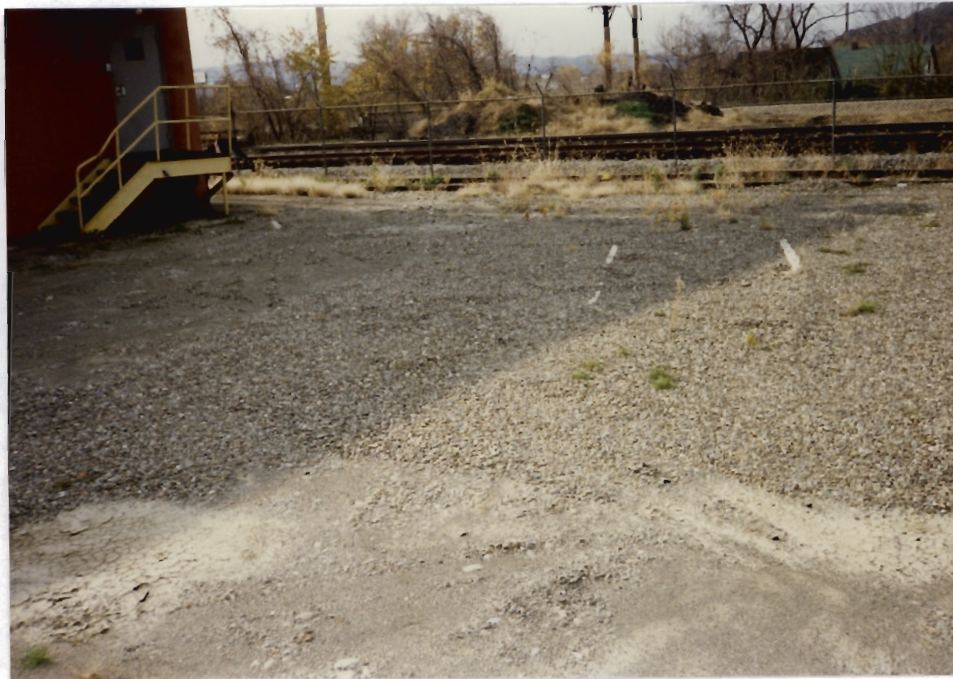
This unit is the area formerly occupied by four underground solvent storage tanks in the immediate vicinity of Warehouse No. 4 in the southwest section of the facility. The tanks were constructed of steel and had two 7,500 gallon compartments each. The tanks were

anchored to a concrete pad reportedly situated above the water table. The tanks were three feet below grade. The tanks were excavated in April 1986 and had been operating since at least 1969. The tanks contained mineral spirits, toluene, methyl ethyl ketone (MEK), acetone, methanol, xylene, and isopropyl alcohol. Excavation activities were monitored with an HNu meter. Soils that registered twice the ambient background on the HNu meter or soils that appeared discolored were stockpiled. Two piles of contaminated soil approximately 10 cubic yards each were generated from these activities. The two piles are referred to in this report as the Former Waste Piles (SWMU 8) and consist of the soils that were closest to the pump pits associated with the tanks. During the excavation of the tanks, composite soil samples were collected from beneath the concrete pad; from the Former Waste Piles (SWMU 8); and from the soils intended for backfill. The samples were analyzed for mineral spirits, toluene, MEK, acetone, methanol, xylenes, and isopropyl alcohol. Results of the analysis indicated 0.008 to 0.21 ppm toluene in the samples from beneath the concrete pad; 0.22 ppm acetone from the backfill; and 2.2 to 310 ppm mineral spirits, 0.007 to 1.95 ppm toluene, and 0.28 to 0.34 ppm acetone from the Former Waste Piles (SWMU 8). The Former Waste Piles (SWMU 8) were staged at unknown locations on plastic liners and covered with plastic tarps for two years. The Former Waste Piles (SWMU 8) were returned to the Old Underground Storage Tank Area (SWMU 7) during the summer of 1988. The excavated area had been filled, leveled, and was covered with a gravel/soil mix at the time of the VSI.

29. View of the southwest section of the facility showing the location of the Old Underground Storage Tanks Area (SWMU 7). This unit is the location of the former underground solvent storage tanks. This area is also the disposal location of the two former Waste Piles (SWMU 8).

An RFI is suggested for the Old Underground Storage Tank Area (SWMU 7) due to the documented soil contamination discovered during the tank excavation activities. In addition soil contaminated with mineral spirits, acetone, and toluene was staged at an unknown on-site location and later returned to the former underground tank area. As part of the RFI investigation for the Old Underground Storage Tank Area (SWMU 7), it is suggested the facility locate and sample the staging areas for the Former Waste Piles (SWMU 8).

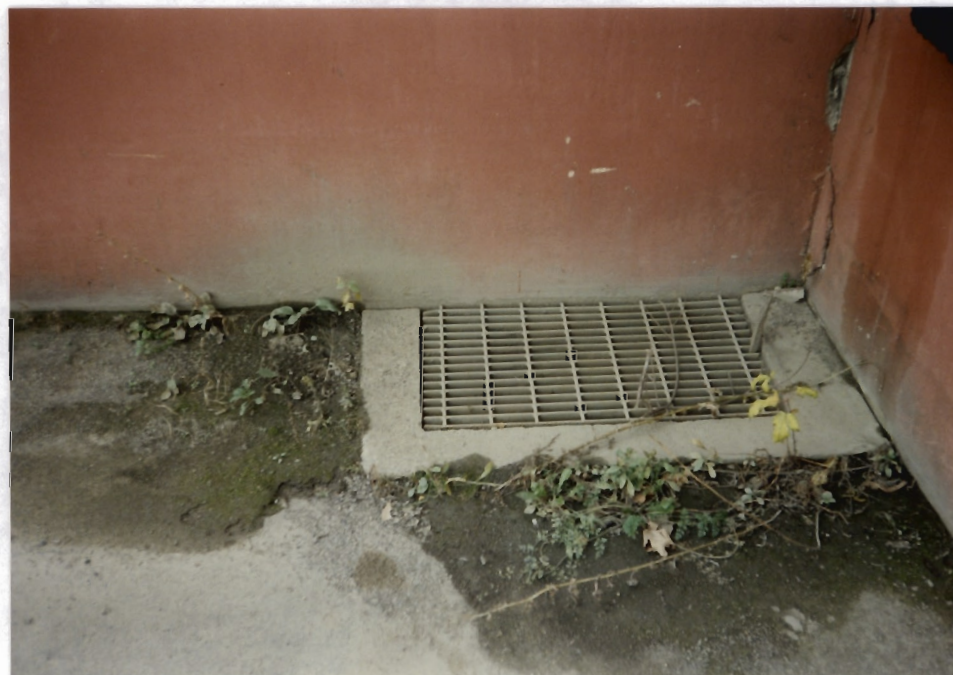
30. Close-up of a catch basin located outside Warehouse No. 4 in the southwest section of the facility.
