Reference: EPA Contract No. 68-W9-0040; Work Assignment
No. R02-10-01; Ashland Chemical, Inc.;
Binghamton, New York; EPA I.D. NYD049253719;
RCRA Facility Assessment; Visual Site
Inspection Summary Report; Final Deliverable

FINAL VSI SUMMARY REPORT

ASHLAND CHEMICAL, INC.
BINGHAMTON, NEW YORK
EPA. I.D. No. NYD049253719

I. INTRODUCTION

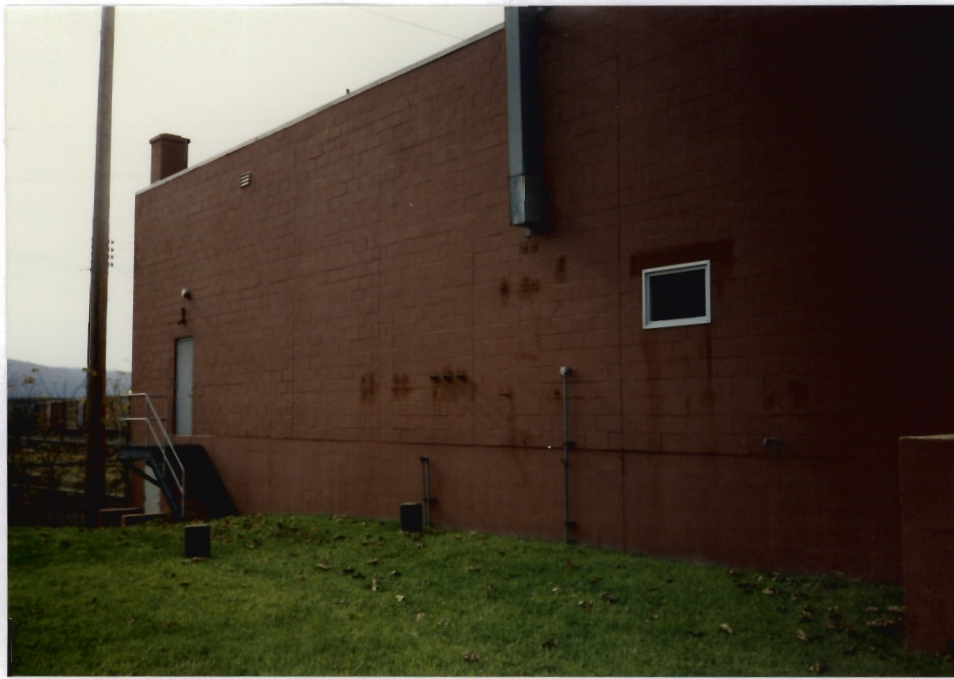
31. View of the east wall of Warehouse No. 4 showing the former intake lines from the Solvent Blend Tanks (Tks 101-103) in the center of the photograph. The view is facing southwest.

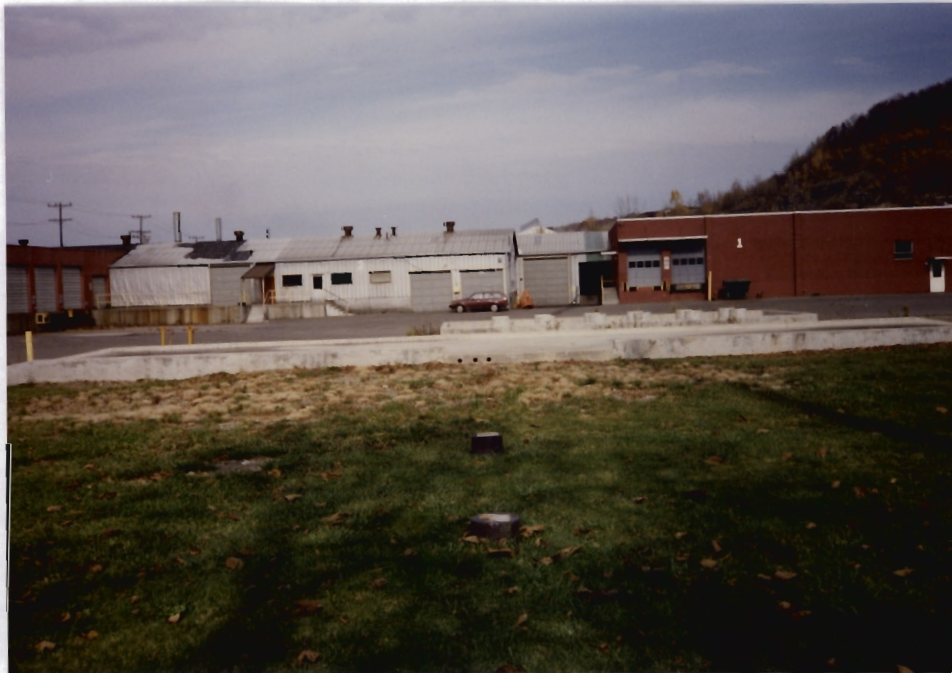
32. Overview of the facility facing north. The unused Solvent Tank Truck Loading/Unloading Area (for Tks 101-103) is shown in the center of the photograph. Warehouse No. 1 and Warehouse No. 2 are shown in the background. The black objects in the foreground are part of the pipe stand that was part of the Solvent Blend Tanks (Tks 101-103).

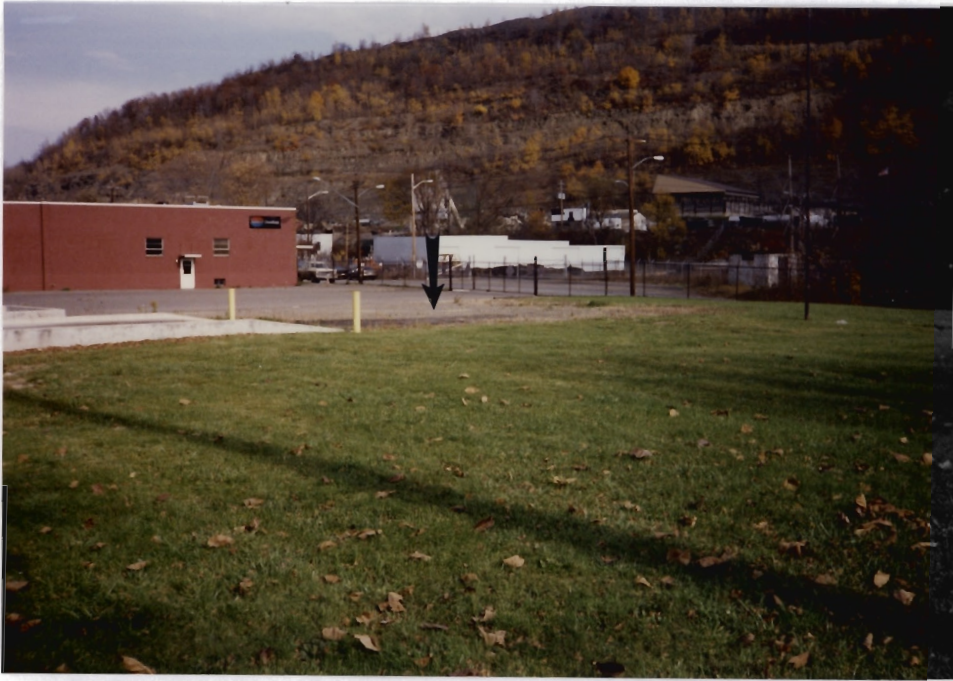
This unit consists of two piles of contaminated soil excavated from the Old Underground Storage Tank Area (SWMU 7) in 1986. The piles were staged on plastic and covered with plastic tarps for two years. The exact location of the waste pile staging areas could not be determined during the VSI. Eventually, the piles were respread over the Old Underground Storage Tank Area (SWMU 7). Each pile consisted of approximately 10 cubic yards of soil contaminated with toluene, acetone, and mineral spirits. The results of the soil samples collected from the two piles indicated 2.2 to 310 ppm mineral spirits, 0.007 to 1.95 ppm toluene, and 0.28 to 0.34 ppm acetone. The analysis was conducted in 1986. No additional sampling was conducted. A suspected staging area, identified during the VSI, is located next to the unused blending tanks 101-103 in the east section of the facility. The suspected staging area, identified by the facility representatives, is shown in photographs 33 and 34.

33. Overview of the east section of the facility facing northeast. The area to the right of the yellow poles (indicated by an arrow) is a suspected staging area for the Waste Piles (SWMU 8). The facility beyond the fence is a quarry.

An RFI is suggested for the Old Underground Storage Tank Area (SWMU 7) due to the documented soil contamination discovered during the tank excavation activities. In addition soil contaminated with mineral spirits, acetone, and toluene was staged at an unknown on-site location and later returned to the former underground tank area. As part of the RFI investigation for the Old Underground Storage Tank Area (SWMU 7), it is suggested the facility locate and sample the staging areas for the Former Waste Piles (SWMU 8).

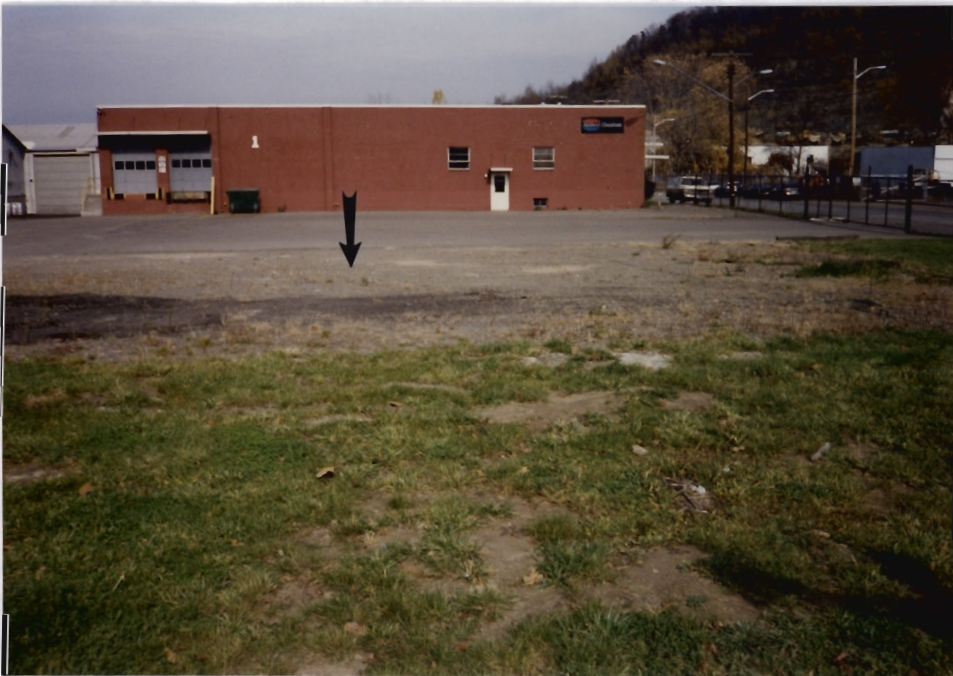
34. Close-up of the suspected staging area (indicated by an arrow) for the Waste Piles (SWMU 8) shown in photograph 33. The view is facing north.

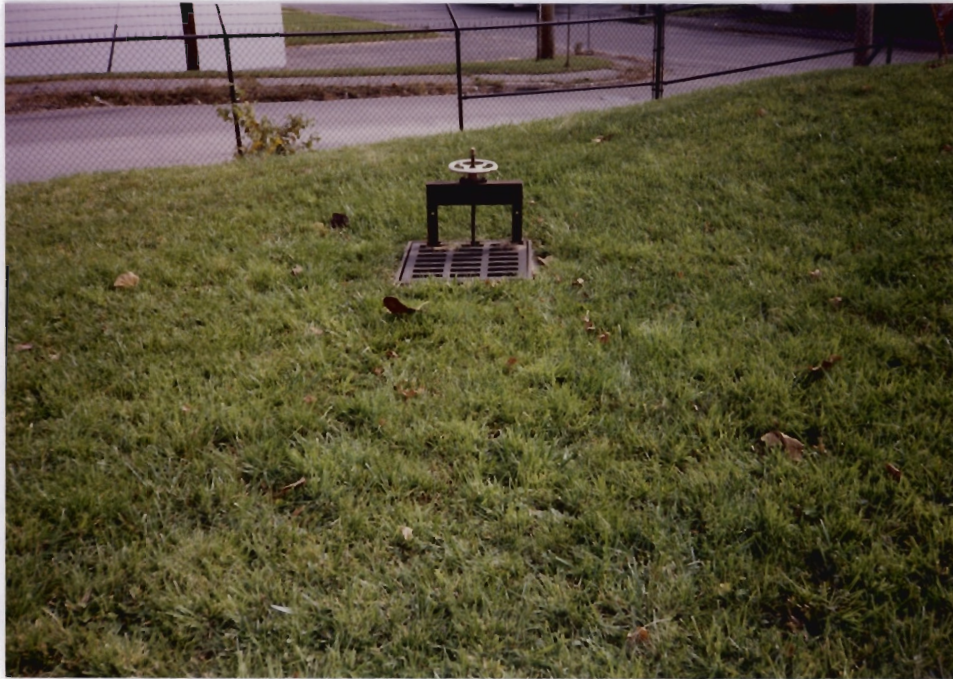
35. View of the emergency storm sewer control valve located in the southeast section of the facility.
