**Phase III
Hydrogeologic/Subsurface
Contamination Investigation
Powerex Facility
Auburn, New York**

**General Electric Company
Corporate Environmental Programs
Fairfield, Connecticut**

DUNN GEOSCIENCE CORPORATION

May, 1988

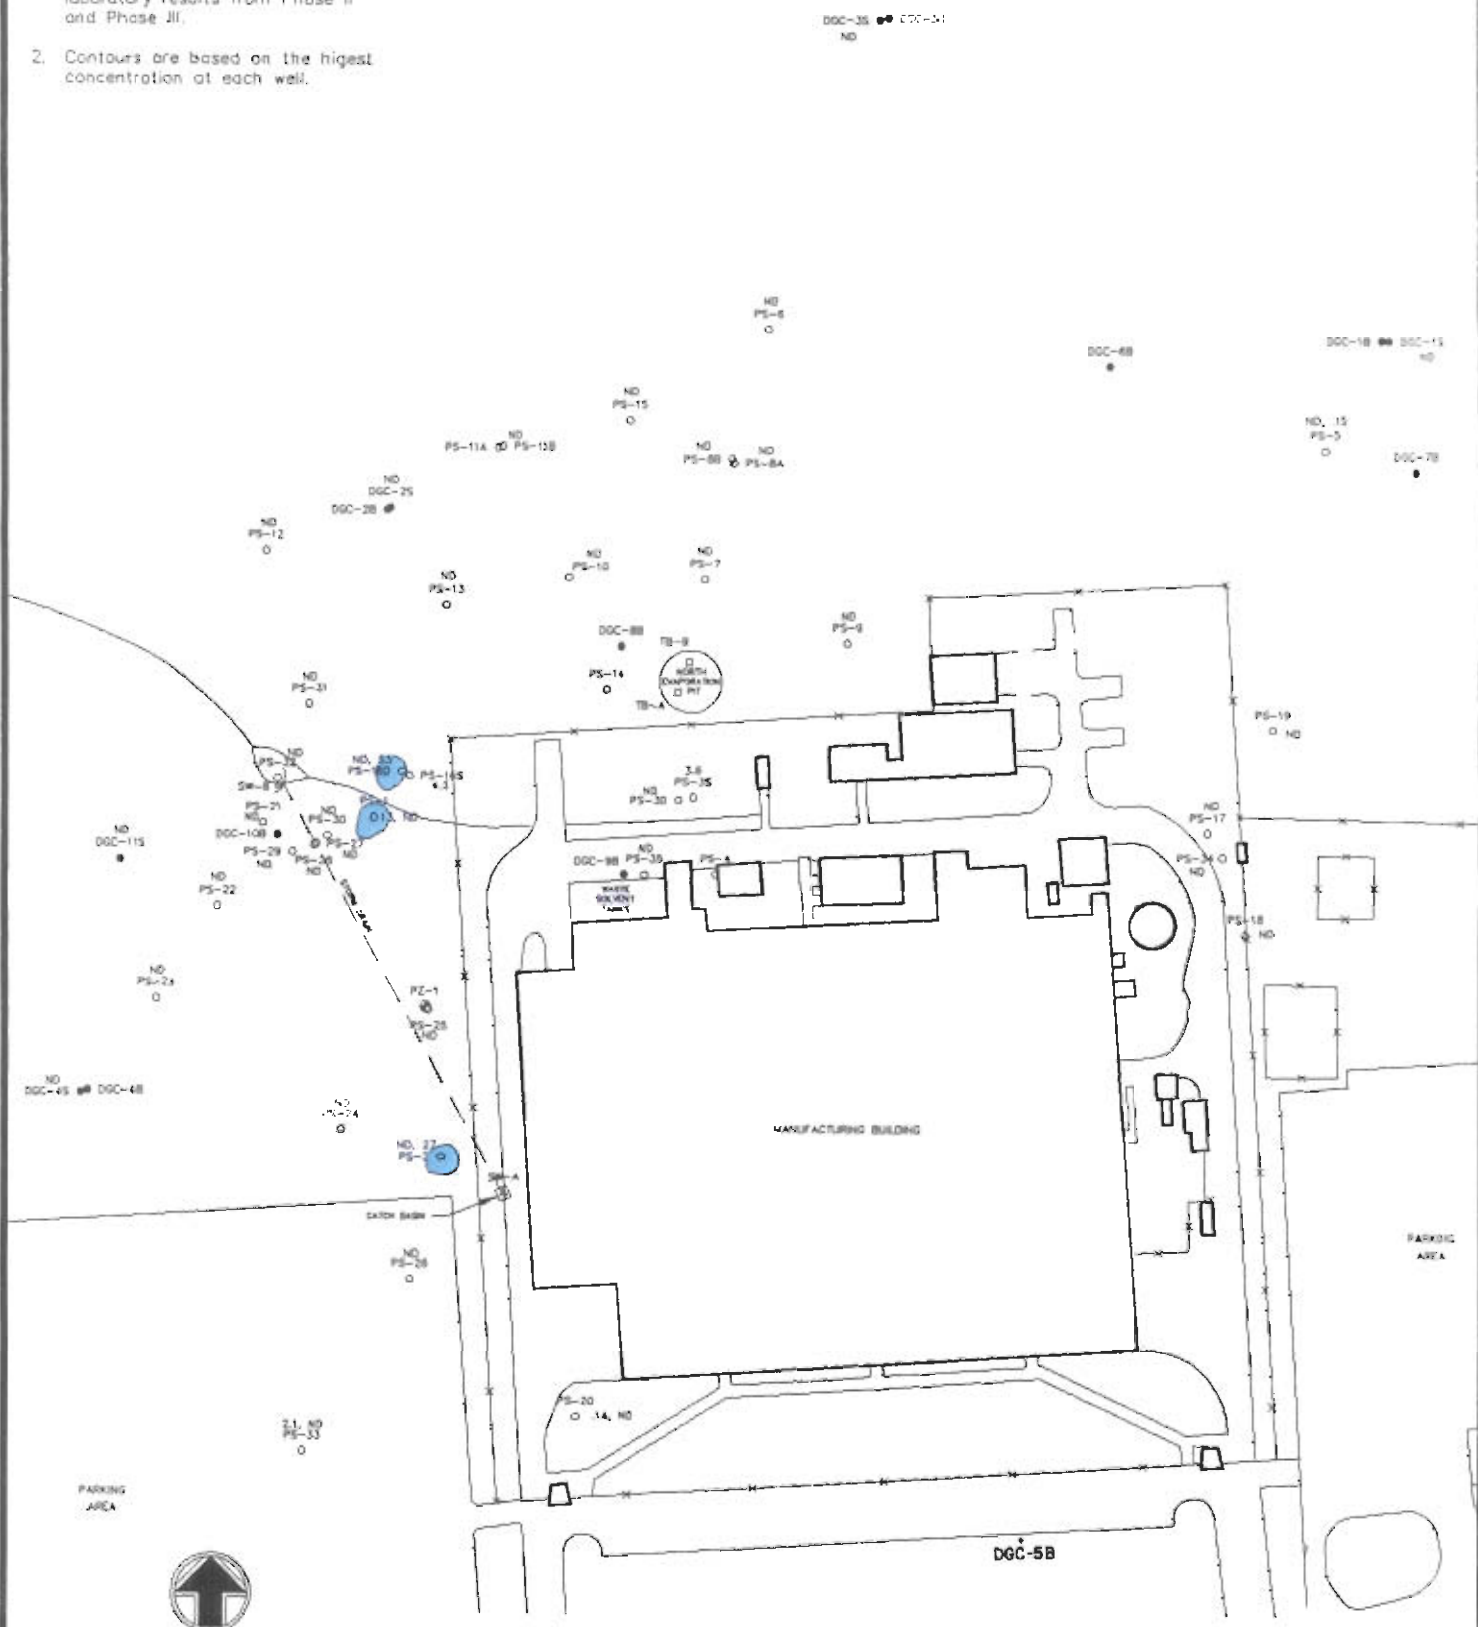
1. Concentrations include field and laboratory results from Phase II and Phase III.
2. Contours are based on the highest concentration at each well.

- > 10
- > 100
- > 1000
- > 10,000
- > 100,000

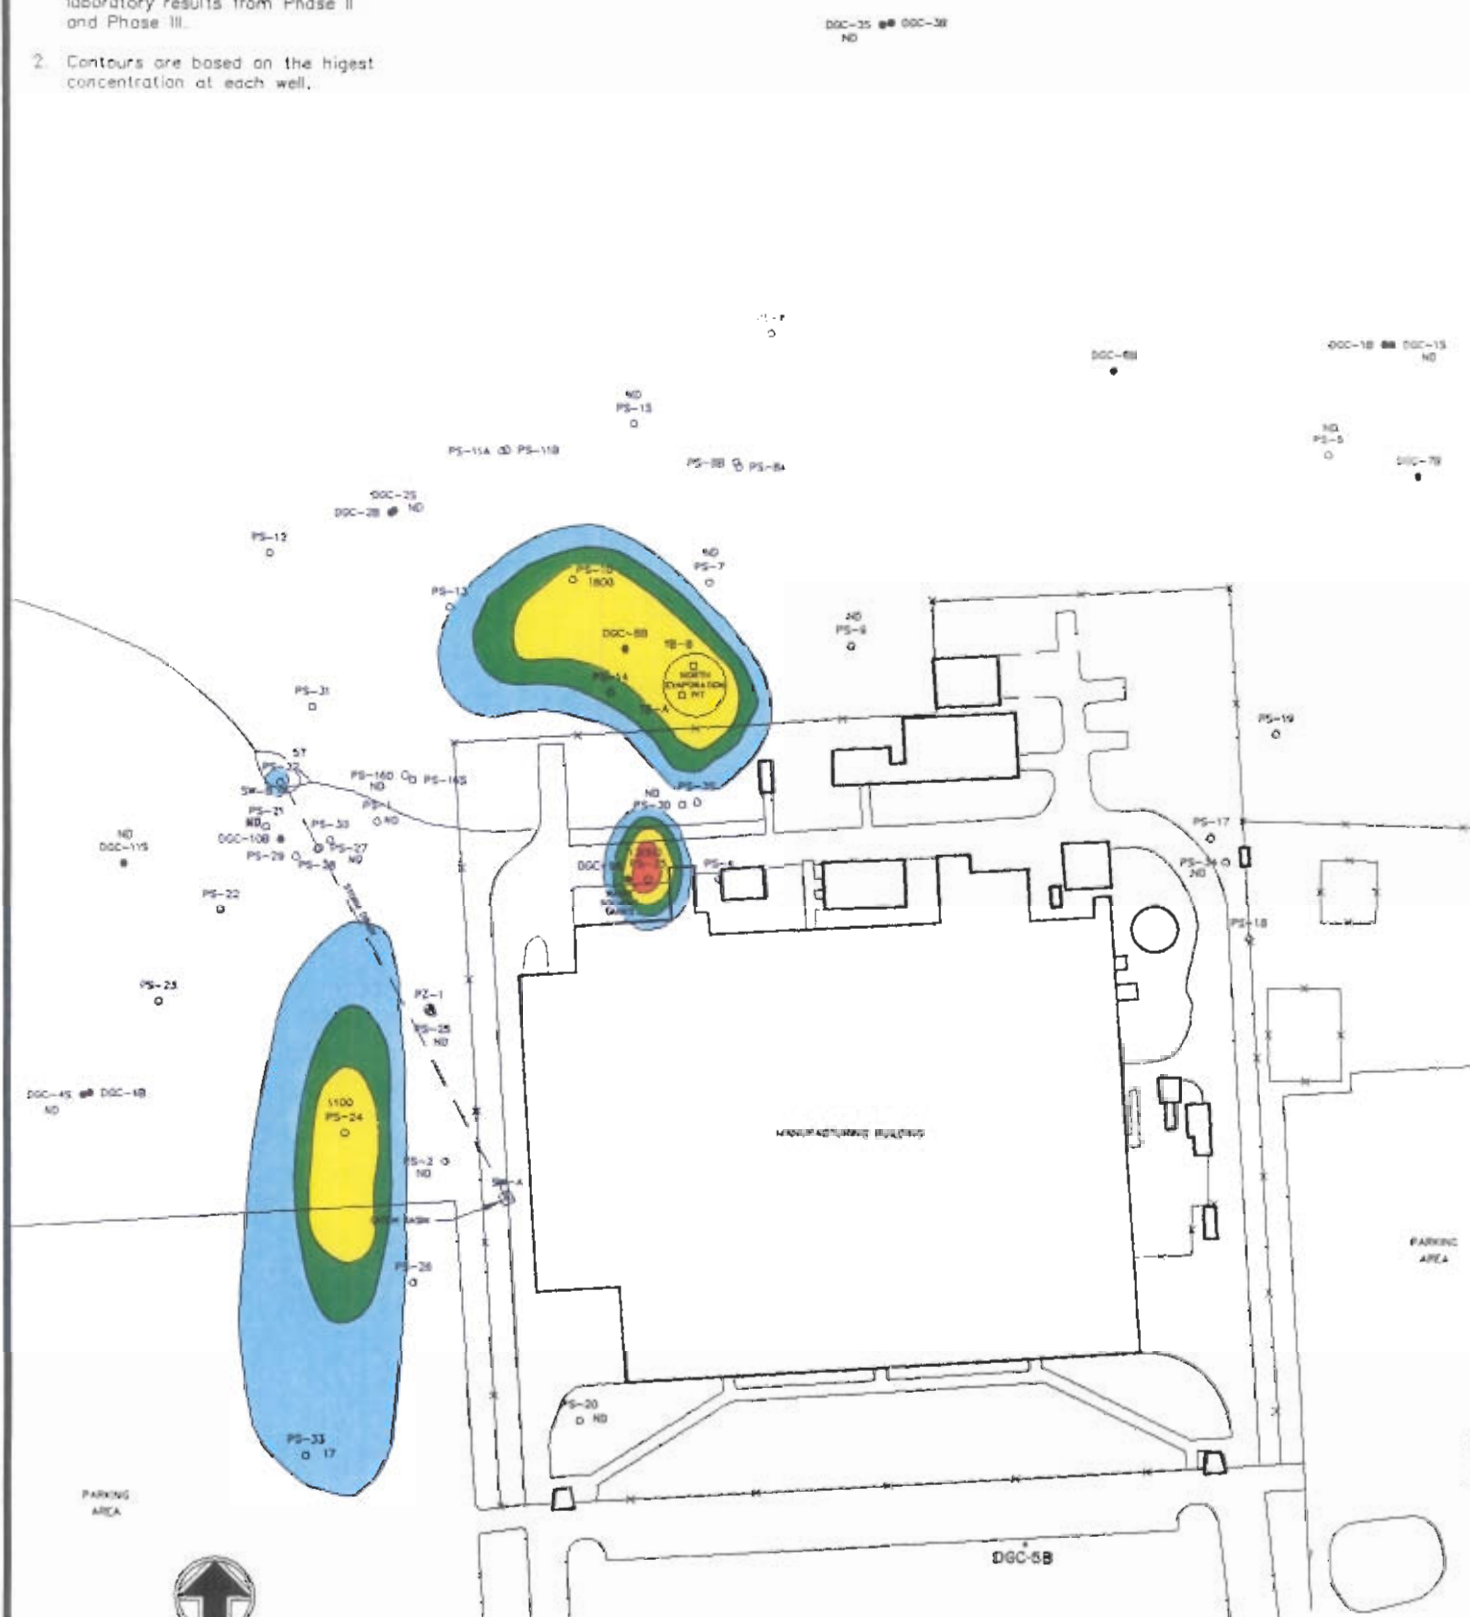
1. Concentrations include field and laboratory results from Phase II and Phase III.
2. Contours are based on the highest concentration at each well.

Blue	> 10
Green	> 100
Yellow	> 1000
Orange	> 10,000
Red	> 100,000

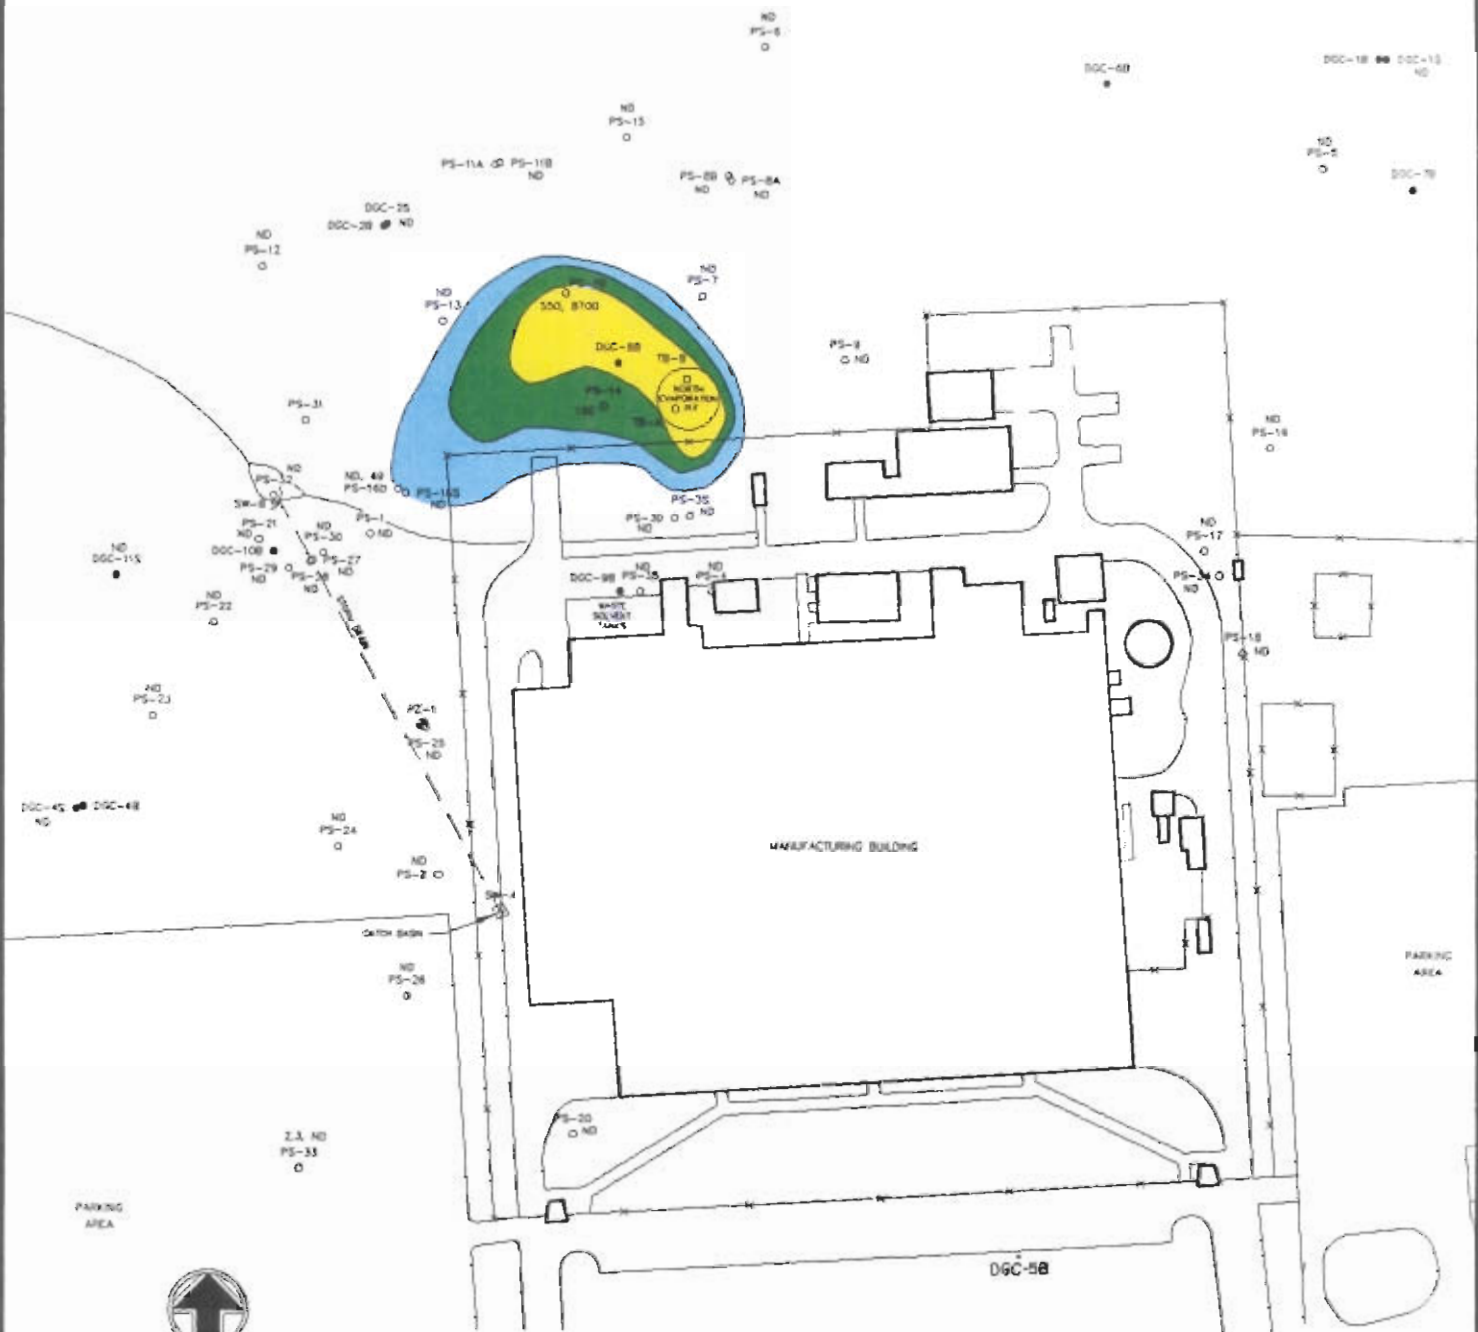
1. Concentrations include field and laboratory results from Phase II and Phase III.
2. Contours are based on the highest concentration of each well.

Blue	> 10
Green	> 100
Yellow	> 1000
Orange	> 10,000
Red	> 100,000
