SUBJECT: Clark Street Supplemental Investigation in the Owasco Outlet

This Supplemental Investigation Report summarizes Owasco Outlet investigation activities at the Clark St. Former Manufactured Gas Plant (MGP) Site (the Site) (Site No. 7-06-008) conducted on November 30, 2017 and December 20, 2017. This report has been prepared by Parsons on behalf of NYSEG, in accordance with the Supplemental Investigation Work Plan (SIWP) approved by NYSDEC on October 12, 2017 and with the additional scope presented via e-mail on December 19, 2017

NYSEG  
CLARK STREET FORMER MGP SITE  
AUBURN, NEW YORK

**SEDIMENT REMOVAL PLAN  
(PHASE 4)**

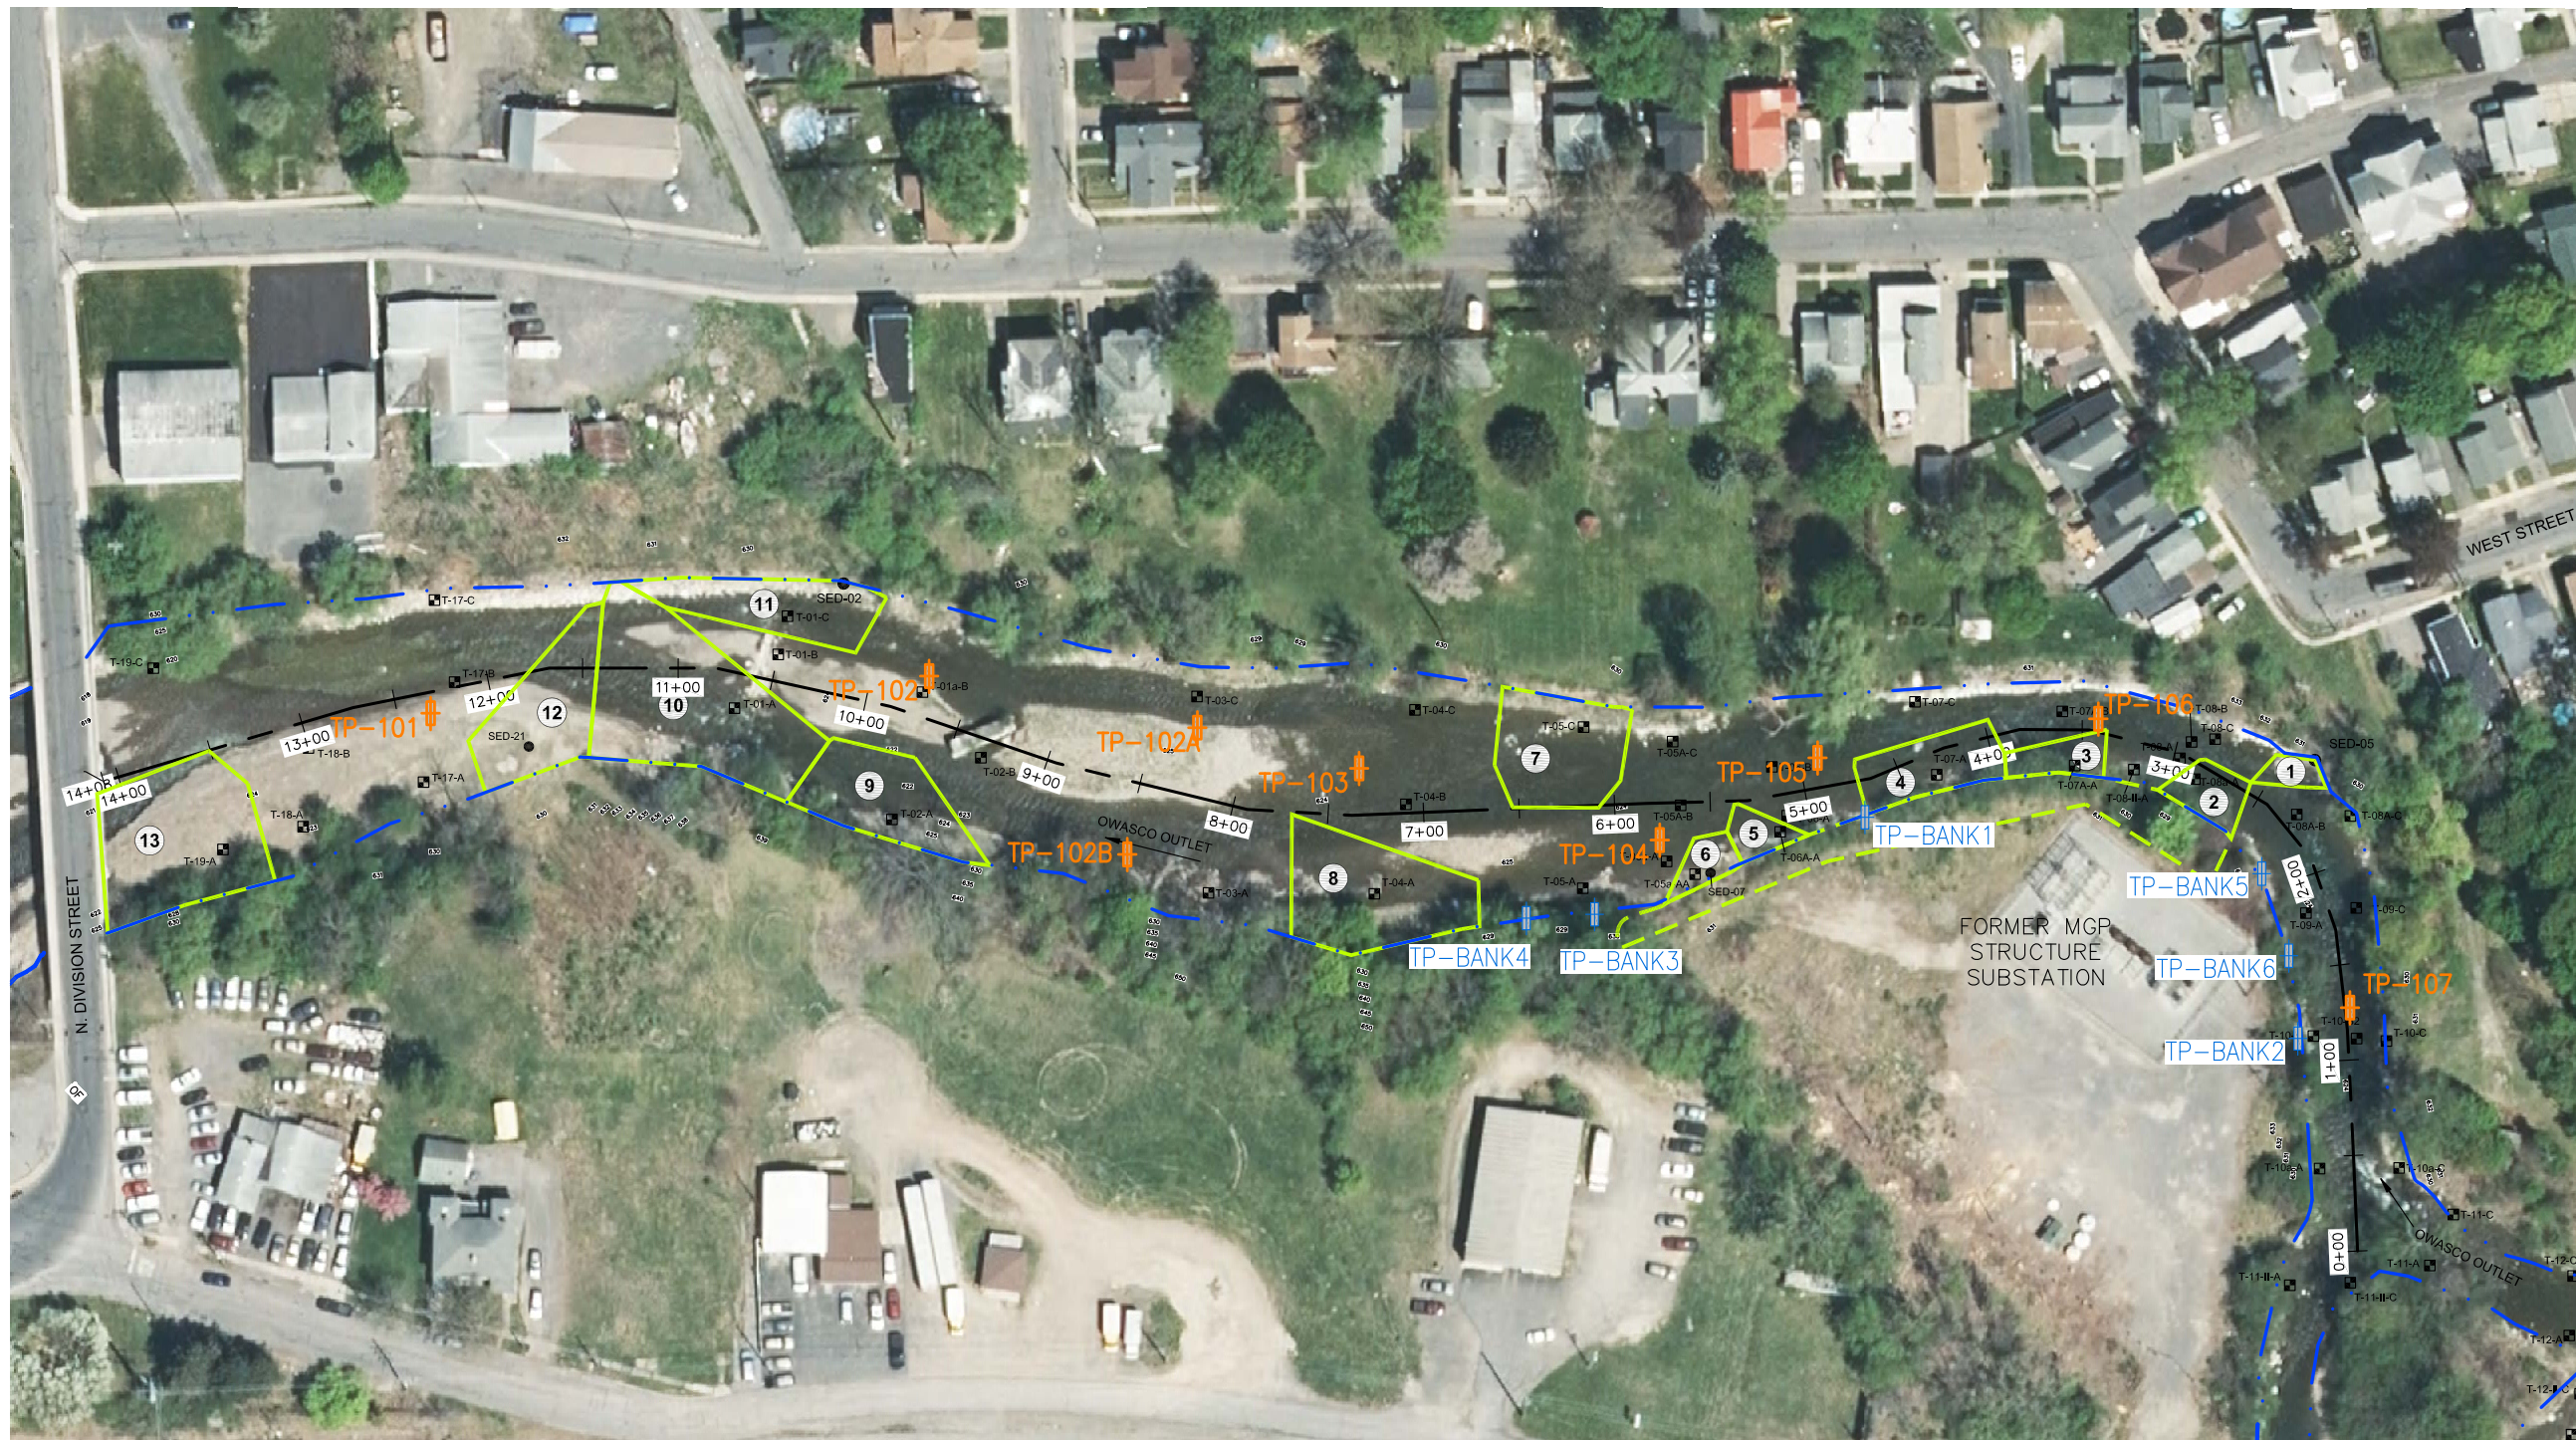
**FIGURE 1**

The test pit excavations were conducted using an excavator with rock bucket at the locations shown on Figure 1. Test pits were extended vertically to the top of bedrock. The location and elevation of most of the test pits were surveyed as noted on Figure 2. Prior to and during test pit excavations, oil booms, as well as an oil-philic curtain as a secondary measure, were installed downstream to capture any sheens that were released during test pit excavations.

Test pits were installed at the locations shown on Figure 1. Visual impacts were observed at three of the in-stream test pits excavated on November 30<sup>th</sup>. Test pits TP-102A, TP-102B, and TP-103 all exhibited the presence of MGP-like odors, sheens, and NAPL in varying amounts. TP-BANK1 was excavated to confirm the presence of MGP material in the recommended bank removal area. Upon excavation, heavy MGP-like odors as well as the presence of NAPL was observed. During the December 20<sup>th</sup> test pit event, MGP related impacts were noted in two additional test pits outside of the designed excavation areas along the south bank. At TP-Bank4, a slight MGP-like odor and NAPL blebs/sheens were noted on the stream-facing edge of the test pit, indicating that impacts are likely present in stream sediments in this vicinity (i.e. not originally from the bank). Additionally, medium to large (6 to 12 inch) pieces of solidified coal tar were noted in TP-Bank5.

TEST PIT LOCATIONS

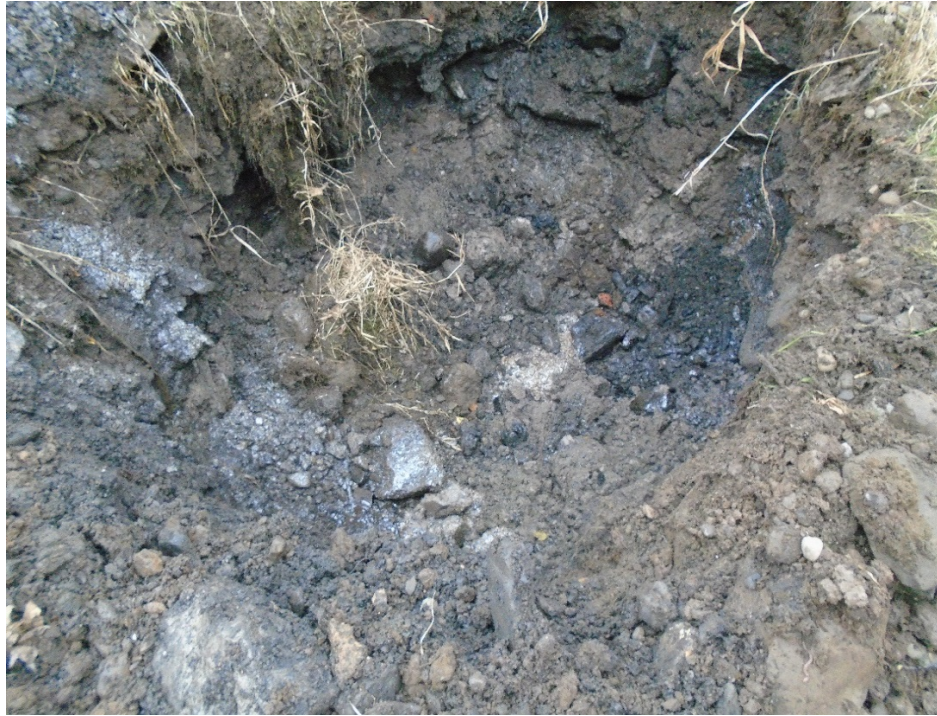
DEPTH (feet bgs)	FIELD IDENTIFICATION OF MATERIAL	COMMENTS
0	(0-1 ft) Dark brown fine to coarse SAND, some fine gravel, some silt, trace organics (TOPSOIL).	Grass at surface, roots to 6"
1	(1-5 ft) Brown with black inclusions fine to moist coarse sand, some gravel, little sand, trace cobbles. Moist.	(2-5 ft) Heavy MGP odors and NAPL
2		
3	Becomes saturated.	
4		
5	Terminated test pit at 5'; did not reach bedrock

TP-BANK-1  
Picture  
looking into  
bank test pit  
from North

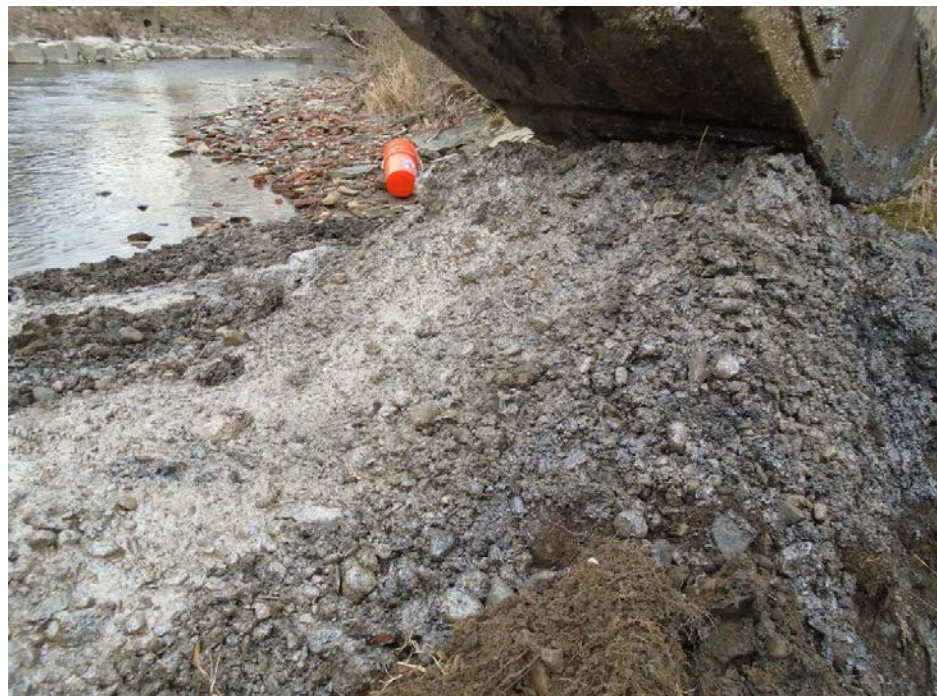
TP-BANK-1  
Picture of  
material from  
bank test pit  
looking East

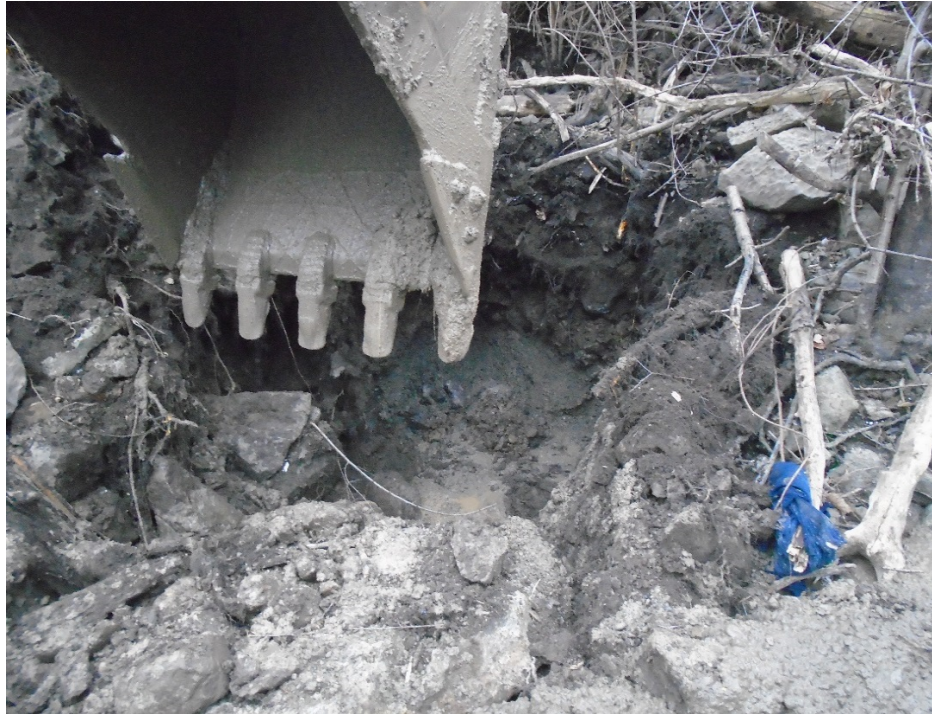
DEPTH (feet bgs)	FIELD IDENTIFICATION OF MATERIAL	COMMENTS
0	(0-5 ft) COBBLES and medium to coarse dark gray sand, trace gravel. Moist.	No odors or sheens. Woody debris in top 6".
1		
2		
3		
4		
5	Saturated. Terminated test pit at 5', did not reach bedrock.

TP-BANK-2  
Picture  
looking into  
bank test pit

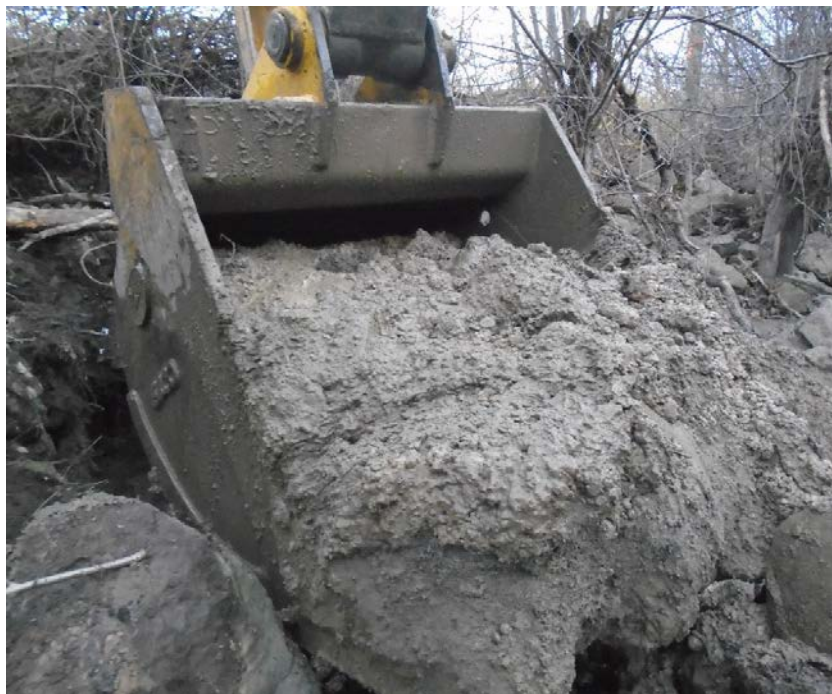
TP-BANK-2  
Picture of  
material from  
bank test pit

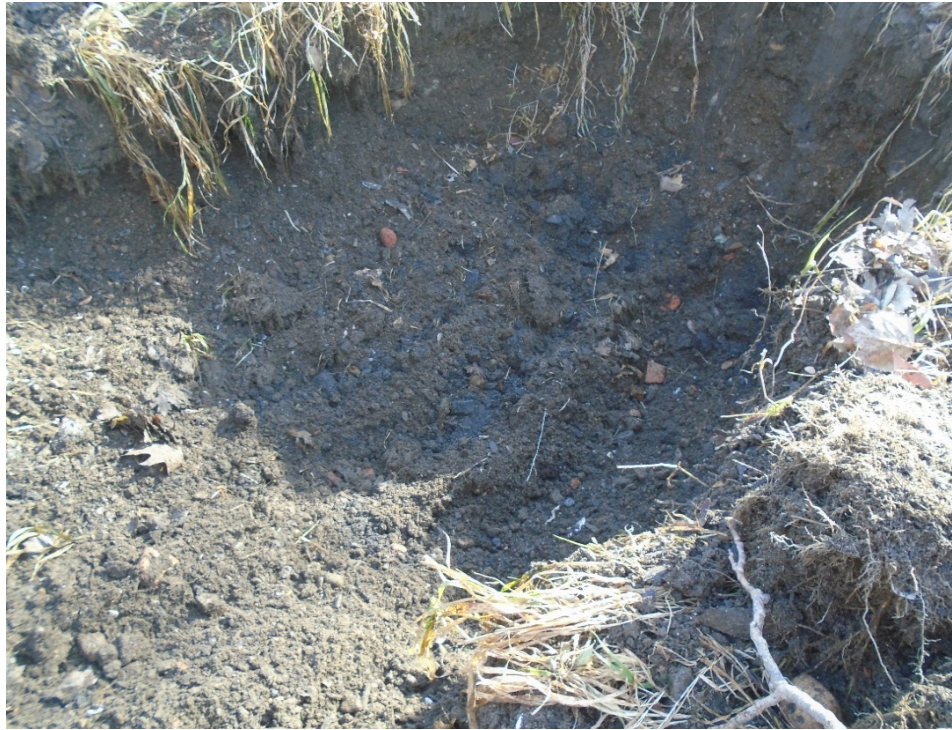
DEPTH (feet bgs)	FIELD IDENTIFICATION OF MATERIAL	COMMENTS
0	(0-3 ft) Dark brown fine to coarse SAND, little medium gravel, trace organics.  Becomes moist.  Top of bedrock at ~3'. TP terminated at 3' due to excavator refusal.	In floodplain, bedrock visible in channel. Grass at surface, roots to 6". No odors/sheens.
1		
2		
3

TP-101  
Picture  
looking into  
test pit looking  
south

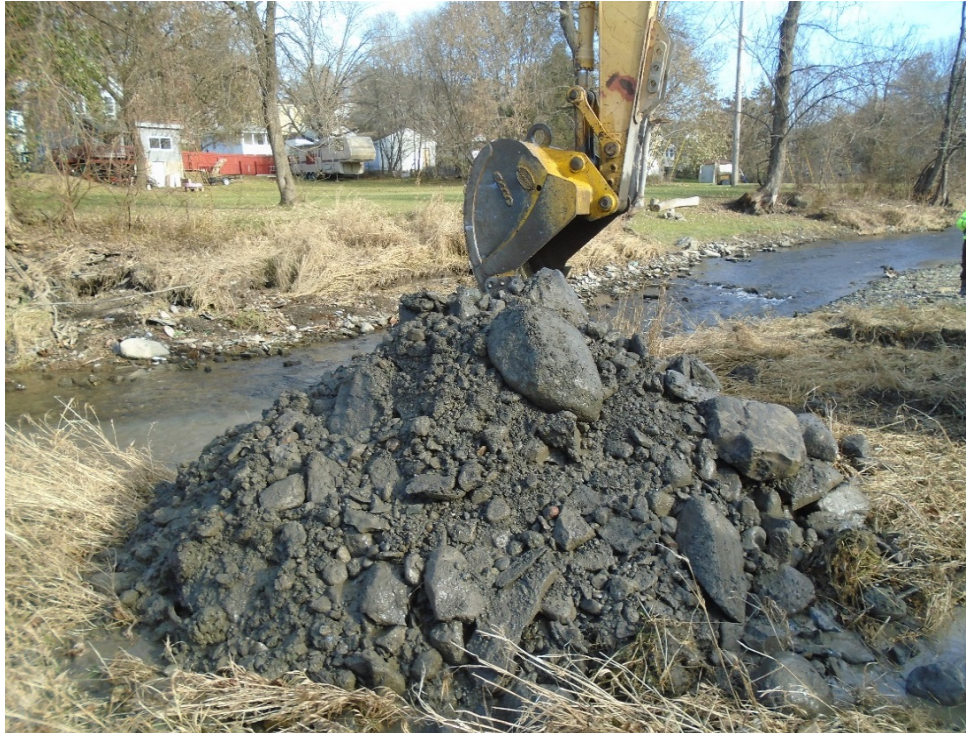
DEPTH (feet bgs)	FIELD IDENTIFICATION OF MATERIAL	COMMENTS
0	(0-3 ft) BOULDERS and cobbles, little coarse gravel, trace coarse sand. Wet.	Elevations based on channel elevation not edge of island
1		
2		(2-3 ft) strong odors/sheens. NAPL and pure product observed.
3		Sample collected for analysis.

TP-102A  
Picture of  
material from  
test pit looking  
north

In addition to the removals presented in the 100% Design (Arcadis 2014), supplemental removals to bedrock are recommended in the vicinity of TP-102A, TP-102B, TP-103, and TP-Bank4 (Figure 2). Additionally, it is recommended that the extent of the bank excavations be extended upstream to encompass the impacted materials noted in TP-Bank5. Removals in this area are to be conducted based on visual observations of impacts; during excavations, once visual impacts are no longer observed in the area, excavations in the area will cease. These additional removal areas result in approximately 5,200 cubic yards of material to be excavated. Control points for the additional removal areas are shown on Figure 2.

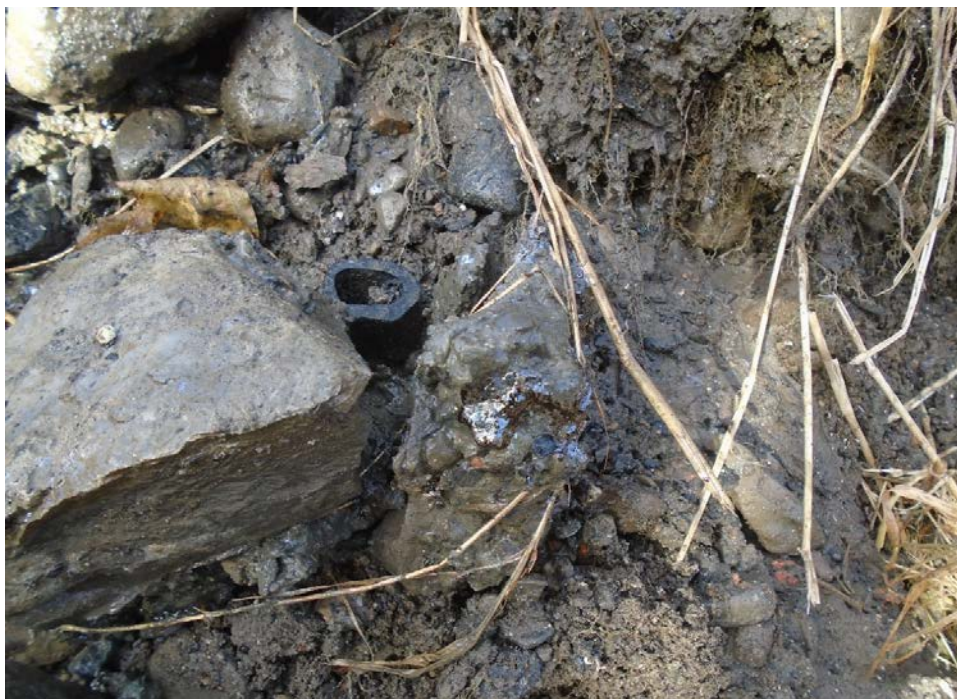
TP-102A  
Picture of  
NAPL blebs  
from test pit

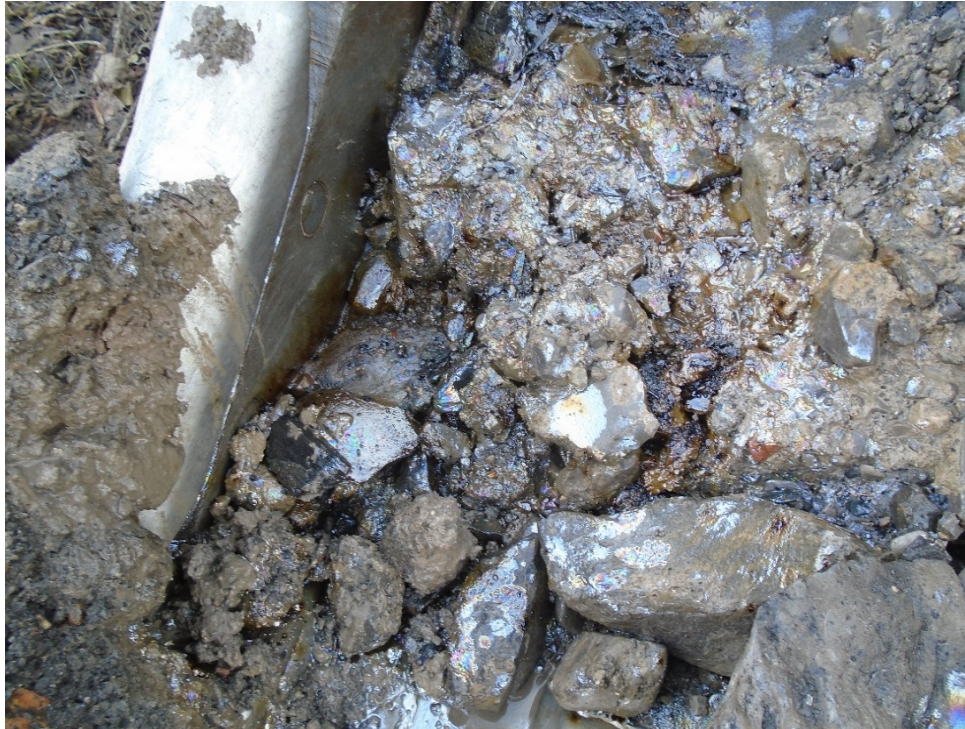
PROJECT NAME: <u>Iberdrola Clark Street Site, Auburn, NY</u>		<b>TEST PIT ID:</b> TP-102B
PROJECT NUMBER: <u>449523</u>		<b>LOCATION:</b> Iberdrola Auburn, NY
WEATHER: <u>Partly cloudy, windy, temperature in the 50s</u>		Approximate L X W X D
DATE/TIME START: <u>11/30/17 1157</u>		= 8' X 5' X 3'
DATE/TIME FINISH: <u>11/30/17 1215</u>		Located Against south bank,
CONTRACTOR: <u>Sevenson</u>		downstream of upland site
INSPECTOR: <u>Shane Blauvelt/Paul Roth/Ray D'Hollander</u>		
DEPTH (feet bgs)	FIELD IDENTIFICATION OF MATERIAL	COMMENTS
0	(0-2 ft) Sub-angular to sub-rounded COBBLES and coarse gravel, some sand, trace brick. Wet.	Strong petroleum odor/sheens, PID Reading 2.7 PPM
1		(1-2 ft) Strong petroleum odor/sheens, Staining prominent Sample collected. PID Reading 9.5 PPM
2	(2-3 ft) Sub-angular COBBLE, and coarse gravel, some sand, little boulders.	Strong MGP odor, NAPL. PID reading 14.2 PPM
3	Top of bedrock. TP terminated due to excavator refusal.	Sample collected

TP-102B  
Picture of  
material from  
test pit with  
NAPL present

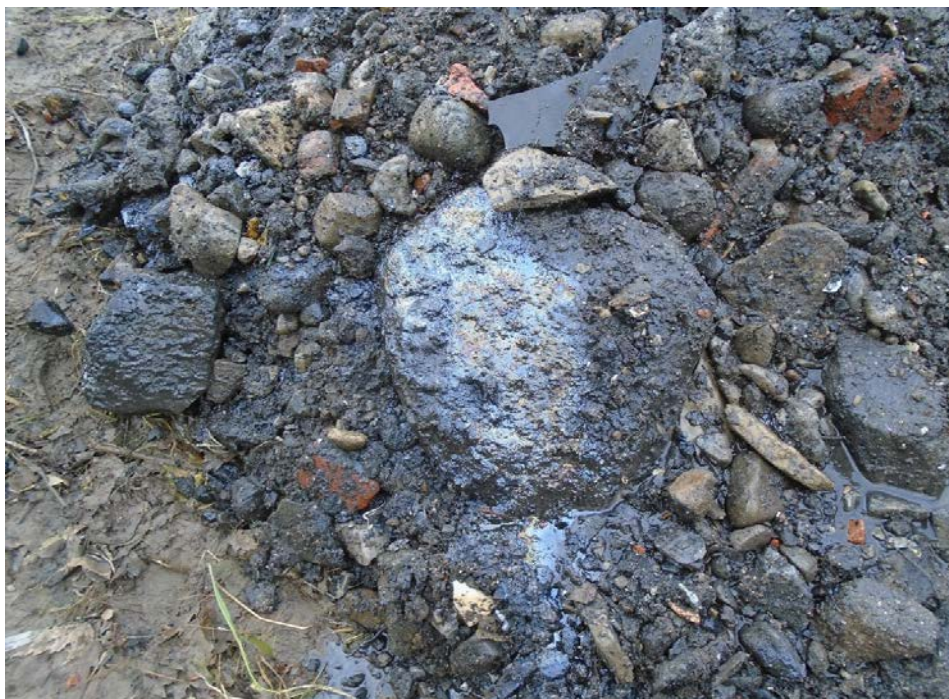
TP-102B  
Picture of  
sheens on  
material from  
test pit

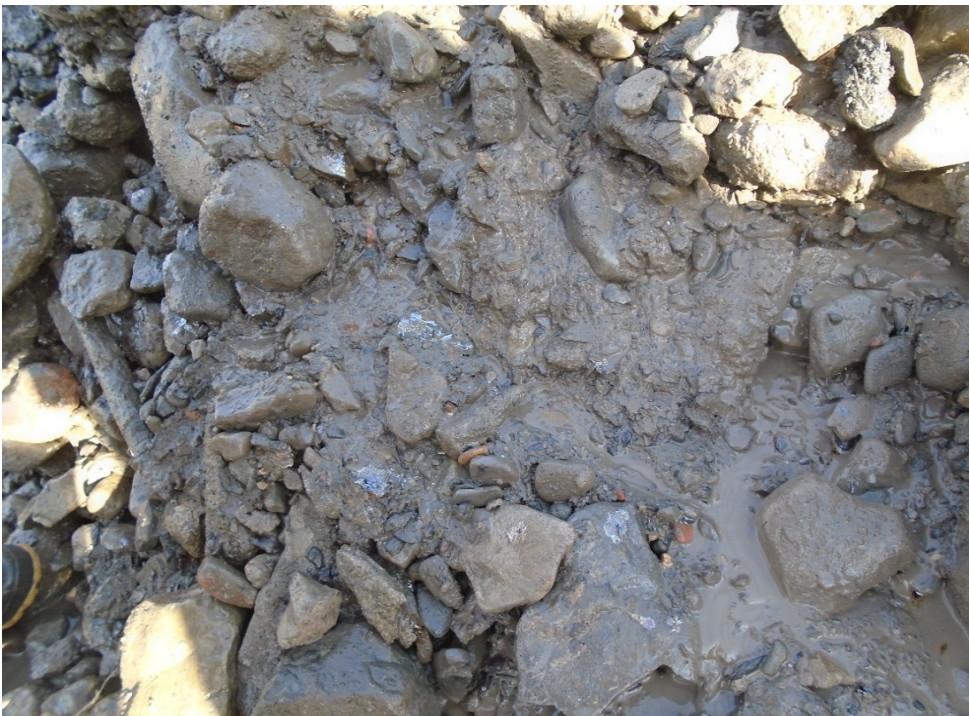
DEPTH (feet bgs)	FIELD IDENTIFICATION OF MATERIAL	COMMENTS
0	(0-3.0 ft) Angular to sub-rounded GRAVEL, some angular to sub-rounded cobble with some sand, trace silt. Wet	No odors or sheens.
2		
3	(3.0 -4.0 ft) Sub-angular COBBLE with some angular limestone boulders, little coarse gravel, trace sand	(3-4 ft) Odors/sheens present, some NAPL blebs. PID Reading 1.4 PPM
4		
5	(4.5 ft) Top of bedrock. TP terminated at 4.5' due to excavator refusal.	Little odor, PID Reading 0.4 PPM

TP-103  
Picture of  
sheens/NAPL  
blebs from test  
pit

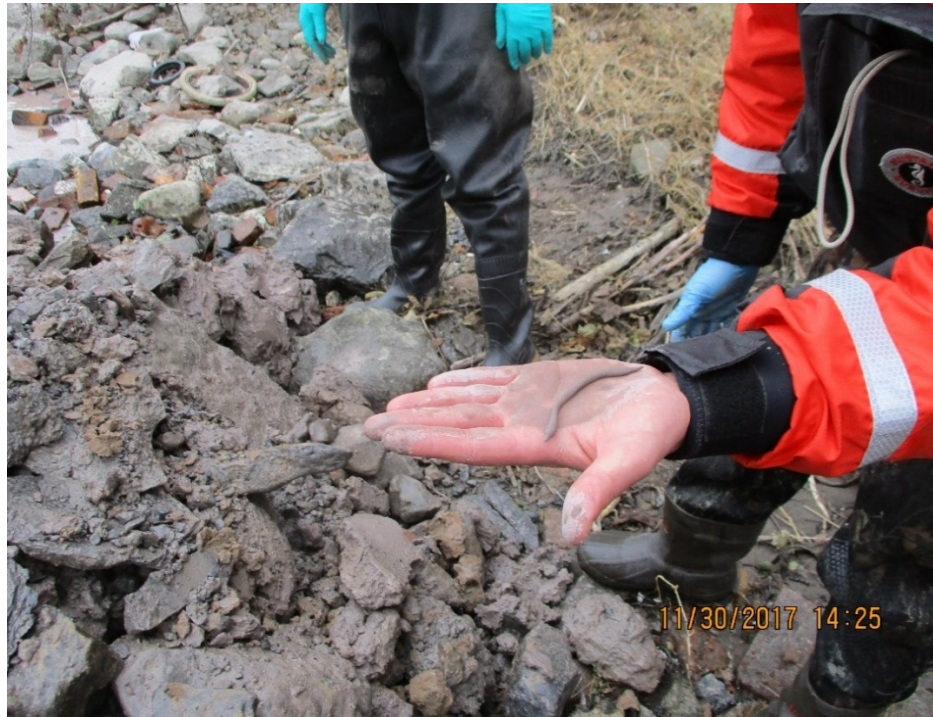
DEPTH (feet bgs)	FIELD IDENTIFICATION OF MATERIAL	COMMENTS
0  1  2	(0-2.5 ft) Very angular to angular BOULDERS and cobbles, little fine to medium gravel.	No sheen or odor.
3  4	(2.5-4 ft) Angular to sub-angular COBBLES, some coarse gravel, little low plasticity clay.  Bedrock at ~4 feet. TP terminated at 4' due to excavator refusal.

TP-107  
Picture of  
clay from test  
pit

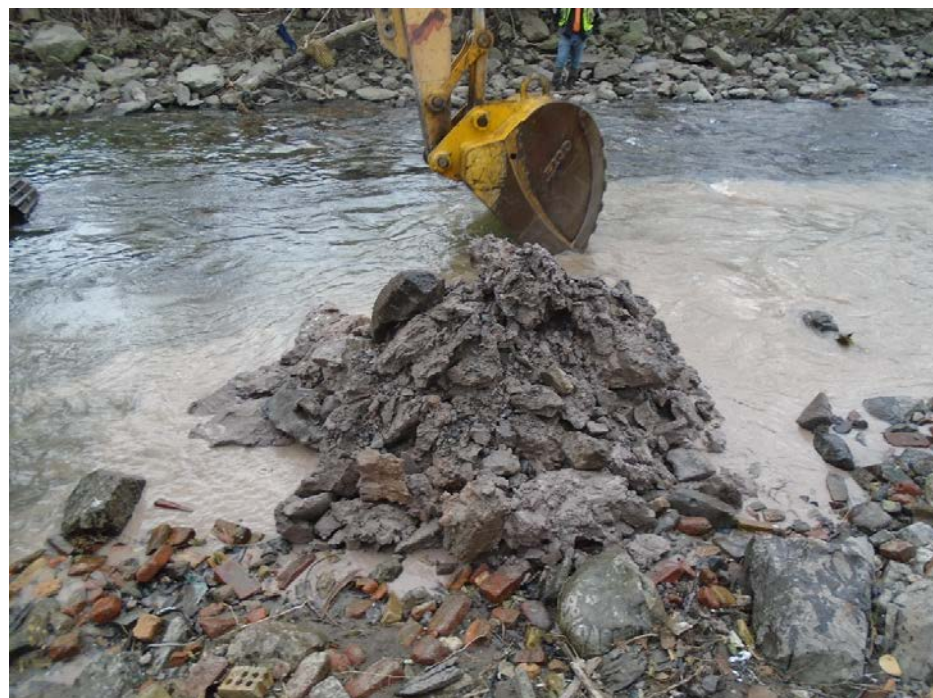
TP-107  
Picture of  
material from  
test pit looking  
north

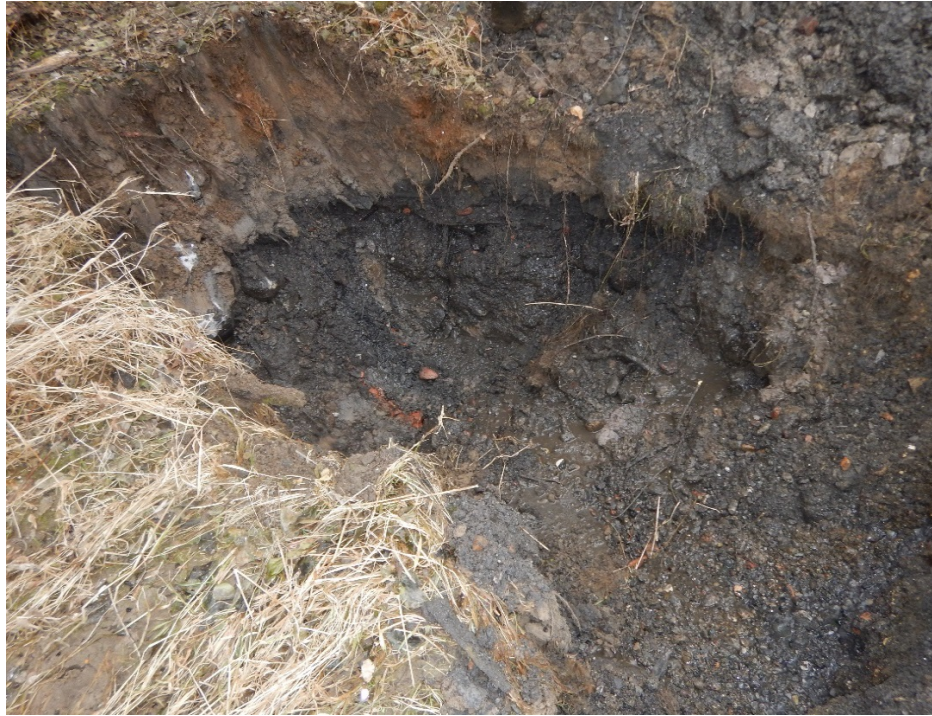
DEPTH (feet bgs)	FIELD IDENTIFICATION OF MATERIAL	COMMENTS
0	(0-3 ft) Fine to coarse brown SAND and medium gravel, little brick.	
1		
2		
3	(3-6 ft) Sub-angular to sub-rounded COBBLES and coarse gravel, some sand, little silt. Gray, moist.	
4		
5		
6	(6 ft) Bedrock, terminated test pit at 6' due to excavator refusal

TP-BANK-3  
Picture of  
looking into  
bank test pit  
from north

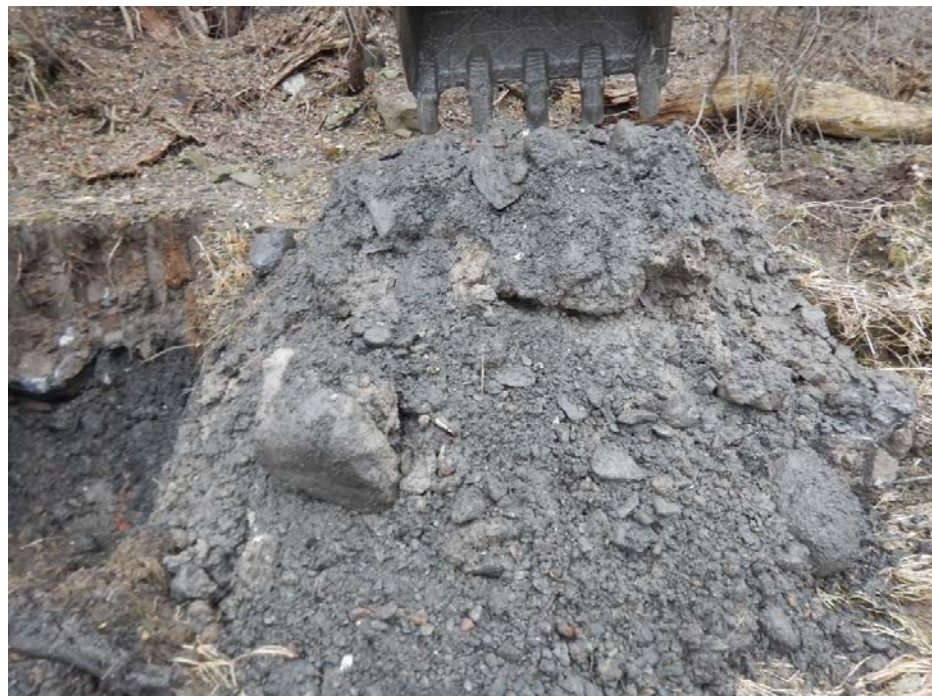
TP-BANK-3  
Picture of  
material from  
bank test pit  
from north

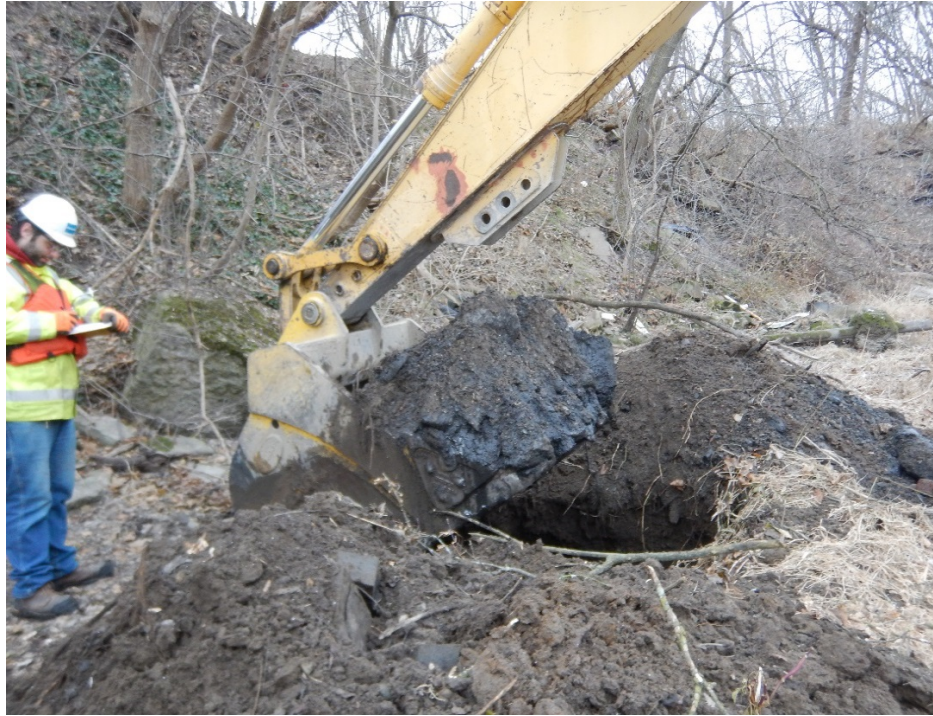
DEPTH (feet bgs)	FIELD IDENTIFICATION OF MATERIAL	COMMENTS
0	(0-4 ft) Dark brown fine to coarse SAND and coarse gravel, little silt, trace brick.	
1		
2		
3		
4	(4-4.5 ft) Dark brown fine to coarse SAND and coarse gravel, trace clay. (4.5 ft) bedrock, terminated test pit at 4.5' due to excavator refusal	Sheens and NAPL blebs present. PID reading 1.0 ppm
5

TP-BANK-4  
Picture of  
material from  
bank test pit

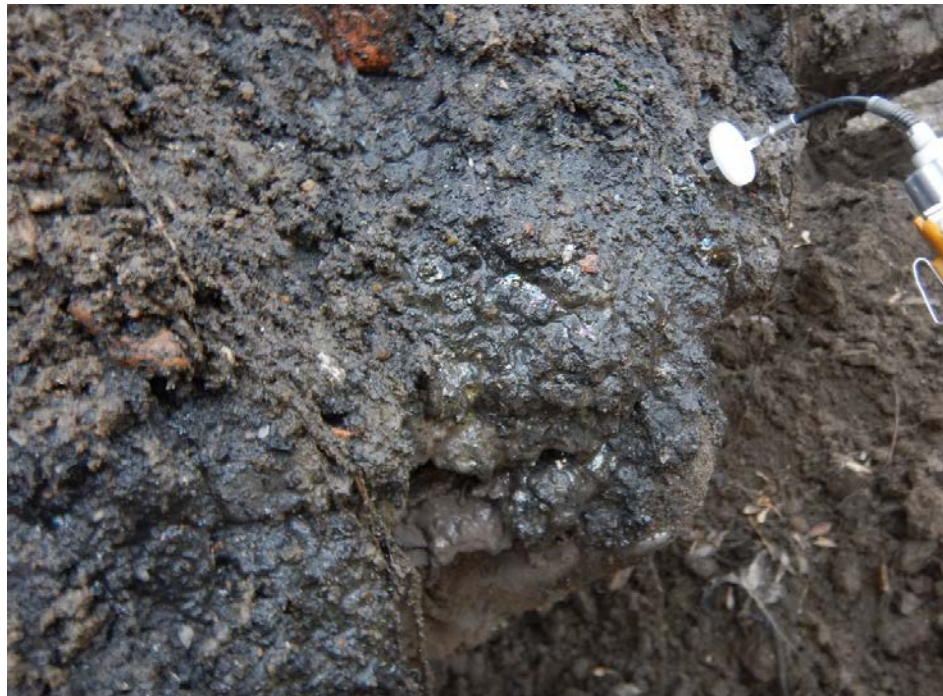
TP-BANK-4  
Picture of  
sheens on  
bank test pit  
material

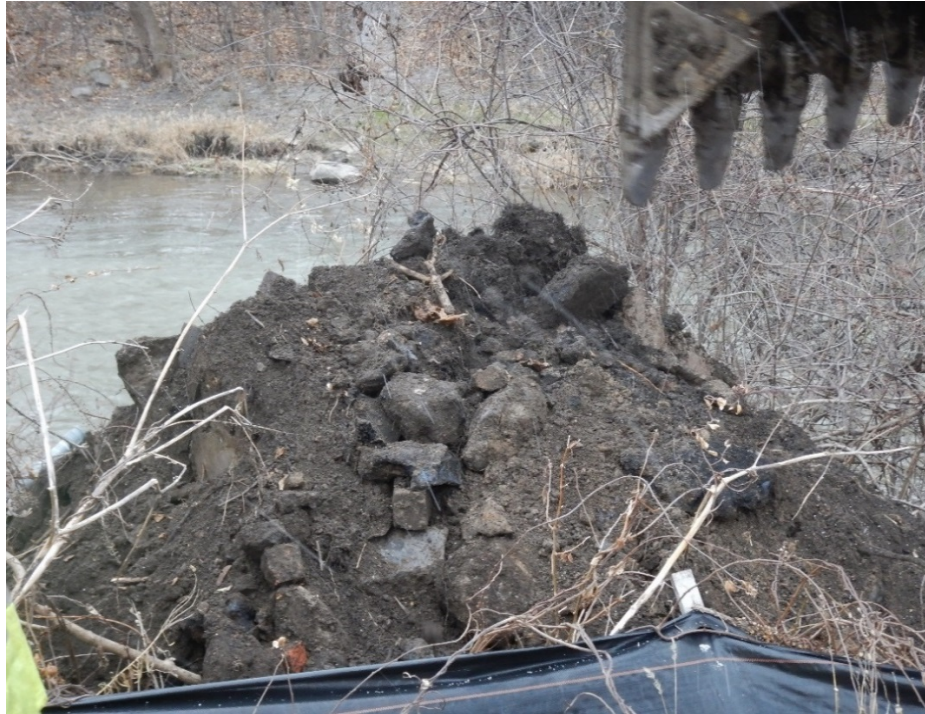
TP-BANK-5  
Picture of  
material from  
bank test pit

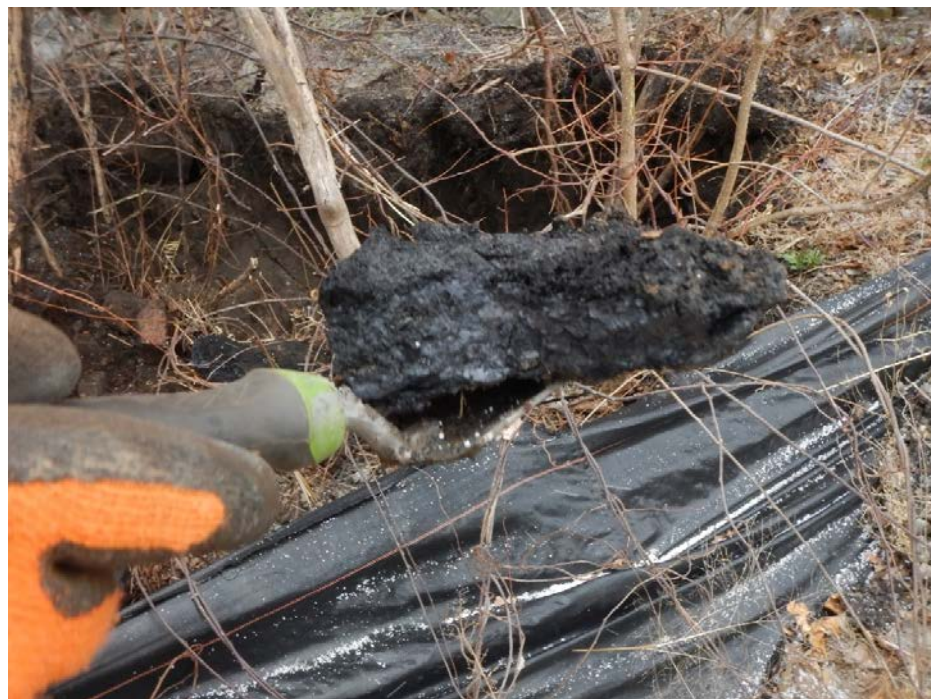
TP-BANK-5  
Picture of broken  
piece of solid  
coal tar

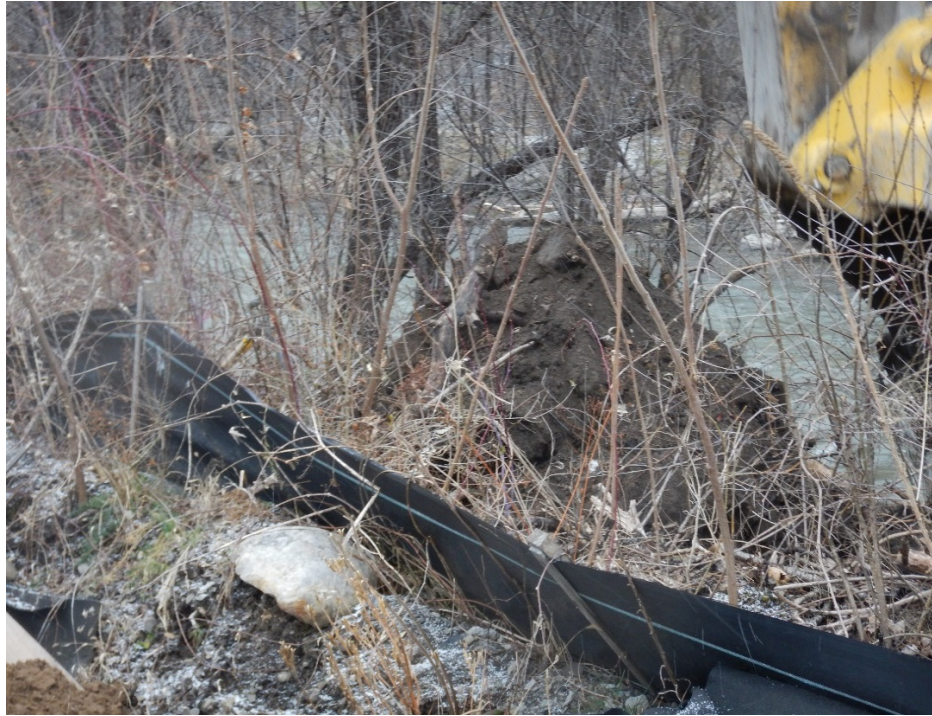
TP-BANK-5  
Picture of  
material from  
bank test pit

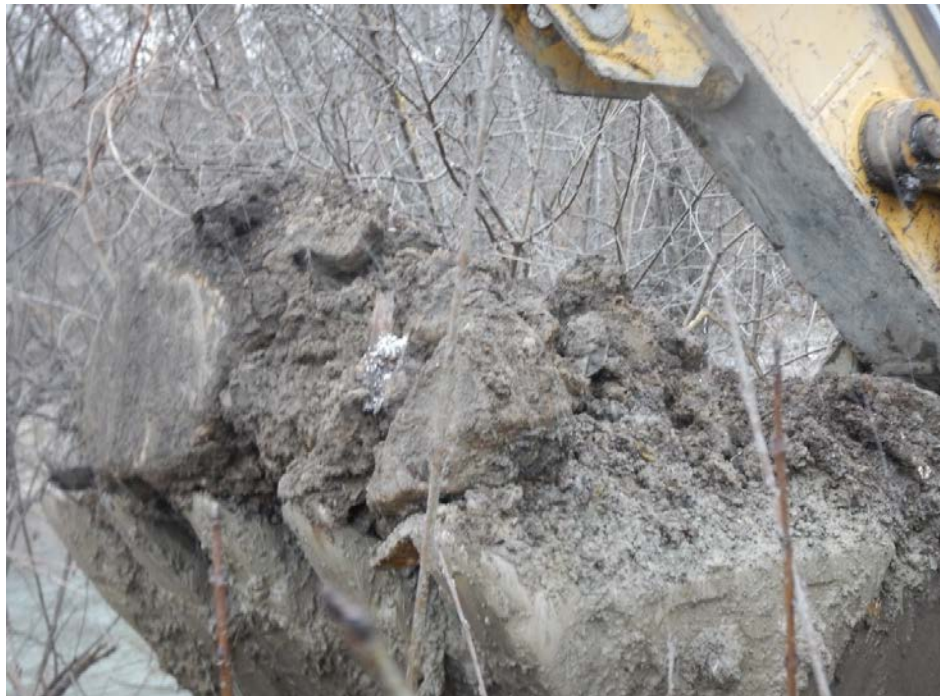
TP-BANK-5  
Picture of  
material from  
test pit
