2023 - 2024 PERIODIC REVIEW REPORT
CLARK STREET FORMER MANUFACTURED GAS PLANT SITE
AUBURN, NEW YORK
NYSDEC SITE NUMBER: 706008

MAY 2024

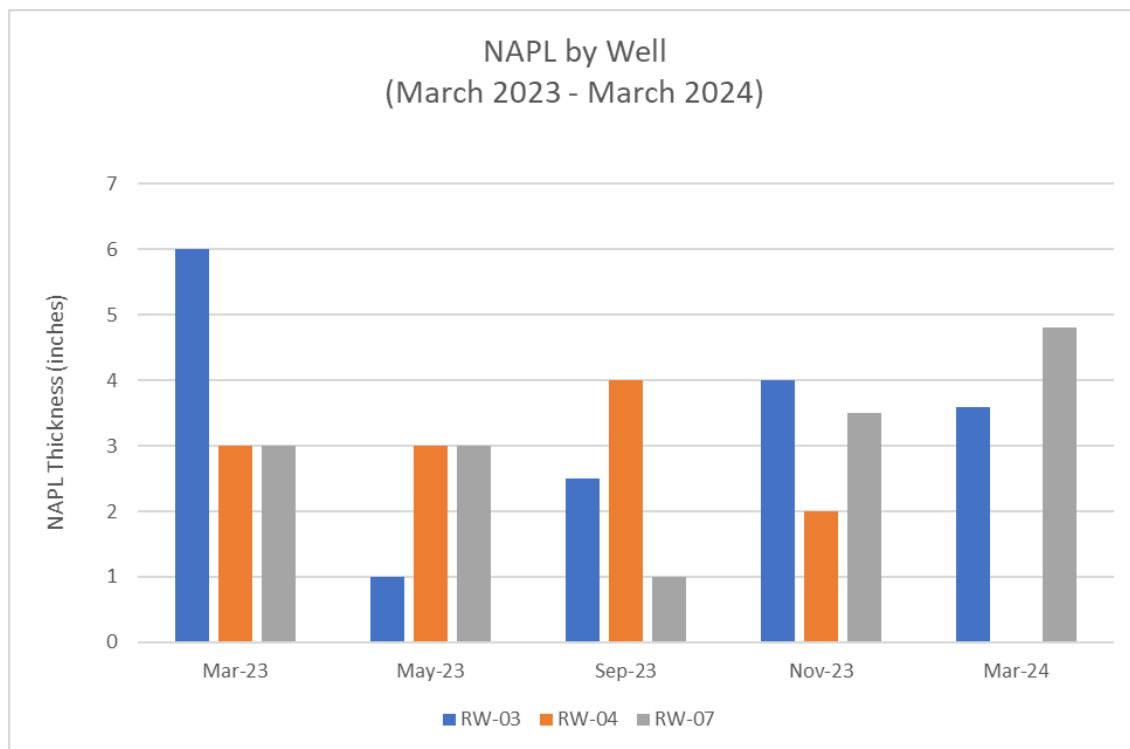
Figure 5.3. Accumulated NAPL Thickness by Recovery Well Collected Using the Active Removal Method – March 2023 – March 2024

The active removal method consisted of removing NAPL accumulated within a recovery well using a peristaltic pump. Active NAPL recovery allowed for direct measurement of NAPL thickness in wells with accumulating product. Sufficient NAPL to warrant active removal was observed in RW-03, RW-04, and RW-07. The amount of NAPL measured in these wells ranged from zero inches to 6.0-inches-thick during the reporting period. Measured NAPL thicknesses were used to estimate the volume of NAPL present in each well. The largest accumulated volume of NAPL estimated during a single event was 0.326 gallons in RW-03.

A graphical representation of accumulated NAPL thickness by recovery well collected using the active removal method for the March 2023 through March 2024 removal events is provided in **Figure 5.3** below. NAPL removal volumes for these events are provided in **Table 5.2**.

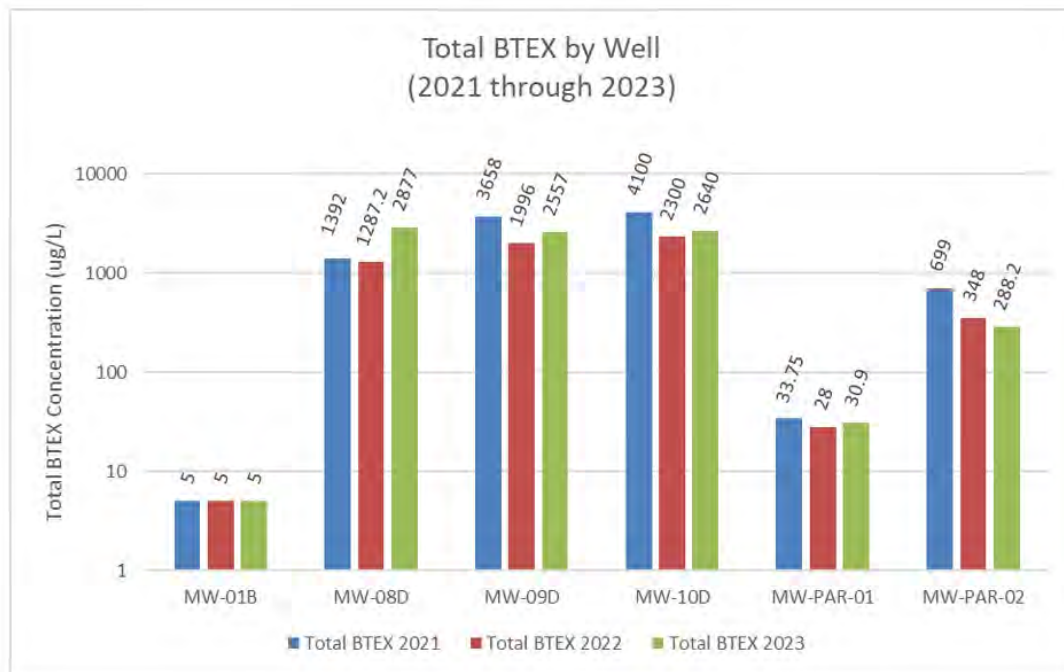
Figure 5.4. Total BTEX Concentration by Monitoring Well – 2021 through 2023

Groundwater sampling was conducted at the Site on September 30, 2021, September 21, 2022, and October 17, 2023. Consistent with the RAO to restore the groundwater aquifer to meet NYSDEC Class GA AWQS criteria to the extent practicable, concentrations of Site constituents of concern are generally trending downward.

BTEX concentrations remained stable in MW-01B with concentrations at 5 ug/L from 2021 to 2023. BTEX concentration decreased in all wells from 2021 to 2023 except MW-08D, which increased from 1,287.2 ug/L in 2022 to 2,877 ug/L in 2023. Analytical results of BTEX and PAHs for each monitoring well for all monitoring events (September 2021 through October 2023) are presented in **Table 5.3**. A graphical representation of total BTEX concentrations by monitoring well for the 2021, 2022, and 2023 sampling events is provided in **Figure 5.4** below. PAH concentrations are generally consistent over the past three years, with naphthalene and acenaphthene exceeding the criteria in all wells.

monitoring wells with the highest detection for a single PAH analyte as 14,000 ug/L of naphthalene. From 2021 to 2023, BTEX concentrations remained stable in one monitoring well (5 ug/L) and decreased in all monitoring wells except one, which increased (from 1,287.2 ug/L in 2022 to 2,877 ug/L in 2023). PAH concentrations are generally consistent over the past three years, with naphthalene and acenaphthene exceeding the criteria in all wells. Due to detections of contaminants of concern in collected groundwater, it is recommended that groundwater sampling continues annually through 2024.

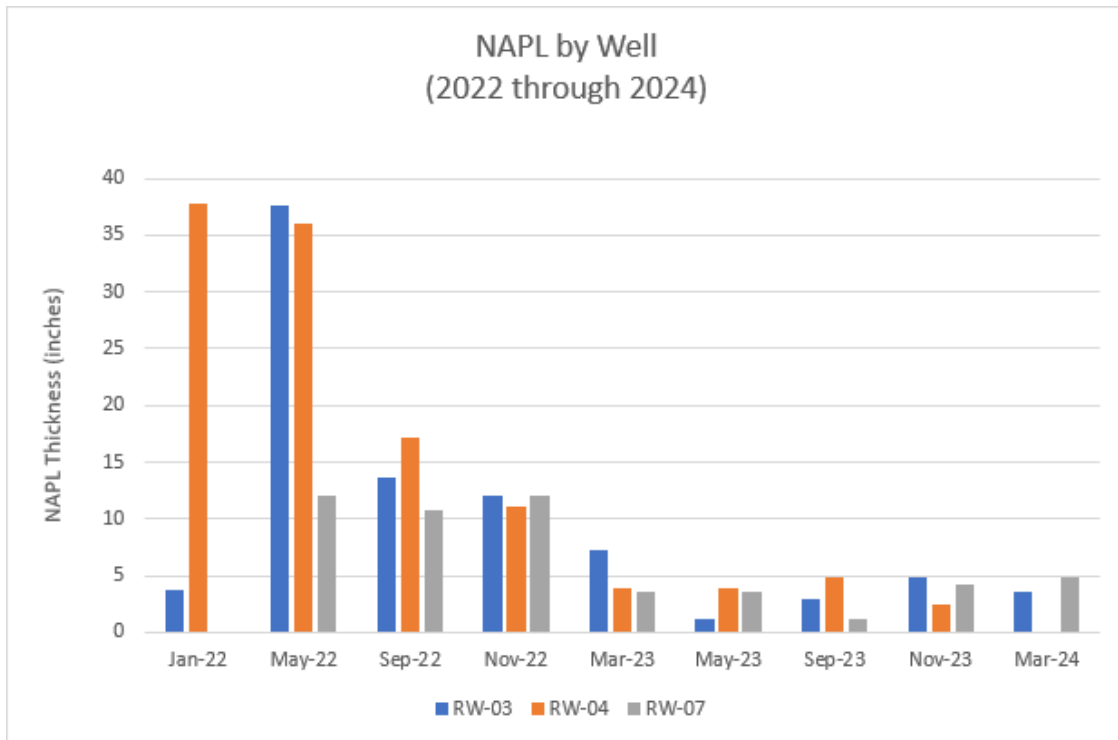
Figure 5.5. Accumulated NAPL Thickness by Recovery Well Collected Using the Active Removal Method – January 2022 – March 2024

NAPL removal was conducted at the Site in 2021 (August, October, and November), 2022 (January, May, September, and November) 2023 (March, May, September, and November) and 2024 (March). The active removal method was used to collect NAPL from January 2022 through March 2024. Consistent with the RAO to restore the groundwater aquifer to meet NYSDEC Class GA AWQS criteria to the extent practicable, NAPL accumulation observed in recovery wells using the active removal method is generally trending downward over collection events.

Quantities on recovered NAPL continue to decrease from 2021 with measurable quantities only being observed in three wells (RW-03, RW-04, and RW-07). A graphical representation of accumulated NAPL thickness by recovery well collected using the active removal method for the January 2022 through March 2024 removal events is provided in **Figure 5.5** below. NAPL removal volumes for all collection events using the passive and active removal methods are provided in **Table 5.4** (the August 2021 collection event has been excluded from Table 5.4 since this event consisted of deployment of hydrophobic absorbent socks and no NAPL was collected).

A network of 10 NAPL collection wells is being used for quarterly NAPL removal at the Site. NAPL removal was conducted in 2023 (March, May, September, and November) and 2024 (March). Previous NAPL removal occurred in 2021 (August, October, and November) and 2022 (January, May, September, and November). Quantities on recovered NAPL continue to decrease from 2021 with measurable quantities only being observed in three wells (RW-03, RW-04, and RW-07). Due to observation of continual NAPL buildup during the reporting period, it is recommended that NAPL removal continues quarterly through 2024.

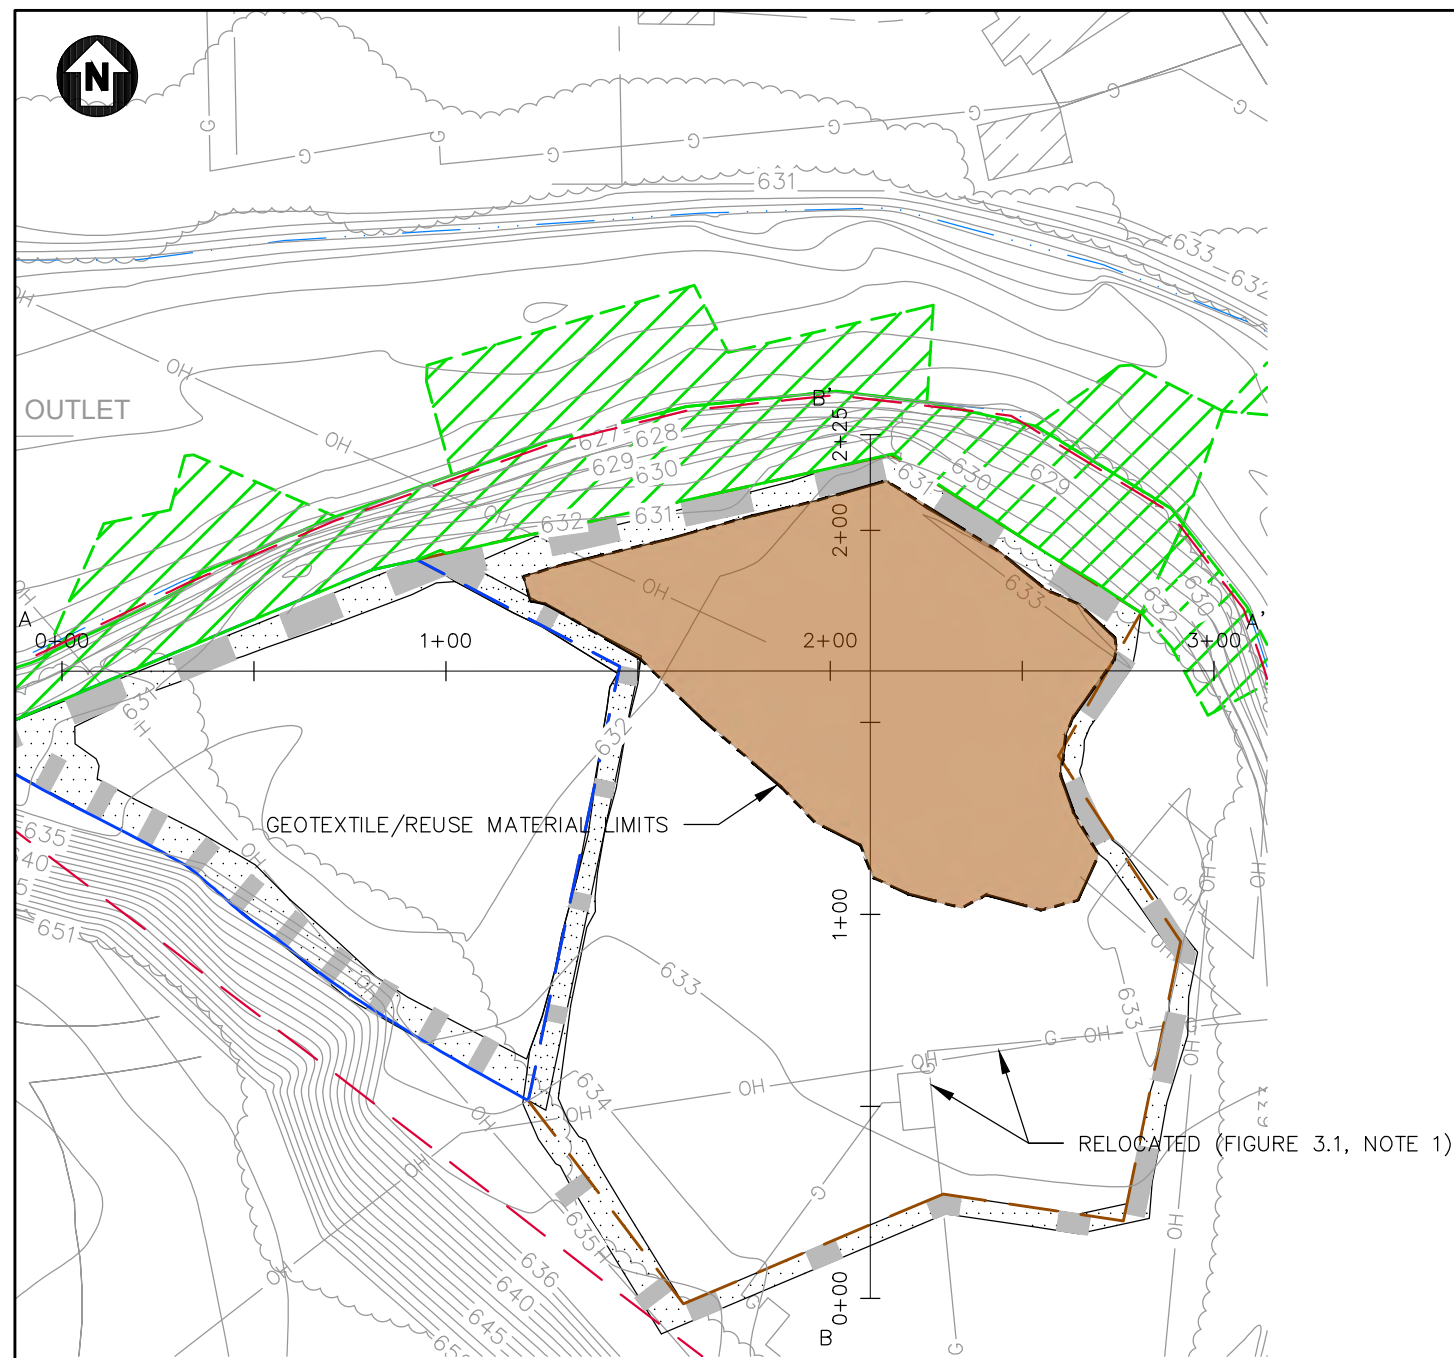
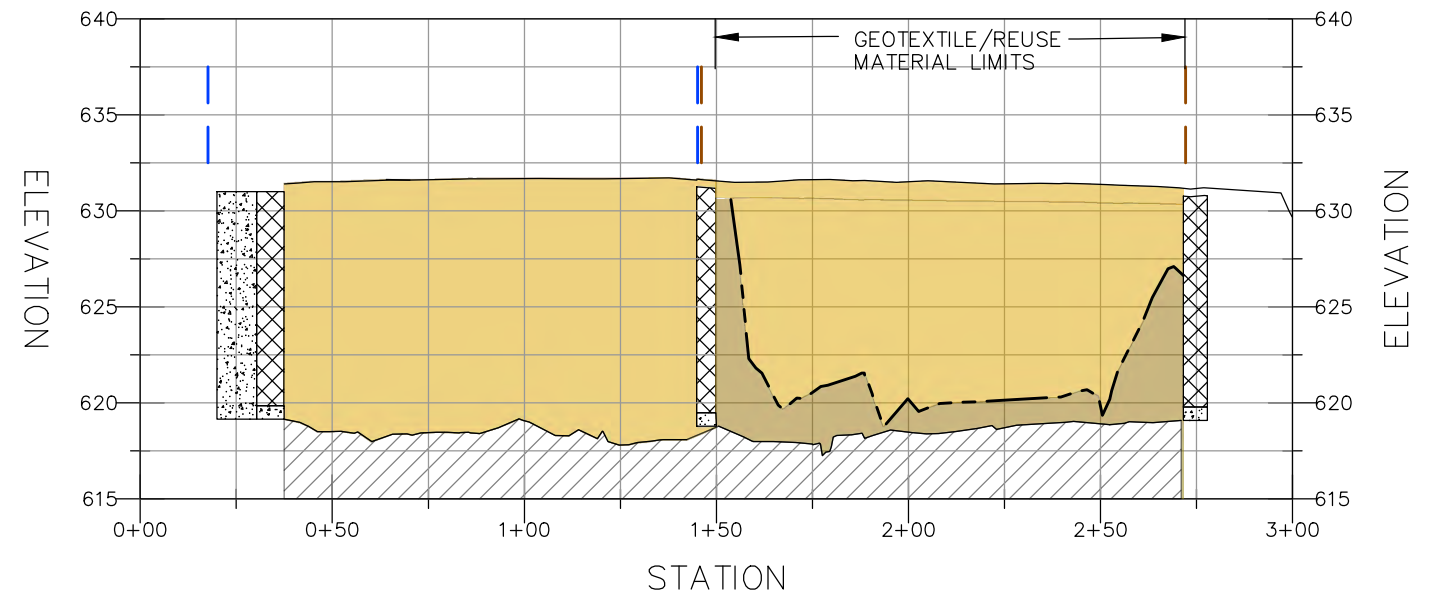
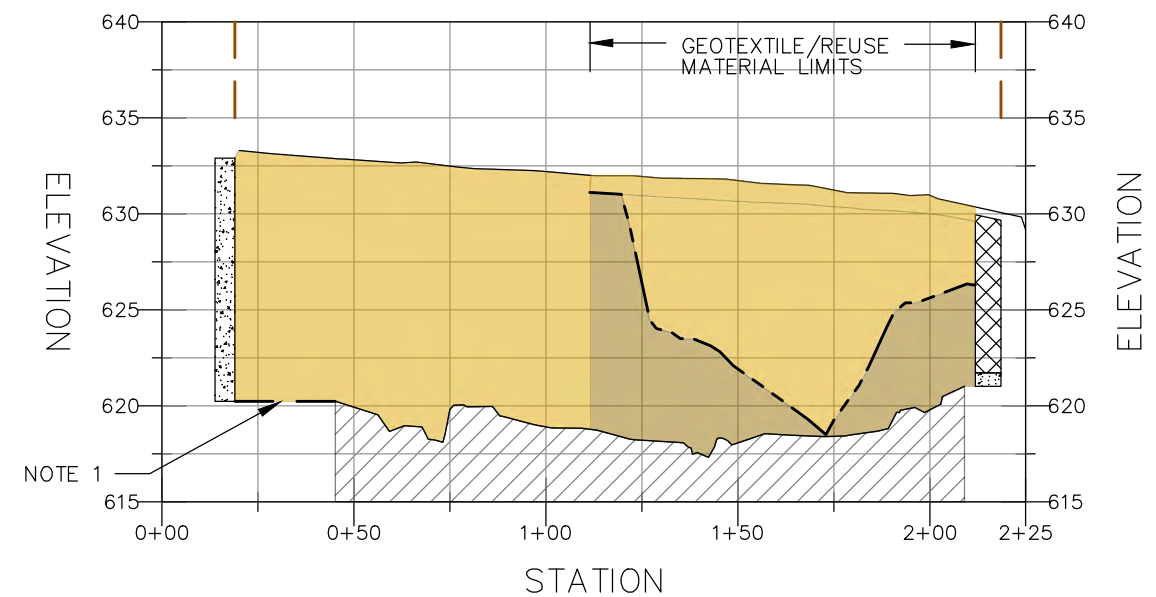
COVER SYSTEM EXTENTS AND
HORIZONTAL PROFILE

Cover system installation at the Site was effective in meeting the Soil RAOs for the Site. Exposure to remaining contamination in bedrock and soil at the Site is prevented by a soil cover system. This cover system is comprised of a minimum of 12 inches of backfill that satisfied the SCOs for restricted commercial use and the protection of groundwater. Where impacted soils (i.e., NYSDEC-approved reuse material) remained on-site, a demarcation geotextile layer was placed between these materials and the clean soil cover. As a part of the cover system, an ecological buffer zone was established along the southern edge of the Owasco Outlet, approximately 25 feet wide measured laterally from the high-water level. The top two feet of soil in this zone was vegetated and consisted of soils that met the SCO for protection of ecological resources. **Figure 3.1** presents the location of the cover system in relation to other remedial elements and **Figure 3.2** presents an overview of the location of the cover system and demarcation layers, where applicable.

PROFILE ALIGNMENT – A–A'

PROFILE ALIGNMENT – B–B'

ISS LIMITS PROFILE

1" = 50'-0" HORIZONTAL
1" = 10'-0" VERTICAL 5X EXAGGERATION

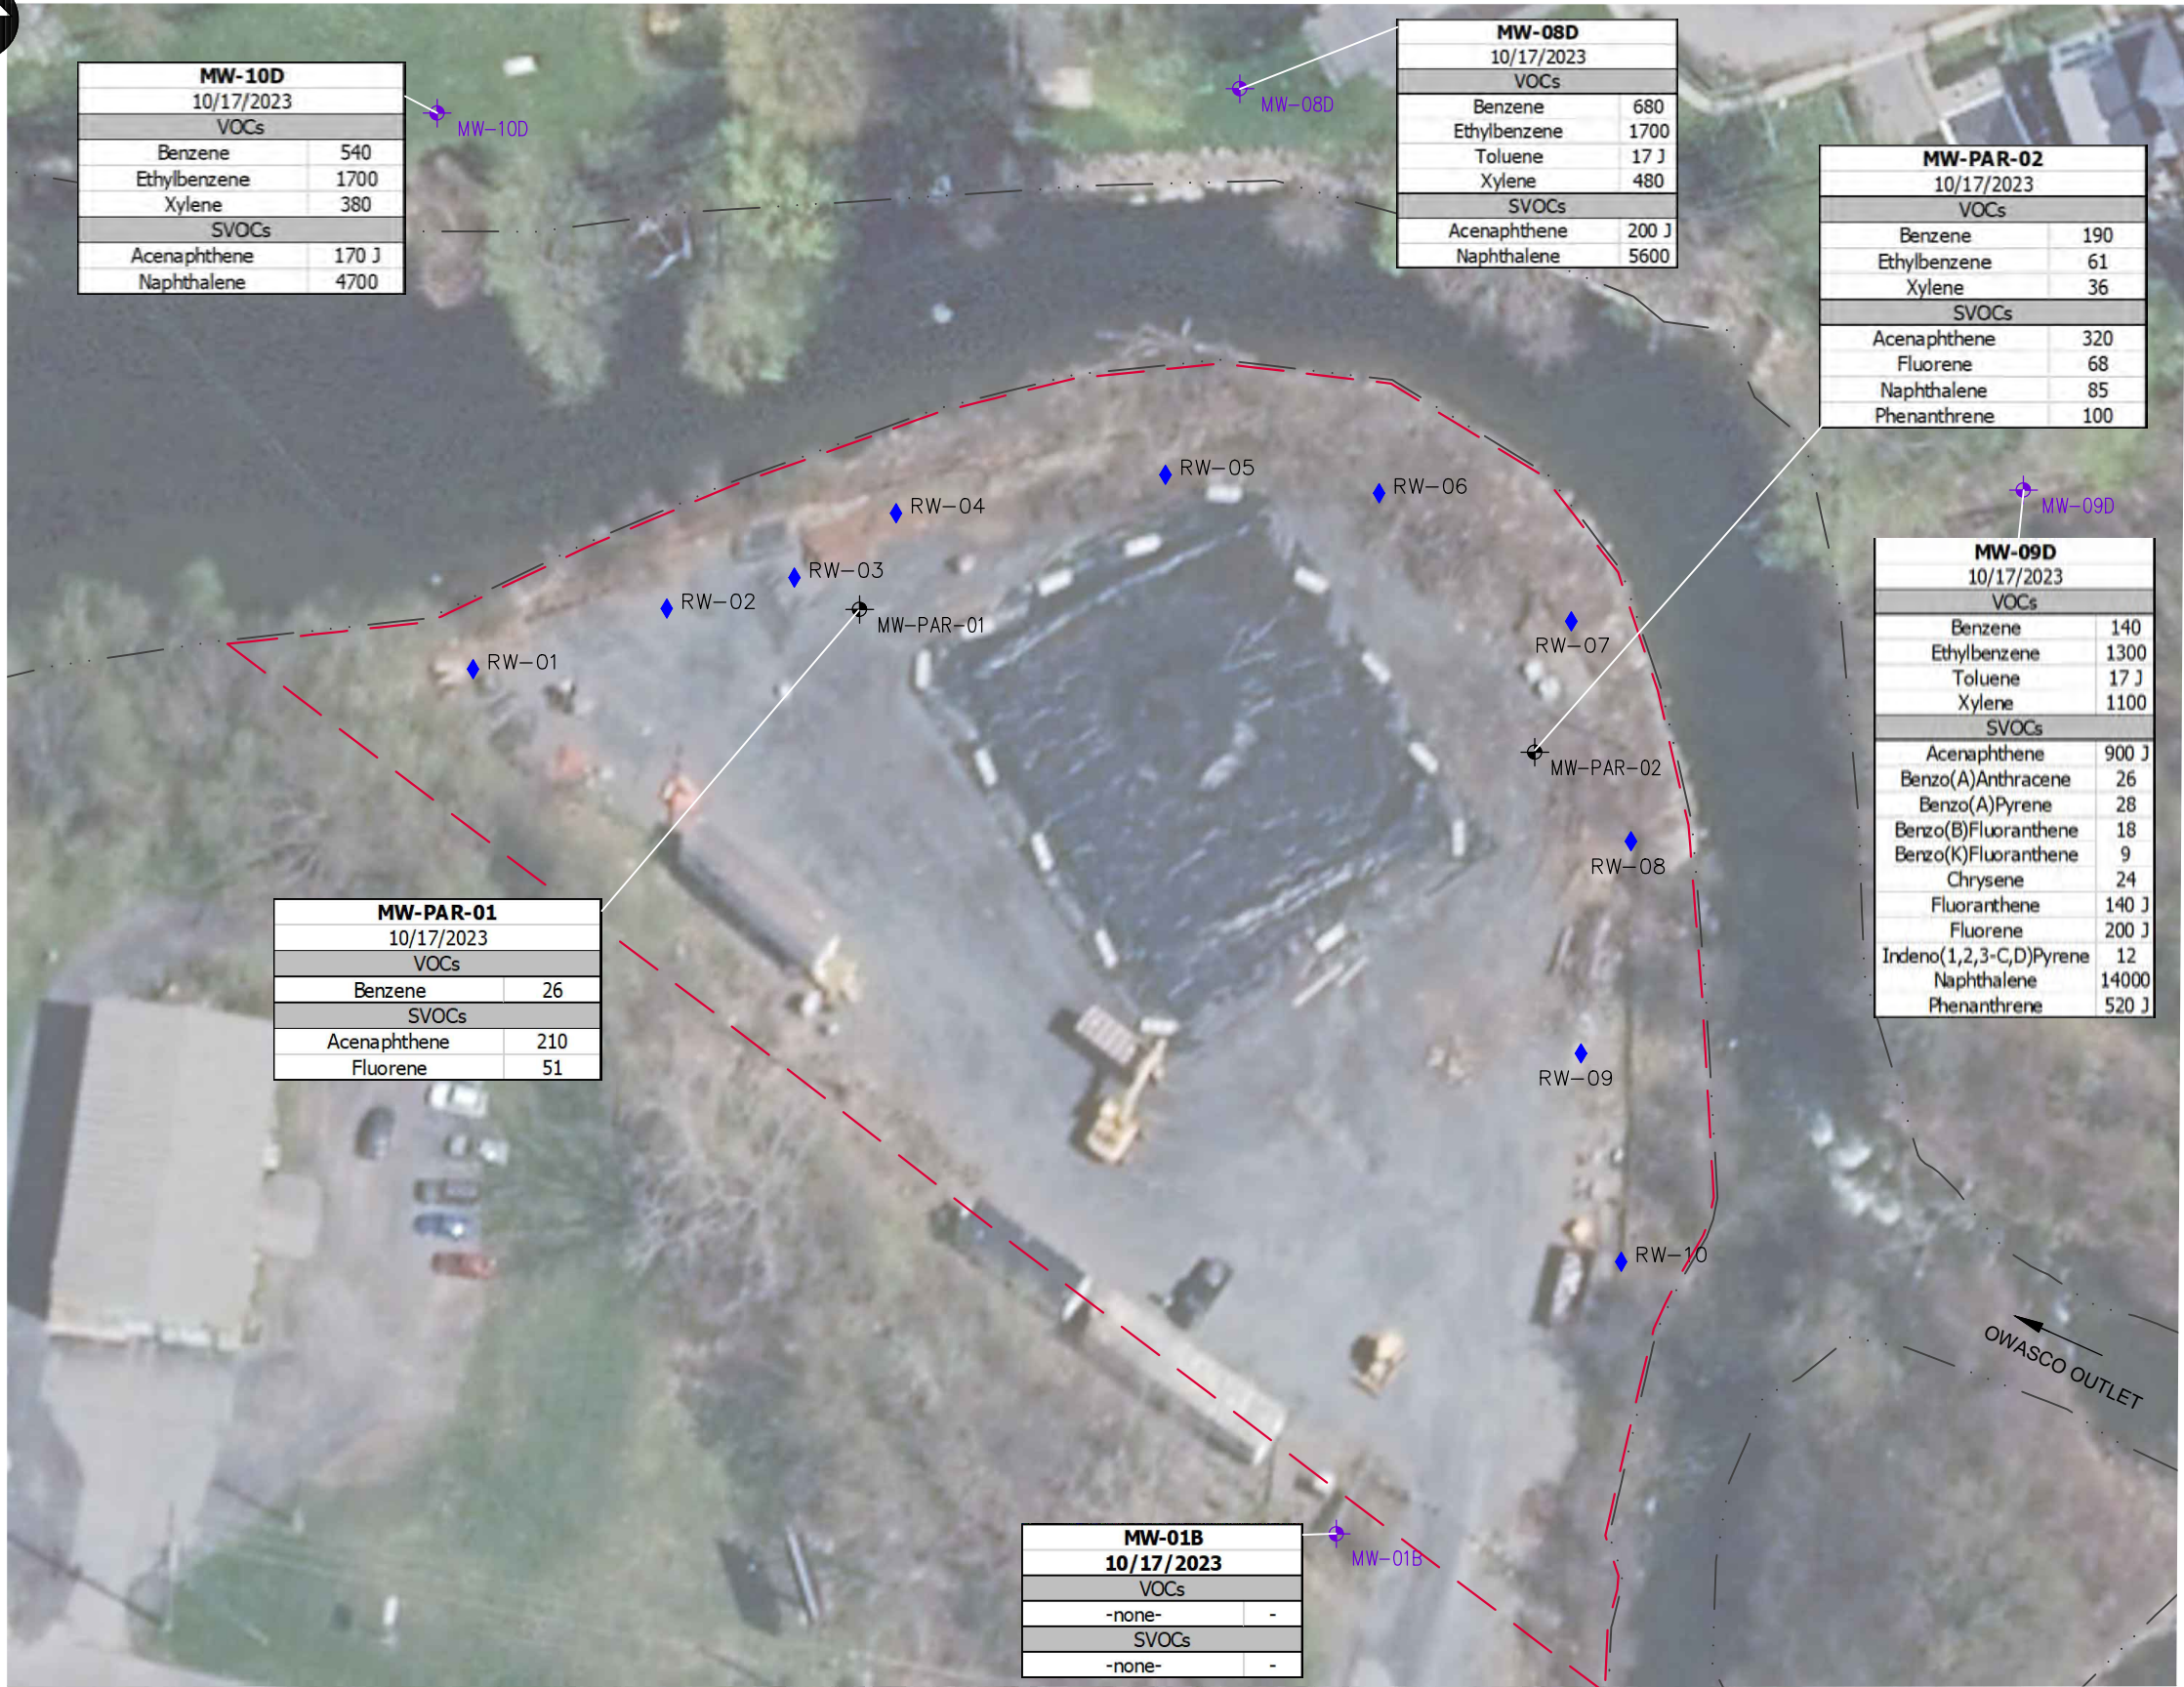
FIGURE 5.2

- LEGEND:
- ENVIRONMENTAL EASEMENT/SITE BOUNDARY (FIGURE 3.1, NOTE 2)
 - RECOVERY WELL
 - OVERBURDEN MONITORING WELL
 - BEDROCK MONITORING WELL
- NOTES:
- PROPERTY LINE DIGITIZED FROM INFORMATION TAKEN FROM CAYUGA COUNTY GIS, 2024. LOCATION IS APPROXIMATE.
 - VALUES SHOWN IN ug/L.
 - TABLE QUALIFIERS:
 - U: COMPOUNDS NOT DETECTED ABOVE THE REPORTING LIMIT
 - J: ESTIMATED VALUE
 - ONLY COMPOUNDS WITH VALUES EXCEEDING THE NYS CLASS GA STANDARDS CRITERIA ARE SHOWN.
