**New York State Electric & Gas
Corporation**

Remedial Investigation Report

Former Manufactured Gas Plant Site
McMaster Street, Auburn, New York

August 2008

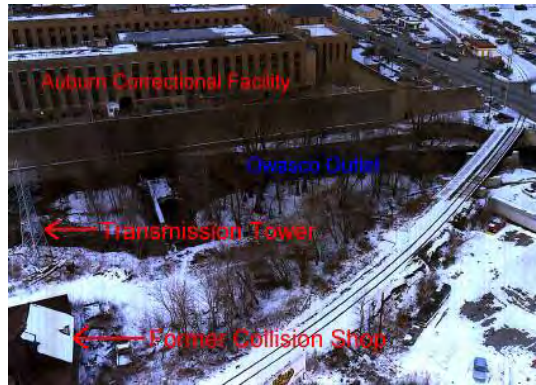
Figure 1.1 – Low Altitude Aerial Photo of Site, looking north.

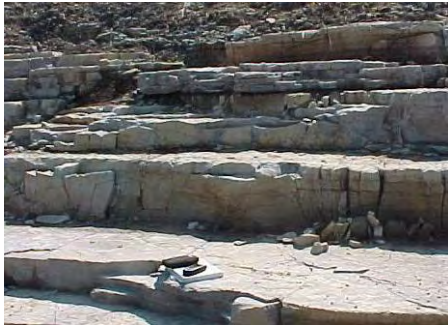
**Figure 3.1 – Photograph of
Bedrock Outcrop Near Site.**

The bedding plane dip (i.e., direction in which the layers of rock tilt) of rock beneath the site, as determined by mapping of the top of the Manlius Formation (Figure 7), is approximately 70 feet per mile to the south-southeast, which is slightly higher than the regional dip of approximately 40 feet per mile to south. Such local variation in dip angle and direction between is not uncommon due to minor flexures in the rock. Based on review of bedrock cores obtained at

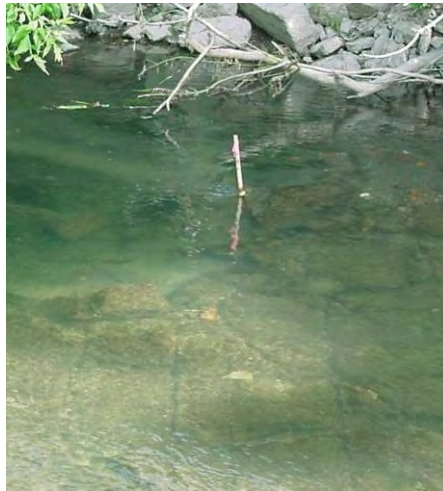
Figure 3.2 – Photograph of Bedrock Surface in Owasco Outlet Upstream of Site (looking northwest).

Jointing was observed in the Onondaga Limestone at several exposures in the Outlet near the site. Those joints appeared to be vertical/ near vertical with a horizontal spacing of approximately 2 to 4 feet. High-angle fractures in the Onondaga and Manlius Limestones were also observed in bedrock cores obtained at several boring locations.

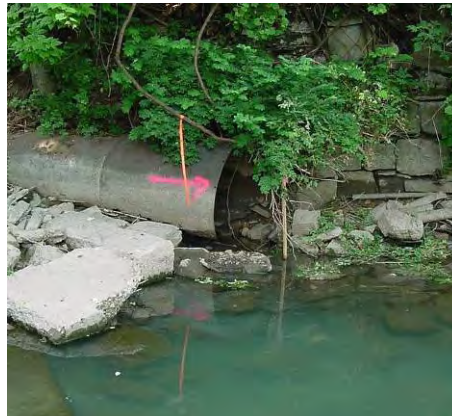
Figure 3.4 – Photograph of Outfall 16.

Strong sewage-like odors were noticed at OF 5 and OF 16 during the reconnaissance, probing and sampling activities. A suspended solids plume, making the water appear grey, was also observed issuing from OF16.

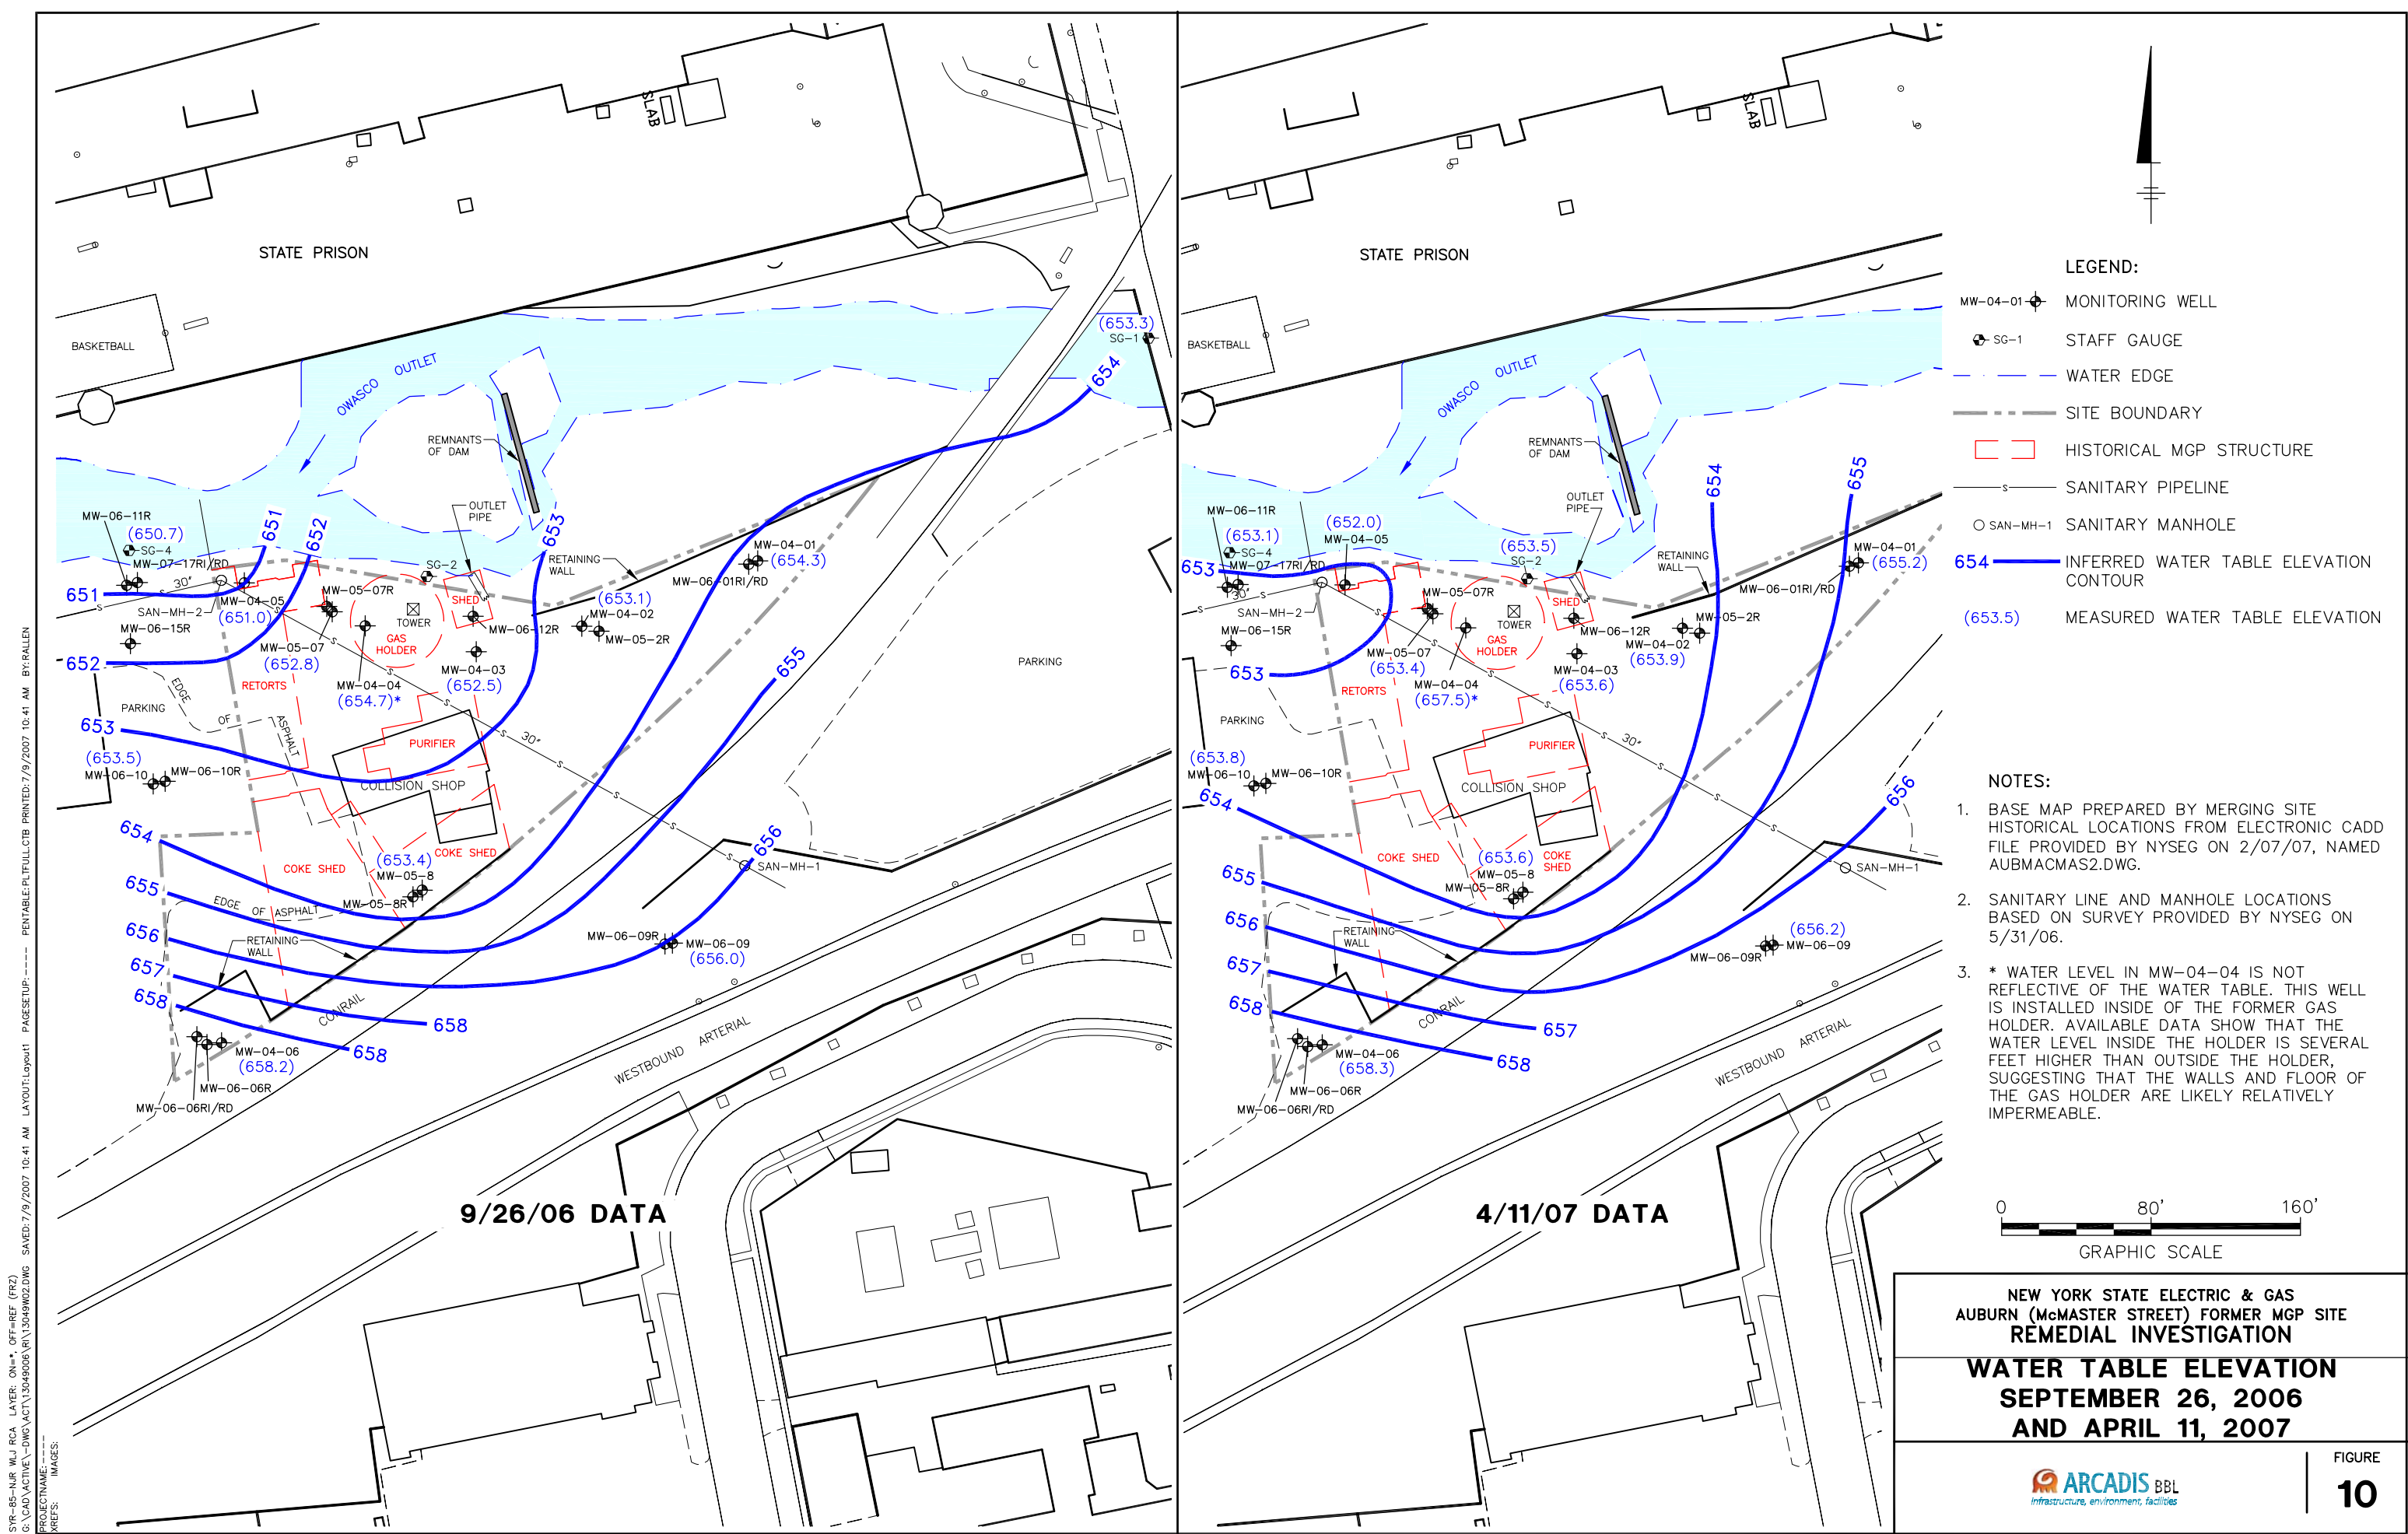
**REGIONAL GROUNDWATER
FLOW DIRECTION**

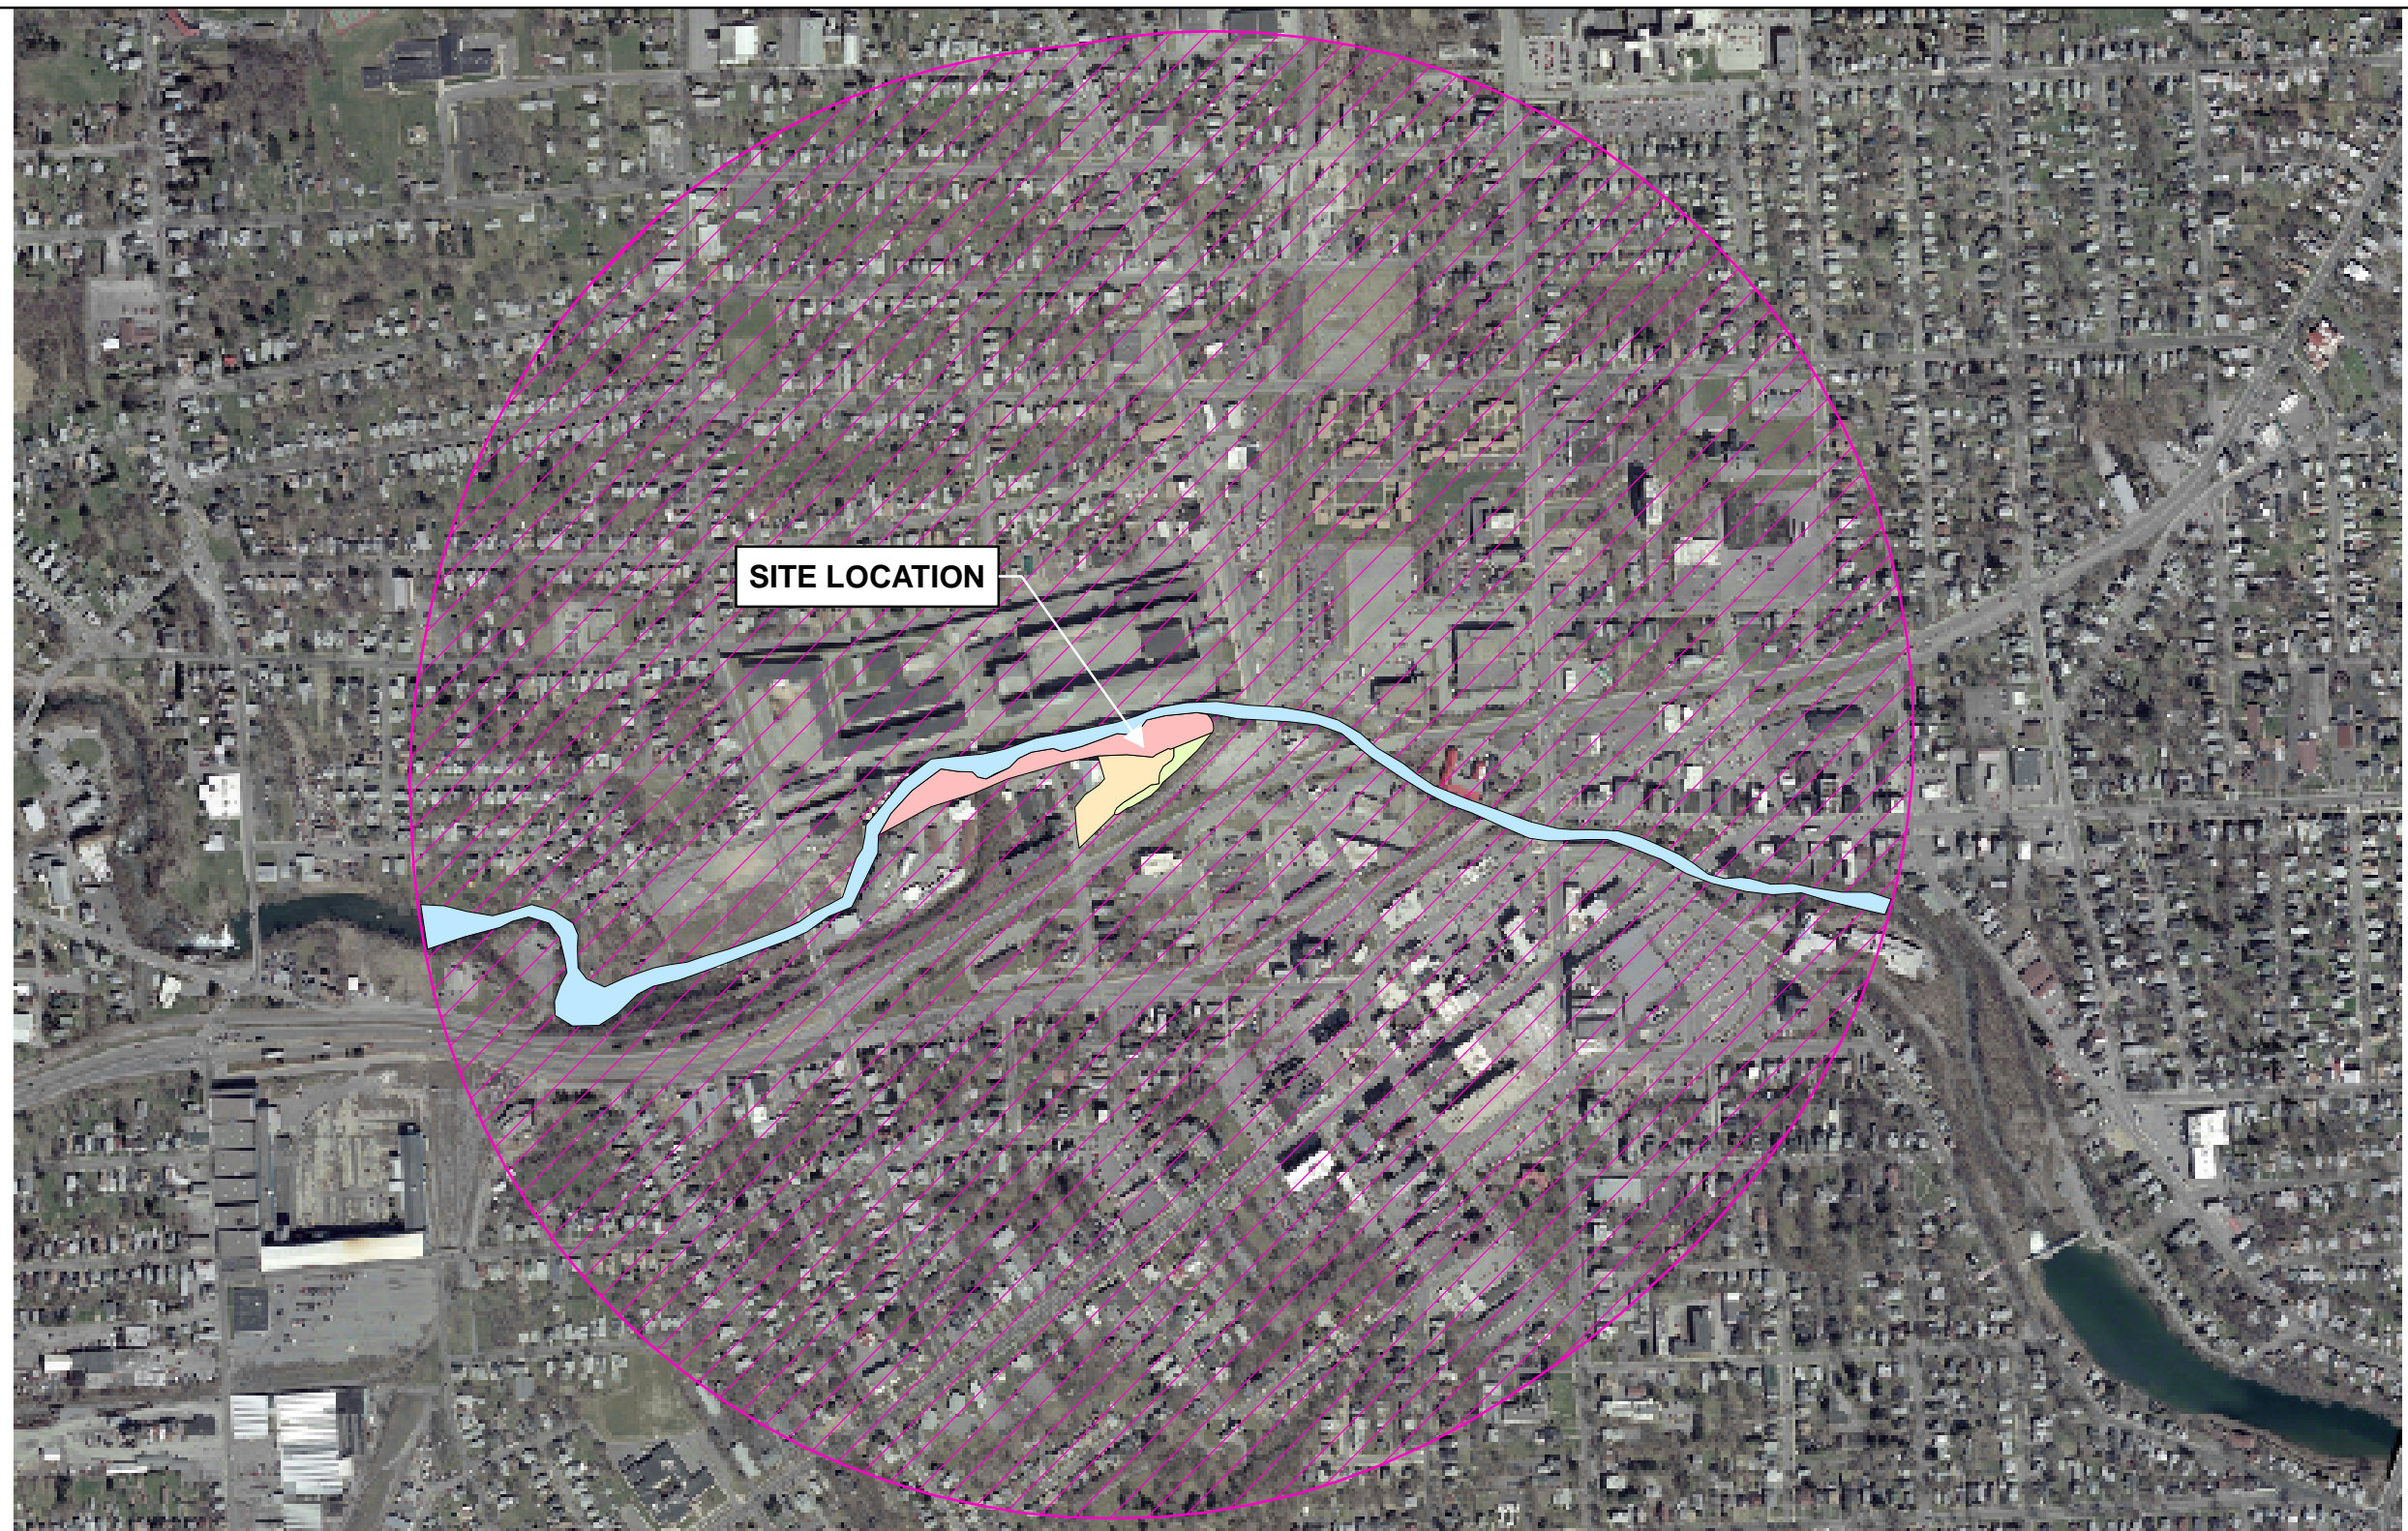
COVERTYPE MAP
