PERIODIC REVIEW REPORT

Gladding Cordage Site

Site Number 7-09-0097

June 2017

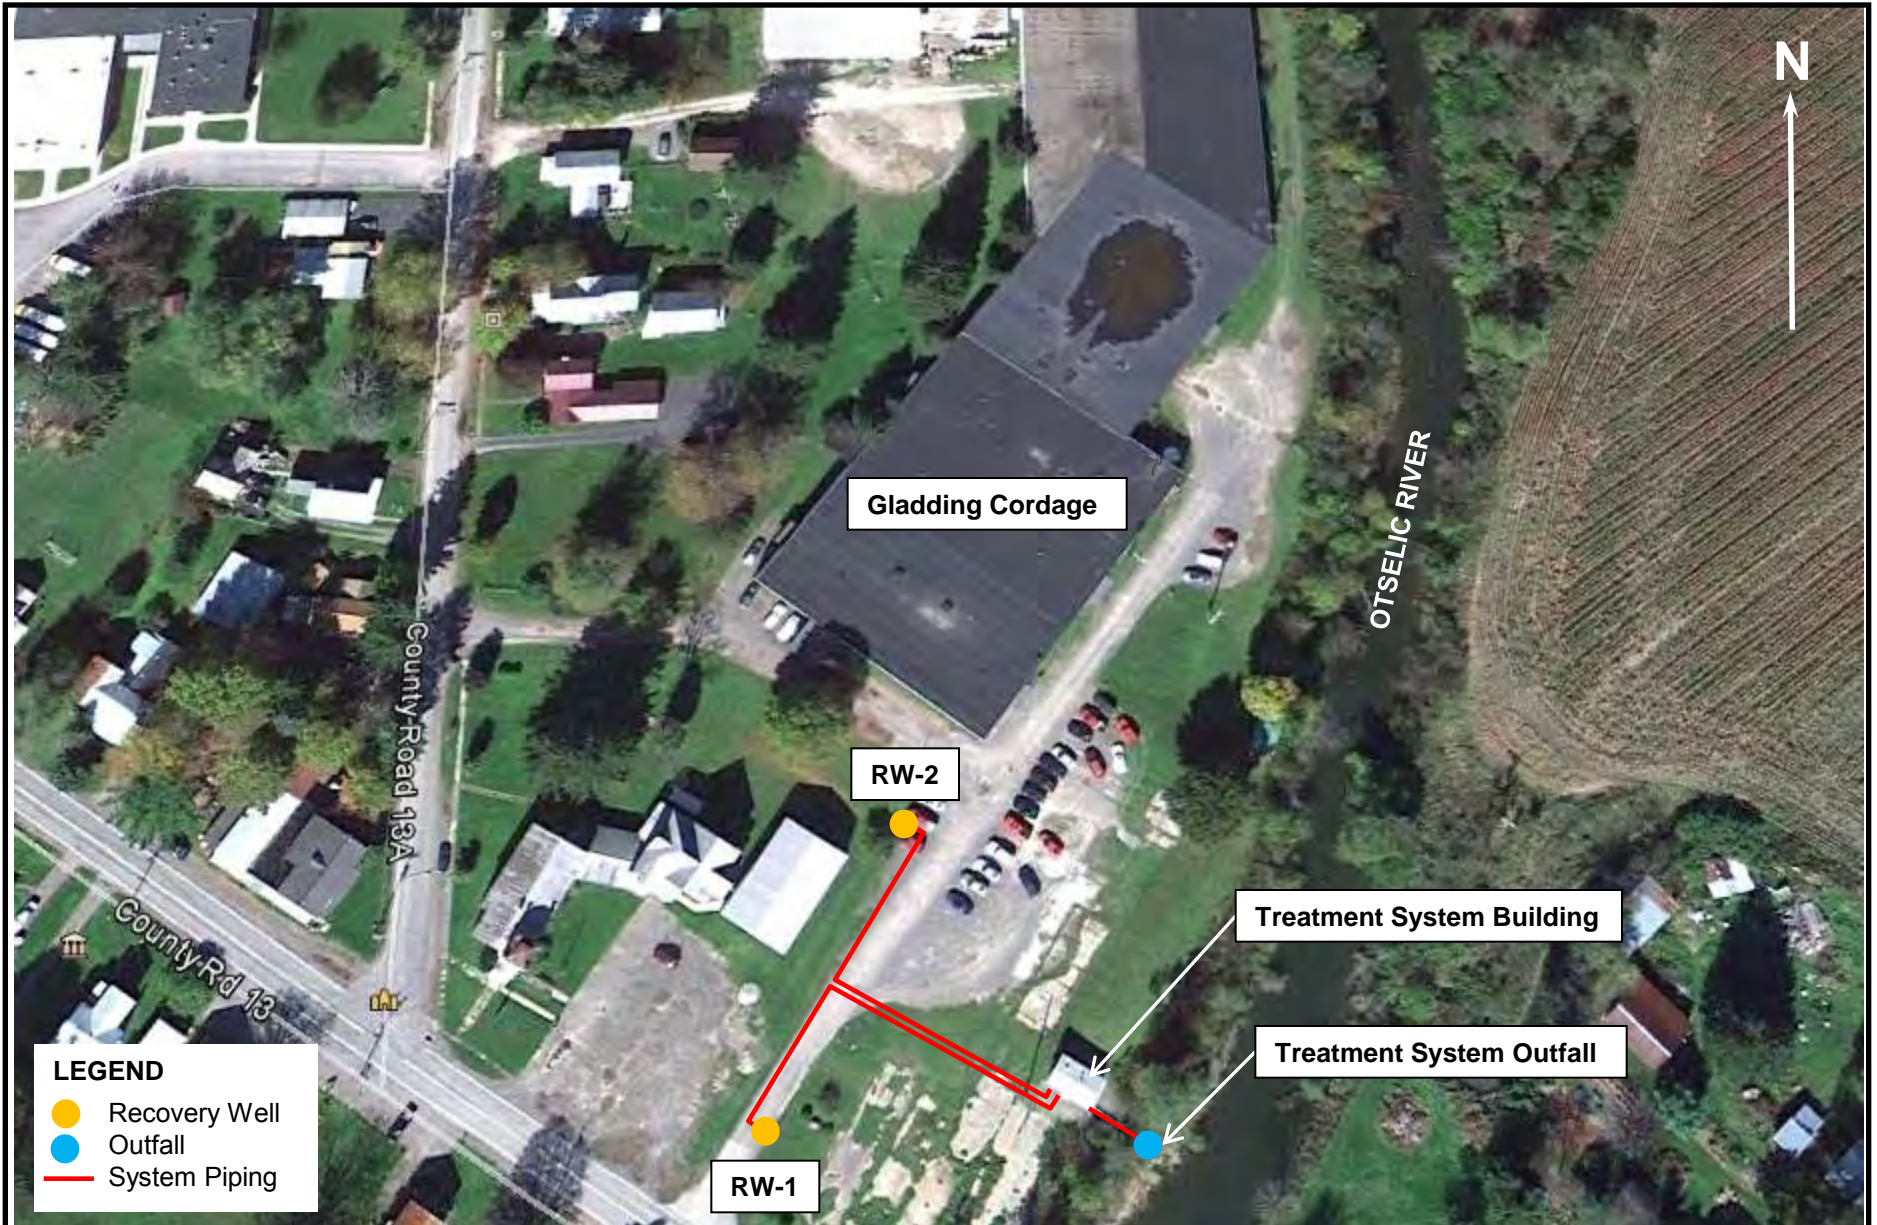
FIGURE 2-2

SITE FEATURES AND TREATMENT SYSTEM LAYOUT

The Gladding Cordage Site is located at 110 County Road 13A, South Otselic, in Chenango County (Figure 2-1). The Site is approximately 7.5 acres and includes an active manufacturing facility, a groundwater treatment system (Figure 2-2), and a monitoring well network (Figure 2-3). The Site is currently classified as a Class 4 inactive hazardous waste site.

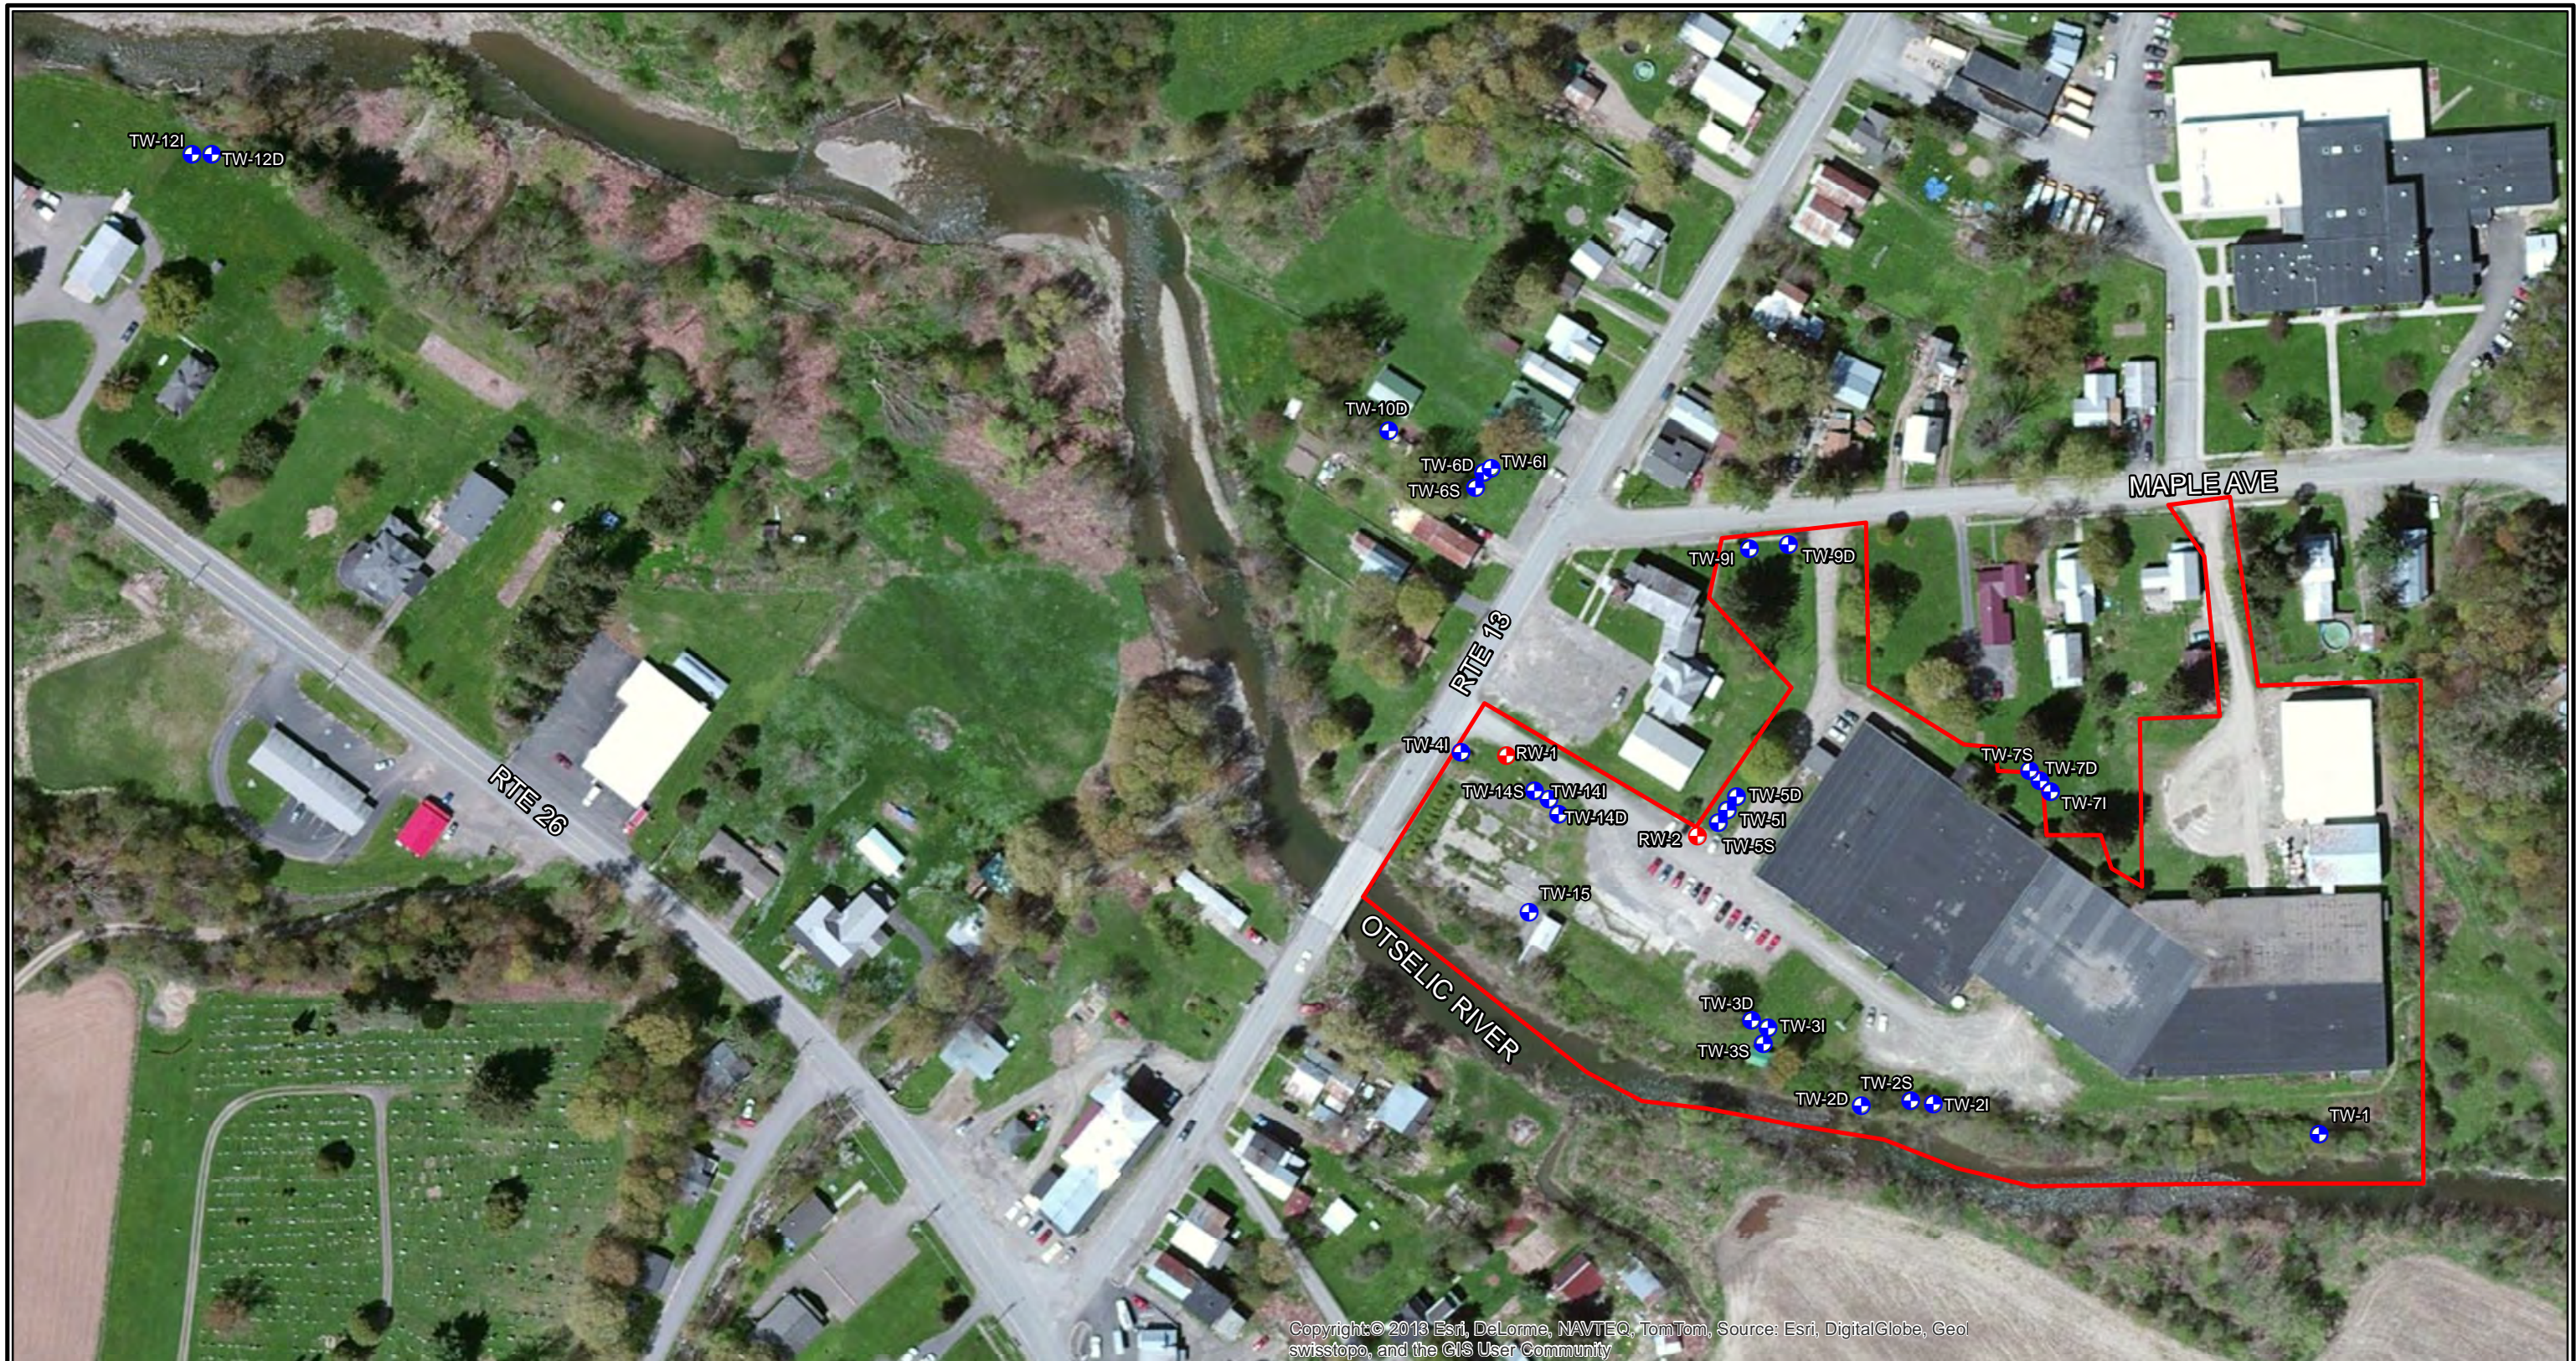
NYSDEC STANDBY CONTRACT NO. D004443-5
 GLADDING CORDAGE SITE 7-09-009
 SOUTH OTSELIC, NEW YORK
SITE MANAGEMENT PLAN

Groundwater sampling was conducted to provide information on groundwater quality, monitor potential contaminant migration in the groundwater at the site, and assess hydrogeologic site conditions, including groundwater flow direction. Groundwater monitoring well locations are shown on Figure 2-3.

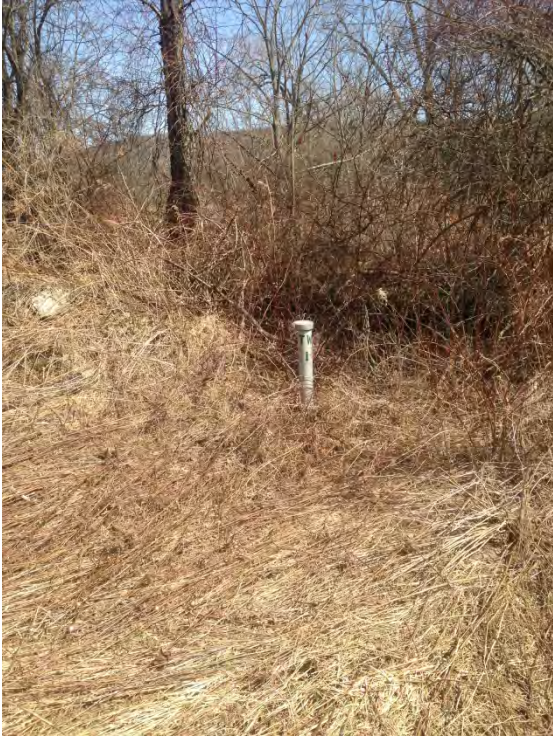
TW-1

The integrity of each well is inspected to evaluate the integrity and suitability for groundwater monitoring and water levels. Each well was identified as being in acceptable condition during the 2014 through first quarter 2017 visits and no repairs were required.

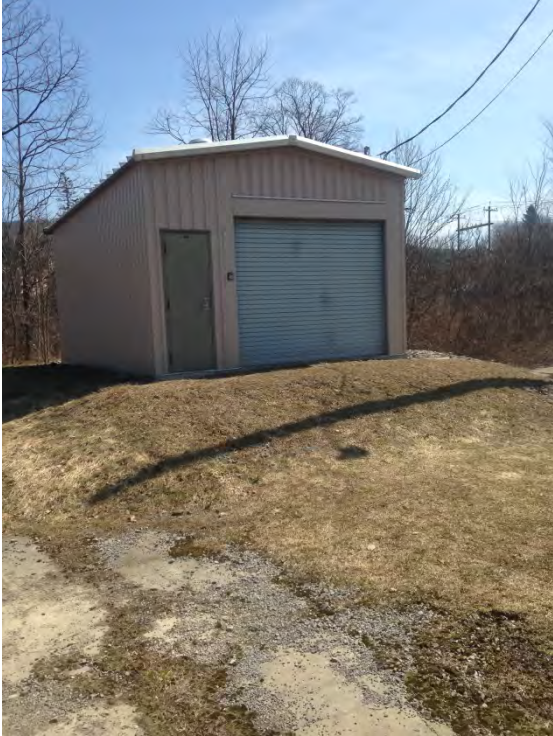
Treatment Building

Results from the 2014 through first quarter 2017 inspections are presented in Appendix A. The Site was observed to be well-kept and the grounds appeared to have been maintained during all inspections.
