**INTERIM REMEDIAL MEASURES COMPLETION REPORT
FOR
SYSTEM ENHANCEMENT
NORWICH FORMER MGP SITE
NORWICH, NEW YORK**

IT Corporation Project 108196

March 18, 2002

New York State Electric and Gas Corporation
Kirkwood Industrial Park
Kirkwood, New York 13902

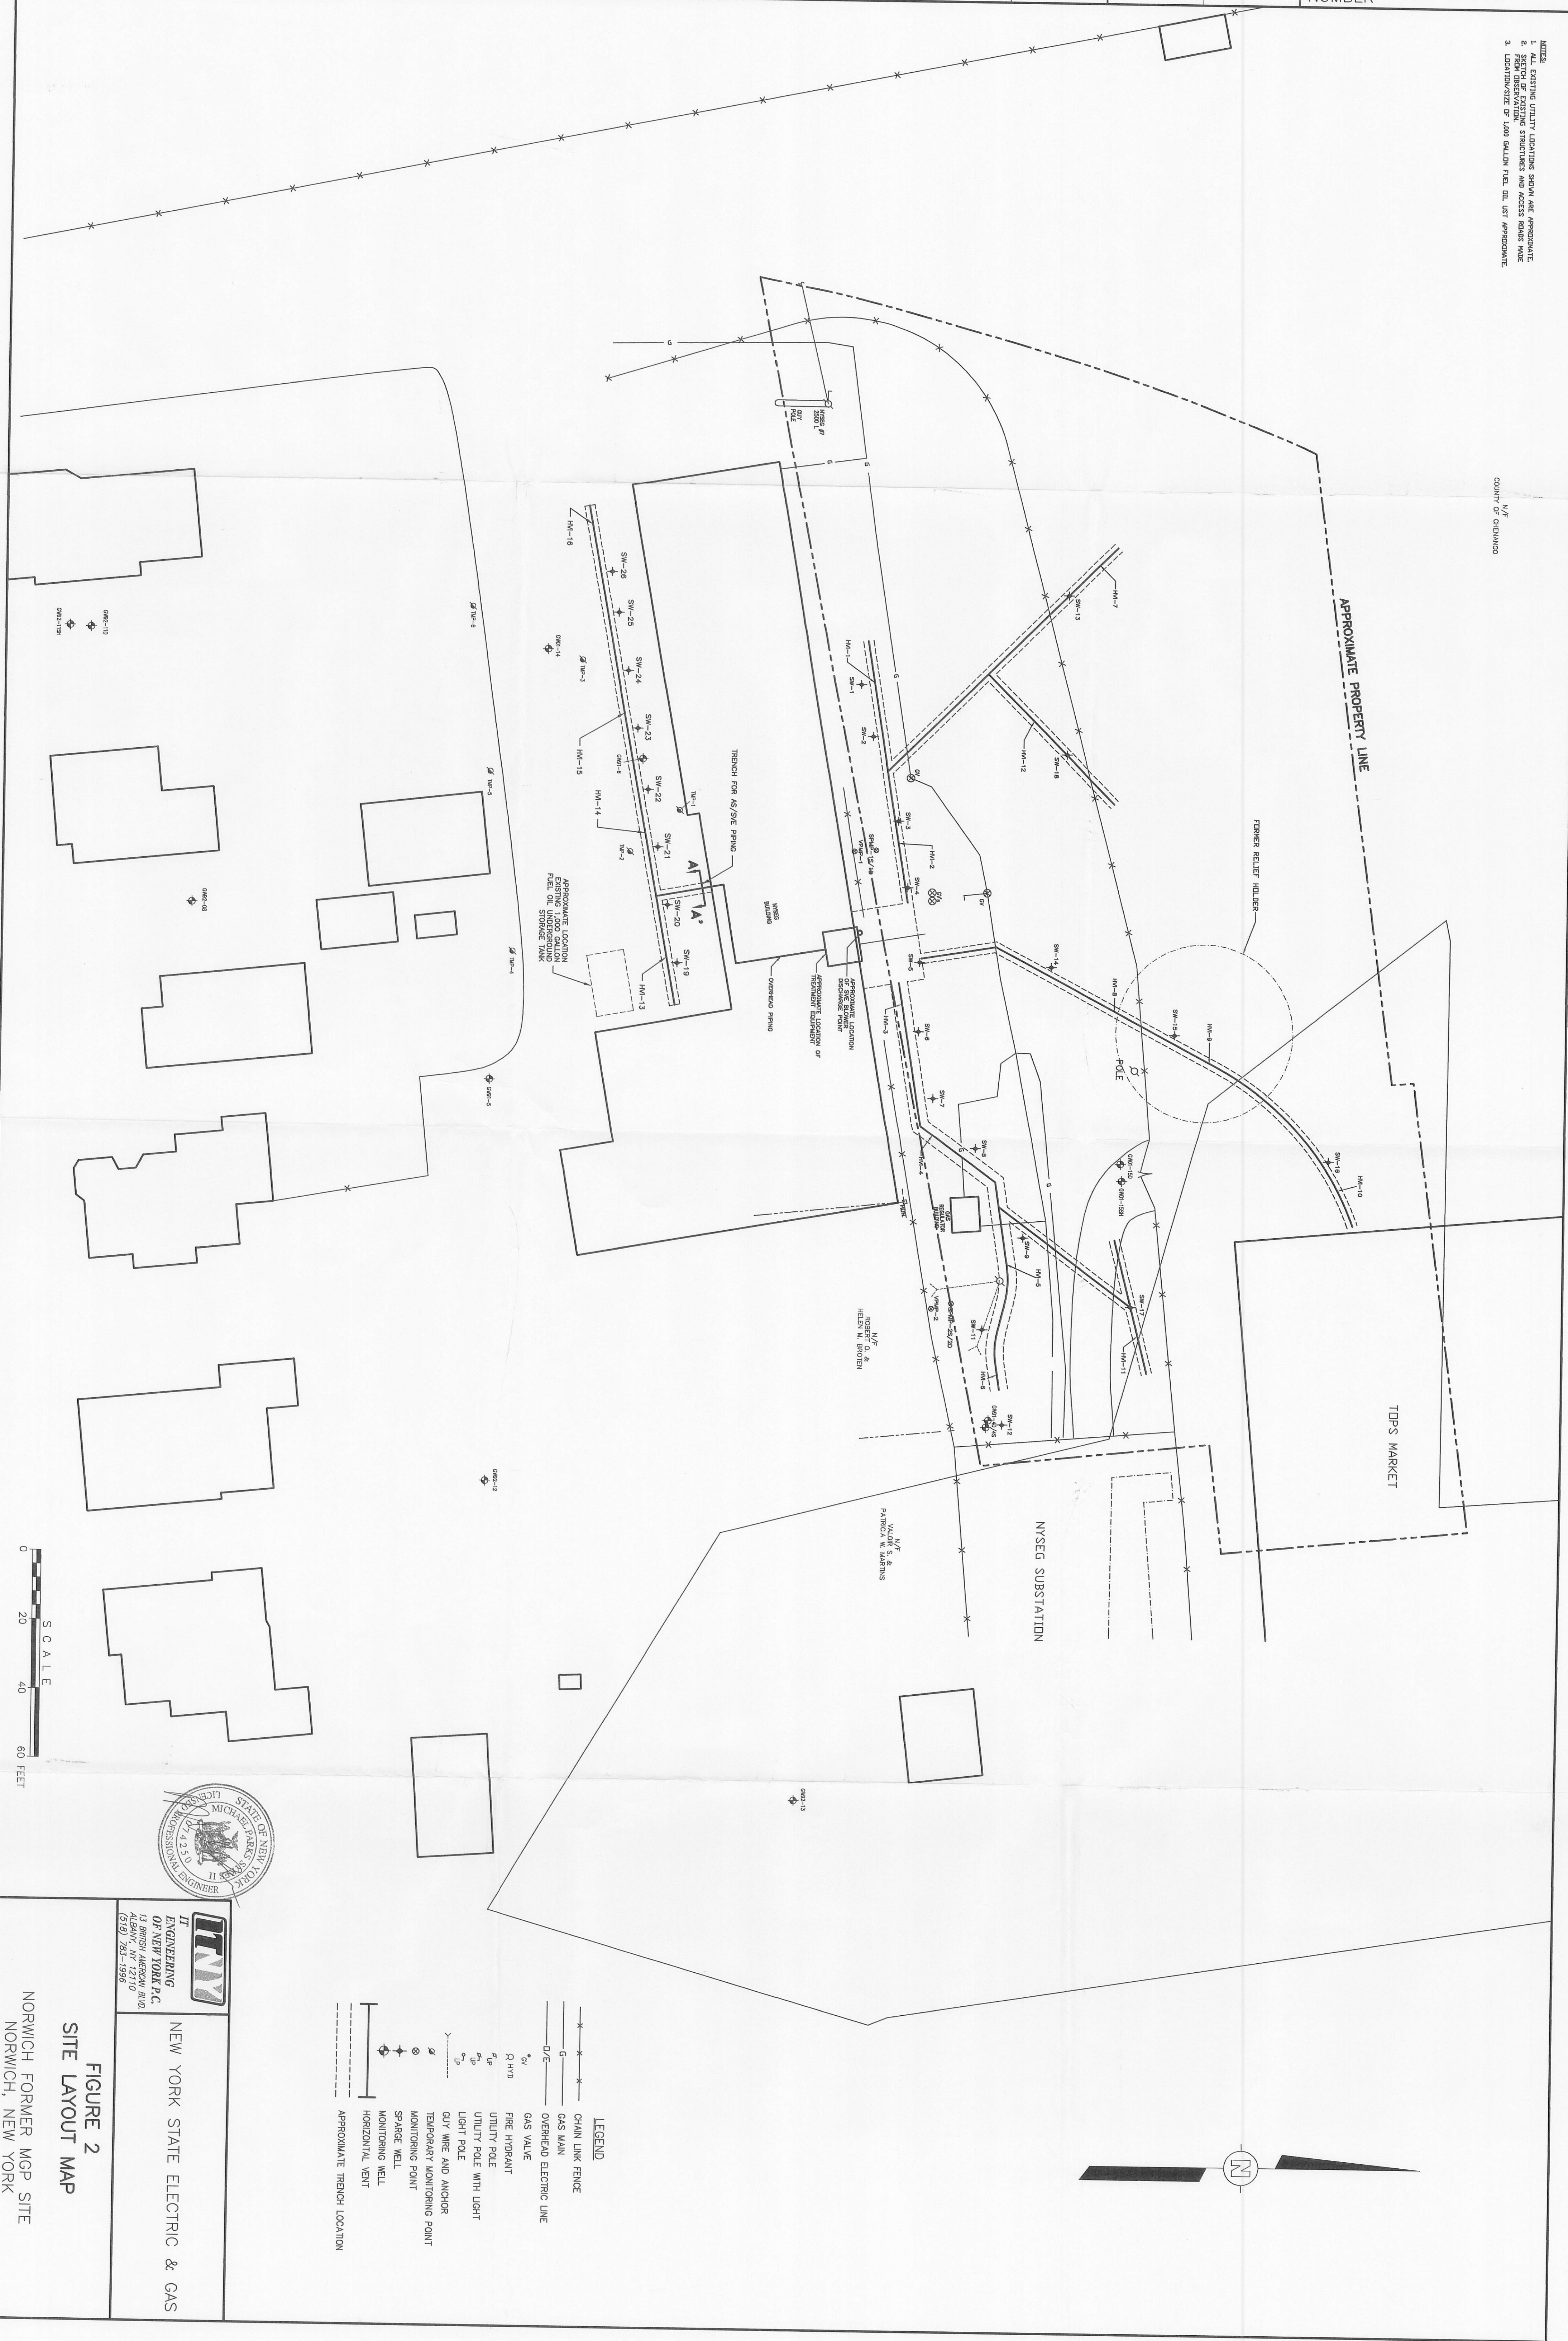
FIGURE 2
SITE LAYOUT MAP

The Site is currently owned by NYSEG and is an irregularly shaped parcel of land located in the central portion of the City of Norwich (**Appendix A, Figure 2**). The Site is bounded by the Tops Market and adjacent shopping complex to the north, a NYSEG electrical substation and residences to the east, residences to the south, and railroad tracks and a day care center adjacent to a freight station to the west. The Site is being used by NYSEG gas services department as a regulator station and satellite gas operations center.

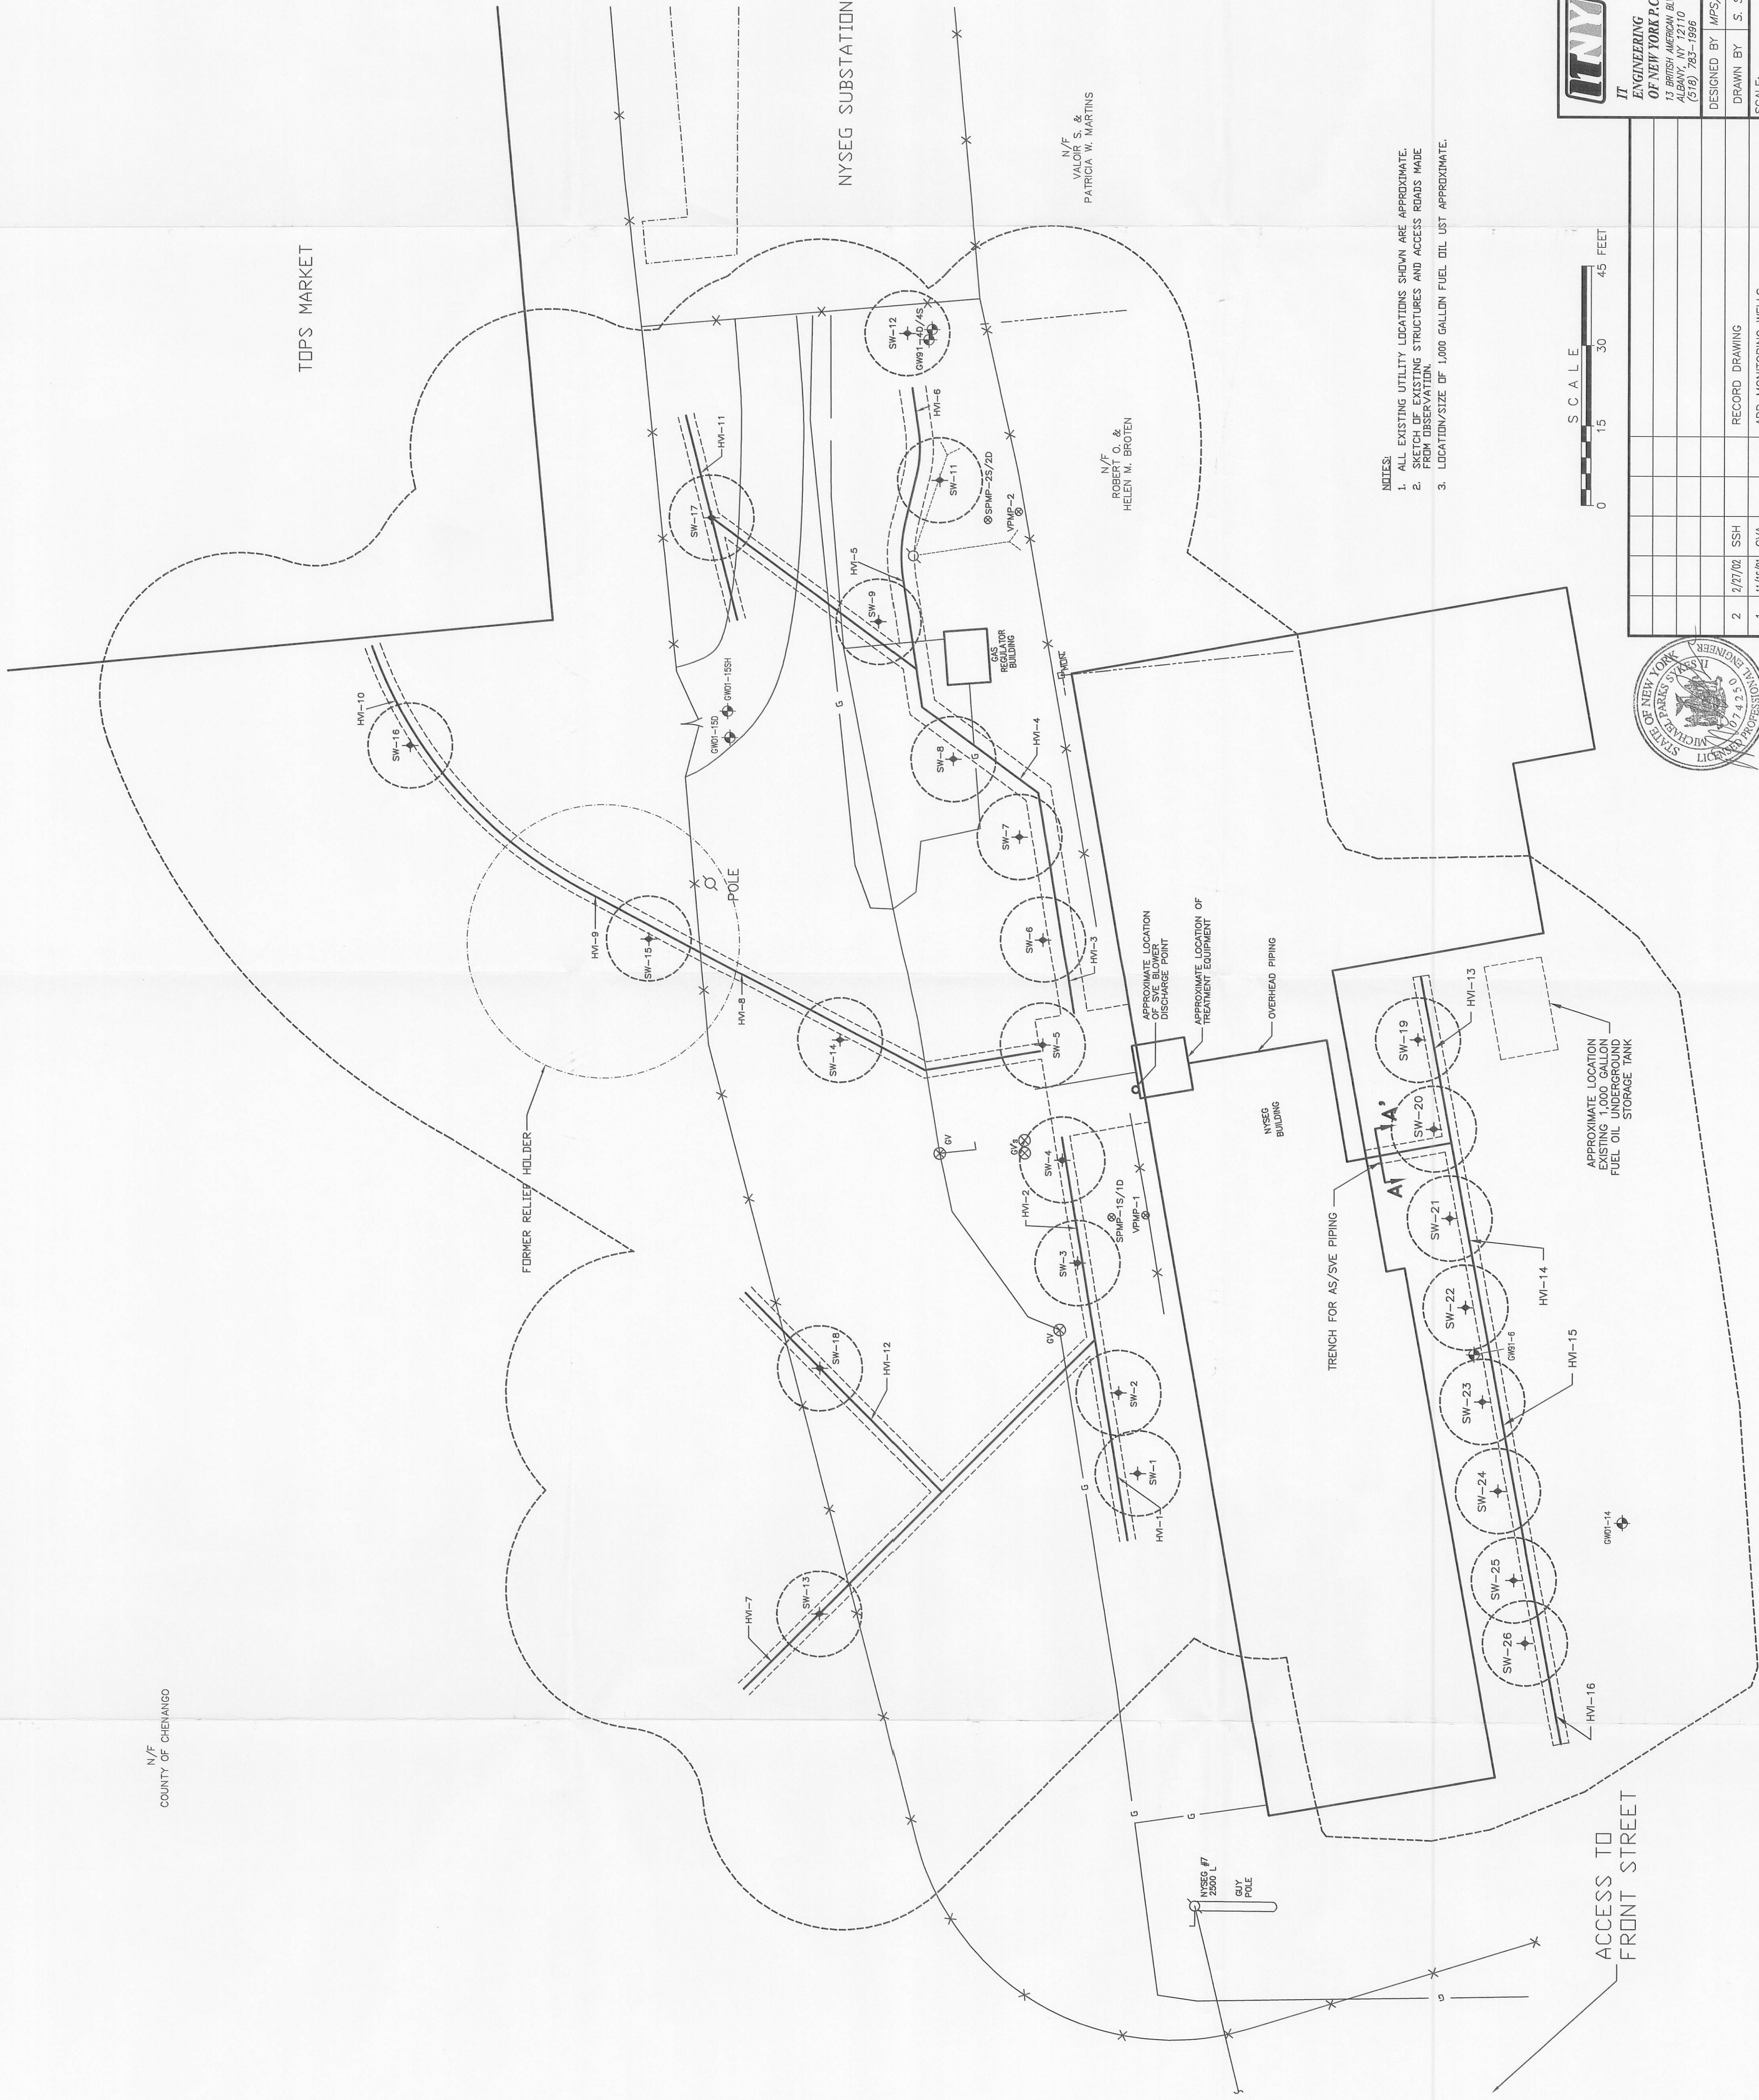
NEW YORK STATE ELECTRIC & GAS		AS/SVE RADIUS OF INFLUENCE	
NORWICH FORMER MGP SITE NORWICH, NEW YORK		DRAWING NO. 108196D6	
DESIGNED BY MPS/GWA/MTD 09/24/01		CHECKED BY	
DRAWN BY S. SHKOLNIK 09/24/01		APPROVED BY	
SCALE: 1" = 15'		DRAWING	
2		2	
1		2

Monitoring well GW91-6 will continue to be monitored quarterly to track the effectiveness of the system enhancement. In addition, downgradient monitoring wells will be sampled and analyzed quarterly to evaluate potential migration of VOCs and SVOCs. Downgradient wells include GW91-5, GW92-08, GW92-11SH and GW92-11D (**Appendix A, Figure 2**). Monitoring points SMPM-1S and SPMP-2S will continue to be monitored quarterly to evaluate subsurface conditions and system effectiveness. An additional monitoring well (GW01-14) was installed to the southwest of proposed ASW-26 to assist in evaluating groundwater quality and system effectiveness downgradient of the treatment system. Location of this monitoring well is presented in **Appendix B, Sheet 2**. A well construction log for GW01-14 is included in **Appendix C**.

A total of four horizontal vent intervals (HVI -13 through 16) were installed in the area south of the existing NYSEG building. Horizontal vent intervals and leg identifications are shown on **Sheet 2, Appendix B**. Each leg consists of approximately forty feet of four-inch 0.020 slot PVC well-screen, plumbed with two-inch PVC Sch 80 pipe, back to the four-inch manifold location inside the building. HVI-14 was shortened to a length of 35 feet, while HVI-13 was reduced to approximately 29 feet due to an obstruction near the foundation of the NYSEG building. Construction details for horizontal vent intervals are presented in **Appendix B on Sheet 3**.

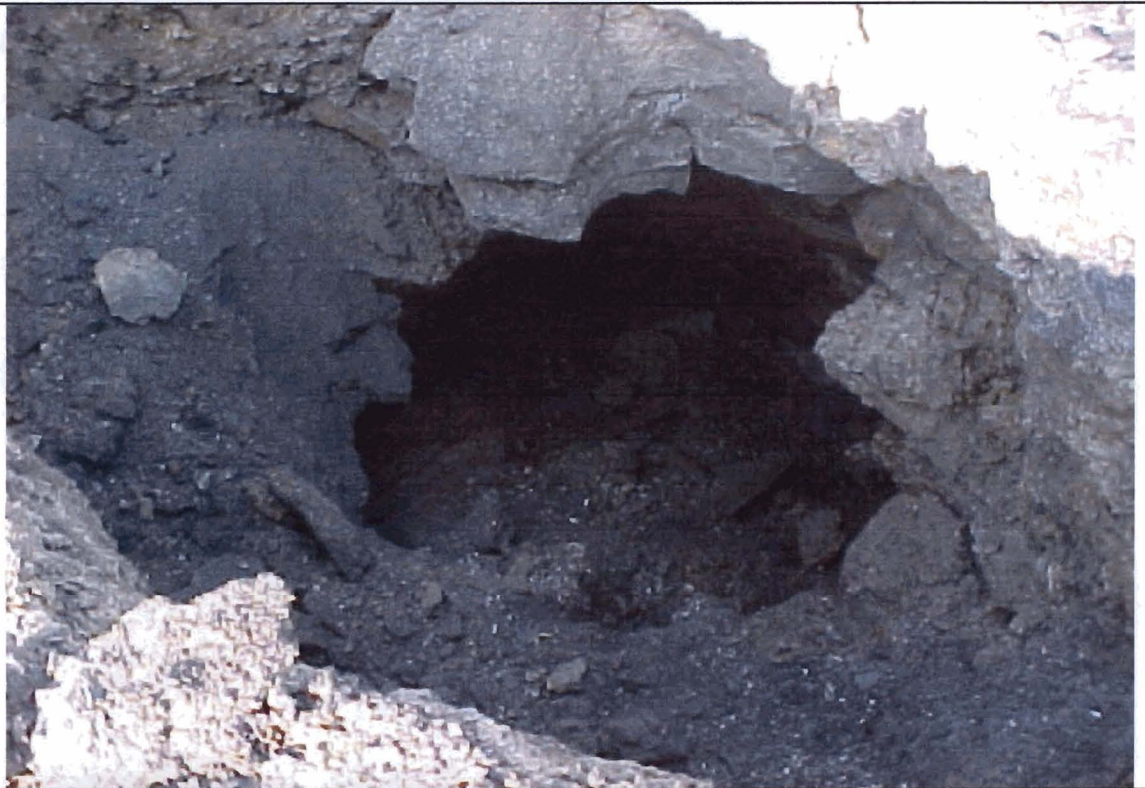
View of vault interior
prior to placement of
backfill.

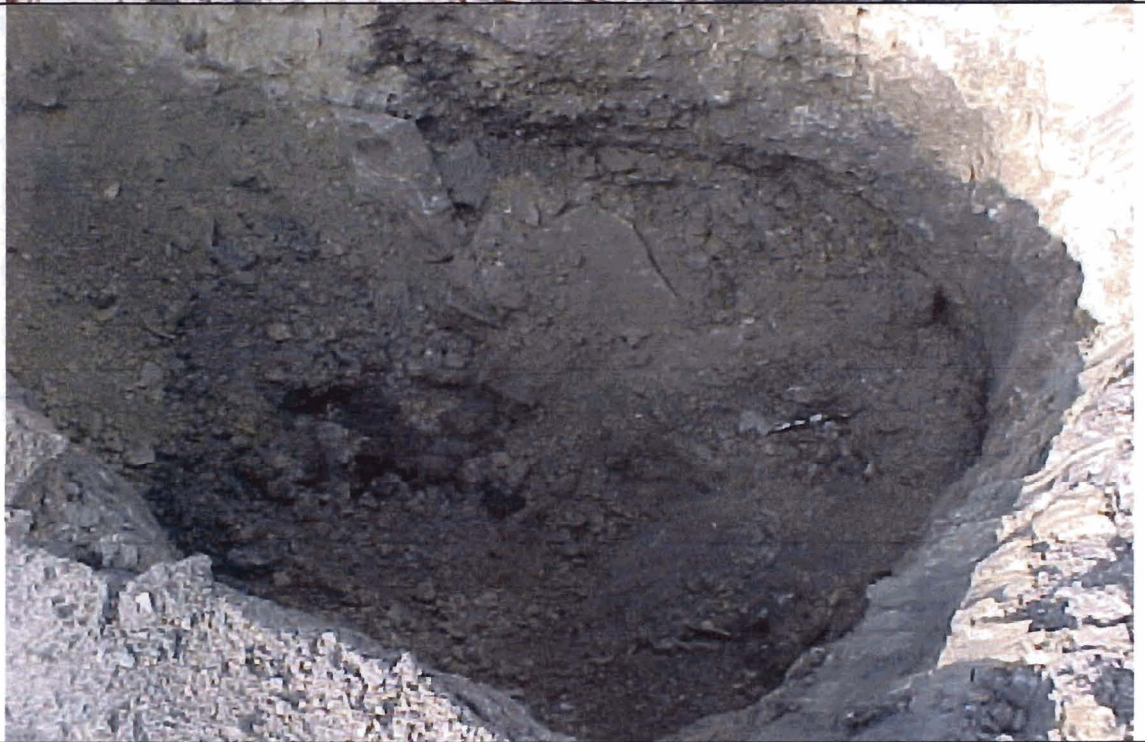
View of vault floor.

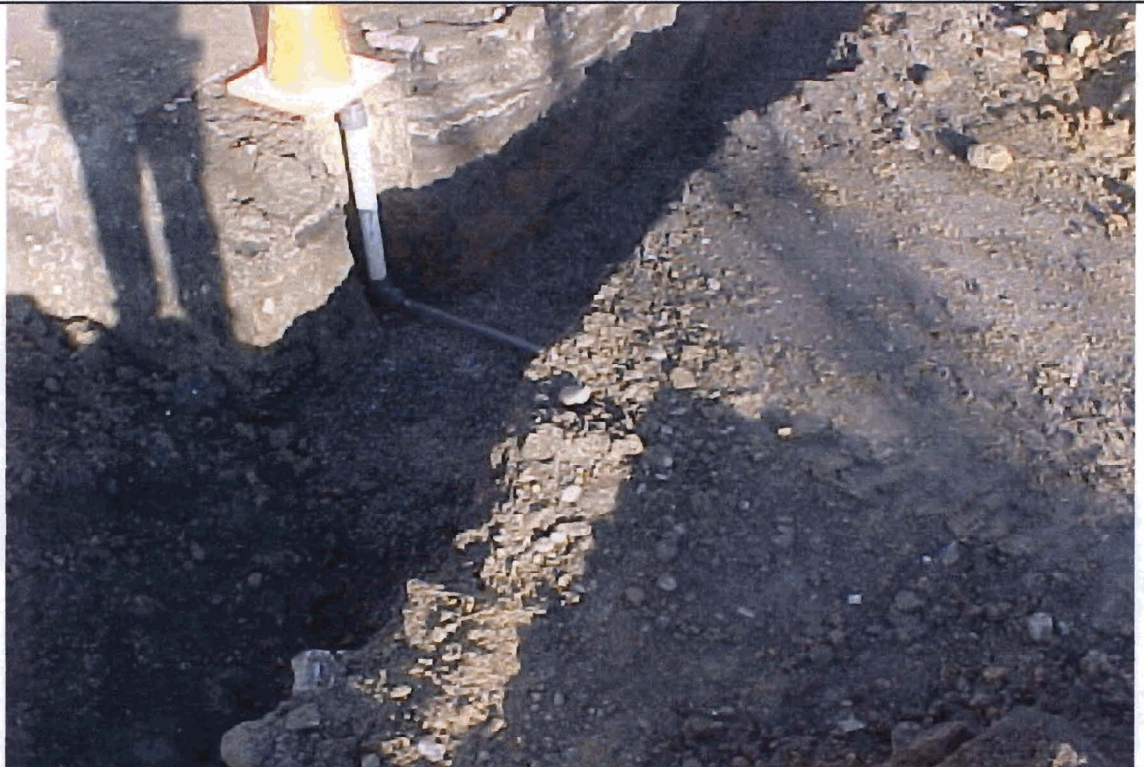
View of Air Sparge
Piping in partially
backfilled trench.

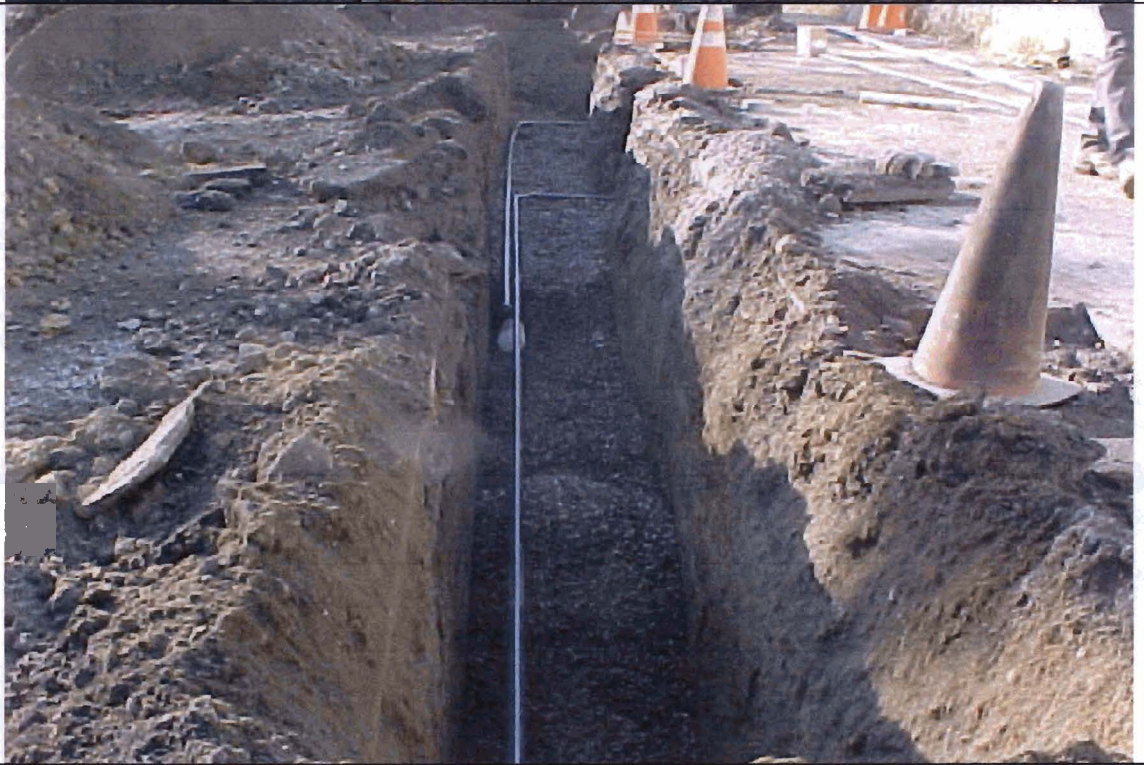
View of Air Sparge
Piping in partially
backfilled trench.

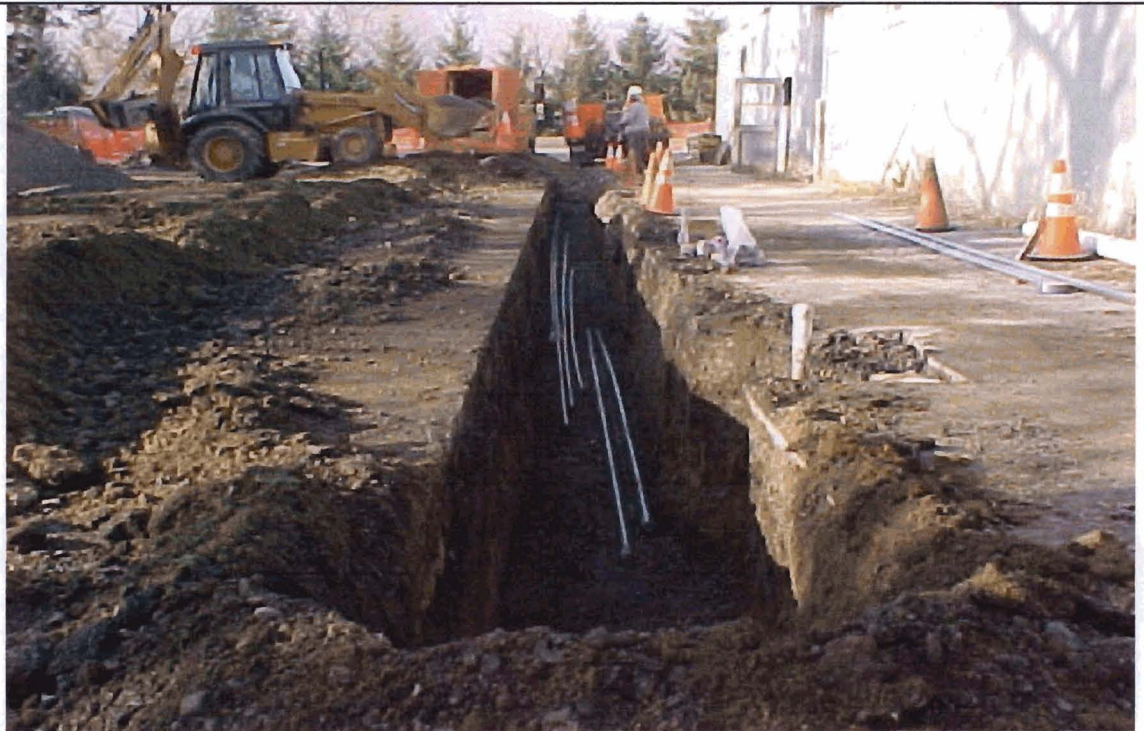
View of Air Sparge
Piping (left) and SVE
Piping (right) in
partially backfilled
trench.

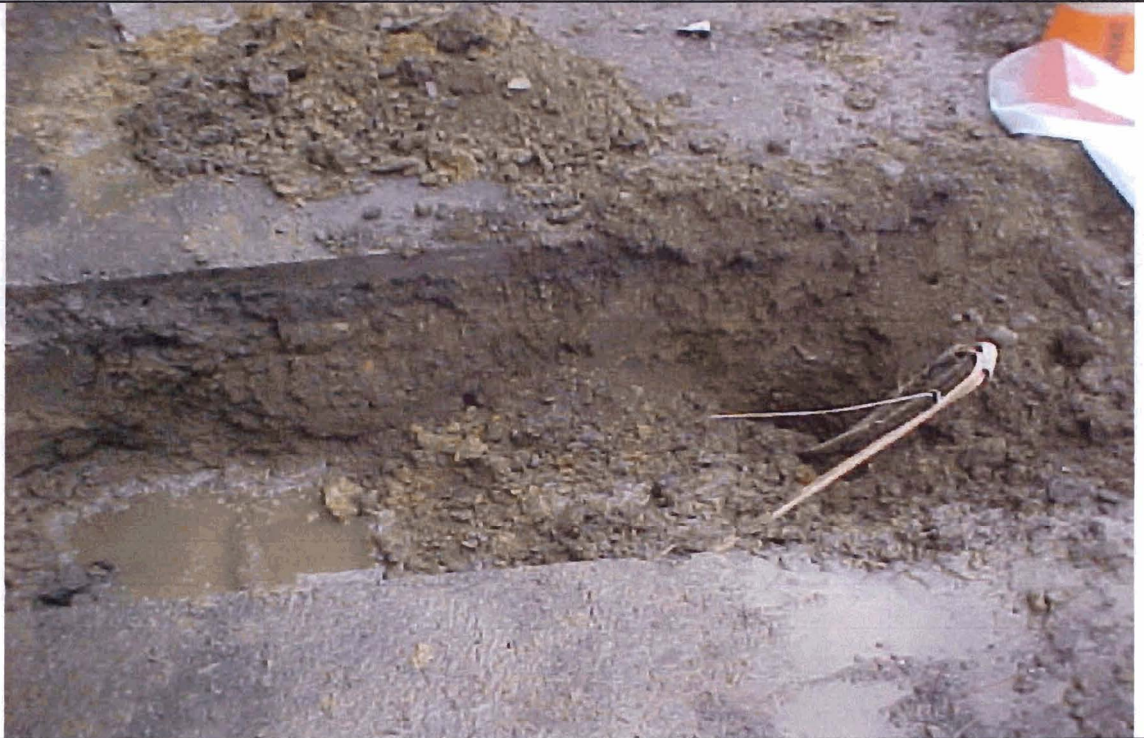
View of damaged
fuel oil feed line.

View of repaired fuel
oil feed line.

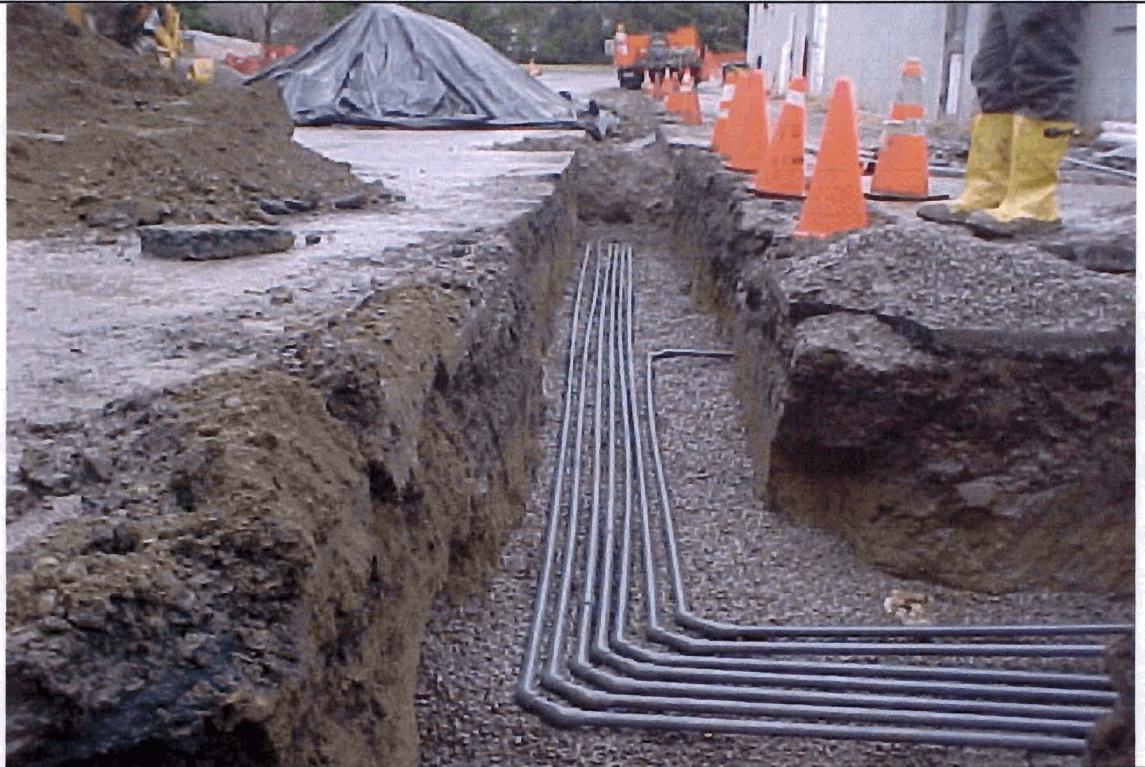
View of Air Sparge
Piping in partially
backfilled trench.

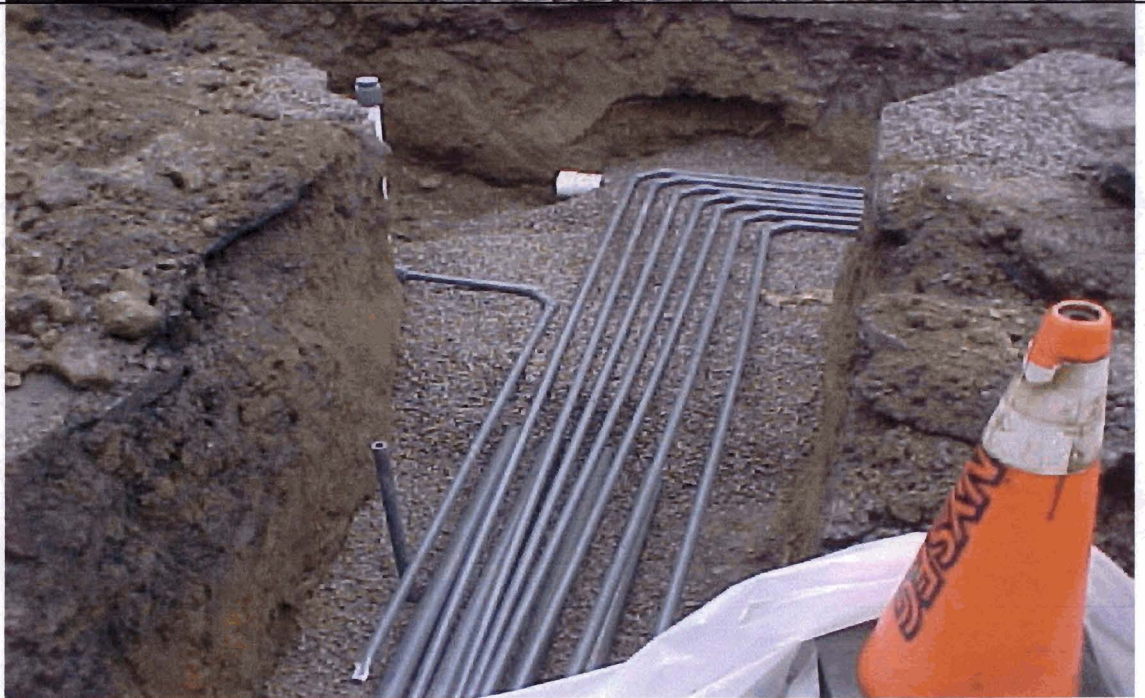
View of Air Sparge
and SVE Piping
south of building
penetration.

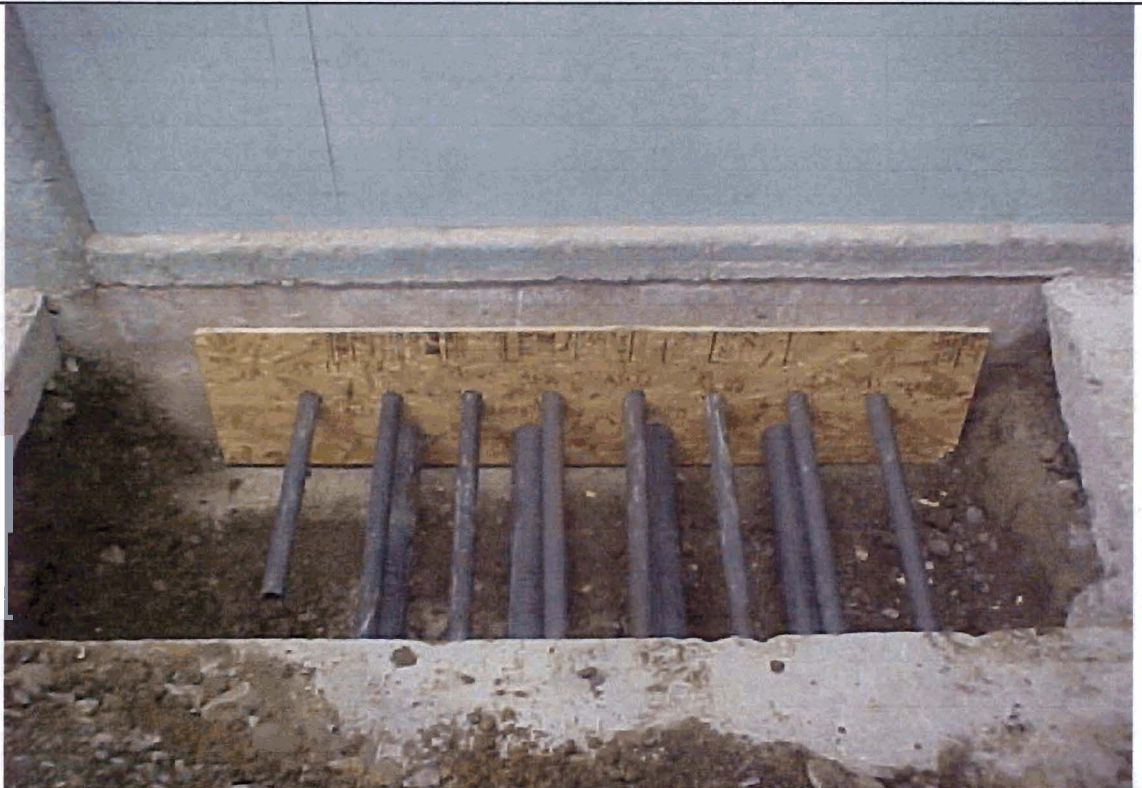
View of Air Sparge
and SVE Piping
penetration into
building.

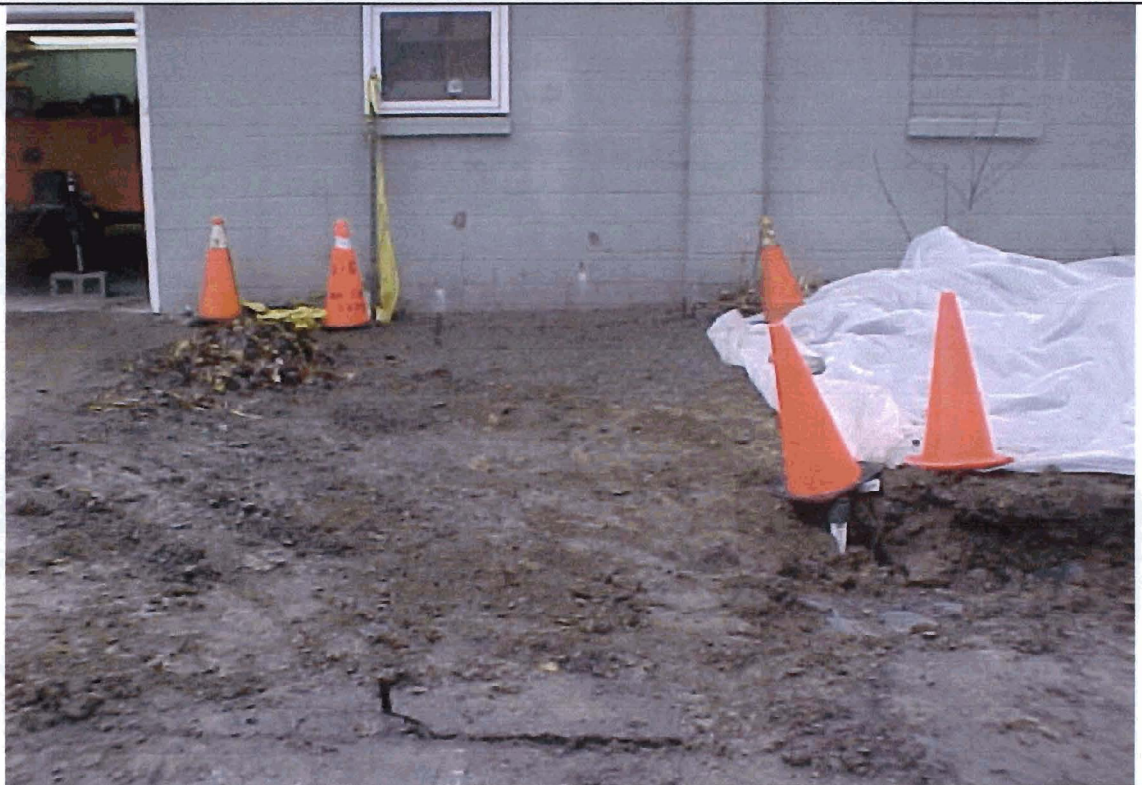
View of backfilled
area of penetration
into building.

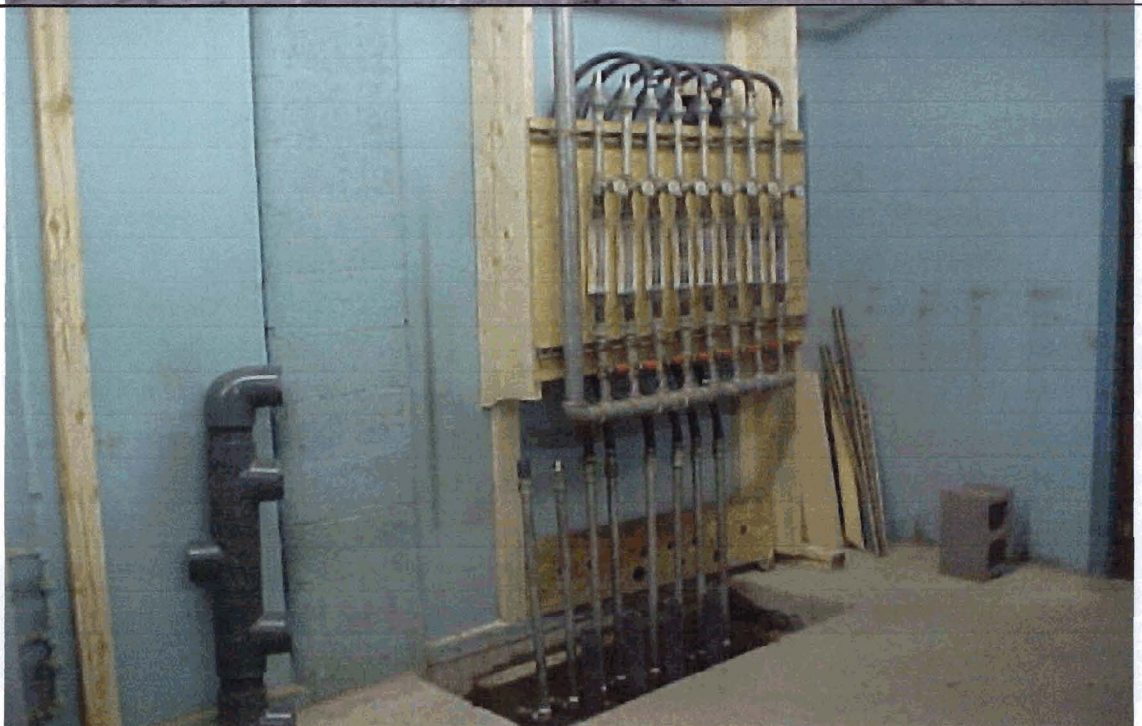
View of Air Sparge
Manifold.

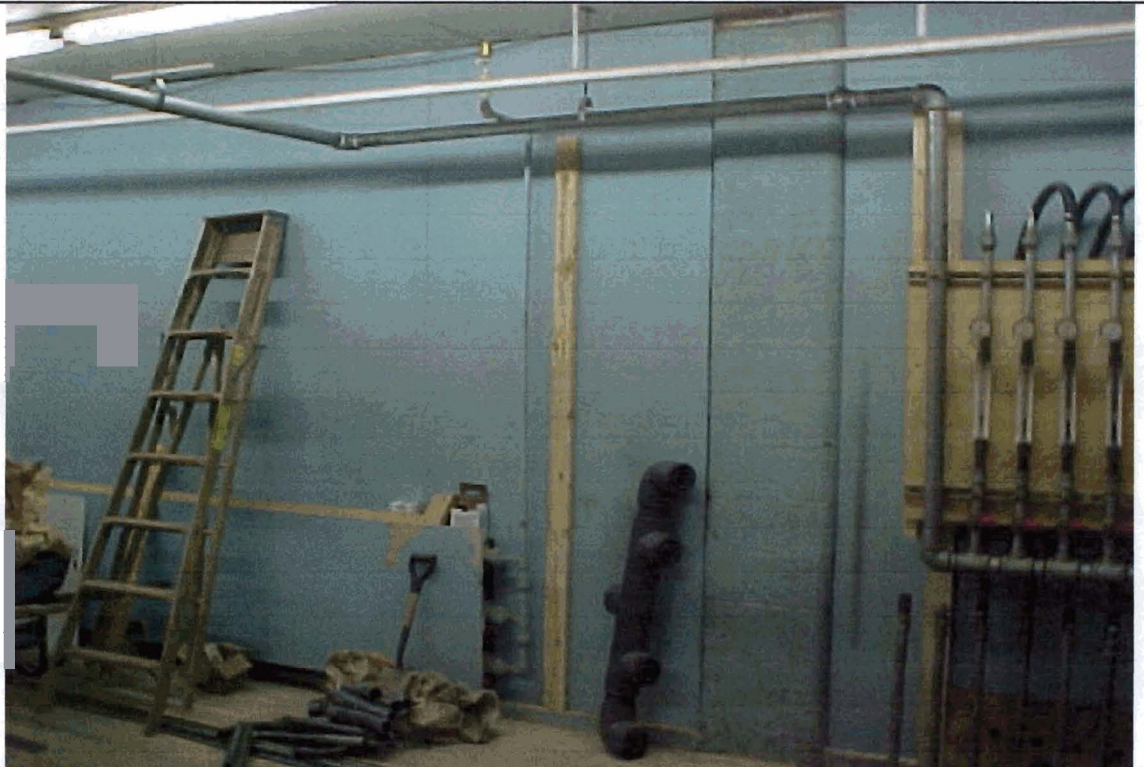
View of iron Air
Sparge Piping
hanging from ceiling.

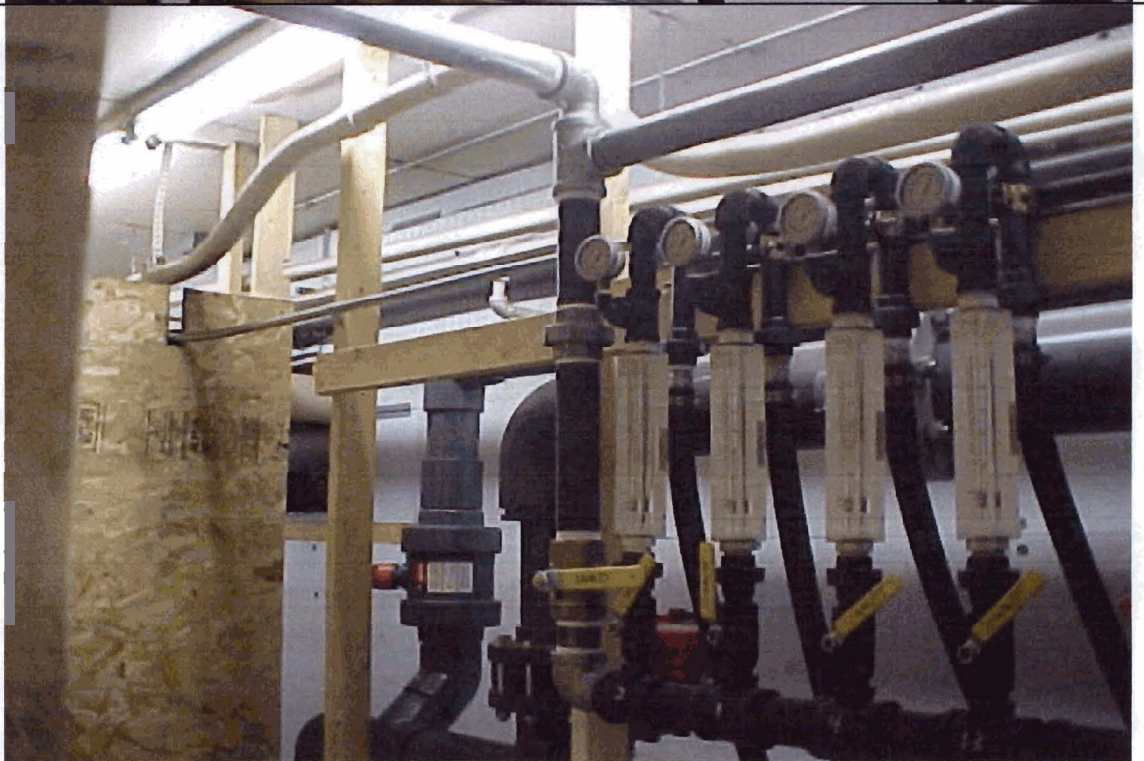
View of added Air Sparge piping (iron piping on left).

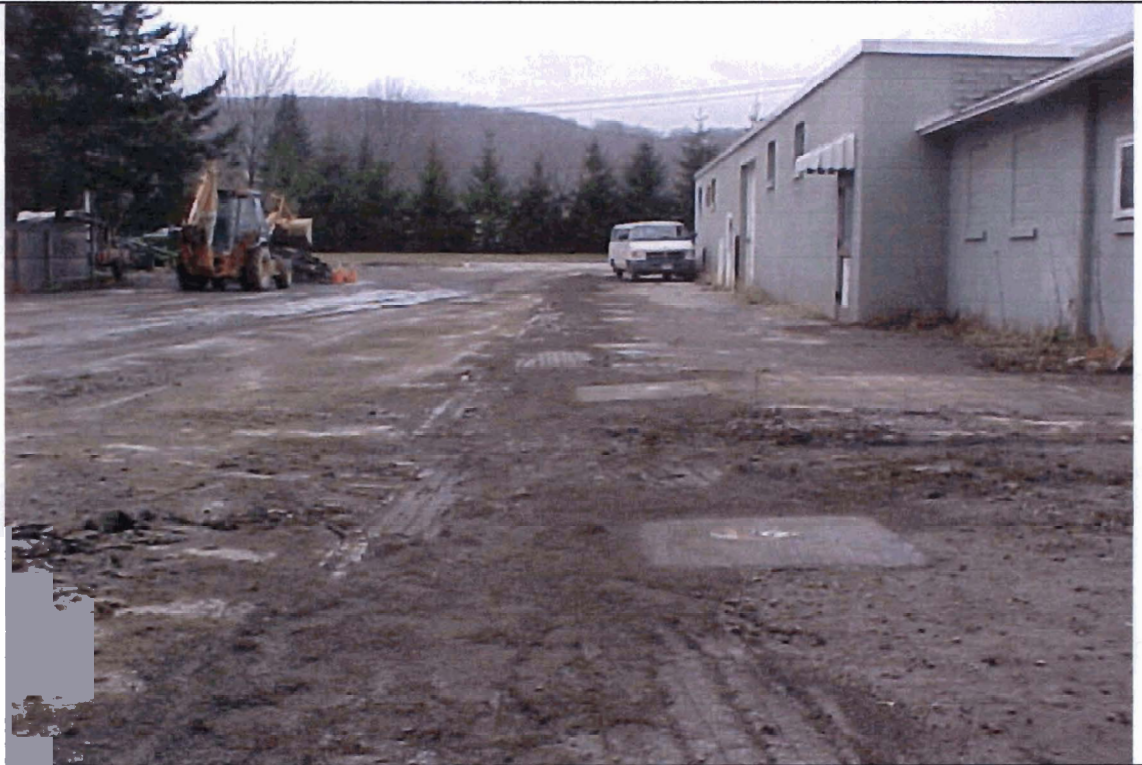
View of backfilled
trench and air sparge
well road boxes.

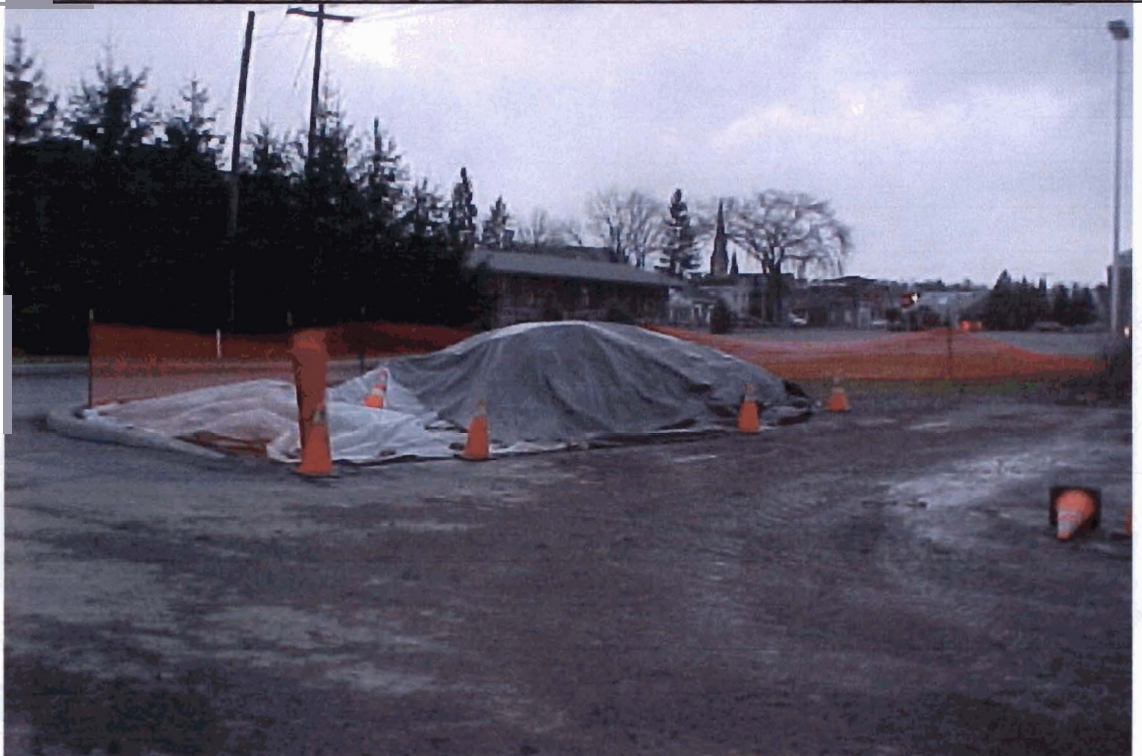
View of trench spoil
piles.
