Subject: **2023 Restoration Monitoring Report Comment-Response**

NYSEG Cortland-Homer Former MGP Site

Site No. 7-12-005

NYSEG - CORTLAND-HOMER FORMER MGP SITE HOMER, NEW YORK 2023 RESTORATION MONITORING REPORT	
AREA 2 VEGETATION MONITORING LOCATIONS	
ARCADIS	FIGURE 2

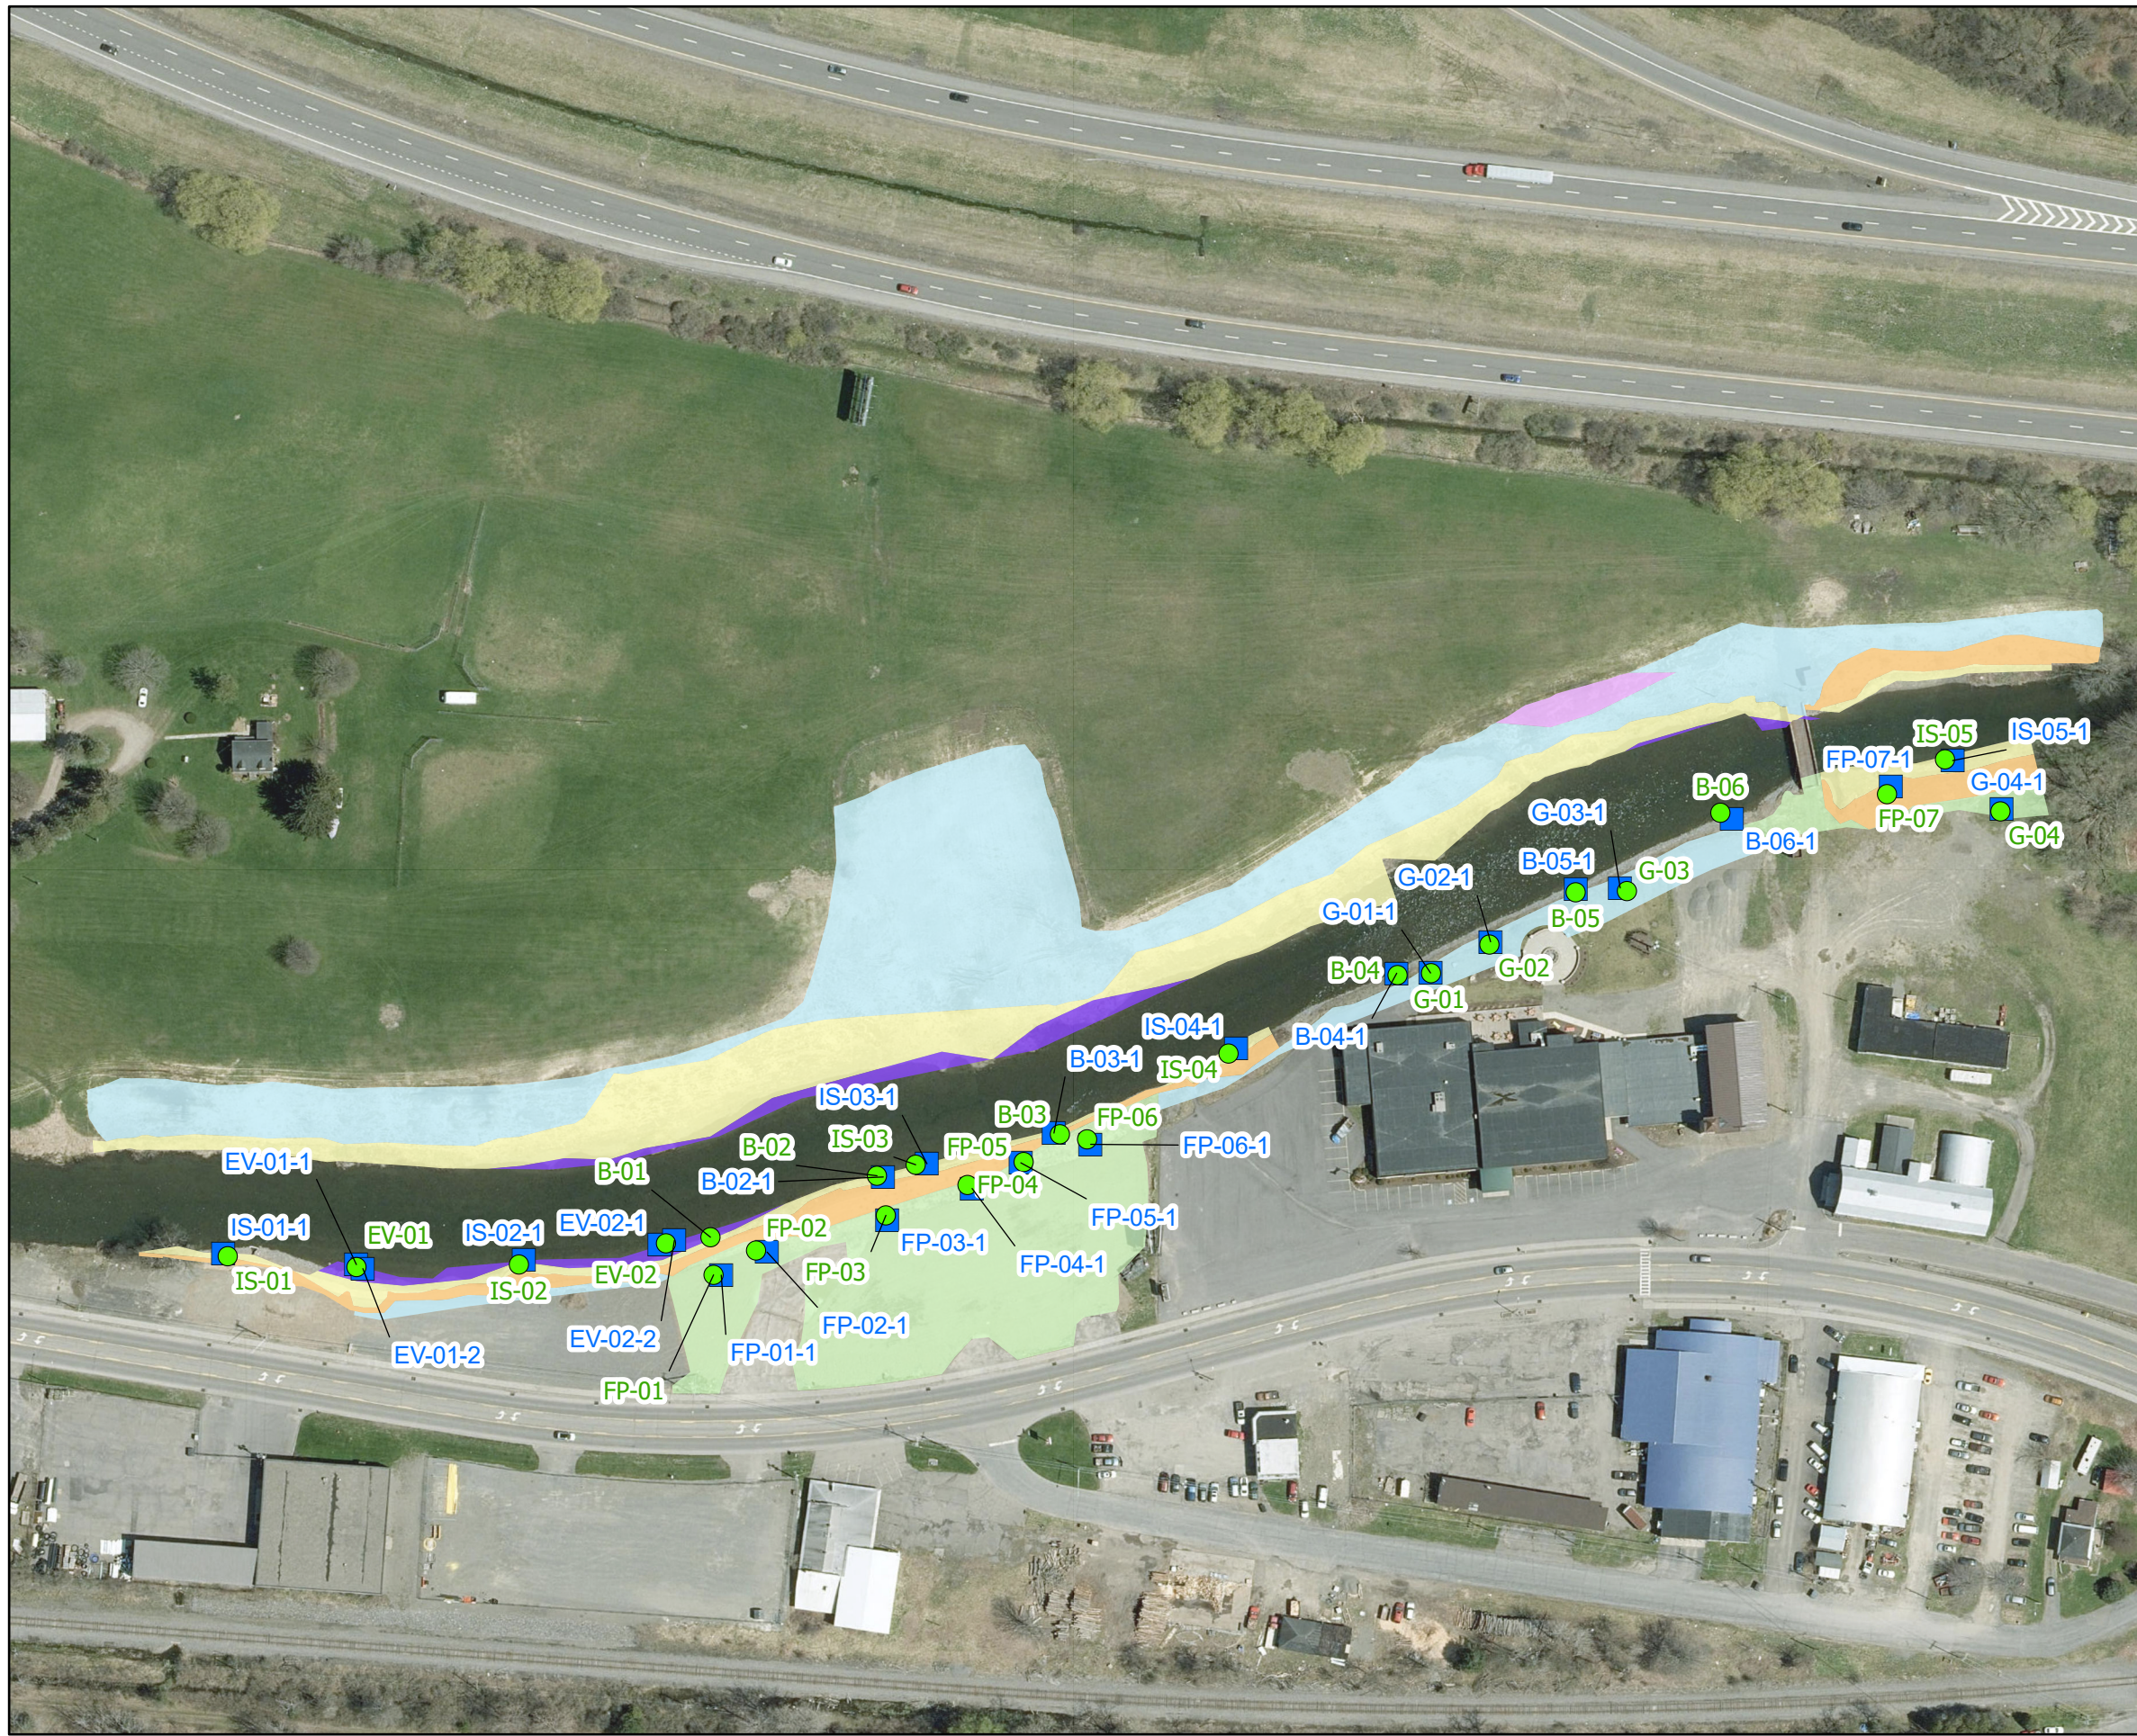
FIGURE
1

Path: T:\ENV\NYSEG\Cortland-Homer\VegetationMonitoring_2023\2023 Restoration Monitoring Report.aprx\Figure 1 AREA 1 VEGETATION MONITORING LOCATIONS Photograph Locations Last Saved By: hav3848 5/10/2024

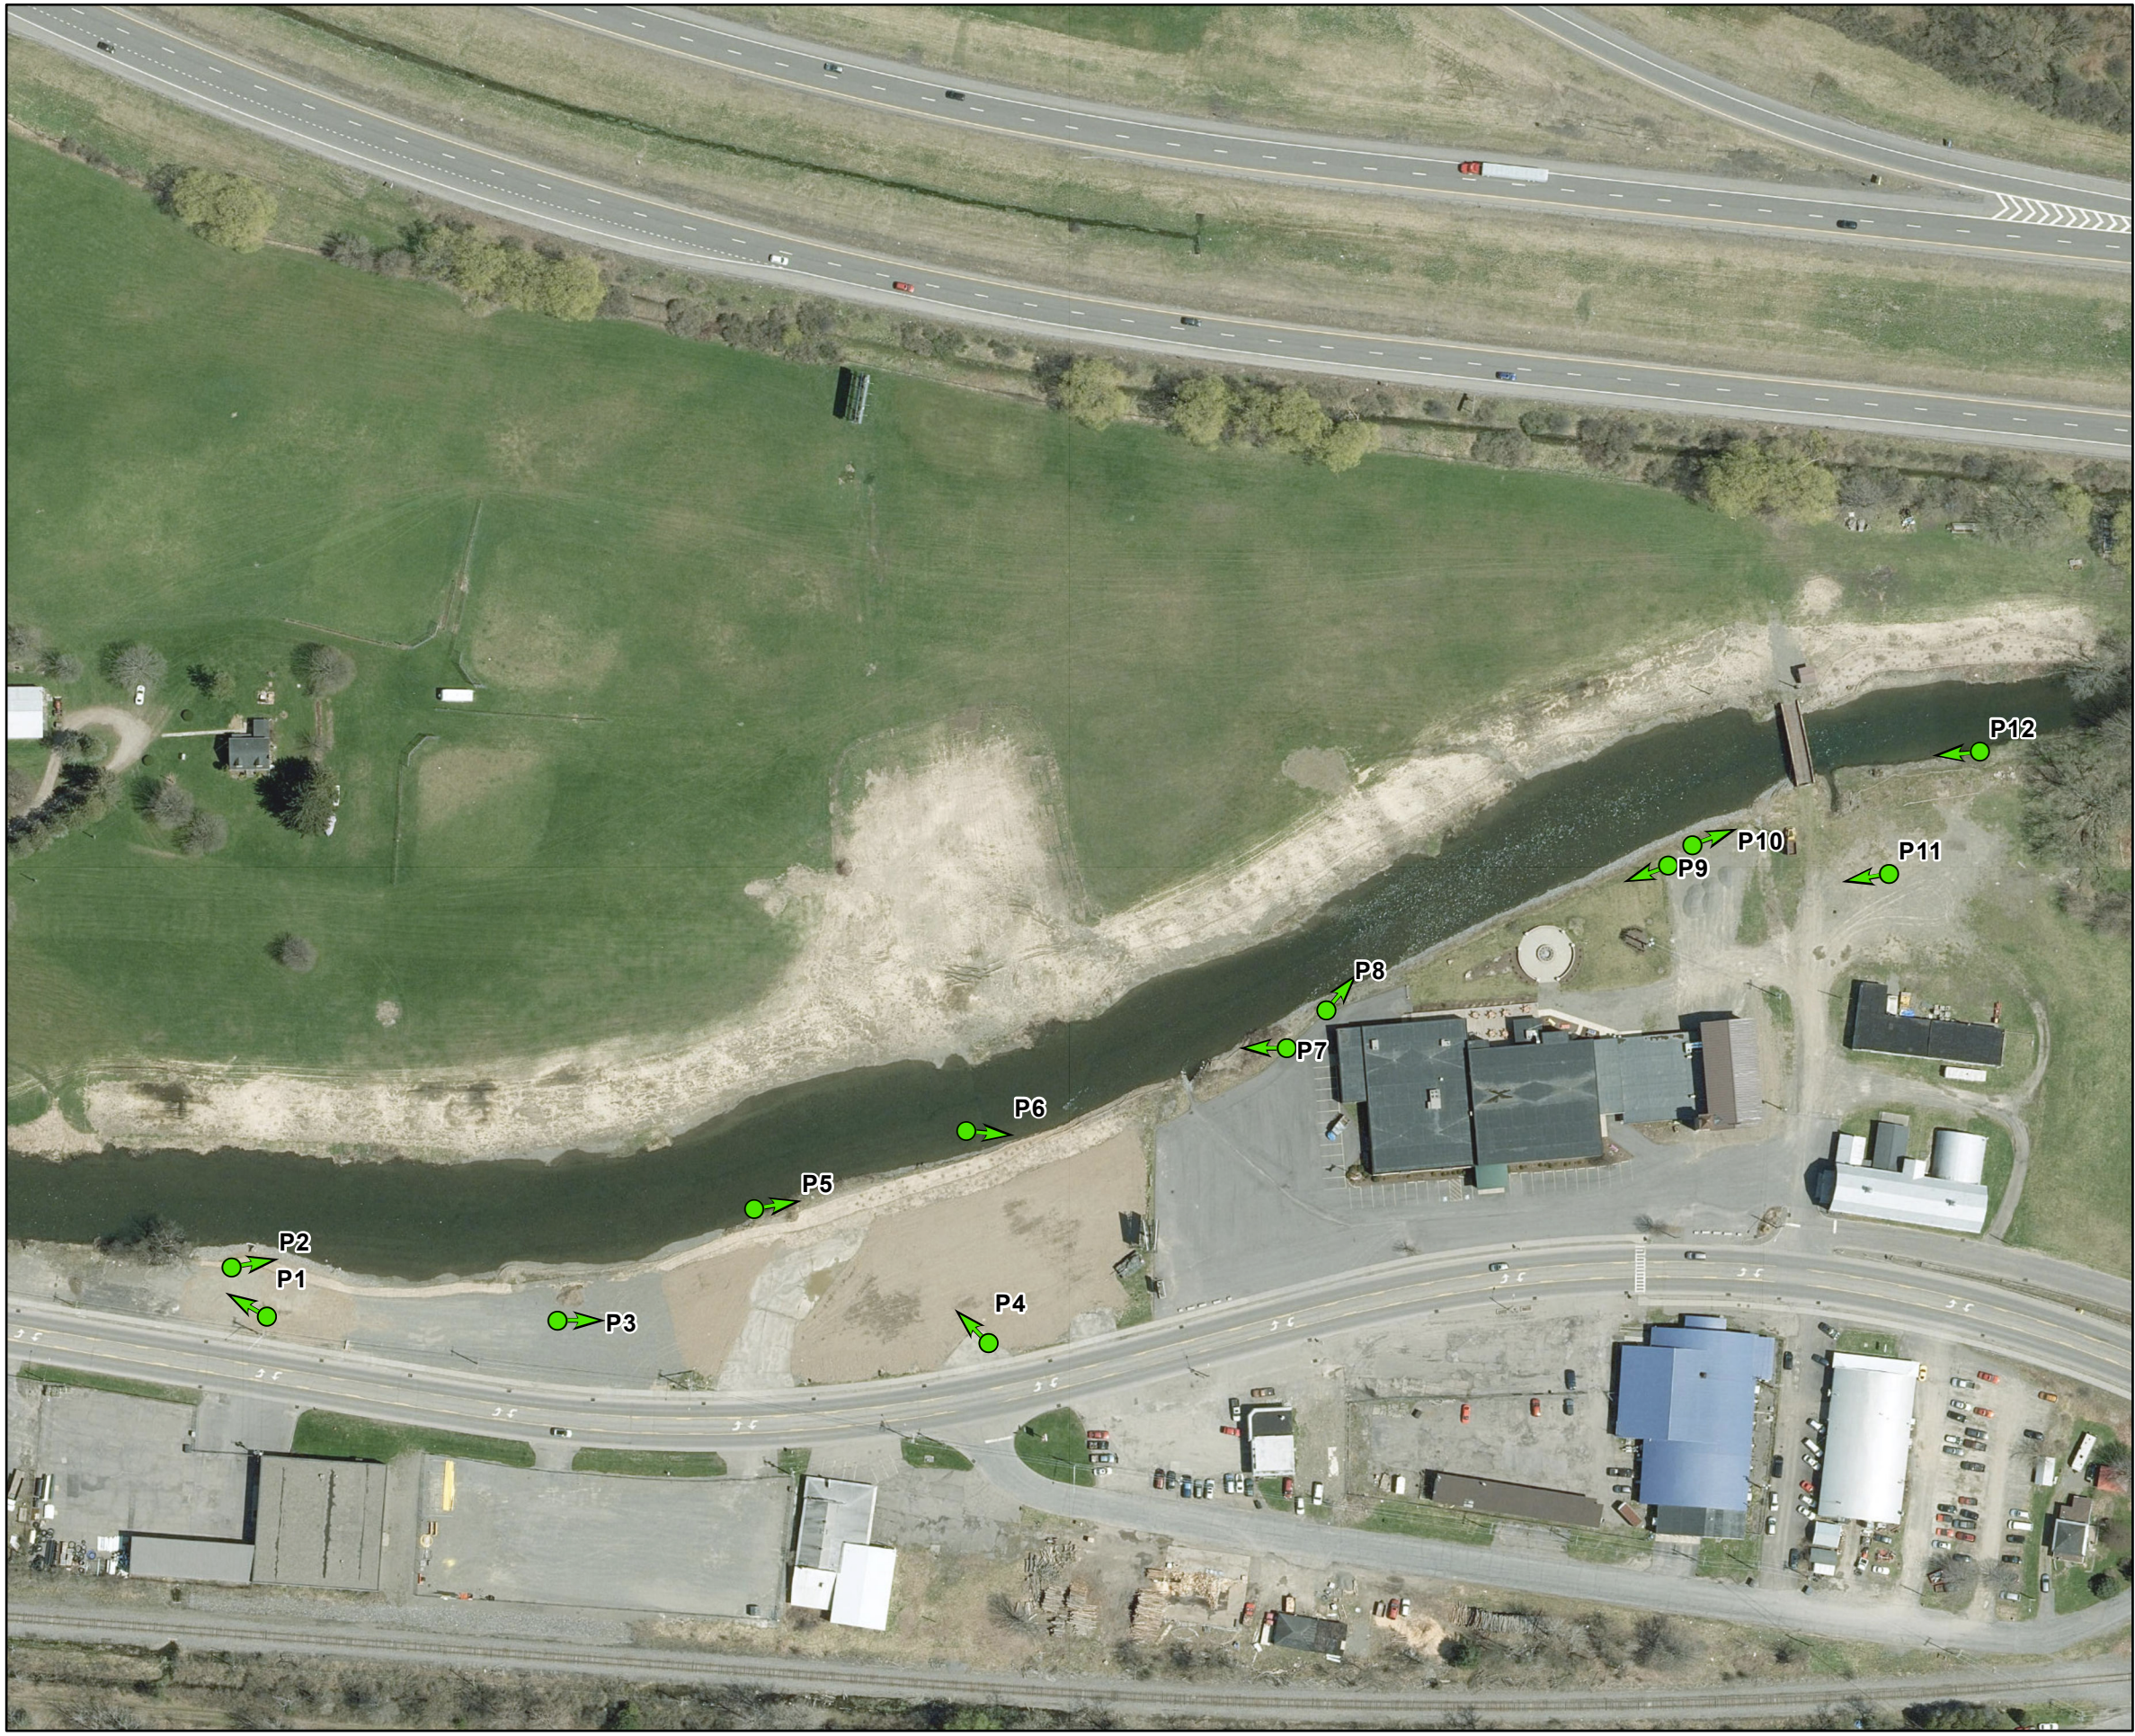
FIGURE 3

Path: T:\ENV\NYSEG\Cortland-Homer\VegetationMonitoring_2023\2023 Restoration Monitoring Report.aprx\Figure 3 AREA 1 POST-CONSTRUCTION MONITORING PHOTOGRAPH LOCATIONS Last Saved By: hav3848 5/10/2024

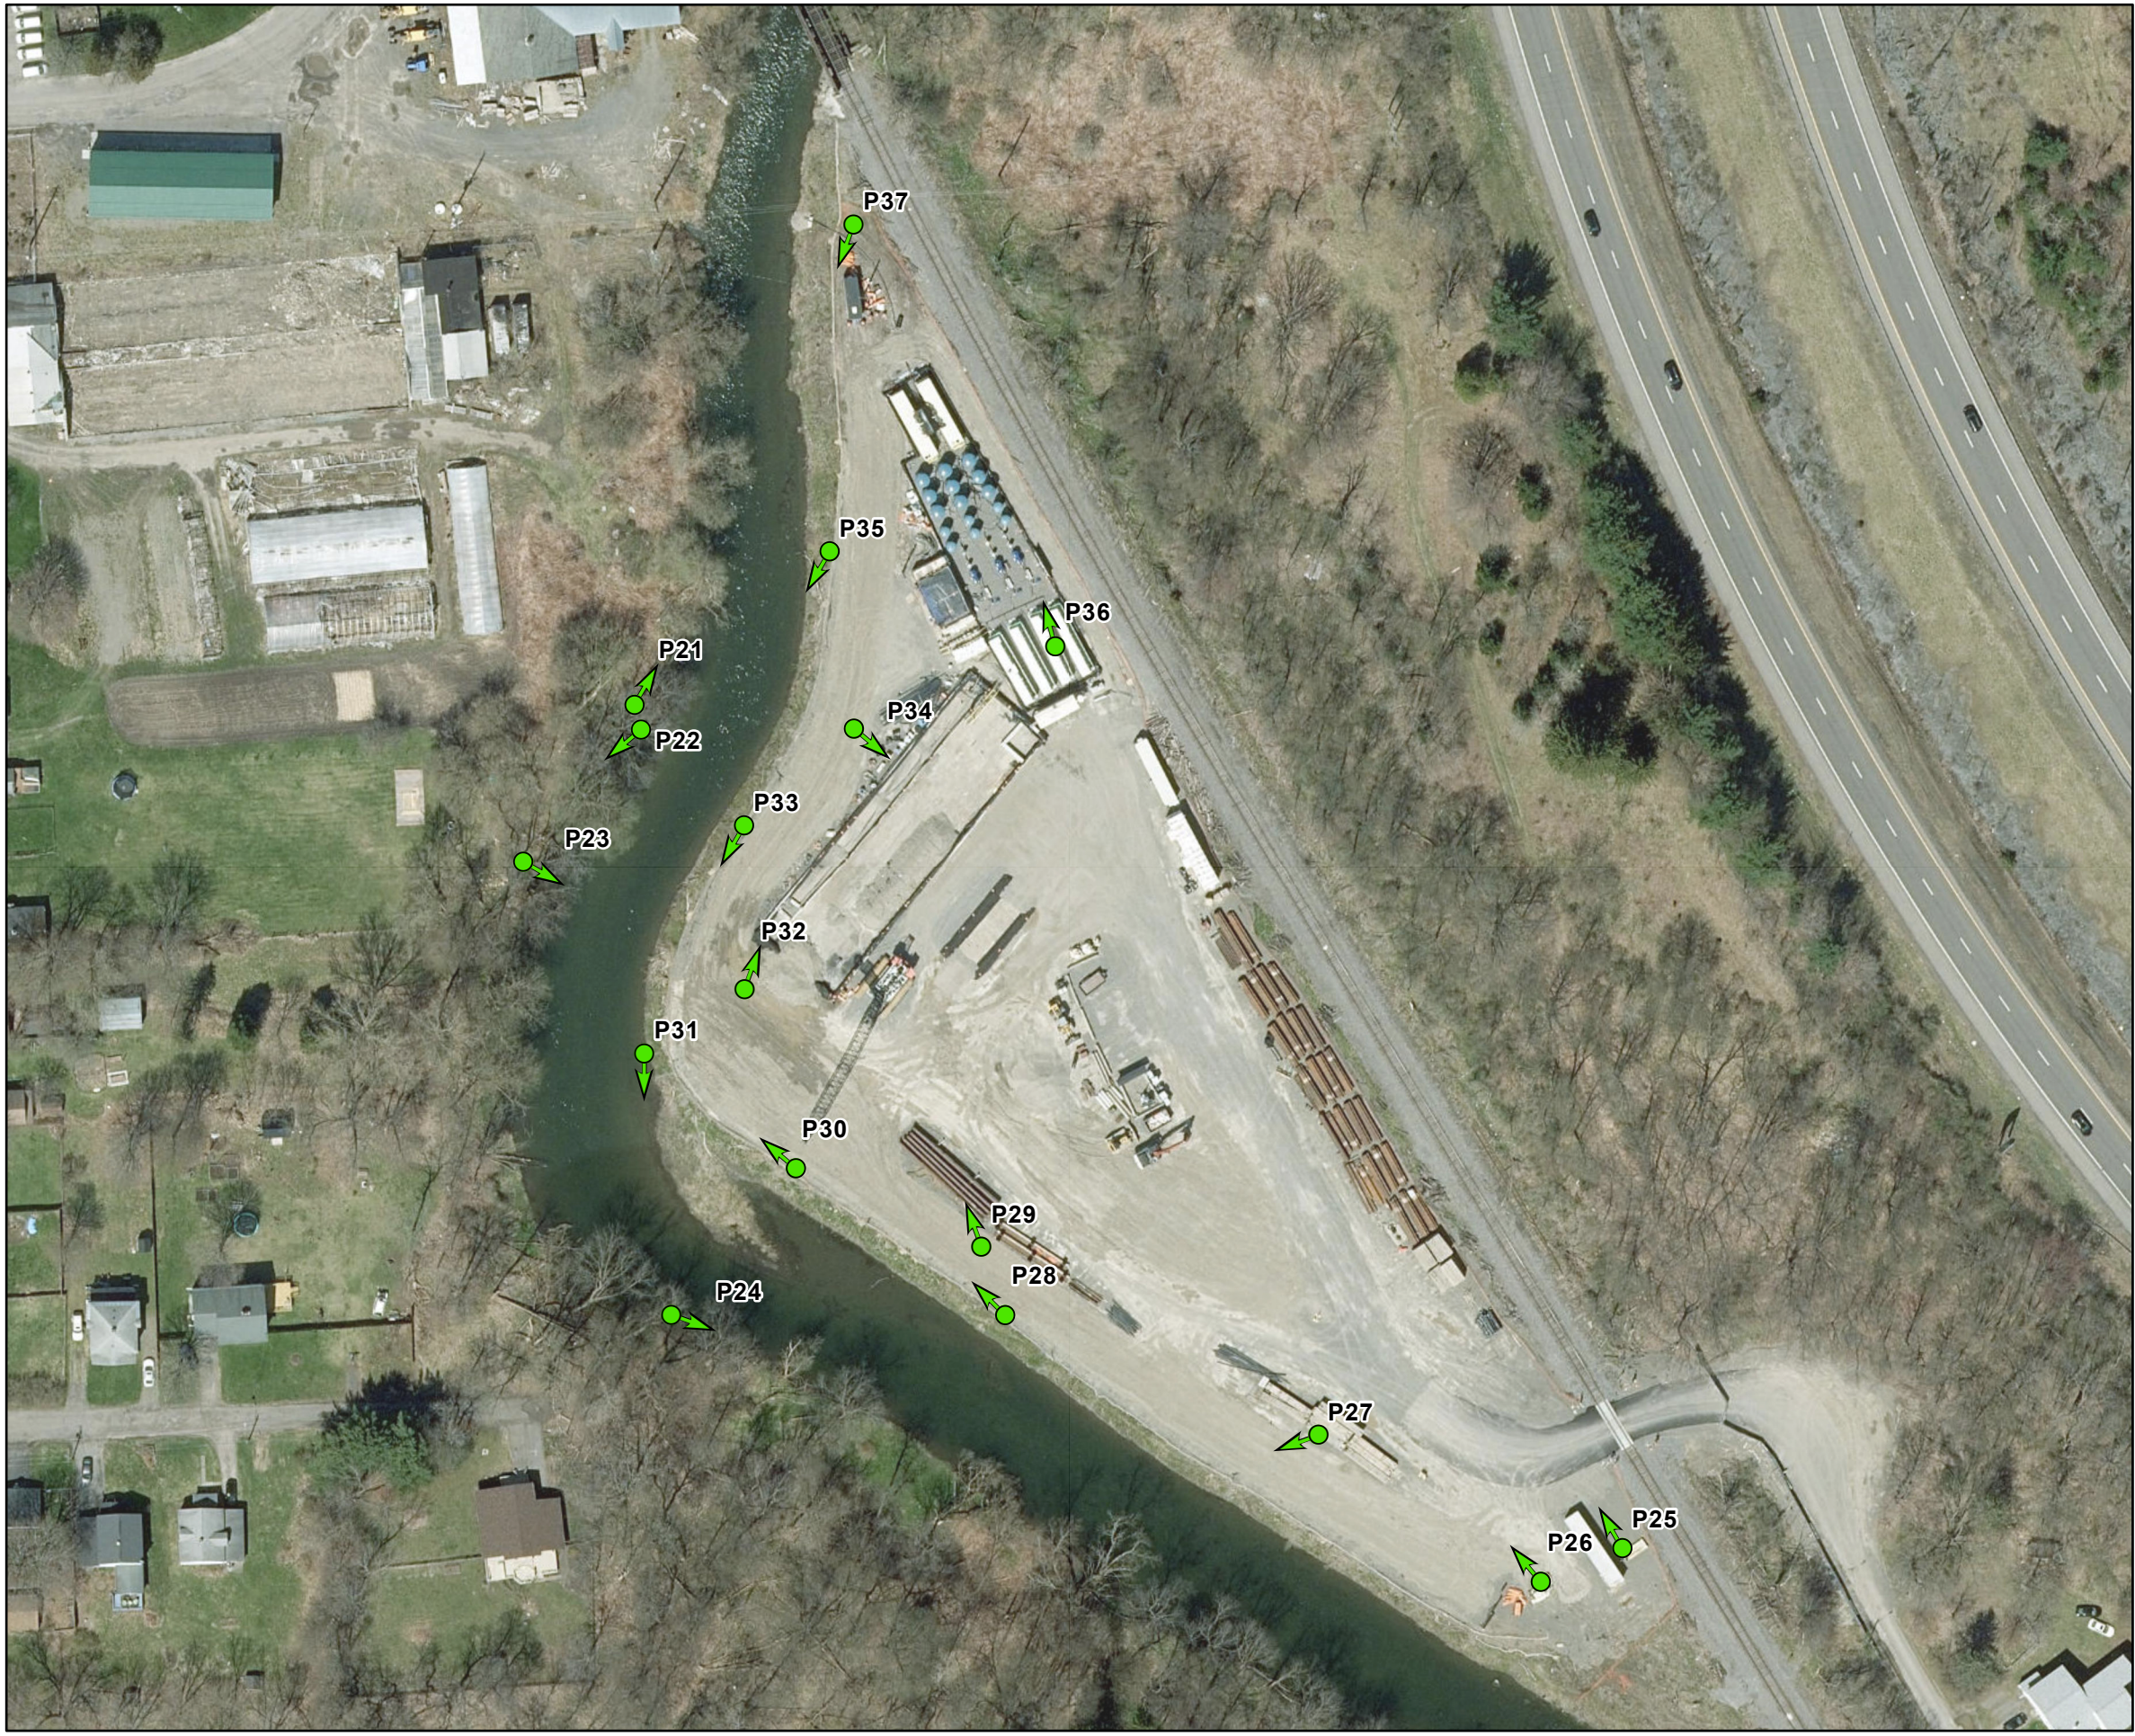
Path: T:\ENV\NYSEG\Cortland-Homer\VegetationMonitoring_2023\2023 Restoration Monitoring Report.aprx\Figure 4 AREA 2 POST-CONSTRUCTION MONITORING PHOTOGRAPH LOCATIONS Last Saved By: hav3848 5/10/2024

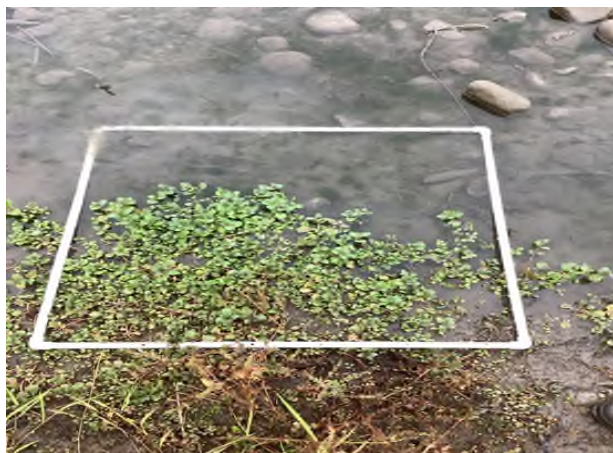
Photograph of Aerial Cover Quadrat

Total Cover (%)		50		
Native Cover (%)		5		
Invasive/Target Weed (%)		0

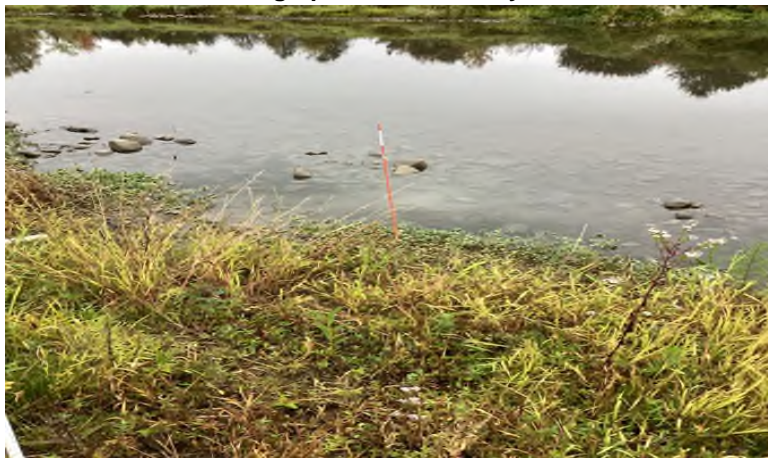
Photograph of Survivability Radius

Radial Dimensions	0.01		acres		
Common Name	Scientific Name	Alive (Installed)	Alive (Recruited)	Dead (Installed)	Survival (%)
Eastern Cottonwood	Populus deltoides	0	1	0	100
				Stems per acre	0
				Total % Survival	100
<u>Radial Aerial Cover</u>		Dominant Herbaceous Species			
Strata	Absolute Cover Estimate (%)	Common Name		Scientific Name	
Tree	0	Water Speedwell		Veronica anagallis-aquatica	
Shrub	1	Rice Cut Grass		Leersia oryzoides	
Herbaceous	25				
Note: Survivability calculations are limited to plantings, and do not include recruited plants.

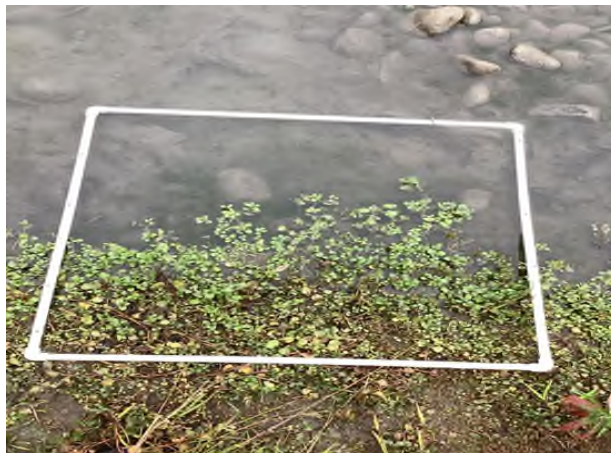
Photograph of Aerial Cover Quadrat

Total Cover (%)		50		
Native Cover (%)		5		
Invasive/Target Weed (%)		0

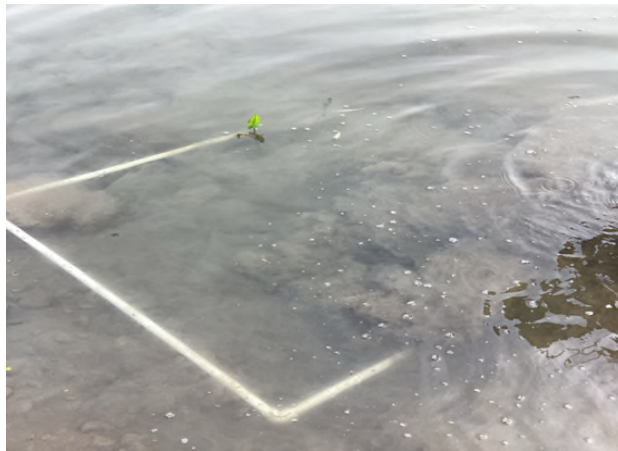
Photograph of Aerial Cover Quadrat

Total Cover (%)		1		
Native Cover (%)		1		
Invasive/Target Weed (%)		0

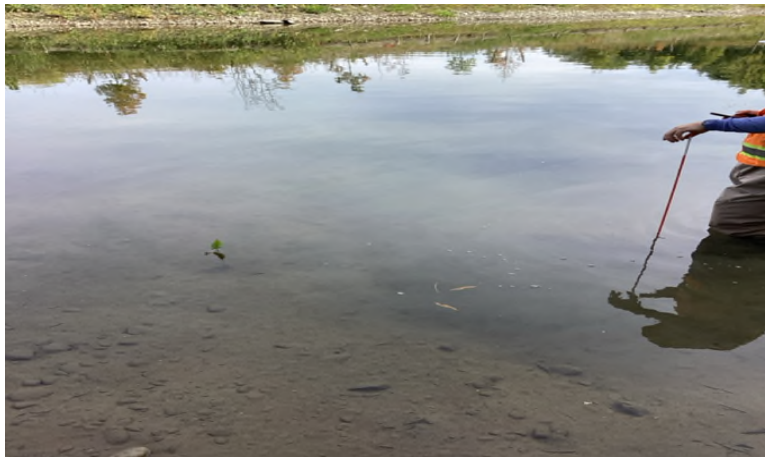
Photograph of Survivability Radius

Radial Dimensions		0.01		acres	
Common Name	Scientific Name	Alive (Installed)	Alive (Recruited)	Dead (Installed)	Survival (%)
Arrow Arum	Peltandra virgnica	2	0	0	100
Coon's Tail	Ceratophyllum demersum	0	1	0	100
Canadian Waterweed	Elodea canadensis	0	1	0	100
				Stems per acre	200
				Total % Survival	100
<u>Radial Aerial Cover</u>		Dominant Herbaceous Species			
Strata	Absolute Cover Estimate (%)	Common Name		Scientific Name	
Tree	0	Not assessed		Not assessed	
Shrub	0				
Herbaceous	10				
Note: Survivability calculations are limited to plantings, and do not include recruited plants.

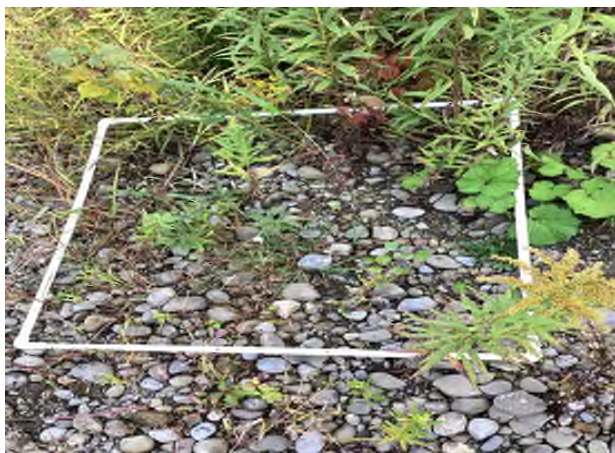
Photograph of Aerial Cover Quadrat

Total Cover (%)		58		
Native Cover (%)		45		
Invasive/Target Weed (%)		0

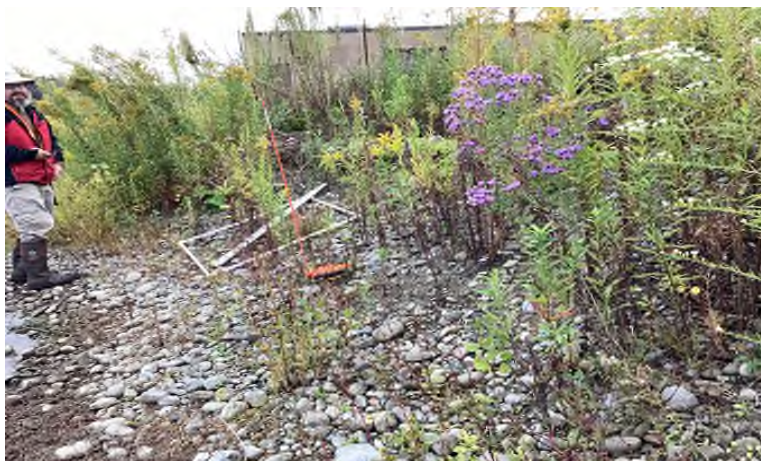
Photograph of Survivability Radius

Radial Dimensions		0.01		acres	
Common Name	Scientific Name	Alive (Installed)	Alive (Recruited)	Dead (Installed)	Survival (%)
Black Willow	Salix nigra	8	0	0	100
Red-osier Dogwood	Cornus sericea	1	0	0	100
Eastern Cottonwood	Populus deltoides	0	1	0	100
				Stems per acre	900
				Total % Survival	100
<u>Radial Aerial Cover</u>		Dominant Herbaceous Species			
Strata	Absolute Cover Estimate (%)	Common Name		Scientific Name	
Tree	0	Common Boneset		Eupatorium perfoliatum	
Shrub	15	White Panicled American Aster		Symphyotrichum lanceolatum	
Herbaceous	30	Tall Goldenrod		Solidago altissima	
Note: Survivability calculations are limited to plantings, and do not include recruited plants.

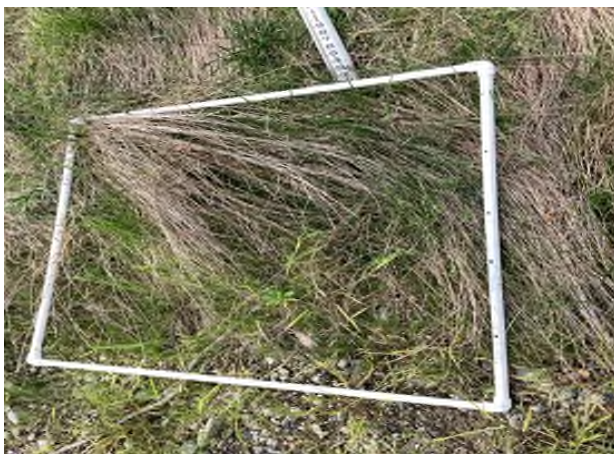
Photograph of Aerial Cover Quadrat

Total Cover (%)		104		
Native Cover (%)		21		
Invasive/Target Weed (%)		0

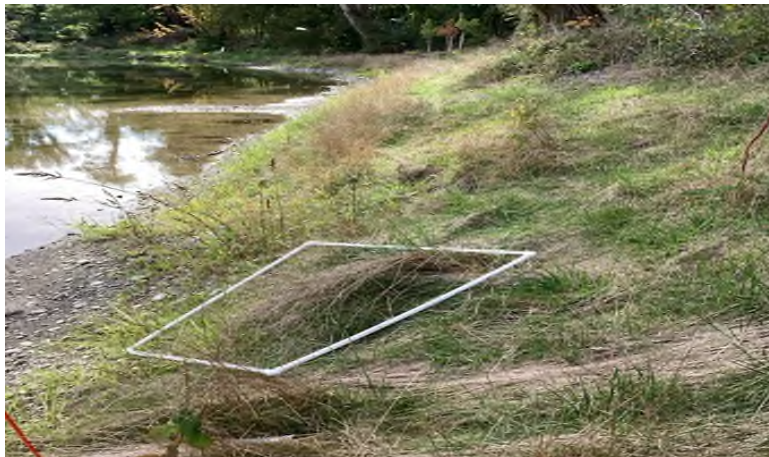
Photograph of Survivability Radius

Radial Dimensions	0.01 acres				
Common Name	Scientific Name	Alive (Installed)	Alive (Recruited)	Dead (Installed)	Survival (%)
Silky Dogwood	Cornus amomum	1	0	0	100
Red-osier Dogwood	Cornus sericea	1	0	0	100
Southern Arrowwood	Viburnum dentatum	1	0	0	100
				Stems per acre	300
				Total % Survival	100
<u>Radial Aerial Cover</u>		Dominant Herbaceous Species			
Strata	Absolute Cover Estimate (%)	Common Name		Scientific Name	
Tree	0	Perennial Rye Grass		Lolium perenne	
Shrub	3	Large Barnyard Grass		Echinochloa crus-galli	
Herbaceous	77				
Note: Survivability calculations are limited to plantings, and do not include recruited plants.

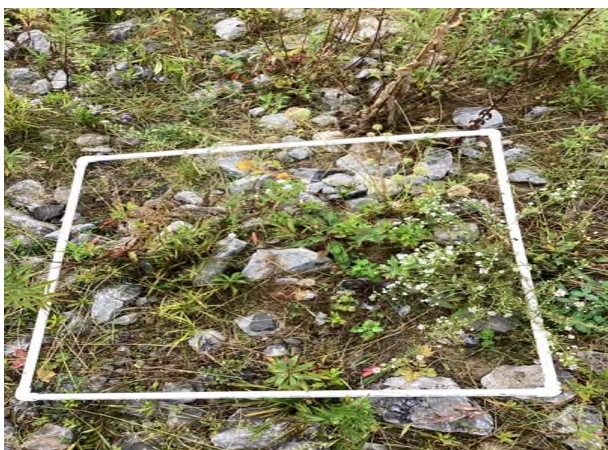
Photograph of Aerial Cover Quadrat

Invasive/Target Weed (%)	7
--------------------------	---

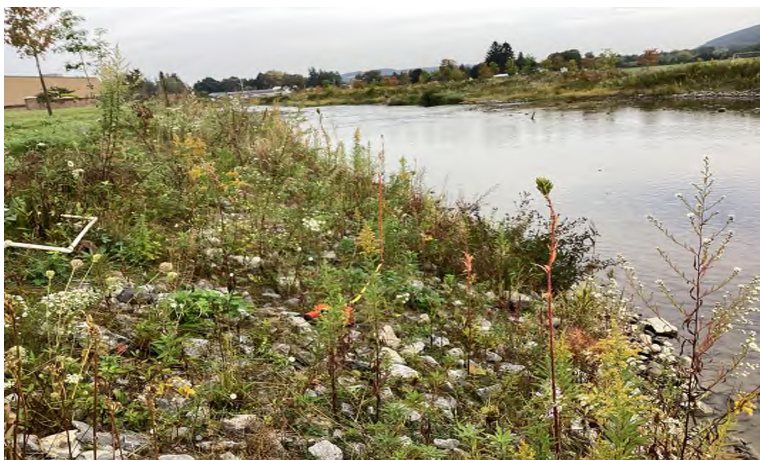
Photograph of Survivability Radius

Radial Dimensions		0.01	acres		
Common Name	Scientific Name	Alive (Installed)	Alive (Recruited)	Dead (Installed)	Survival (%)
Staghorn Sumac	Rhus typhina	0	1	0	0
Black Willow	Salix nigra	2	0	0	100
Red-osier Dogwood	Cornus sericea	4	0	0	100
Downy Serviceberry	Amelanchier arborea	1	0	0	100
				Stems per acre	700
				Total % Survival	100
<u>Radial Aerial Cover</u>		Dominant Herbaceous Species			
Strata	Absolute Cover Estimate (%)	Common Name		Scientific Name	
Tree	0	Common Wormwood		Artemisia vulgaris	
Shrub	8	White Panicled American-Aster		Symphyotrichum lanceolatum	
Herbaceous	60	Tall Goldenrod		Solidago altissima	
Note: Survivability calculations are limited to plantings, and do not include recruited plants.

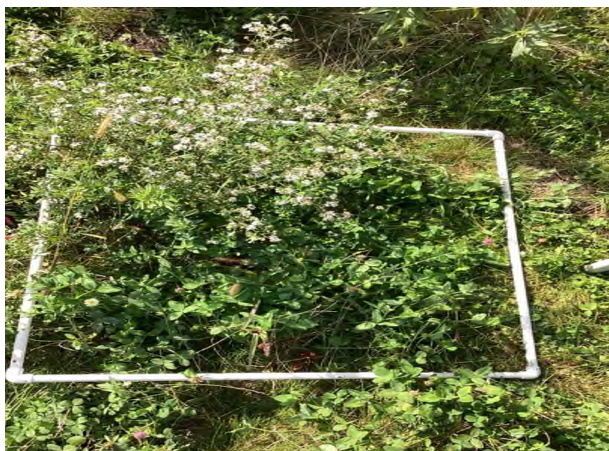
Photograph of Aerial Cover Quadrat

Total Cover (%)		126		
Native Cover (%)		45		
Invasive/Target Weed (%)		0

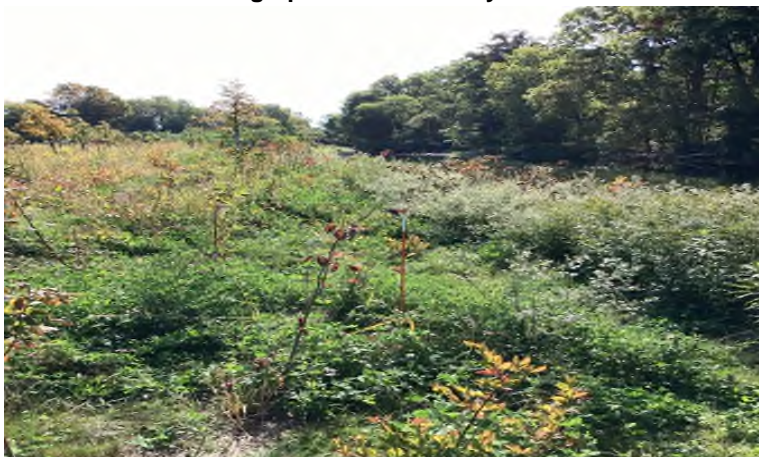
Photograph of Survivability Radius

Radial Dimensions		0.01 acres			
Common Name	Scientific Name	Alive (Installed)	Alive (Recruited)	Dead (Installed)	Survival (%)
Staghorn Sumac	Rhus typhina	0	2	0	0
Red-osier Dogwood	Cornus sericea	3	0	0	100
Dogwood Species	Cornus spp	7	0	0	100
Southern Arrowwood	Viburnum dentatum	2	0	0	100
Downy Serviceberry	Amelanchier arborea	5	0	0	100
Silky Dogwood	Cornus amonum	2	0	0	100
Black Chokeberry	Aronia melanocarpa	1	0	0	100
				Stems per acre	2000
				Total % Survival	100
<u>Radial Aerial Cover</u>		Dominant Herbaceous Species			
Strata	Absolute Cover Estimate (%)	Common Name		Scientific Name	
Tree	0	Yellow Sweetclover		Melilotus officinalis	
Shrub	25	Red Clover		Trifolium pratense	
Herbaceous	80	Wild Rye Species		Elymus spp	
Note: Survivability calculations are limited to plantings, and do not include recruited plants.

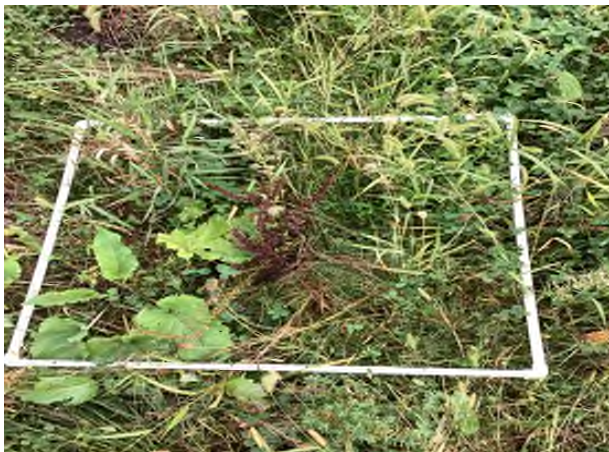
Photograph of Aerial Cover Quadrat

Total Cover (%)		133		
Native Cover (%)		18		
Invasive/Target Weed (%)		0

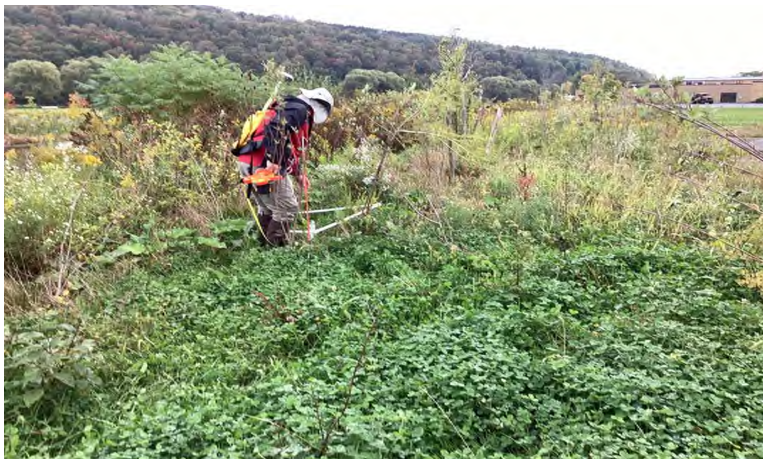
Photograph of Survivability Radius

Radial Dimensions	0.01	acres			
Common Name	Scientific Name	Alive (Installed)	Alive (Recruited)	Dead (Installed)	Survival (%)
Black Willow	Salix nigra	1	0	0	100
Red-osier Dogwood	Cornus sericea	3	0	0	100
Downy Serviceberry	Amelanchier arborea	2	0	0	100
Black Chokeberry	Aronia melanocarpa	4	0	0	100
Southern Arrowwood	Viburnun dentatum	2	0	0	100
Late Lowbush Blueberry	Vaccinium angusifolium	1	0	0	100
American Hazelnut	Corylus americana	1	0	0	100
				Stems per acre	1400
				Total % Survival	100
<u>Radial Aerial Cover</u>		Dominant Herbaceous Species			
Strata	Absolute Cover Estimate (%)	Common Name		Scientific Name	
Tree	2	Not assesed		Not assessed	
Shrub	15				
Herbaceous	90				
Note: Survivability calculations are limited to plantings, and do not include recruited plants.

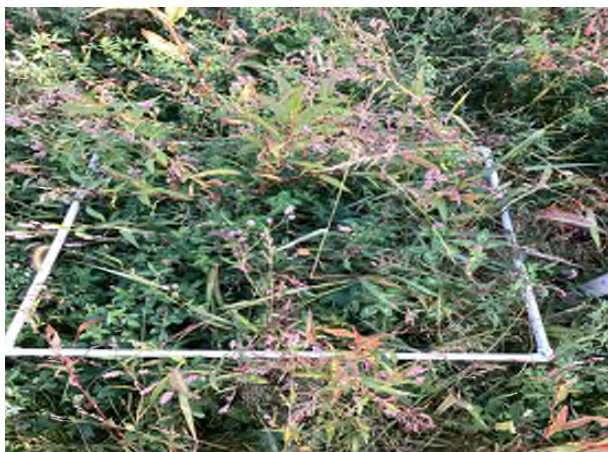
Photograph of Aerial Cover Quadrat

Total Cover (%)		128		
Native Cover (%)		15		
Invasive/Target Weed (%)		0

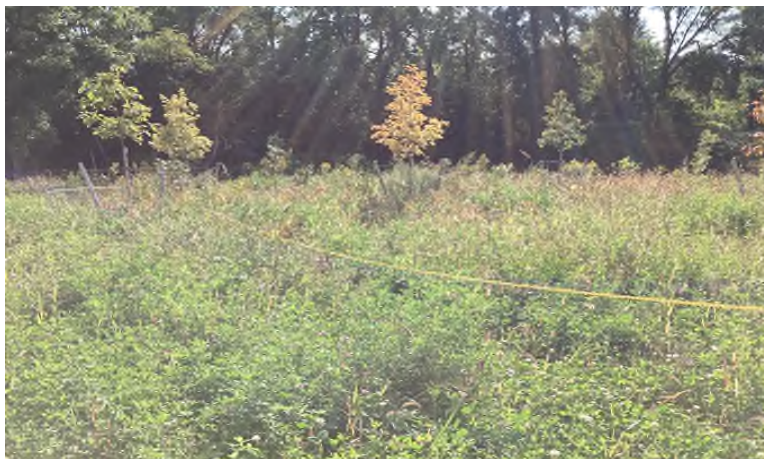
Photograph of Survivability Radius

Radial Dimensions	0.1 acres				
Common Name	Scientific Name	Alive (Installed)	Alive (Recruited)	Dead (Installed)	Survival (%)
Gray Dogwood	Salix nigra	6	0	0	100
Red-osier Dogwood	Cornus sericea	13	0	0	100
Black Cherry	Prunus serotina	2	0	0	100
Southern Arrowwood	Viburnum dentatum	8	0	0	100
Northern Red Oak	Quercus rubra	3	0	0	100
Downy Serviceberry	Amelanchier arborea	15	0	0	100
Black Chokeberry	Aronia melanocarpa	2	0	0	100
Sugar Maple	Acer saccharum	2	0	0	100
Silky Dogwood	Cornus amomum	1	0	0	100
Dogwood Species	Cornus spp	6	0	0	100
				Stems per acre	580
				Total % Survival	100
<u>Radial Aerial Cover</u>		Dominant Herbaceous Species			
Strata	Absolute Cover Estimate (%)	Common Name		Scientific Name	
Tree	10	Not assesed		Not assessed	
Shrub	20				
Herbaceous	85				
Note: Survivability calculations are limited to plantings, and do not include recruited plants.

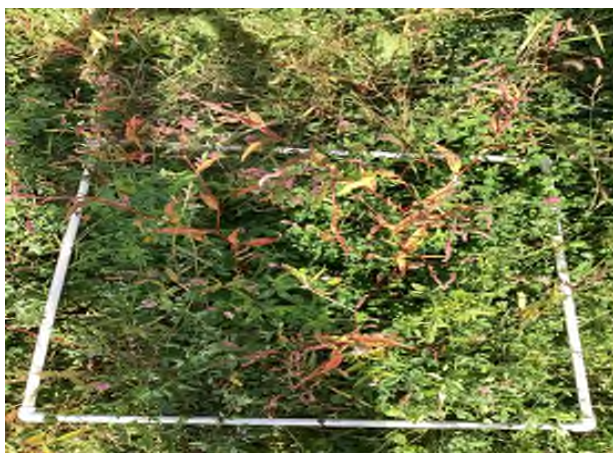
Photograph of Aerial Cover Quadrat

Total Cover (%)		152		
Native Cover (%)		5		
Invasive/Target Weed (%)		15

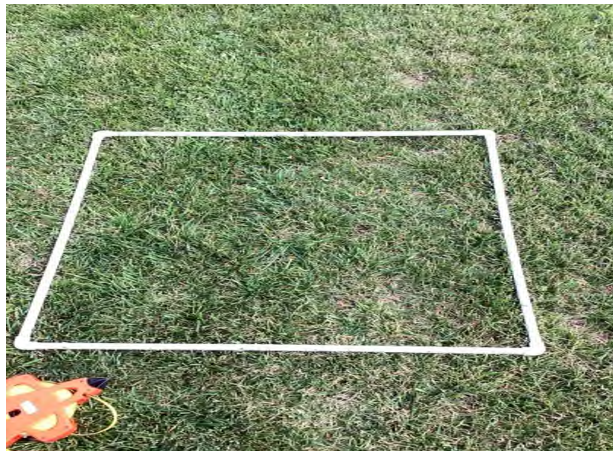
Photograph of Aerial Cover Quadrat

Total Cover (%)		95		
Native Cover (%)		0		
Invasive/Target Weed (%)		0

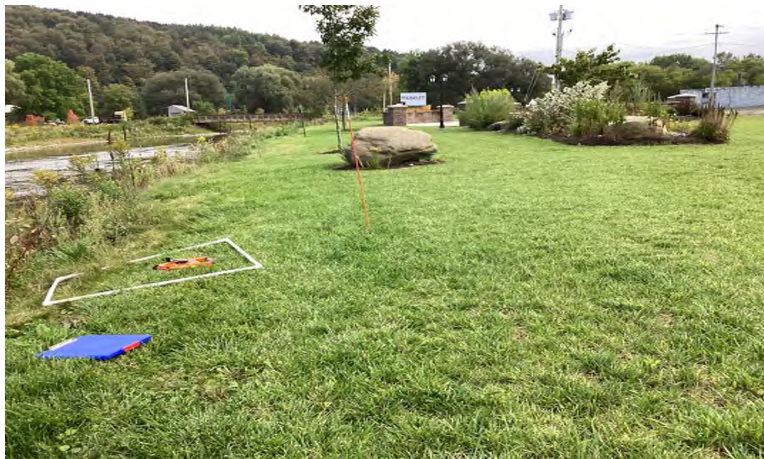
Photograph of Survivability Radius

Radial Dimensions		0.01	acres		
Common Name	Scientific Name	Alive (Installed)	Alive (Recruited)	Dead (Installed)	Survival (%)
Red-osier Dogwood	Cornus sericea	1	0	0	100
Downy Serviceberry	Amelanchier arborea	1	0	0	100
				Stems per acre	200
				Total % Survival	100
<u>Radial Aerial Cover</u>		Dominant Herbaceous Species			
Strata	Absolute Cover Estimate (%)	Common Name		Scientific Name	
Tree	0	Perennial Rye Grass		Lolium perenne	
Shrub	2	White Clover		Trifolium repens	
Herbaceous	93				
Note: Survivability calculations are limited to plantings, and do not include recruited plants.
