FINAL ENGINEERING REPORT
SOUTH HILL DUMP REMEDIAL ACTION
SITE NUMBER: 712009
(T) CORTLANDVILLE (C) CORTLAND
REMEDIAL ACTION CONTRACT NUMBER: D007992

New York State Department of Environmental Conservation
Division of Environmental Remediation
Remedial Bureau E
Albany, New York

MACTEC Engineering and Consulting, PC
Portland, Maine

FEBRUARY 2014

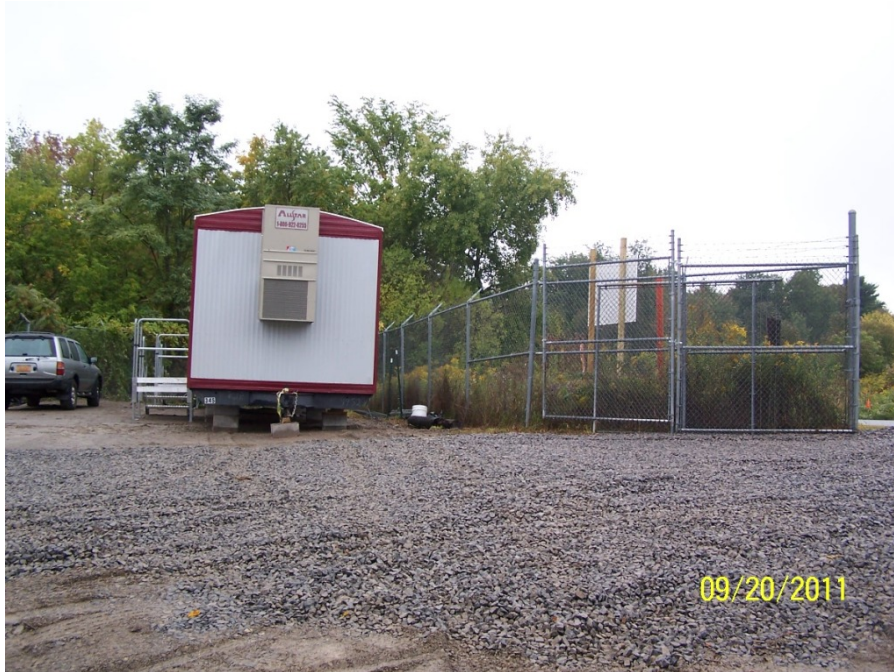
Office Trailer Installed at the Parking Area near the Entrance to the Site, Looking West

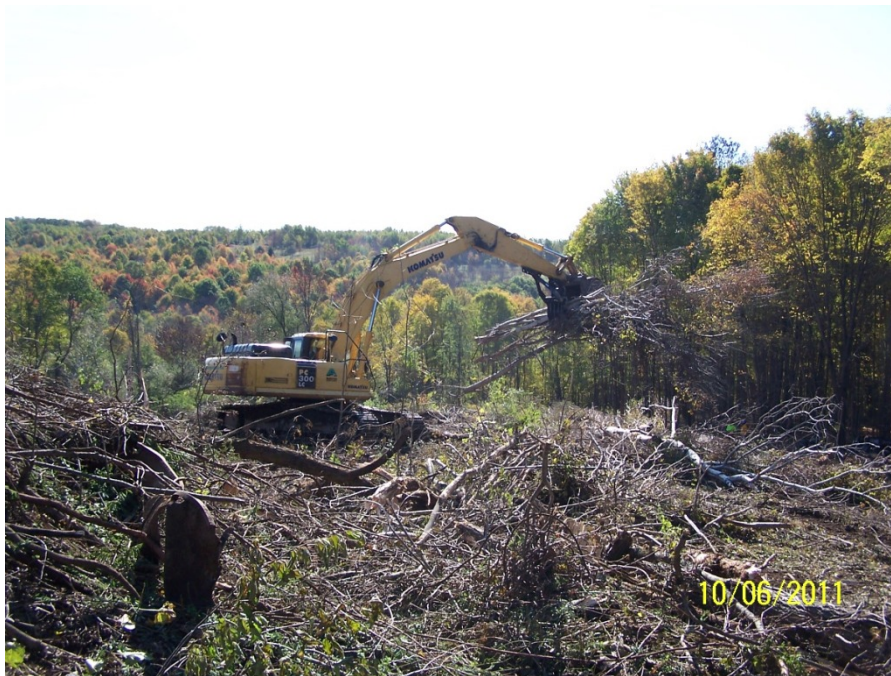
Excavator with “Thumb” Attachment, Stacking Cut Trees and Brush, Looking Southeast

The Site was relatively heavily wooded, and ESG cleared the trees with chain saws. The trees were stacked using a “thumb” attachment to the excavator, then dragged using steel cables with a dozer to the properties of two abutting owners located on the east and west sides of the site, with the owners’ prior approval. Both property owners were provided with cut trees and logs generated from Site clearing activities, thereby eliminating the need to transport and dispose the cleared trees off-Site. In addition, ESG and the owner on the east side executed a mutual, private agreement (with compensation) for brush from the Site to be disposed on the east property. With Engineer approval, ESG elected not to clear the trees and brush at the location indicated as the Contractor Staging and Storage Area (Contract Drawing C-102) adjacent to the private property at the southwest portion of the Site.

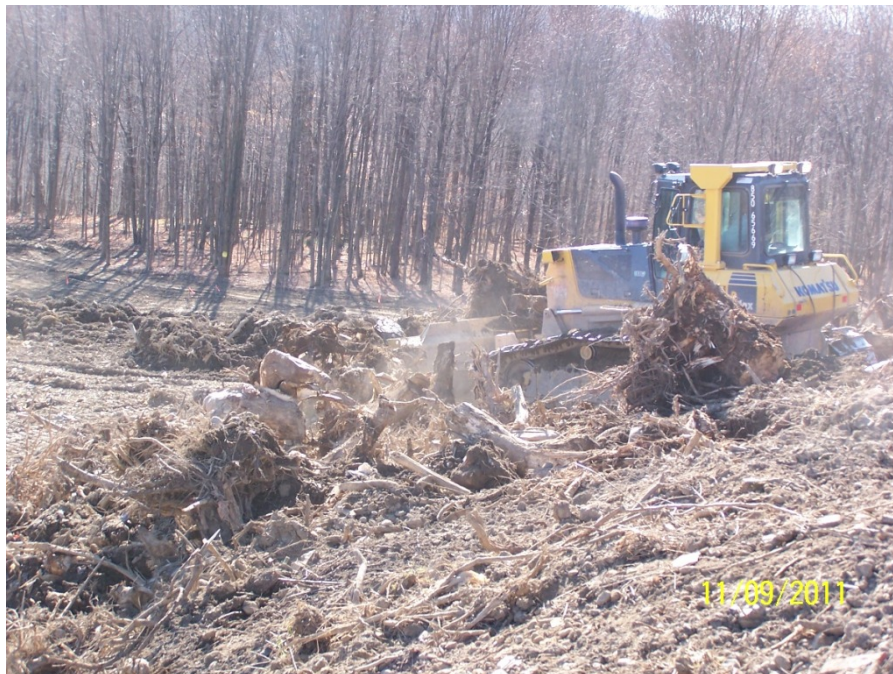
Dozer Tracking Grubbings during Placement within the Landfill Limits, Looking South

Grubbing of the root systems was performed with the excavator (Komatsu PC-300). Subsequently, all grubbed material was placed inside the landfill. Grubbings greater than six inches in diameter were broken down into smaller pieces using dozer tracks and the teeth of the excavator bucket. The grubbings were placed in single lifts of four ft or less with care to prevent the creation of large void spaces. The resulting disposal area for the grubbings was surveyed and plotted on the redline drawing, Submittal 91, Appendix C. Disposal of grubbings in the landfill was completed by November 15, 2011.

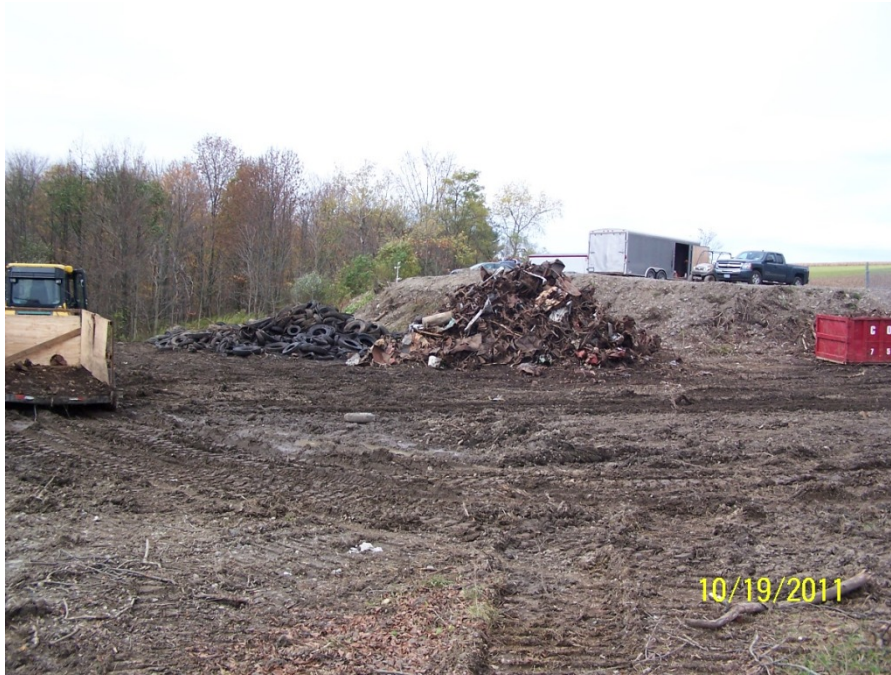
Scrap Metal and Tires Stockpiled Below the Toe of Slope of the Parking Area, Looking Northwest

Metal and tires were loaded onto a small trailer by the Case CX 130 excavator and pulled to the top of the landfill with the D-51 dozer. ESG stockpiled metal and tires at the top of the landfill, immediately below the toe of slope of the parking area. As roll-offs were delivered to the Site, the Case CX 130 excavator loaded metal and tires into separate roll-offs. Contentos (Cortland, NY) provided the roll-offs and transported them for off-Site disposal. Contentos recycled the metal, and transported the tires to Seneca

Meadows Landfill (Waterloo, NY) for disposal. Tires with hubs greater than 20 inches were processed for disposal at Alpco Recycling (Macedon, NY), and then transported for disposal at Seneca Meadows Landfill.

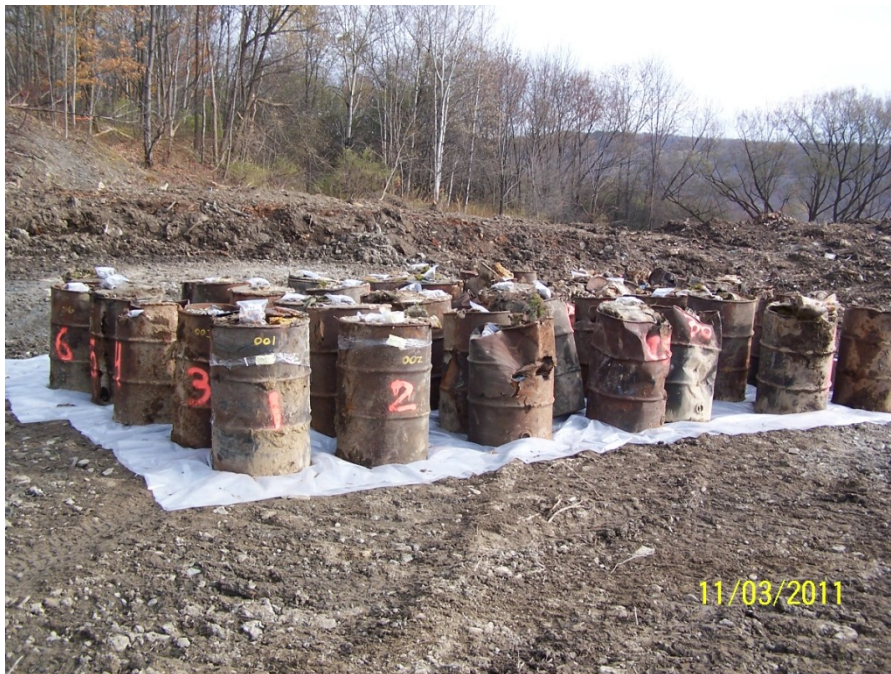
Drums Staged on Plastic for Off Site Transportation and Disposal, Looking Northeast

A total of 56 intact and damaged drums were relocated and staged on plastic and covered with plastic. Each drum was assigned a unique number, photographed, and categorized into one of four waste streams. The waste streams consisted mostly of the following solids: epoxy solids, fiberglass, paint, and ash mixed with soil. Waste characterization samples were collected from various drums to represent the four waste streams. A drum log with photographs and descriptions is included in Submittal 28 (Appendix C).

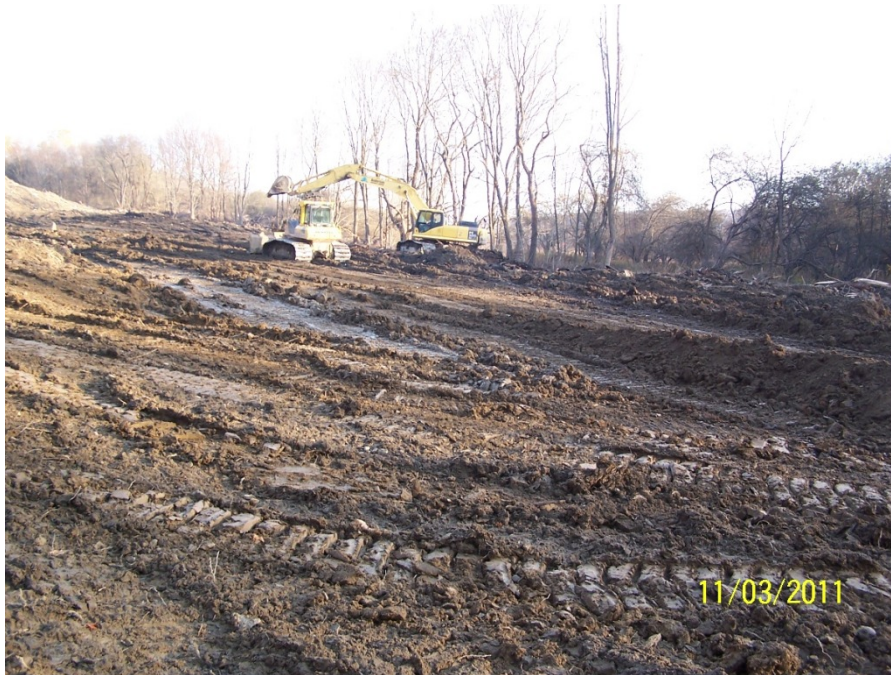
Consolidation of Waste Soil, Looking East

Solid waste encountered during the work consisted primarily of soil (presumed from use as historic daily cover), construction and demolition material (e.g., wood and various metal and plastic products), household waste (e.g., plastic containers, plastic bags, and toys), typewriter parts and ribbon, auto parts, tires, appliances and appliance parts, textiles, fishing line, glass bottles, shoes, glass, ash, newspapers, and other paper products. Exposed waste gave off a typical aged municipal solid waste odor close to the surface which typically dissipated quickly and was not encountered off-Site during the course of the contract work.

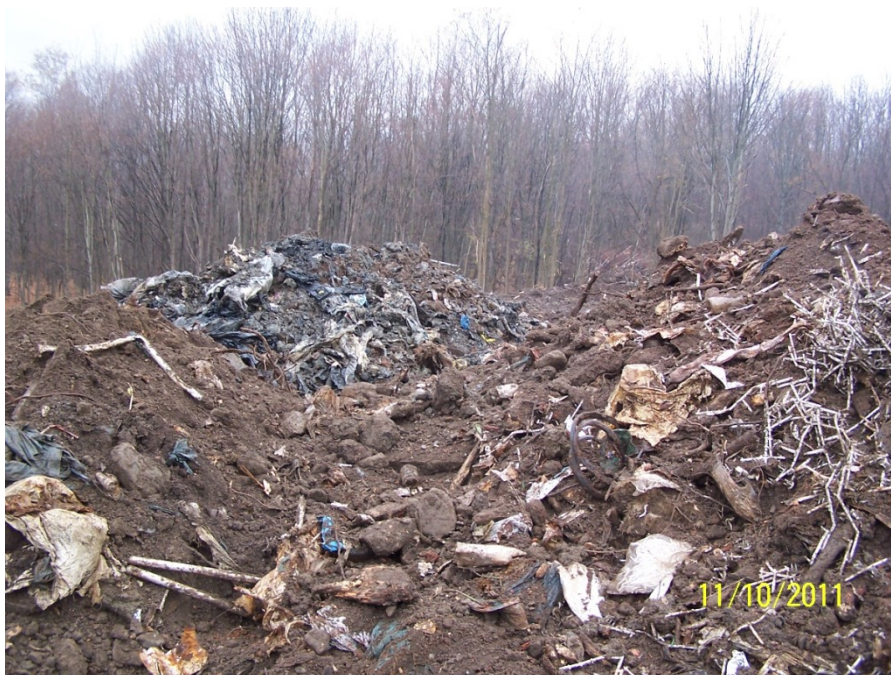
Solid Waste Consolidation (1), Looking West

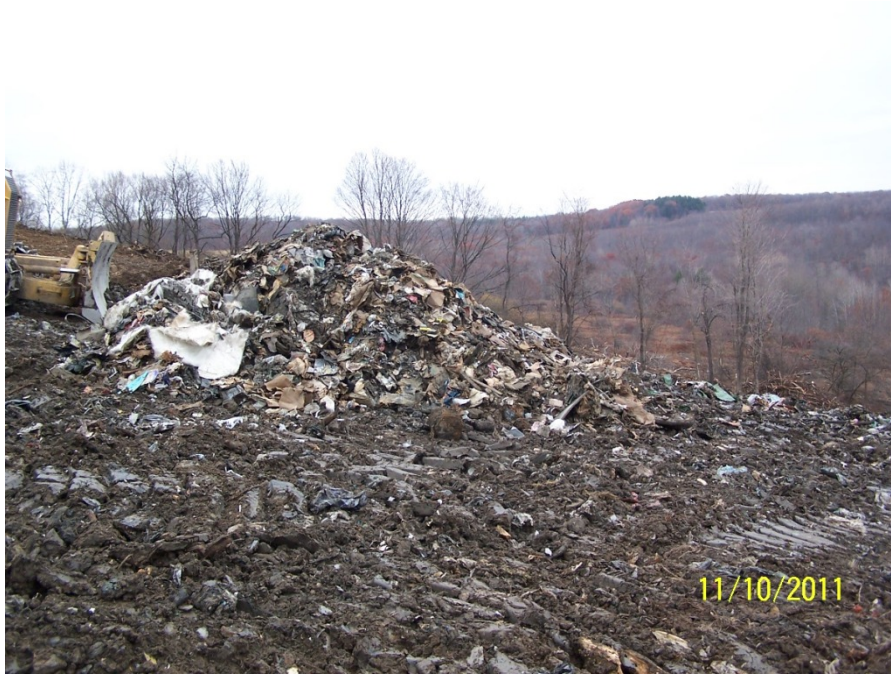
Solid Waste Consolidation (2), Looking East

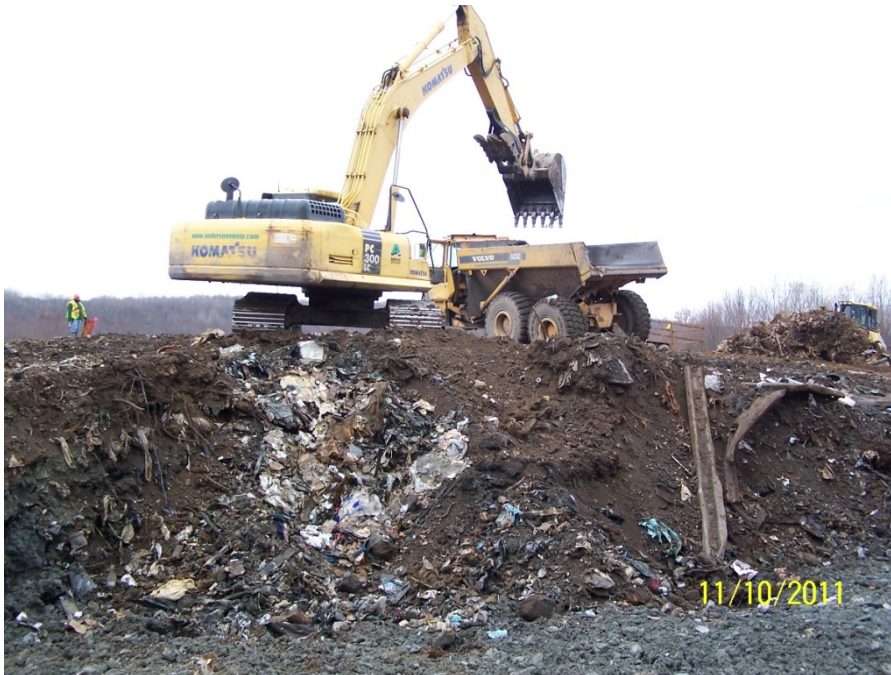
Solid Waste Consolidation (3), Looking South

Inspections and observations made during ESG’s waste consolidation activities confirmed the presence of municipal/household and industrial wastes, consistent with the Site’s reported past usage. Visual

evidence of past burning activities (ash and charred solid waste) was also encountered, supporting reports of burning as a means of disposal during landfill operation. Though an oil pit was reported to have been present during the landfill's years of operation (or a portion thereof), no direct evidence of such a pit was encountered during waste consolidation.

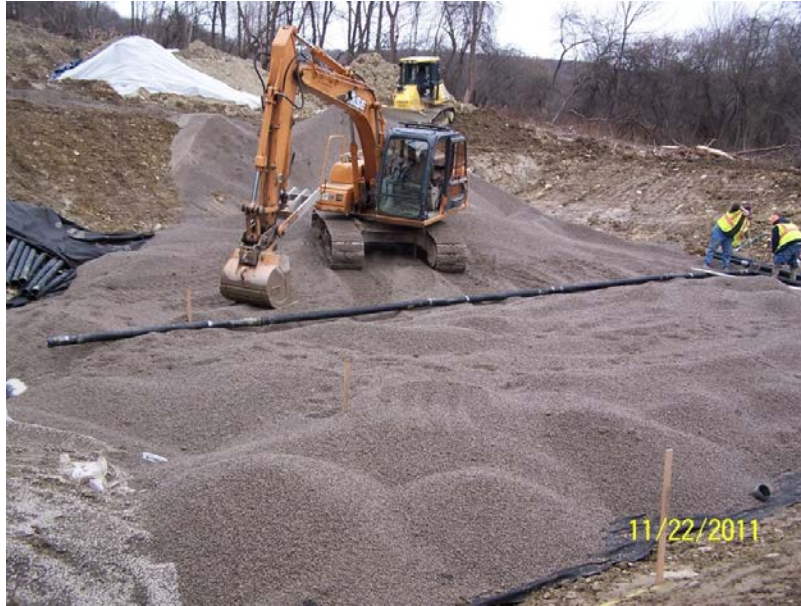
Installing Crushed Stone and Underdrain Piping at the Sedimentation Basin, Looking Northeast

Storm water runoff from the landfill was directed to the sedimentation basin (constructed per Detail E, Contract Drawing C-302), which was filled with two ft of crushed stone and four-inch diameter underdrain piping. The crushed stone and subsequent build-up of sediment provided filtering for storm water before it entered the outlet culvert and discharged off-Site. Clean storm water run-on from the hill north of the Site was captured in the on-Site eastern drainage swale. ESG installed and maintained stone check dams and hay bales in the eastern drainage swale to provide erosion and sedimentation control.

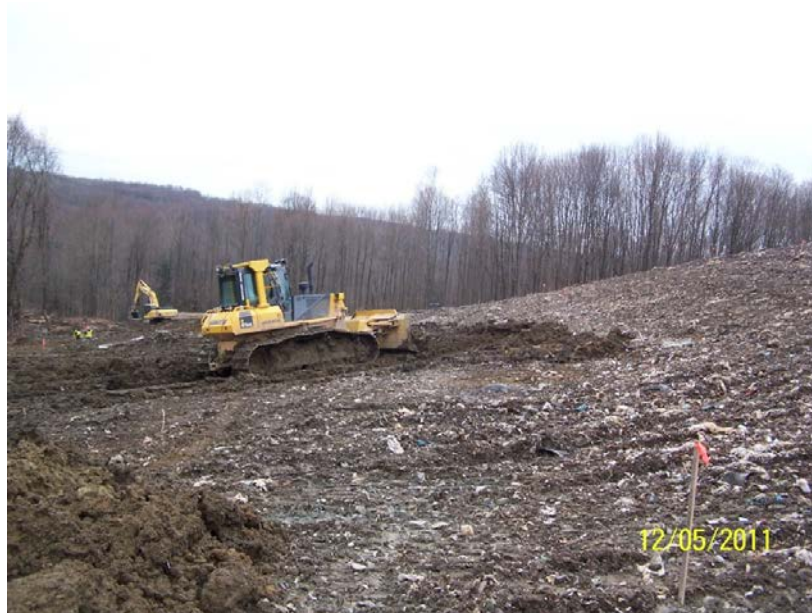
Landfill Subgrade Preparation, looking South

Subgrade preparation occurred simultaneously with waste consolidation and was performed primarily with the D-61 dozer. During subgrade preparation, ESG installed slope benches and downdrains as shown on the Contract Drawings C-104 through C-107. ESG employed GPS technology in the placement of survey stakes on the landfill indicating cut or fill locations in relation to the final subgrade.

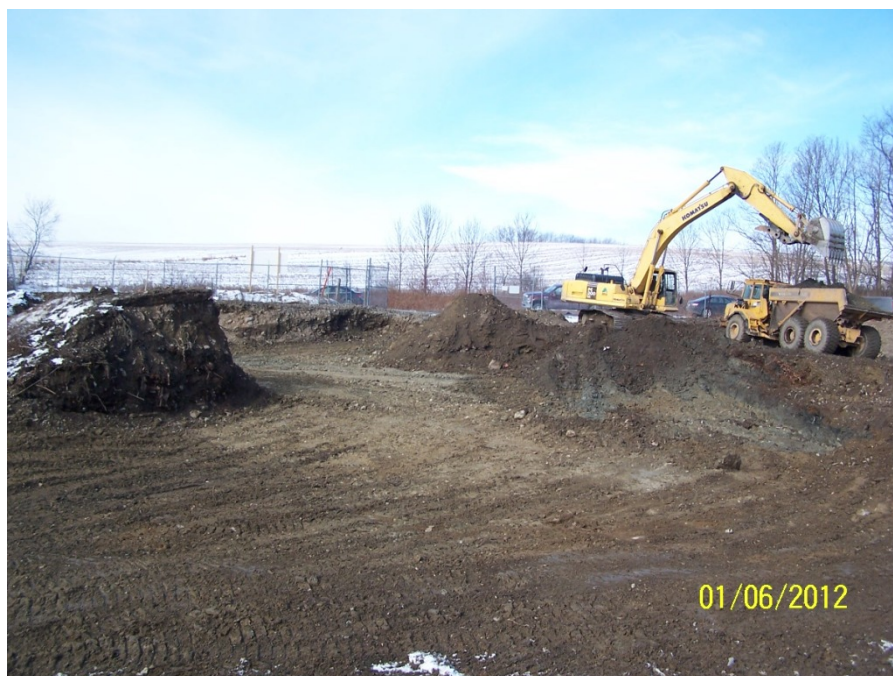
Excavation at the Former Parking Area, Looking Northwest

ESG completed work associated with the removal of solid waste at the parking area on January 10, 2012. The as-built survey of excavation indicated that 3,432 cy of overburden and solid waste were excavated from the parking area. The solid waste was re-located to the landfill, and the re-constructed entrance road was backfilled with 684.3 cy of overburden. A 10 ft x 10 ft x 2 ft deep excavation (included in the 3,432 cy amount) was required at the bottom of the excavation as a result of the bottom confirmation sample exhibiting concentrations of PCBs above the restricted residential use cleanup objectives. Subsection

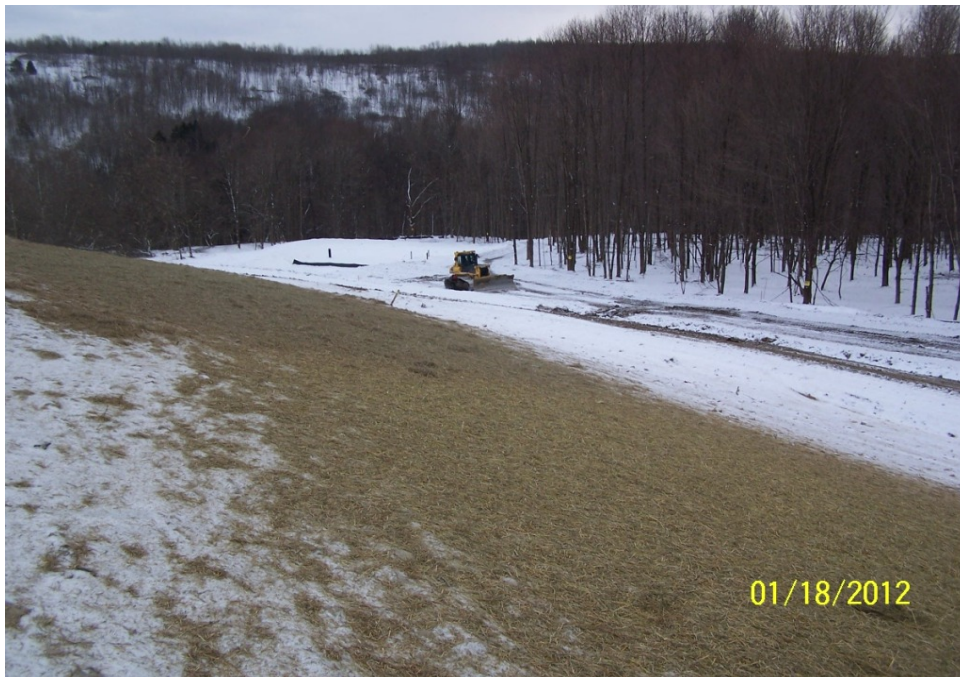
Solid Waste Covered with Six Inches of Select Borrow and Hay for Winter Shutdown, Looking Southeast

During January 2012, in preparation for the winter shutdown , ESG covered the solid waste on the landfill with up to six inches of select borrow and placed hay on exposed soil throughout the Site. In addition, ESG added rip-rap, stone, and hay bale checkdams at erosion-sensitive locations on the Site as indicated on their winter shutdown plan submittal (Submittals 32 and 32A, Appendix C).

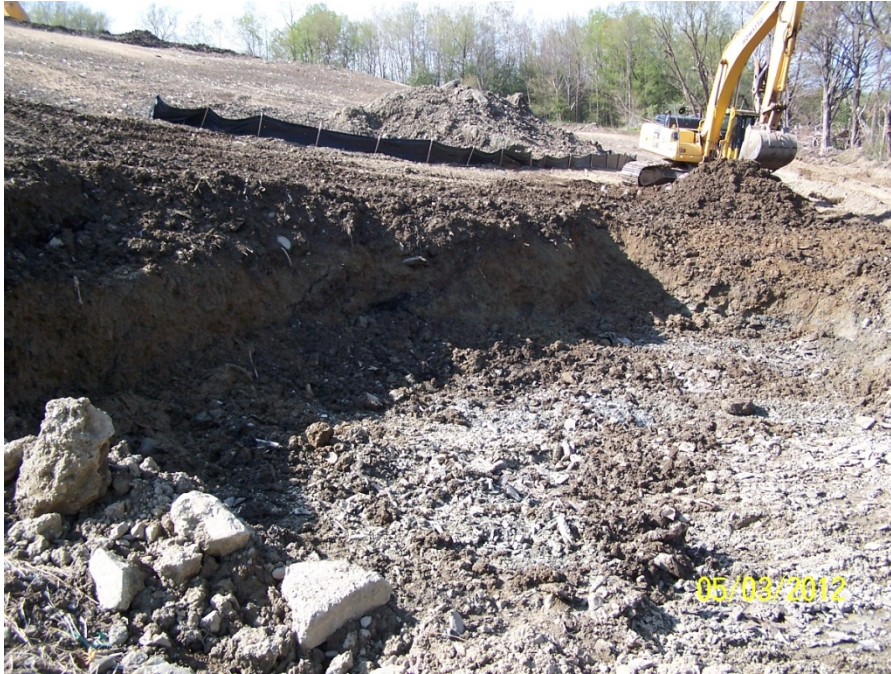
Excavation of Soil at Groundwater Seep, Looking North

ESG submitted PCO 9 (Appendix F) to remove saturated soil and solid waste at the seep area to bedrock (fractured shale). The excavated soil and waste was placed at the top of the landfill and allowed to dry. The seep was backfilled with loose nine-inch lifts of select borrow. Each lift of select borrow was compacted with the vibratory roller and "keyed" into the competent subgrade material beyond the excavation. In addition, ESG installed a geogrid material (Submittal 53A, Appendix C) that extended beyond the limits of the seep repair area to provide additional support for the landfill cover system that would be installed over it. Relatively smaller additional groundwater seeps were subsequently observed at ground surface at a few locations downgradient from the original seep on the eastern side of the landfill. Saturated soil was excavated to fractured shale at these groundwater seep locations, and rip rap imported from off-Site was backfilled in the excavation to provide a structural surface on which to backfill select borrow. A total of 790 cy of saturated soil and solid waste was removed from the multiple groundwater seeps and placed on top of the landfill.

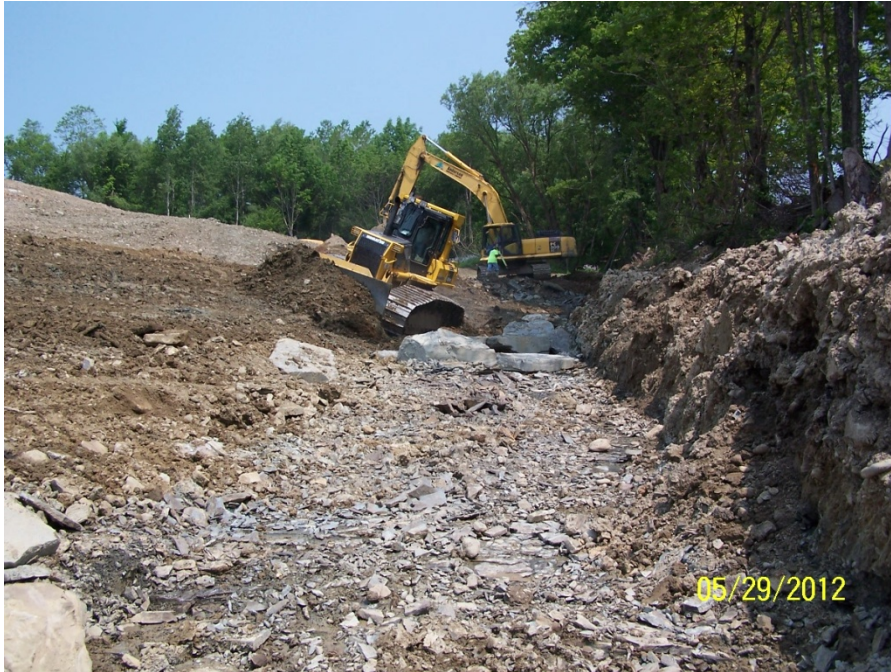
Southern End of the Eastern Perimeter Road Excavated to Weathered Shale, Looking North

Similarly, the silty subgrade soil along the southern end (approximately 250 ft long) of the eastern perimeter road was observed to be saturated. MACTEC determined that the soil was unsatisfactory for use as roadway subbase, as it was too wet to compact and did not meet Specification Section 02300, Sub-Part 1.06C of the Contract Documents. Thus, ESG submitted PCO 11 (Appendix F) to remove the saturated soil to the fractured shale. The excavated soil was placed at the top of the landfill and allowed to dry, and the excavation was backfilled with structural fill material imported from off-Site (Type 2 crushed limestone, see PCO 11 [Appendix F] for sieve analysis) and compacted. On-Site select borrow material was backfilled in lifts and compacted to achieve the required subgrade elevation. A total of 401 cy of the unsatisfactory soil was excavated from the southern end of the eastern perimeter road and placed on top of the landfill.

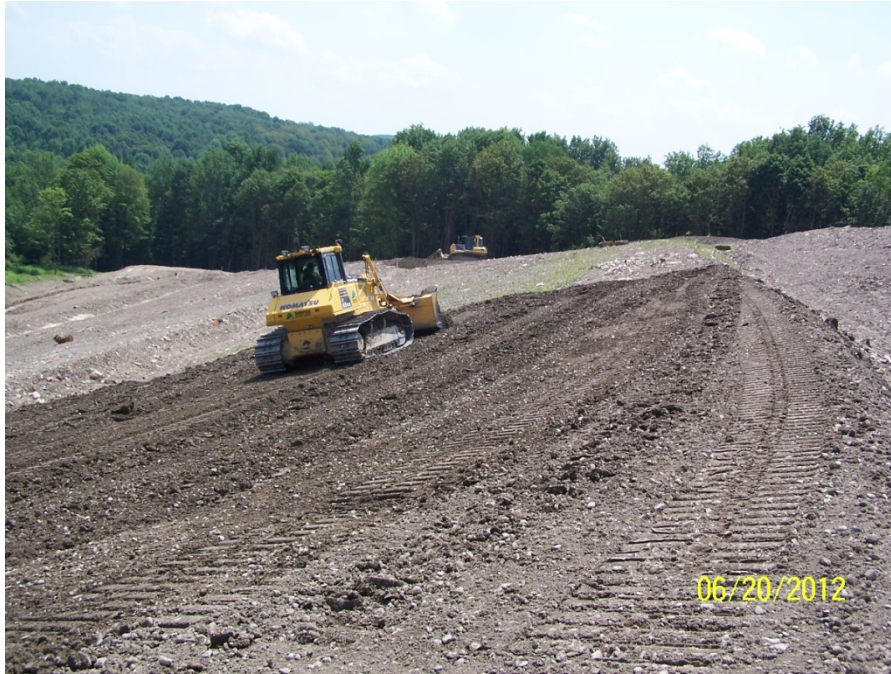
Placing and Grading Cover Soil on the Landfill, Looking Southeast

Cover soil was placed in two nine-inch compacted lifts by the dozers. Cover soil was installed to mimic the subgrade surface, including the slope benches and downdrain. Compaction was achieved using the vibratory sheepsfoot roller. Compaction testing was performed by nuclear method by SJB Services, Inc. (SJB), Cortland, NY, on each lift at a rate of one test per 4,000 square feet (sf). Compaction testing results are included in Submittal 74 (Appendix C).

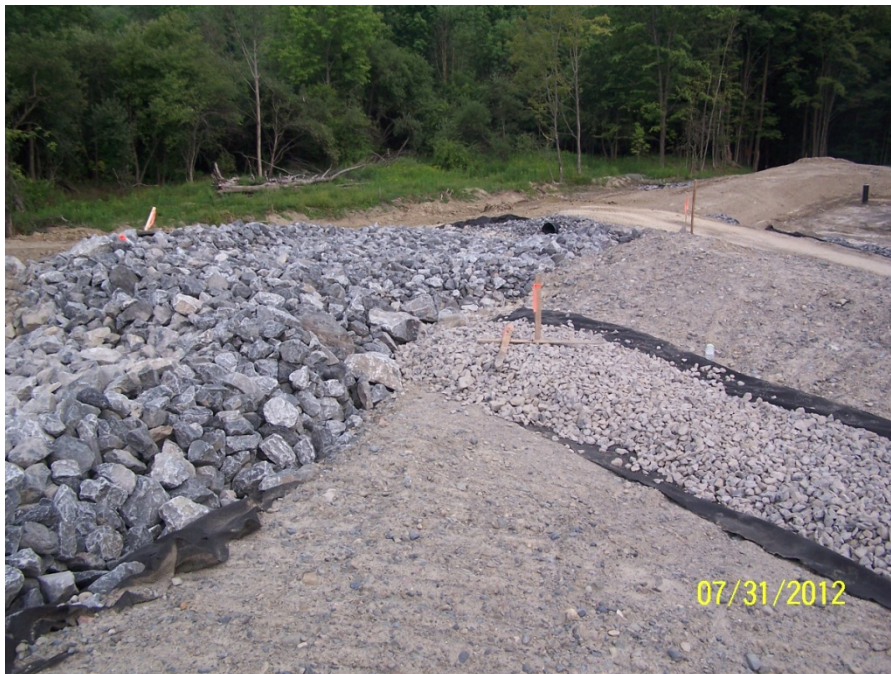
Rip Rap Installed at the Downdrain and the Bottom Slope Bench on the Western Side, Looking Southeast

The specified size of the rip rap for installation at the downdrain was “standard” sizes D_{50} =eight inches and D_{100} =twelve inches. The guidance for selection of this “standard” riprap was the New York State Standards and Specifications for Erosion and Sediment Control (NYSDEC, Division of Water, August 2005). Rip rap suppliers in the area, however, were prepared to provide rip rap based on NYSDOT specifications. With MACTEC approval, ESG installed a mixture of two rip rap sizes (NYSDOT Stone Filling Fine and NYSDOT Stone Filling Light) to provide a comparable size to the required D_{50} =eight inches. The installed D_{100} upper size limit was closer to D_{100} =18 inches (originally specified as D_{100} =12 inches) and was approved by MACTEC. The rip rap was obtained from TH Kinsella in Syracuse, NY. The rip rap sizes for the fine and light stone were approved as Submittal 67A (Appendix C).

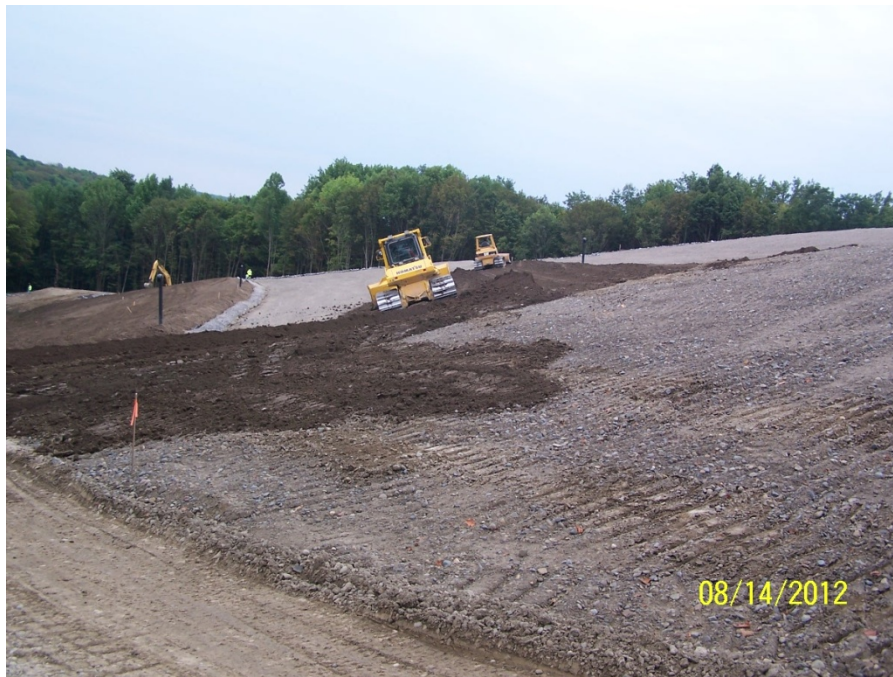
Placing and Grading Topsoil on the Landfill, Looking Southwest

ESG placed and graded the six-inch topsoil layer (topsoil was imported from off-Site) beginning on August 13, 2012. Topsoil testing results (particle size, organic content, pH, soluble salt content, and soil nutrient analysis) are included in Submittals 69 and 69A (Appendix C). Analytical testing results for topsoil are discussed in Subsection 4.2. Topsoil was obtained from Homer Quarry in Homer, NY, operated by TH Kinsella. TH Kinsella also provided transport of the topsoil in dump trucks to the Site via Interstate 81, State Route 11, and the southern end of South Hill Road. The topsoil layer – with the exclusion of the slope benches, perimeter apron, and downdrain - was installed to mimic the finished subgrade surface. Approximately 7,000 tons of topsoil was installed.

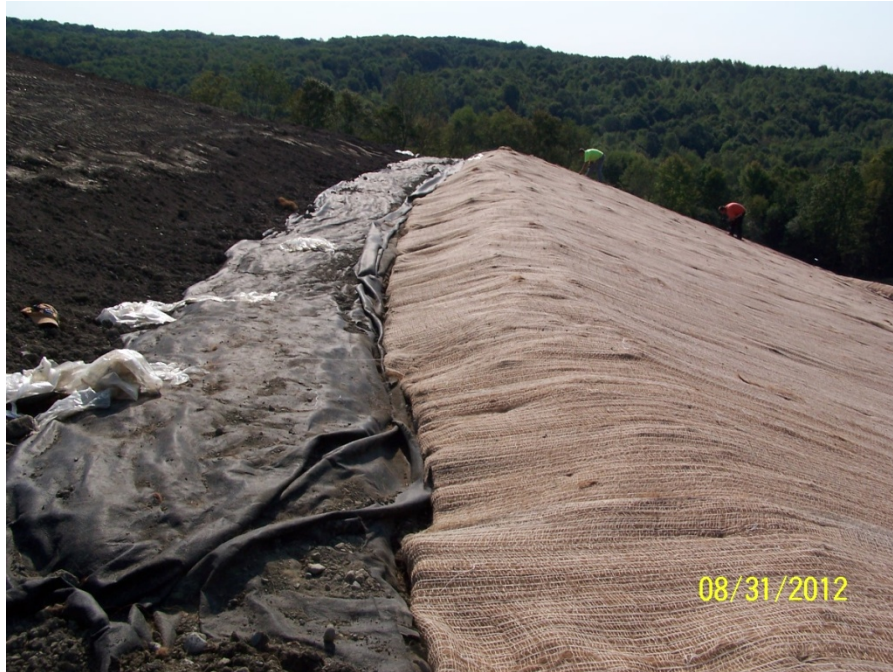
Laborers Installing Erosion Control Blankets on the Landfill Slope, Looking Southeast

ESG commenced hydroseeding on August 29, 2012 with a 600-gallon capacity hydroseeder pulled by the dozer, at areas on the landfill that had been completed to date with topsoil. The hydraulic seeding method (Submittal 72A), grass seed vendor's certificate (Submittal 71), and the fertilizer manufacturer's product data (Submittal 72A) were provided as submittals (Appendix C). ESG installed erosion control blankets (Submittal 68B, Appendix C) by hand on landfill slopes at the hydroseeded areas.

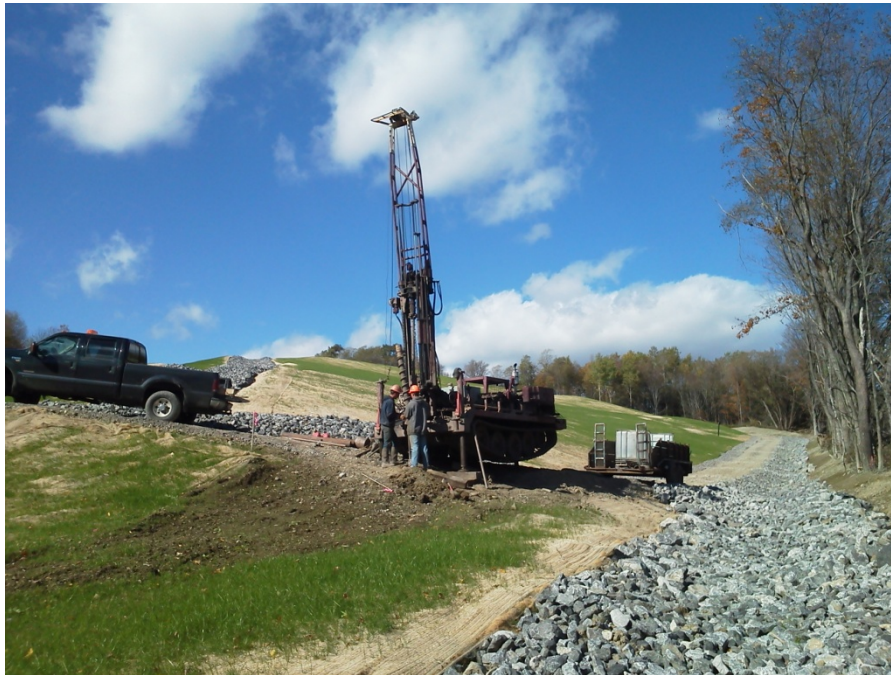
Installing Replacement Groundwater Monitoring Wells, Looking Northwest

Two new groundwater monitoring wells were installed between October 11, 2012 and October 16, 2012, to replace wells MW-3S and MW-3B. SJB installed new well MW-3SR to replace MW-3S in accordance with Detail V, Contract Drawing C-306 and new well MW-3BR to replace MW-3B in accordance with Detail U, Contract Drawing C-306. The new bedrock well, MW-3BR, was installed to 41 ft below ground surface (bgs), 15 ft deeper than specified in Detail U because competent rock was actually reached at 27 ft bgs (not 13 ft bgs, as anticipated in Detail U). The bottom of the new overburden well, MW-3SR, was installed at 24 ft bgs (not 15 ft bgs, as anticipated in Detail V) because groundwater was not encountered until 22.6 ft bgs during drilling. Well installation drilling records, well details, and well development records are included as Submittal 87 and 87A (Appendix C).

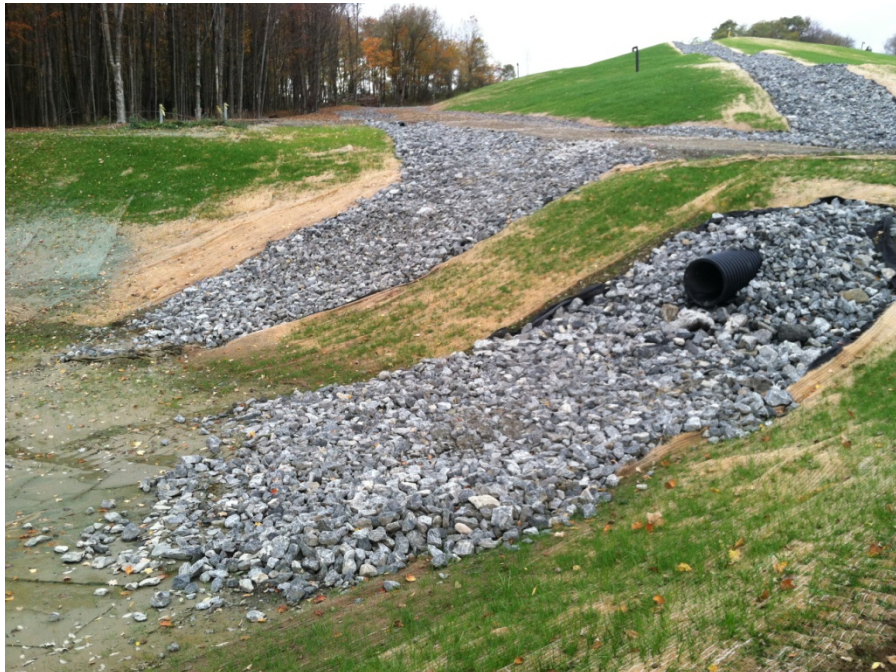
Culvert and Rock Outlet Protection at the Detention Basin, Looking Northwest

Contract Drawing C-304 and in accordance with the alignment as shown on Contract Drawings C-106 and C-107. Three corrugated polyethylene (PE) culverts were installed. One twelve-inch culvert was installed along the western drainage channel, another twelve-inch culvert was installed as the outlet from the detention basin, and a 24-inch culvert was installed at the bottom of the downdrain to the detention basin. The culverts were installed as shown in Section 1, Contract Drawing C-305. The crushed stone bedding gradation was provided as Submittal 15 (Appendix C), and the PE piping specifications were provided as Submittal 23 (Appendix C).

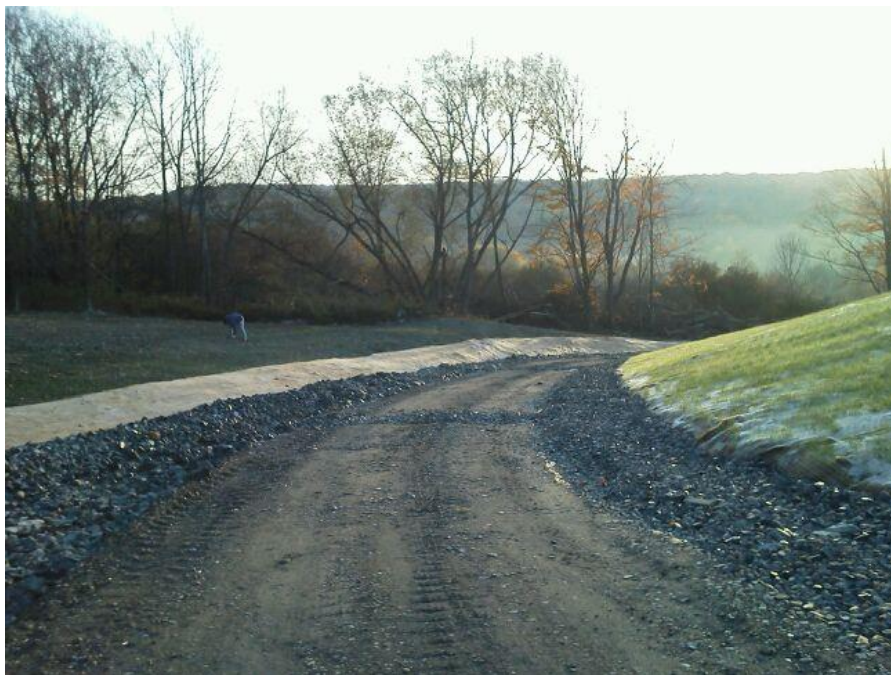
Eastern Perimeter Access Road, Looking Southeast Along Eastern Edge of Landfill

As part of the final Site work, ESG installed the rock outlet protection at the culverts with the rip rap mix (NYSDOT Stone Filling, Fine and Light) as shown in Section 1, Contract Drawing C-305. Also, the perimeter access road was constructed by placing, grading, and compacting two nine-inch lifts of aggregate base (Submittal 11A, Appendix C). The perimeter access road was compacted with a smooth drum roller, and compaction testing was performed by the nuclear method by SJB at one test per 2,000 sf. Compaction testing results for the perimeter access roads are included in Submittal 79, Appendix C. MACTEC relaxed the compaction testing requirement for the second lift because MACTEC was satisfied with the compaction effort observed during installation of the second lift. A total of 27 water bars were installed per Detail O, Contract Drawing C-304, in the perimeter access road, to promote drainage from the perimeter roads to the perimeter drainage swales/channels.

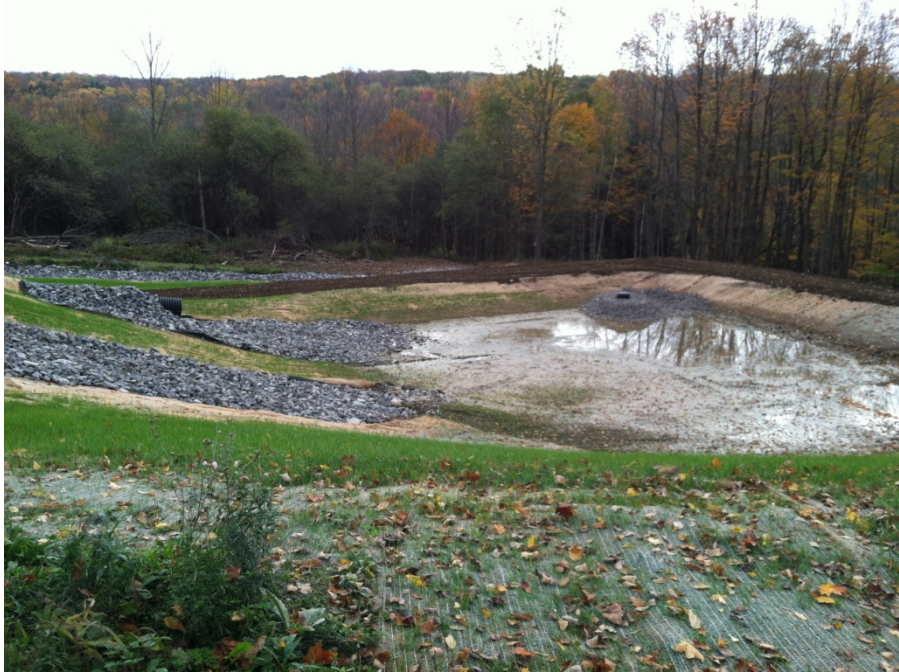
Detention Basin, Looking Southeast

ESG converted the sedimentation basin to a storm water detention basin on August 14, 2012, per Contract Addendum No. 1, by removing accumulated sediment and twelve inches of crushed stone and installing twelve inches of topsoil. In addition, ESG installed three orifices in the basin riser pipe at elevation 1553.5 ft. A concentric trash rack and anti-vortex device was installed per Field Order 5, Appendix G. Also, crushed stone was piled up around the base of the riser pipe in accordance with direction provided in Addendum No. 1. The sedimentation basin to detention basin conversion was completed in accordance with the Contract Documents.
