# 2025 PERIODIC REVIEW REPORT

## Cortland Remote Holder Cortland, New York

OCTOBER 2025

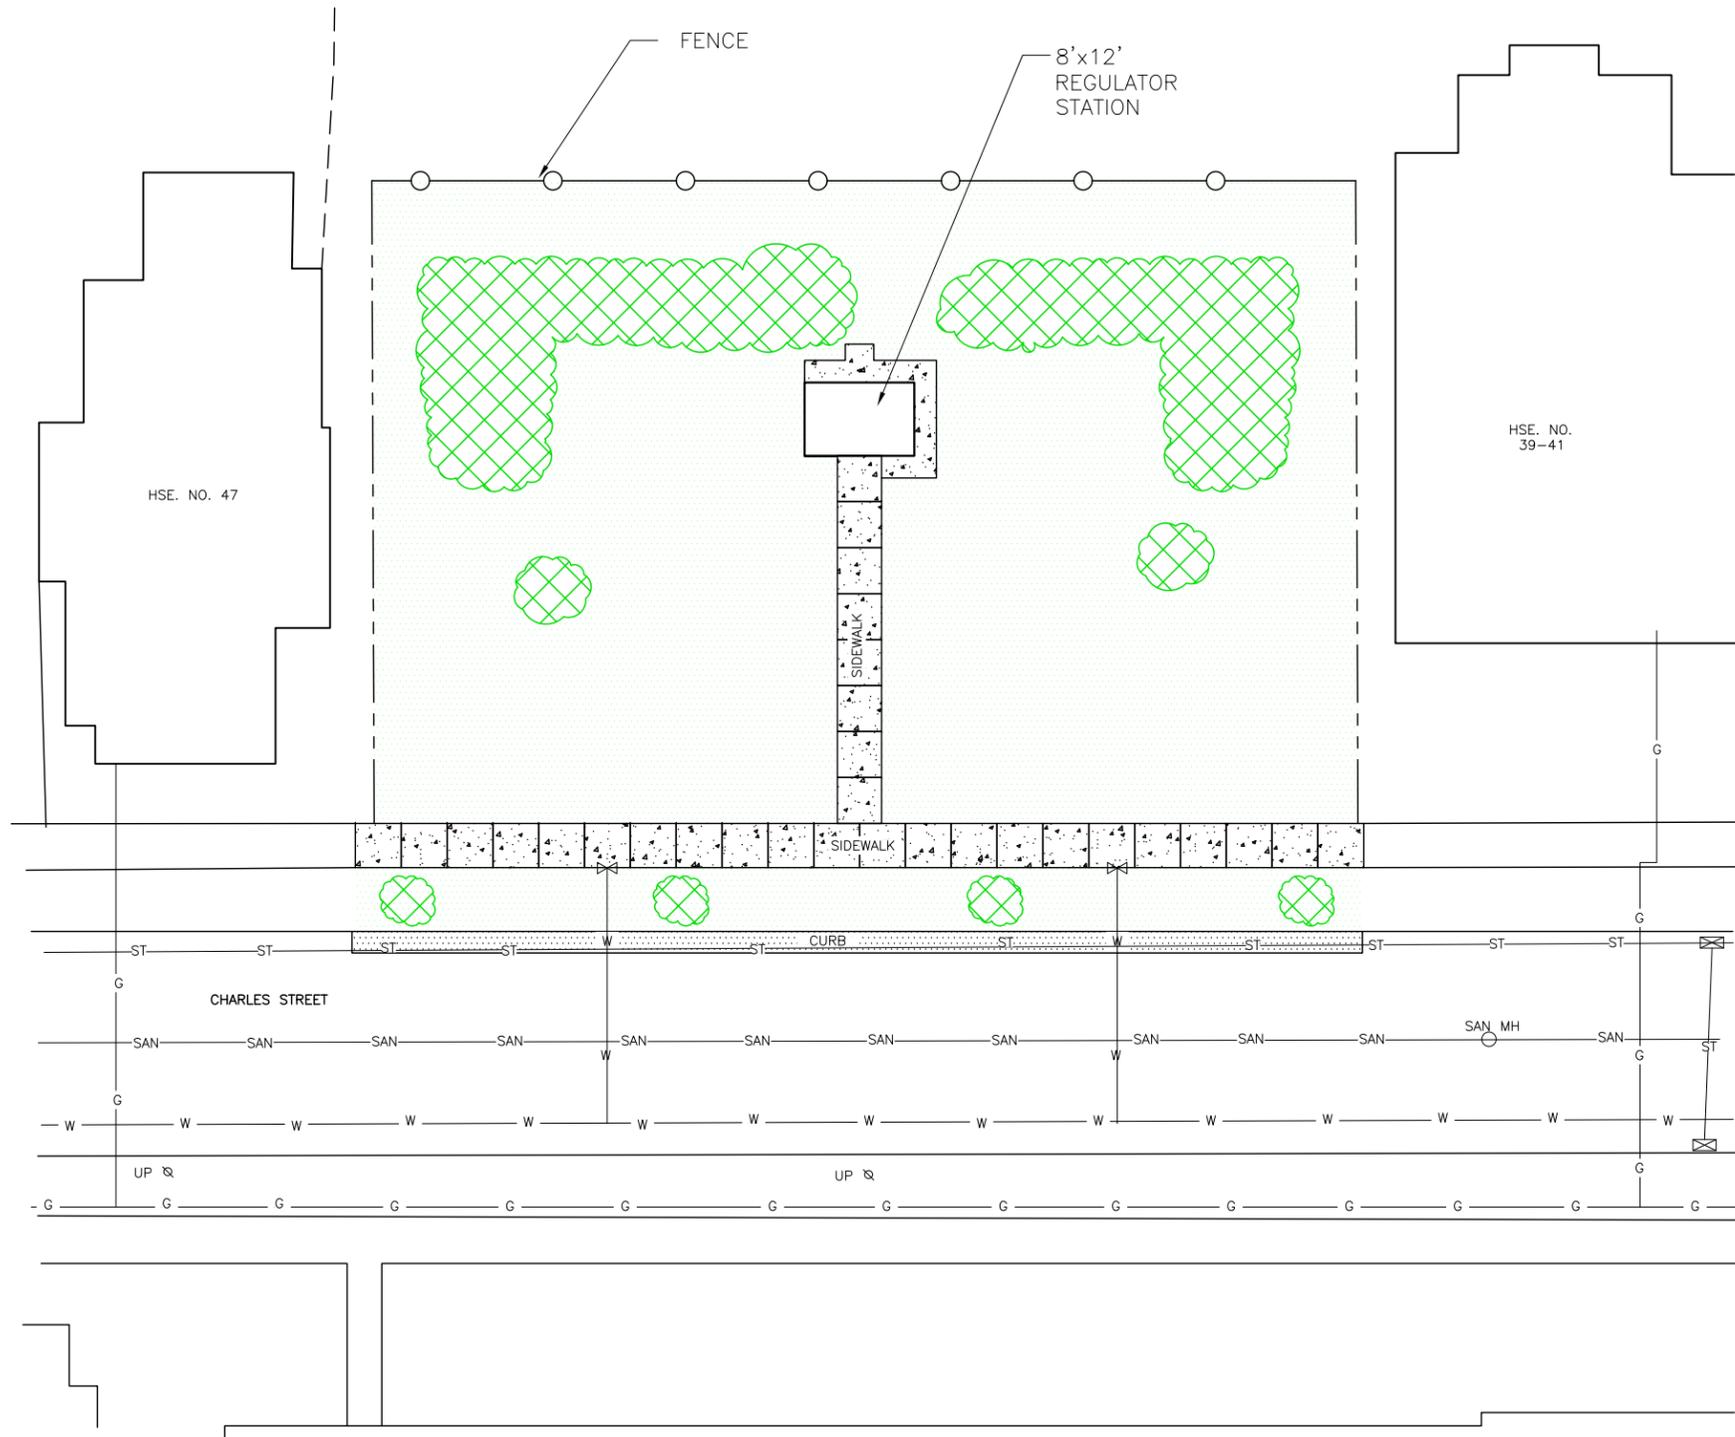
- LEGEND:
- AREA COVERED WITH CONCRETE SIDEWALK
  - AREA COVERED WITH GRASS
  - AREA COVERED WITH PAVEMENT IN CHARLES STREET
  - APPROXIMATE LOCATION OF LANDSCAPING FEATURES
  - BUILDING

- NOTE:
1. BASE MAP: URS CORPORATION, FIGURE 4 SITE MANAGEMENT PLAN (JULY 2012)
  2. LOCATION OF GAS REGULATOR STATION FEATURES ARE APPROXIMATED BASED ON DOCUMENTATION PROVIDED BY NYSEG.

In 2016, a new aboveground gas regulator station was installed at the 43-45 Charles Street property (**Appendix A**). This regulator station was installed to replace a problematic underground pit regulator located on Grant Street, approximately 300 feet from the 43-45 Charles Street property. Installation of the aboveground regulator station was designed to coincide with replacement of a leakage prone gas main that was formerly connected to the Grant Street regulator pit. The new aboveground regulator station was connected to the replacement gas main section and the corresponding control valves and piping installed along Charles Street. The current Site layout is presented on **Figure 2**.

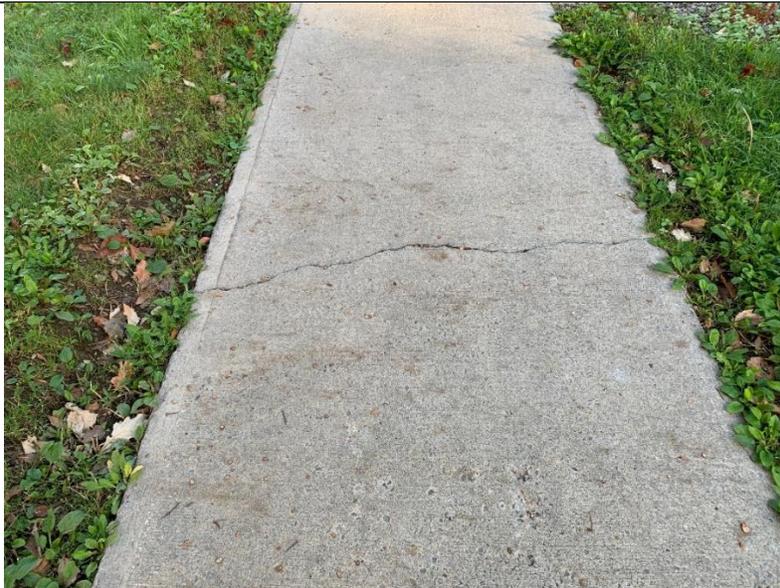
Title: Photo 6

Description: Crack observed in sidewalk, one of three on site, all located inline with curb side trees

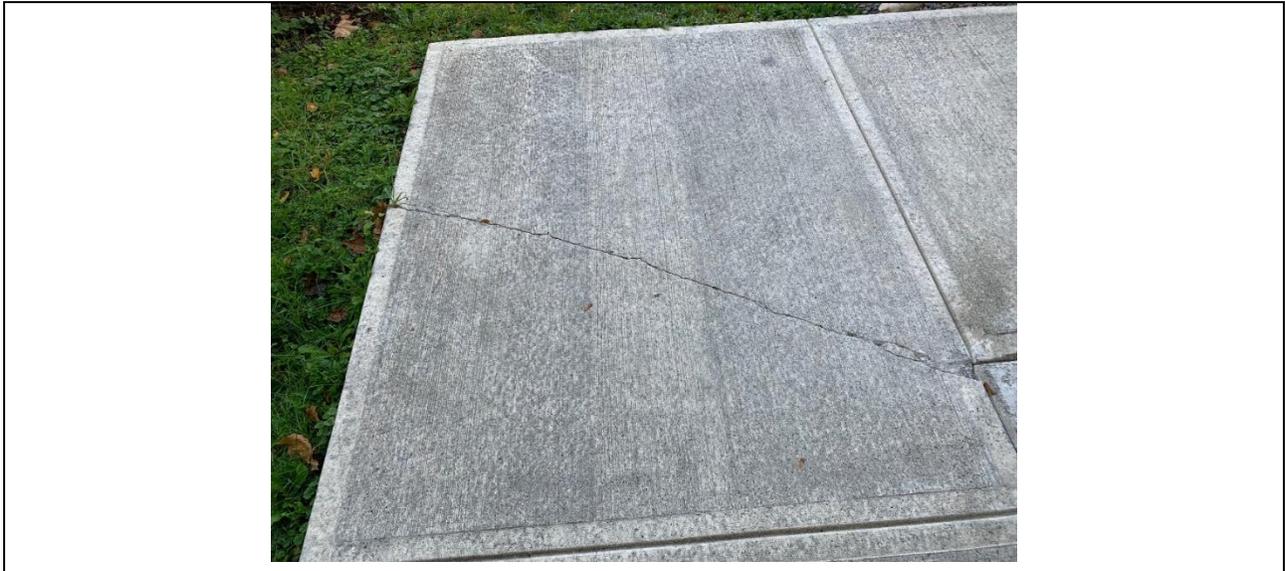
Title: Photo 9

Description: Crack in concrete adjacent to regulator building (central portion of parcel)

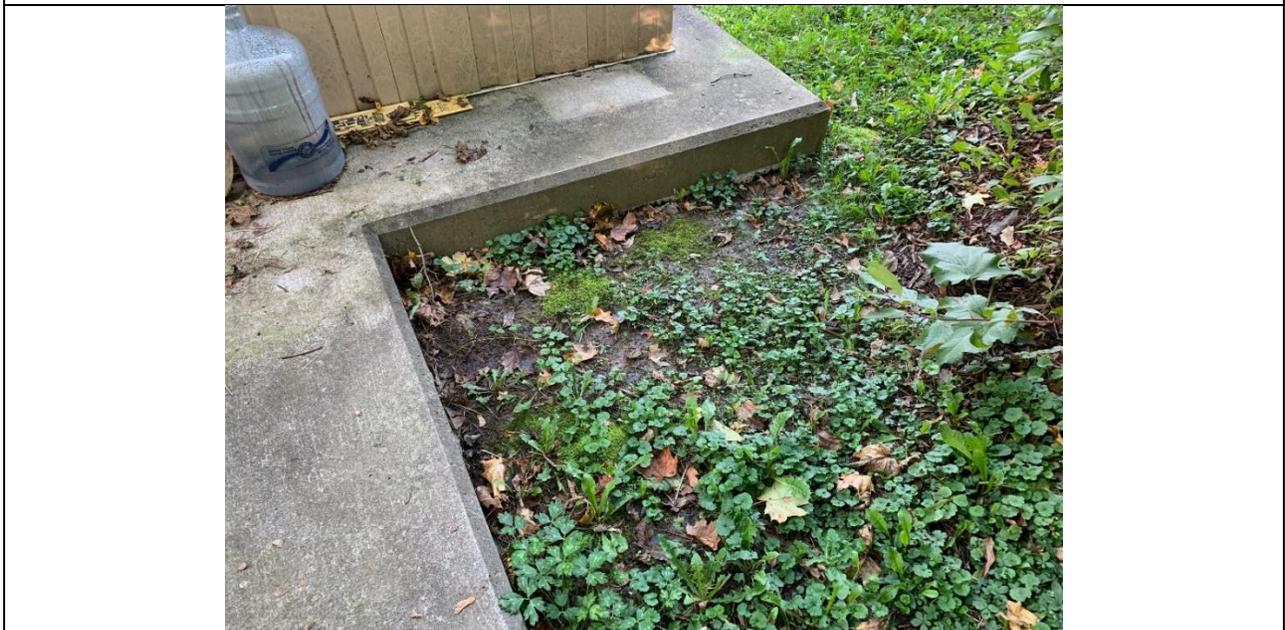
Title: Photo 10

Description: Minor evidence of frost heaving in surface soils, rear of regulating building (east side of parcel)

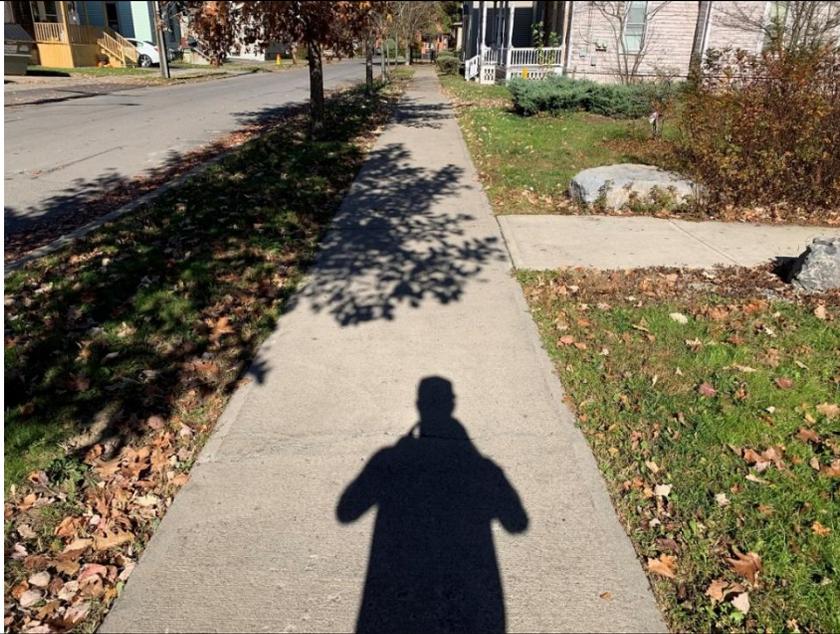
Title: Photo 5

Description: Crack observed in sidewalk, one of three on site, in line with curb side trees

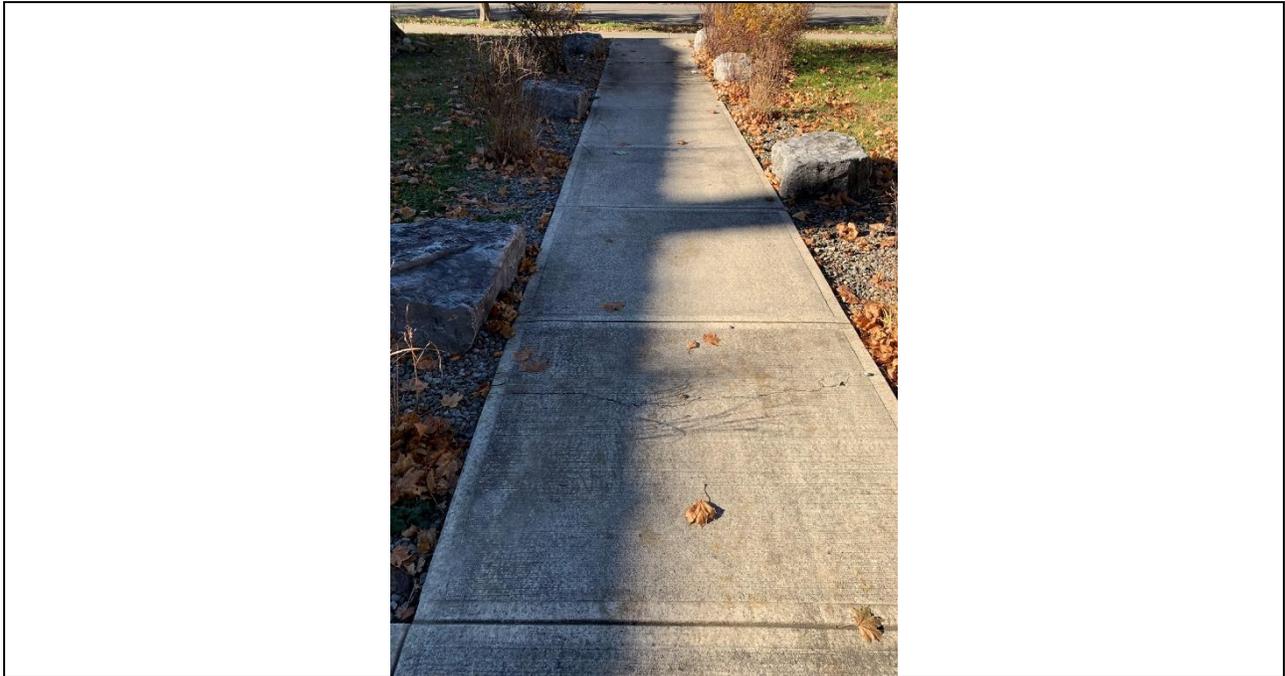
Title: Photo 5  
Location: Parcels 43 and 45 Charles St, Cortland, NY  
Date: 11/20/2023  
Description: Crack observed in sidewalk, one of three on site, in line with curb side trees

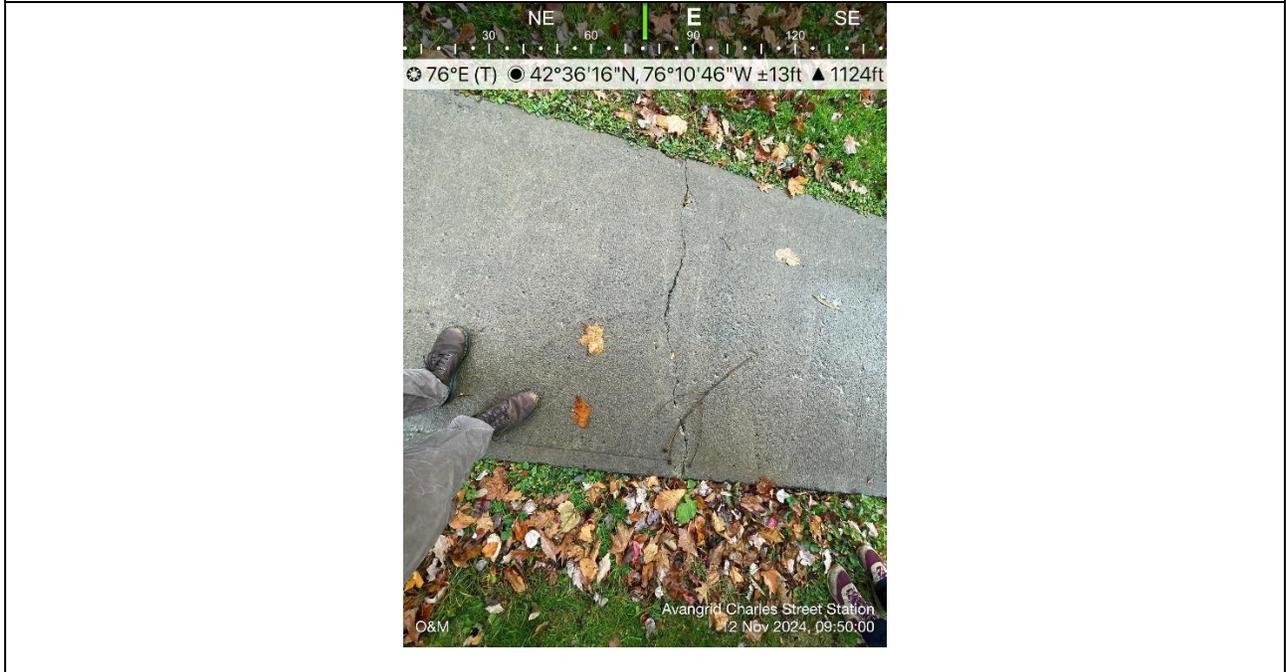
**Title:** Photo 2  
**Location:** Parcels 43 and 45 Charles St, Cortland, NY  
**Date:** 11/12/2024  
**Description:** Crack observed in sidewalk, one of three on site, all located in line with curb side trees

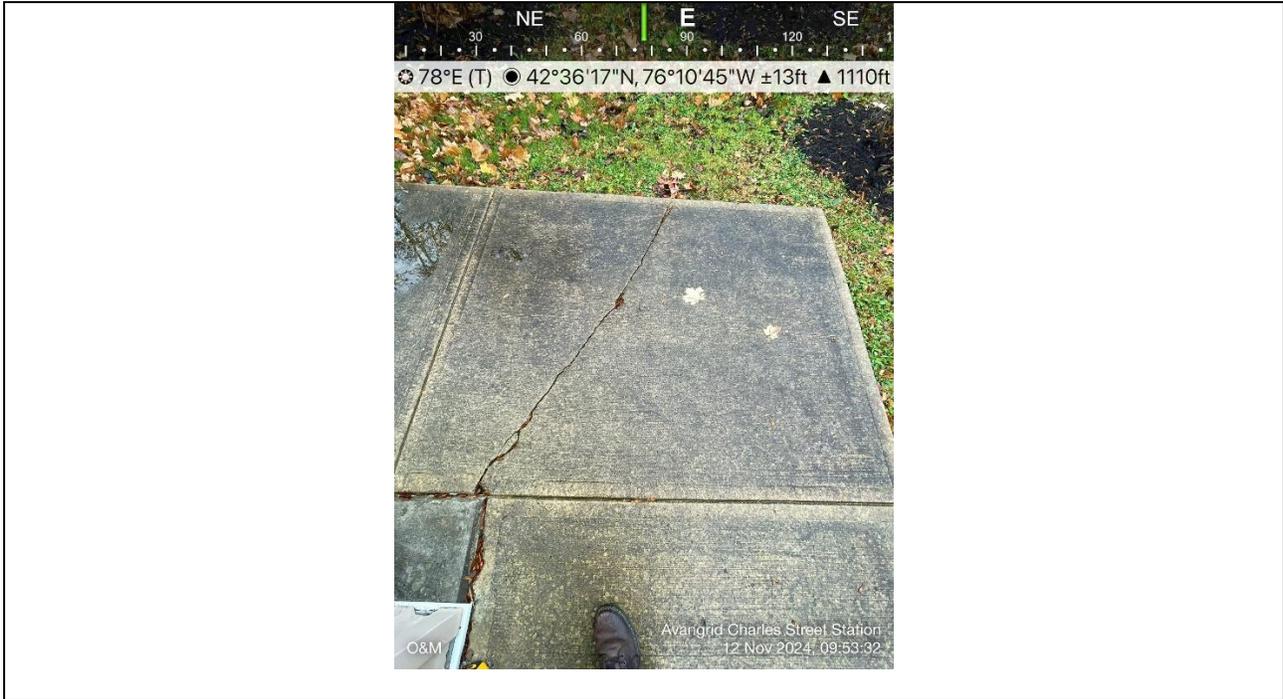
Title: Photo 5  
Location: Parcels 43 and 45 Charles St, Cortland, NY  
Date: 11/12/2024  
Description: Crack observed in corner of sidewalk

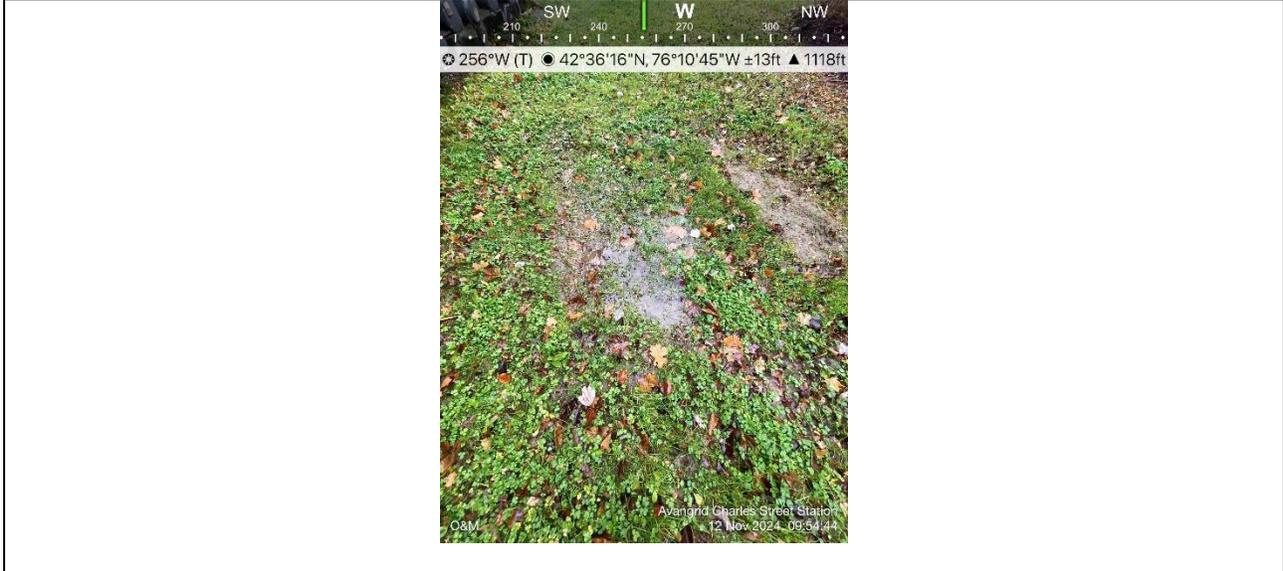
Title: Photo 6  
Location: Parcels 43 and 45 Charles St, Cortland, NY  
Date: 11/12/2024  
Description: Standing water observed on site

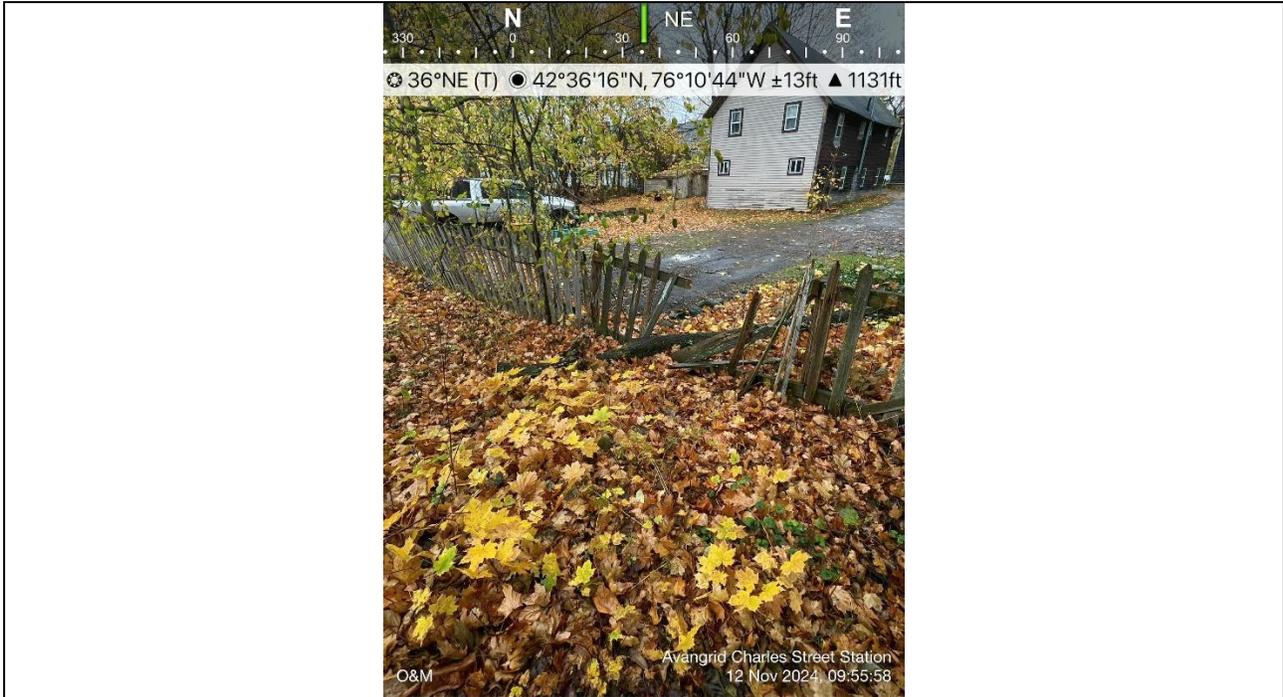
Title: Photo 7  
Location: Parcels 43 and 45 Charles St, Cortland, NY  
Date: 11/12/2024  
Description: Damaged fence along backside of property (facing Northeast)

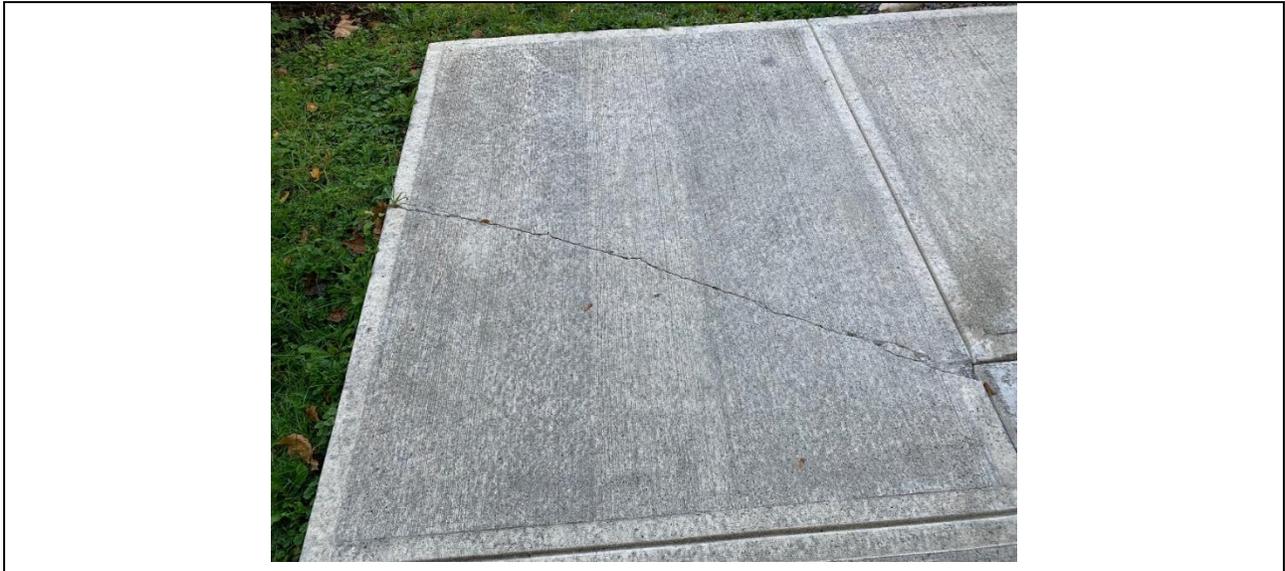
Title: Photo 9

Description: Crack in concrete adjacent to regulator building (central portion of parcel)

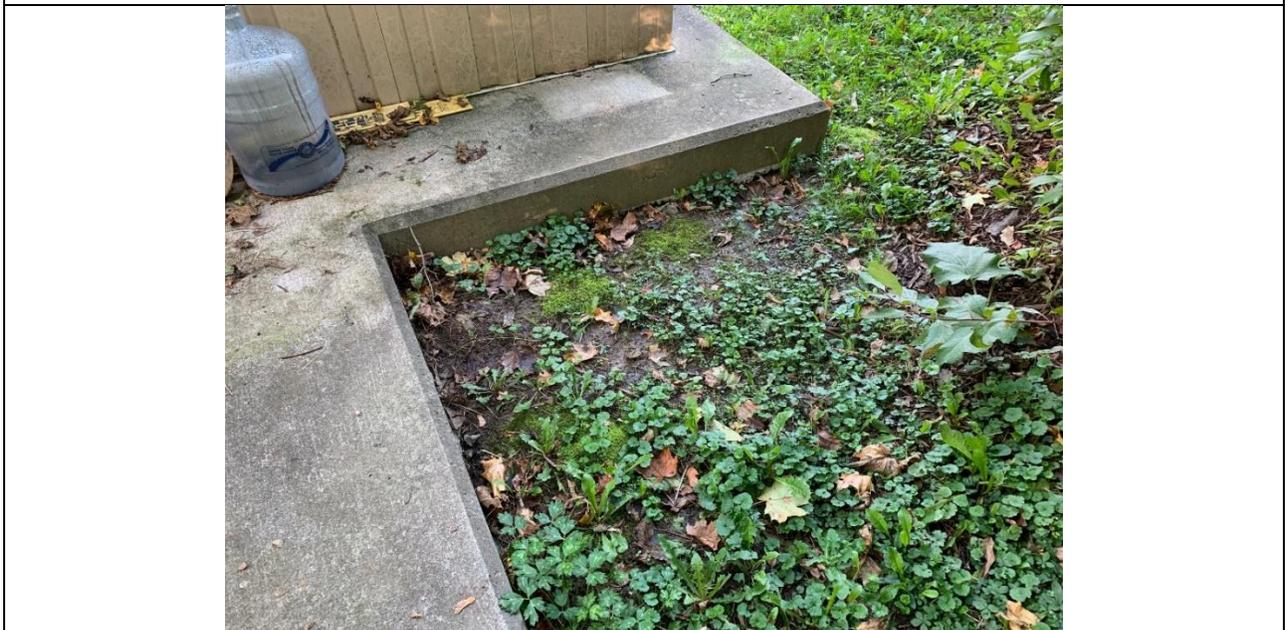
Title: Photo 10

Description: Minor evidence of frost heaving in surface soils, rear of regulating building (east side of parcel)

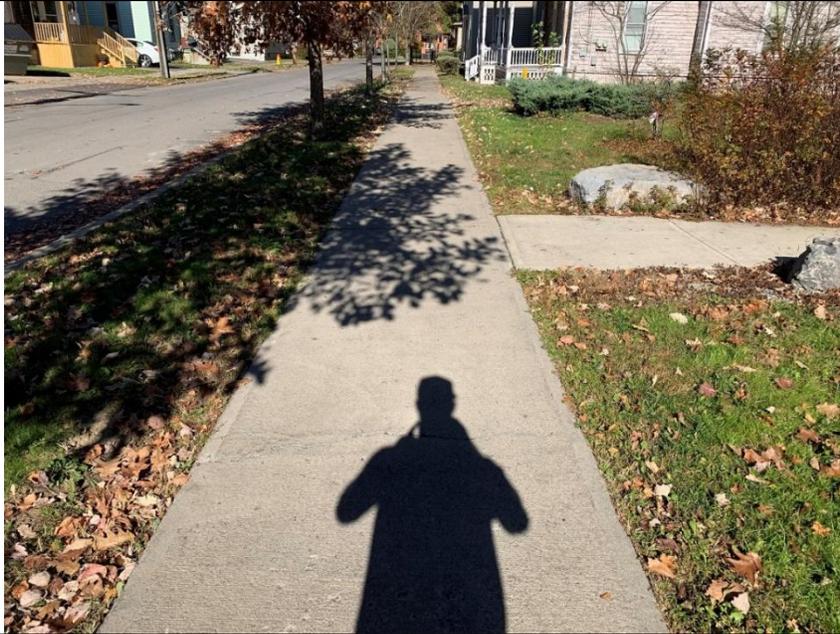
Title: Photo 5

Description: Crack observed in sidewalk, one of three on site, in line with curb side trees

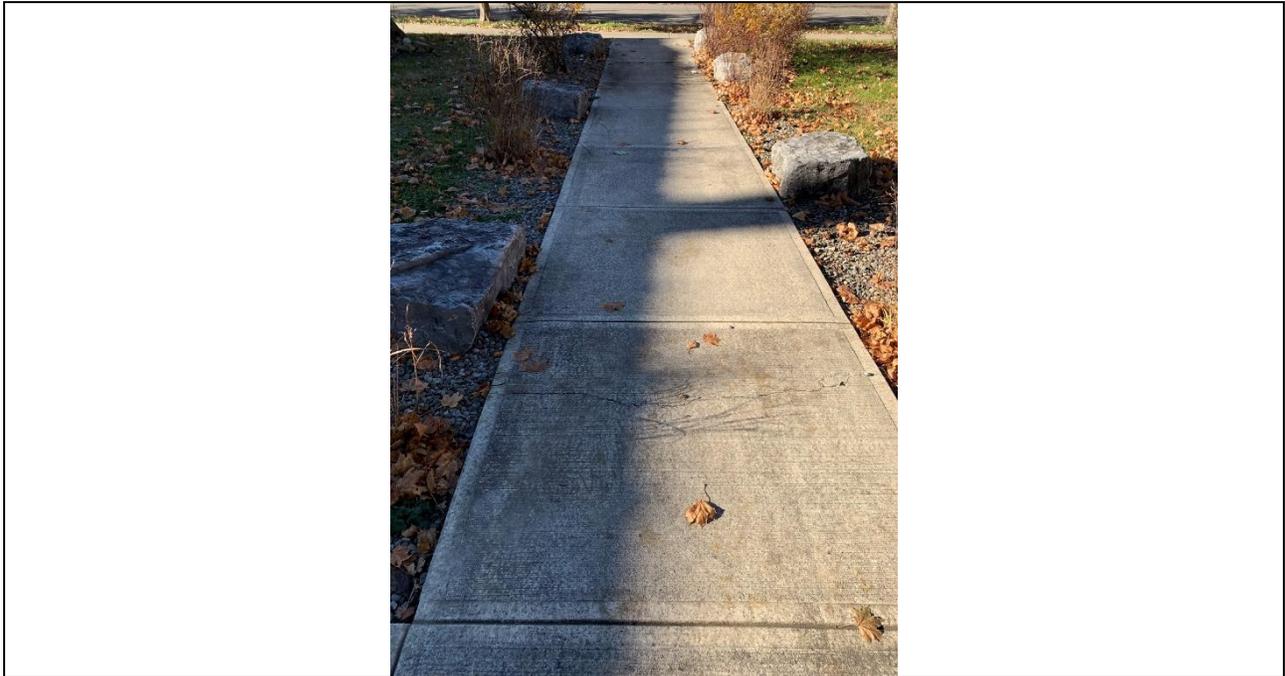
Title: Photo 5  
Location: Parcels 43 and 45 Charles St, Cortland, NY  
Date: 11/20/2023  
Description: Crack observed in sidewalk, one of three on site, in line with curb side trees

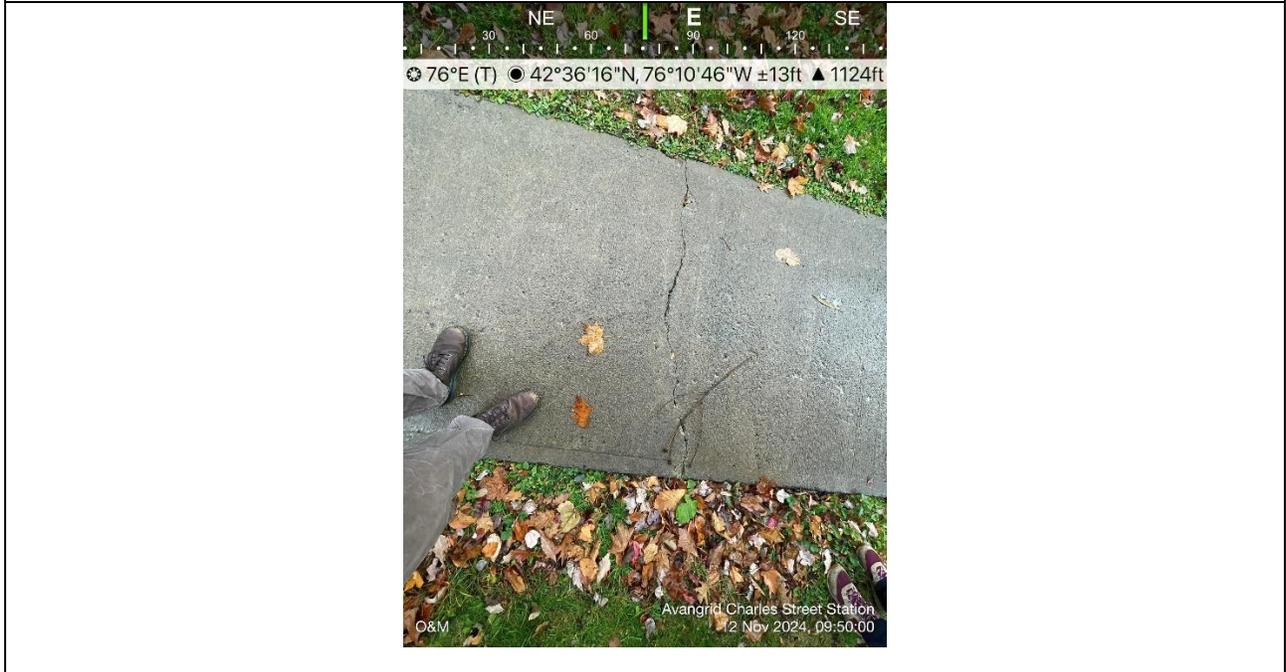
Title: Photo 2  
Location: Parcels 43 and 45 Charles St, Cortland, NY  
Date: 11/12/2024  
Description: Crack observed in sidewalk, one of three on site, all located in line with curb side trees

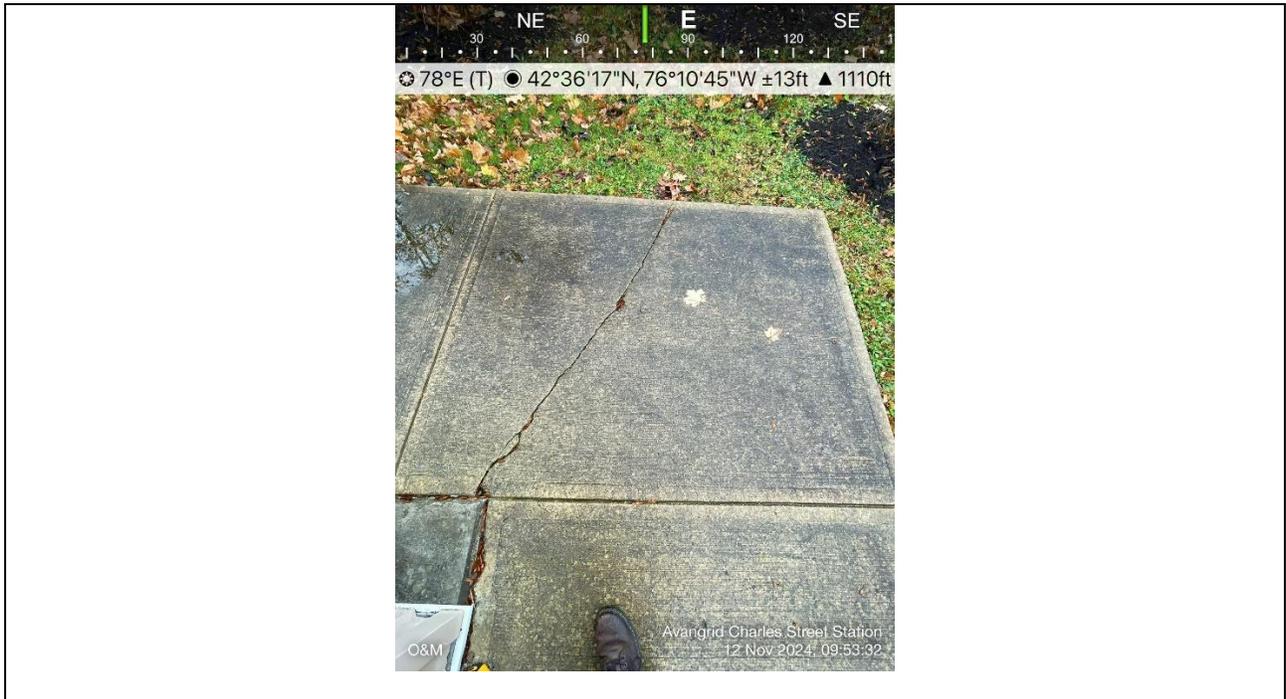
Title: Photo 5  
Location: Parcels 43 and 45 Charles St, Cortland, NY  
Date: 11/12/2024  
Description: Crack observed in corner of sidewalk

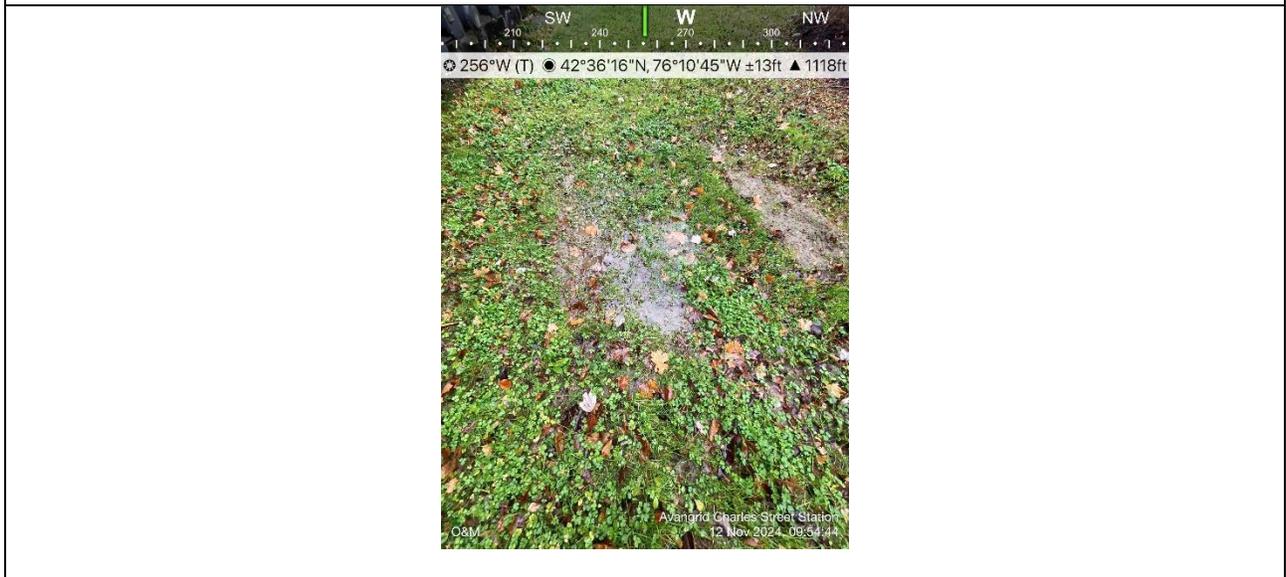
Title: Photo 6  
Location: Parcels 43 and 45 Charles St, Cortland, NY  
Date: 11/12/2024  
Description: Standing water observed on site

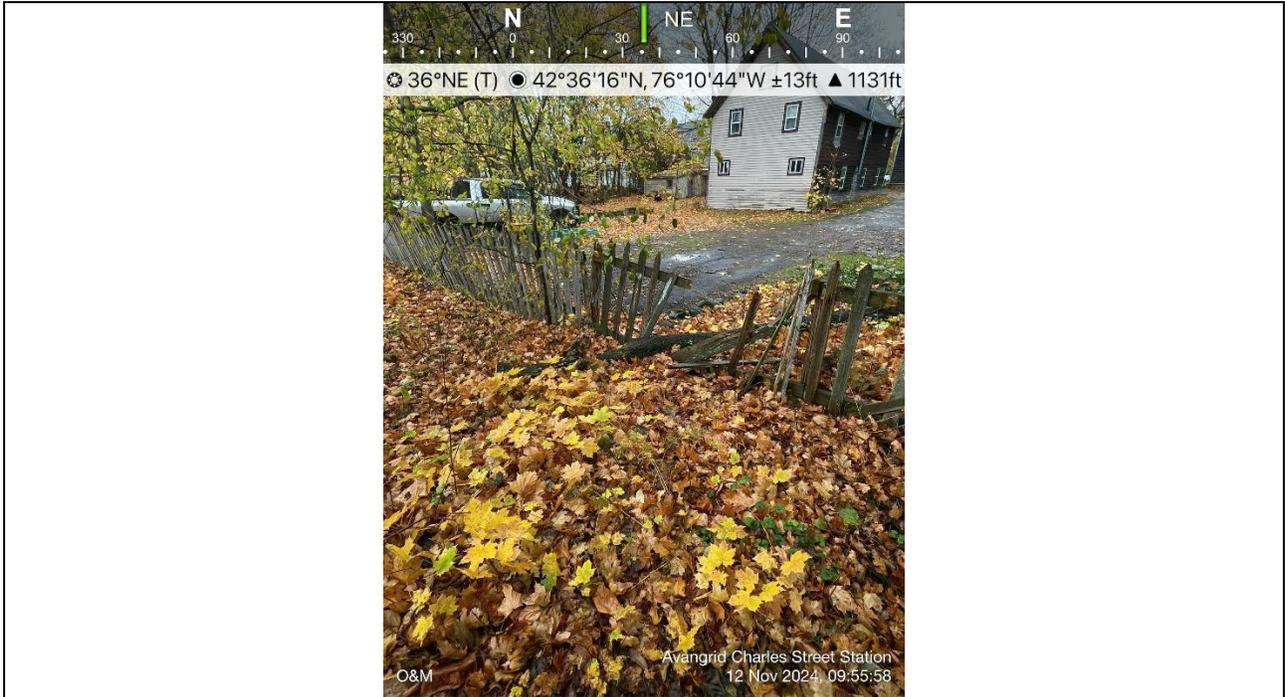
**Title:** Photo 7  
**Location:** Parcels 43 and 45 Charles St, Cortland, NY  
**Date:** 11/12/2024  
**Description:** Damaged fence along backside of property (facing Northeast)
