Date: November 1, 2022  
Subject: Responses to NYSDEC Comments on Remedy Optimization Work  
Plan  
Krutulis Site  
848 Marsh Mill Road, Kirkville, New York  
NYSDEC Site No. 72709

# Remedy Optimization Work Plan

**Krutulis Site, Kirkville, New York**

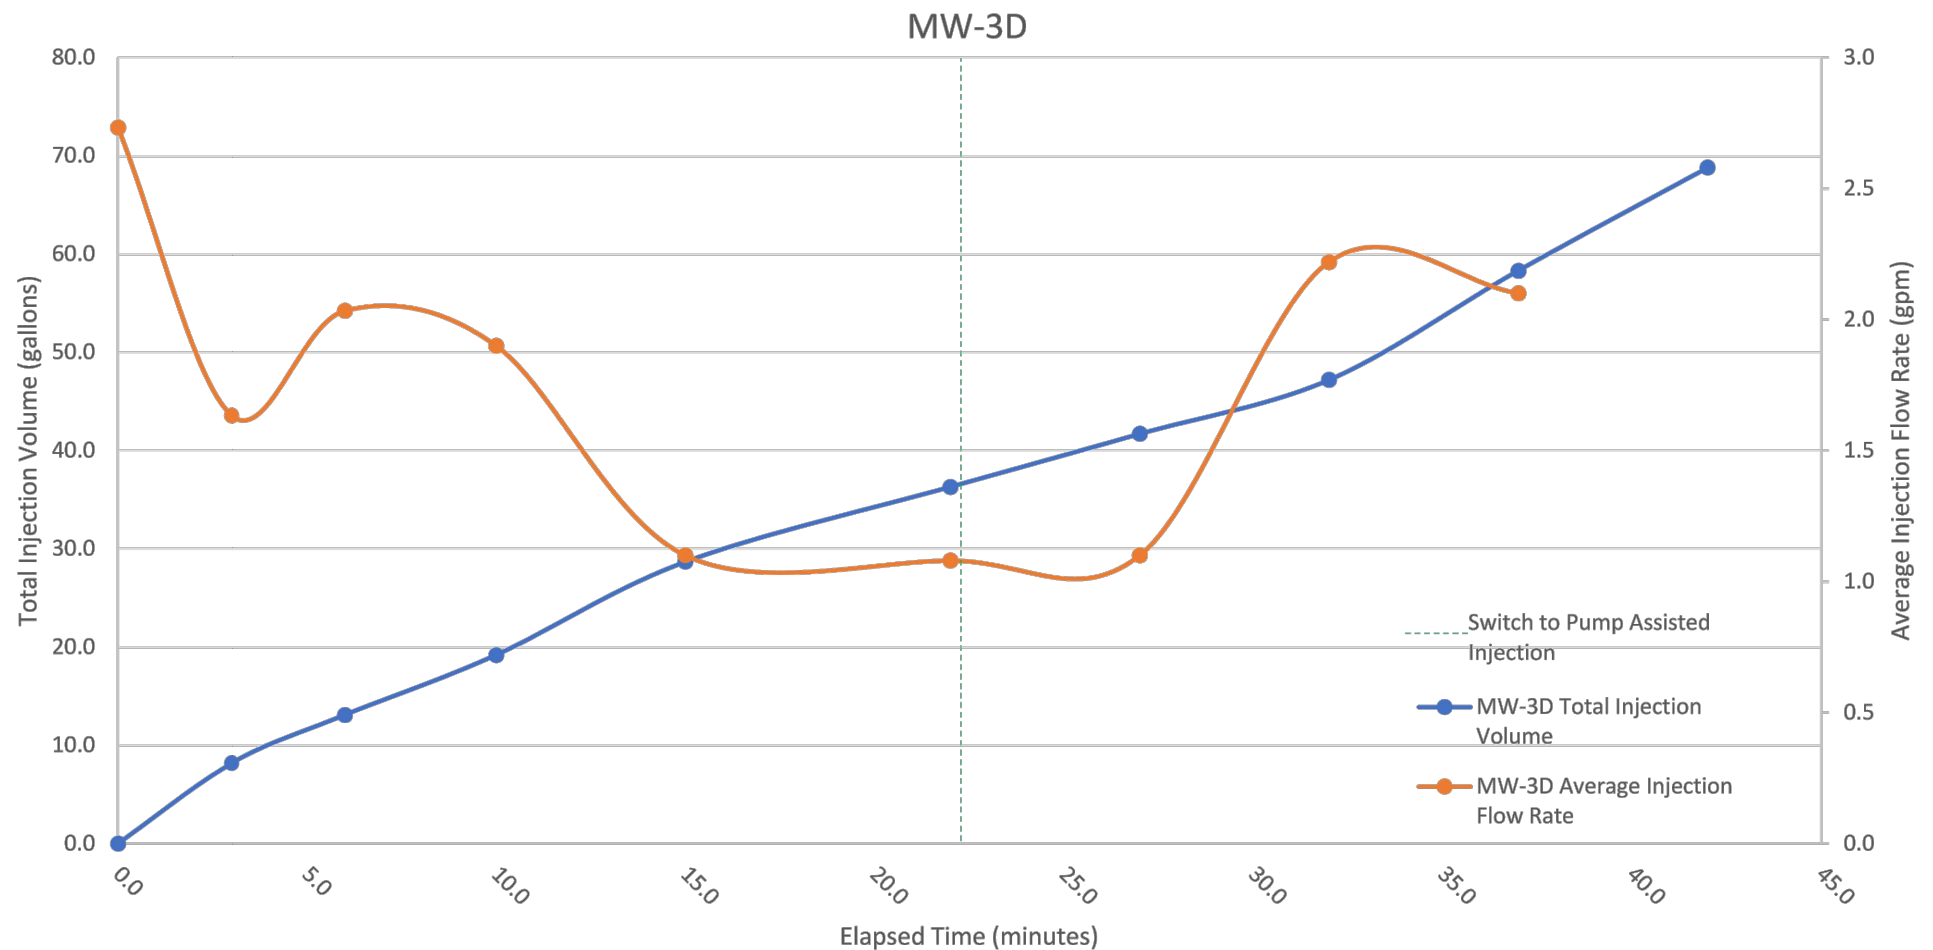
## MW-3D CLEAN WATER INJECTION DATA

A total of approximately 29 gallons of water was injected at MW-3D under gravity flow conditions over a 15-minute period. This corresponds to an average formation injection flow rate of approximately 1.8 gallons per minute (gpm), accounting for the volume of water required to prime the injection system and fill the headspace in monitoring well MW-3D. An additional approximately 40 gallons of clean water was injected over a 22-minute period under pumping conditions, at an average flow rate of approximately 1.8 gpm. A total of approximately 13 gallons of water was injected at MW-6S under gravity flow conditions over a 12-minute period at an average flow rate of approximately 0.95 gpm. An additional approximately 38 gallons of water was injected over a 16-minute period under pumping conditions at an average flow rate of approximately 2.4 gpm. The increase in flow rate observed at MW-6S between gravity and pumping injection suggests that MW-6S has a higher specific capacity than MW-3D, which saw no increase in flow rate. This could be due, at least in part, to MW-6S being installed approximately 8 feet shallower than MW-3D, as an aquifer will be more accommodating to groundwater displacement at shallower depths.
