# Town of Dewitt Landfill Annual Engineer's Report

**2024 Annual Post-Closure Monitoring Report  
Town of Dewitt Landfill  
Fisher Road  
East Syracuse, NY  
Onondaga County, New York**

**Prepared for  
Town of Dewitt**

**By  
Miller Engineers  
Manlius, NY  
April 2025**

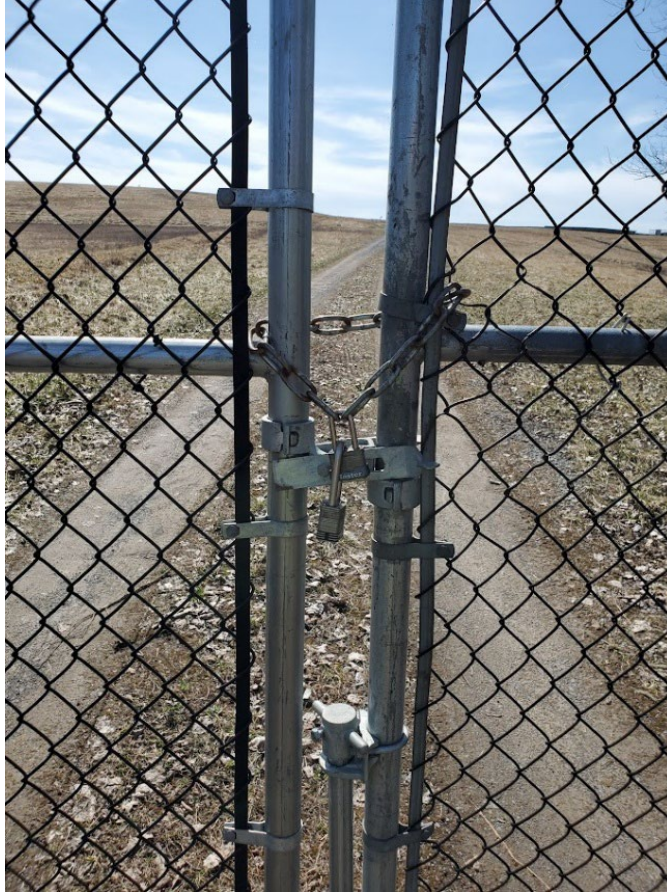
**Photo 1. Fisher Road access gate facing south – March 2024.**

A crushed stone access road surrounds the landfill and is located on the lower side slope. Vehicle traffic accesses the road through a locked chain link fence gate located on the north side of the landfill at the southern end of Fisher Road (see Figure 1 and Appendix B, Photo 1). In March 2024, the access road was observed to be in good repair with no washouts and no impassable dips or ruts.

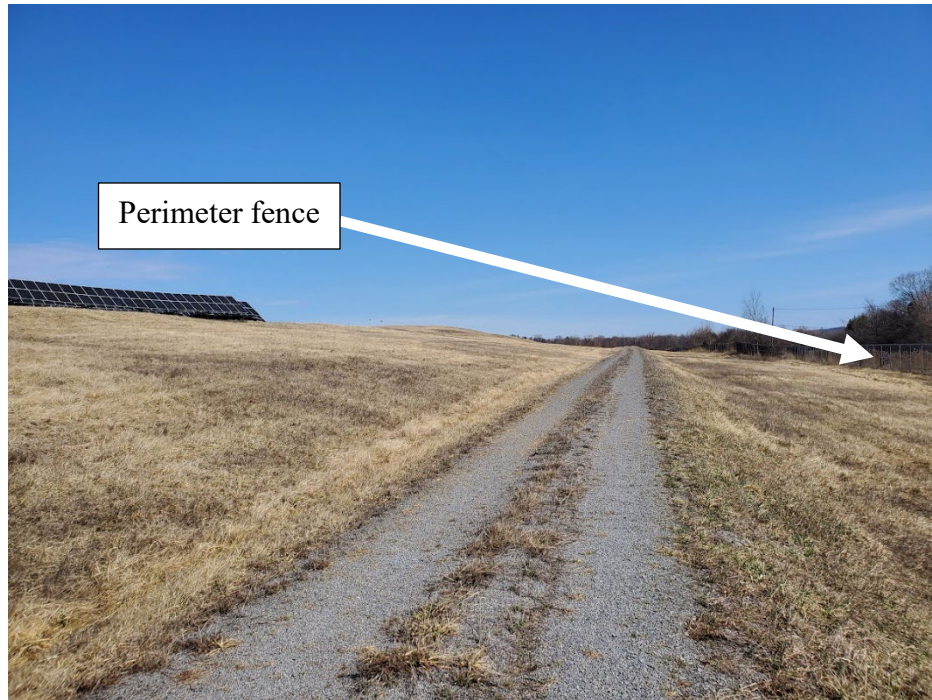
**Photo 2. Sothern access road facing ESE at perimeter fence and Erie Canal. – March 2024**

The landfill is bounded on the south by an eight-foot-tall chain link fence that separates the Erie Canal towpath from the landfill (see Appendix B, Photo 2). The fence was observed to be in good repair with no openings or breaks in the fence and no damaged posts or rails. A short section of fence is also located at the access gate at Fisher Road and spans the access road at the northern landfill boundary between a stand of mature trees and a wetland. The fence and gate adequately prevent automobile and truck traffic from unauthorized entry to the landfill. On occasion, recreational ATV tracks have been observed, at various times of the year, circumventing the fence and accessing the landfill via the wetland.

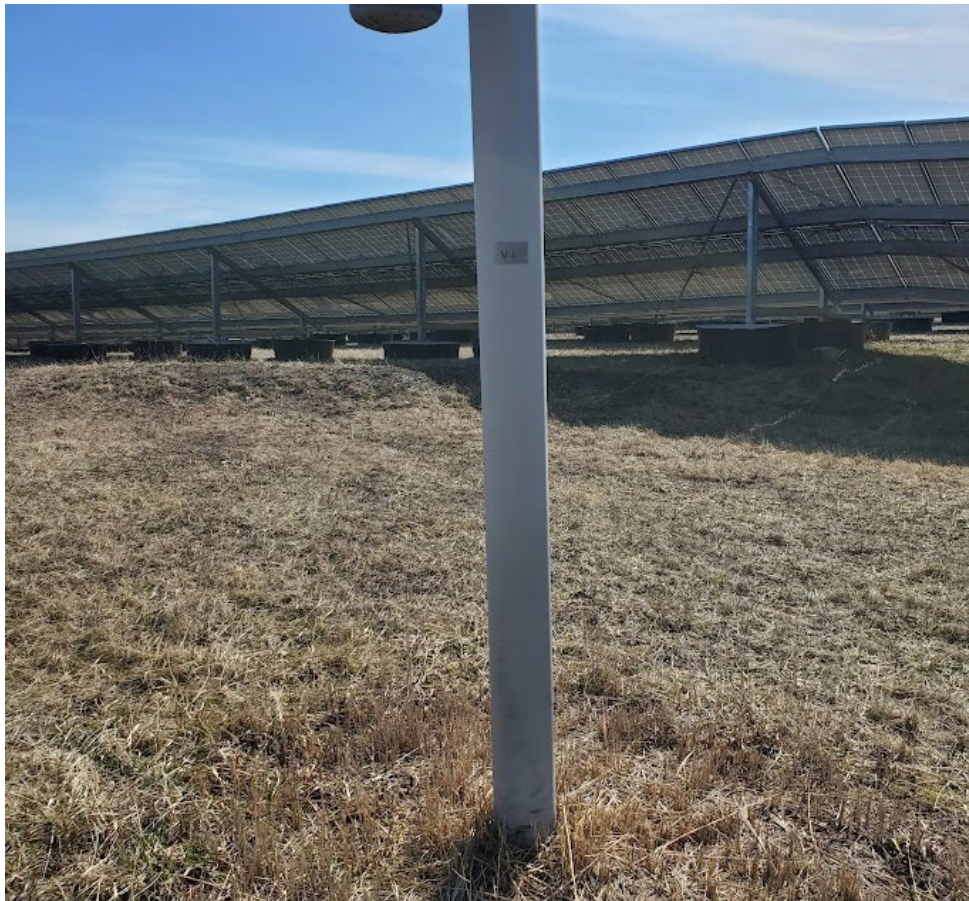
**Photo 3. Typical Gas vent. – March 2024.**

The site visits revealed uniform, healthy growth of grass across the landfill (See Appendix B, Photo 5). No woody bushes were observed near the gas vents, in down-chutes, or beneath solar panels (see Appendix B, Photos 3, 5, 6 and 8).

There are a total of 22 gas vents that comprise the passive gas venting system at the landfill (see Figure 1). All gas vents were observed to be in good repair and operable during the March 2024 visit. Vent screens were free of debris and blockages and appeared to be operating as designed.

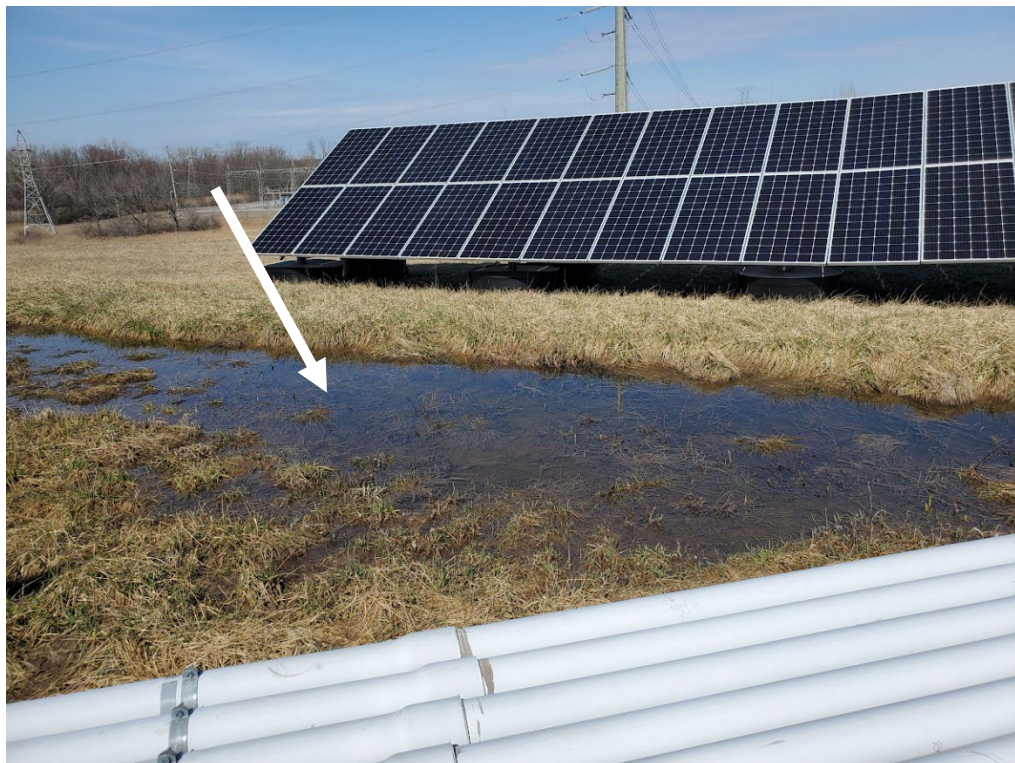
**Photo 4. Temporary wet spot from spring rains and snowmelt, viewing northeast toward solar panels. March 2024.**

| Overall conditions are good. I cleared some fallen branches off of the access road. There are several small areas of standing water at gas vent depressions and adjacent to the perimeter access road. These wet spots are typical and will dry up when the grass begins to grow. The cap is in good shape. |

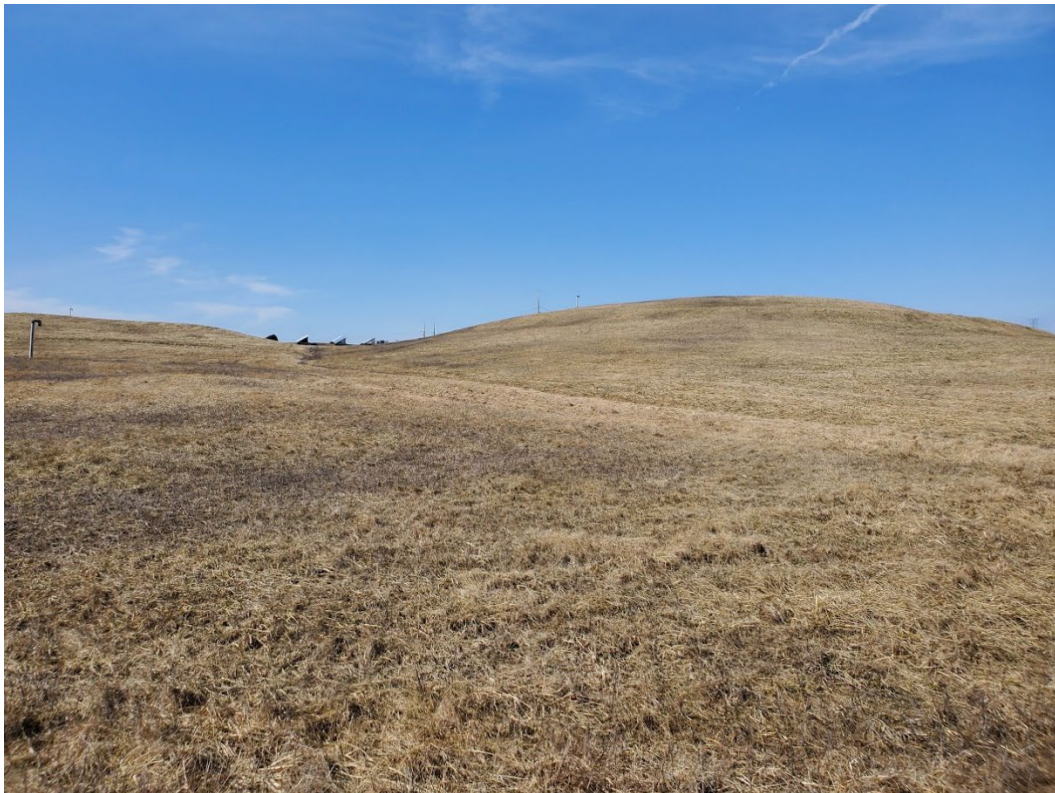
**Photo 5. Healthy dormant grass, viewing NW from perimeter access road. – March 2024.**

Based on these observations, the cover layer and cap material are in good repair and there are no deep-rooted plants or ruts compromising the low-permeability cap layer or allowing precipitation to infiltrate the waste layer.

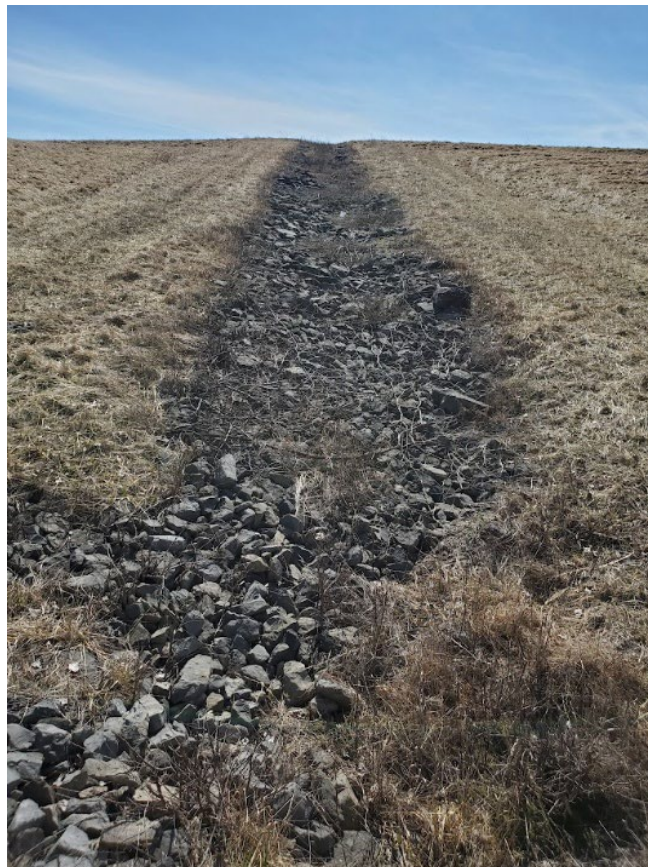
**Photo 6. Down chute on NW corner of landfill is open and clear. – March 2024.**

A series of radial drainage ditches lined with riprap overlying perforated drainpipe are spaced around the landfill to facilitate storm water run-off and to minimize ponding and infiltration into the waste mass. During each of the 2024 site visits the ditches were observed to be unobstructed by woody growth under the solar array or adjacent to above ground electrical conduit. The drainage features are in good repair with no signs of erosion, or fine sediment accumulation. Some temporary ponding was observed on the top of the landfill slope near the solar array (see Appendix B, Photo 4). There were no small trees or tall woody plants observed in the down chutes

and the ditches appeared to drain efficiently. At this time, the drainage system appears to be functioning as designed.

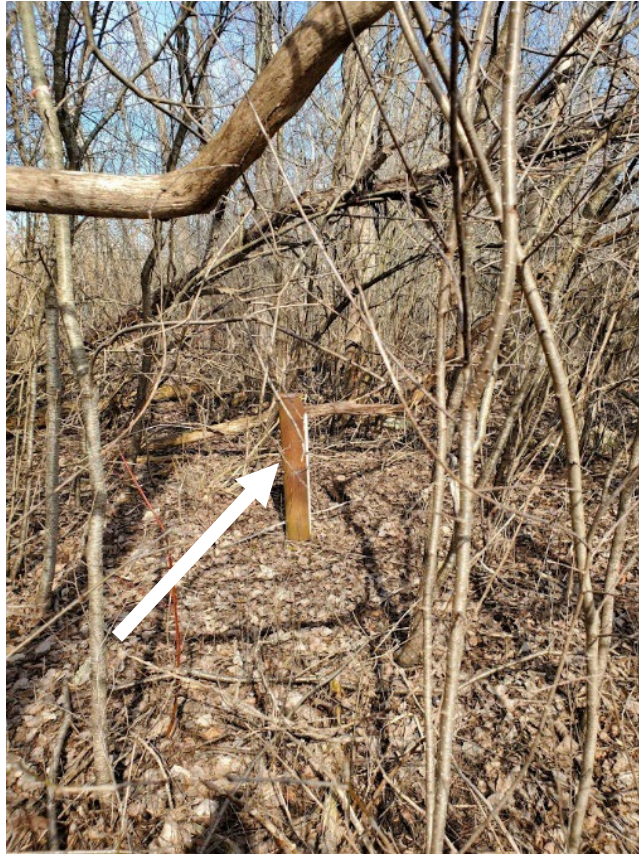
**Photo 7. Monitoring Well MW-6S near North gate. March 2024.**

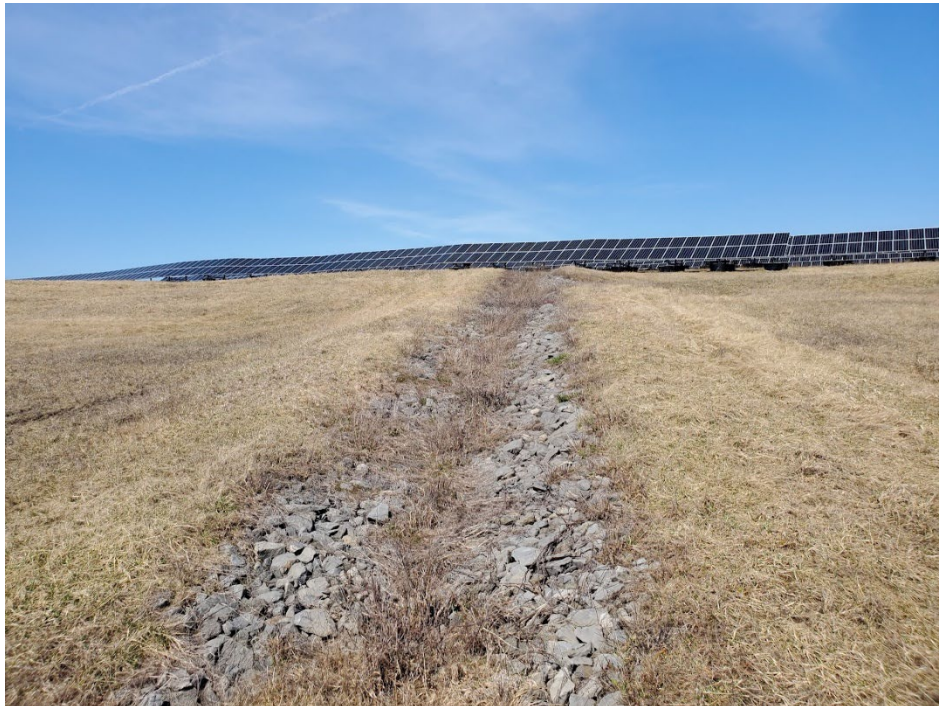
**Photo 8. Viewing north at top of landfill and front side of solar array. – March 2024.**
