# **DRUM DELINEATION REPORT**

**Onondaga Drum Site  
Nedrow, New York**

**FEBRUARY 1994**

**REF. NO. 5067 (5)**

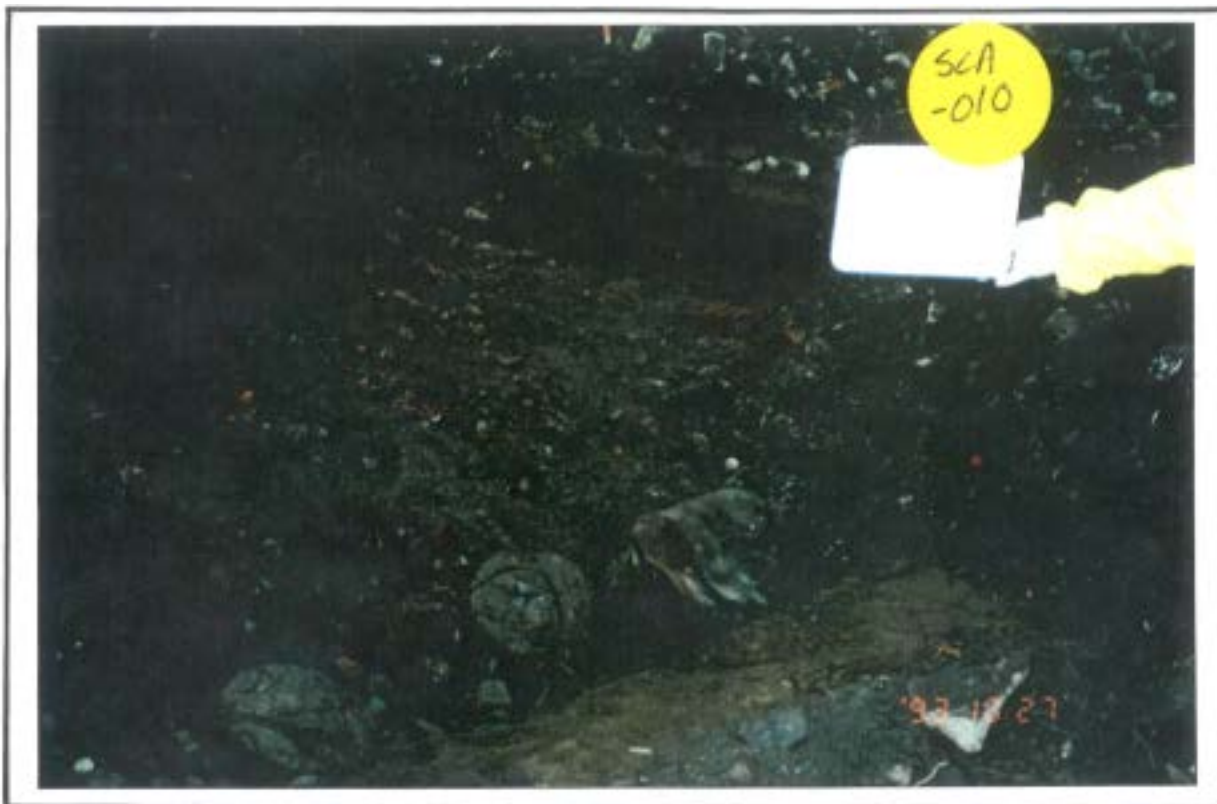
Photograph 1 - Test Pit SCA-010 - Partially Uncovered Drums

A total of 74 drums/drum fragments were unearthed in test pits excavated within the stream channel alignment. Forty-nine drums/drum fragments were identified in SCA test pits SCA-003, SCA-004, SCA-006A, SCA-010 and SCA-017. Twenty-five drums/drum fragments were identified in test pits CIA-003B, CIA-027, CIA-027B and SDP-020 also located within the boundaries of the stream channel alignment. A listing of drums encountered is presented in Table 2.3.

The proposed 5-foot excavation will uncover the majority, if not all, of the buried drums and the deep trench will have a high potential for identifying any additional drums not found during the previous work.

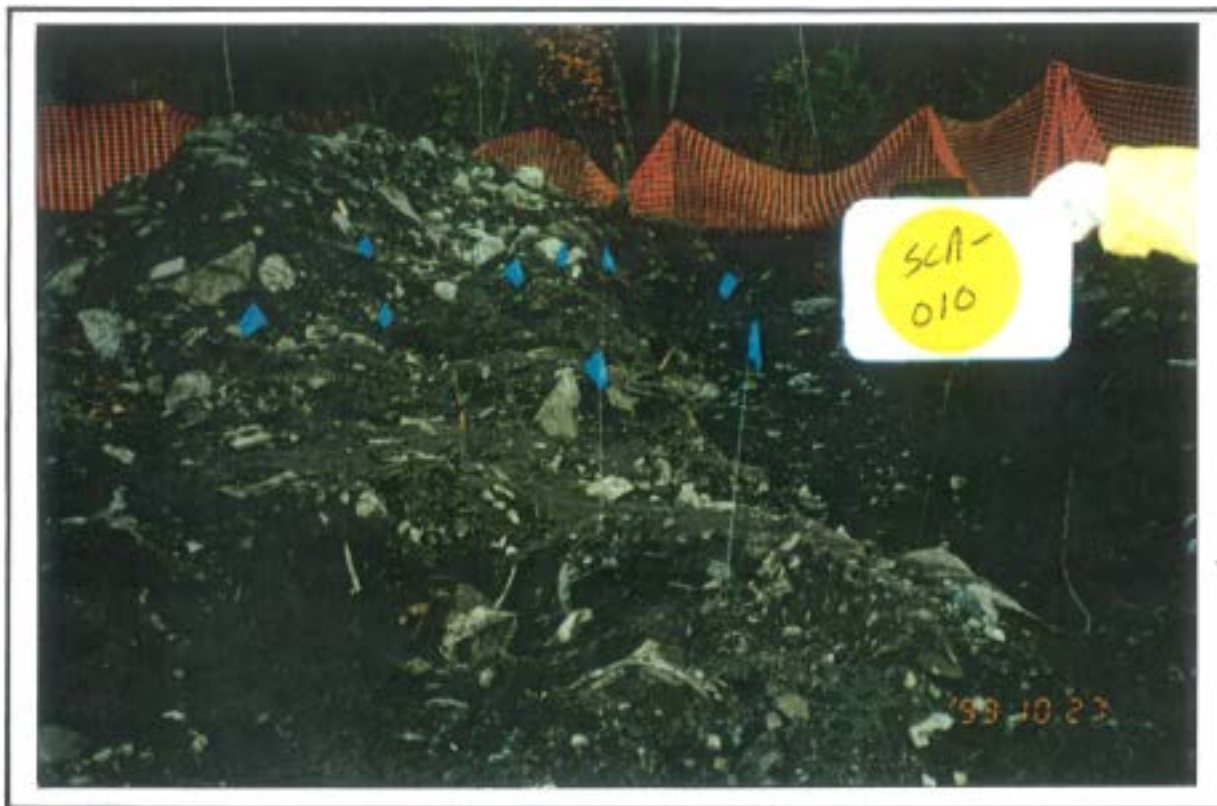
Photograph 3 - Test Pit SCA-010 - Blue Flags Locate Individual Drums Partially Uncovered

Each drum/drum fragments was inspected for obvious trade names and or other identifying marks. The location of each drum/drum fragment was marked at the ground surface with a blue pin flag.

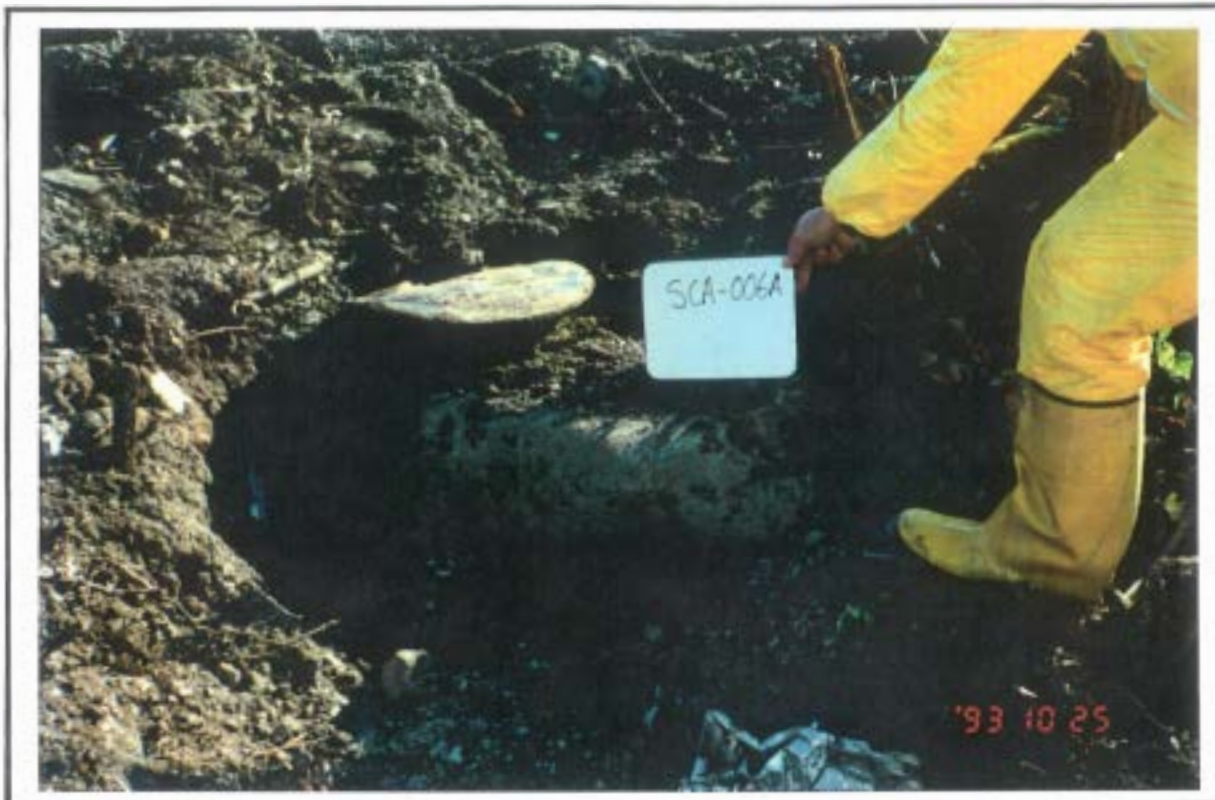
Photograph 5 - Test Pit SCA-006 A - Partially Uncovered Drum

All drums that were reasonably intact and accessible were scanned with an HNu organic vapor analyzer. A total of four drums, unearthed in test pits SCA-006A and associated test pit CIA-003, had organic vapor readings above background. The highest reading of 5 ppm was recorded from within a single drum located at test pit SCA-006A. No visibly contaminated soils were identified in any of the areas where drums were encountered.

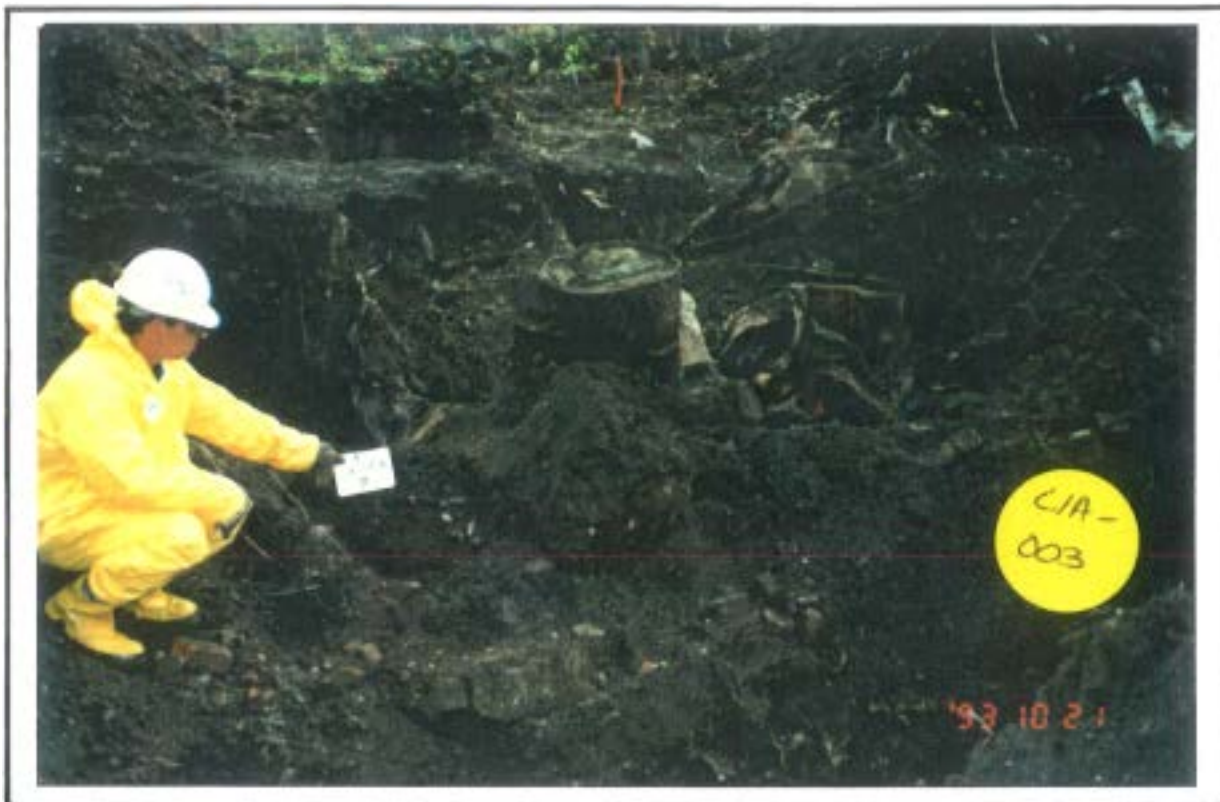
Photograph 7 - Test Pit CIA-003 - Partially Uncovered Drums

A total of 22 drums were identified in two of the CIA areas (CIA-003 and CIA-027). These areas are both within the former stream channel alignment. Table 2.3 presents a summary of all drums encountered.

All drums that were reasonably intact and accessible were scanned with an HNu organic vapor analyzer. Four drums located at CIA-003B registered elevated organic vapor readings of 3 ppm. One of the drums located at CIA-003B contained black residue. The balance of the drums were empty.
