Re: Onondaga Lake 2021 Monitoring and Maintenance Report (734030)

**DRAFT FINAL
ONONDAGA LAKE
2021 MONITORING AND MAINTENANCE REPORT**

ONONDAGA COUNTY, NEW YORK

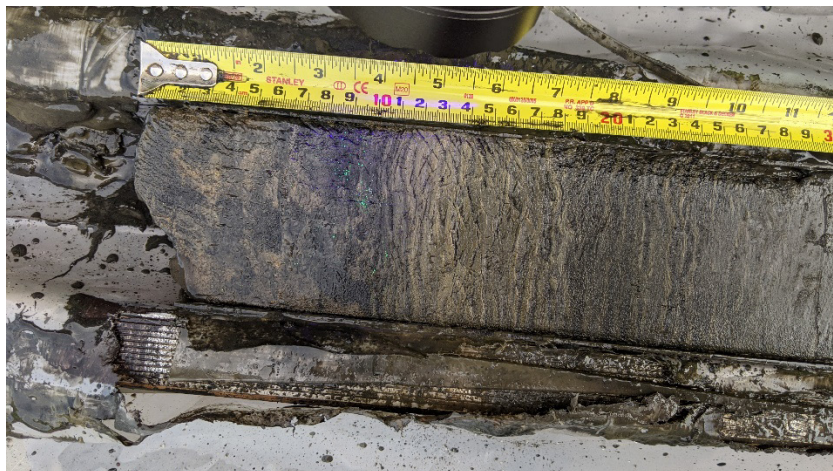
Figure A-2
Core OL-MB-80093-A

Visual inspection of the vertical cross section of microbead core OL-MB-80093-A revealed a light brown and gray mottling to a depth of 9.5 cm. Microbeads were scattered, with the highest density of microbeads observed at a depth of 8.5 to 11 cm. Minimal microbead scatter was observed to the surface. Descriptions of laminations observed in the core are as follows:

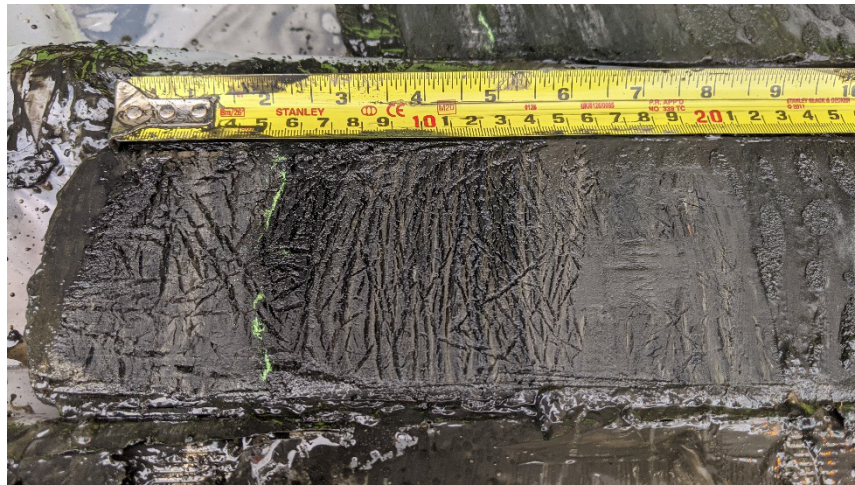
Figure A-11
Core OL-MB-80097-B

Visual inspection of the vertical cross section of microbead core OL-MB-80097-B revealed a 0.1 cm thick layer of microbead marker material from the 5 to 5.1 cm depth interval. A thin film of light brown sediment was observed at the surface with some sediment within the ice above the core. A 1 cm thick layer of black sediment was present at the top of the core followed by light gray and medium gray sediment layers above the microbead marker material layer. Descriptions of laminations observed in the core are as follows:

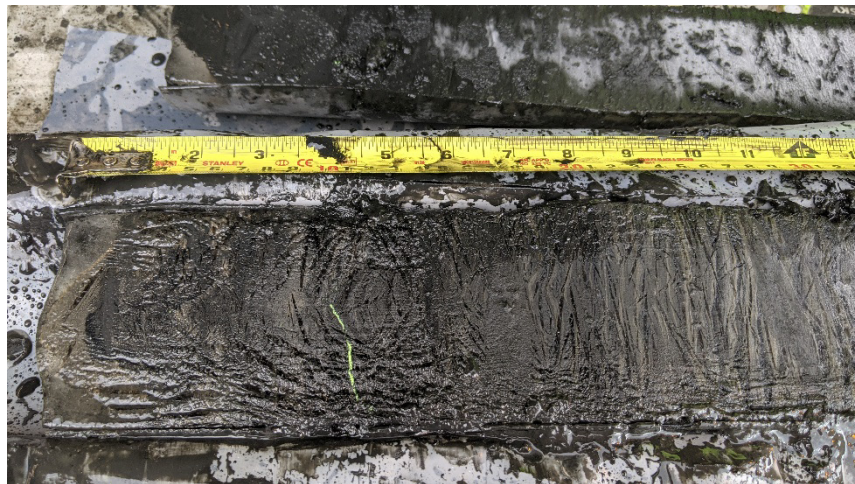
Figure A-13
Core OL-MB-80098-B

Visual inspection of the vertical cross section of microbead core OL-MB-80098-B revealed a 0.1 cm thick layer of microbead marker material from the 10 to 10.1 cm depth interval. A 2 cm thick layer of light brown sediment was present at the top of the core followed by dark gray, medium gray, and black sediment layers above the microbead marker material layer. Descriptions of laminations observed in the core are as follows:

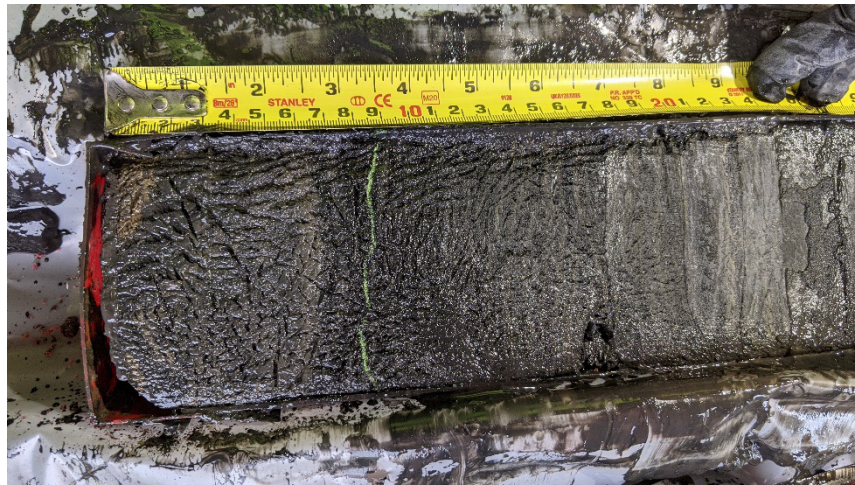
Figure A-14
Core OL-MB-80099-A

Visual inspection of the vertical cross section of microbead core OL-MB-80099-A revealed a 0.1 cm thick layer of microbead marker material from the 8.0 to 8.1 cm depth interval. A 1 cm thick light brown layer of material was present at the top of the core followed by dark gray, light gray, and black sediment layers above the microbead marker material layer. Descriptions of laminations observed in the core are as follows:

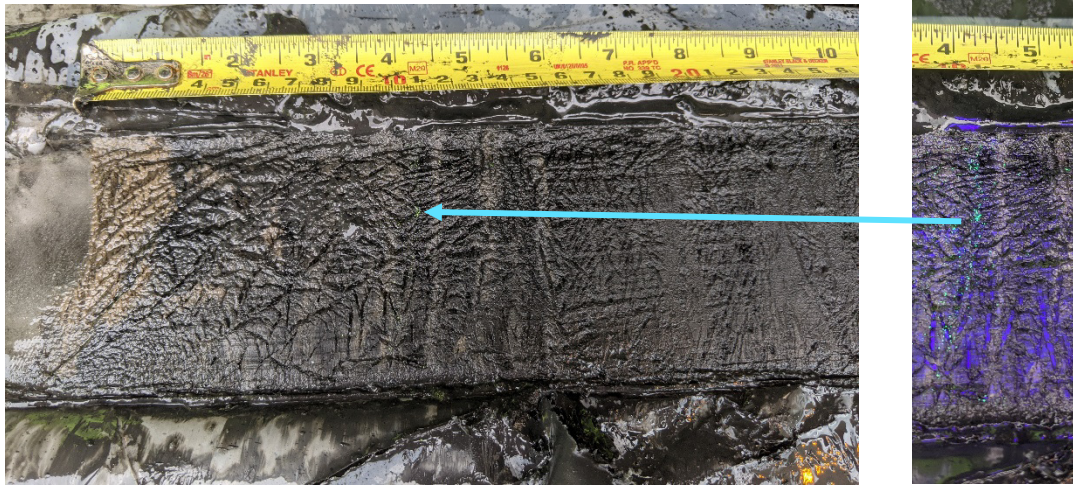
Figure A-18
Core OL-MB-80101-A

Photograph on right shows a section of the core (9 to 14 cm section) under ultraviolet light to better observe the microbead marker material

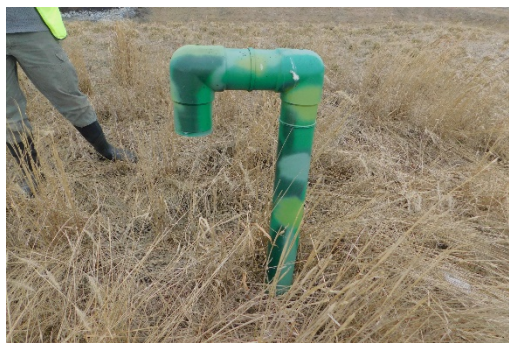
GV-1

Photos below include gas vents 1 to 6 monitored on 3/11/21. All vents were in good condition with tall grasses surrounding them. Additional details found on quarterly forms.

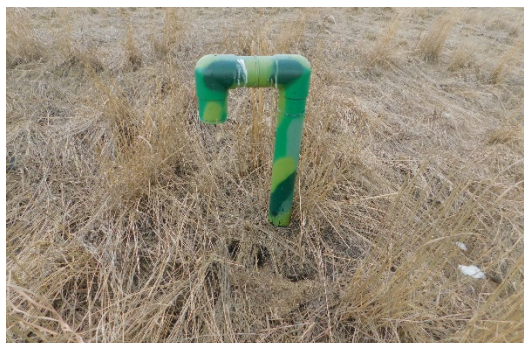
GV-7

Photos below include gas vents 7 to 12 monitored on 3/11/21. All vents were in good condition with tall grasses surrounding them. Additional details found on quarterly forms.

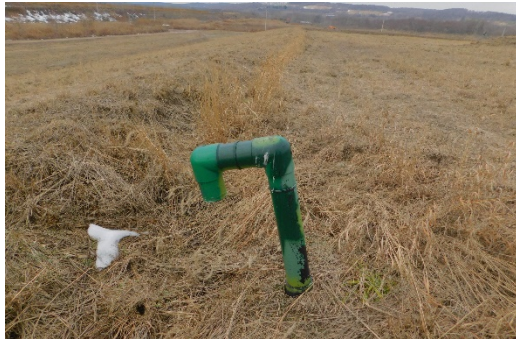
Photos below include gas vents 13 to 17 monitored on 3/11/21. All vents were in good condition with tall grasses surrounding them. GV-13 continues to demonstrate a slight lean, and GV-16 has a very slight lean. Additional details found on quarterly forms.

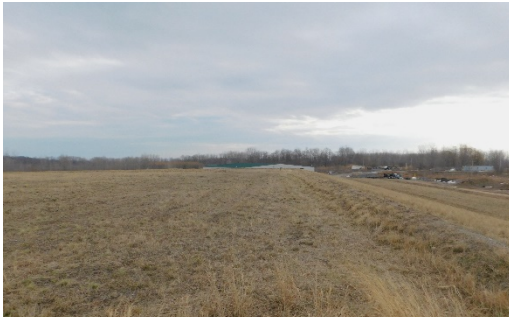
Small animal burrows were noted at GV-4, GV-7, GV-14, GV-15, GV-16. Ground cover was good site-wide despite seasonal senescence, with few areas of patchy vegetation on berms. Additional details found on quarterly forms.

Typical condition of vegetation

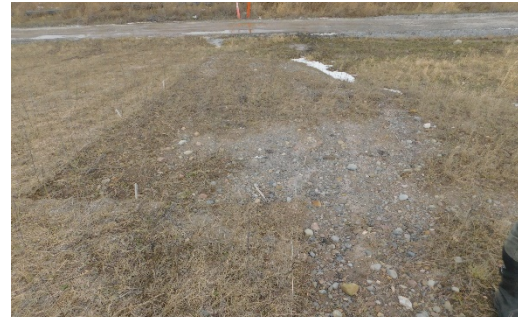
Minor erosion rills forming at toe of previously installed RECP

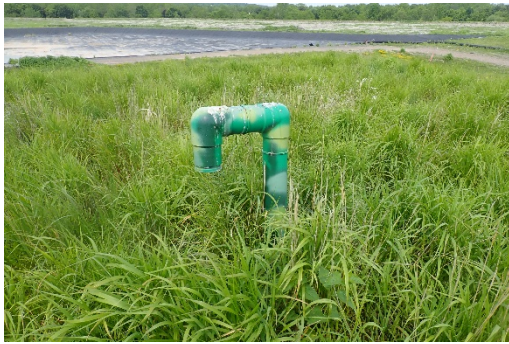
GV-1

Photos below include gas vents 1 to 6 monitored on 6/2/21. All vents were in good condition with tall grasses surrounding them. Additional details found on quarterly forms.

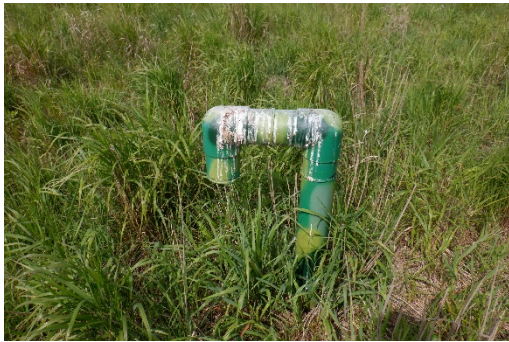
GV-7

Photos below include gas vents 7 to 12 monitored on 6/2/21. All vents were in good condition with tall grasses surrounding them. Additional details found on quarterly forms.

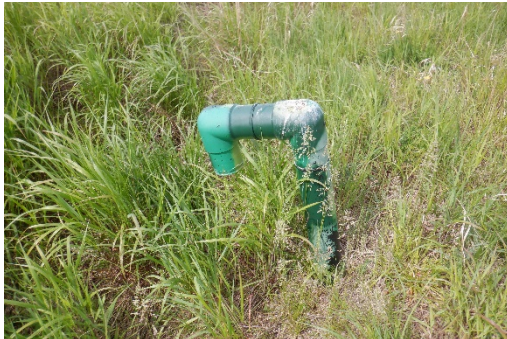
Photos below include gas vents 13 to 17 monitored on 6/2/21. All vents were in good condition with tall grasses surrounding them. GV-13 continues to demonstrate a slight lean, and GV-16 has a very slight lean. Additional details found on quarterly forms.

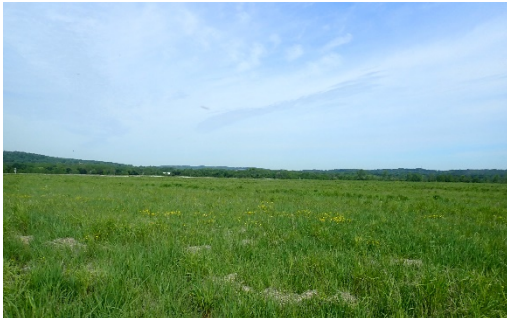
Small animal burrows were noted at GV-2, GV-4, GV-7, GV-8, GV-14, and GV-17. Ground cover was good site-wide, with very few areas of patchy vegetation on berms. Additional details found on quarterly forms.

Typical condition of vegetation

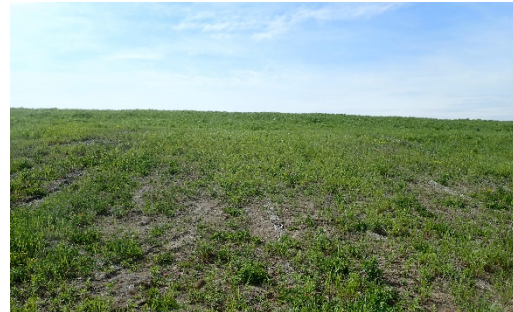
Minor erosion rills noted at toe of RECIP at the northern edge of the site

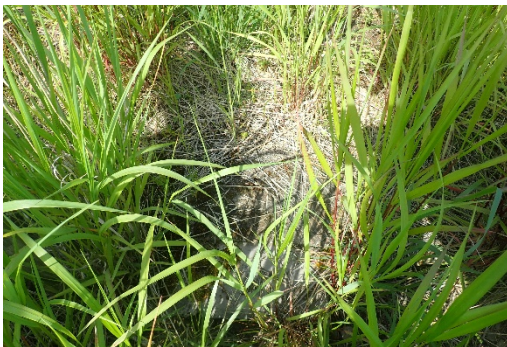
Vegetation surrounding DP-13

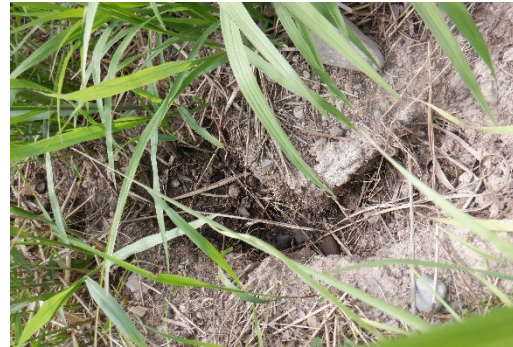
Minor erosion rill noted near GV-11

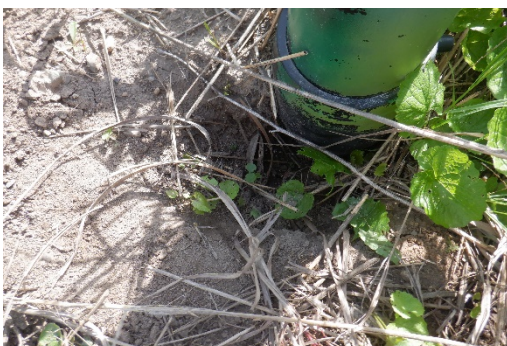
Example of small animal burrow near GV-14

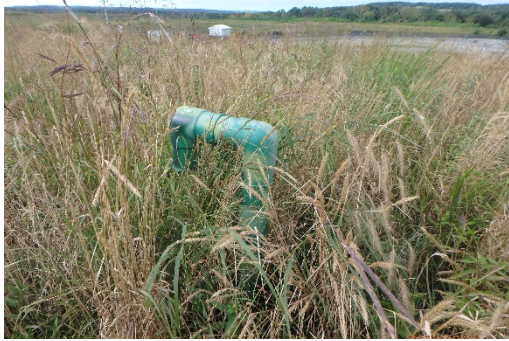
GV-1

Photos below include gas vents 1 to 6 monitored on 9/24/21. All vents were in good condition with tall grasses surrounding them. Additional details found on quarterly forms.

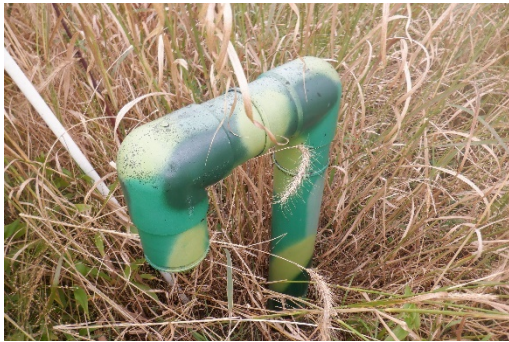
GV-7

Photos below include gas vents 7 to 12 monitored on 9/24/21. All vents were in good condition with tall grasses surrounding them. Additional details found on quarterly forms.

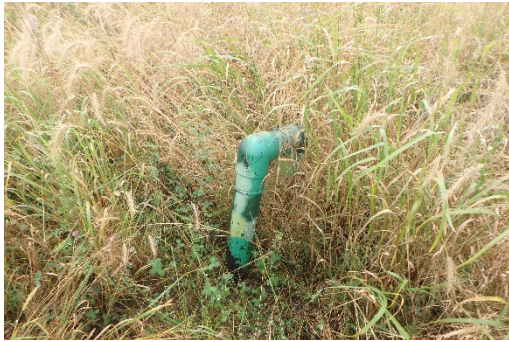
Photos below include gas vents 13 to 17 monitored on 9/24/21. All vents were in good condition with tall grasses surrounding them. GV-13 continues to demonstrate a slight lean, and GV-16 has a very slight lean. Additional details found on quarterly forms.

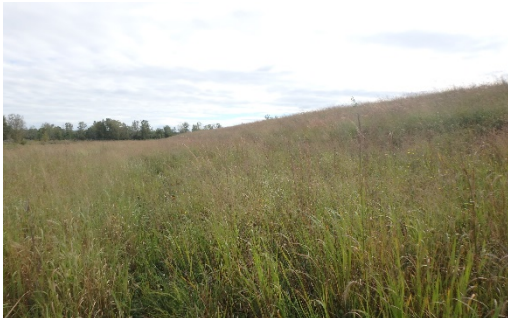
Small animal burrows were noted at GV-4, GV-7, and GV-14. Ground cover was good site-wide, with few areas of patchy vegetation on berms. Additional details found on quarterly forms.

Typical condition of vegetation on slopes

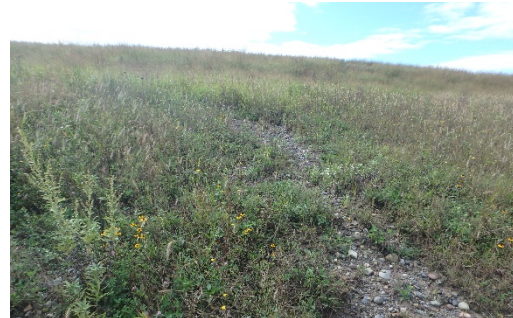
Vegetation growth near RECP

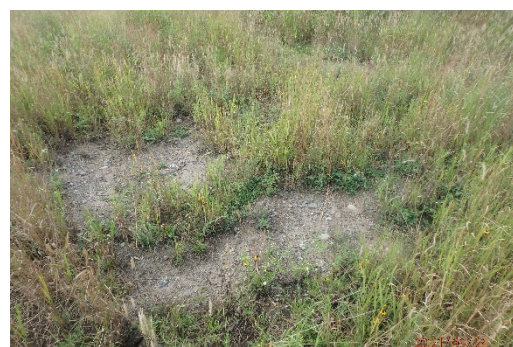
Sparse vegetation noted near GV-11

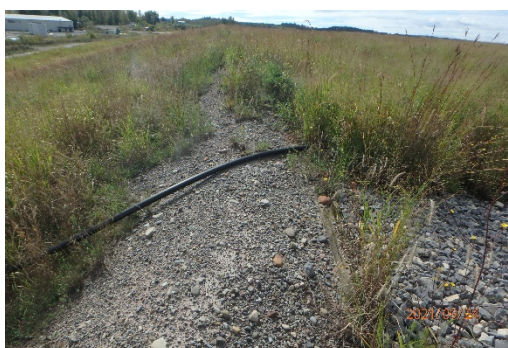
Sparse vegetation located on eastern berm near groundwater swale

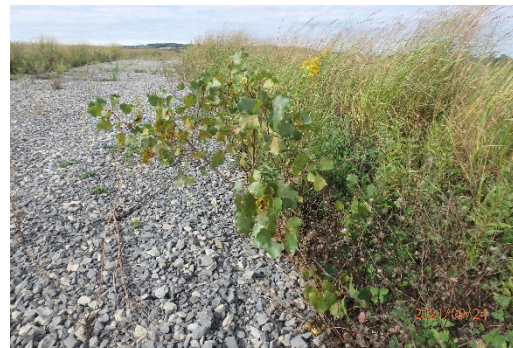
Example of cottonwood noted along northern access road

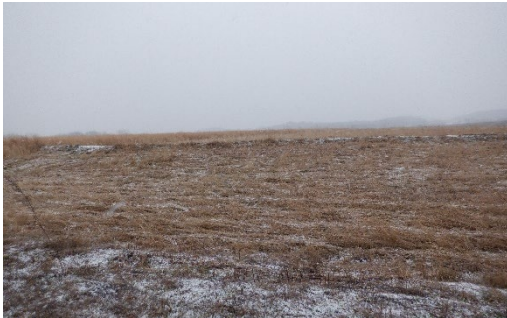
Condition of mowed vegetation

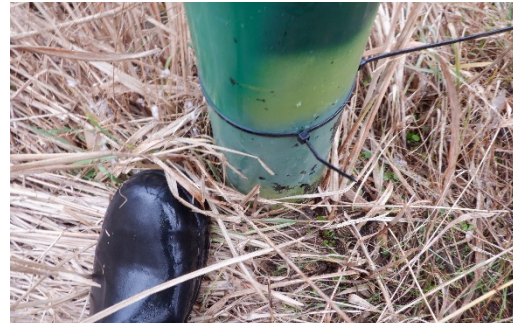
Vegetation covering location of previous animal burrows

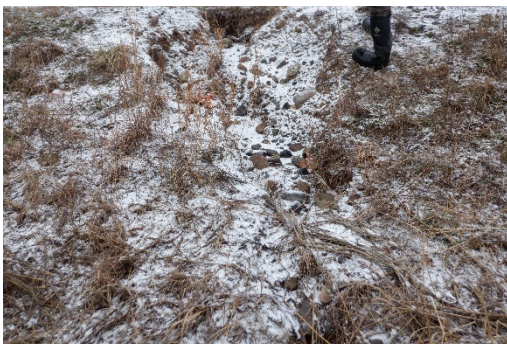
Erosion rill noted on western slope
