Subject: Carrier Corporation, Thompson Road Facility, Syracuse, New York
Corrective Action Order — Index CO 7-20051118-4
Site Registry No.: 734043
Potential for Vapor Intrusion Assessment Report

POTENTIAL FOR VAPOR INTRUSION ASSESSMENT REPORT

United Technologies Corporation/Carrier Site
Thompson Road, Syracuse, NY

Corrective Action Order – Index CO 7-20051118-4
NYSDEC Site Registry #734043

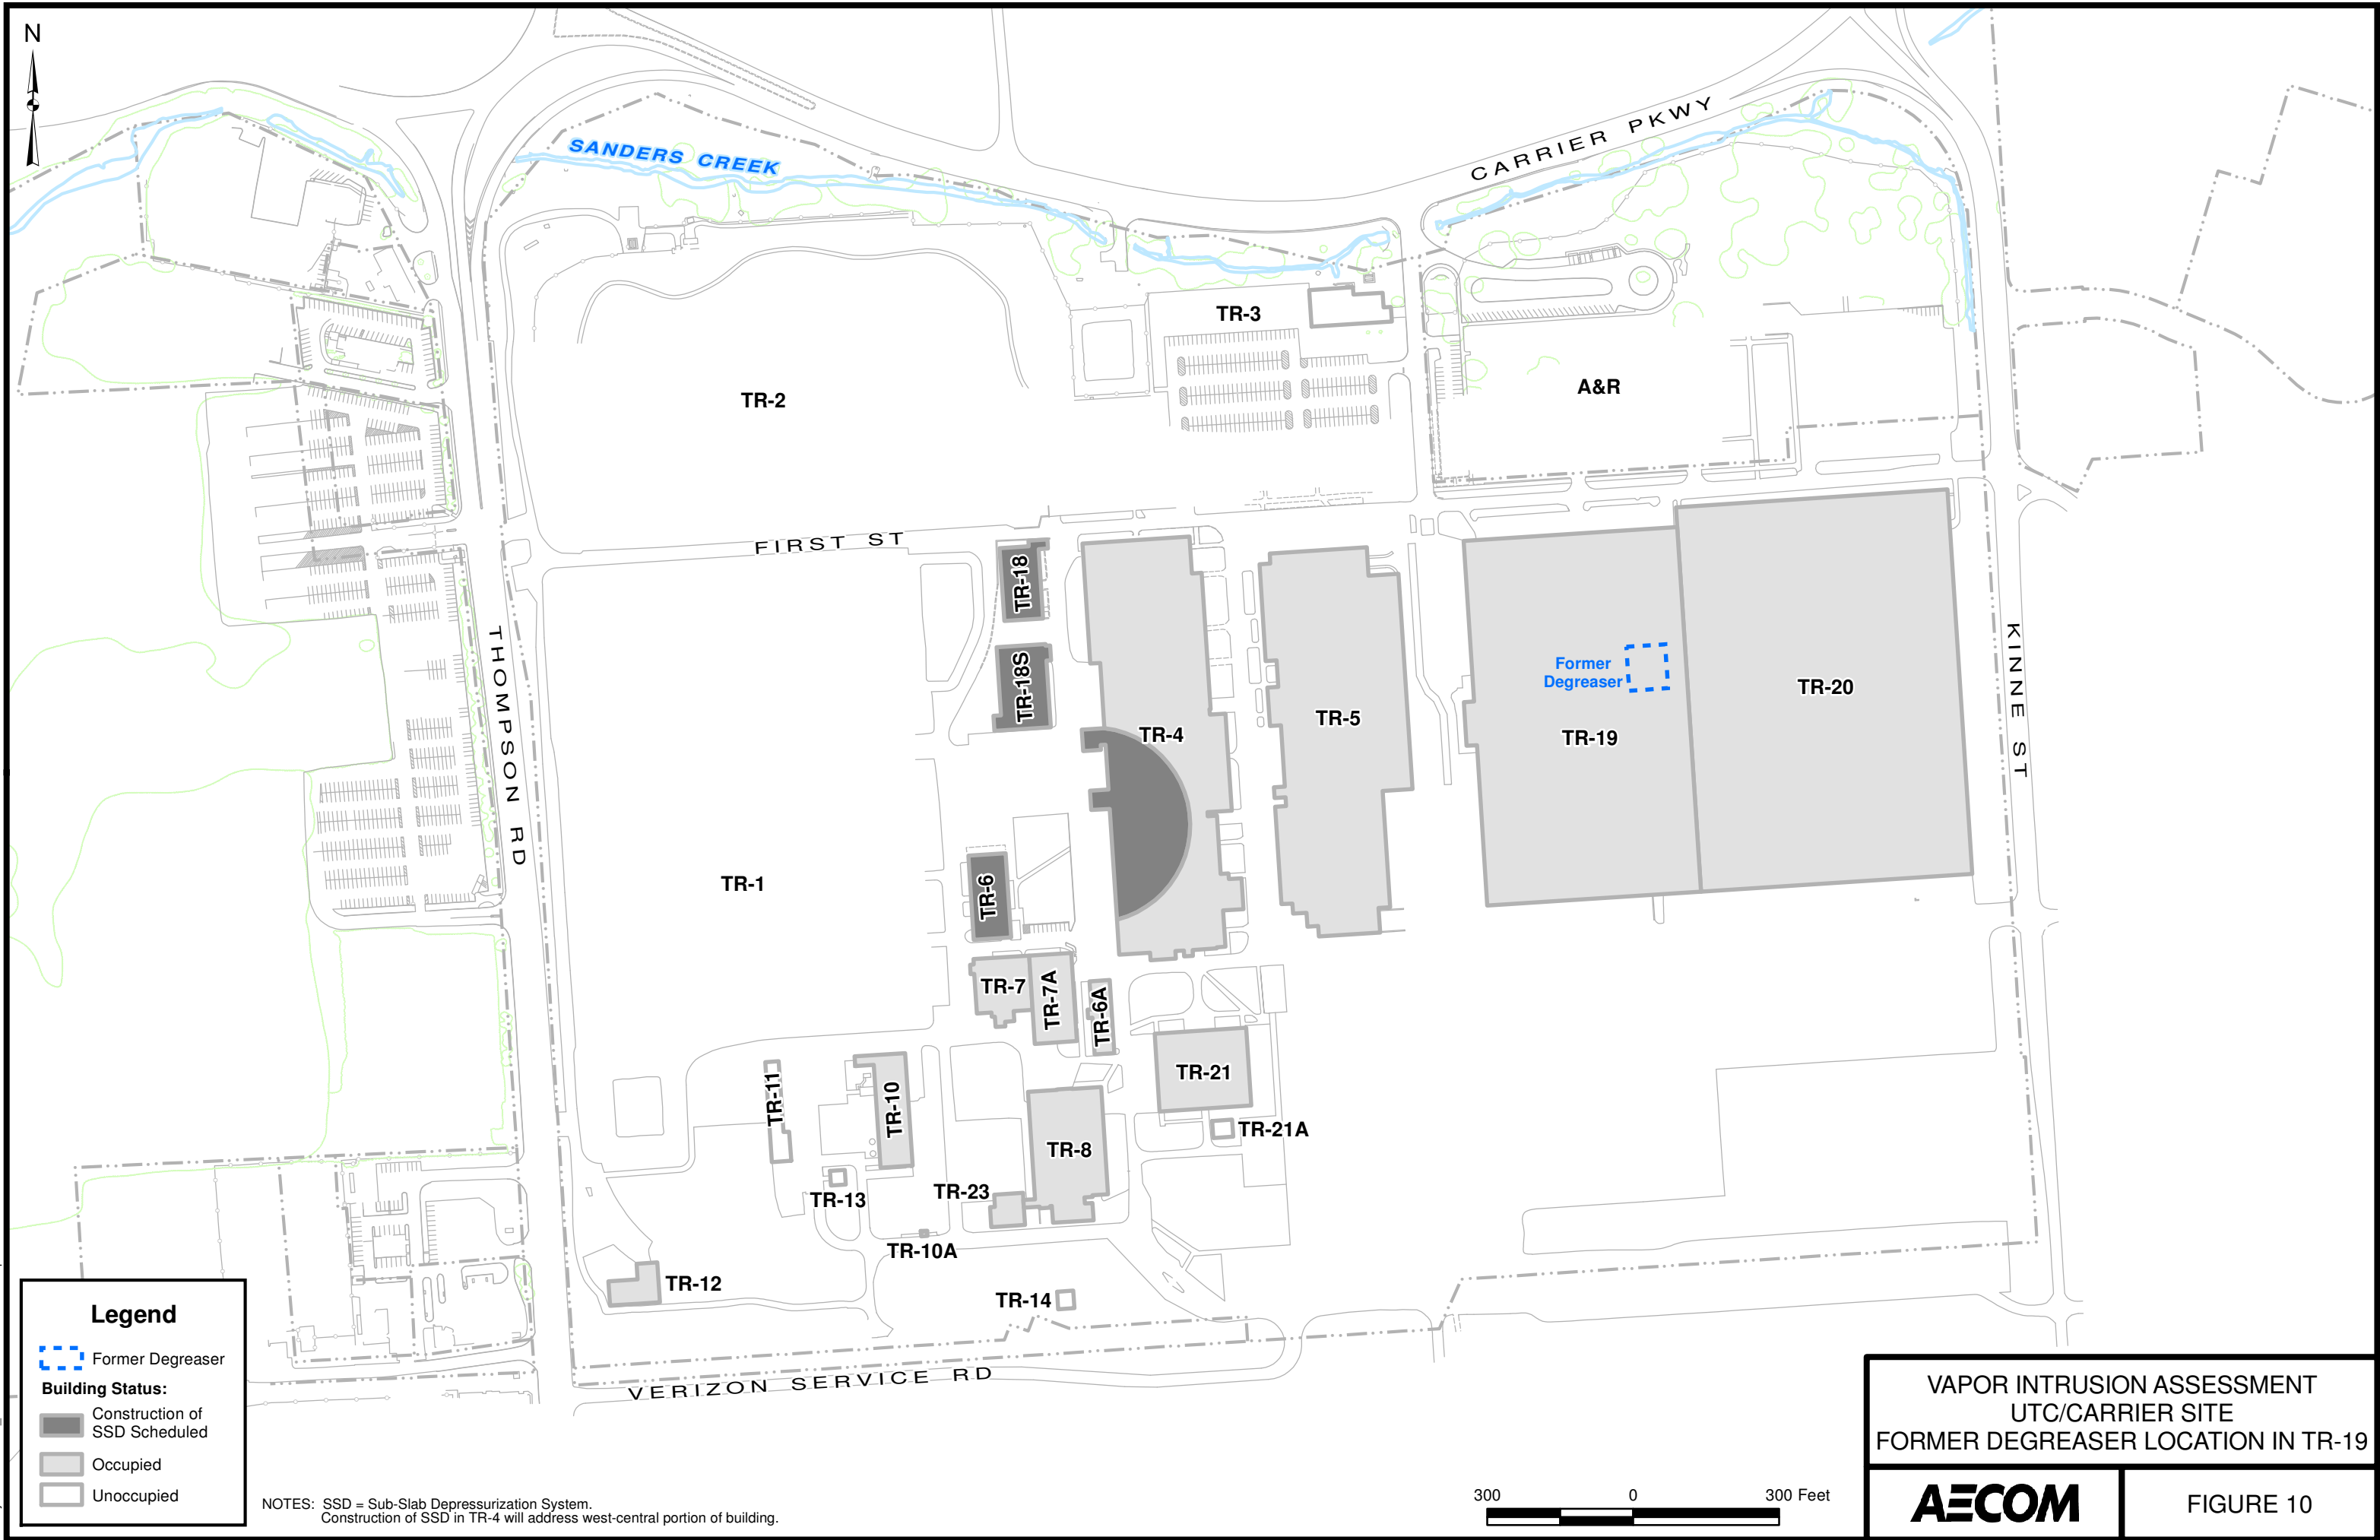
J:\Projects\60310231_UTCAOCGRIMISC\GIS\Maps\SITE-WIDESV\REPORT\10 FORMER DEGREASER LOCATION.mxd 4/25/2017

Facility personnel have anecdotal information indicating a degreaser was formerly located in the eastern half of the TR-19 building. The approximate location of the former degreaser based on the recollection of facility personnel is shown on **Figure 10**.

Based on the anecdotal information regarding the former presence of a degreaser in building TR-19, VI investigations are recommended for building TR-19. Furthermore, given that building TR-20 is immediately adjacent to building TR-19, VI investigations should be planned for TR-20 as well, with a final decision to be made after TR-19 investigation results are reviewed to see if any subsurface contamination extends to the vicinity of TR-20.
