Re: Annual Landfill Inspection Report (Year 9)  
Syracuse China Landfill  
Town of Salina, Onondaga County, New York  
NYSDEC Site Number 7-34-053

Rocterra, LLC (Rocterra), on behalf of TPC-York Inc. (TPC-York), has prepared this letter report to summarize the required monitoring and sampling activities completed at the Syracuse China Landfill located in the Town of Salina, Onondaga County, New York (Site No. 7-34-053). In accordance with New York State Department of Environmental Conservation (NYSDEC) requirements, activities for the ninth year of Operations, Monitoring and Maintenance (OM&M) were performed at the site. Activities included monitoring well repair, groundwater sampling and a landfill inspection. In accordance with the OM&M Plan prepared by Remedial Engineering, PC dated September 25, 2003 and the schedule approved by NYSDEC, the following activities were performed:

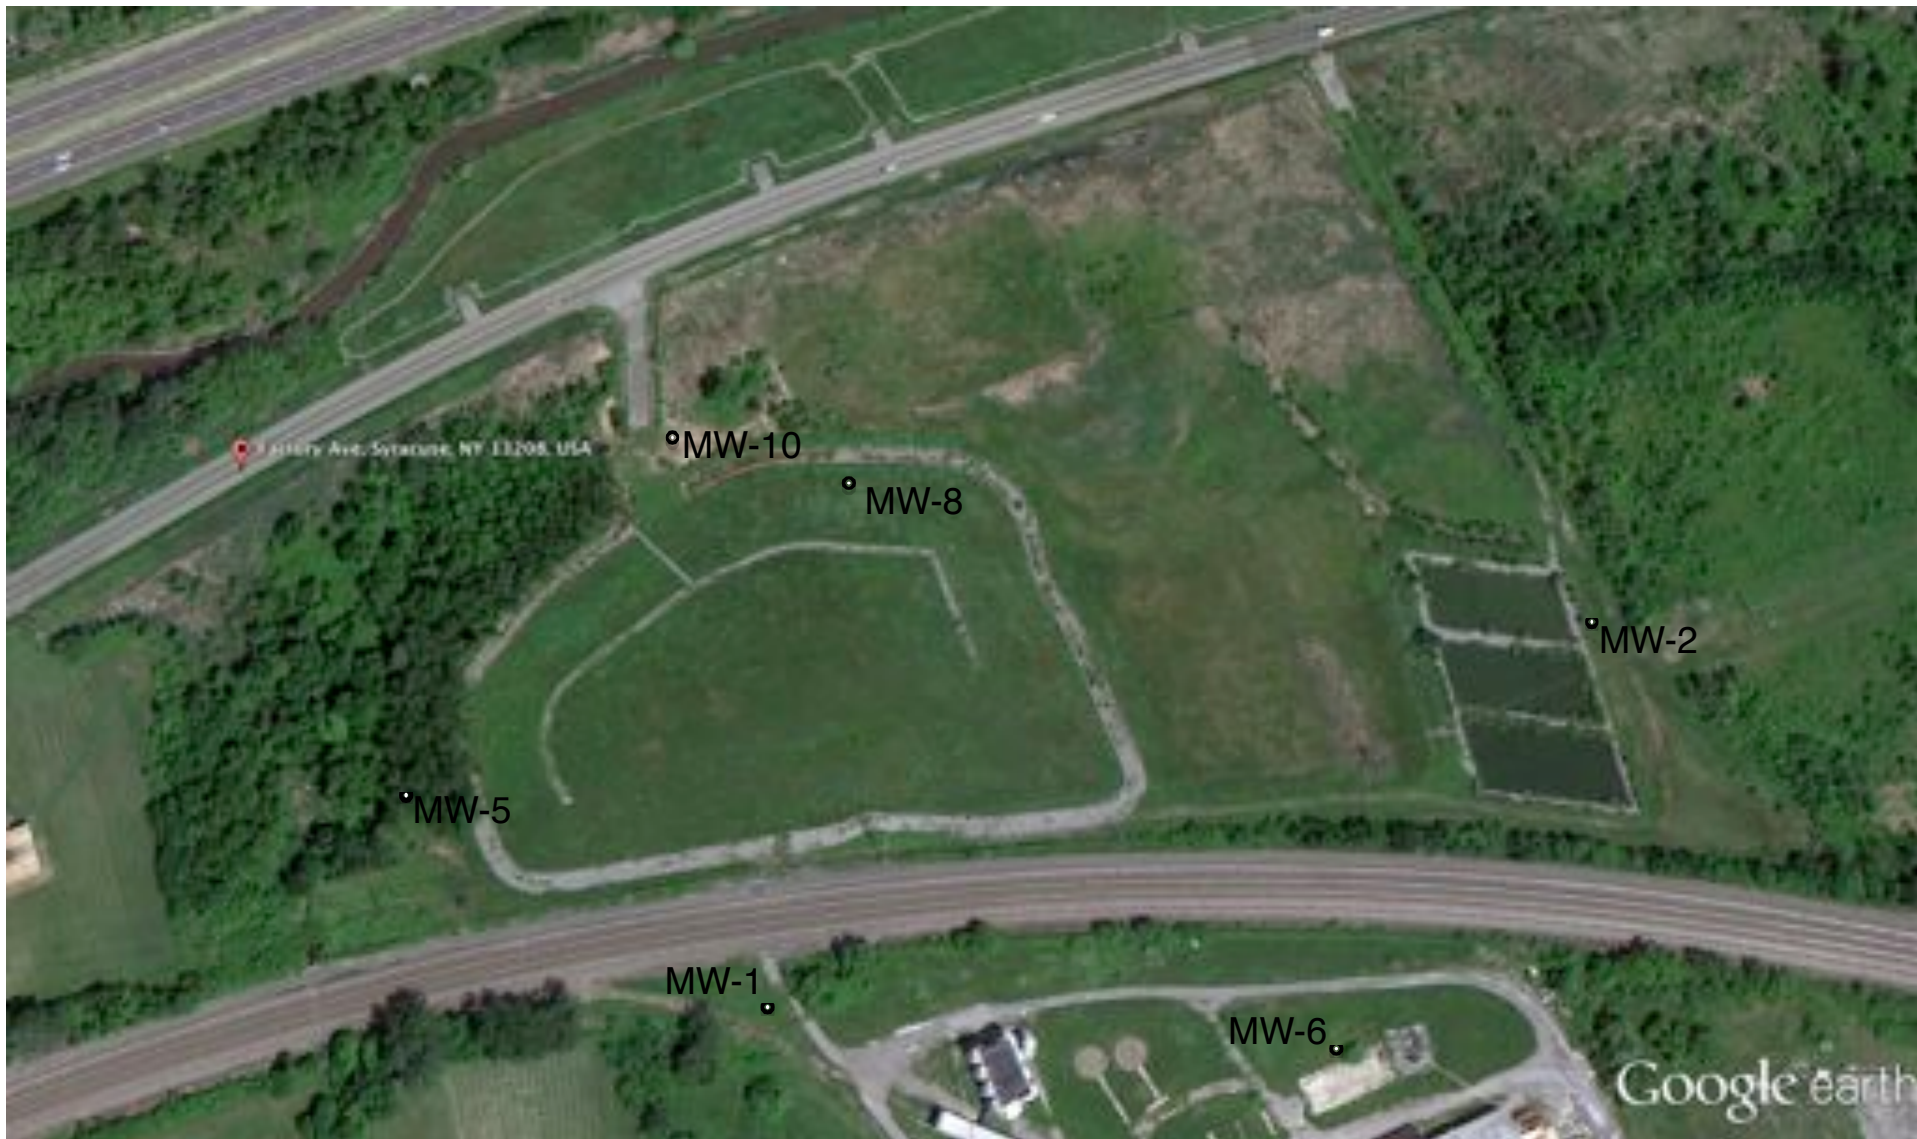
The Site location and site features are represented in figures 1, 2 and 3. A Groundwater Sampling Map showing the location of the sampled monitoring wells is provided as Figure 3. The results of the sampling activities are summarized in the Site Monitoring, Inspection and Maintenance Forms provided in Appendix A. Laboratory analytical reports are provided in Appendix B.

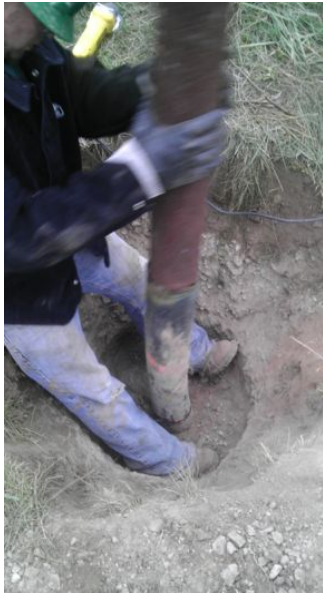
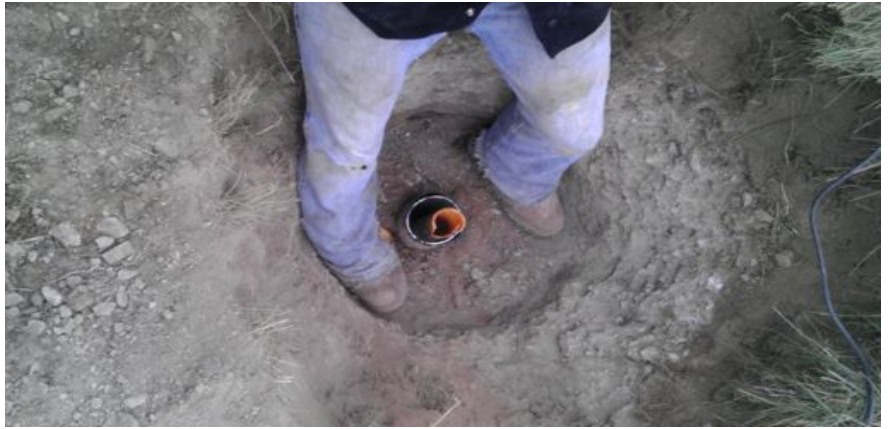
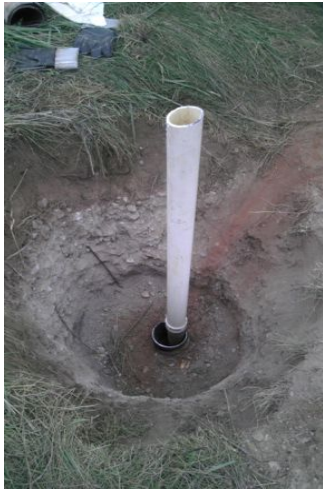
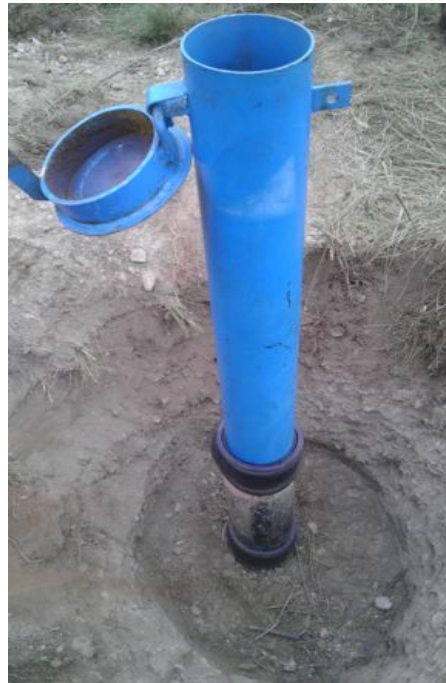
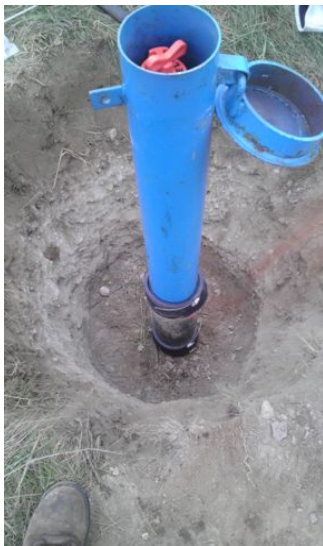
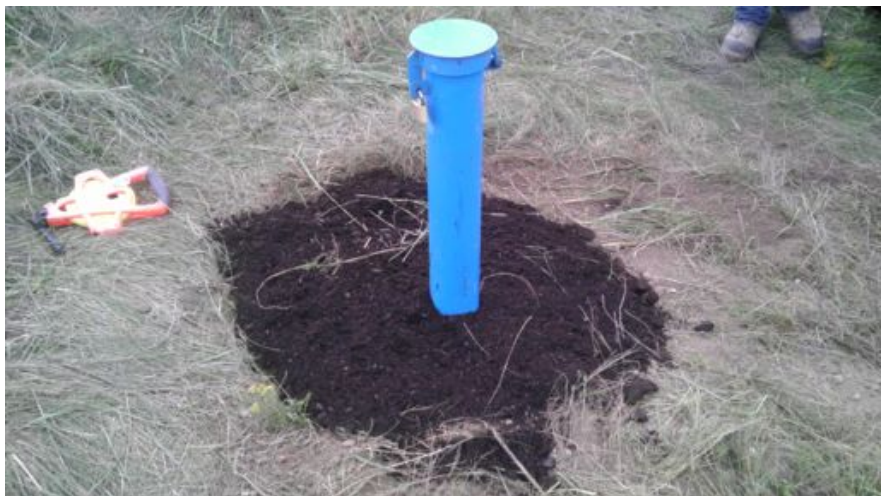
## Well Repair: MW-8

Monitoring well MW-8 was damaged when the well was struck by a Mueller Farms Landscaping Co. mower during their onsite mowing/weed-whacking activities conducted in October 2011. On September 28, 2012 Rocterra subcontracted NYEG Drilling, LLC (NYEG) to repair the well. An approximately three-foot diameter area was excavated around monitoring well MW-8. The damaged steel protective casing and damaged 2" Poly Vinyl Chloride (PVC) well riser was cut away approximately 1.5' below grade. A new 2" PVC riser section was attached to the well using a PVC coupler. A replacement steel riser was welded in place. The liner boot was then secured using a rubber coupler in order to restore the liner integrity. The excavated area was backfilled with native material and finished with topsoil. This area will be monitored in the spring to ensure that vegetation is reestablished in the area and there is no significant erosion. Monitoring well MW-8 was then re-surveyed to a common datum point (MW-10). Survey elevation points are summarized in Appendix A, Table 1. Photographs documenting the repair activities are included within Appendix C.

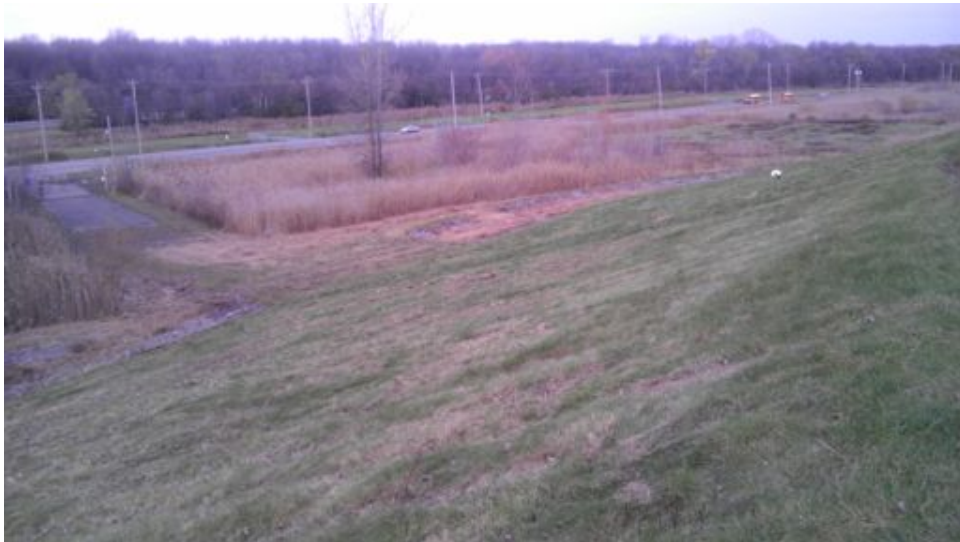
Rocterra's inspection indicated that the site was generally in good condition with no significant erosion or differential settlement. The landfill surface was observed to be entirely stabilized with vegetation. The landfill drainage swales, drop chute and energy dissipation structures were observed to be in good condition with no significant blockage or washout. The permanent gas vents were also observed to be in good condition. The site access road was observed to be generally clear of vegetation, obstructions or significant rutting. The site fence was observed to be in good condition; however, vegetation overgrowth was observed periodically along the east, south and west fence line and there were two breaches on the east and west fence line. The signs on the fence within the Factory Avenue right-of-way were unobstructed.

Cap: Facing Northeast

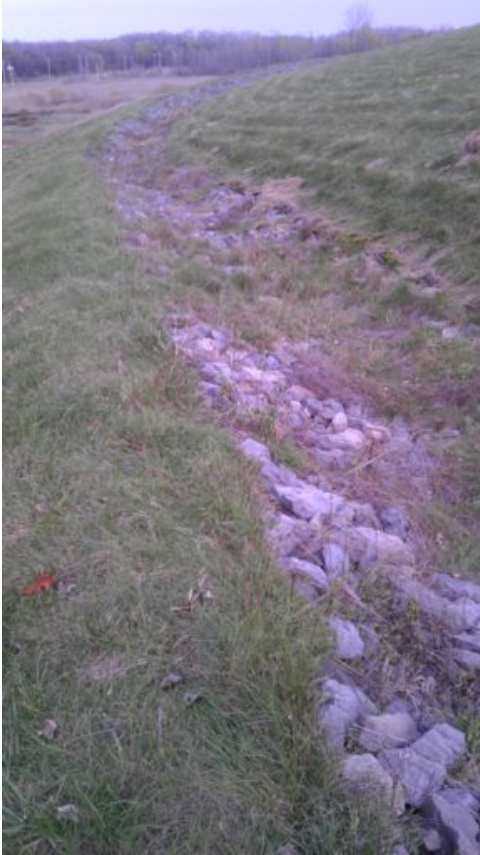
Top Swale: Facing Northeast

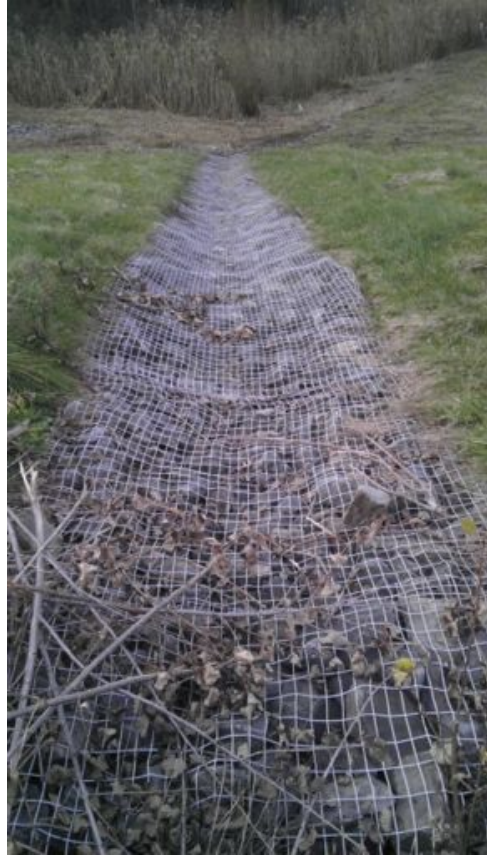
Chute: Facing North

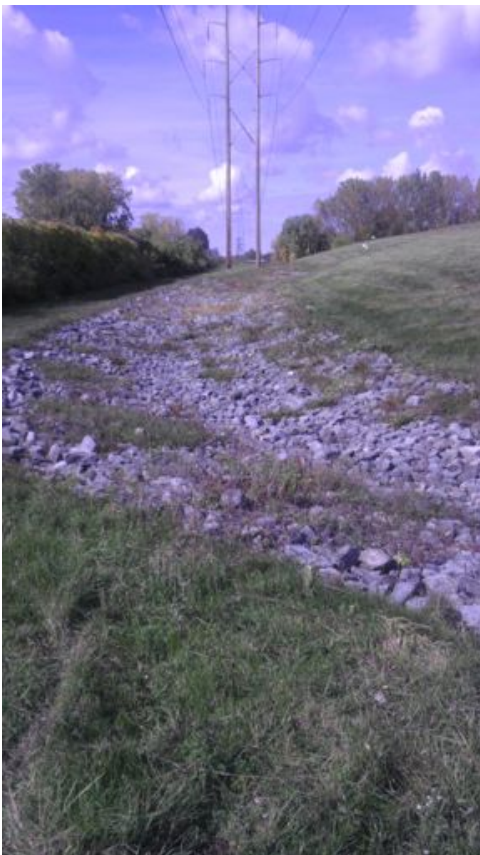
Bottom Swale: Facing West

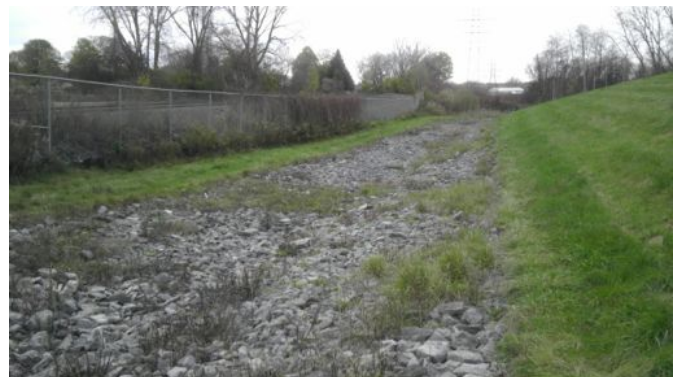
Bottom Swale: Facing West

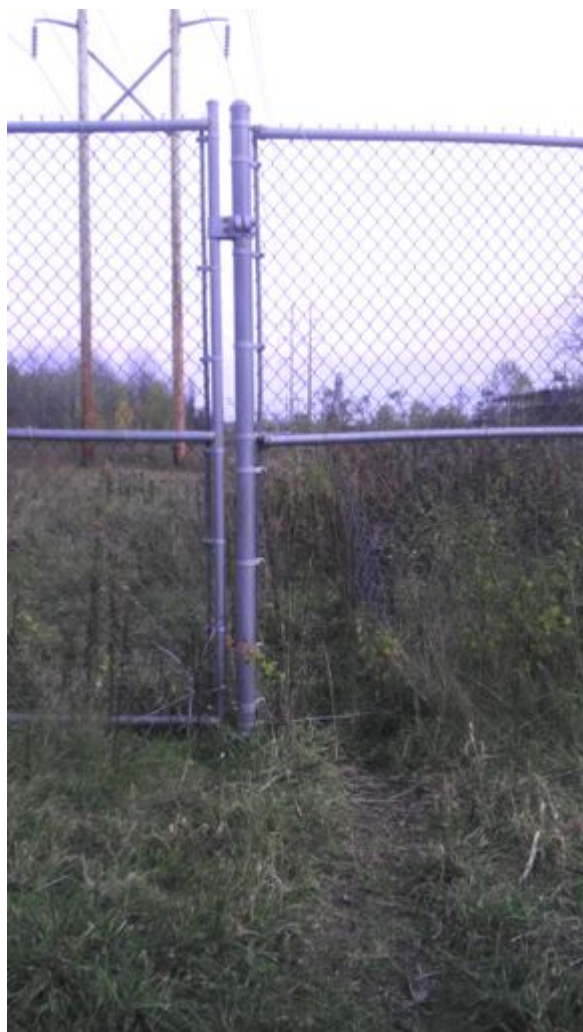
Breach: East Fence Line

Two breaches in the fence line were observed during the 2012 site inspection. Repair activities are anticipated to be performed in March 2013 pending acceptable weather.
