Re: Annual Landfill Inspection Report (Year 10)  
Syracuse China Landfill  
Town of Salina, Onondaga County, New York  
NYSDEC Site Number 7-34-053

Rocterra, LLC (Rocterra), on behalf of TPC-York Inc. (TPC-York), has prepared this letter report to summarize the required monitoring and sampling activities completed at the Syracuse China Landfill located in the Town of Salina, Onondaga County, New York (Site No. 7-34-053). In accordance with New York State Department of Environmental Conservation (NYSDEC) requirements, activities for the tenth year of Operation, Monitoring and Maintenance (OM&M) were performed at the site. Activities included fence repair, groundwater sampling and a landfill inspection. In accordance with the OM&M Plan prepared by Remedial Engineering, PC dated September 25, 2003 and the schedule approved by NYSDEC, the following activities were performed:

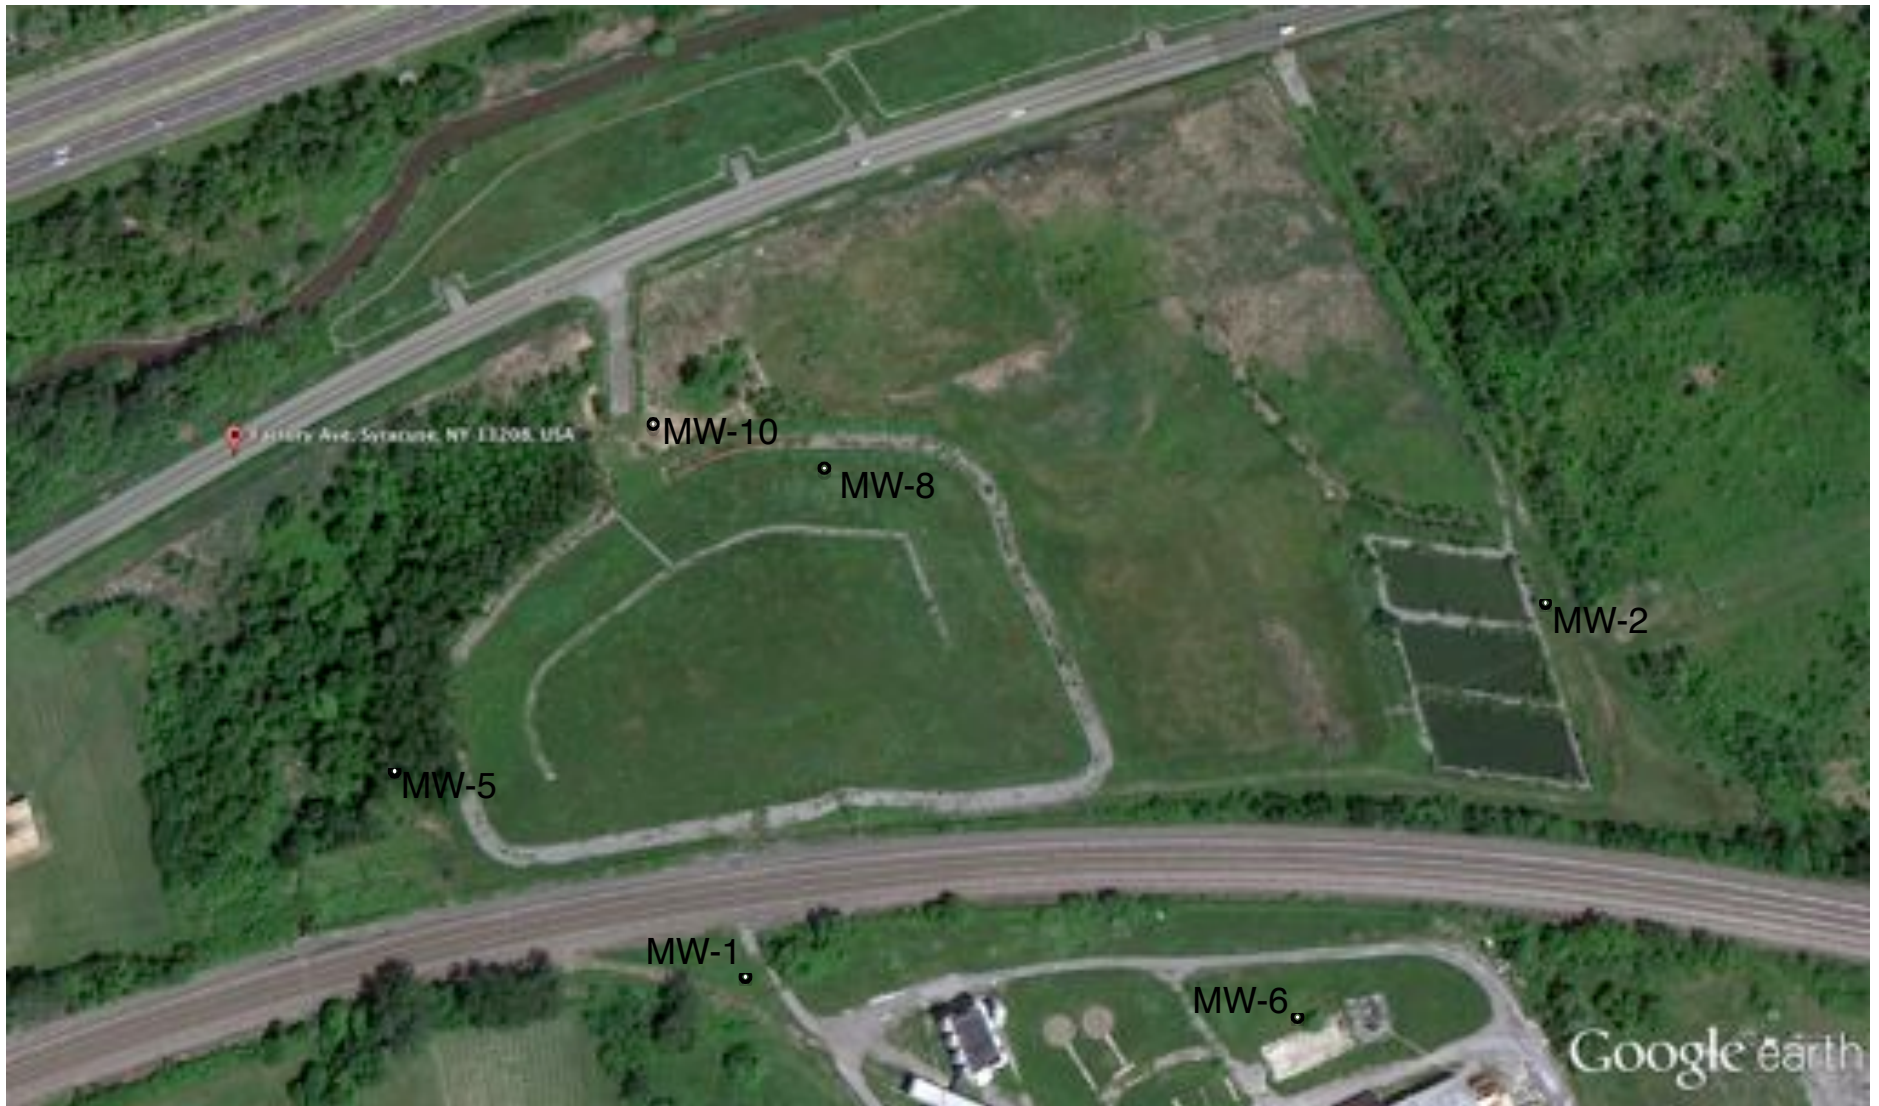
The Site location and site features are represented in figures 1, 2 and 3. A Groundwater Sampling Map showing the location of the sampled monitoring wells is provided as Figure 3. The results of the sampling activities are summarized in the Site Monitoring, Inspection and Maintenance Forms provided in Appendix A. Laboratory analytical reports are provided in Appendix B.

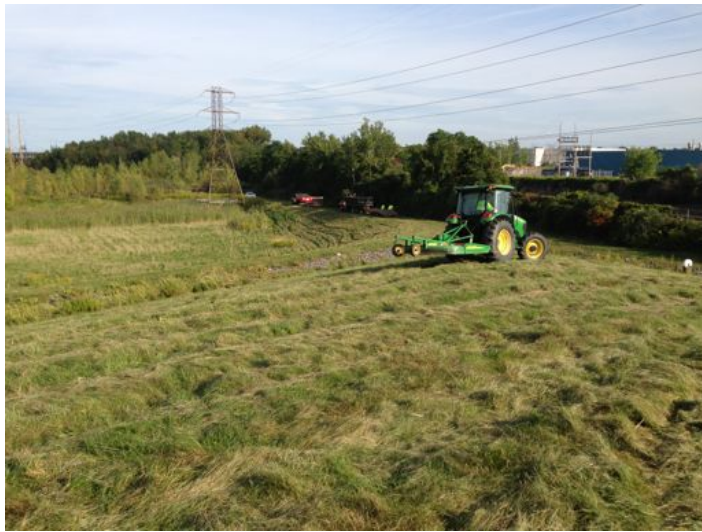
Rocterra's inspection indicates that the site was generally in good condition with no significant erosion or differential settlement. The landfill surface was observed to be entirely stabilized with vegetation. The landfill drainage swales, drop chute and energy dissipation structures were observed to be in good condition, however with a significant amount of vegetation within the riprap. The permanent gas vents were also observed to be in good condition. The site access road was observed to be generally clear of vegetation, obstructions or significant rutting. The site fence was observed to be in good condition; however, vegetation overgrowth was observed periodically along the east, south and west fence line. The signs on the fence within the Factory Avenue right-of-way were unobstructed.

Cap: Facing Southeast

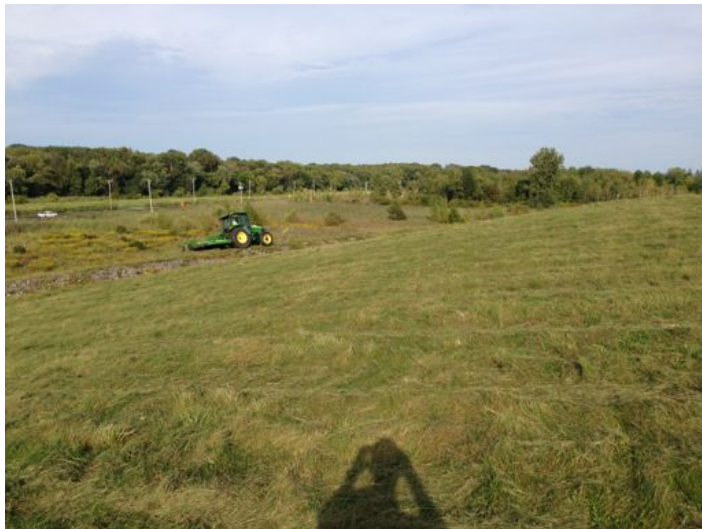
Cap: Facing Northeast

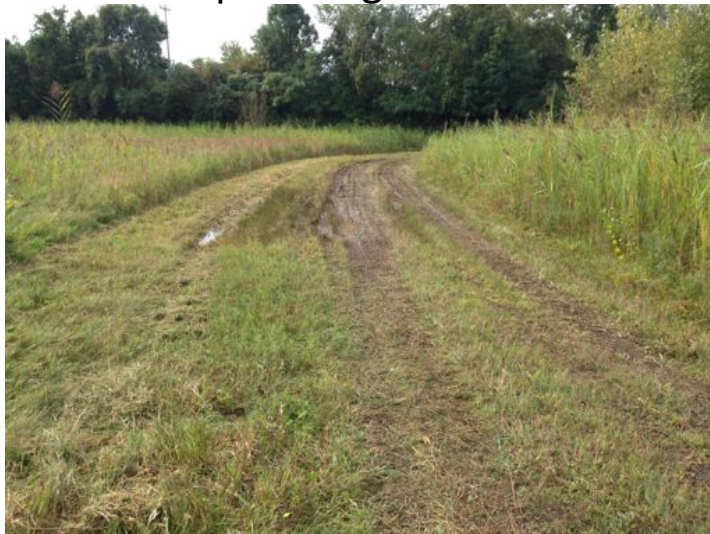
| Item | Action | Notes | Corrective Action Suggested |
|---|---|---|---|
| Access Road (via Factory Ave) | Inspect for erosion, rutting, mowing | Low spot in southeast corner restricts access to the landfill by vehicle due to flooding/wet soils | Add gravel base to raise road elevation |

Access Road (Factory Ave): Facing South

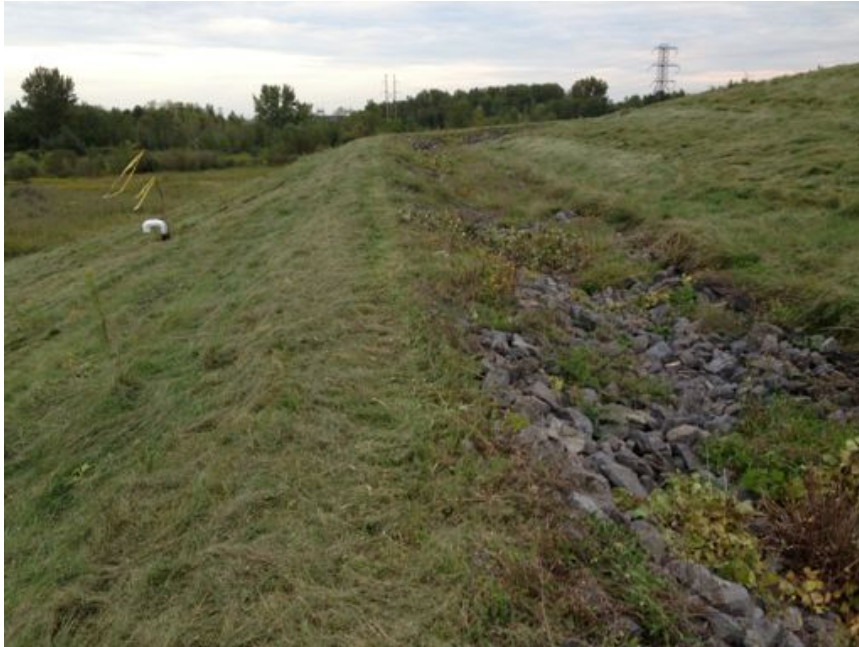
| Item | Action | Notes | Corrective Action Suggested |
|---|---|---|---|
| Swales | Inspect for damage/blockage, weed wacking | Swales have significant vegetation | Herbicide application 2014 |

Top Swale: Facing East

Portions of the swales have become congested with vegetation. In addition, portions of the east, west and south fence line have areas where vegetation is resistant to mechanical removal or have limited access for mechanical removal. Treatment with a widely used aquatic herbicide, Rodeo, is proposed for Spring 2014.

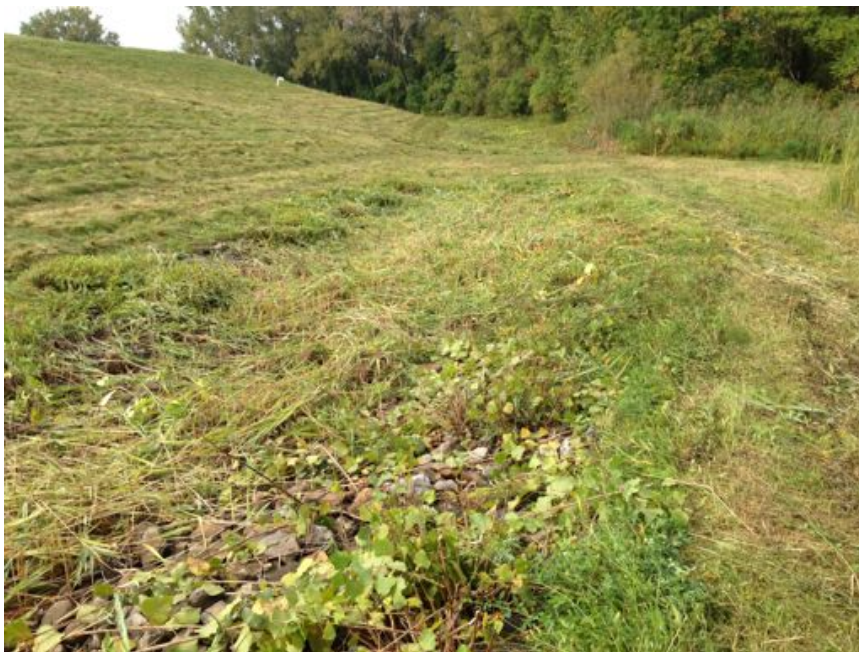
Bottom Swale: Facing West

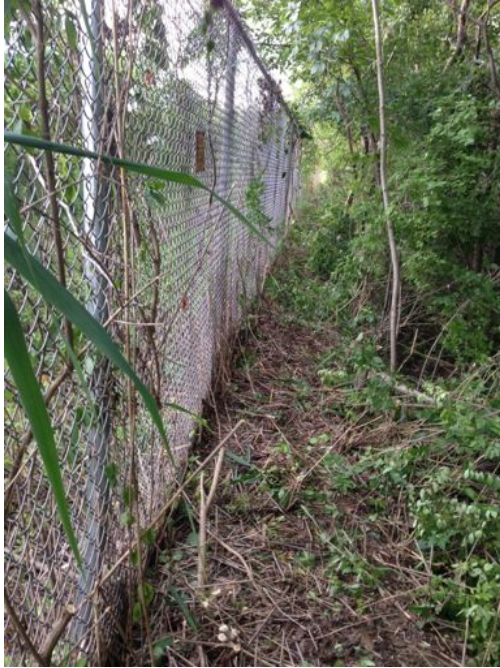
South Fence Line Vegetation  
Removal/fence improvement

Annual mowing and weed-whacking activities were completed by Proscapes Landscaping on September 9, 10 and 11, 2013. Mowing was conducted on the landfill surface, within the eastern portion of the site (outside of wetland areas) and along the access road. Mowing and weed-whacking were conducted within the landfill surface swales to remove woody growth. Areas along the east, west and south fence lines were cleared of vegetation, specifically where there were small trees or woody brush growing into the fence. Photographs documenting the landscaping activities are included within Appendix C.

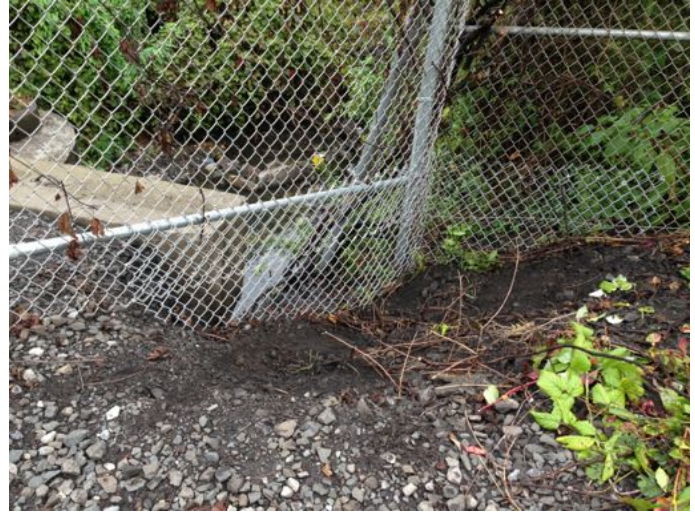
East Fence Line Vegetation Removal

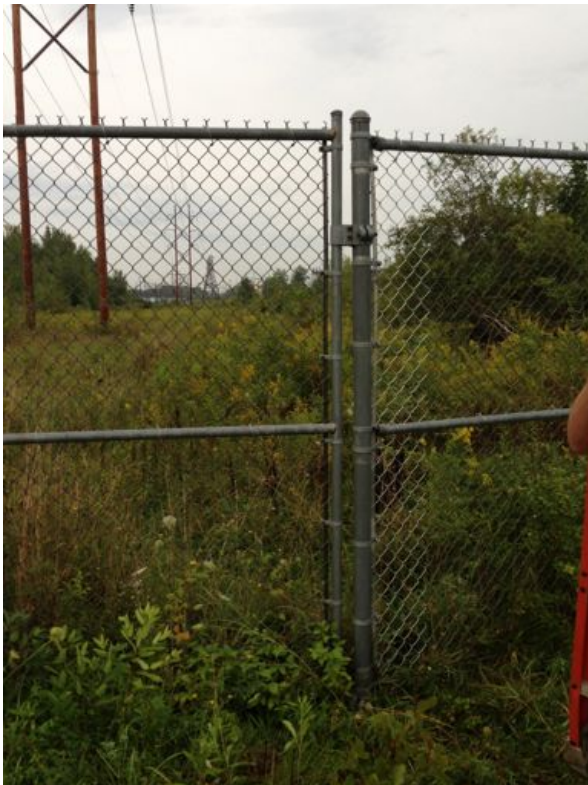
Fence Repair: East Fence Line

Two breaches in the fence were repaired along with some additional gaps along the southern property line. Photographs documenting the repair activities are included within Appendix C.

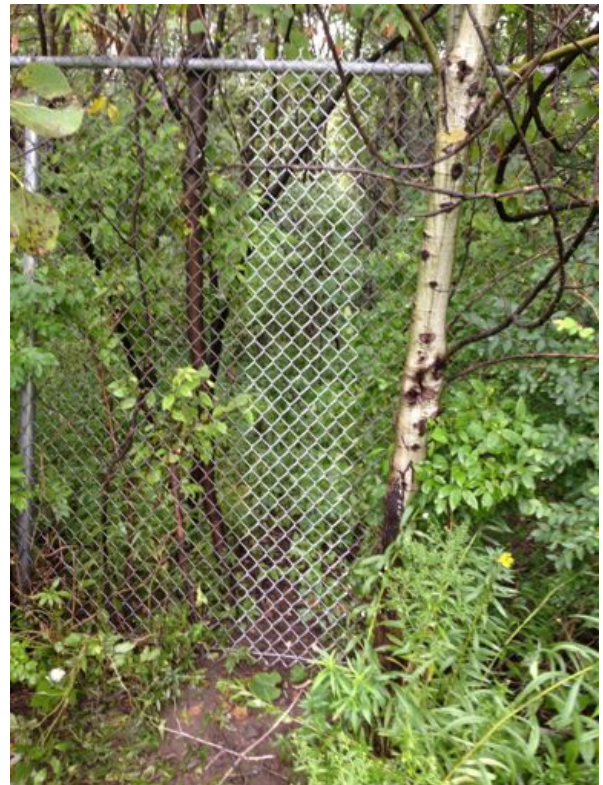
Fence Repair: West Fence  
Line
