Re: Annual Landfill Inspection Report (Year 16)  
Syracuse China Landfill  
Town of Salina, Onondaga County, New York  
NYSDEC Site Number 7-34-053

Rocterra, LLC (Rocterra), on behalf of TPC-York Inc. (TPC-York), has prepared this letter report to summarize the required monitoring and maintenance activities completed at the Syracuse China Landfill site located in the Town of Salina, Onondaga County, New York (Site No. 7-34-053). In accordance with New York State Department of Environmental Conservation (NYSDEC) requirements, activities for the sixteenth year of Operation, Monitoring and Maintenance (OM&M) were performed at the site. In accordance with the OM&M Plan prepared by Remedial Engineering, PC dated September 25, 2003 and the schedule approved by NYSDEC, the following activities were performed:

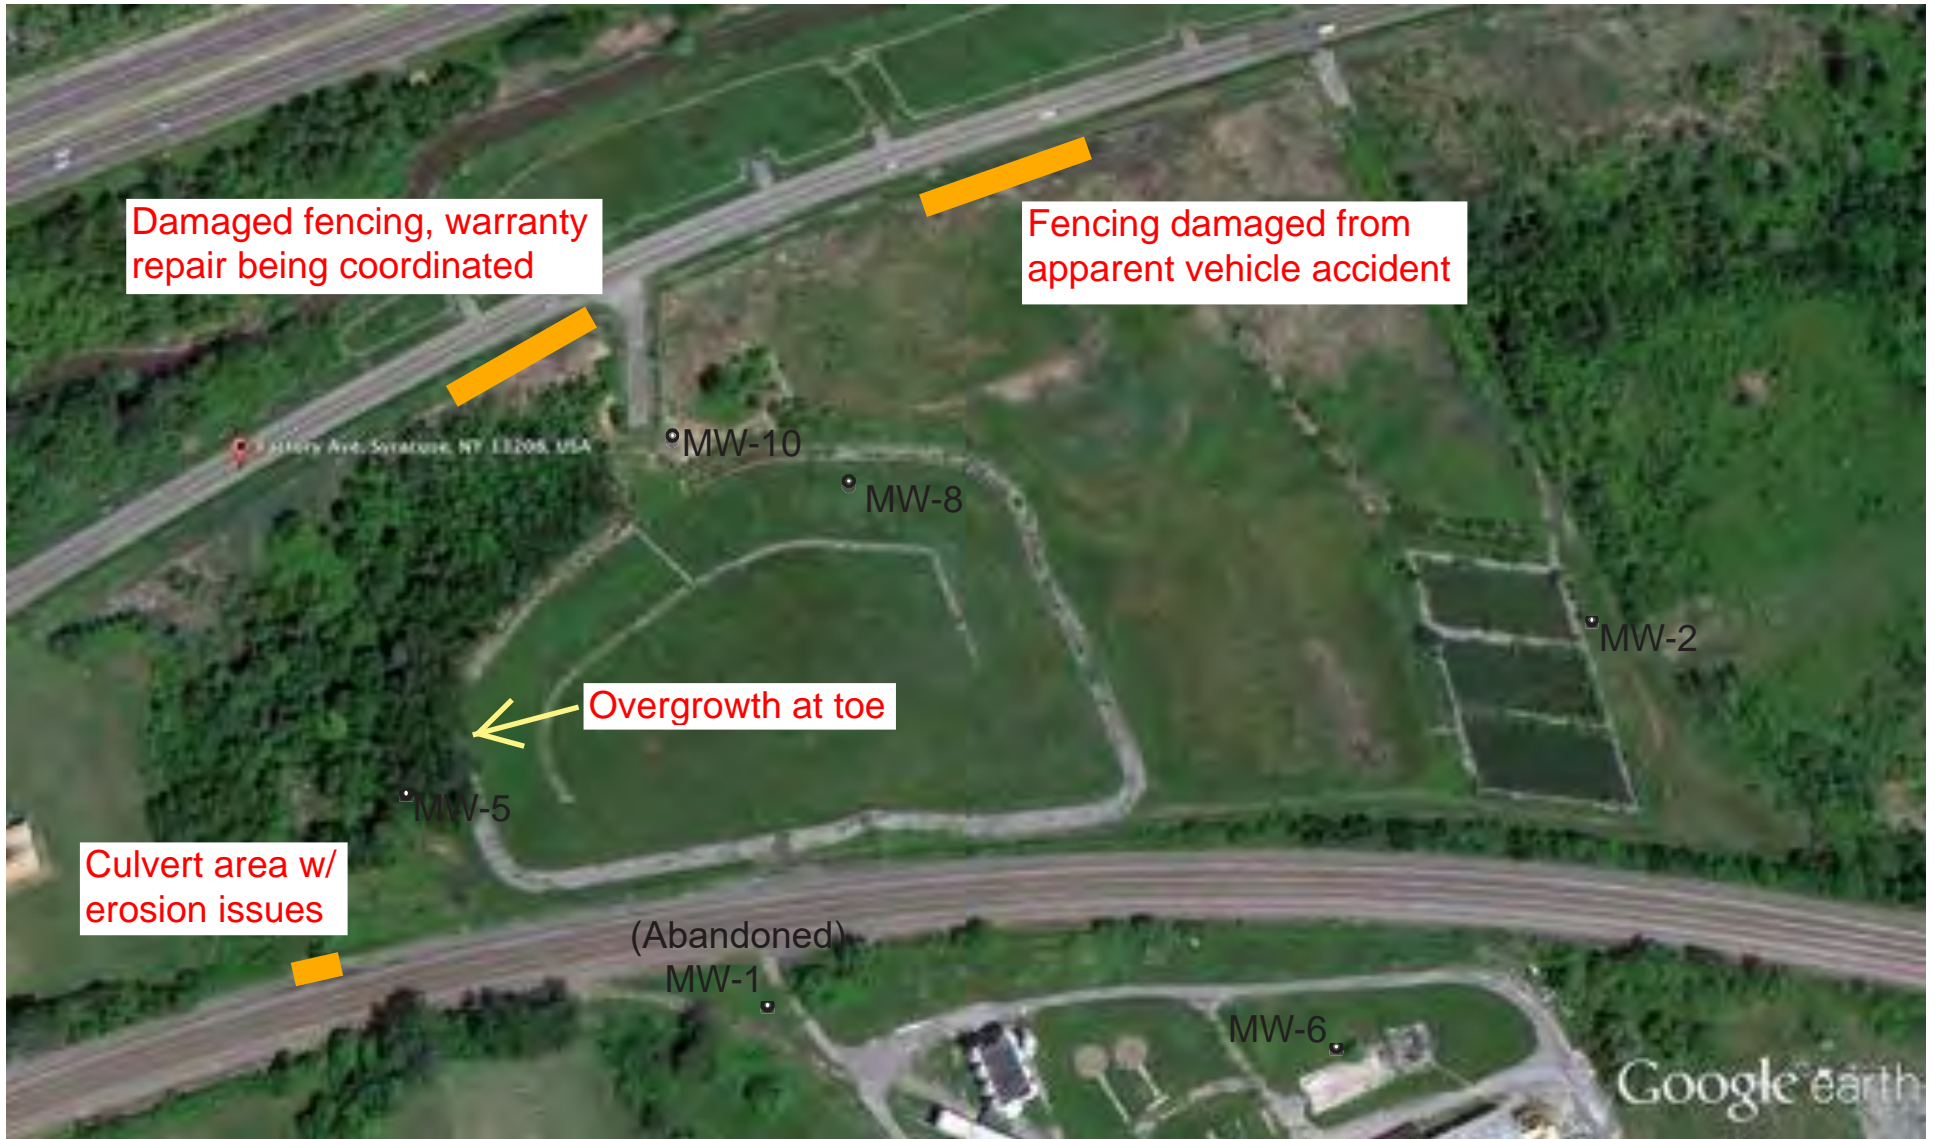
Site Feature Location Plan

The Site location and site features are represented in figures 1, 2 and 3. Groundwater monitoring well locations are provided on Figure 3. The results of the sampling activities are summarized in the Site Monitoring, Inspection and Maintenance Forms provided in Appendix A. Historical groundwater sampling data is summarized in Table 1. Laboratory analytical reports are provided in Appendix B.

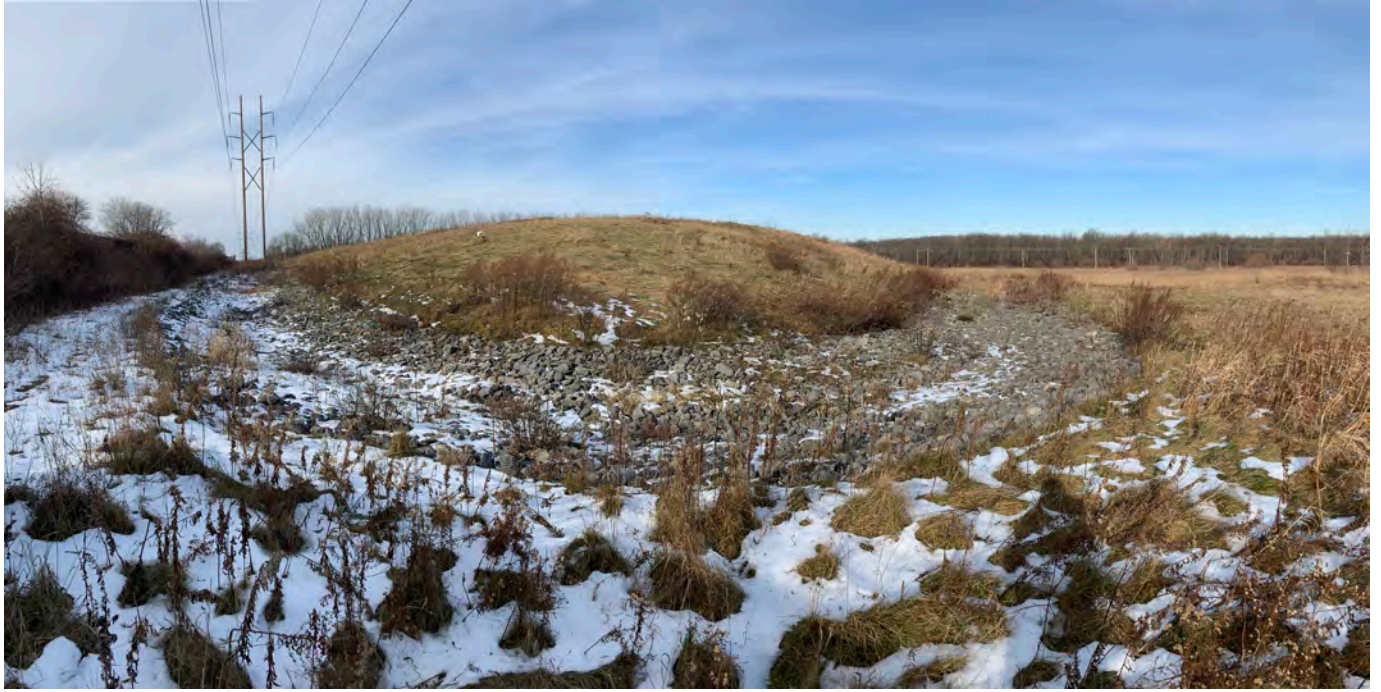
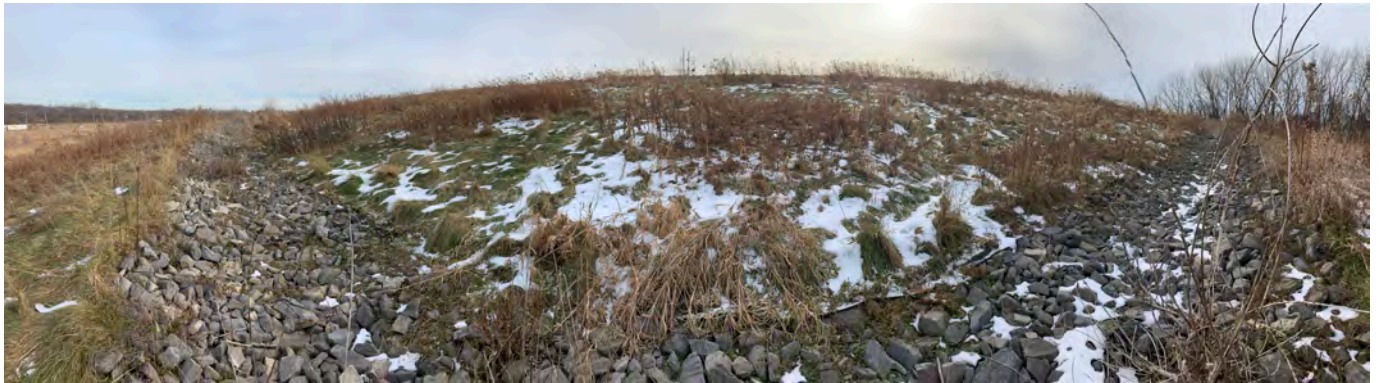
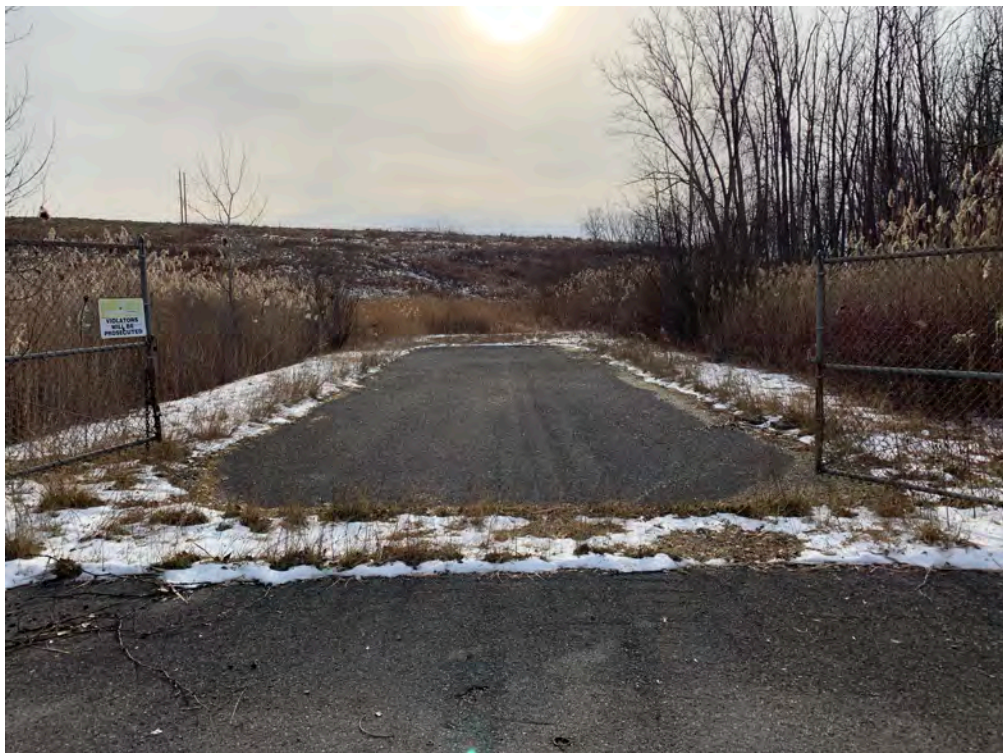
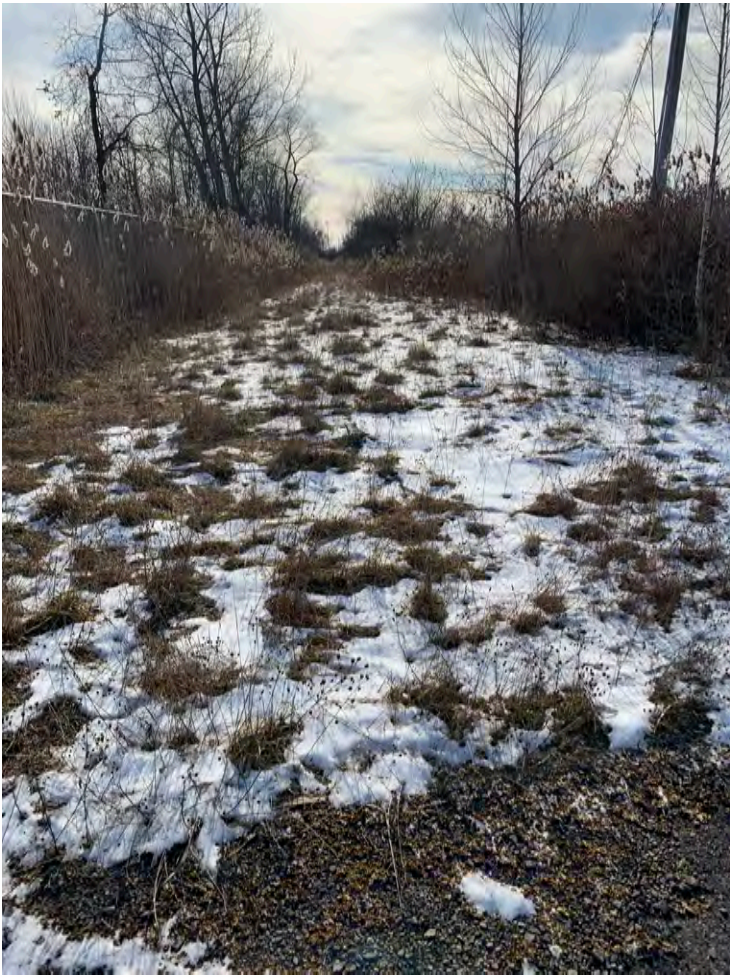
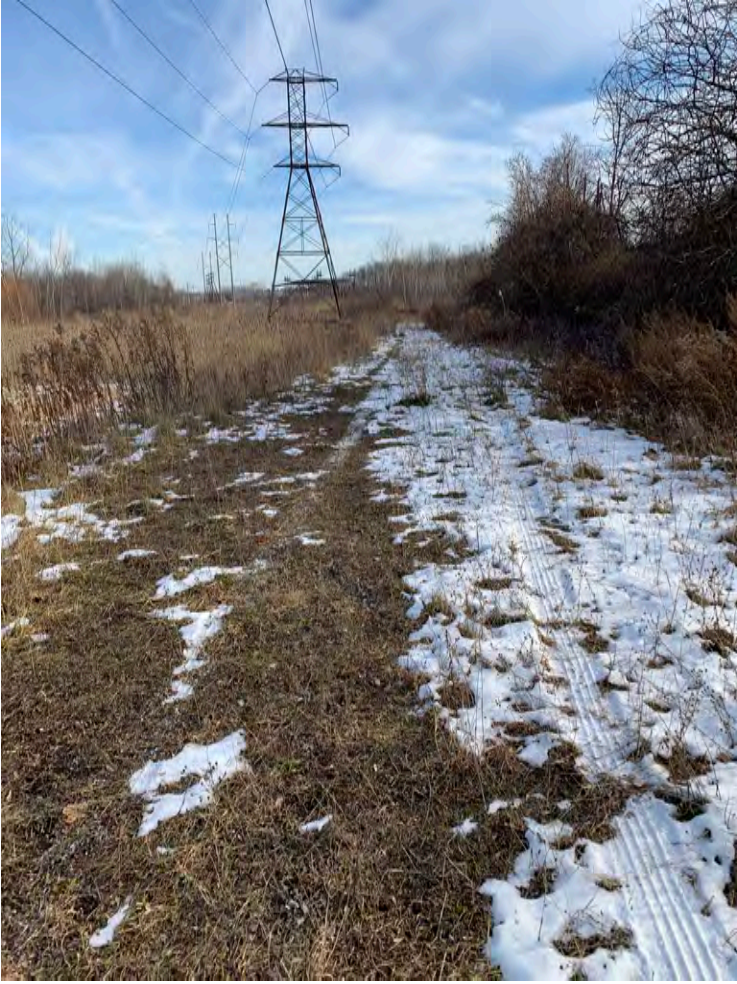
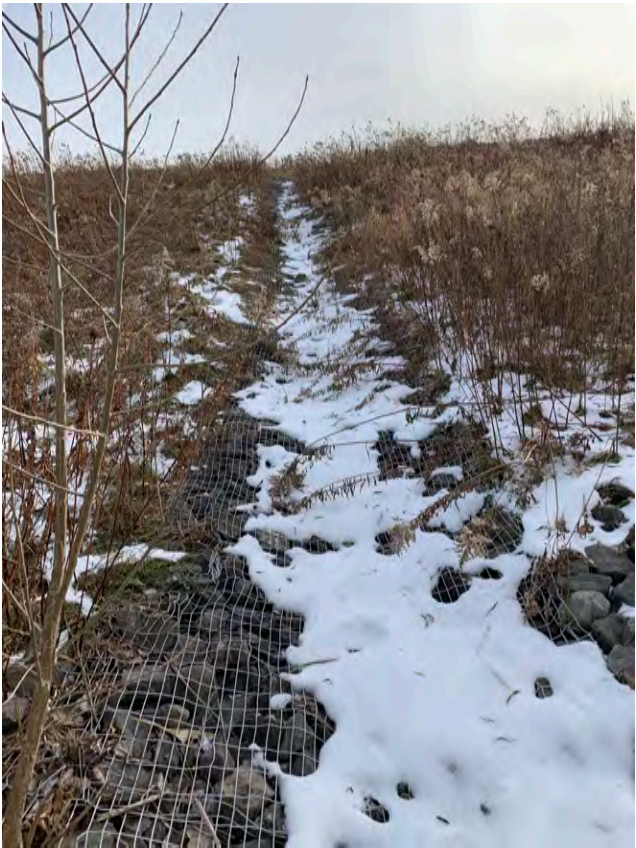
## Site Photos

Approximately 100 feet of fencing along the northern border/Factory Ave has begun to deteriorate due to oxidation of the support posts. An additional, approximately 150 feet of fencing along the northern border/Factory Ave have been damaged. Damage appears to have been caused by a vehicle accident. Broken pieces of autobody parts/plastic/debris were scattered throughout this area of damaged fencing. Repair of this area will occur concurrently with the warranty repair work. An area of fencing at the west side of the culvert area has been compromised. Stone was piled against the fencing, bending the support post and creating a large gap in the fencing. Figure 3 identifies the approximate locations of these areas. Photographs are included within Appendix C. Proposals for repair of the various fence areas will be obtained.

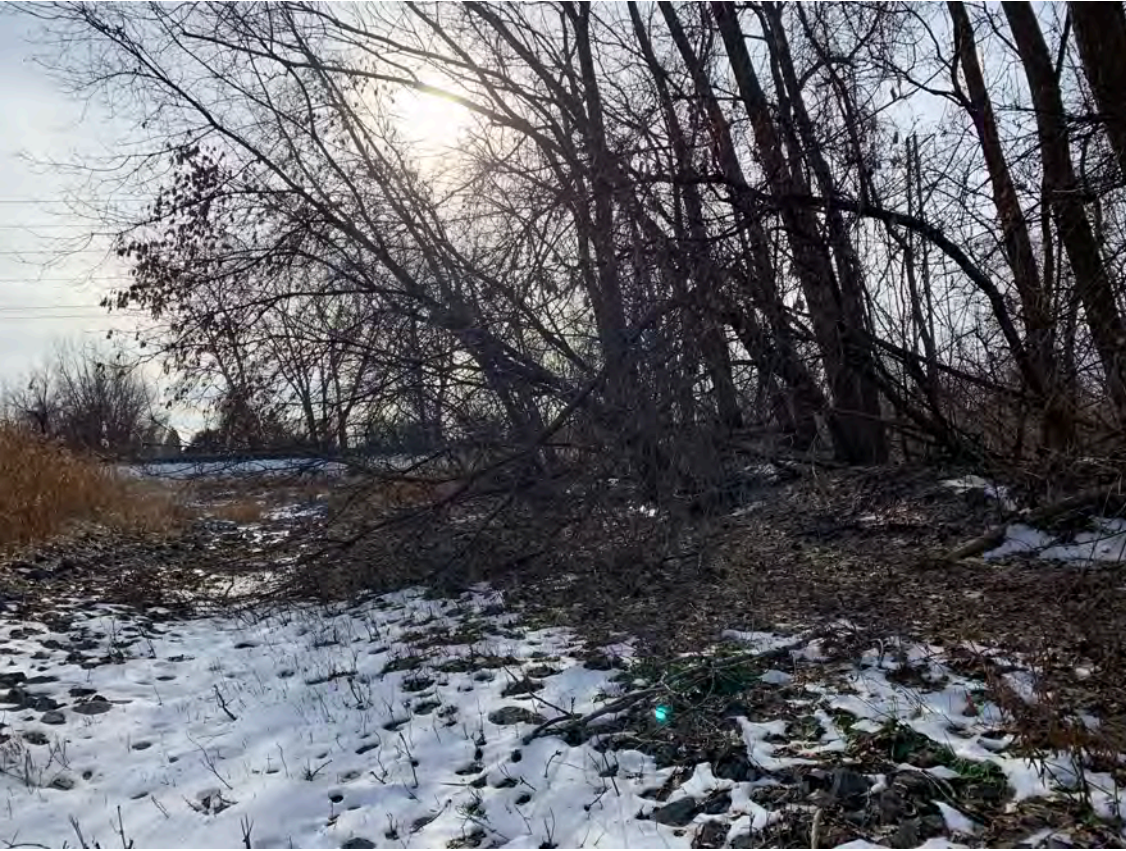
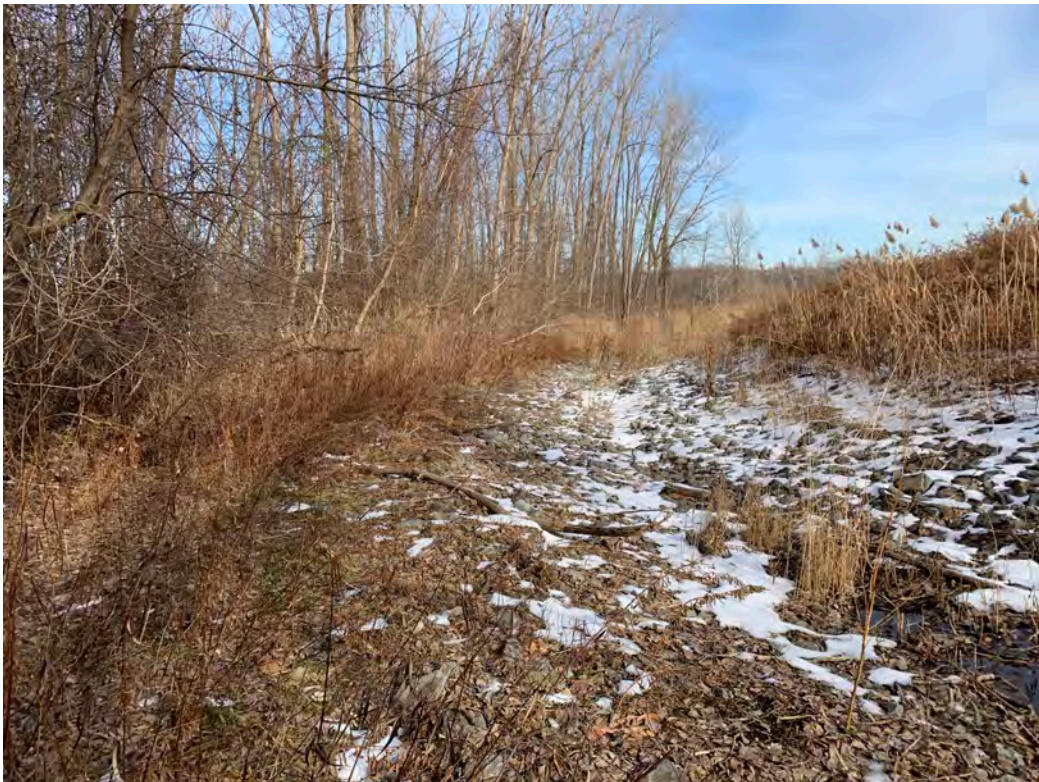
## Toe Overgrowth Area

Portions of the swales have become congested with vegetation. Treatment with a widely used aquatic herbicide Rodeo is proposed for Summer and Fall 2020.
