Groundwater Performance Monitoring Report

**Roth Bros. Smelting Corp.
Corrective Action Management Unit (CAMU)**

East Syracuse, Onondaga County, New York

June 2019 Sampling

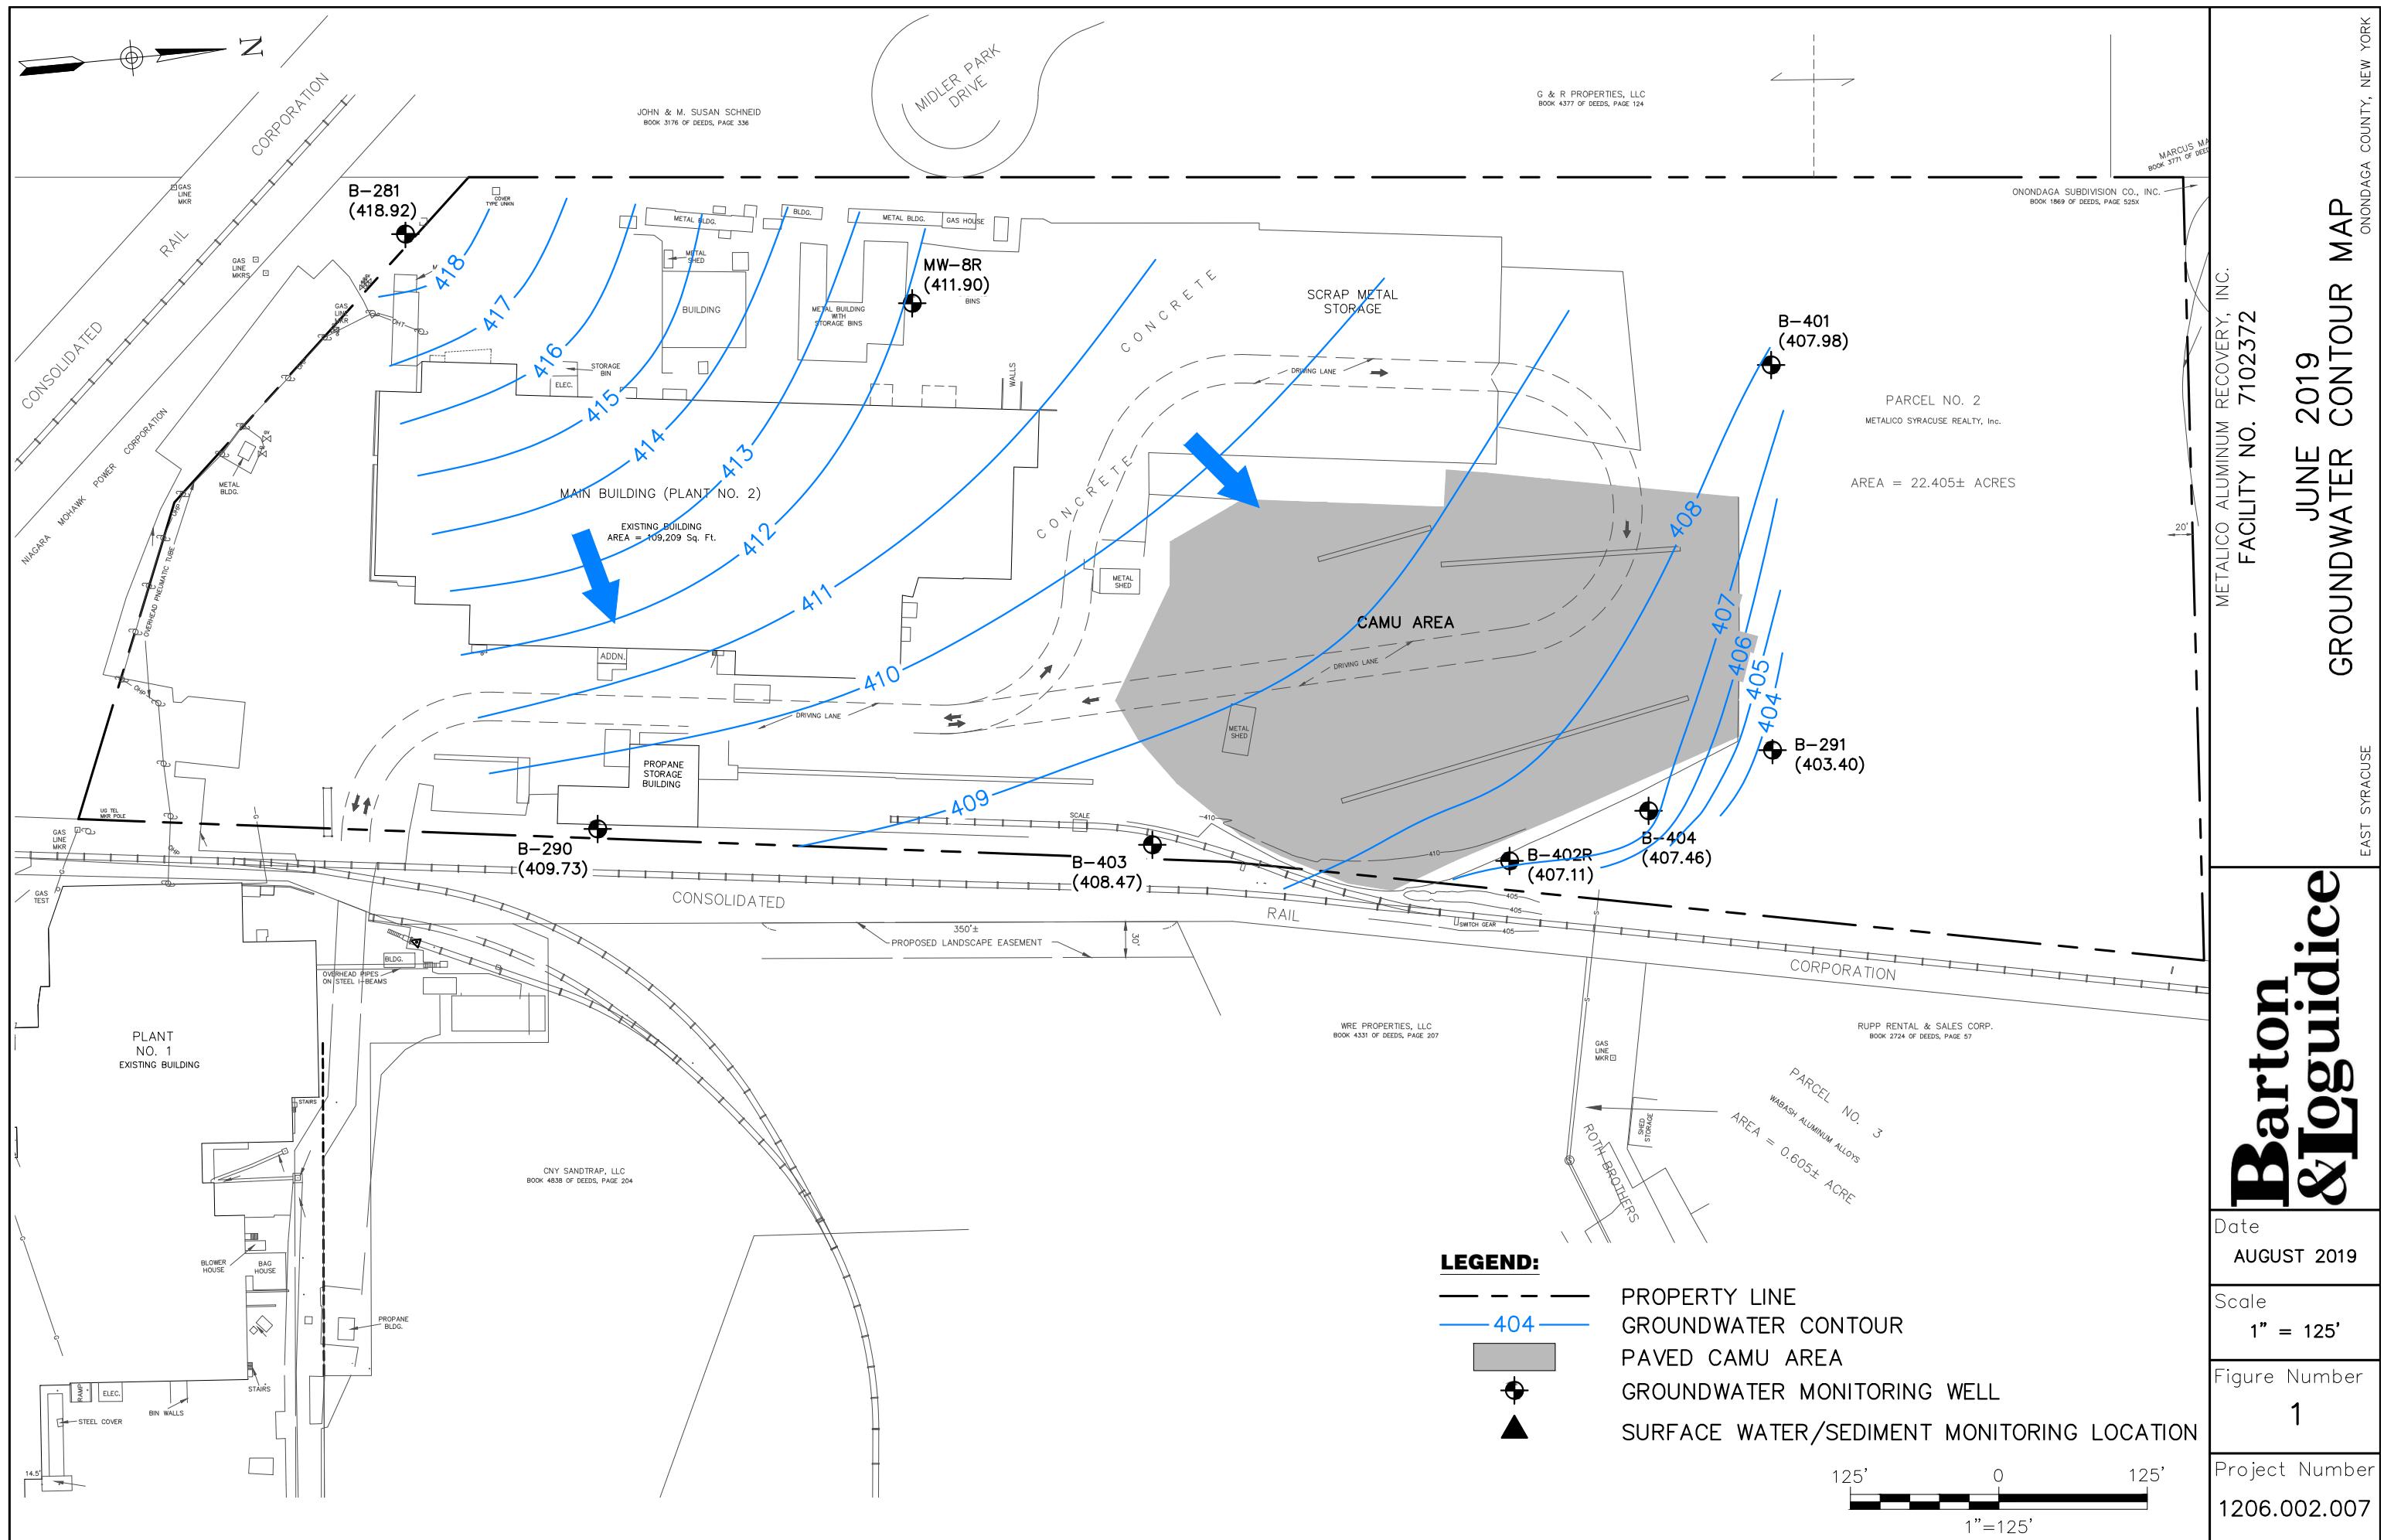
FIGURE 1
Groundwater Contour Map

Figure 1 shows the location of the Plant #1 and Plant #2 properties. The asphalt-paved CAMU area is located north of Plant #2. The monitoring locations associated with the CAMU groundwater performance monitoring, are included on Figure 1.

Figure 1 presents a groundwater contour map that reflects the water level data, which is set forth in Table 2. Table 2 also includes historical water level data prior groundwater sampling events.

The contour map indicates that the general groundwater flow direction at the Site is to the northeast toward the South Branch of Ley Creek. This finding is consistent with historical groundwater contour data.
