# PHASE I ENVIRONMENTAL SITE ASSESSMENT

# HIAWATHA BOULEVARD WEST PROPERTY City of Syracuse Onondaga County, New York

WEITSMAN SYRACUSE HOLDINGS, LLC P.O. Box 420 Owego, New York 13827-0420

April 2015

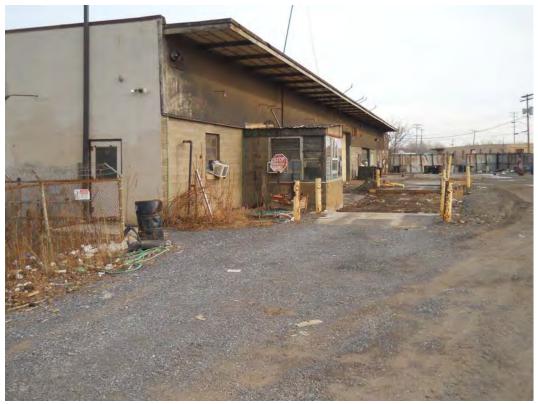
PHOTO 1

- Building 1 is a 40-foot by 200-foot single-story block office and scale house building containing the main office and control rooms for the former on-site scales, as well as some storage space [Photo 1].

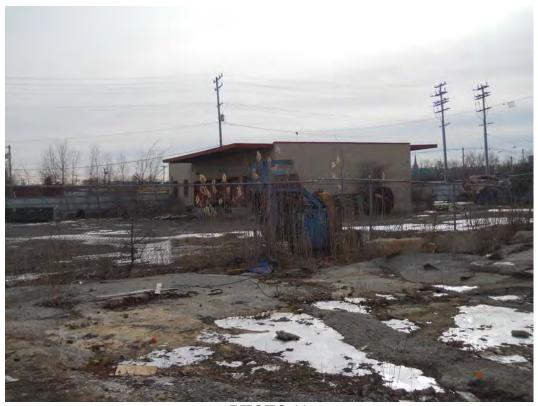
**PHOTO 11**

- Building 5 is a 60-foot by 90-foot single-story block building containing tools and welding supplies, and appears to have been utilized for equipment maintenance [Photos 11 and 12].

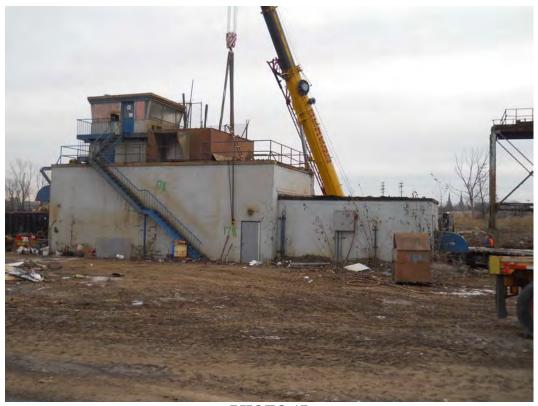
**PHOTO 17**

- Building 8 is a 75-foot by 25-foot two-story building containing mechanical and electrical equipment, as well as controls for the on-site shredder [Photos 17 and 18].
   The shredder, equipment and controls have been removed from the Property.

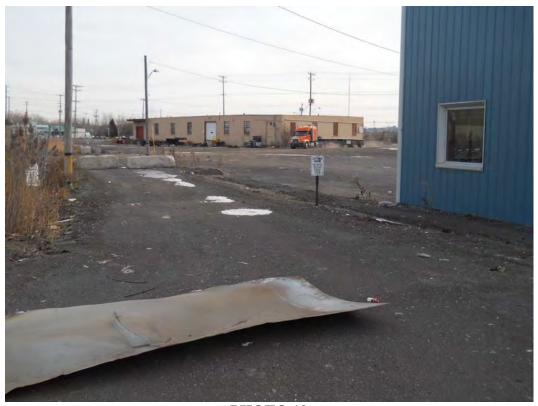
**PHOTO 19**

A paved driveway surrounds Buildings 1, 2 and 3 [Photo 19]. Unpaved driving lanes and scrap storage areas surround Buildings 4, 5, 6, 7 and 8 [Photo 20]. A stormwater pond

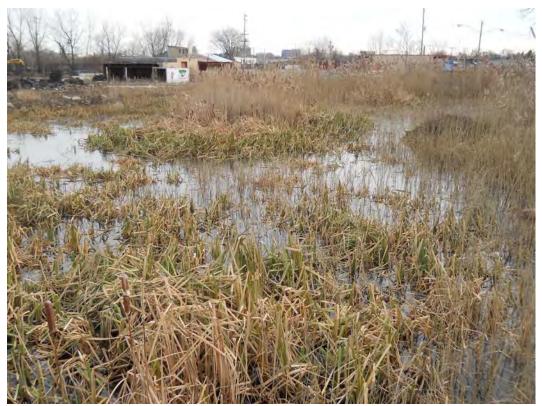
**PHOTO 21**

(approximately 100 feet by 300 feet) surrounded by ASR used as fill [Photos 21 and 22] is located in the central area of the Property.

One stormwater pond was observed on the Property [Photo 21]. This pond is reported to have PCB contamination.

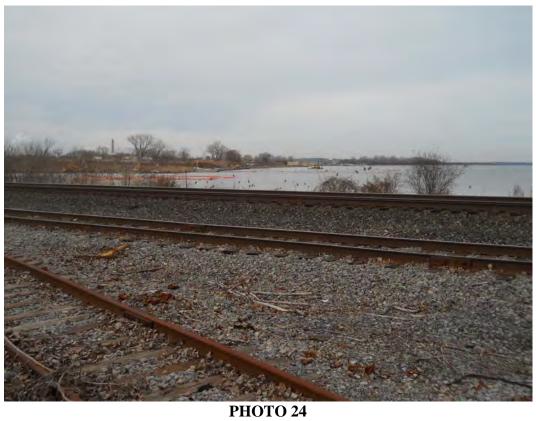
**PHOTO 23**

The Onondaga County Metropolitan Wastewater Treatment Plant (WWTP), CSX railroad tracks and Onondaga Lake are located to the north [Photos 23 and 24]. A metals plating facility, a vacant former tank manufacturing site, offices and a used car dealership are located to the southeast across Hiawatha Boulevard [Photos 25, 26, 27 and 28]. An automotive sales and repair shop, truck stop, motel, diner, rubbish removal company, fencing contractor and industrial waste storage and transfer facility are located to the south along State Fair Boulevard [Photos 29, 30, 31 and 32].

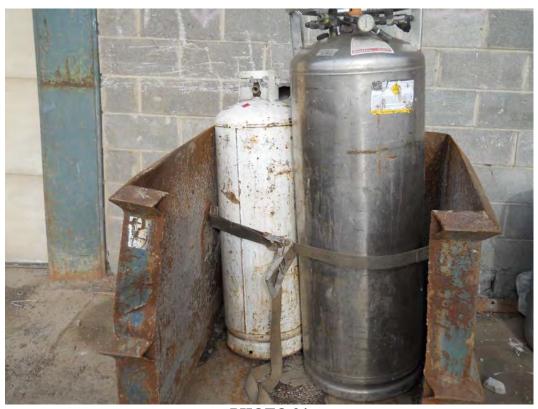
РНОТО 33

Numerous hazardous substances in connection with identified uses were observed on the Property. These substances included PCBs, cleaning supplies, gasoline, oil, waste oil, lubricants, antifreeze, used antifreeze, welding gases and propane [Photos 33 through 41]. Many of the containers observed were not labeled.

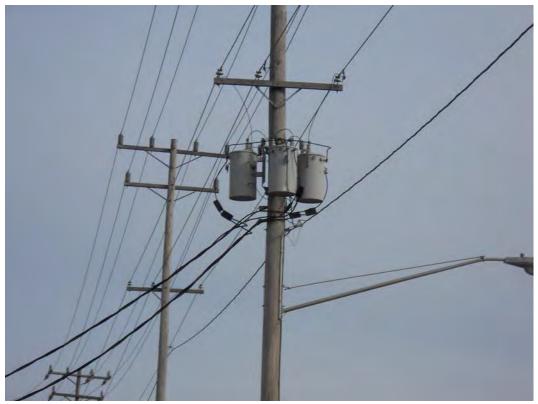
**PHOTO 42**

One large pad mounted transformer and three pole mounted transformers were observed on the Property [Photos 42 and 43]. The pad mounted transformer was labeled as non-PCB [Photo 44] and was subsequently removed from the Property in January 2015. Oil staining as observed in the transformer location during the January 5, 2015 follow-up inspection and reported to the on-site representative [Photo 45]. It is unknown if this oil spill was reported by the on-site representative to the DEC. The pole mounted transformers had no visible labeling to indicate PCB content. Electrical equipment in Building 8 associated with the shredder equipment was labeled as containing PCBs. This equipment has been removed from the Property. A floor drain was identified in close proximity to the electrical equipment [Photo 46]. One drum containing capacitors and other electrical devices suspected of containing PCBs was identified in Building 4 [Photo 47].

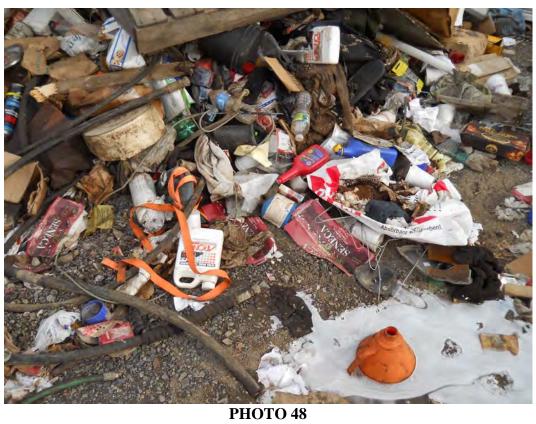
**PHOTO 47**

- One drum containing capacitors and other electrical devices suspected of containing PCBs.
- Various drums and containers of unknown materials.
- Several localized areas of stained soils.

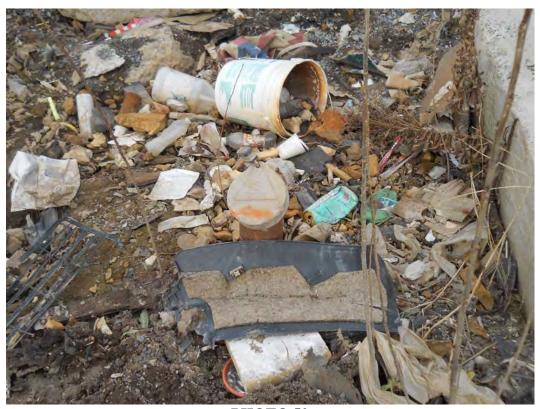
**PHOTO 49**

Various solid waste debris was observed scattered throughout the Property, especially around Buildings 4, 5 and 6 [Photos 48, 49 and 50], and should be removed from the site. ASR was observed in the pond area, former ASR piles area, eddy current test pit area and the ASR cells area [Photos 22, 51, 52 and 53].

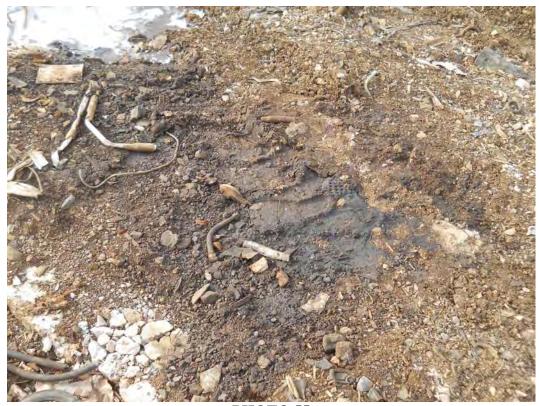
**PHOTO 54**

The Property was observed to be mainly unvegetated. Areas of staining and debris were noted scattered throughout the Property [Photos 54 through 60].

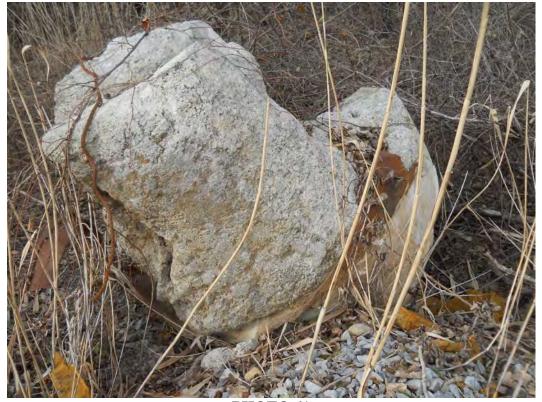
**PHOTO 61**

Portions of the Property are covered with unevenly deposited concrete [Photo 61]. Numerous tires were observed throughout the site [Photo 62]. These tires should be properly disposed of off-site.
