CONSTRUCTION COMPLETION REPORT

Off-Site Sub-Slab Depressurization System –
8 Adler Drive

Northern Circuits (Site No. 734124)
6 Adler Drive, Dewitt, New York

February 2021

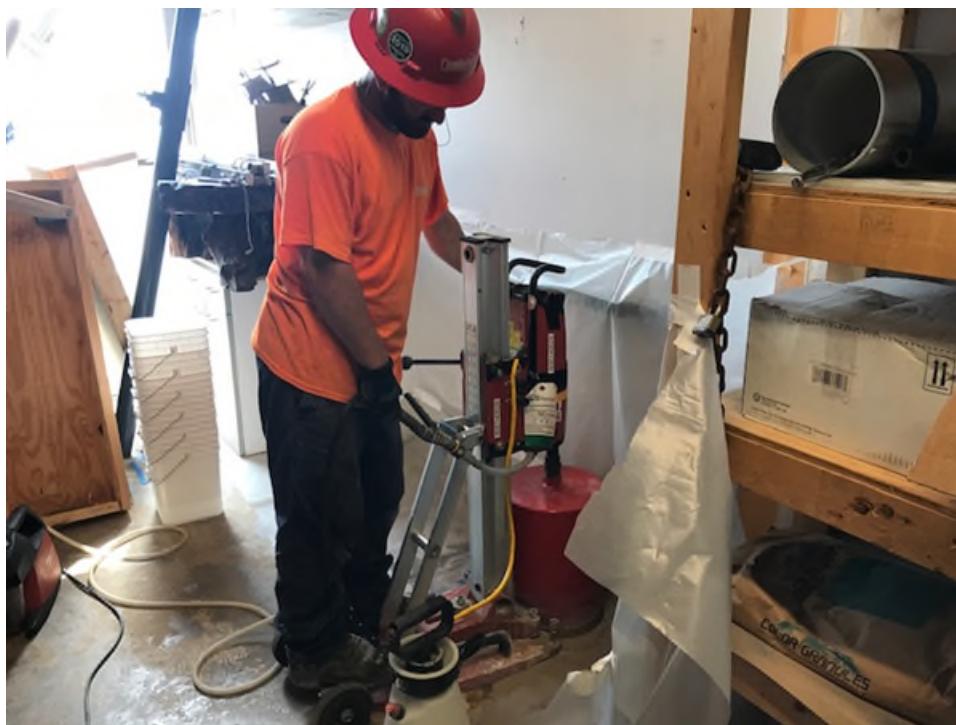
Photograph: 1

Description:
Extraction point EP-2A installation

Seven extraction points (EP-1A, EP-1B, EP-2A, EP-2B, EP-3A, EP-3B, and EP-3C) were installed by core-drilling a hole in the concrete slab, removing material from the area immediately beneath the slab to create a sump (approximately 2-foot diameter and 8 inches deep), and placing $\frac{3}{4}$ -inch-diameter washed gravel up to the bottom of the slab (refer to Detail 1 on Sheet 2, Appendix B). An open-ended section of 3-inch-diameter Schedule 80 polyvinyl chloride (PVC) pipe was installed vertically into each sump, extending to a depth of 1 to 2 inches below the bottom of the concrete floor slab. Prior to installation of new concrete, 6-mil polyethylene sheeting was placed directly above the washed gravel. Concrete was installed flush with the surrounding floor surface.

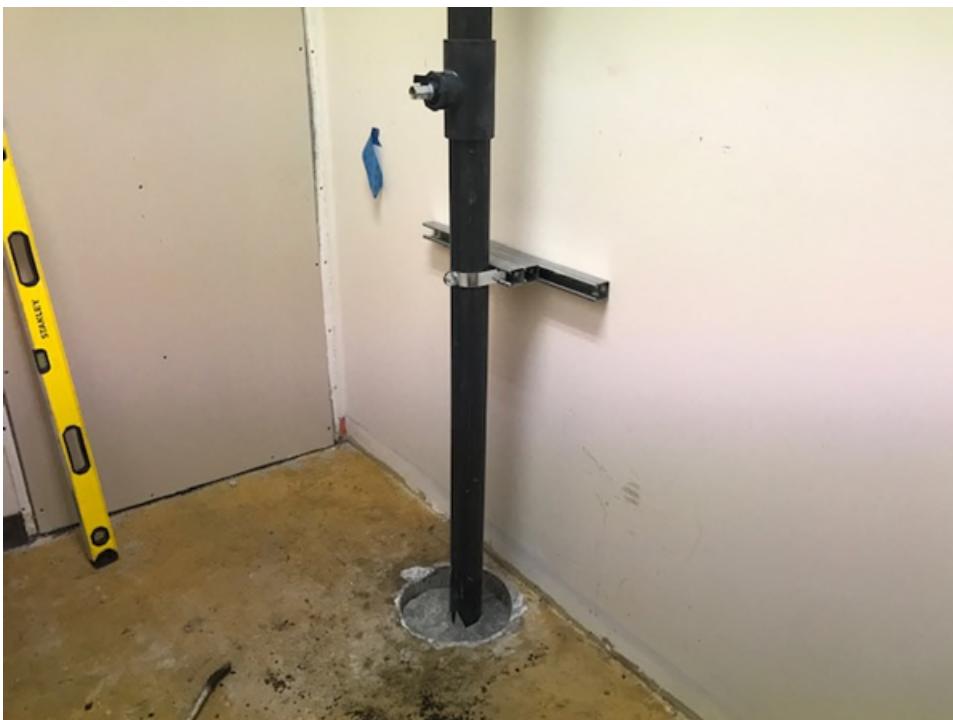
Photograph: 2

Description:
Extraction riser
installation for EP-2B

Mechanical controls and monitoring accessories for each extraction point are installed on an extraction riser that extends vertically from the extraction sump. Riser pipes for the extraction points were constructed of Schedule 80 PVC pipe. Each riser pipe consists of the following components:

- An inline 3-inch-diameter Schedule 80 PVC flow-control butterfly valve.
- A vacuum gauge (-30 to 0 inches of water column [iwc] range for extraction points EP-2A, EP-2B, EP-3A, EP-3B, and EP-3C; and -60 to 0 iwc range for extraction points EP-1A and EP-1B).
- A direct-tap, $\frac{1}{2}$ -inch-diameter stainless steel ball valve to allow for air velocity measurements or extracted sub-slab soil vapor sampling, if required.

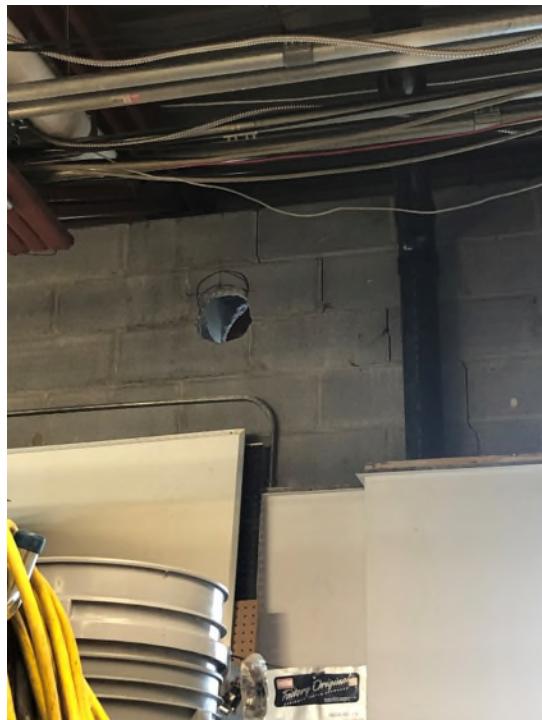
Photograph: 3

Description:
Wall penetration for
conveyance piping

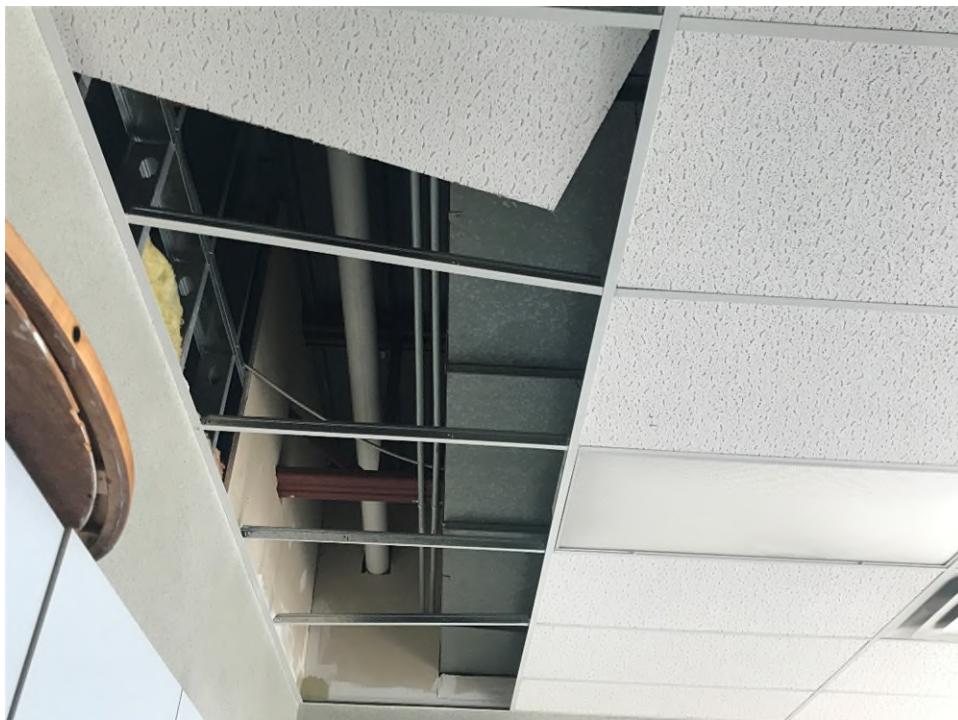
Photograph: 4

Description:
Conveyance pipe
installation above drop
ceiling

will flow by gravity back to the extraction point. Conveyance piping was installed above the drop-ceiling, where present. The SSD system layout, including conveyance piping routes and inline fan locations, is shown on Sheet 1 (Appendix B). An SSD extraction point schedule, including inline fan make/models and specifications (flow/vacuum and power ratings), is included in Table 1.

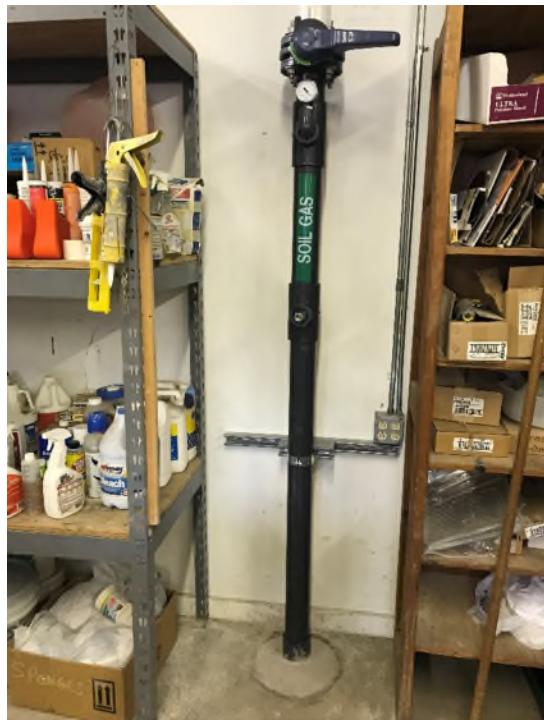
Photograph: 9

Description:
Extraction riser EP-1A

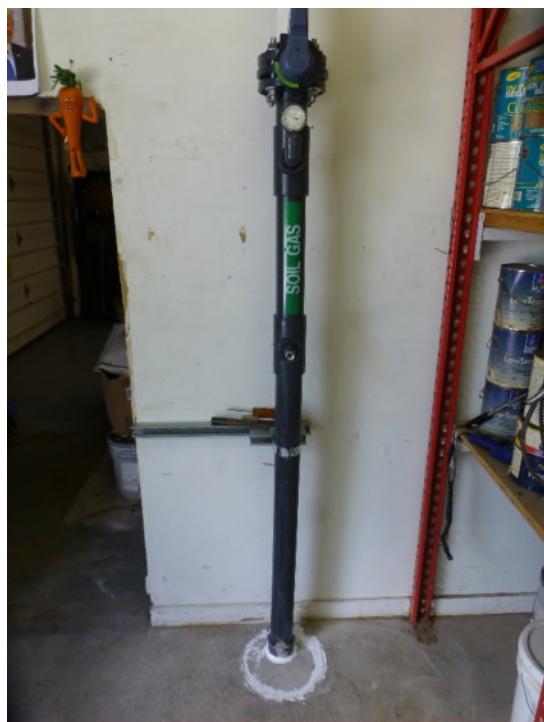
Photograph: 10

Description:
Extraction riser EP-1B

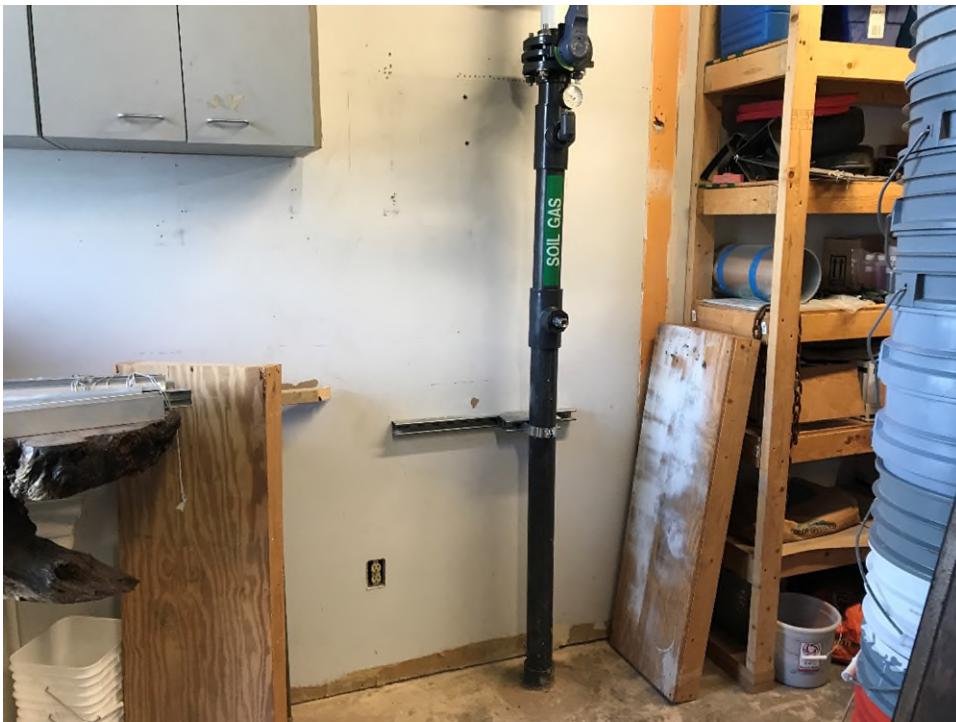
Photograph: 11

Description:
Extraction riser EP-2A

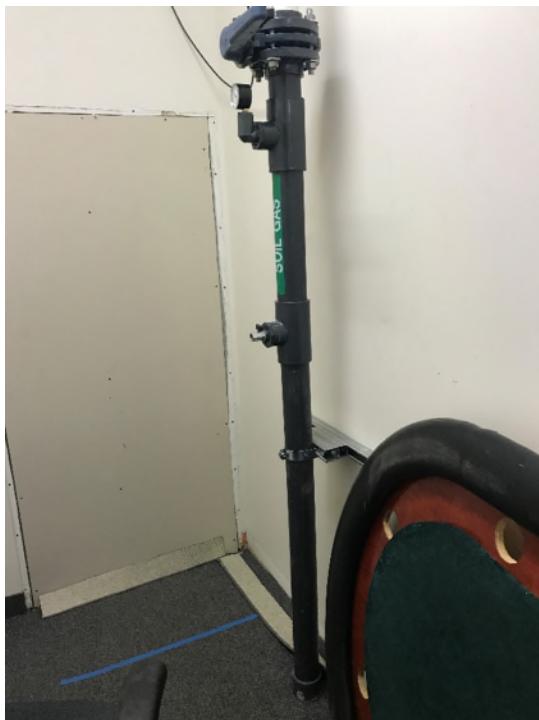
Photograph: 12

Description:
Extraction riser EP-2B

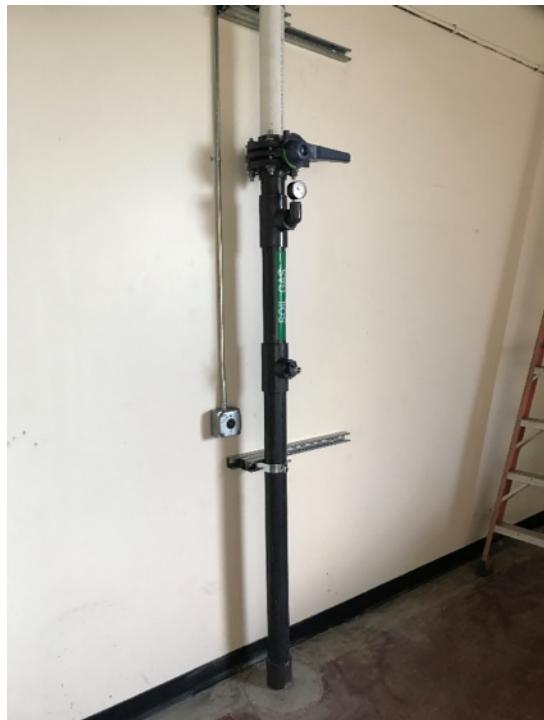
Photograph: 13

Description:
Extraction riser EP-3A

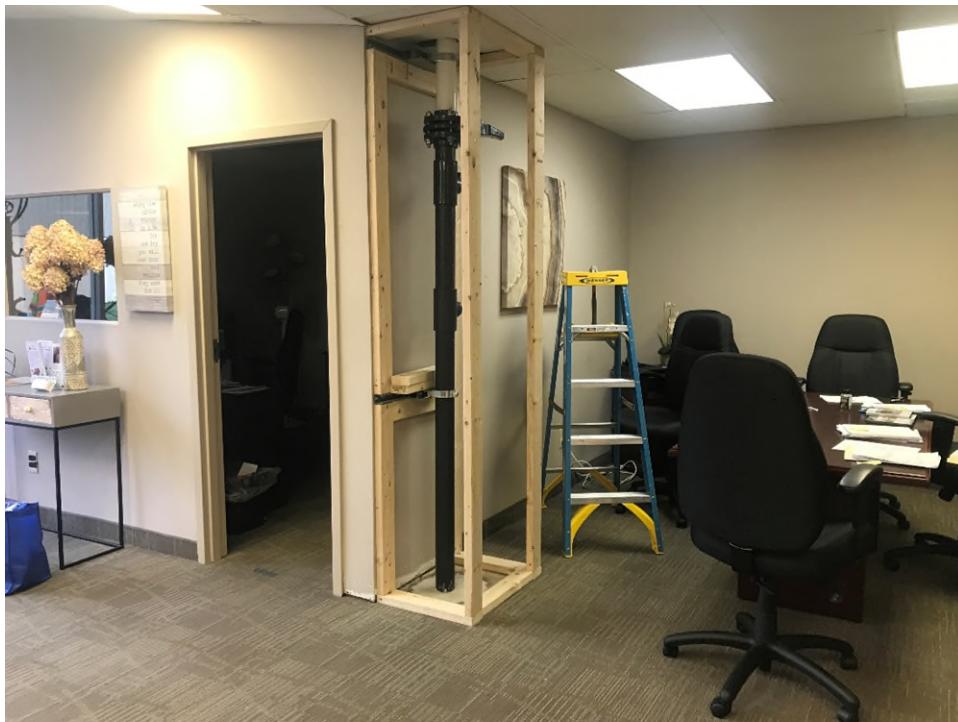
Photograph: 15

Description:
Extraction riser EP-3C
(mid-buildout)

An enclosure was built around the extraction riser for EP-3C, which is located in a conference room. The enclosure consists of wood framing and $\frac{1}{2}$ -inch-thick gypsum board panels. Access panels installed in the enclosure provide access to the inline butterfly valve and direct-tap ball valve for EP-3C. Finish work for the enclosure was left for the building owner to complete, per the building owner's request.

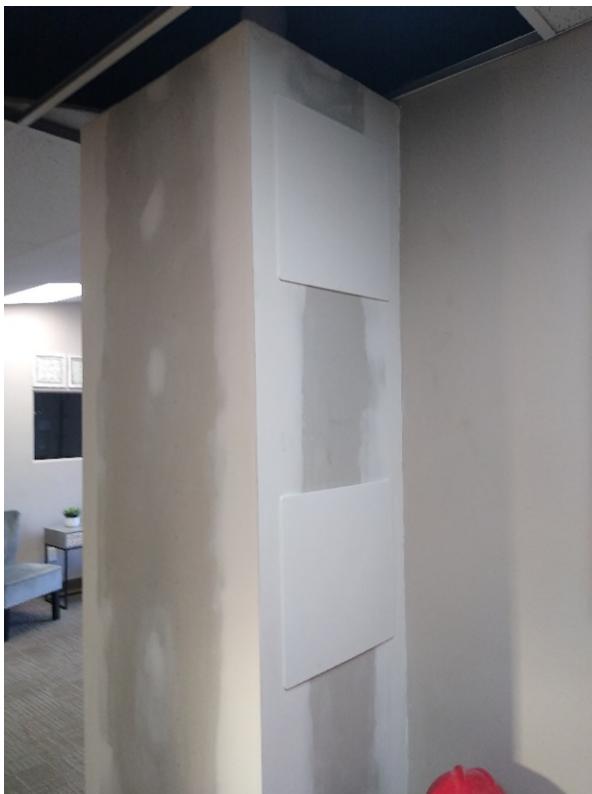
Photograph: 16

Description:
Extraction riser EP-3C
(buildout with access
panels)

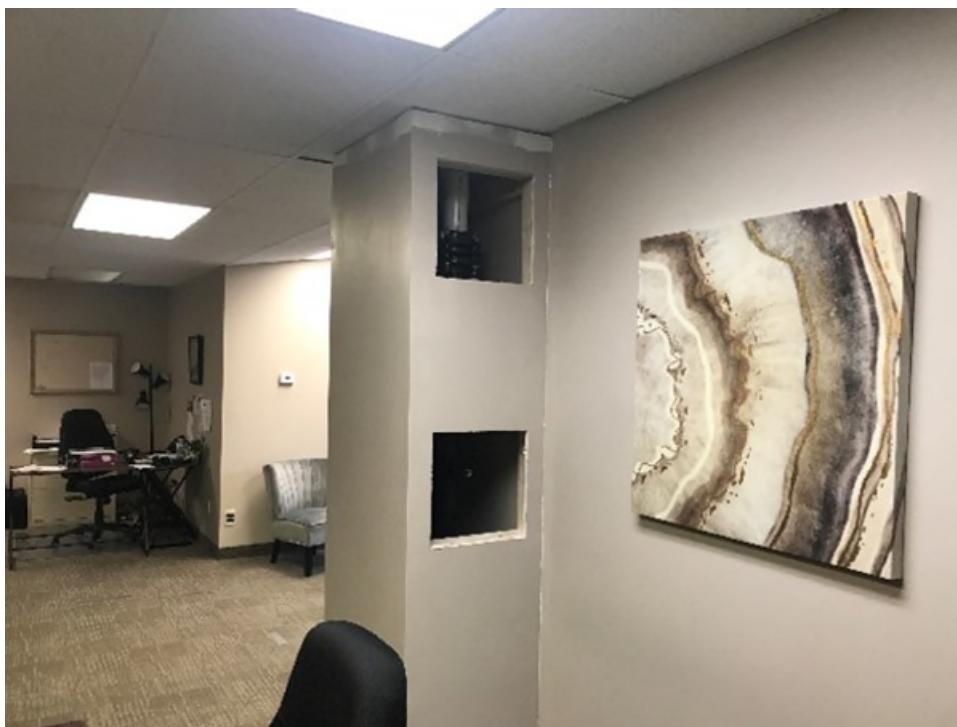
Photograph: 17

Description:
Extraction riser EP-3C
(buildout with access panels)

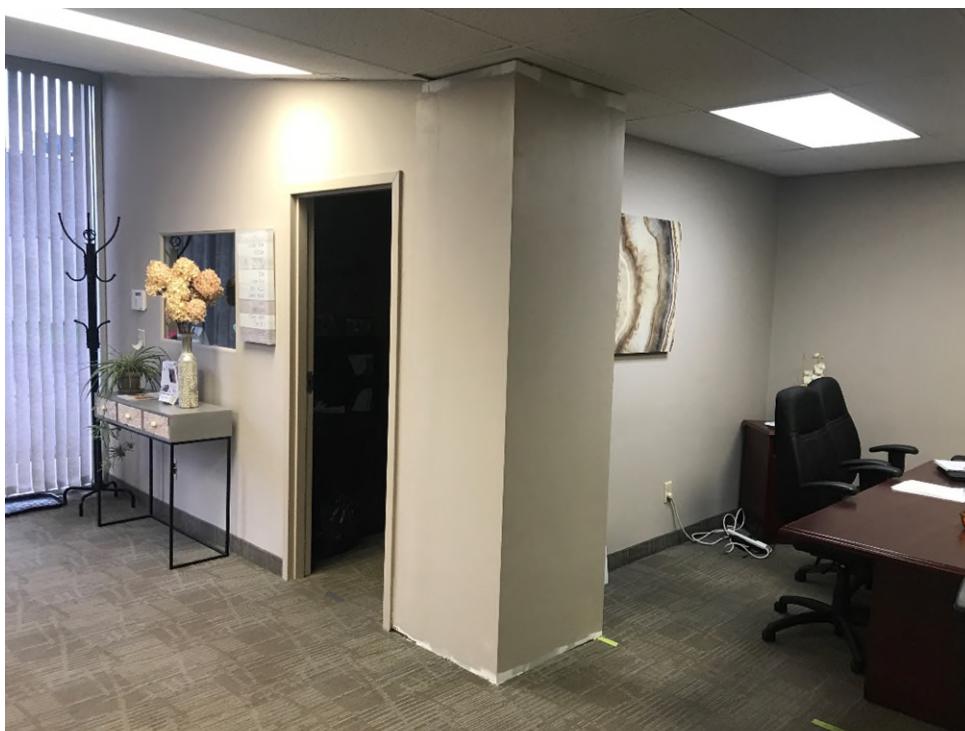
Photograph: 18

Description:
Extraction riser EP-3C
(owner to complete
finish work)

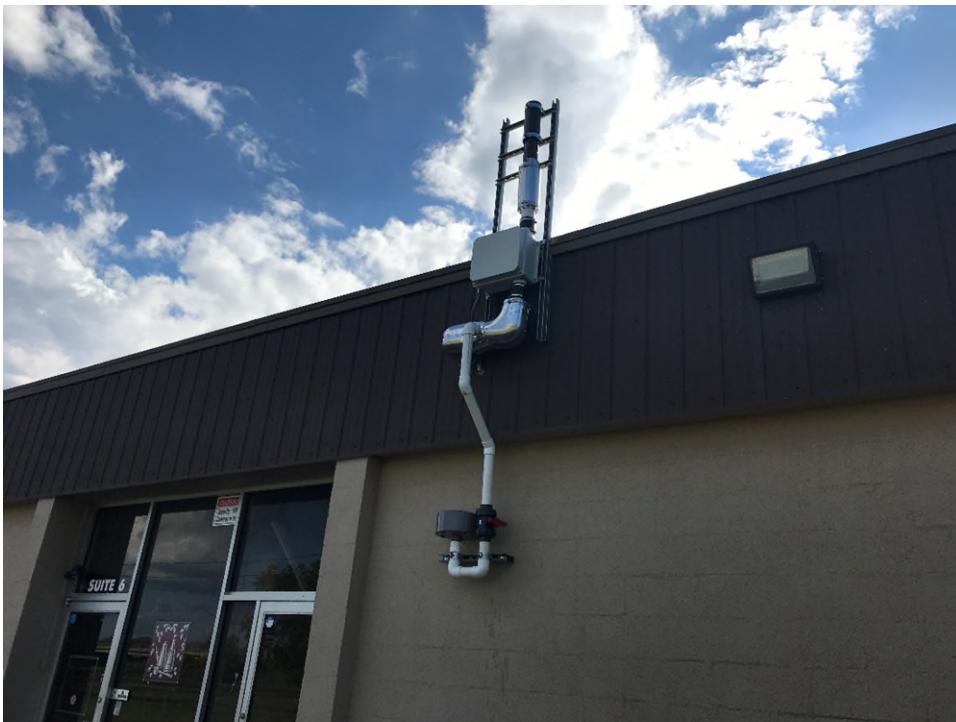
Photograph: 21

Description:
Vertical discharge (fan F-200) for extraction points EP-2A and EP-2B

Each inline fan was installed with a 3-inch-diameter Schedule 40 PVC vertical discharge stack extending to a height of 3 feet above the building roofline. A zero-loss rain cap (Harrison 1034-WCB-03) was installed at the top of each discharge stack. Exterior piping was installed with 1-inch fiberglass insulation and aluminum jacketing. Each fan is rated for exterior use and includes a built-in condensate bypass that allows any condensate that may accumulate above the fan to be directed to the suction side of the fan (i.e., below the fan) where it may drain to the extraction point. For each inline fan, a makeup air assembly was installed on exterior conveyance piping on the suction side of the fan to allow for additional adjustment of applied vacuum at SSD extraction points. Each makeup air assembly consisted of 2-inch-diameter Schedule 40 PVC piping, a 2-inch-diameter Schedule 80 PVC ball valve, and an inlet air filter/silencer (Solberg FS-19P-150). Vertical discharge details are shown on Detail 1 on Sheet 3 (Appendix B).

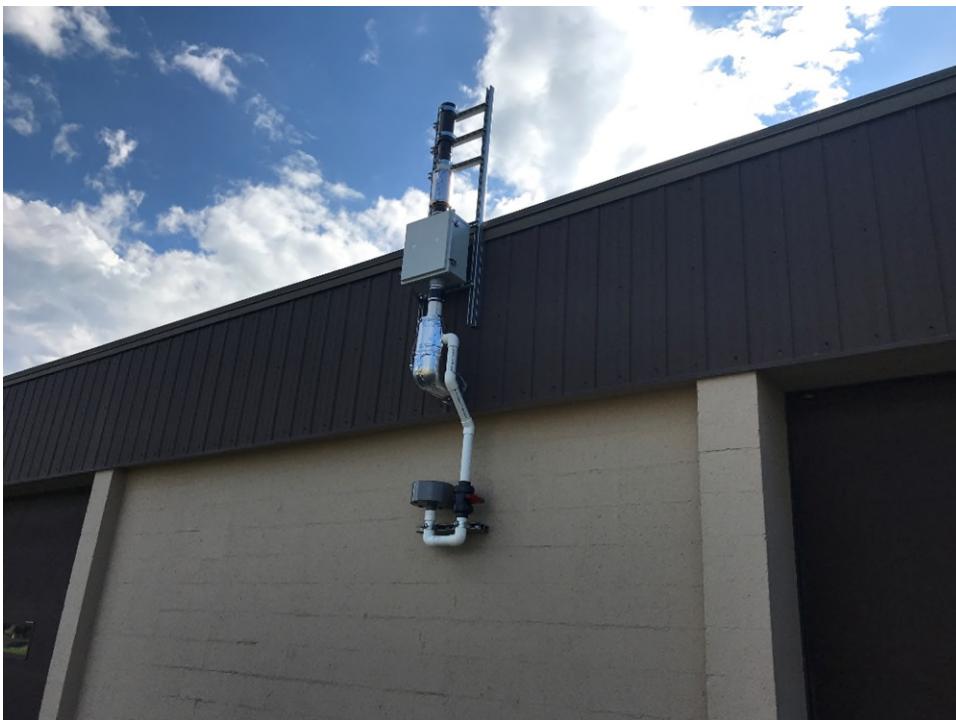
Photograph: 22

Description:
Vertical discharge (fan F-300) for extraction points EP-3A, EP-3B, and EP-3C

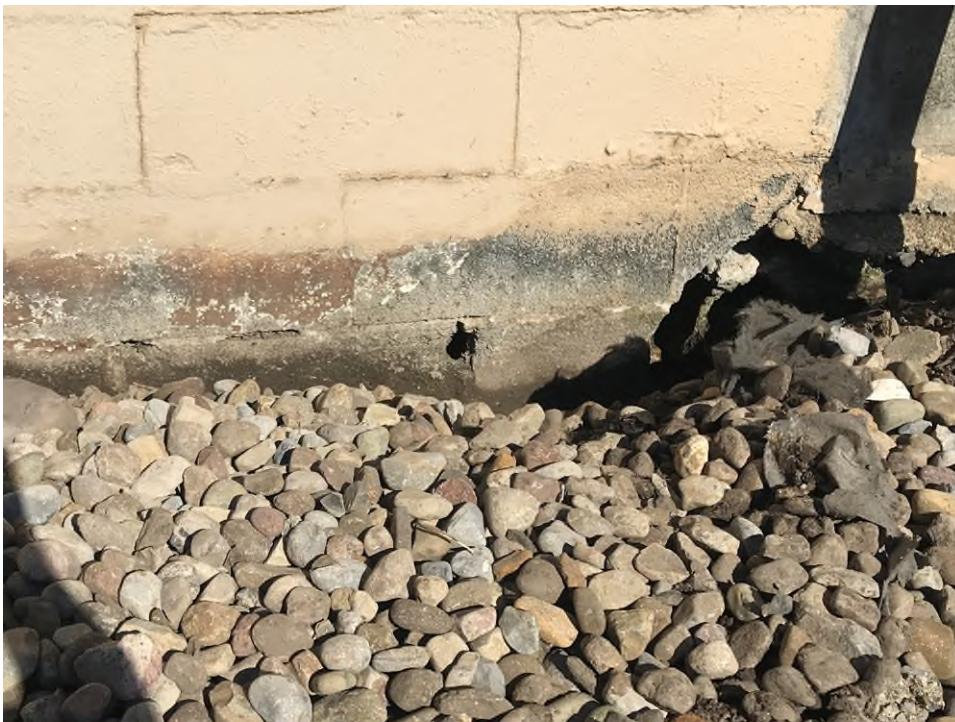
Photograph: 25

Existing damage to block wall foundation on exterior of building near extraction point EP-1A

Shortly after startup of the SSD system, floor cracks were sealed at two locations identified as potential short-circuiting areas. Approximately 30 linear feet of cracks were sealed in the area of vacuum monitoring point VMP-1, and approximately 70 linear feet of cracks were sealed in the area near extraction points EP-3A and EP-3B. Cracks were sealed using polyurethane caulk. Additionally, a damaged portion of the existing block wall foundation was identified as a potential short-circuiting area on the building exterior near extraction point EP-1A. Repairs to the building's foundation were not conducted as part of this work.

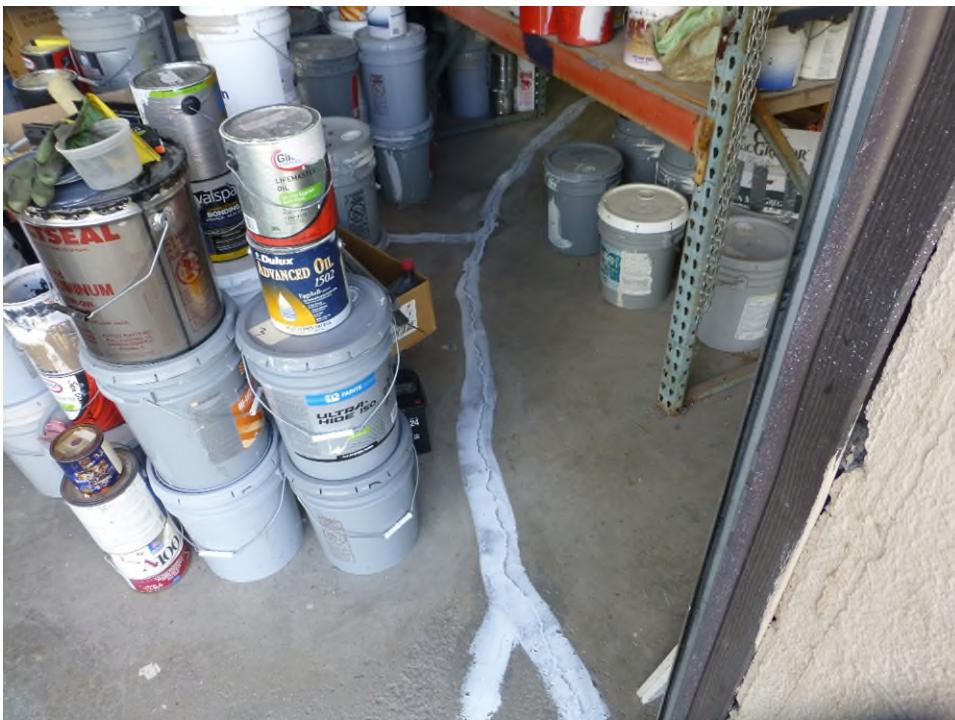
Photograph: 26

Sealed cracks in the northwesternmost room near vacuum monitoring point VMP-1

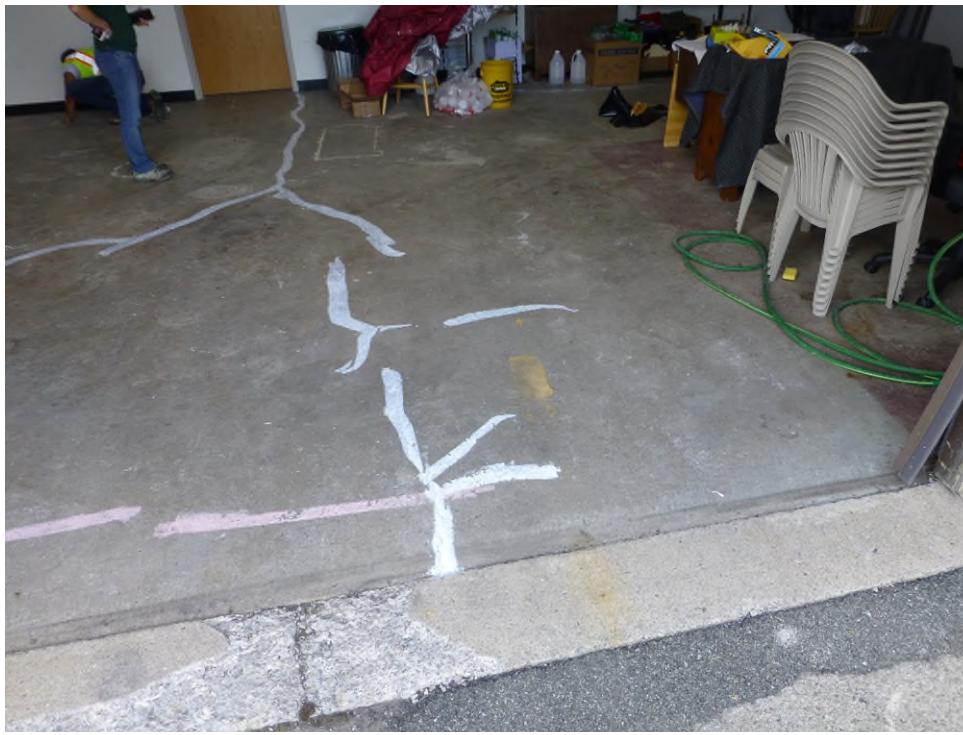
Photograph: 27

Description:
Floor crack sealing in
Suite 3 garage
