*PAS Oswego Superfund Site – 2012 Annual Report*

SLURRY WALL

PAS - OSWEGO  
GROUNDWATER ELEVATIONS (SWW1 and SWW2)

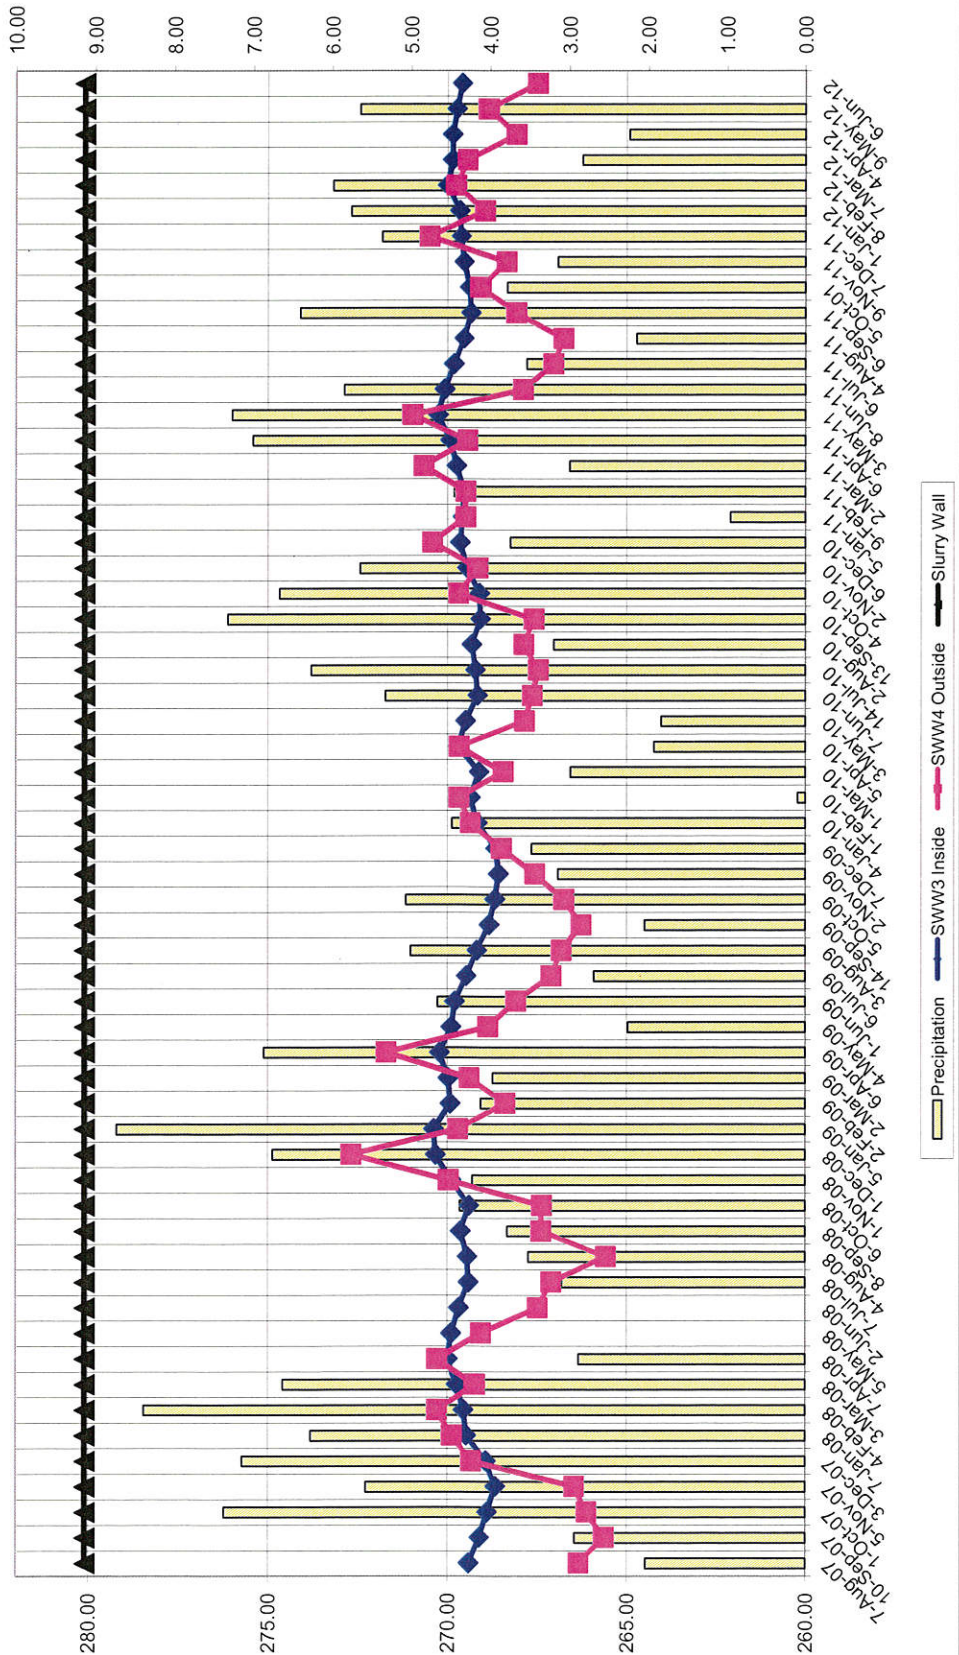
# PAS - OSWEGO GROUNDWATER ELEVATIONS (SWW3 and SWW4)

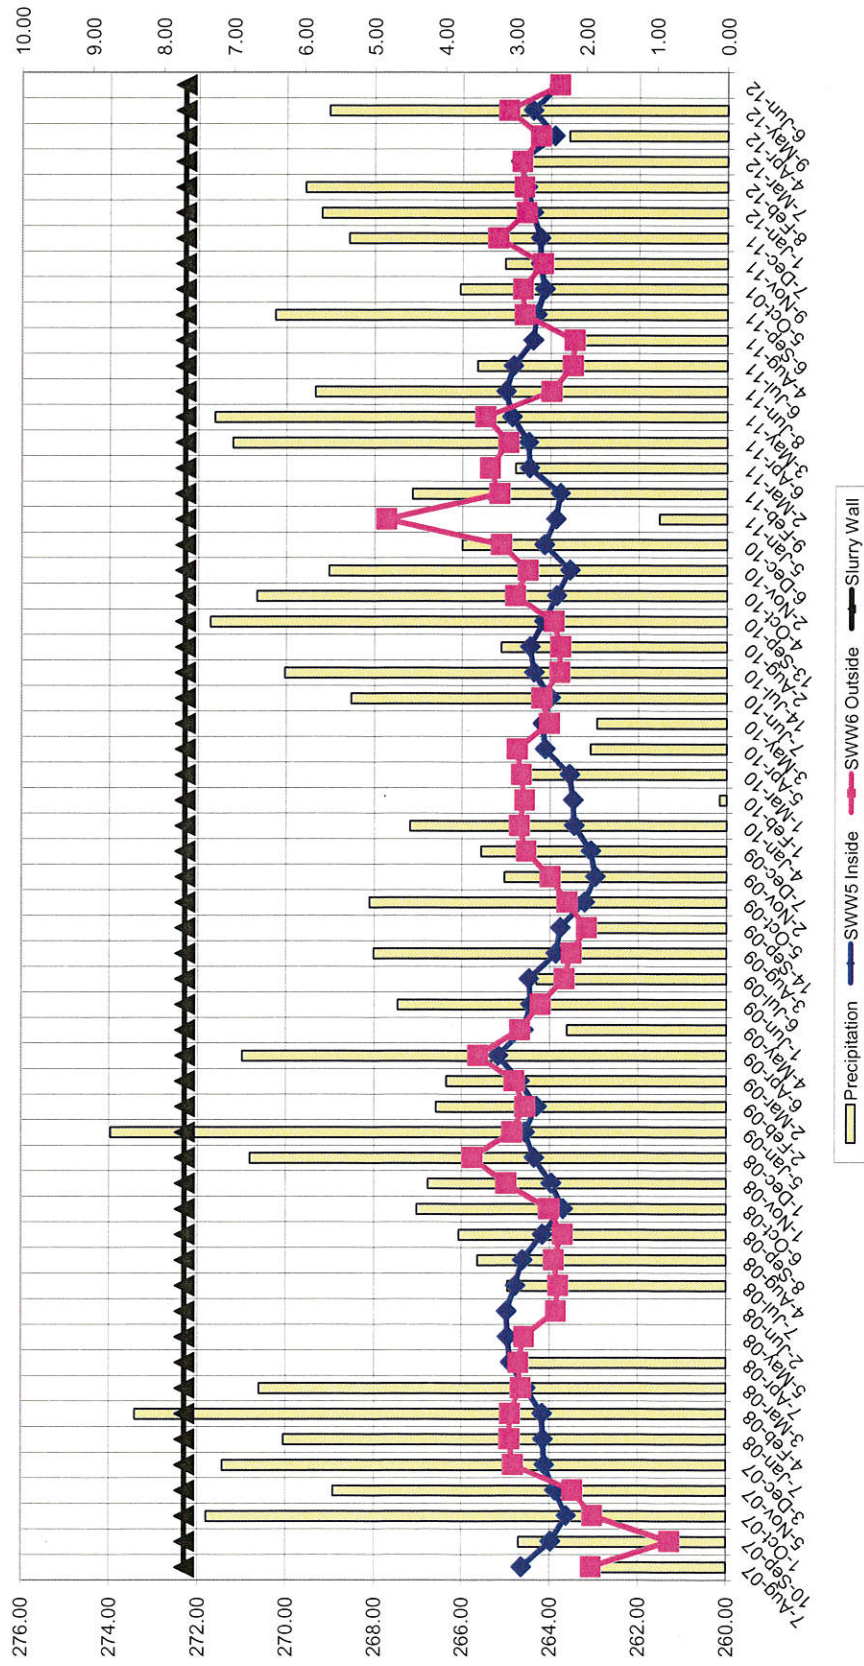
# PAS - OSWEGO GROUNDWATER ELEVATIONS (SWW5 & SWW6)

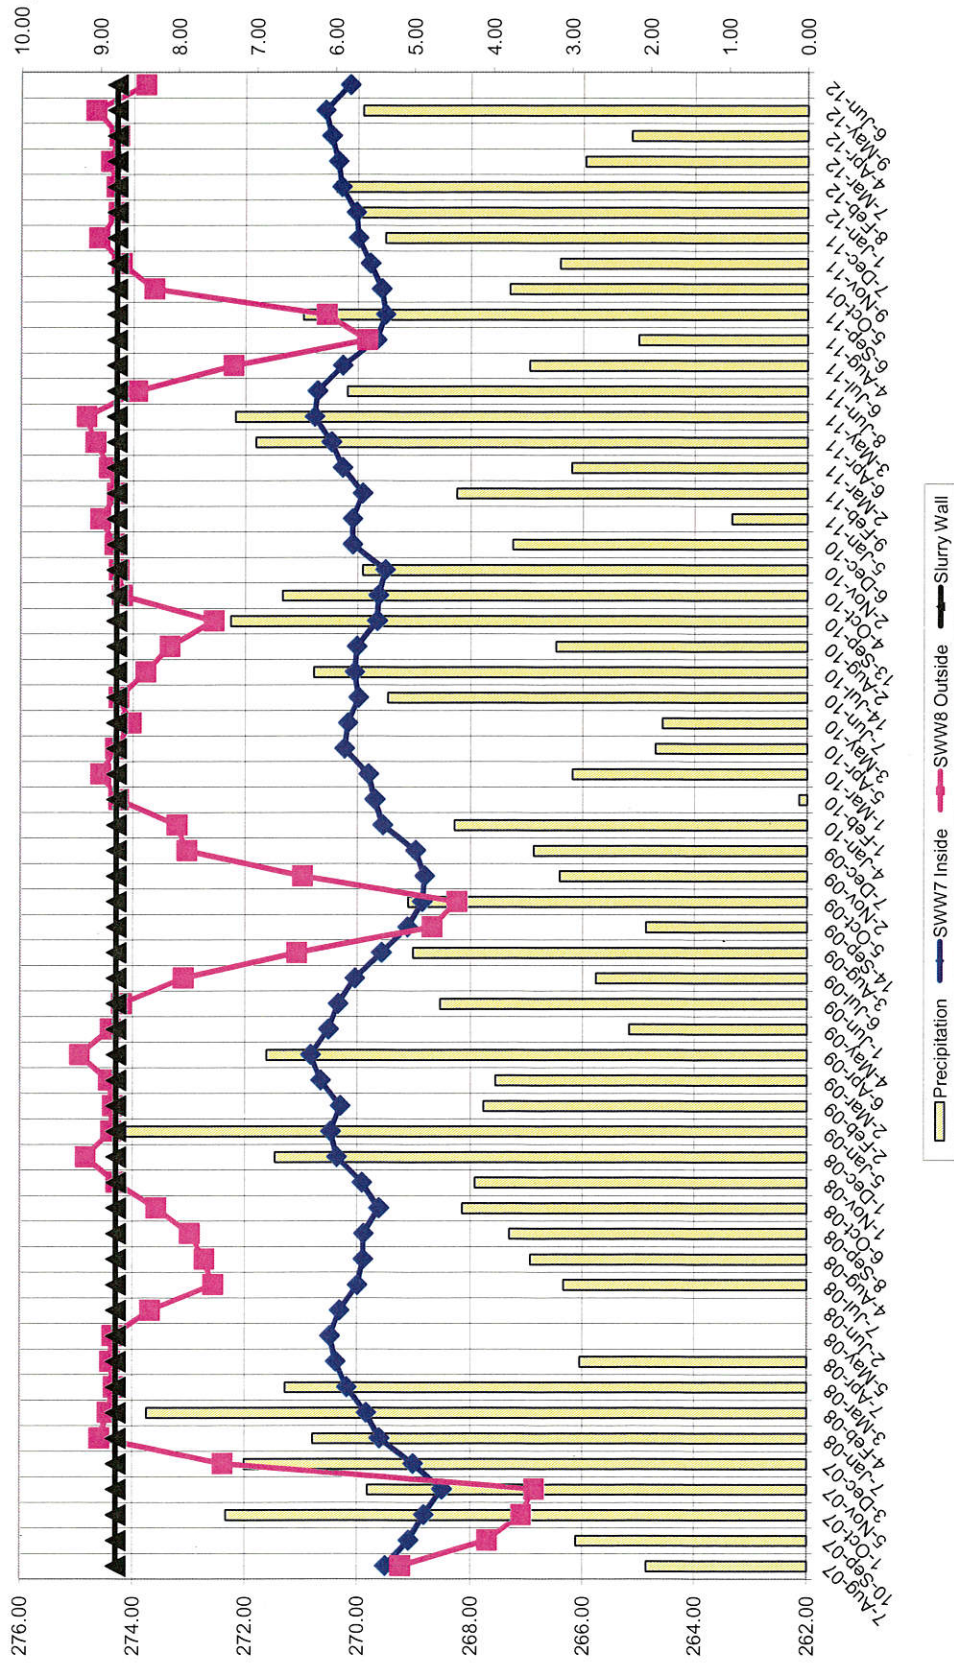
# PAS - OSWEGO GROUNDWATER ELEVATIONS (SWW7 and SWW8)

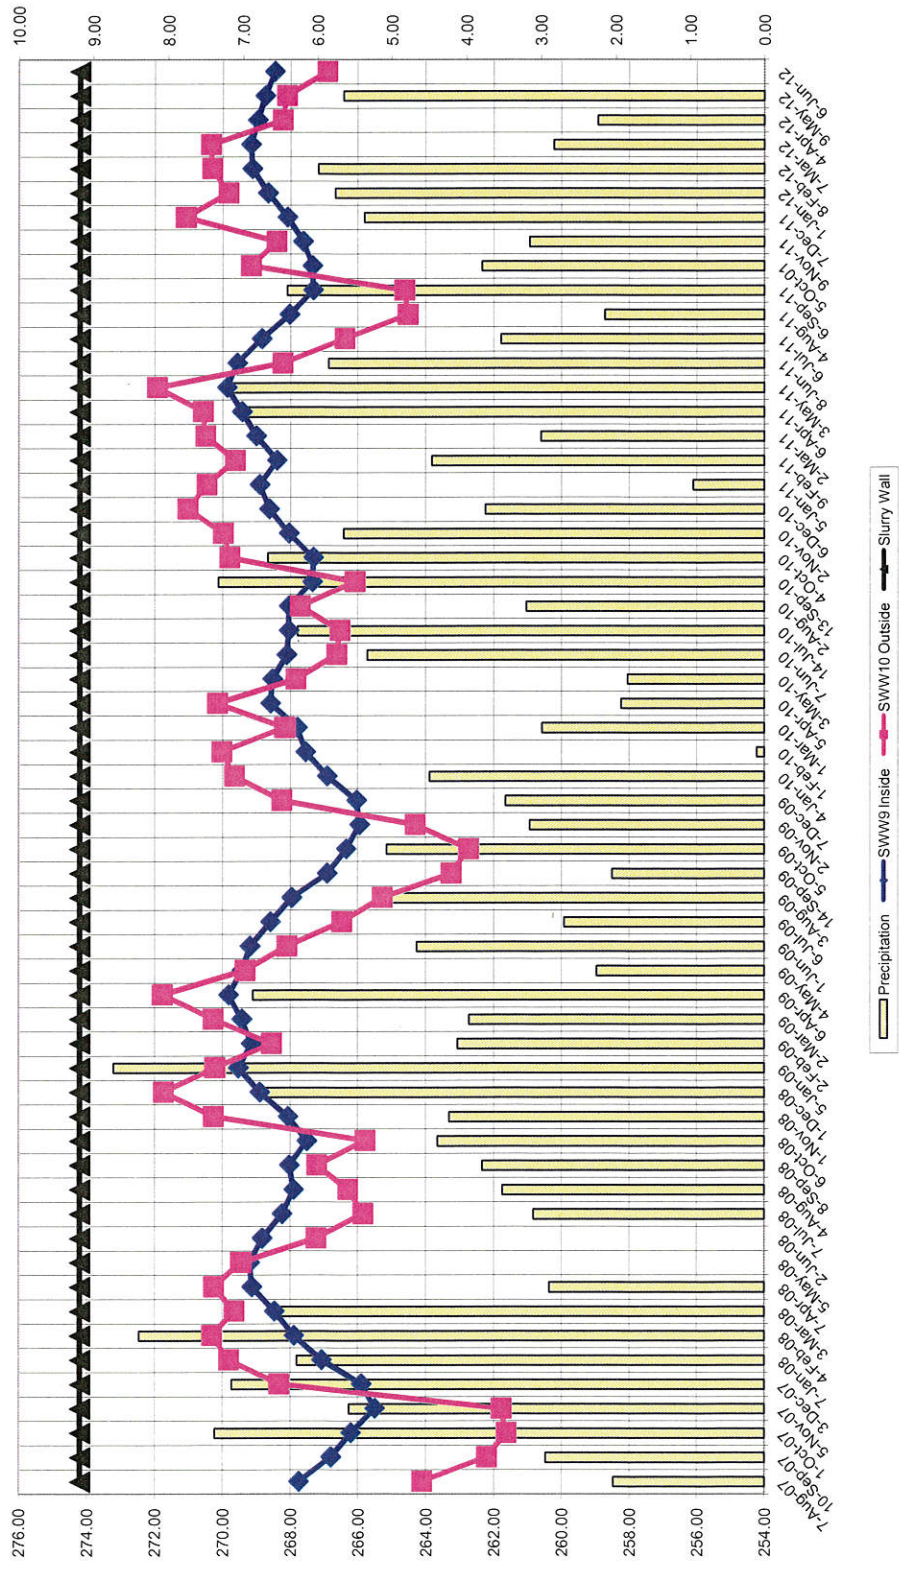
**PAS - OSWEGO  
GROUNDWATER ELEVATIONS (SWW9 and SWW10)**

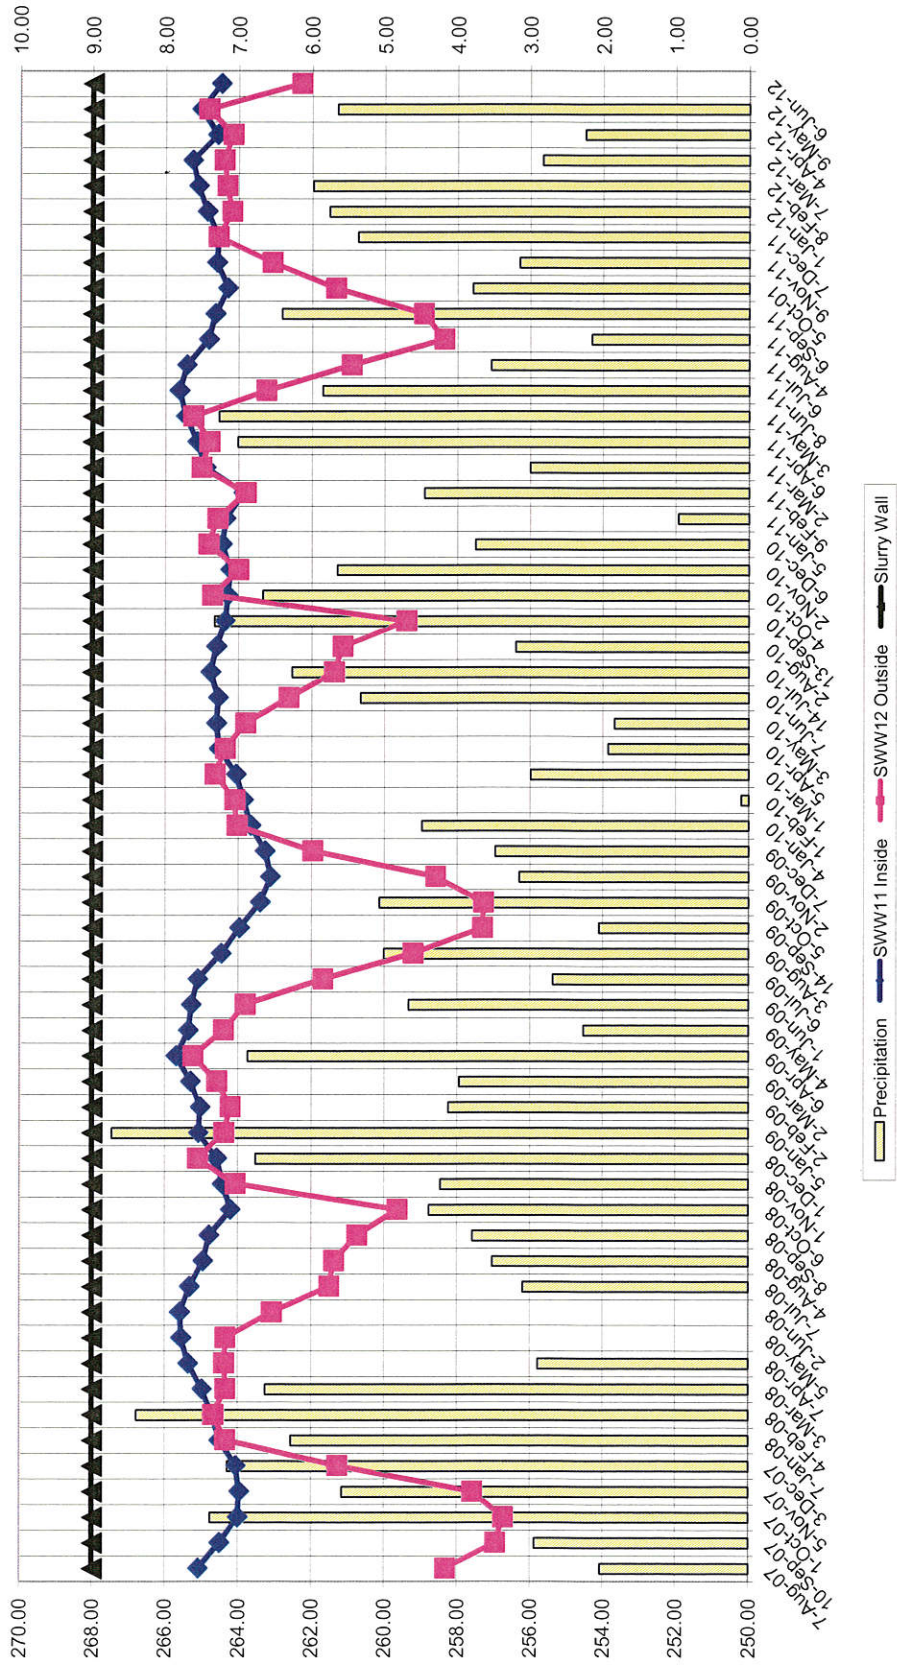
# PAS - OSWEGO GROUNDWATER ELEVATIONS (SWW11 & SWW12)

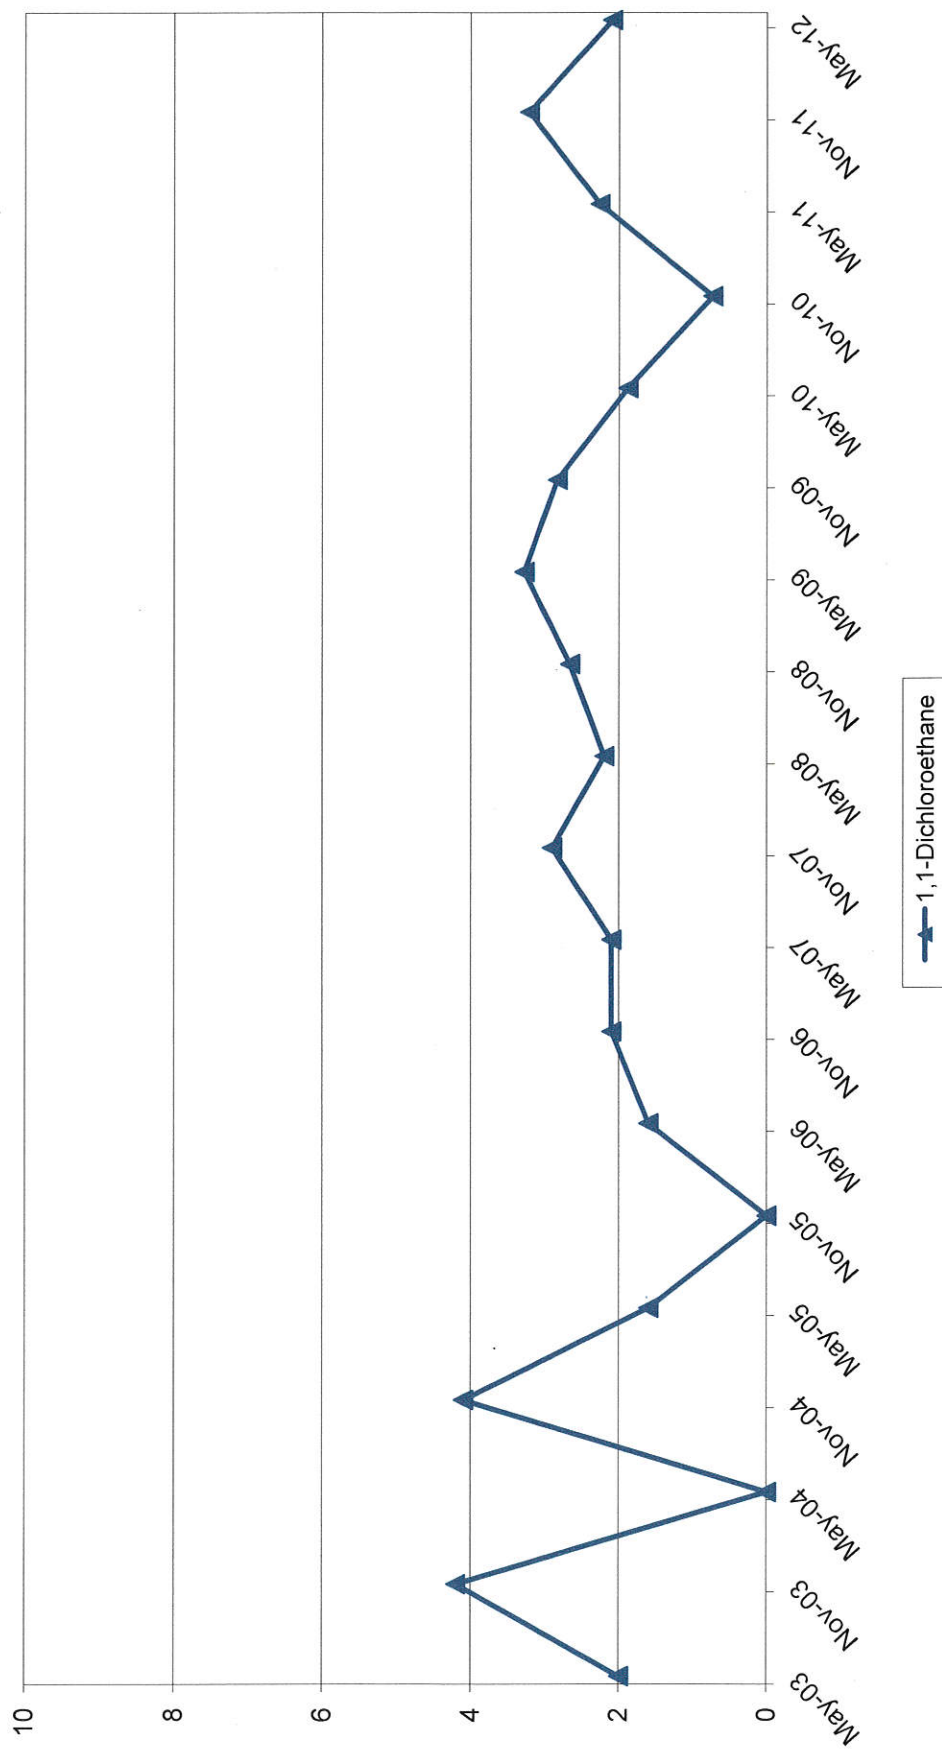
Long Term Groundwater Monitoring at LR-6  
 PAS Oswego Superfund Site Groundwater  
 2003 - 2012

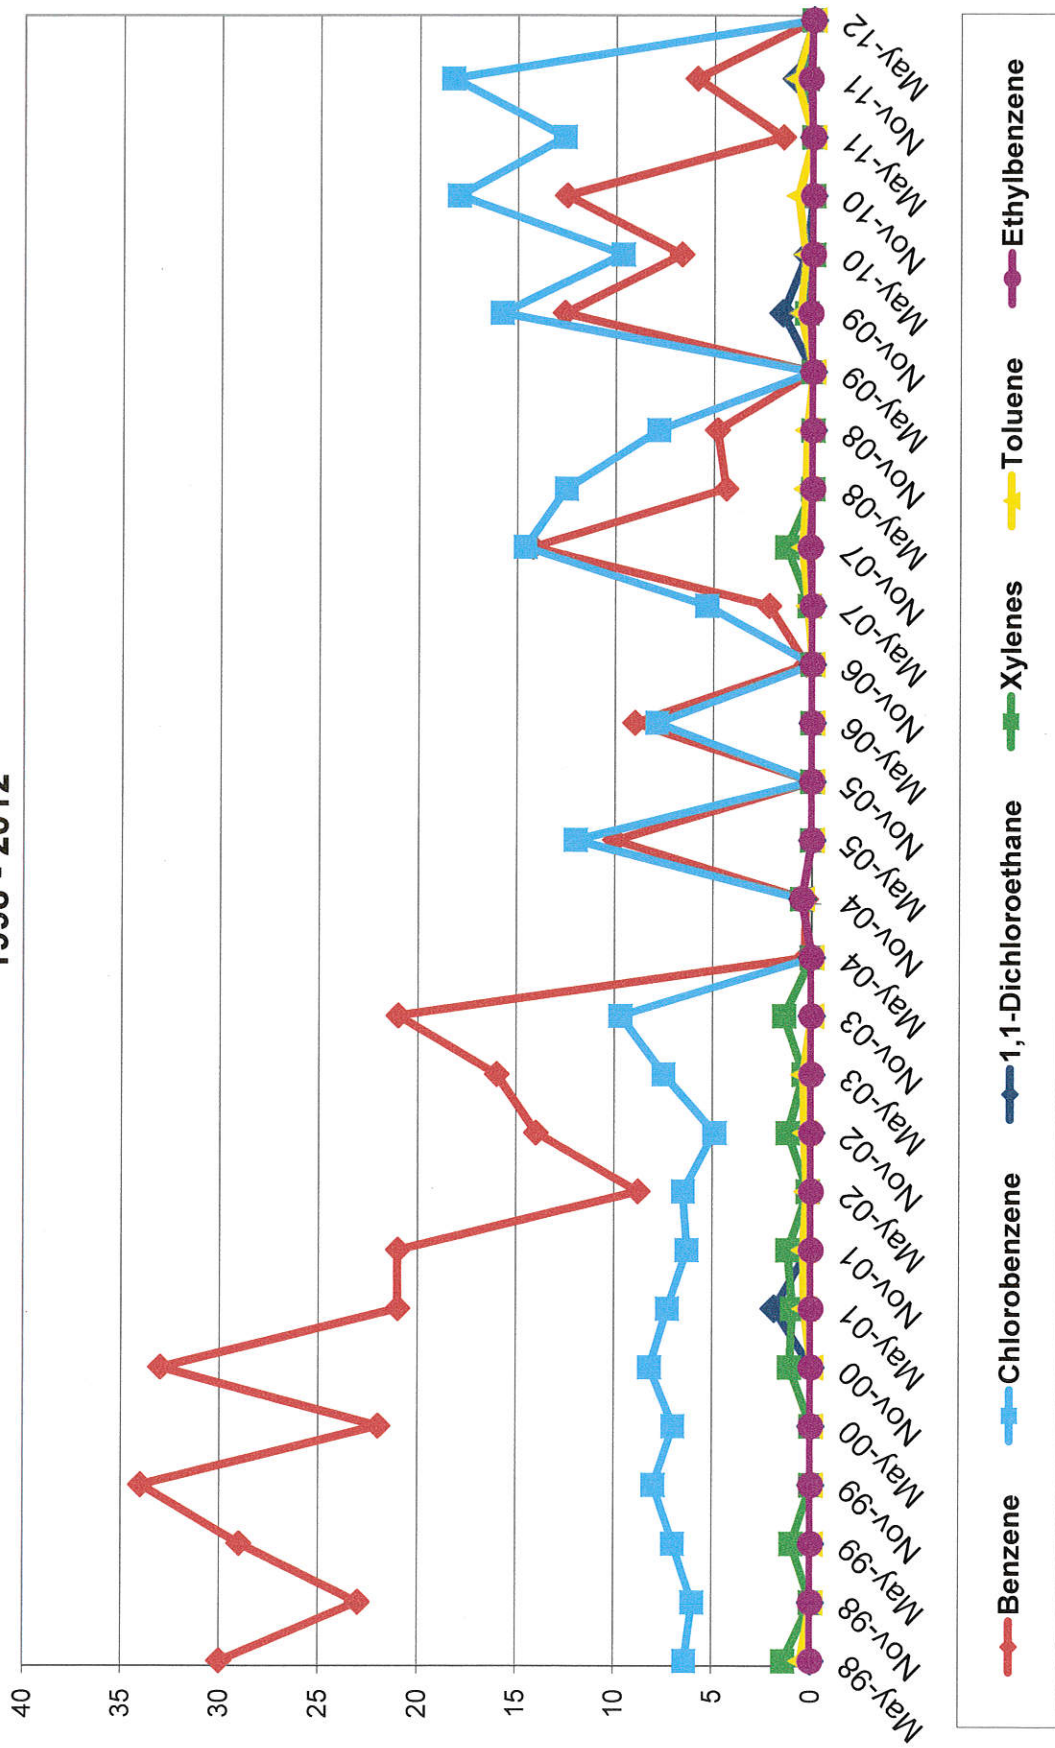
**Long Term Groundwater Monitoring at LR-8  
PAS Oswego Superfund Site Groundwater  
1998 - 2012**

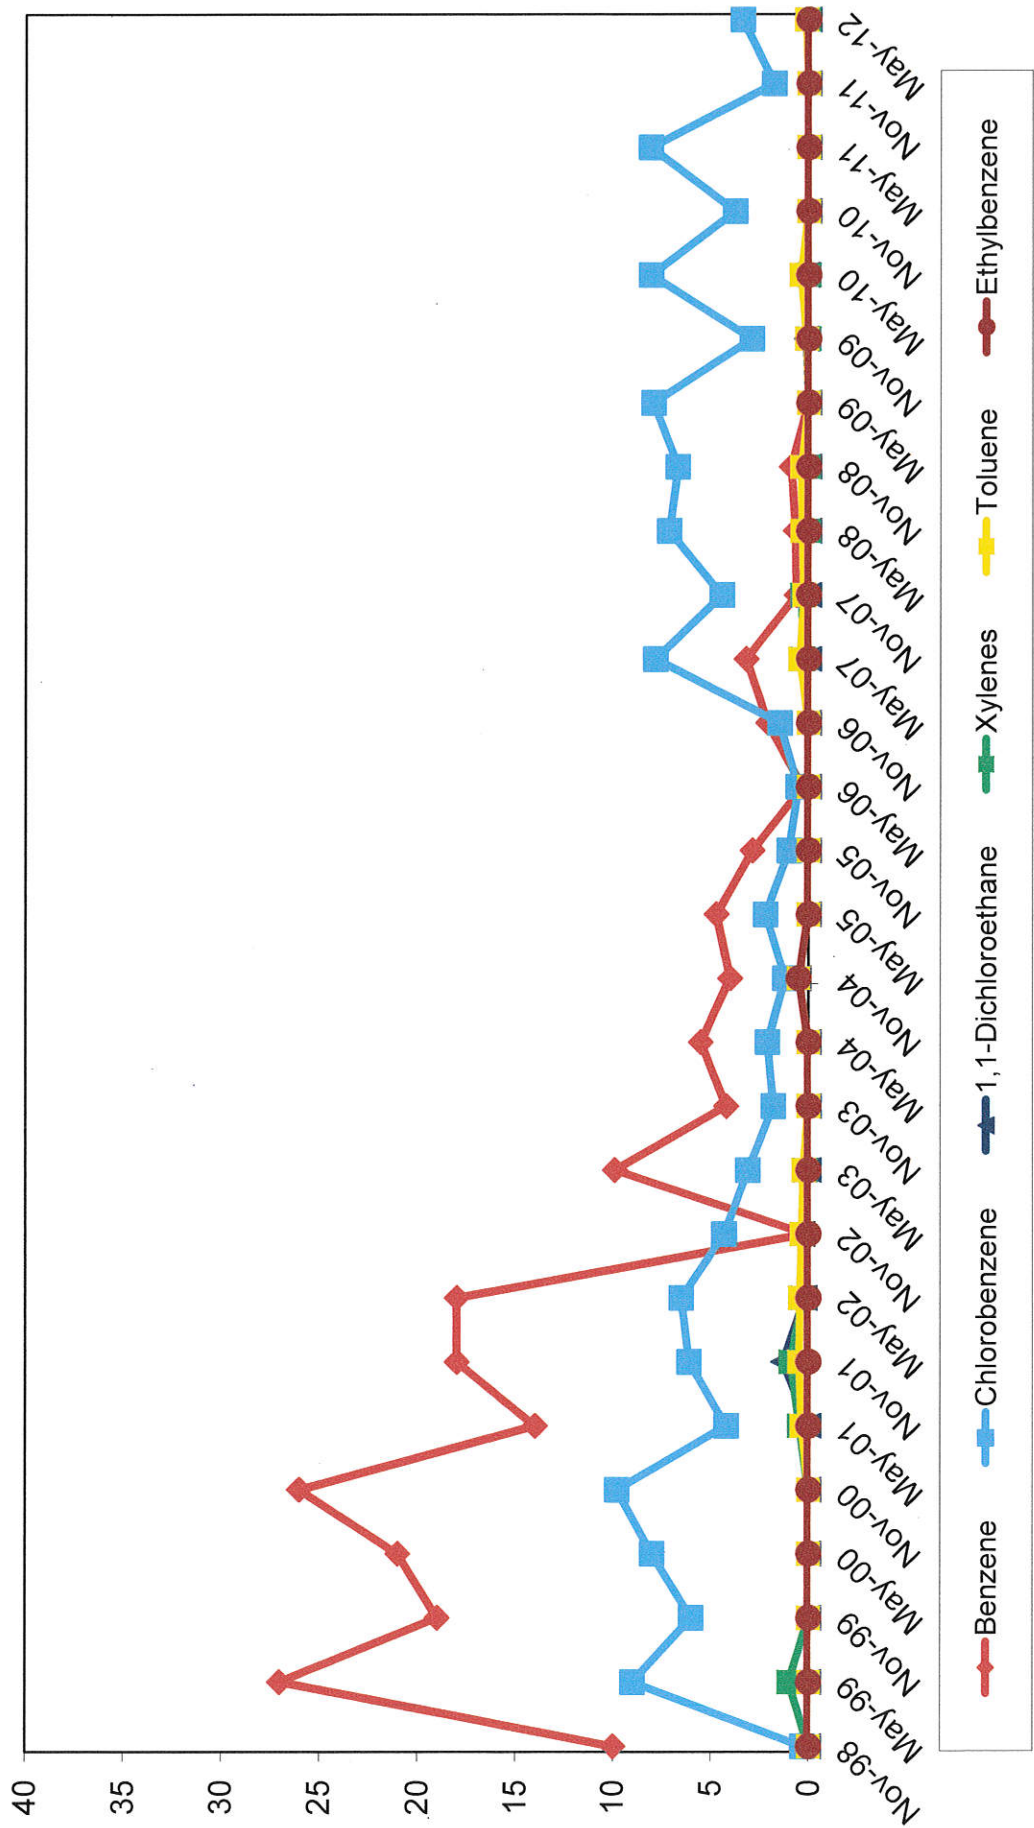
**Long Term Groundwater Monitoring at M-21  
PAS Oswego Superfund Site Groundwater  
1998 - 2012**

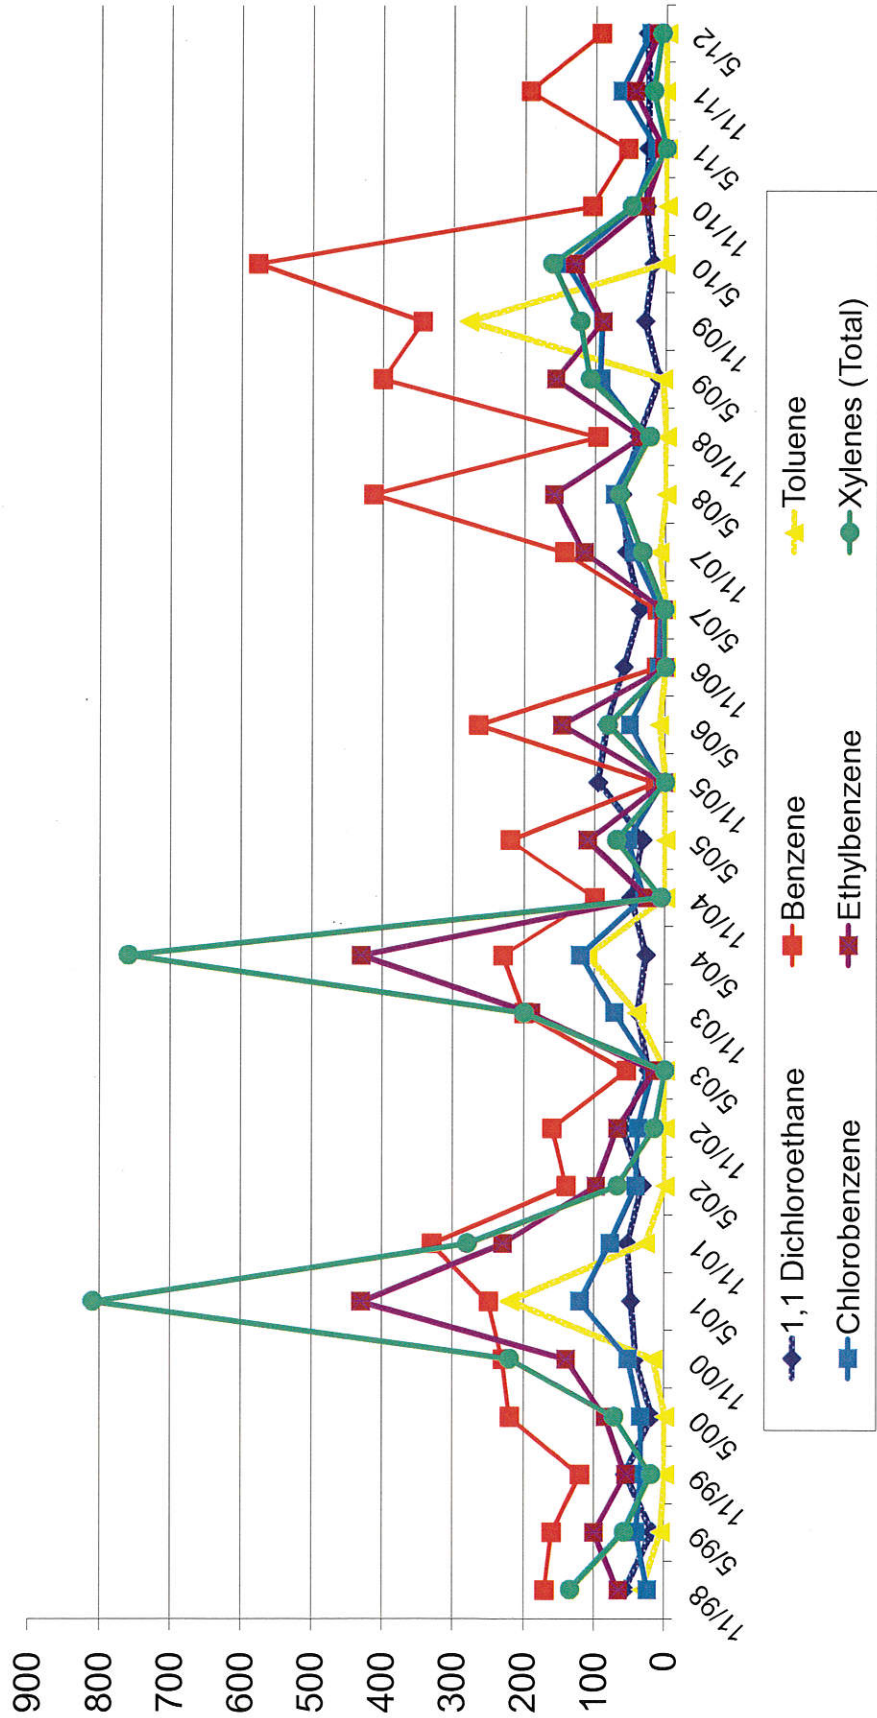
# LCW2 PAS Oswego Superfund Site Leachate Concentrations 1998 - 2012

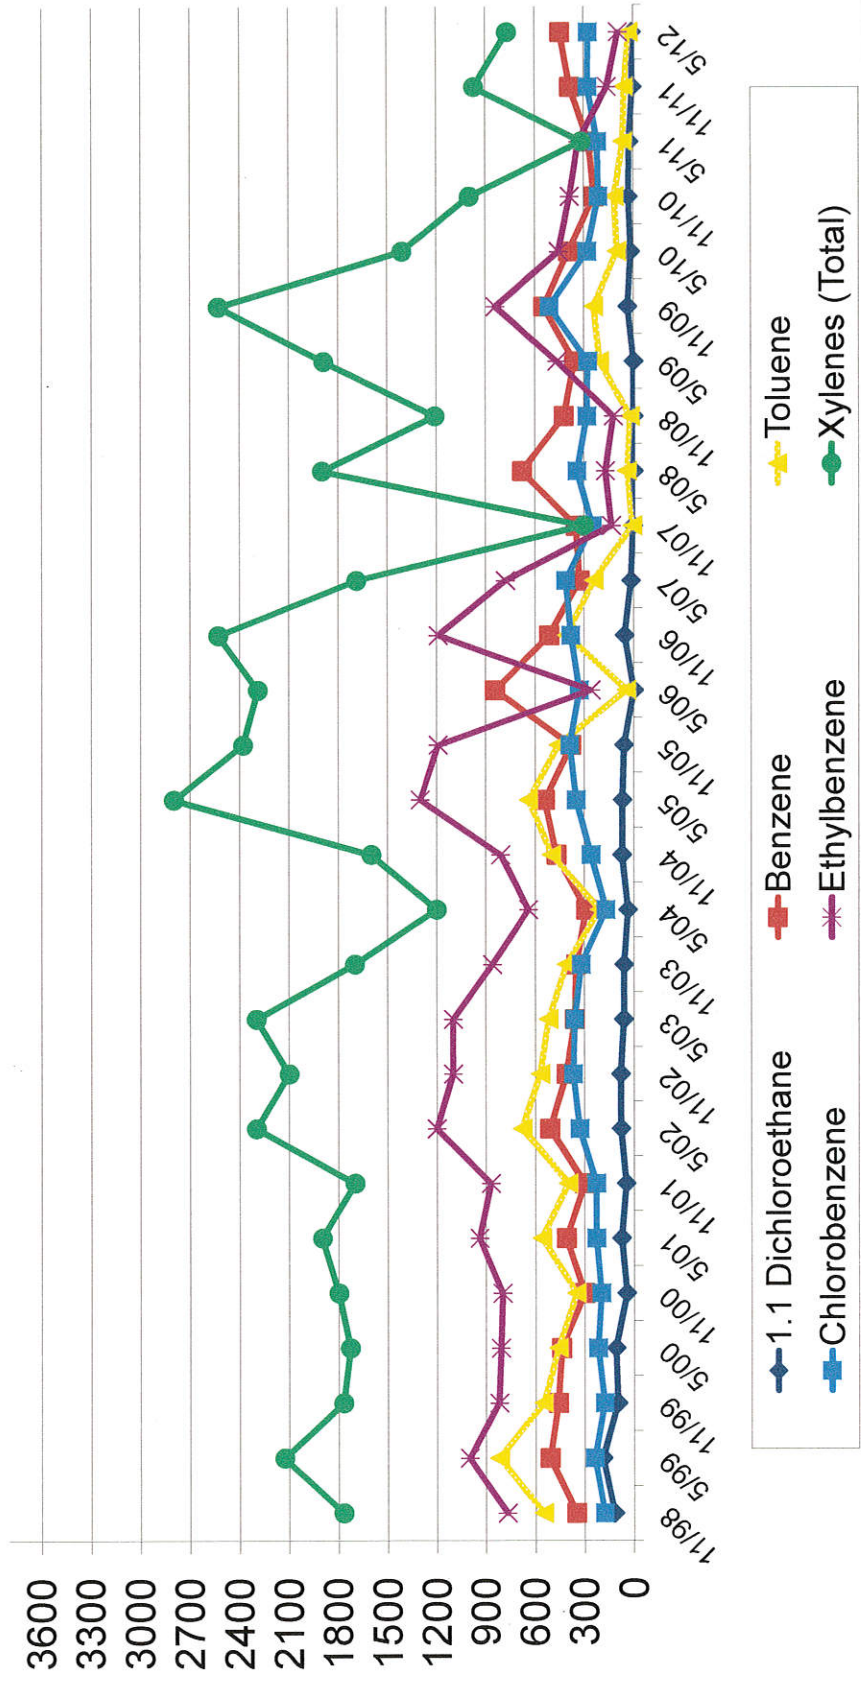
# LCW4 PAS Oswego Superfund Site Leachate Concentrations 1998 - 2012

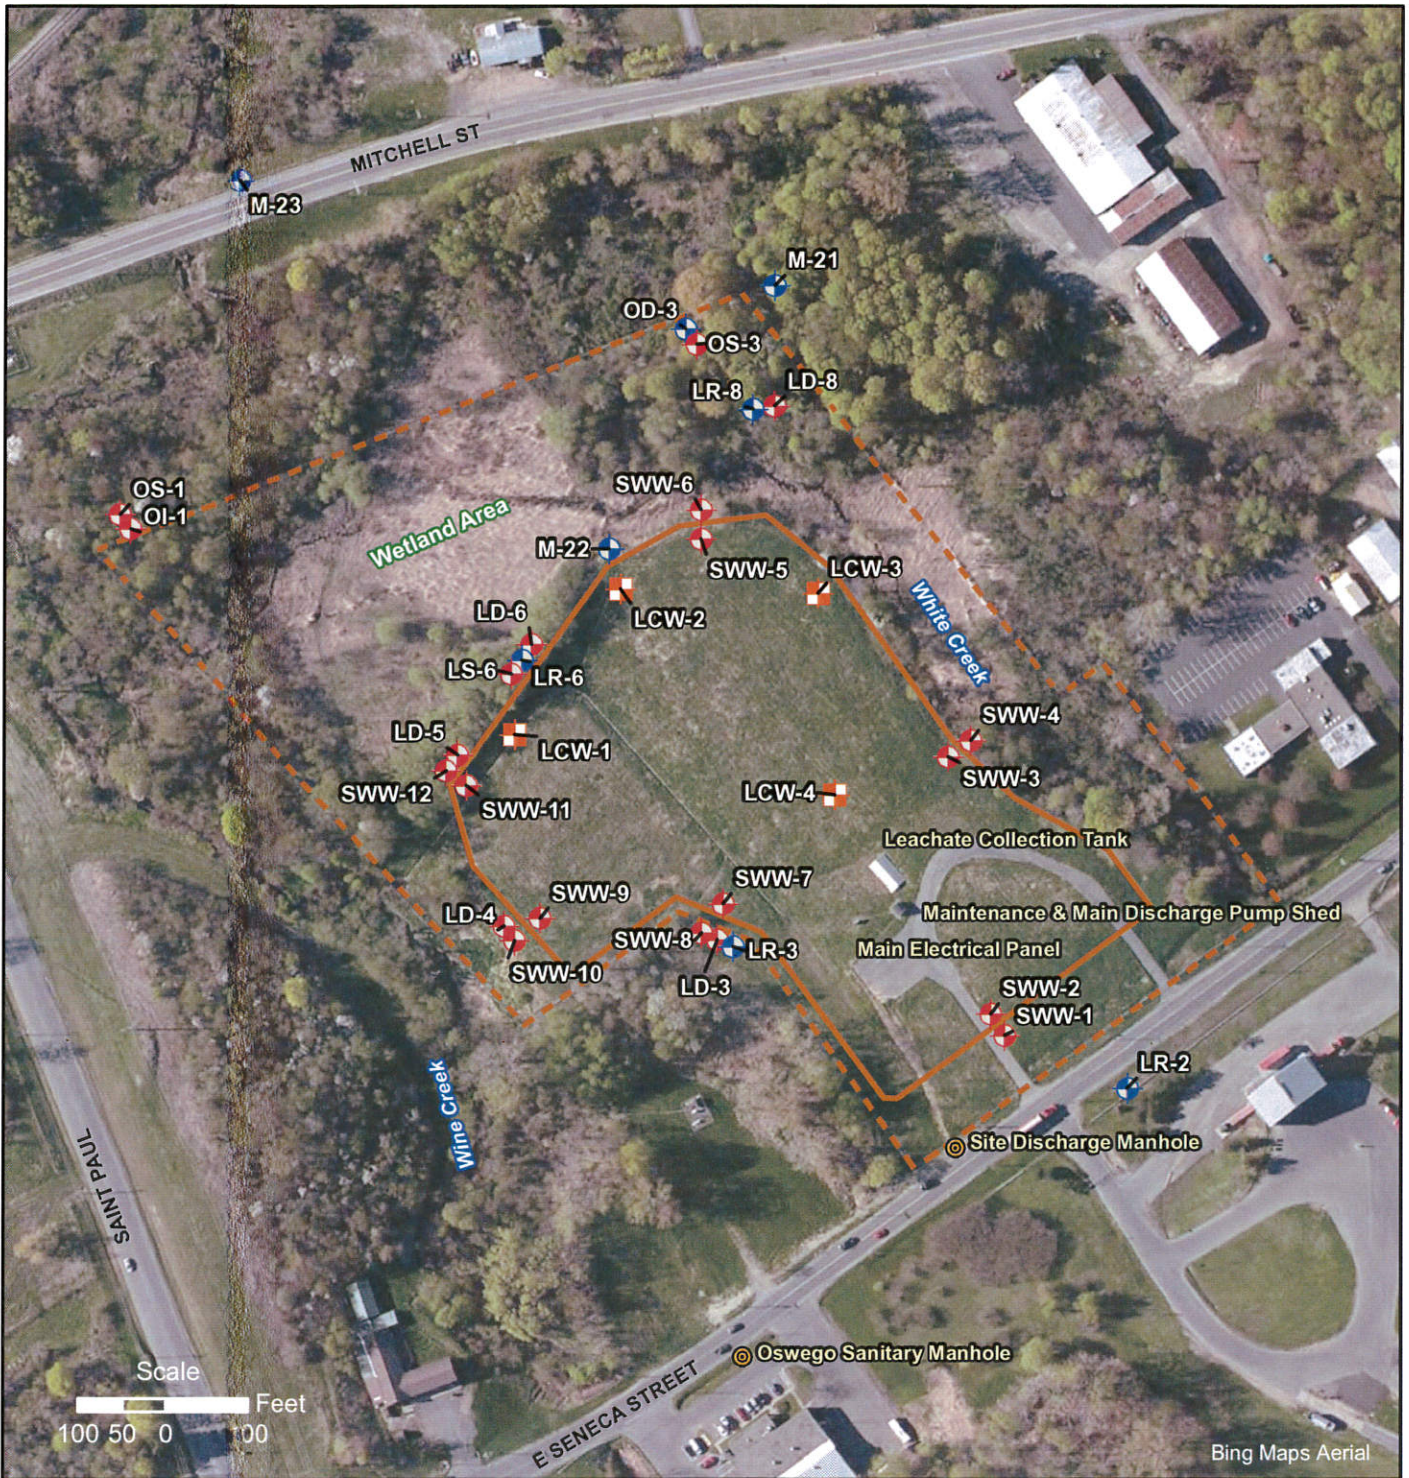
**Figure 1**

**EXISTING SITE WELLS**

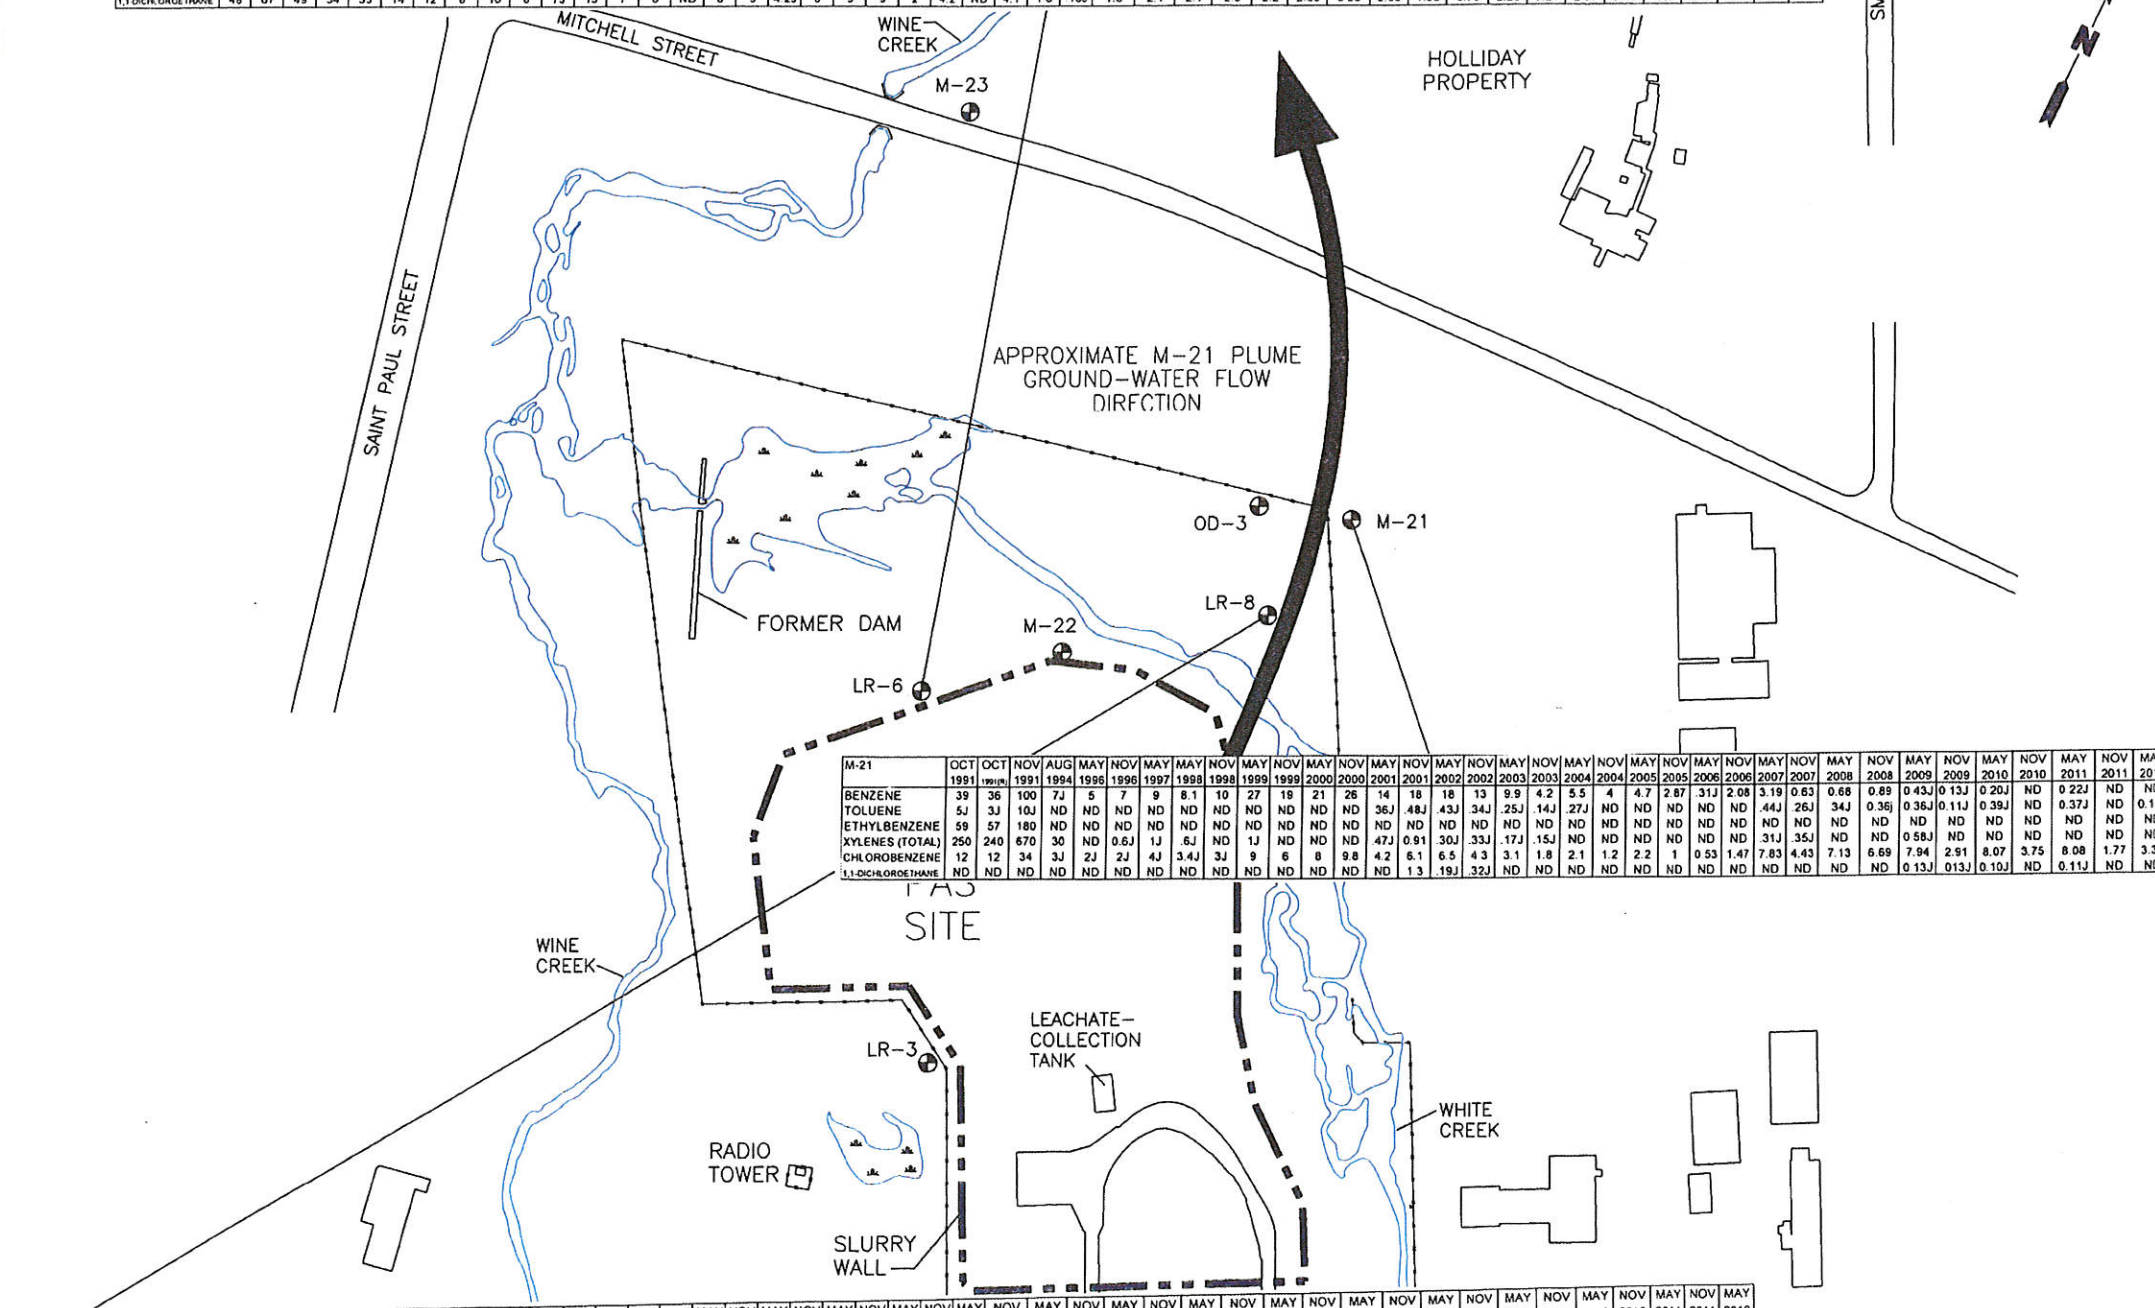
FIGURE 2

CONCENTRATION OF VOC DETECTED IN BEDROCK GROUND WATER, MEASURED IN ug/L.

POLLUTION ABATEMENT SERVICES SITE  
OSWEGO, NEW YORK  
OPERATION AND MAINTENANCE AND  
LONG-TERM MONITORING PLAN  
HISTORICAL CONCENTRATIONS OF VOCs  
OF CONCERN DETECTED IN CONSENT  
DECREE WELLS (1998 - 2012)

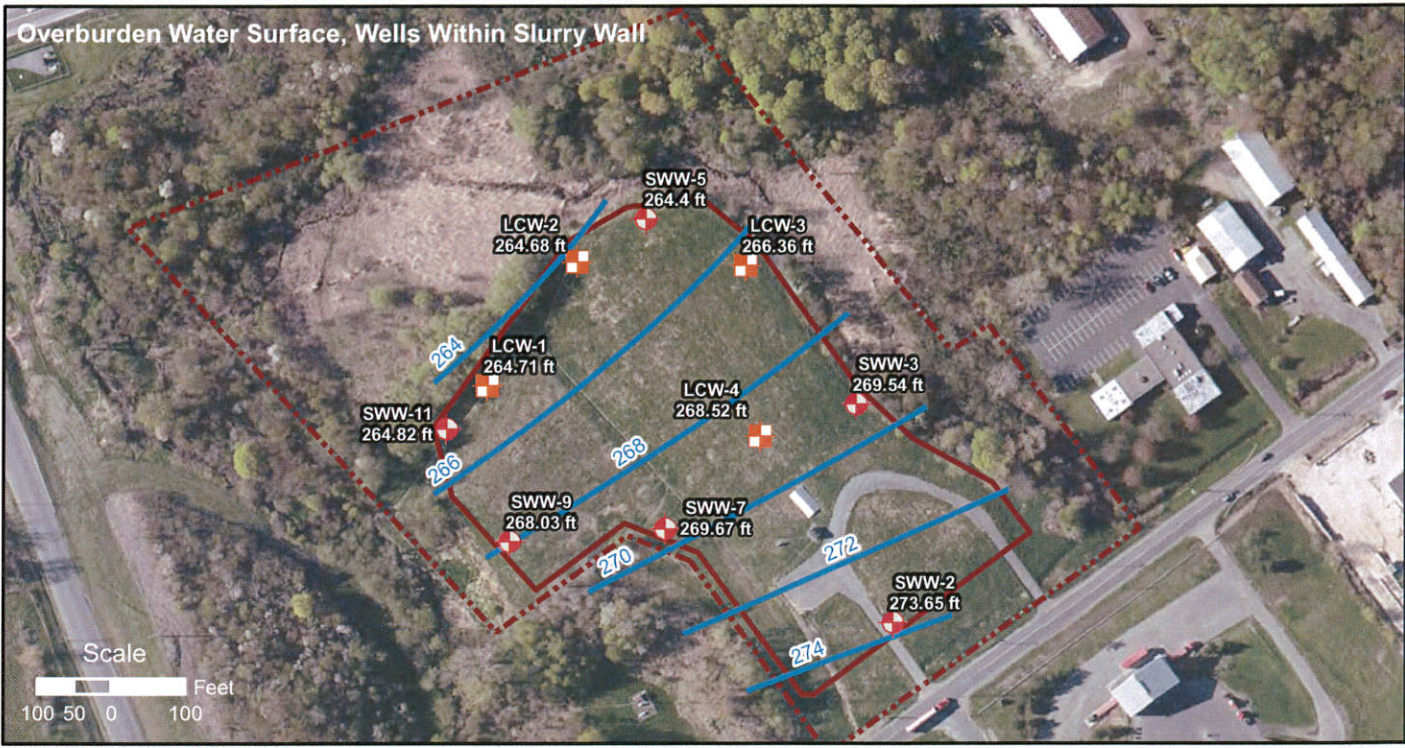
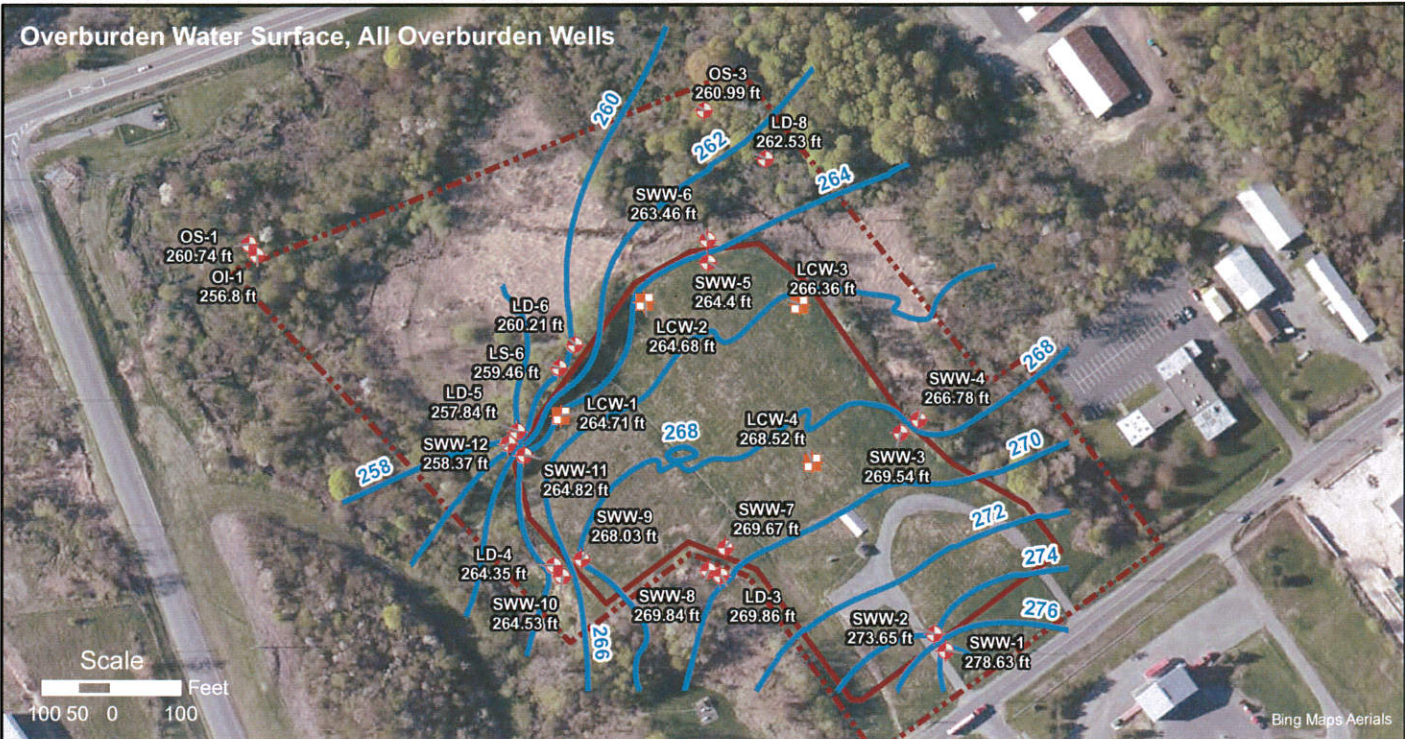
**Figure 2011-Q3-A-ALT**

Notes: Universal kriging was used to determine potentiometric surface of wells within slurry wall; ordinary kriging was used to determine potentiometric surface of all overburden wells.

Some surface contours for the all overburden wells dataset were smoothed to remove jagged areas.

**POTENTIOMETRIC SURFACE  
COMPARISON - OVERBURDEN WELLS  
AUGUST 4, 2011  
PAS Site, Oswego, New York**
