*PAS Oswego Superfund Site – 2012 Annual Report*

SLURRY WALL

PAS - OSWEGO  
GROUNDWATER ELEVATIONS (SWW1 and SWW2)

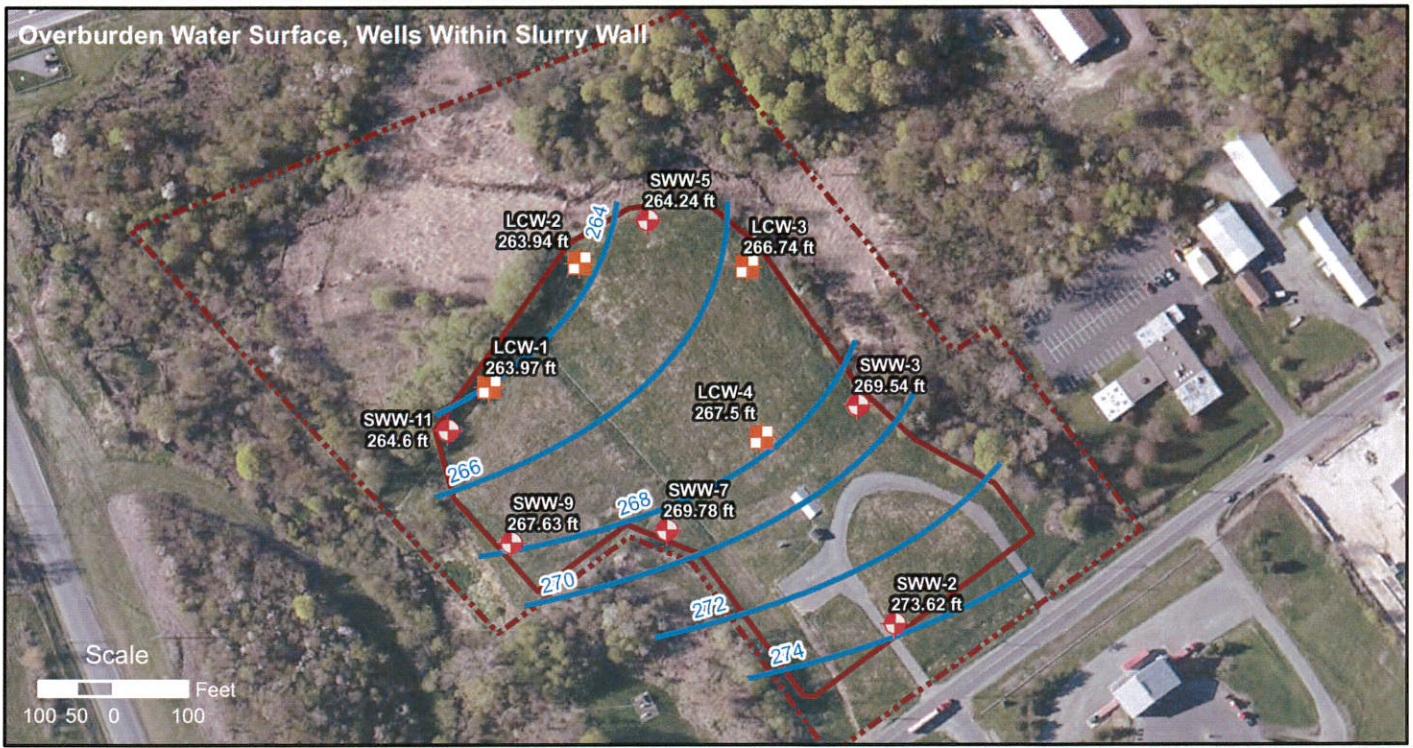
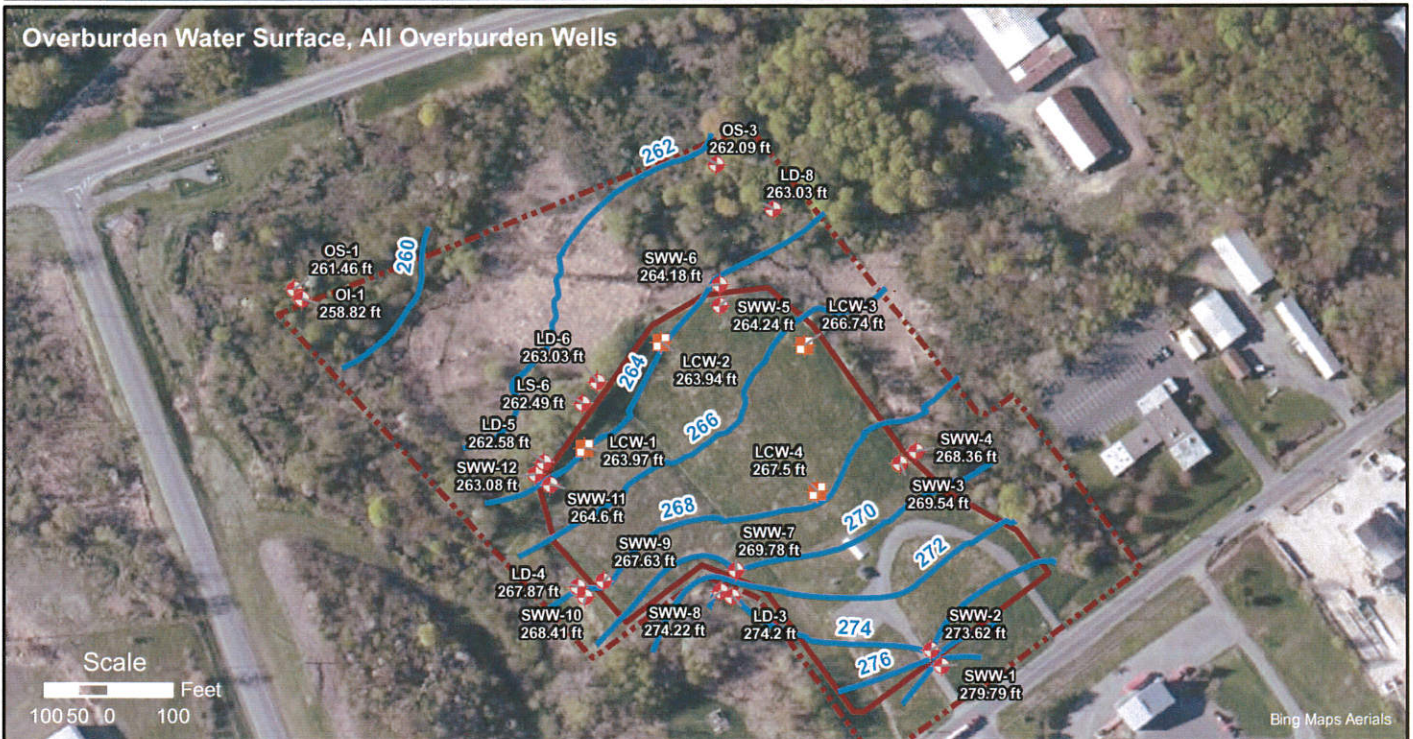
**Figure 2011-Q4-A-ALT**

Notes: Universal kriging was used to determine potentiometric surface of wells within slurry wall; ordinary kriging was used to determine potentiometric surface of all overburden wells.

Some surface contours for the all overburden wells dataset were smoothed to remove jagged areas.

**POTENTIOMETRIC SURFACE COMPARISON - OVERBURDEN WELLS**  
**NOVEMBER 9, 2011**  
 PAS Site, Oswego, New York

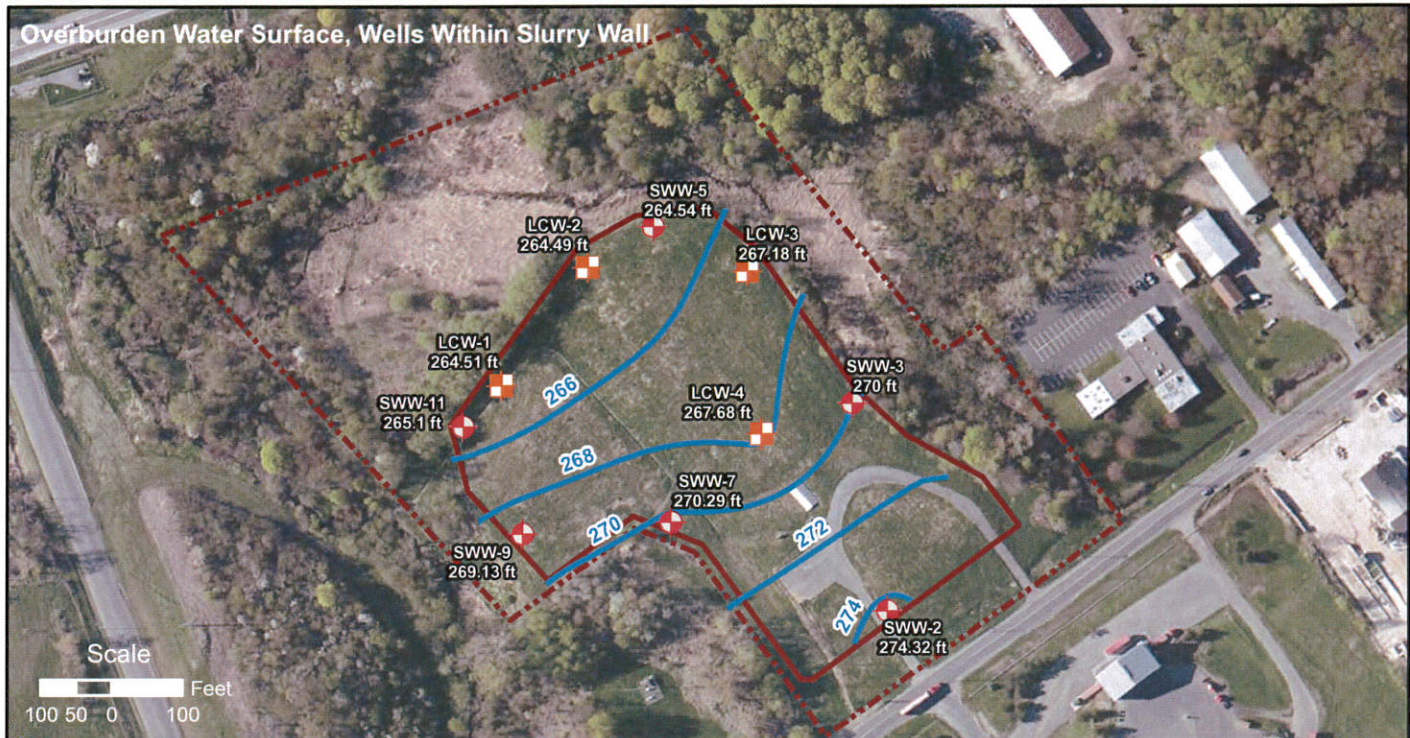
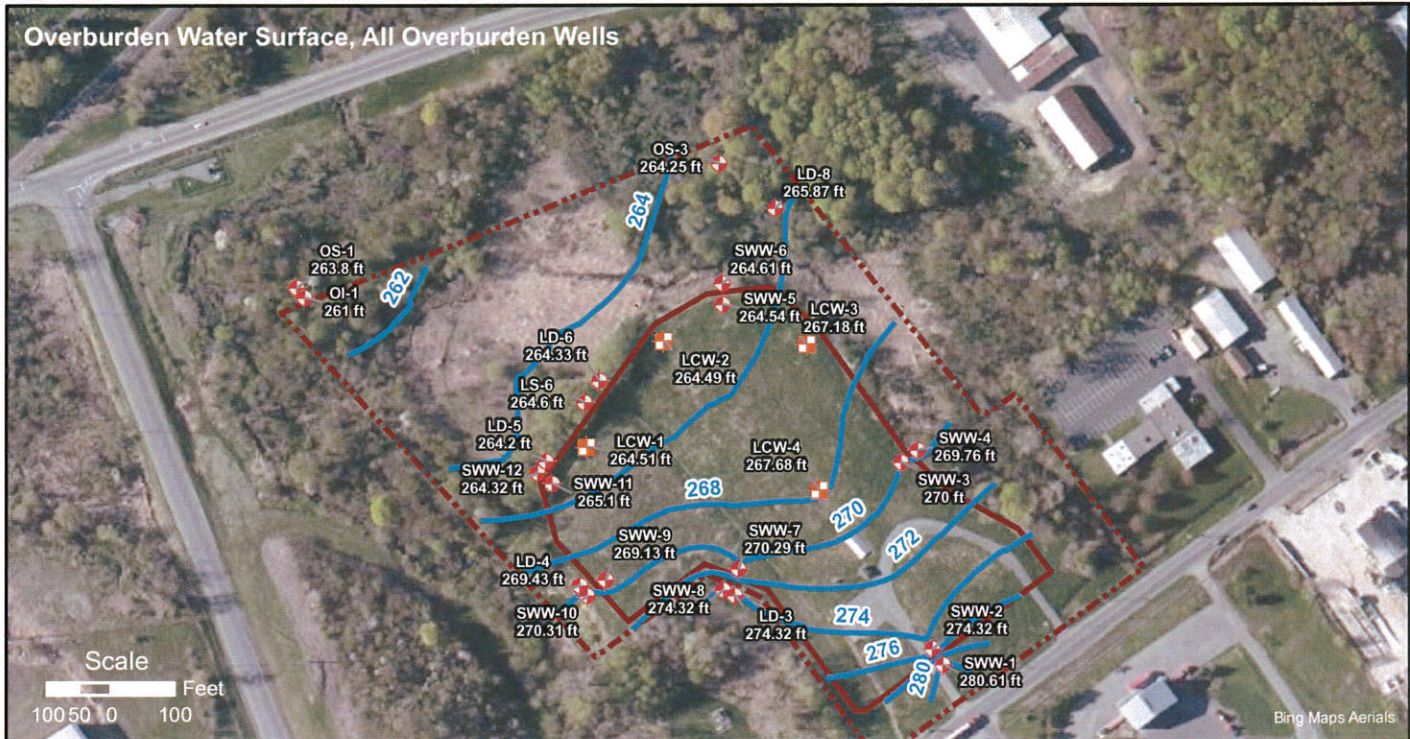
**Figure 2012-Q1-A-ALT**

Notes: Ordinary kriging was used to determine potentiometric surfaces of overburden wells within slurry wall and of all overburden wells.

Some surface contours for the all overburden wells dataset were smoothed to remove jagged areas.

**POTENTIOMETRIC SURFACE  
COMPARISON - OVERBURDEN WELLS  
FEBRUARY 8, 2012**  
PAS Site, Oswego, New York

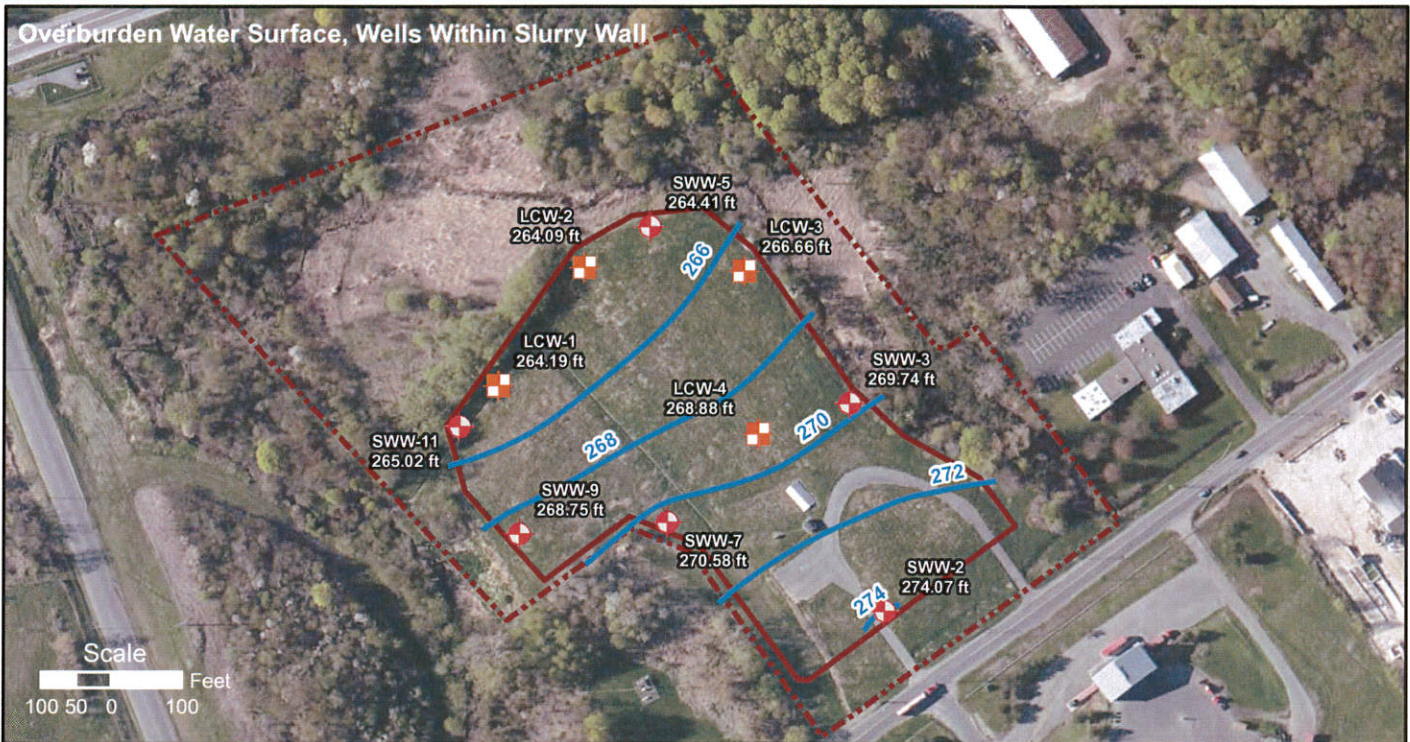
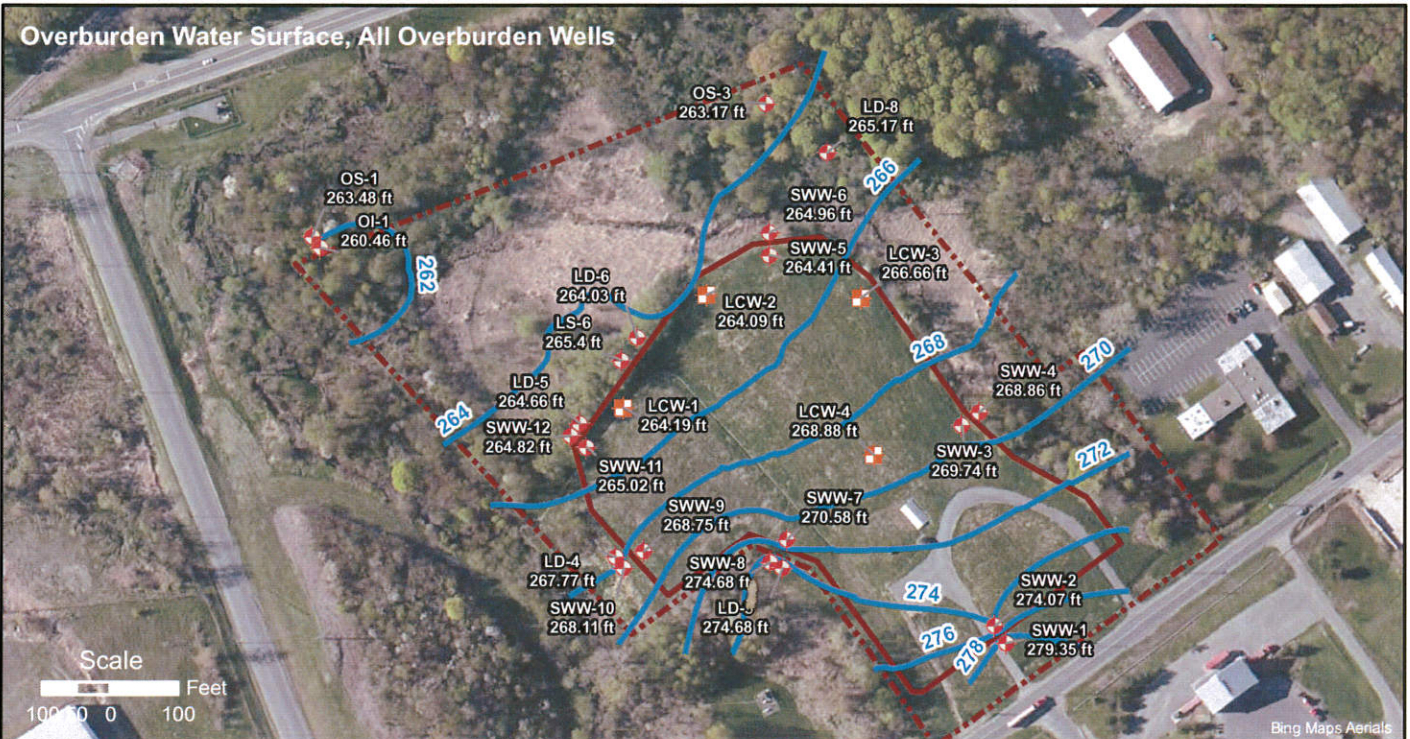
**Figure 2012-Q2-A-ALT**

Notes: Ordinary kriging was used to determine potentiometric surfaces of overburden wells within slurry wall and of all overburden wells.

Some surface contours for the all overburden wells dataset were smoothed to remove jagged areas.

**POTENTIOMETRIC SURFACE  
COMPARISON - OVERBURDEN WELLS  
MAY 9, 2012**  
PAS Site, Oswego, New York

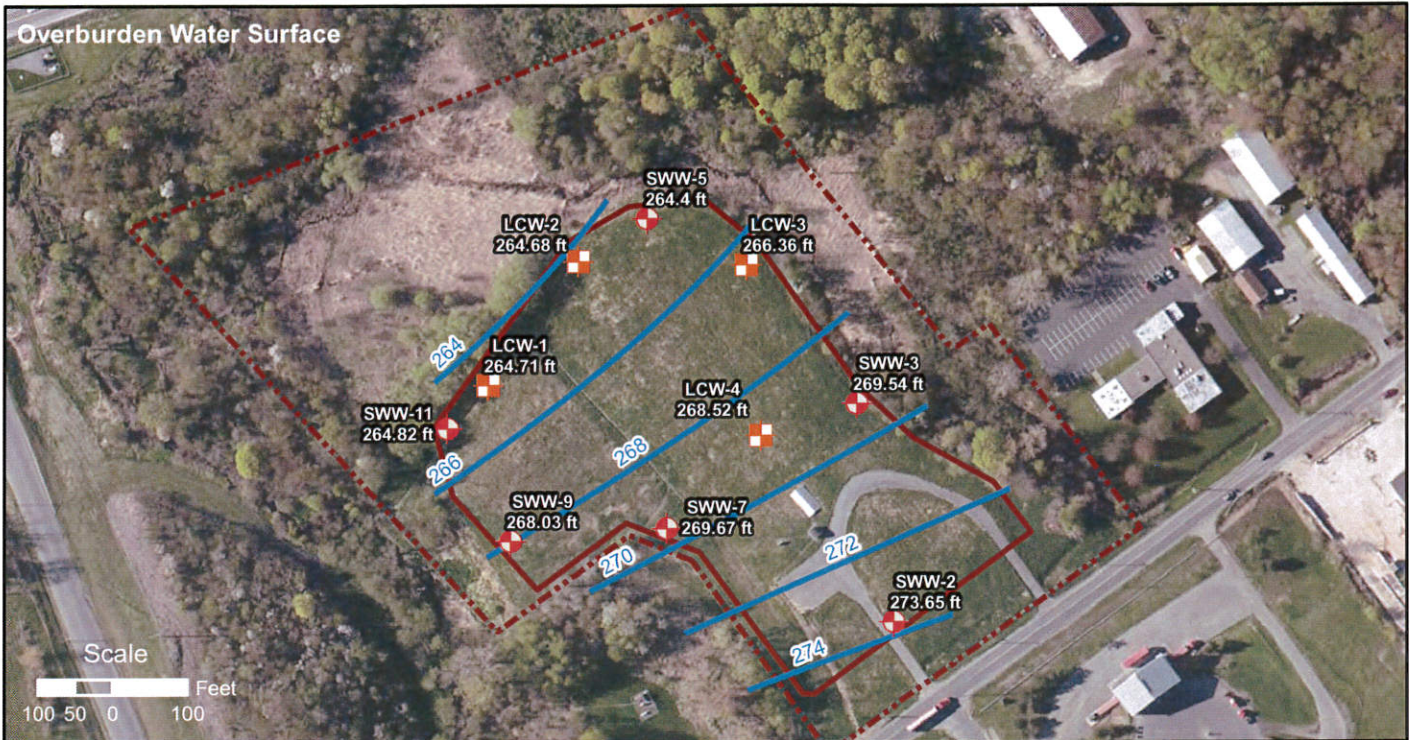
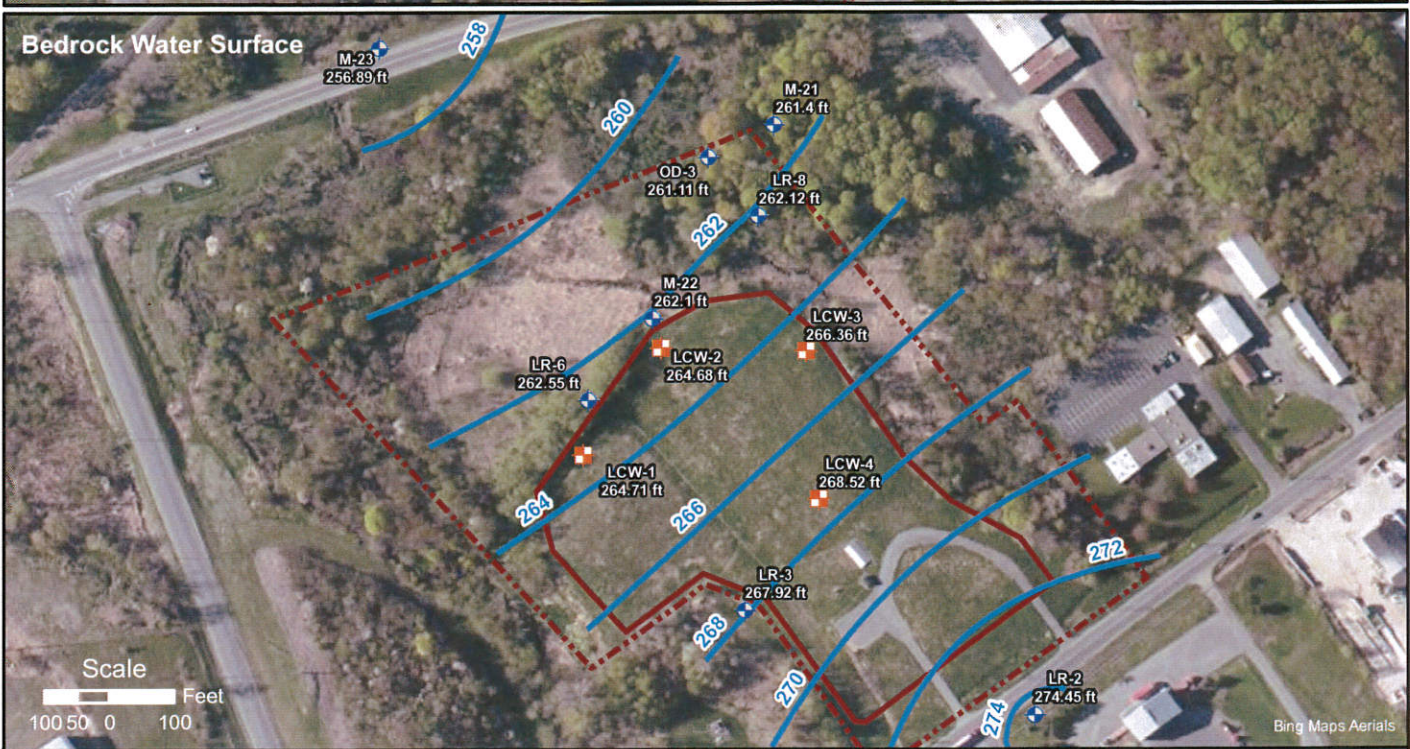
**Figure 2011-Q3-A**

Notes: LCW wells labeled on Bedrock Water Surface map for reference only and were not used in creation of the potentiometric surface.

Linear kriging was used to determine potentiometric surfaces. Bedrock contours within the containment system are inferred from the identified bedrock wells.

**POTENTIOMETRIC SURFACES  
AUGUST 4, 2011**

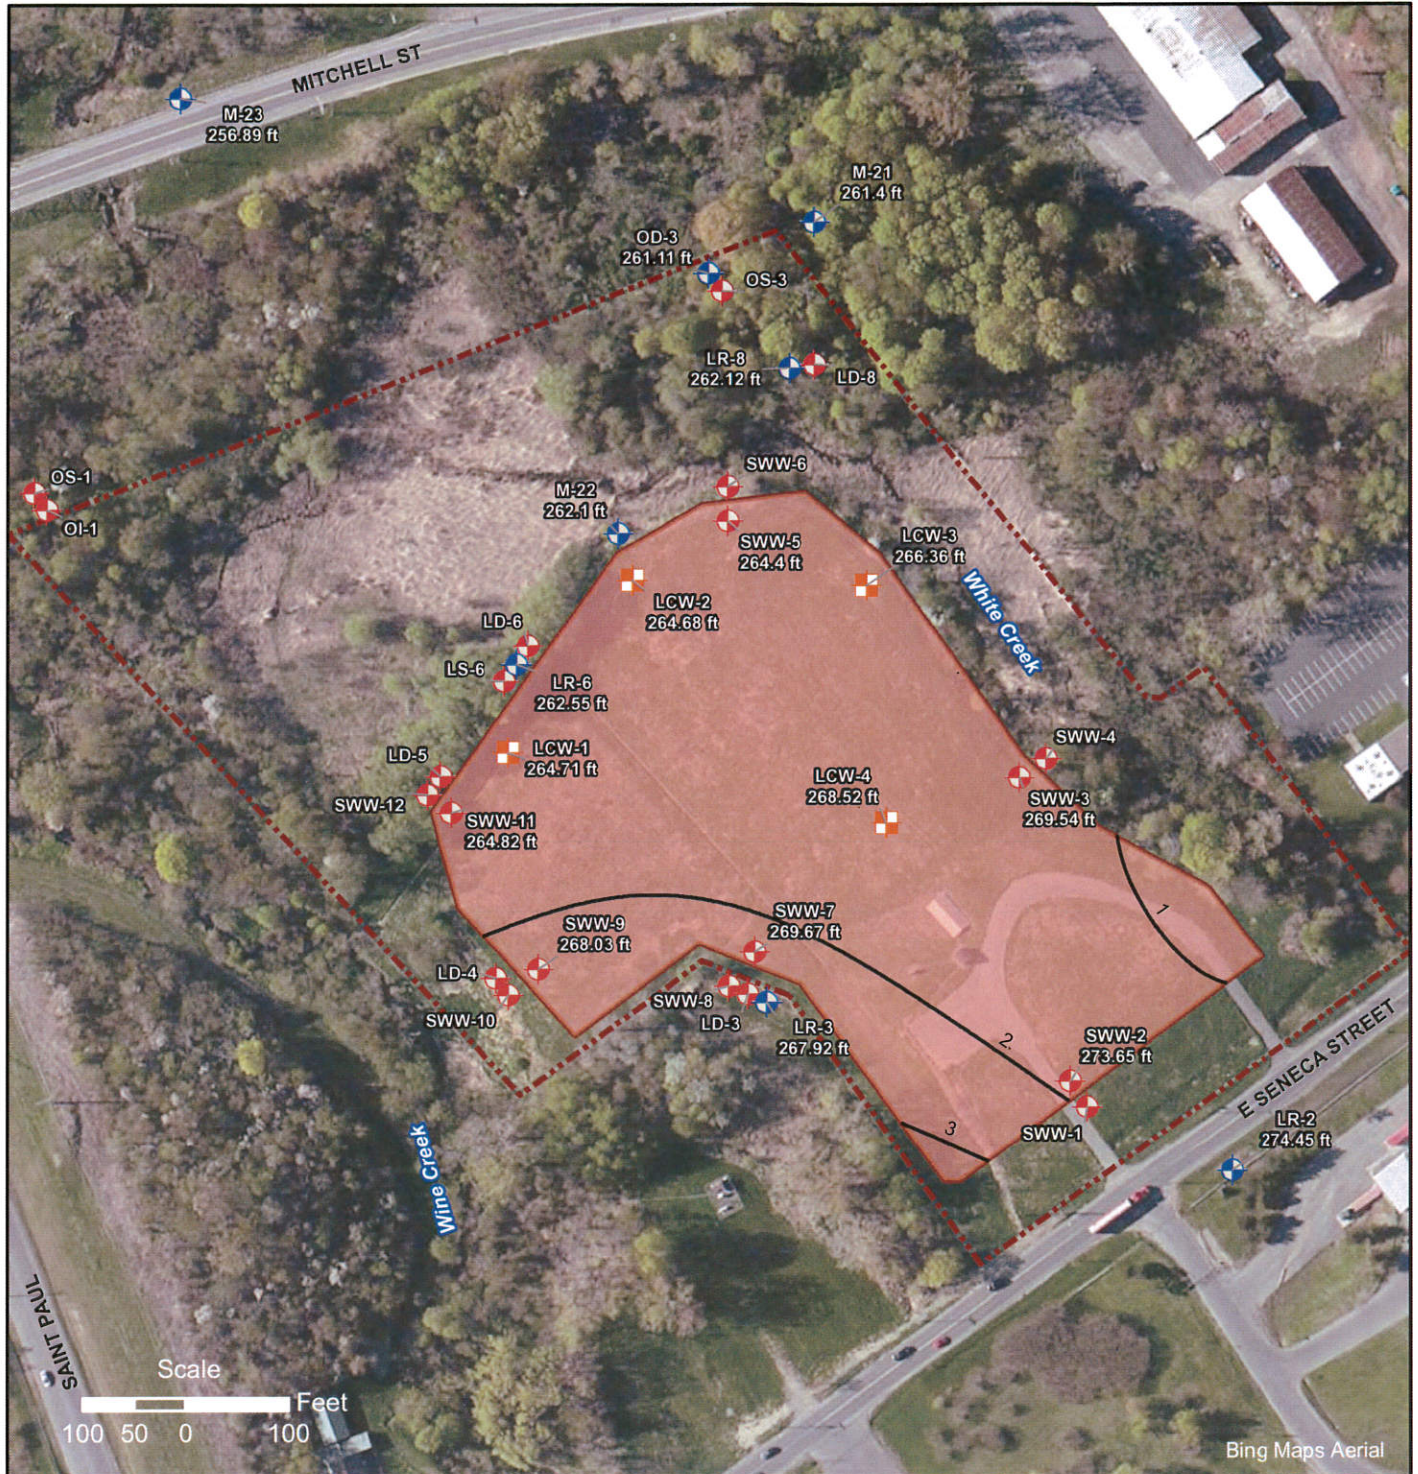
**Figure 2011-Q3-B**

**Notes:**  
 Overburden wells within the slurry wall were used to calculate the overburden potentiometric surface. Bedrock wells outside the slurry wall were used to calculate bedrock potentiometric surface. The bedrock potentiometric surface was subtracted from the overburden surface to produce the inferred vertical hydraulic gradient.

Negative gradient values indicate an upward hydraulic gradient.

**INFERRED VERTICAL HYDRAULIC GRADIENT - AUGUST 4, 2011**

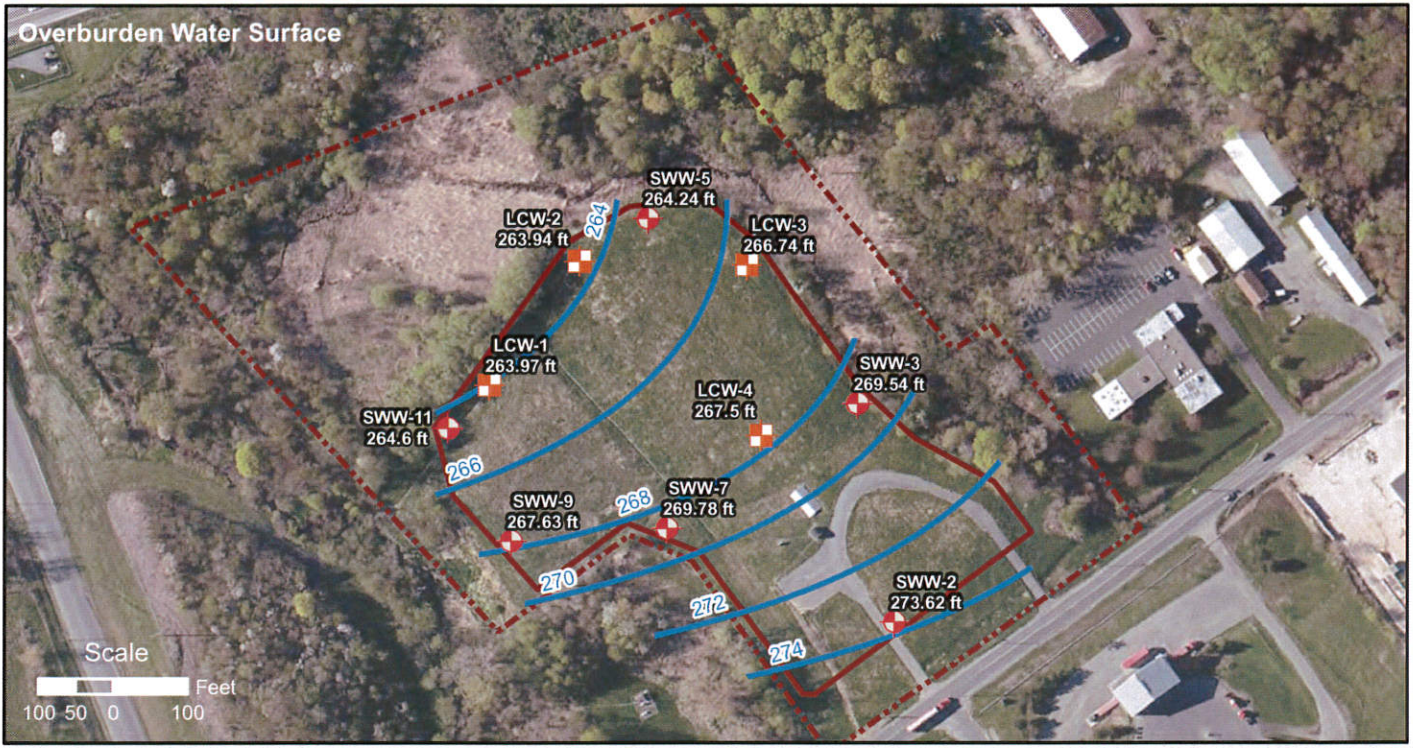
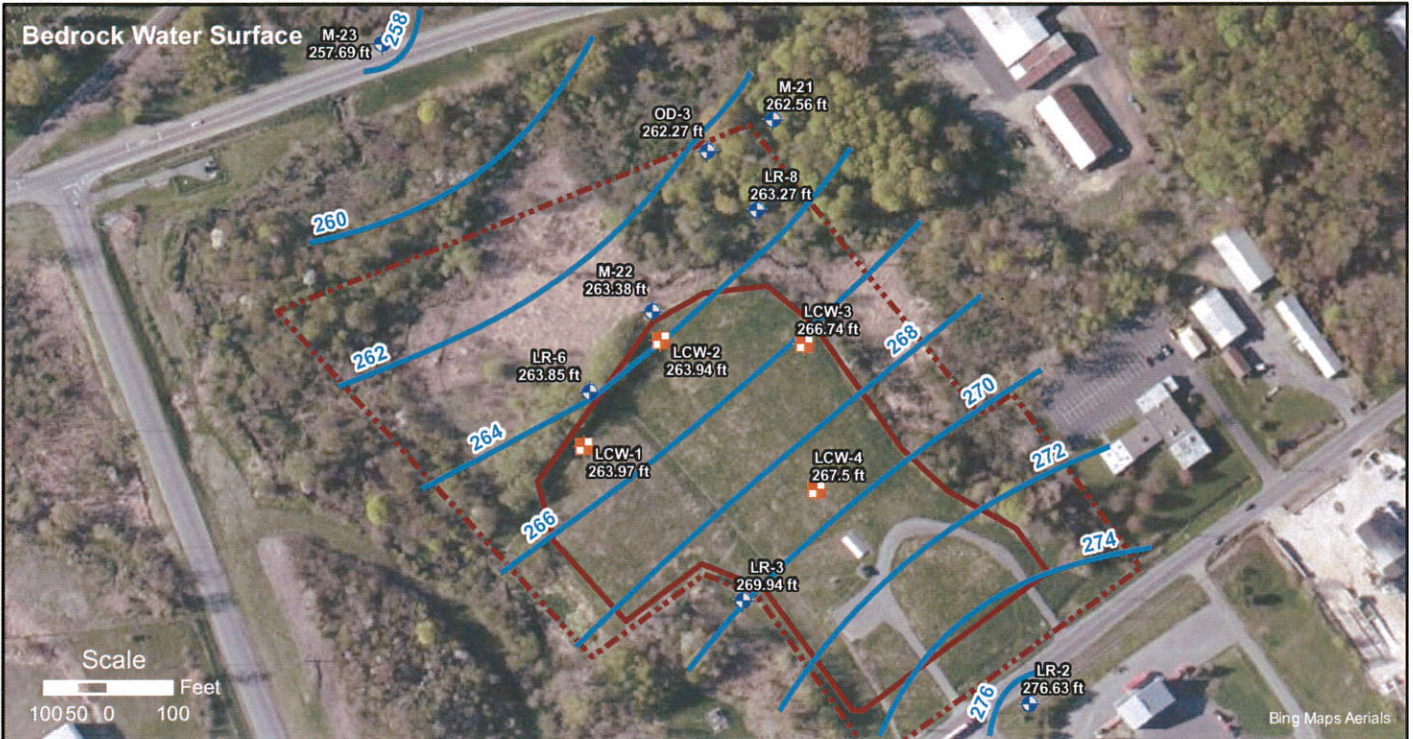
**Figure 2011-Q4-A**

Notes: LCW wells labeled on Bedrock Water Surface map for reference only and were not used in creation of the potentiometric surface.

Linear kriging was used to determine potentiometric surfaces. Bedrock contours within the containment system are inferred from the identified bedrock wells.

**POTENTIOMETRIC SURFACES**  
**NOVEMBER 9, 2011**  
 PAS Site, Oswego, New York

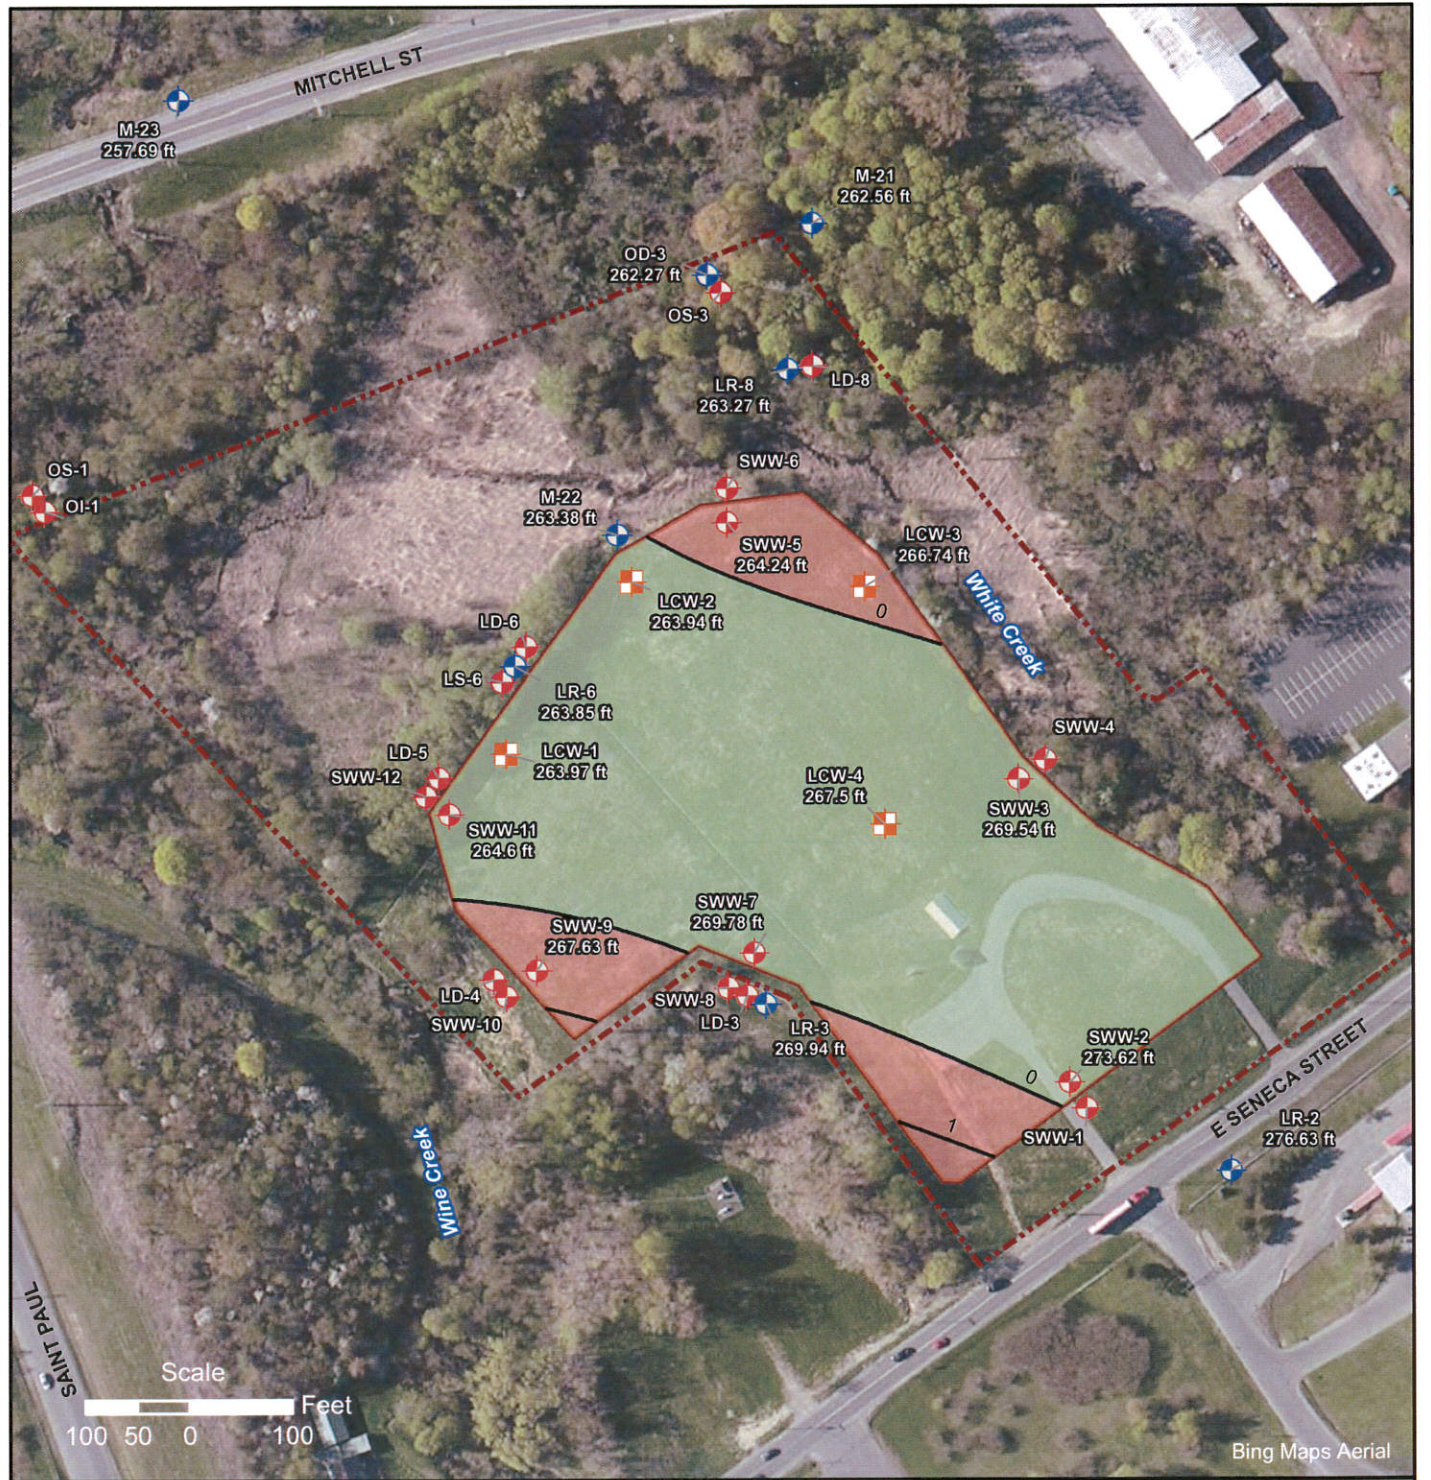
**Figure 2011-Q4-B**

**Notes:**  
 Overburden wells within the slurry wall were used to calculate the overburden potentiometric surface. Bedrock wells outside the slurry wall were used to calculate bedrock potentiometric surface. The bedrock potentiometric surface was subtracted from the overburden surface to produce the inferred vertical hydraulic gradient.

Negative gradient values indicate an upward hydraulic gradient.

**INFERRED VERTICAL HYDRAULIC GRADIENT - NOVEMBER 9, 2011**

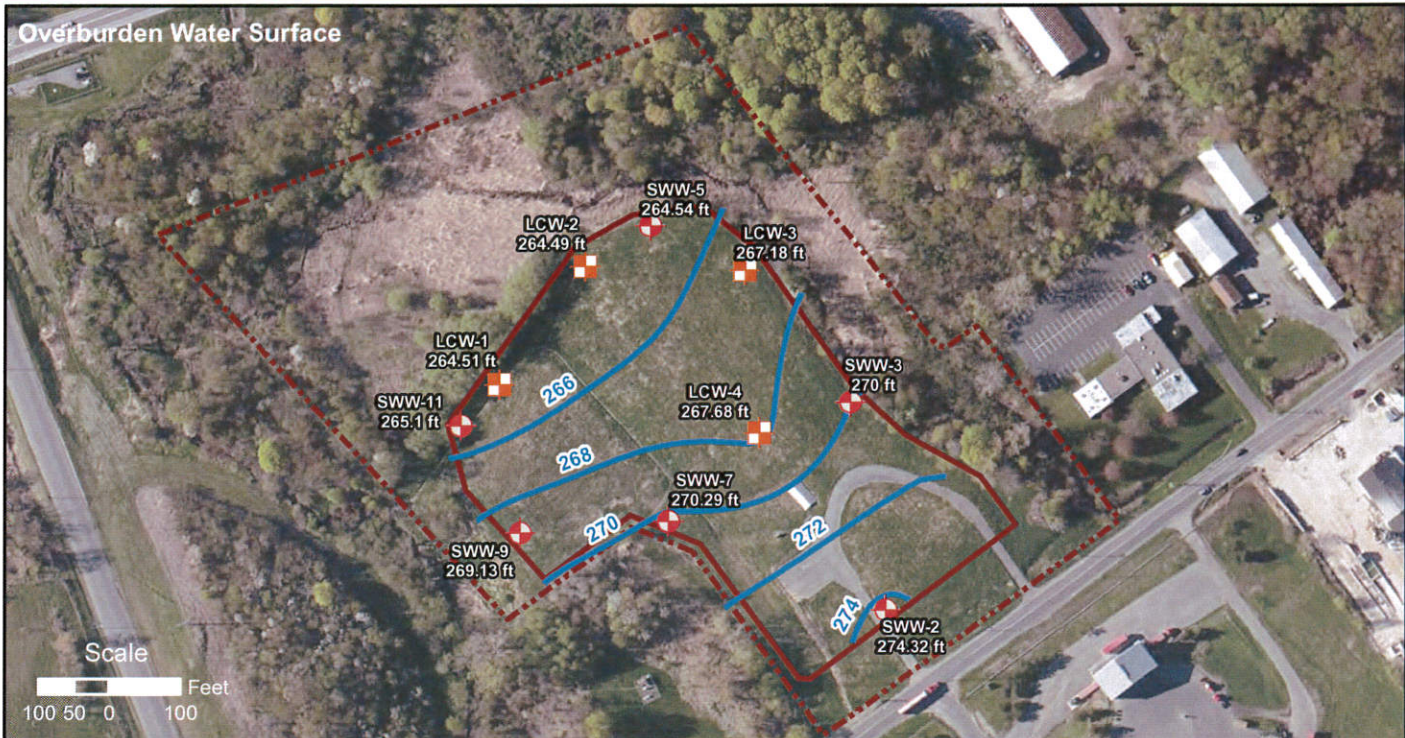
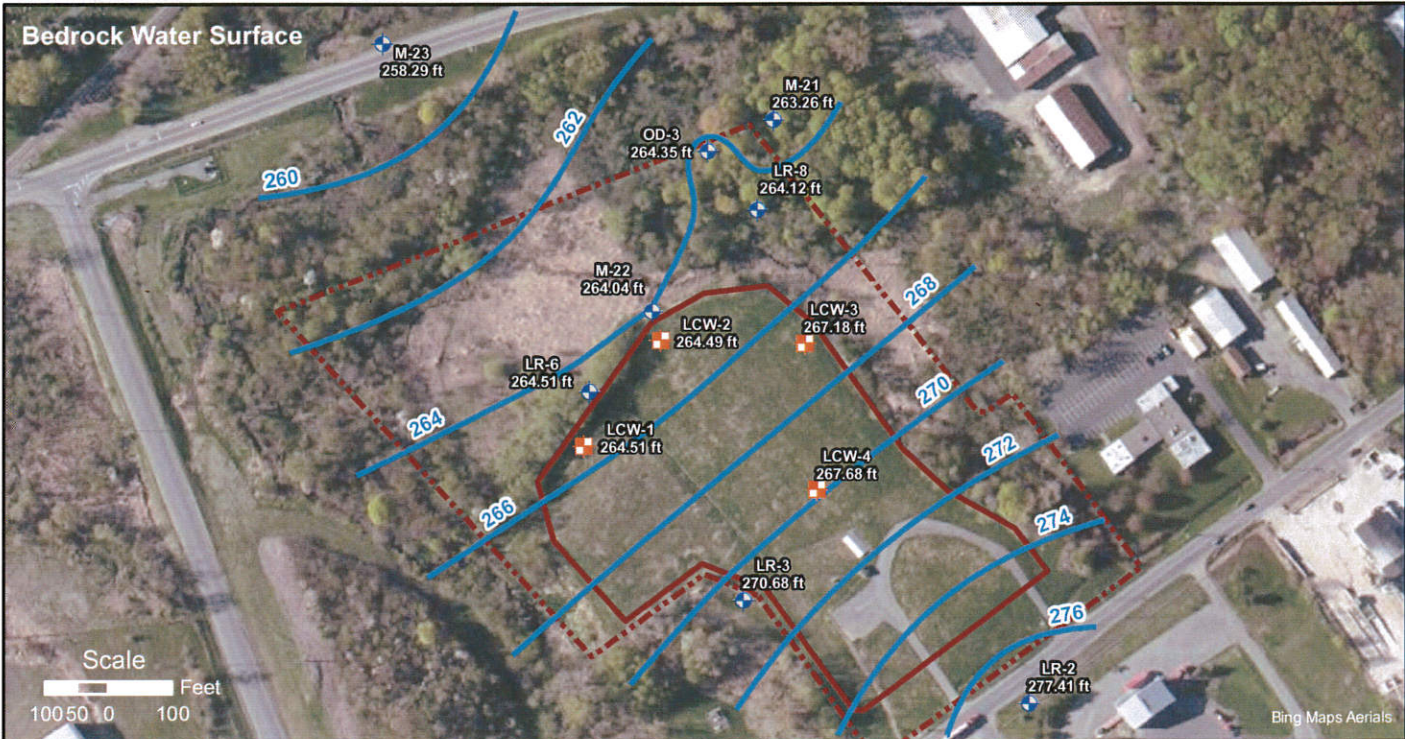
**Figure 2012-Q1-A**

Notes: LCW wells labeled on Bedrock Water Surface map for reference only and were not used in creation of the potentiometric surface.

Linear kriging was used to determine both potentiometric surfaces. Bedrock contours within the containment system are inferred from the identified bedrock wells.

**POTENTIOMETRIC SURFACES  
FEBRUARY 8, 2012  
PAS Site, Oswego, New York**

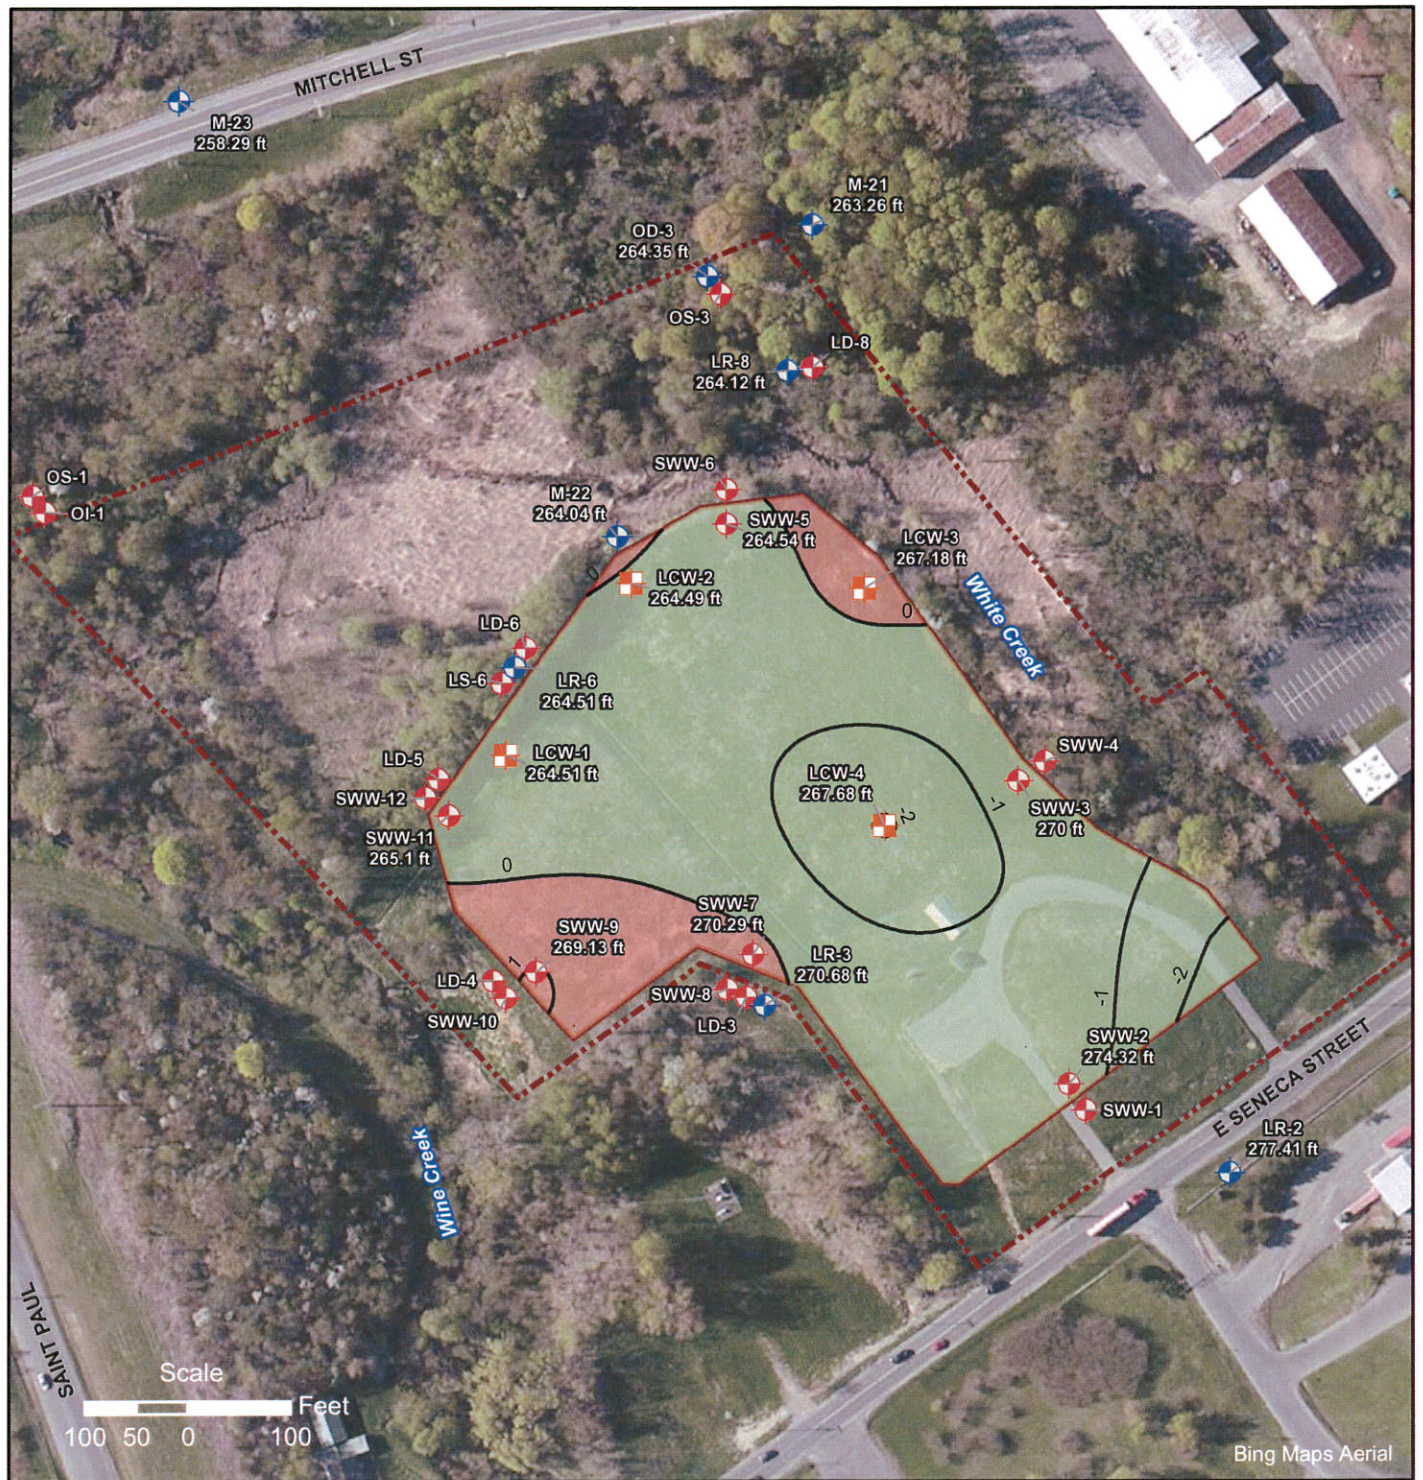
**Figure 2012-Q1-B**

**Notes:**  
 Overburden wells within the slurry wall were used to calculate the overburden potentiometric surface. Bedrock wells outside the slurry wall were used to calculate bedrock potentiometric surface. The bedrock potentiometric surface was subtracted from the overburden surface to produce the inferred vertical hydraulic gradient.

Negative gradient values indicate an upward hydraulic gradient.

**INFERRED VERTICAL HYDRAULIC GRADIENT - FEBRUARY 8, 2012**

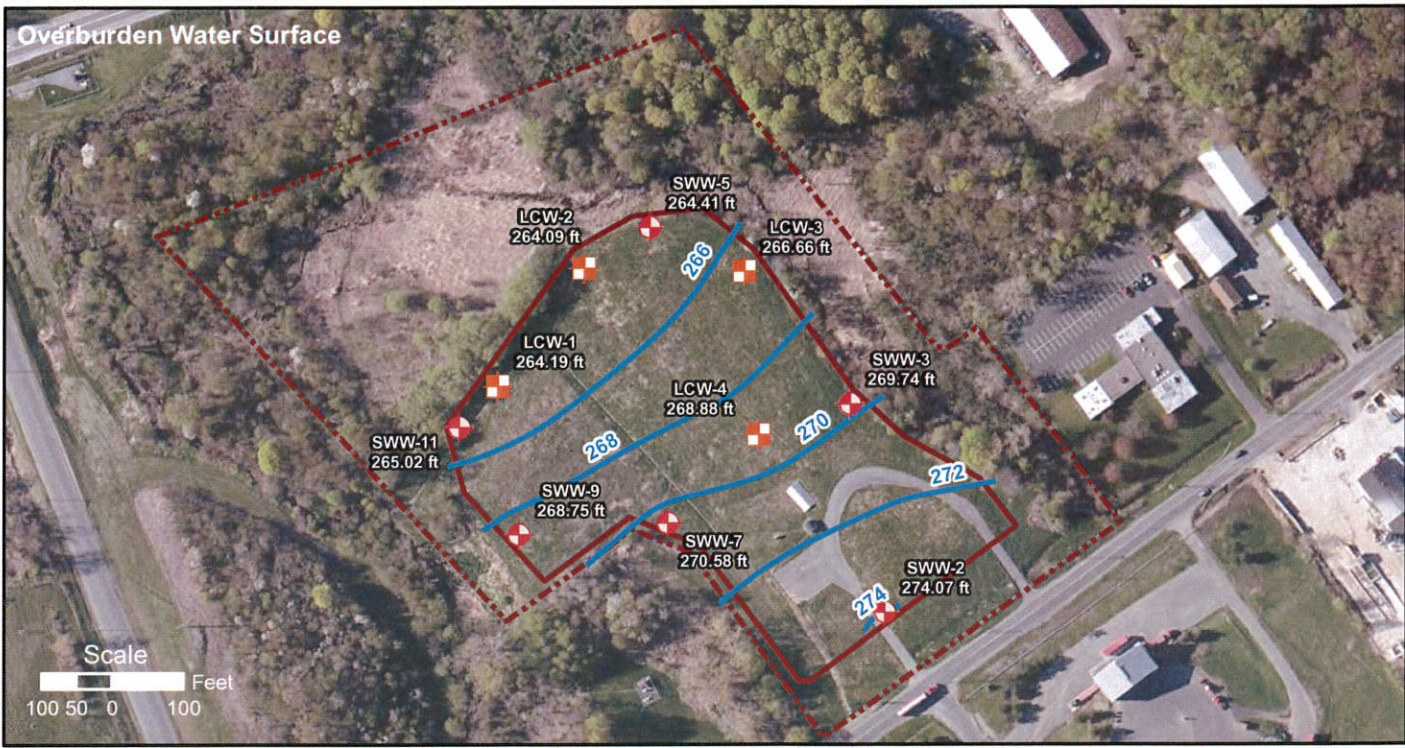
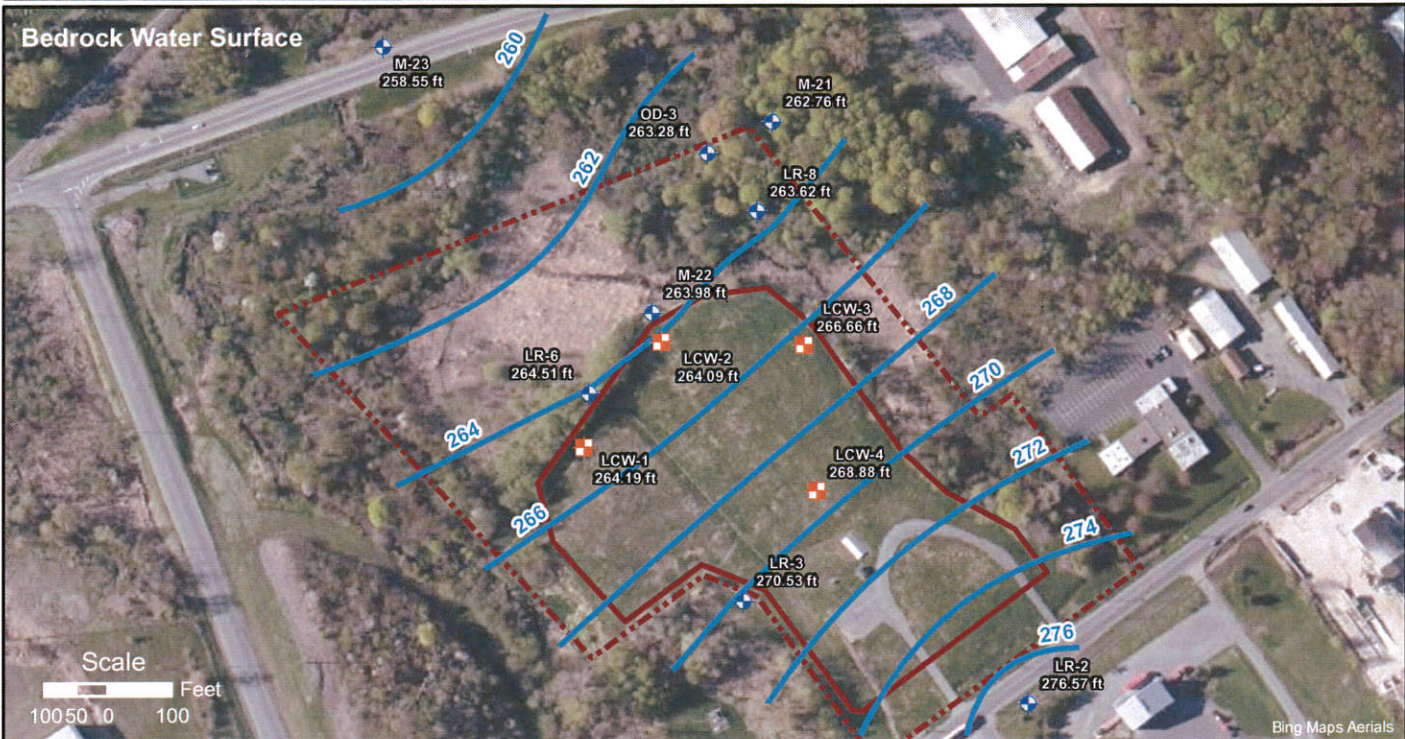
**Figure 2012-Q2-A**

Notes: LCW wells labeled on Bedrock Water Surface map for reference only and were not used in creation of the potentiometric surface.

Linear kriging was used to determine both potentiometric surfaces. Bedrock contours within the containment system are inferred from the identified bedrock wells.

**POTENTIOMETRIC SURFACES**  
**MAY 9, 2012**  
 PAS Site, Oswego, New York
