*PAS Oswego Superfund Site – 2012 Annual Report*

SLURRY WALL

PAS - OSWEGO  
GROUNDWATER ELEVATIONS (SWW1 and SWW2)

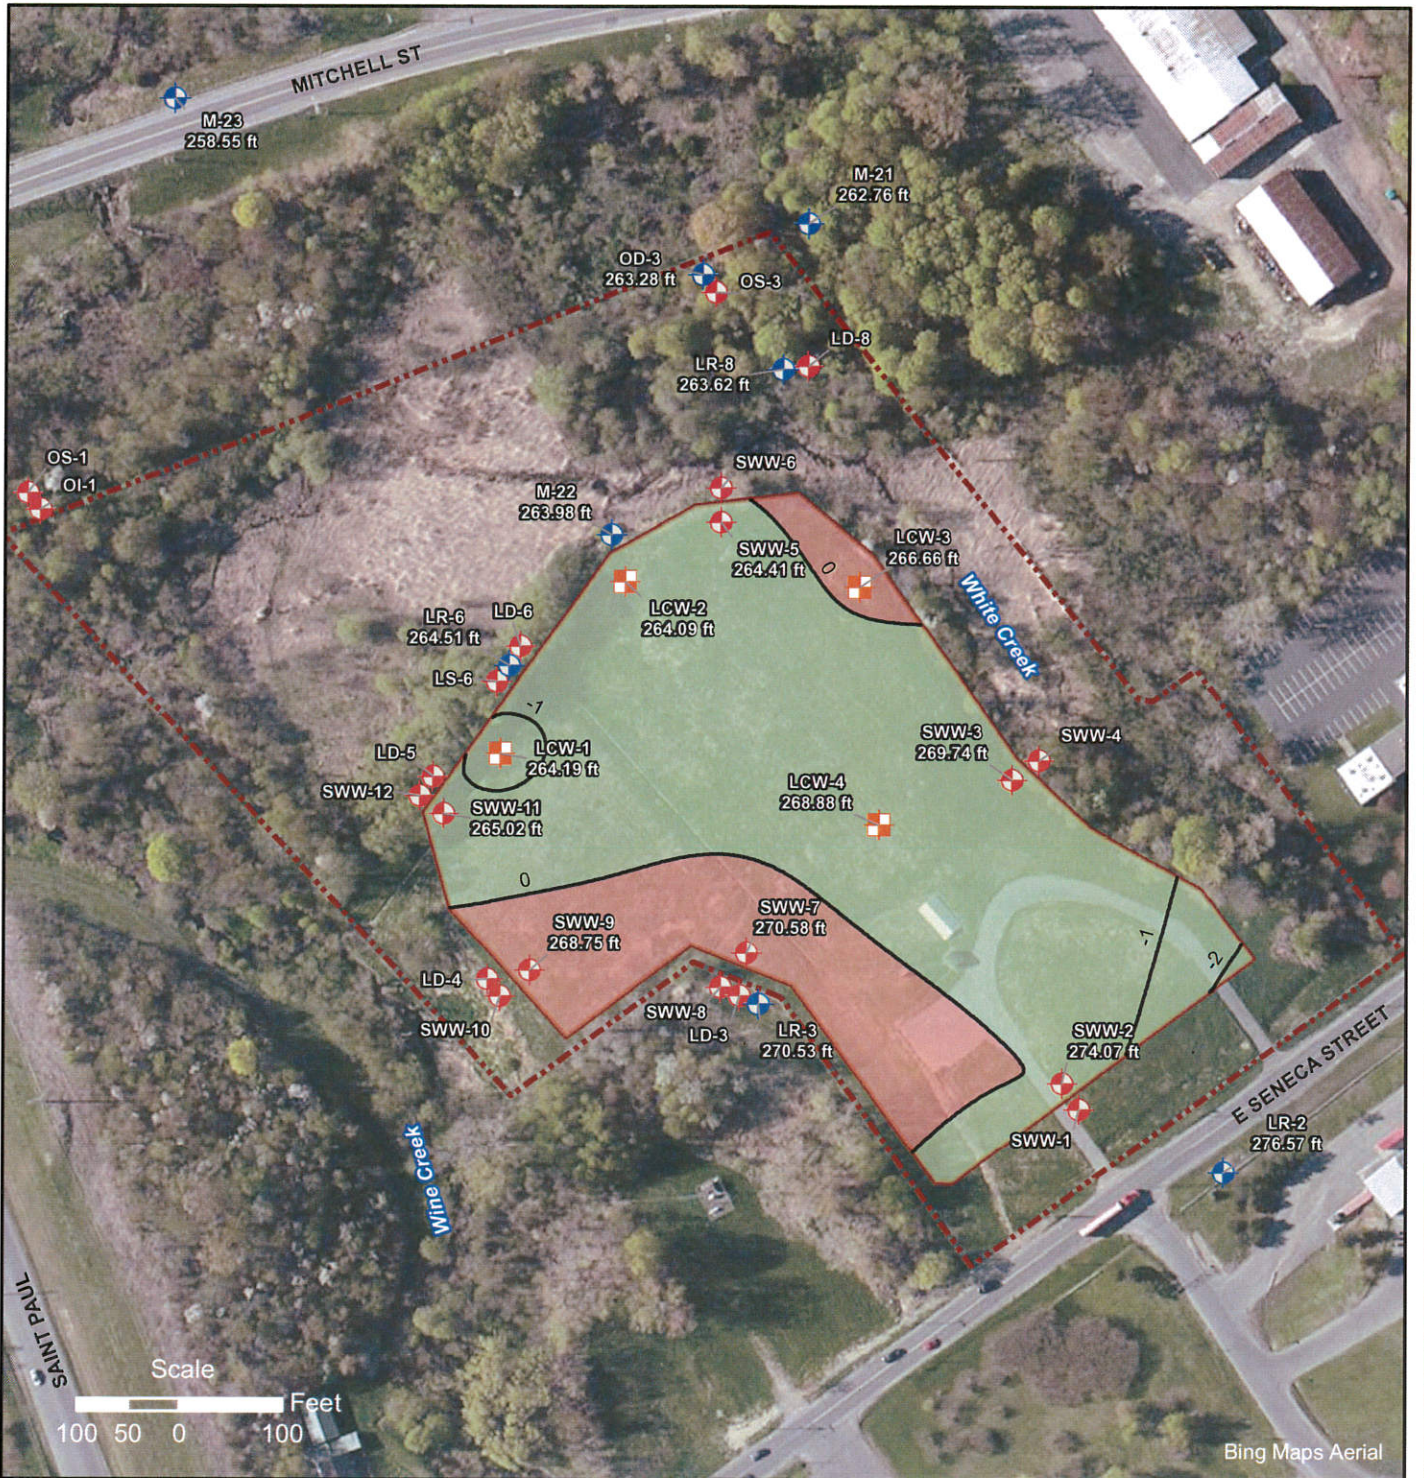
**Figure 2012-Q2-B**

**Notes:**  
 Overburden wells within the slurry wall were used to calculate the overburden potentiometric surface. Bedrock wells outside the slurry wall were used to calculate bedrock potentiometric surface. The bedrock potentiometric surface was subtracted from the overburden surface to produce the inferred vertical hydraulic gradient.

Negative gradient values indicate an upward hydraulic gradient.

**INFERRED VERTICAL HYDRAULIC GRADIENT - MAY 9, 2012**

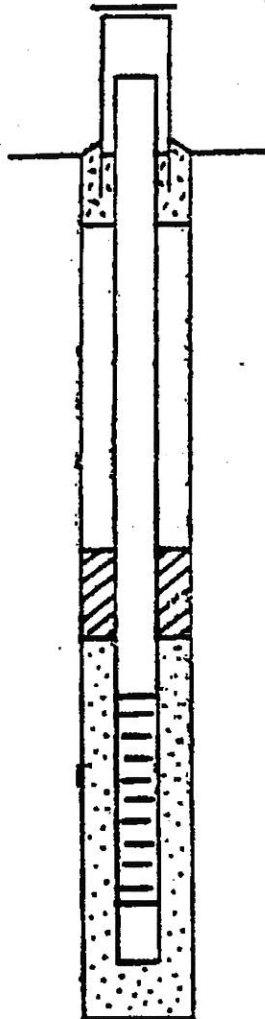
Seal Type bentonite slurry

Sand Pack Type/Size #4 QROK

39" Prot. Csg stickup

36" Riser stickup

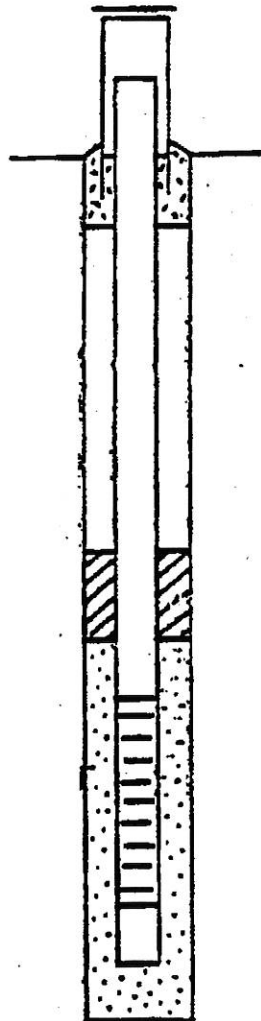
Seal Type  bentonite slurry

Sand Pack Type/Size #4 QROK

38" Prot. Csg stickup

36" Riser stickup

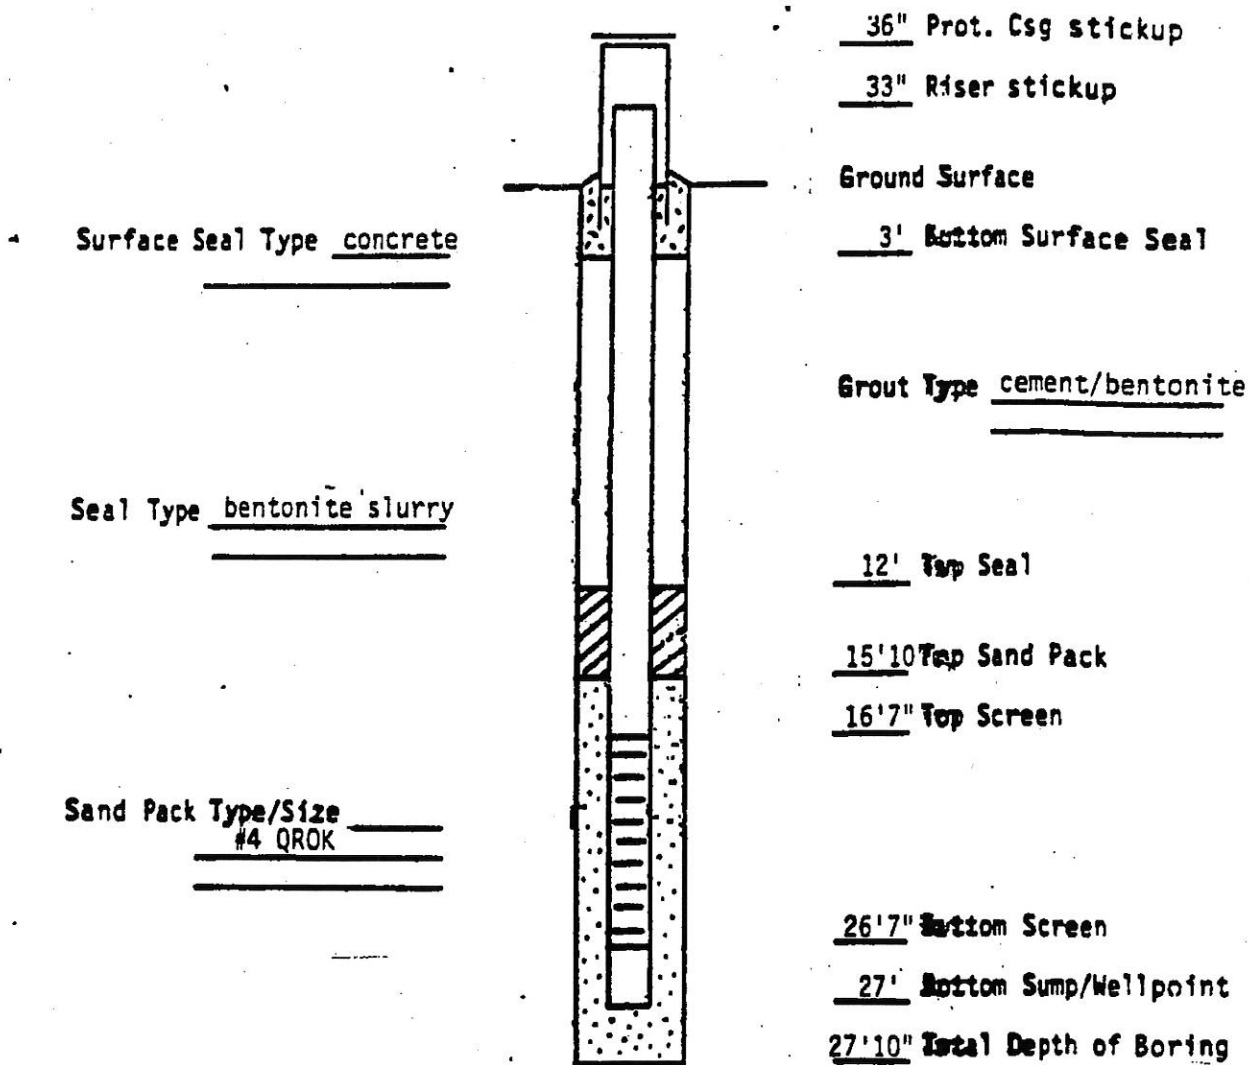
SCHEMATIC

Riser:	Dia. <u>2"</u>	Material <u>304 s.s.</u>	Length <u>20'</u>	Slot Size <u>0.010"</u>
Screen:	Dia. <u>2"</u>	Material <u>304 s.s.</u>	Length <u>10'</u>	
Prot. Csg:	Dia. <u>6"</u>	Material <u>steel</u>	Length <u>7'</u>

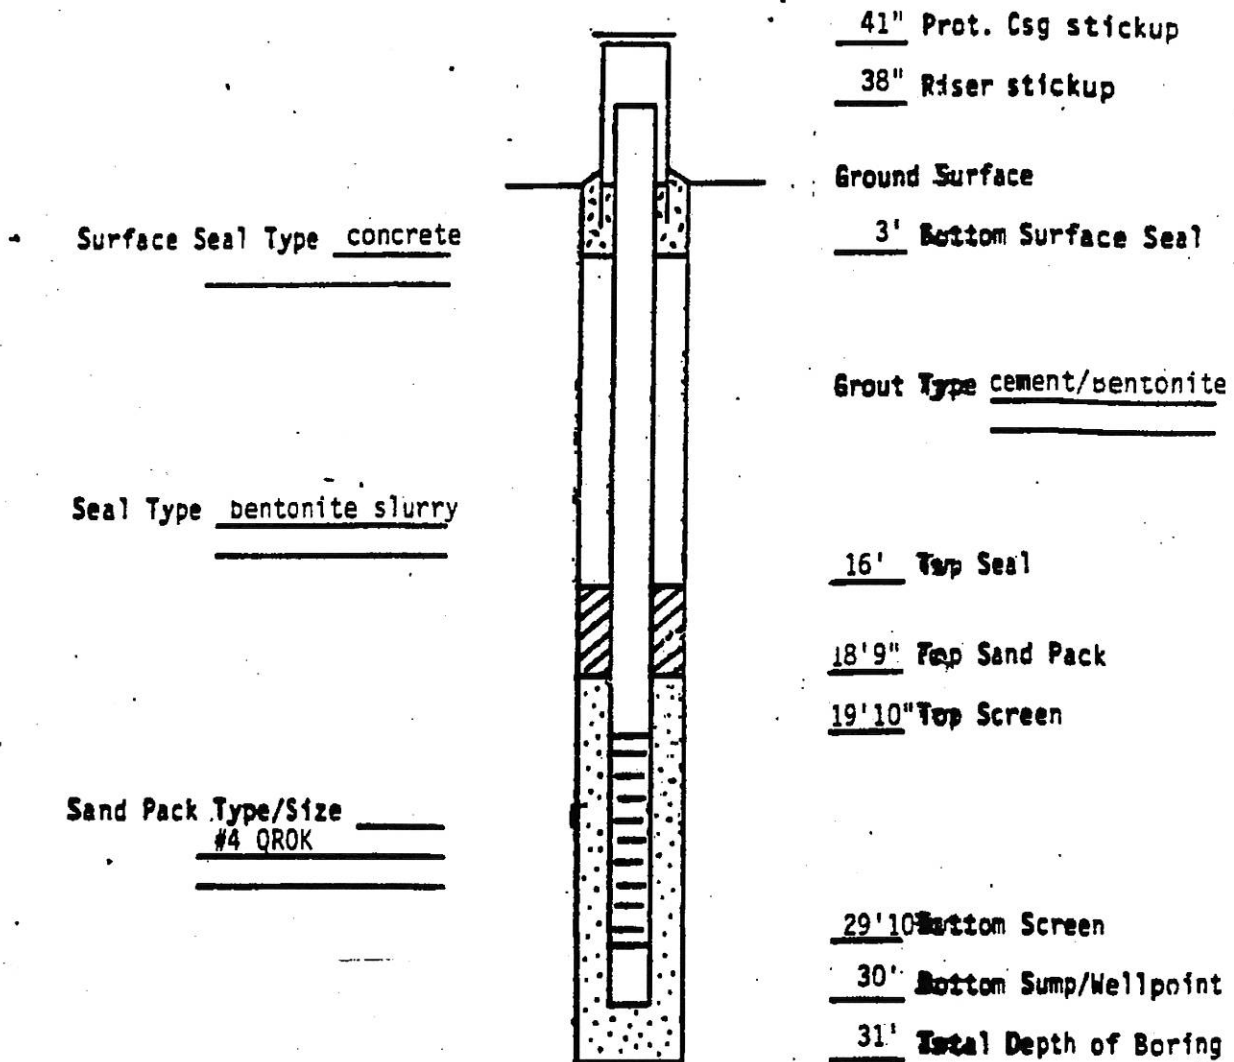
SCHMATIC

Riser:	Dia. <u>2"</u>	Material <u>304 s.s.</u>	Length <u>23'</u>	
Screen:	Dia. <u>2"</u>	Material <u>304 s.s.</u>	Length <u>10'</u>	Slot Size <u>0.010"</u>
Prot. Csg:	Dia. <u>6"</u>	Material <u>steel</u>	Length <u>7'</u>

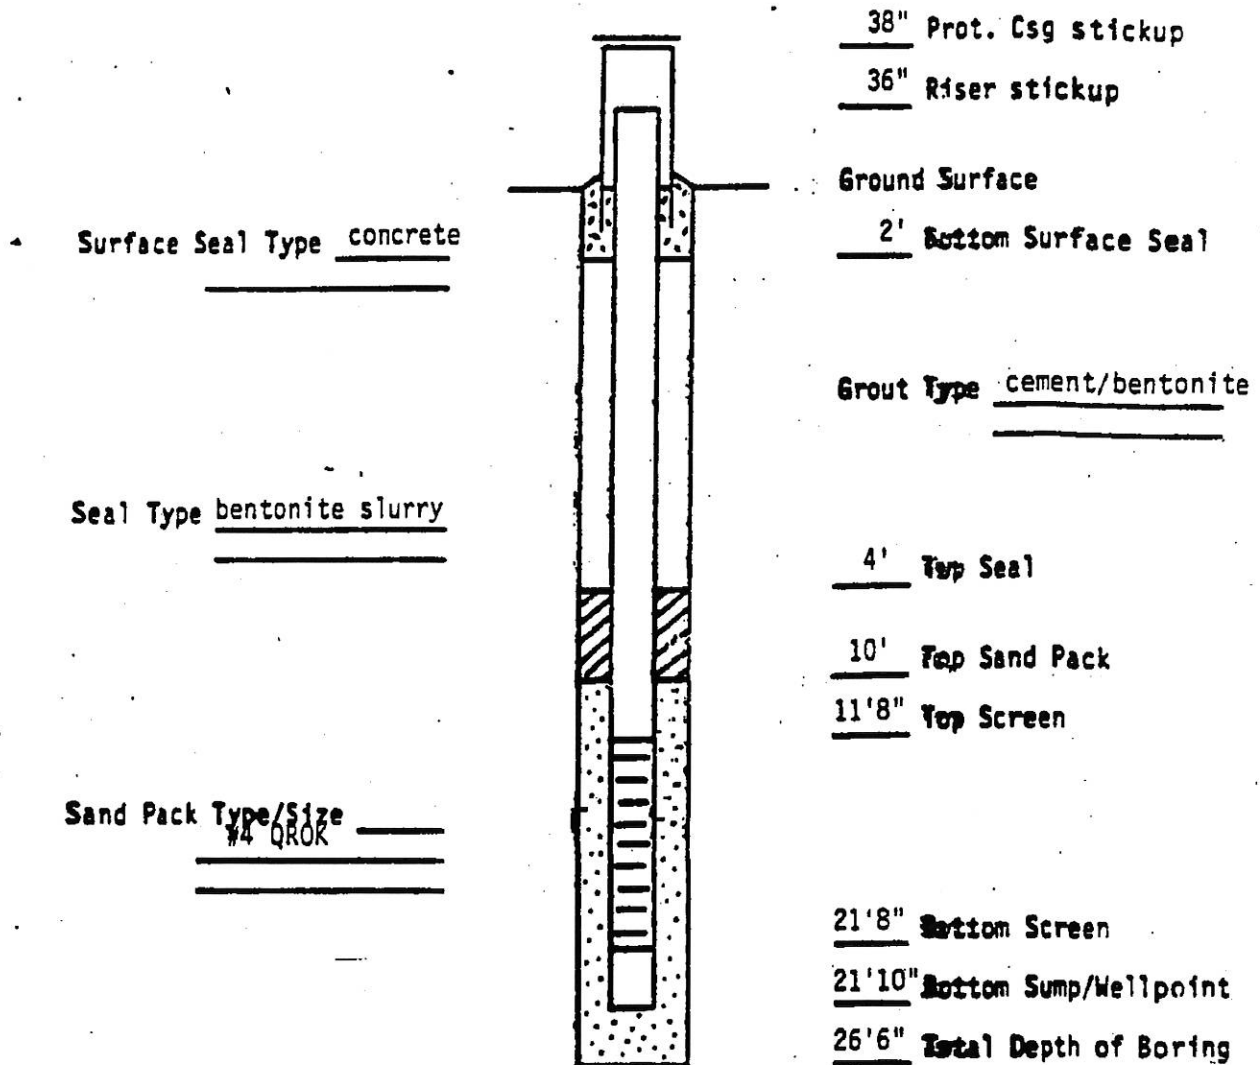
SCHEMATIC

Riser:	Dia. <u>2"</u>	Material <u>304 s.s.</u>	Length <u>15'</u>	Slot Size <u>0.010"</u>
Screen:	Dia. <u>2"</u>	Material <u>304 s.s.</u>	Length <u>10'</u>	
Prot. Csg:	Dia. <u>6"</u>	Material <u>steel</u>	Length <u>7'</u>

Comments pellets from b.o.n. to 23'
