de maximis, inc.

July 31, 2020

***Subject: Annual Progress Report for July 2019 through June 2020
Operations, Maintenance and Long Term-Monitoring Activities
Pollution Abatement Services (PAS) Site, Oswego, NY***

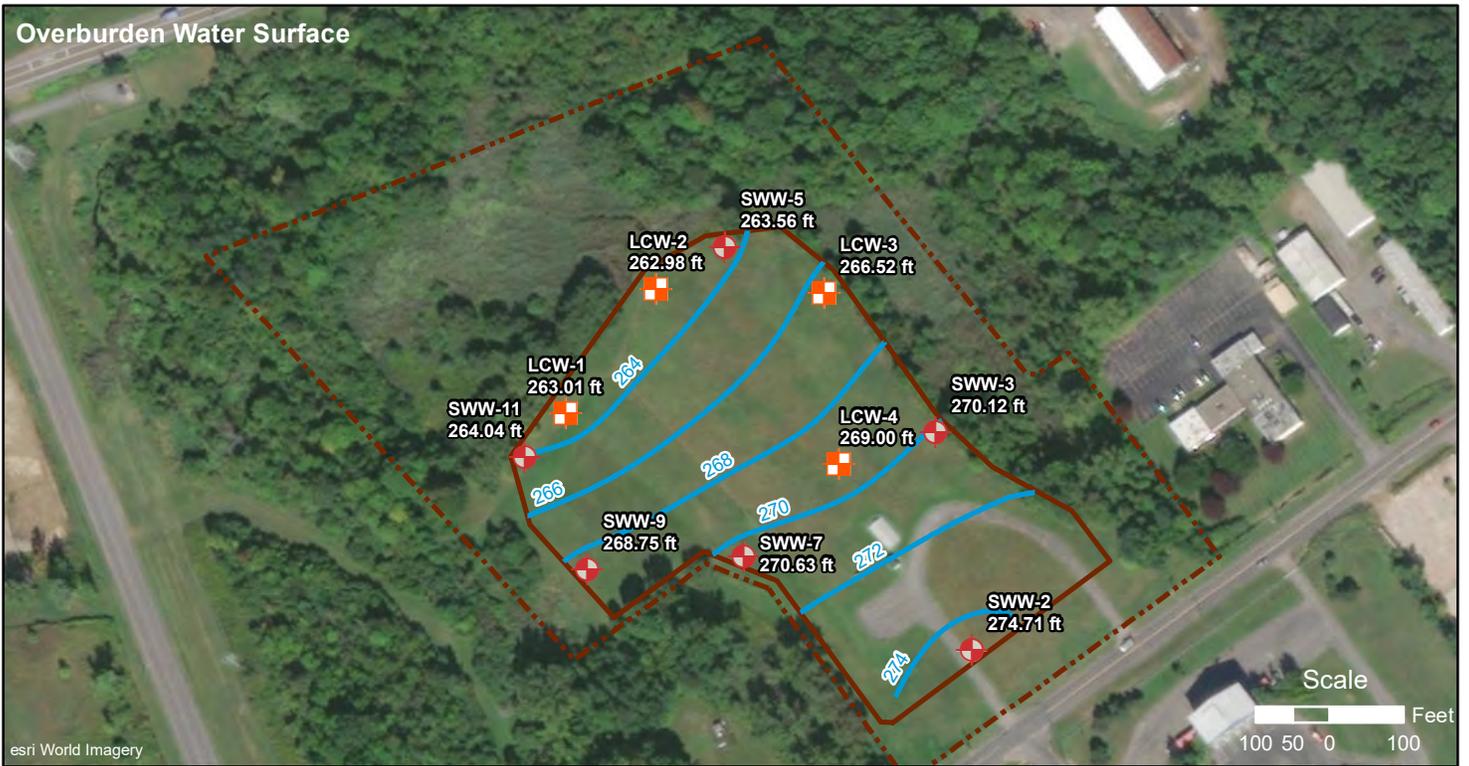
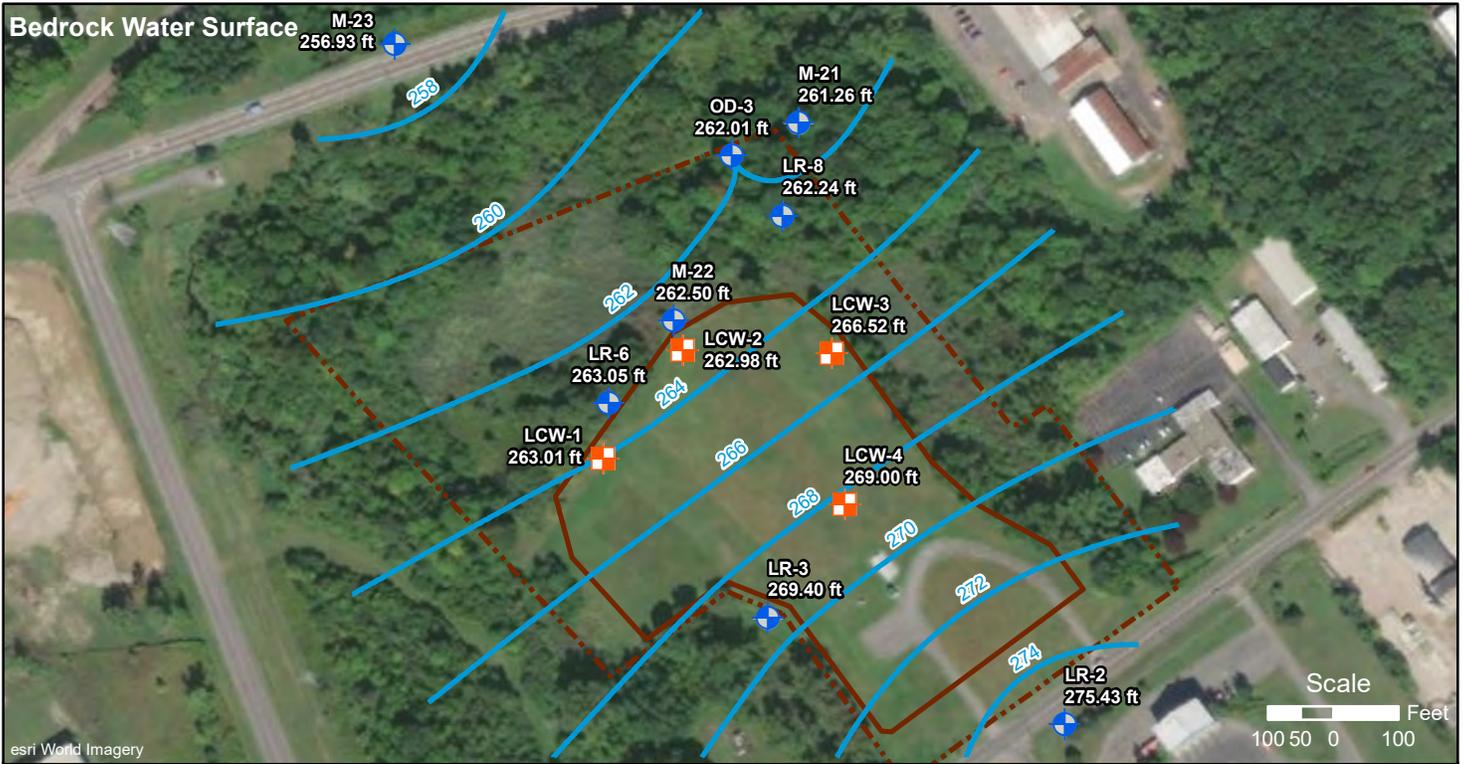
FIGURE SET 3
HYDRAULIC GRADIENT

The effectiveness of the hydraulic control of the slurry wall containment system is evaluated based on a review of water level elevations used to determine hydraulic gradients, both horizontal and vertical, around and beneath the containment system. Its effectiveness is also evaluated by determining whether the water level elevations are maintained below the top of the slurry wall at its downgradient extent. Horizontal gradients around the containment system are calculated using quarterly water level elevations recorded at the SWW-series monitoring wells which are located around the perimeter of the slurry wall as shown in Attachment I-B. Vertical gradients beneath the containment system are calculated based on the difference in the water level potentiometric surface in the overburden and the bedrock monitoring wells located in the vicinity of the containment system. Figures showing the potentiometric water surfaces for both the bedrock and overburden monitoring wells for each of the quarterly water level monitoring events are presented in Attachment I-A (Set 3).

The water level data for the upgradient SWW wells SWW1/2 and SWW3/4 show the regional groundwater is consistent with the past few years. The horizontal gradients at well pairs SWW-5/6 and SWW-11/12 are influenced by both leachate pumping and seasonal regional water level elevations, while horizontal gradients at other SWW well pairs are primarily affected by regional water level elevations outside the containment system. During the reporting period, the water levels at SWW-5 and SWW-11, the two interior SWW wells at the downgradient extent of the slurry wall, remained stable and showed the continued inward gradient pattern of recent years. Generally, the charts indicate that leachate pumping at the rates prescribed effectively maintains hydraulic control to the degree practicable, although seasonal levels outside the containment system influence the gradients.

Overburden Water Surface

Bedrock Water Surface

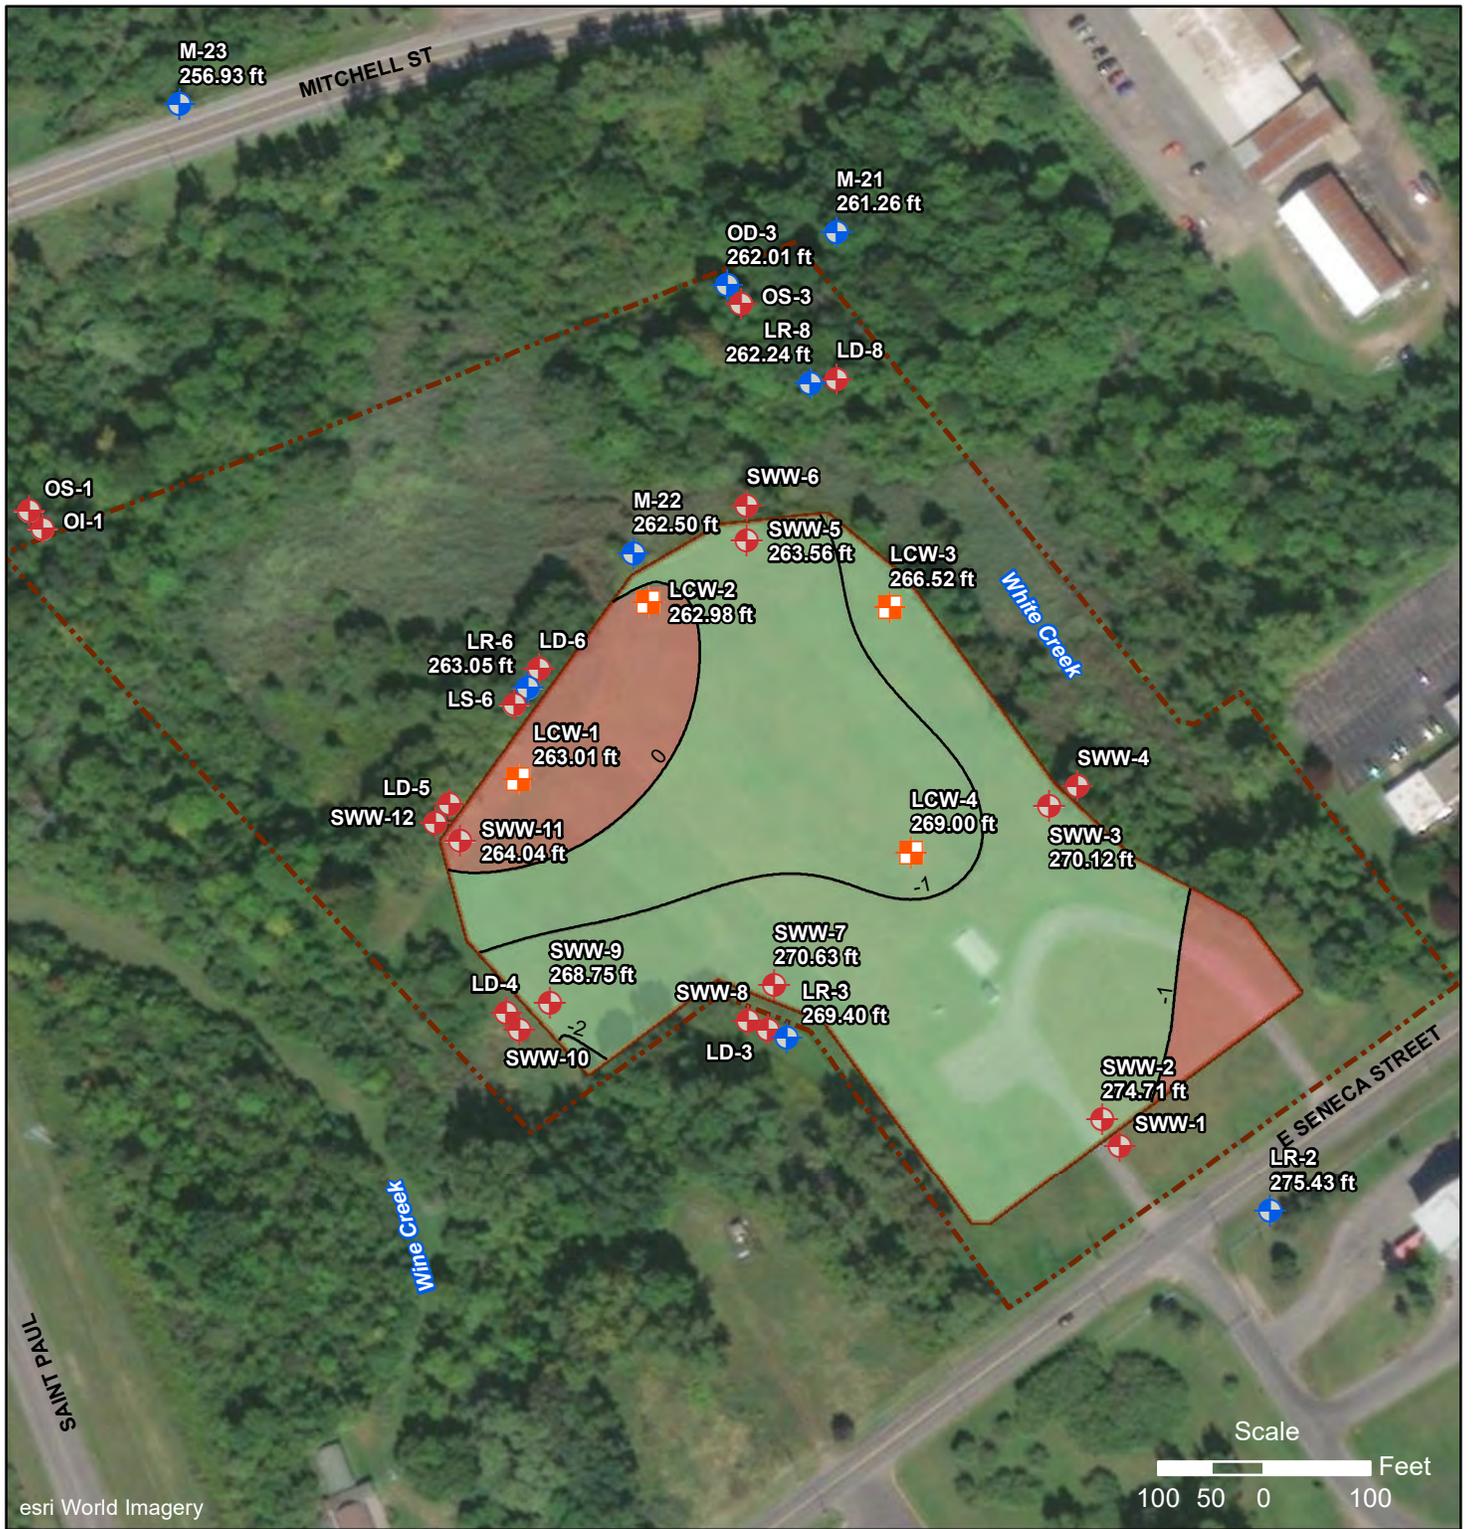
Figure 2019-Q3-B

- Bedrock Monitoring Well
- Leachate Collection Well (Overburden)
- Overburden Monitoring Well
- Fence (Site Boundary)
- Line of Potentiometric Surface Difference (ft)
- Upward Vertical Hydraulic Gradient
- Downward Vertical Hydraulic Gradient
- Slurry Wall

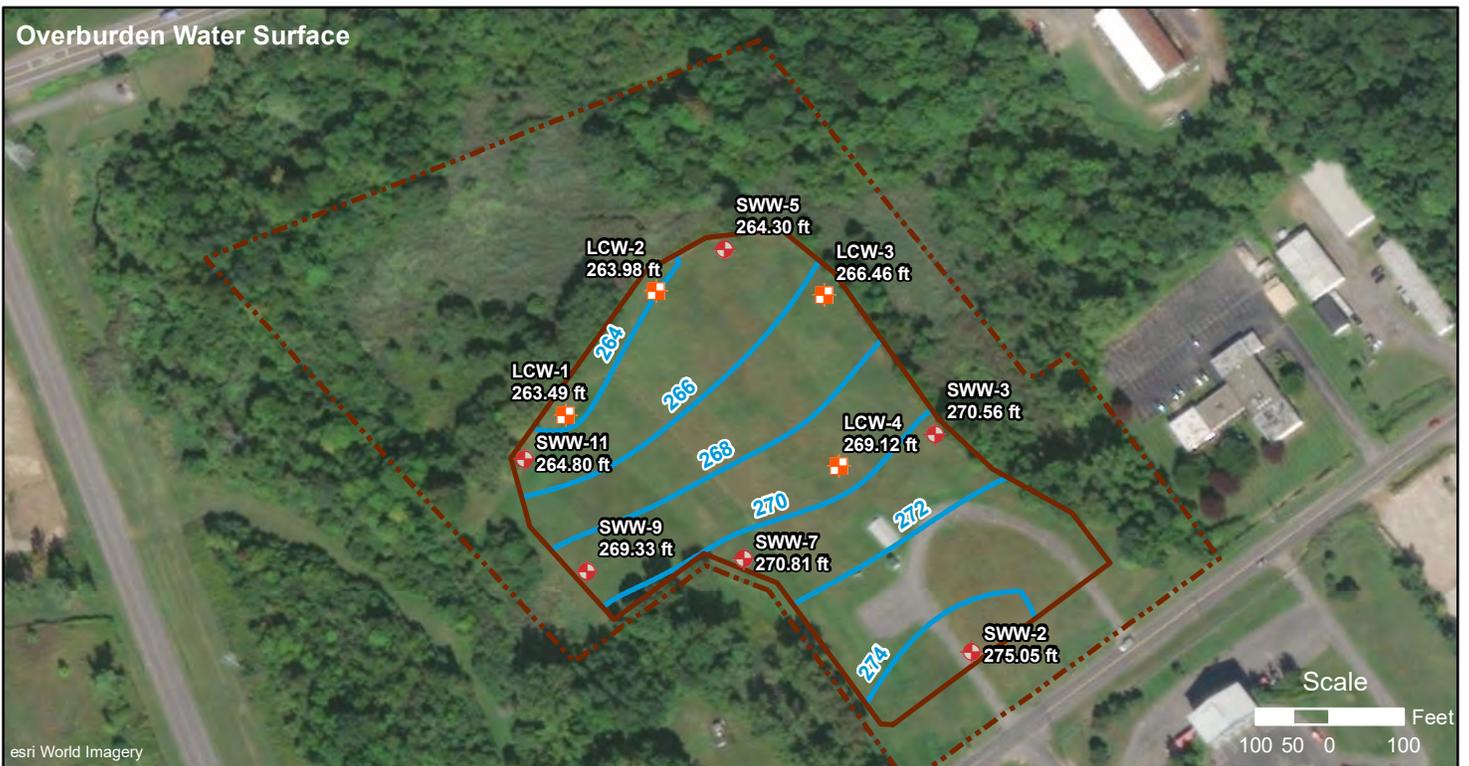
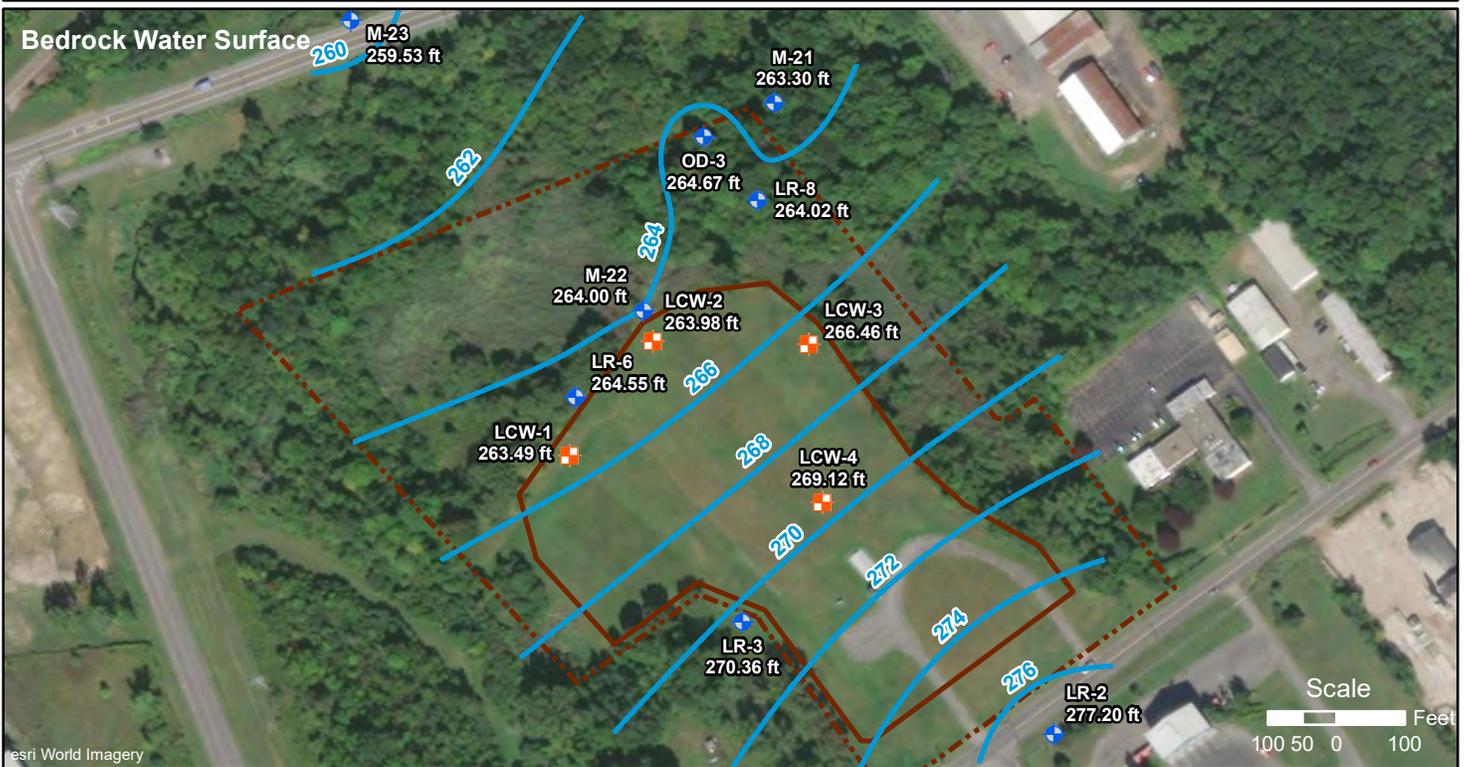
Figure 2020-Q1-A

Overburden Water Surface

Bedrock Water Surface
