COLUMBIA MILLS PROPERTY

INVESTIGATIVE REPORT

OSWEGO COUNTY

JUNE 1984

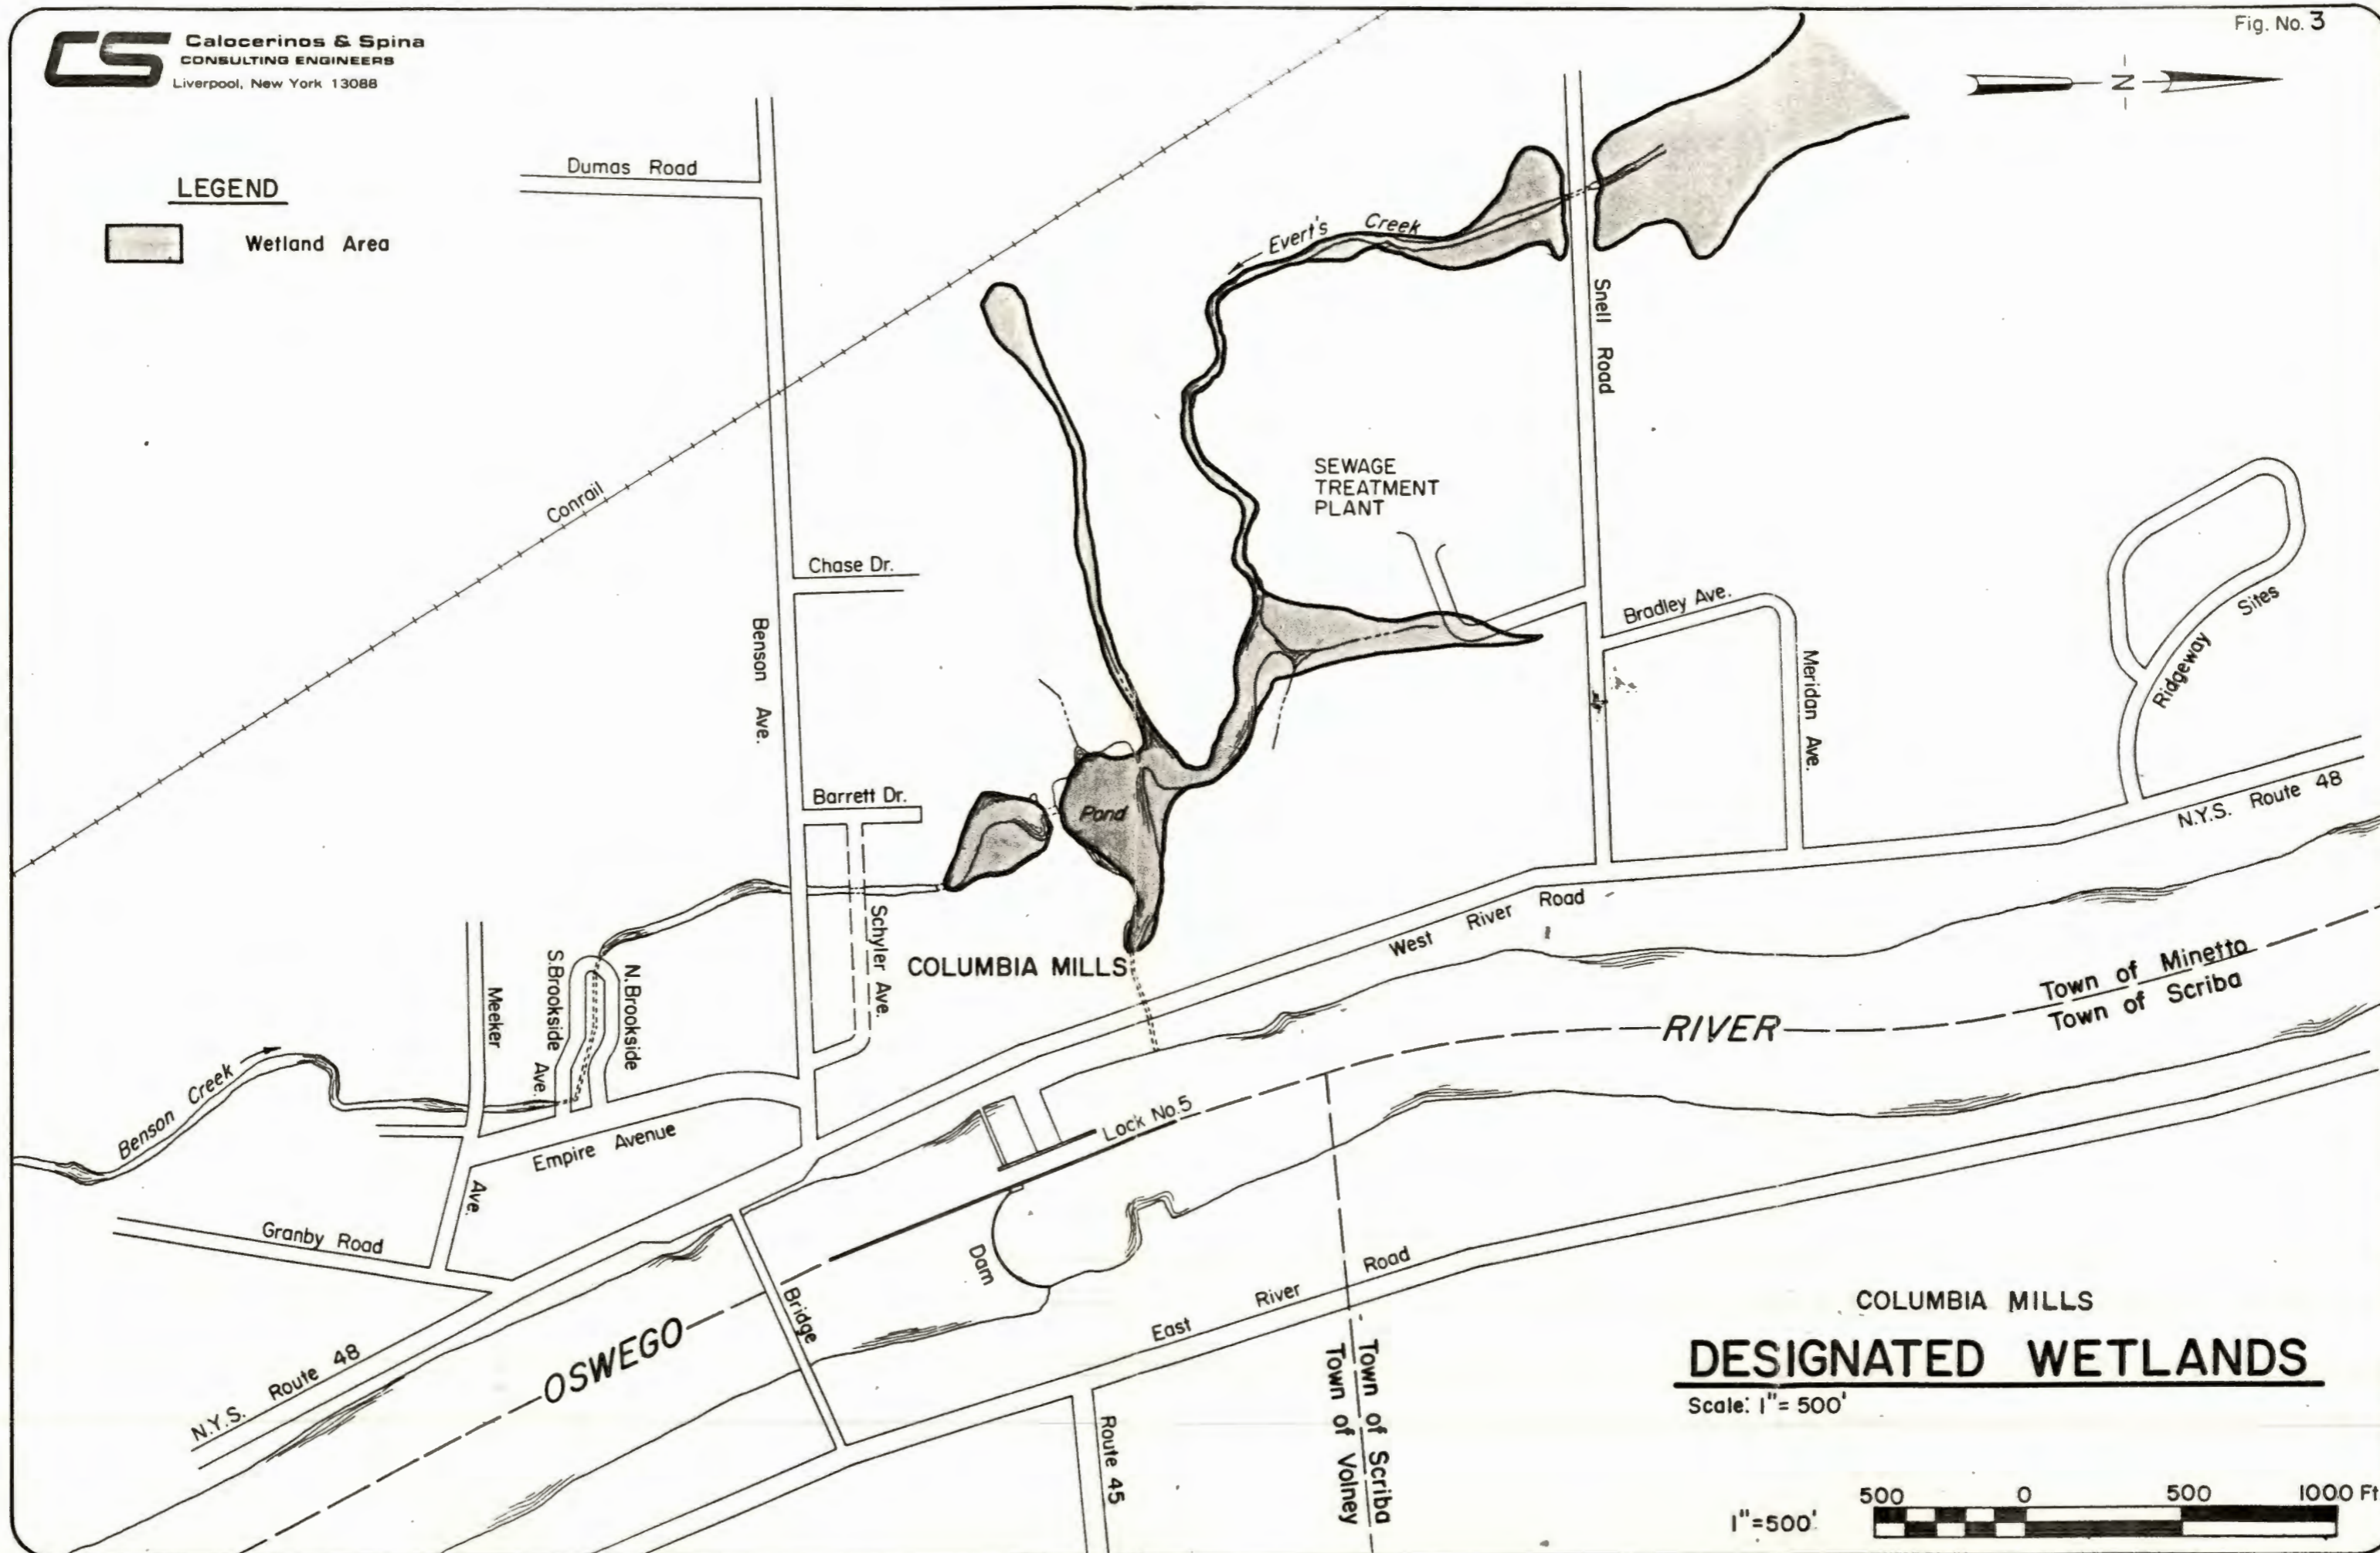
COLUMBIA MILLS
DESIGNATED WETLANDS

Wetland Area

An additional item should be noted when considering site cleanup. Demolition and debris material cannot be buried within the wetland areas (See Figure 3). In fact, no activity in these defined areas is permitted without written permission from DEC. This includes vehicle traffic, grading work, burial of materials, etc.

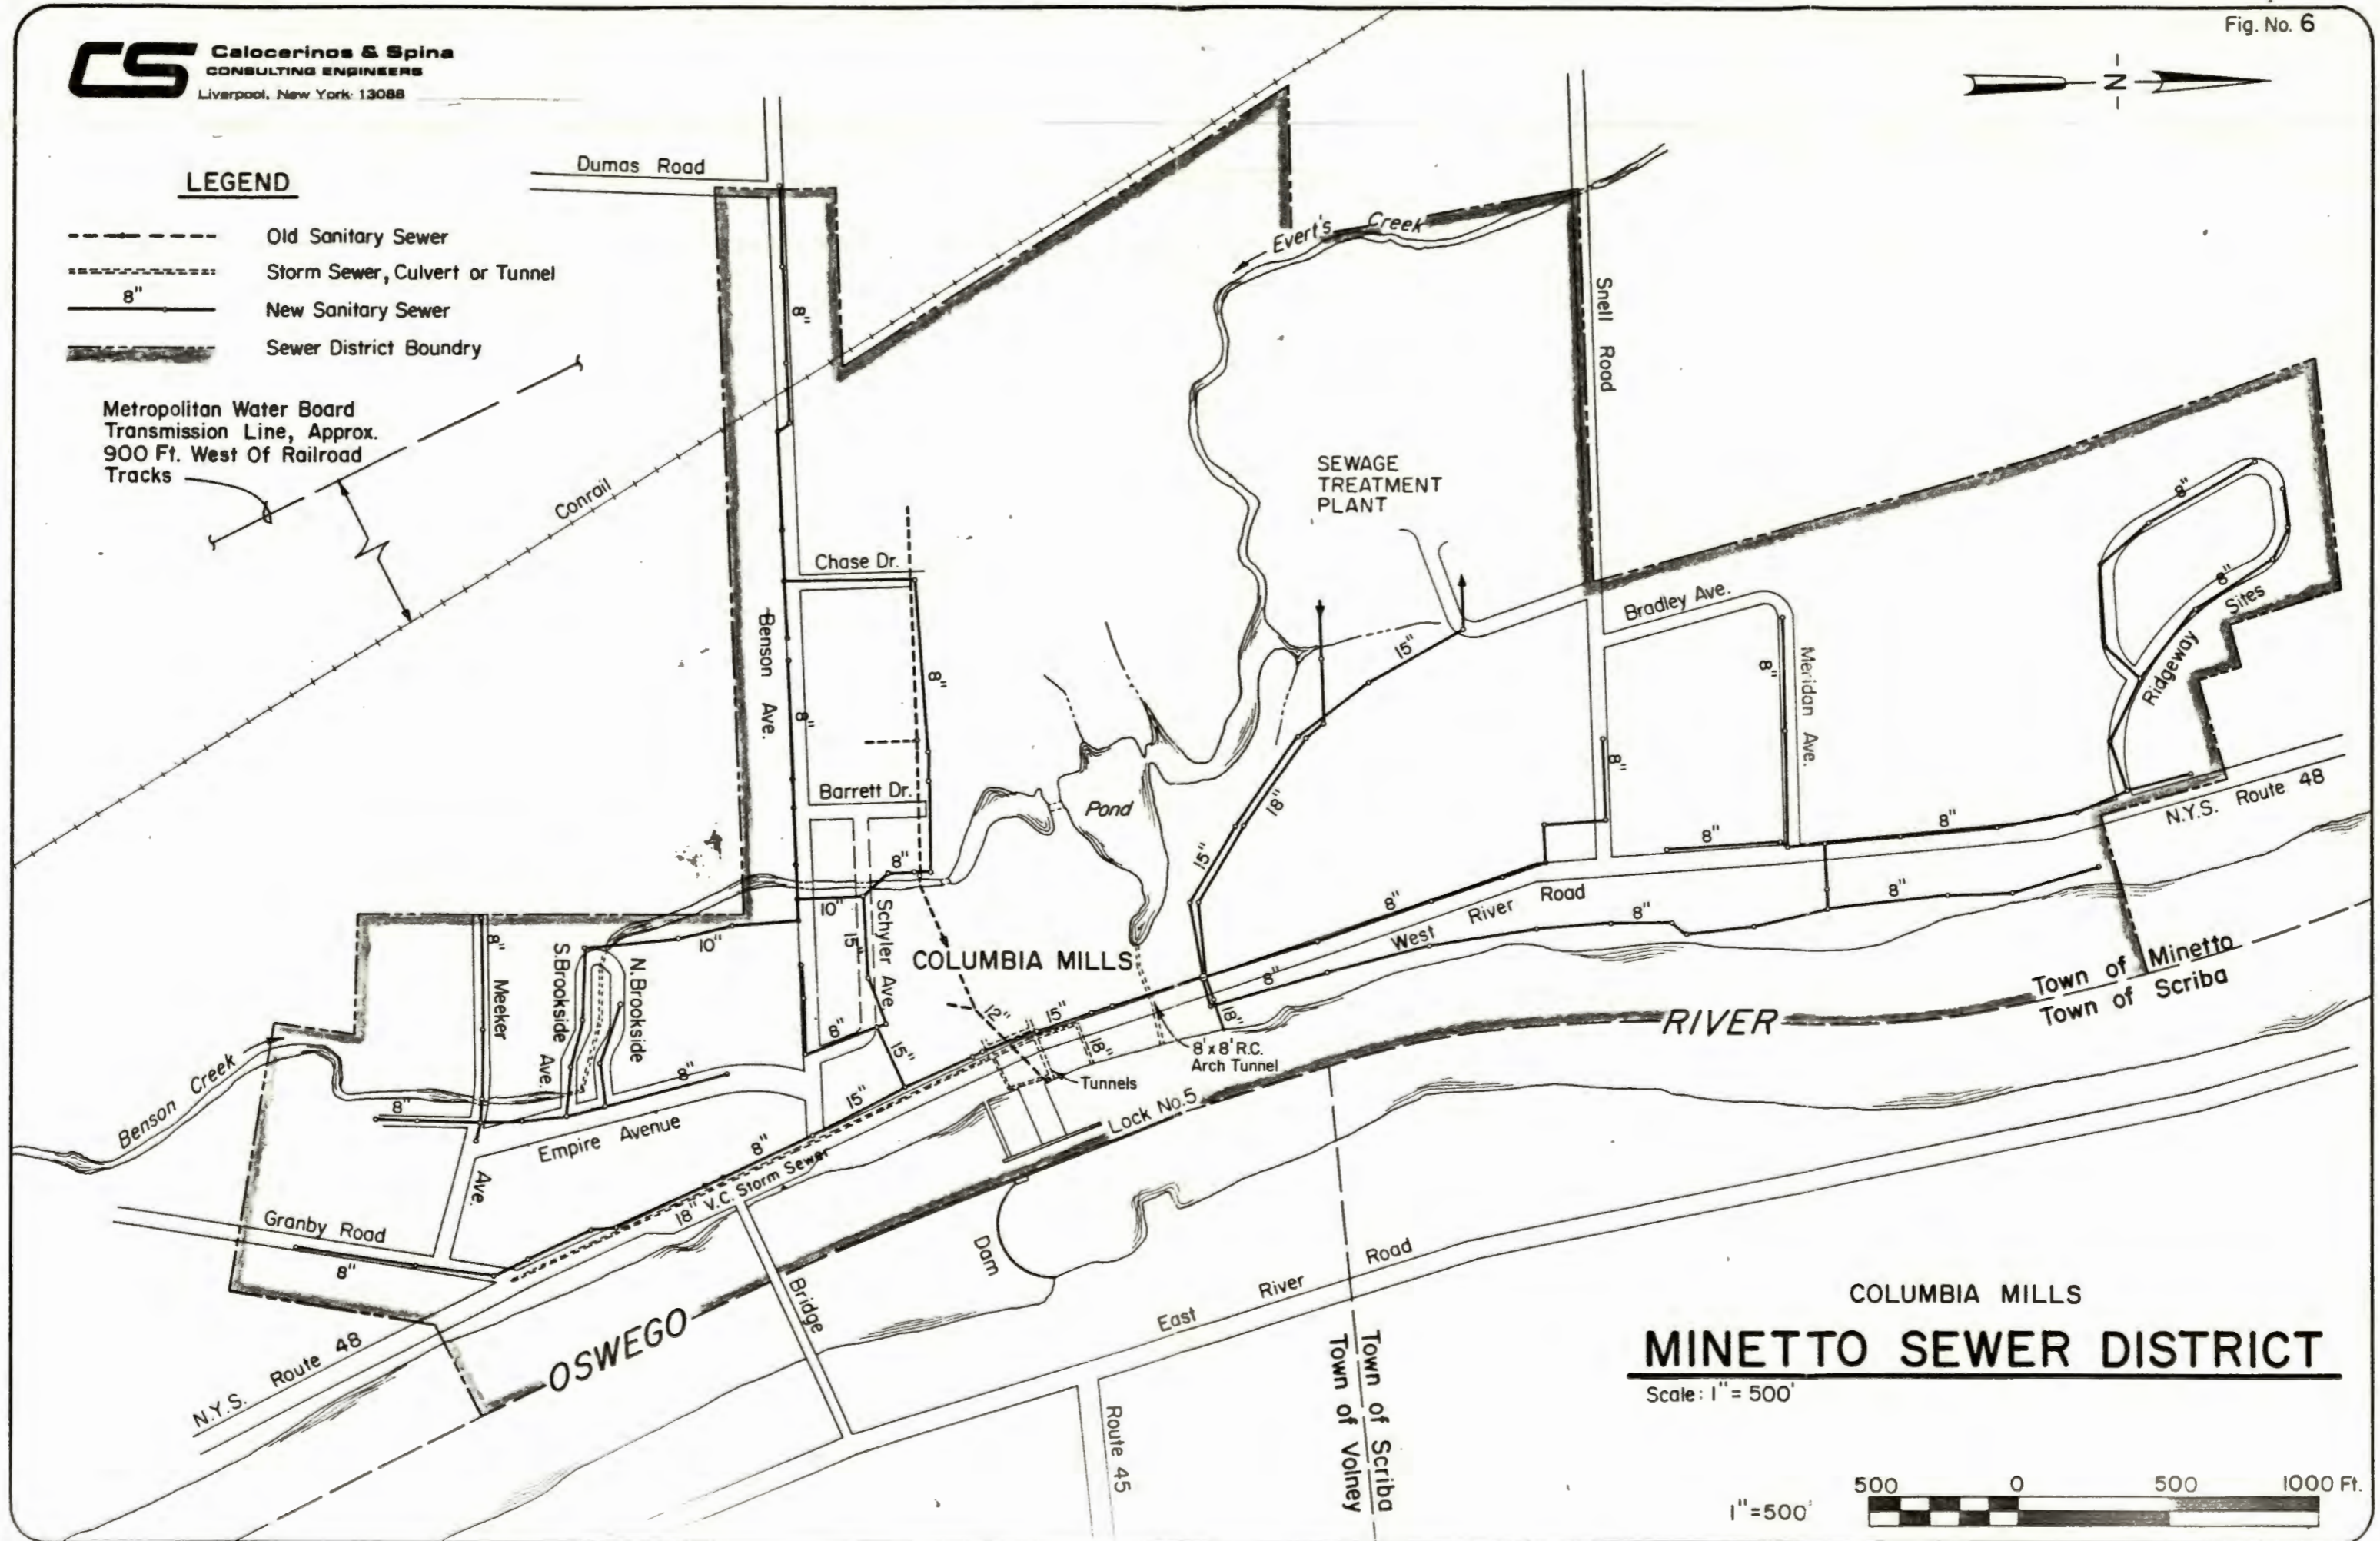
**COLUMBIA MILLS
MINETTO SEWER DISTRICT**

Approx. 2 1/2 Miles Of 12" To 20", Then 1 1/4 Miles Of 20" To Pump Station

- Old Sanitary Sewer
- - - - Storm Sewer, Culvert or Tunnel
- 8" New Sanitary Sewer
- Sewer District Boundry

Metropolitan Water Board
Transmission Line, Approx.
900 Ft. West Of Railroad
Tracks
