Columbia Mills Site 2009 Annual Groundwater Monitoring Report

NYSDEC Site Number 7-38-012

November 2009

Malcolm Pirnie, Inc.

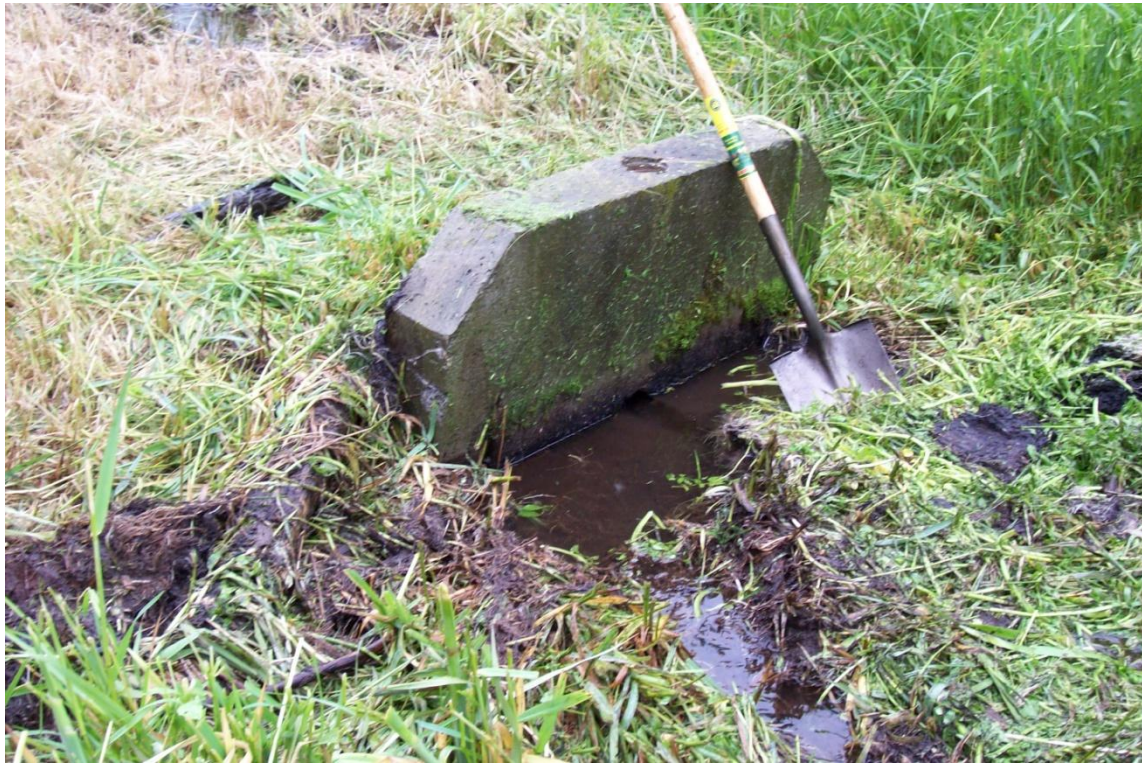
Photo 1: Discharge structure to Amphibian Breeding Pond.

A concrete leachate discharge structure was located near the inlet to the amphibian breeding pond (ABP) (Photo 1). Flow was observed in the pipe discharging to the ABP. The combination sampling sump was located between the discharge structure and the leachate collection tank (Photo 2). Three inlet pipes and one discharge were noted in the structure. The ends of two of the inlet pipes were fitted with ball valves. Water was observed flowing into the structure from each inlet pipe. The combined flow was estimated at less than one gallon per minute (gpm). The level of water in the discharge structure was sufficient to allow flow into the structure discharge pipe, which was apparently discharging to the ABP.

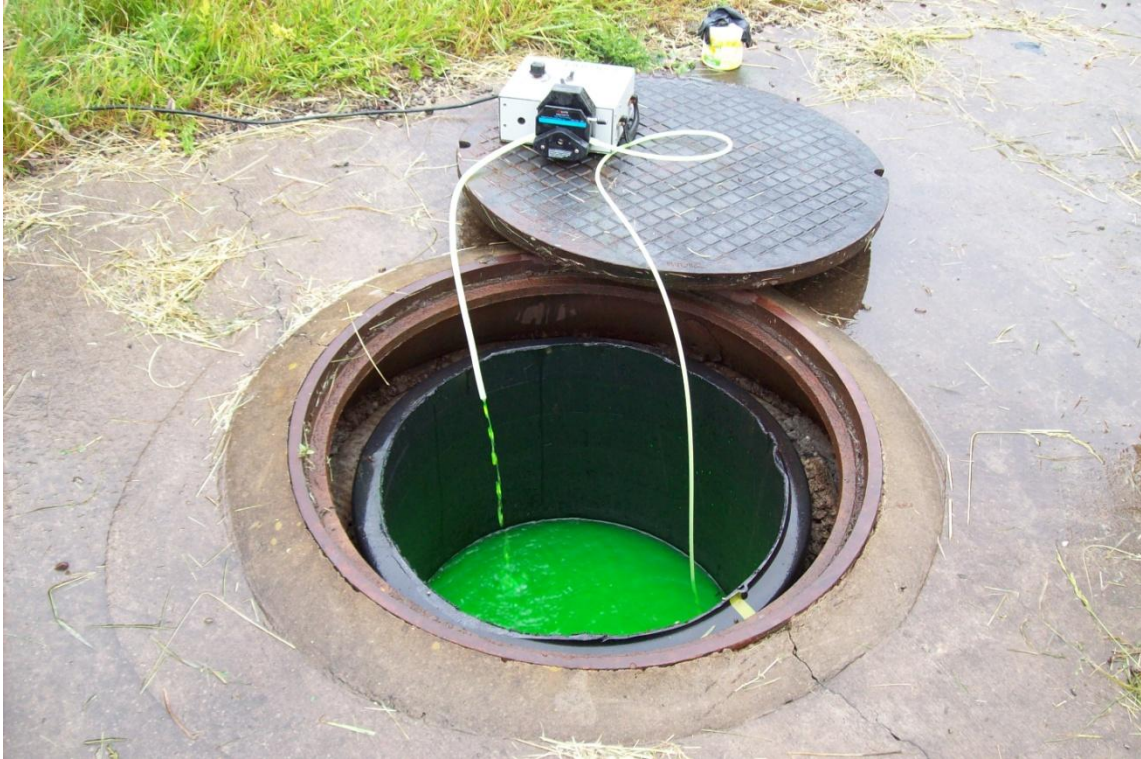
Photo 3: Fluorescent dye in leachate collection tank.

On June 19, 2009, covers were removed from cleanouts for the leachate collection pipes and pore-pressure relief system (PPRS). The bottom sides of the covers were identified as either “Leachate” or “Groundwater”. Water with fluorescent dye was poured into respective cleanout pipes to evaluate flow through the system. When dye-trace water was added to a “Groundwater” cleanout, flow increased and dye was observed in one of the three pipes (designated North PPRS) flowing into the combination sampling sump. Water with fluorescent dye was then added to a “Groundwater” cleanout pipe located on the southern perimeter of the landfill and an increase in flow and the presence of tracer dye were observed in a second pipe (designated South PPRS) flowing into the combination sampling sump. Finally, water with fluorescent dye was added to a “Leachate” cleanout pipe and increased flow and tracer dye was observed in the remaining inlet to the combination sampling sump. The combined discharge to the ABP from the combination sampling sump was also confirmed by the presence of fluorescent dye. Flow was then diverted to the Town sewer via the flow control valves; tracer dye was subsequently observed discharging to the Town sewer.

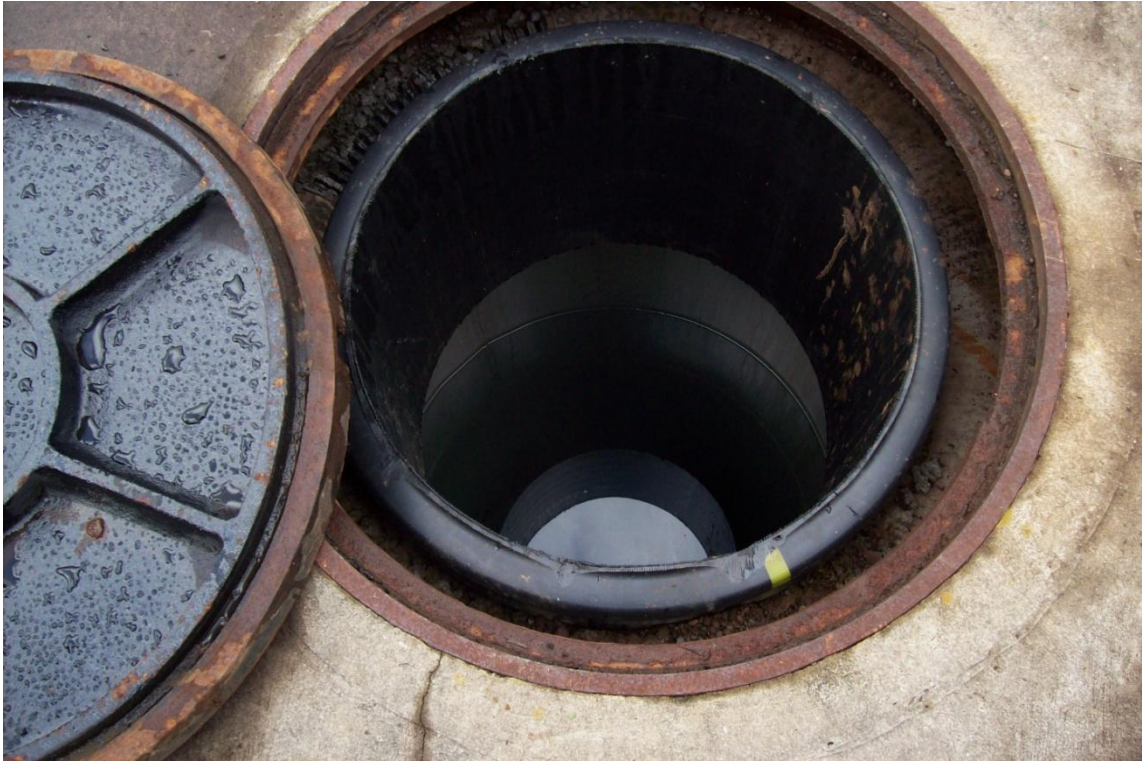
Photo 5: 2008 collection tank level.

A second alternative to explain the elevation in the tank is that the collection tank was filled to capacity and the inlet valve was closed and leachate flow was diverted to the ABP. Therefore, leachate could not “backflow” into the collection system. If a portion of precipitation was able to enter the manway openings, then the level in the collection tank would rise above the top of the collection tank as was observed. This scenario may be plausible as the level in the manway openings in 2009 were higher than what was observed in 2008 (Photos 6 and 7).

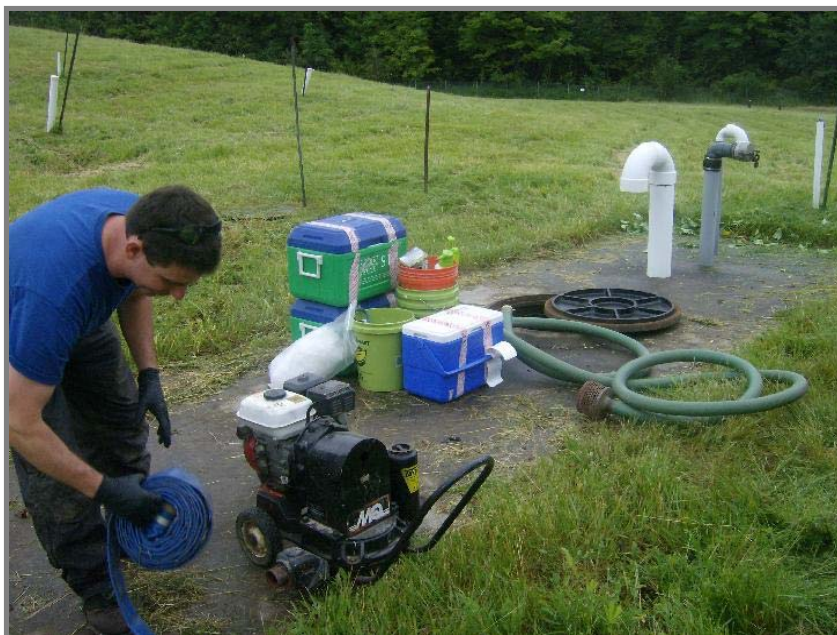
Friday we obtained a diaphragm pump. We pumped water here and there testing various theories. We drained the manway riser and discovered a leaky collar joint.

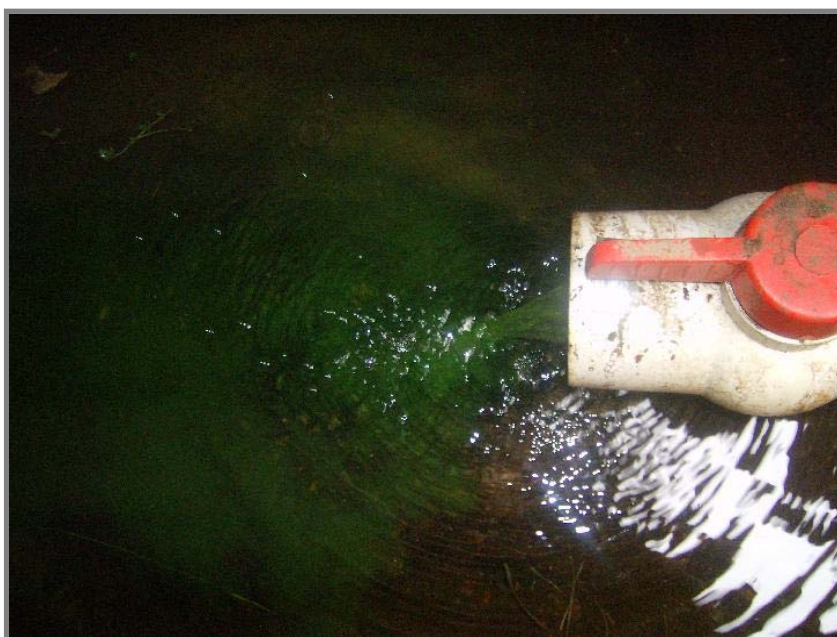
Success! We now have green dye in the first pipe inside the vault. This is a leachate pipe.
