# **Columbia Mills Site 2019 Annual Groundwater Monitoring Report**

NYSDEC Site Number 7-38-012

October 2019

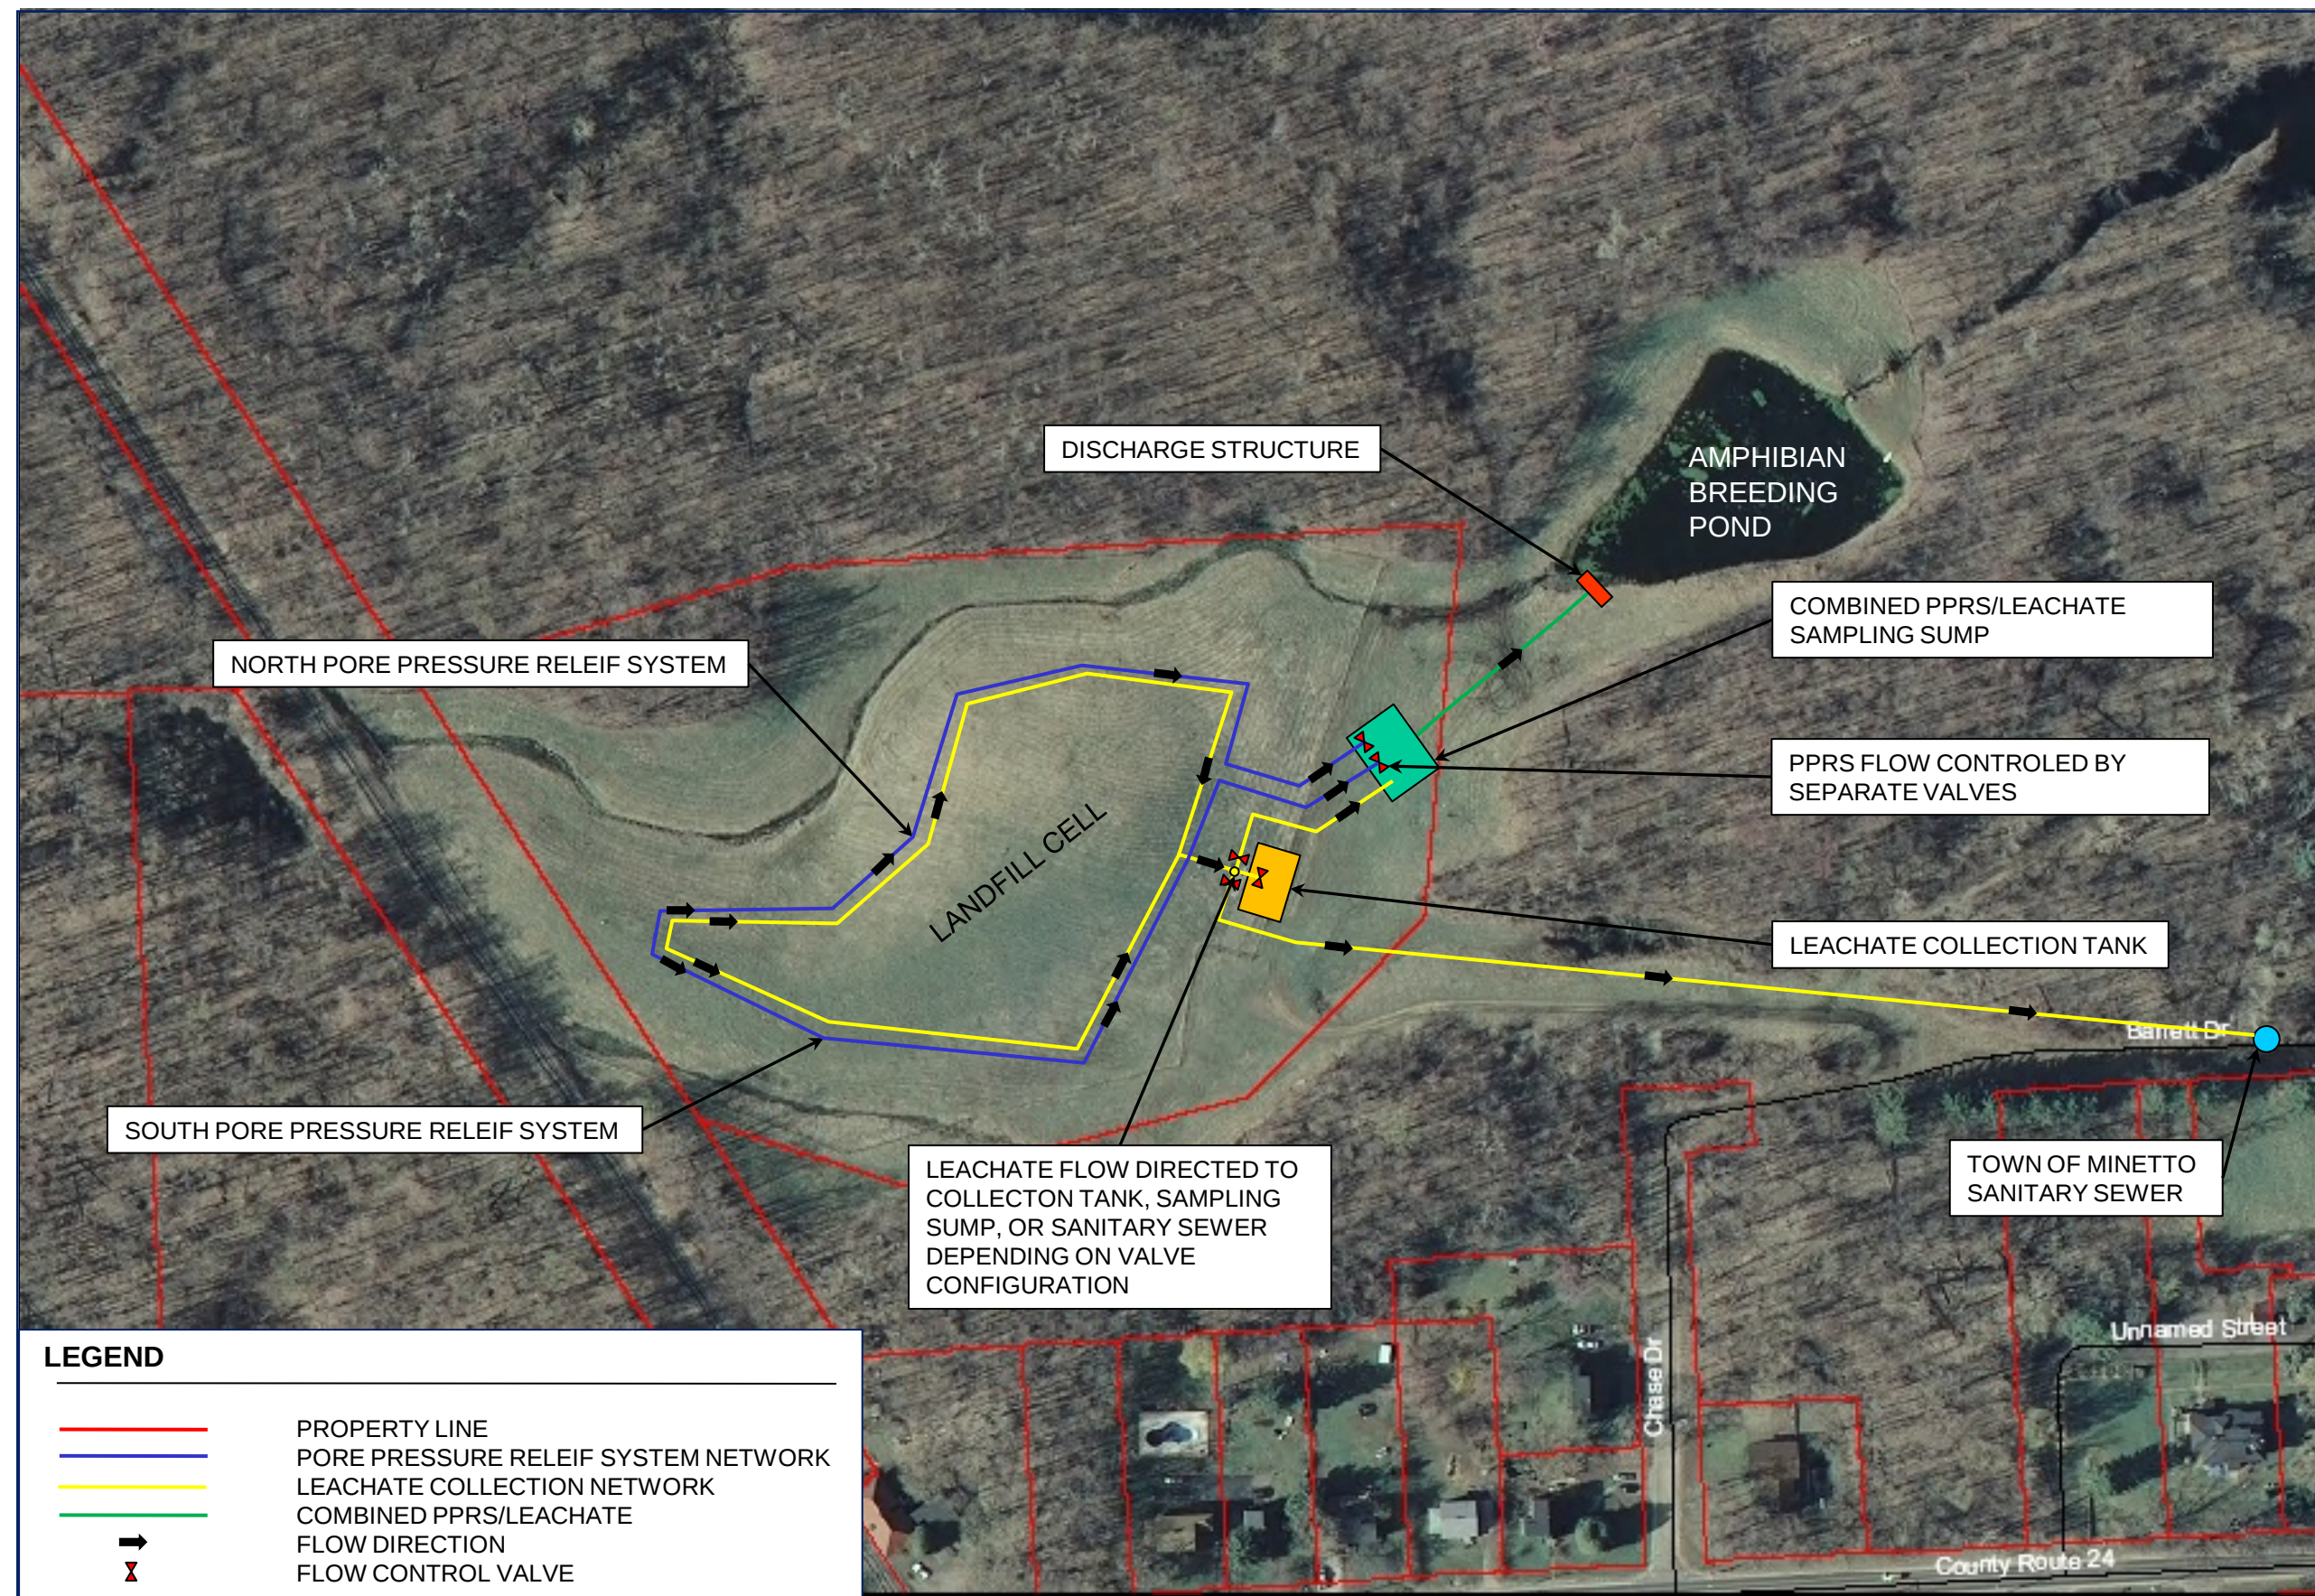
**FIGURE 4-1**

Existing on-site groundwater monitoring wells and piezometers (Figure 4-1) were evaluated for integrity and suitability for groundwater monitoring and water levels. The condition of each well and piezometer was recorded on well inspection logs (Appendix B). As shown in Appendix B, (and the photographs in Appendix A) the integrity of the groundwater monitoring wells and piezometers was acceptable, and no repair or maintenance is required at this time.

The groundwater monitoring wells and piezometers are generally in acceptable condition. Based on the water level survey, groundwater flow across the site is generally toward the northeast.

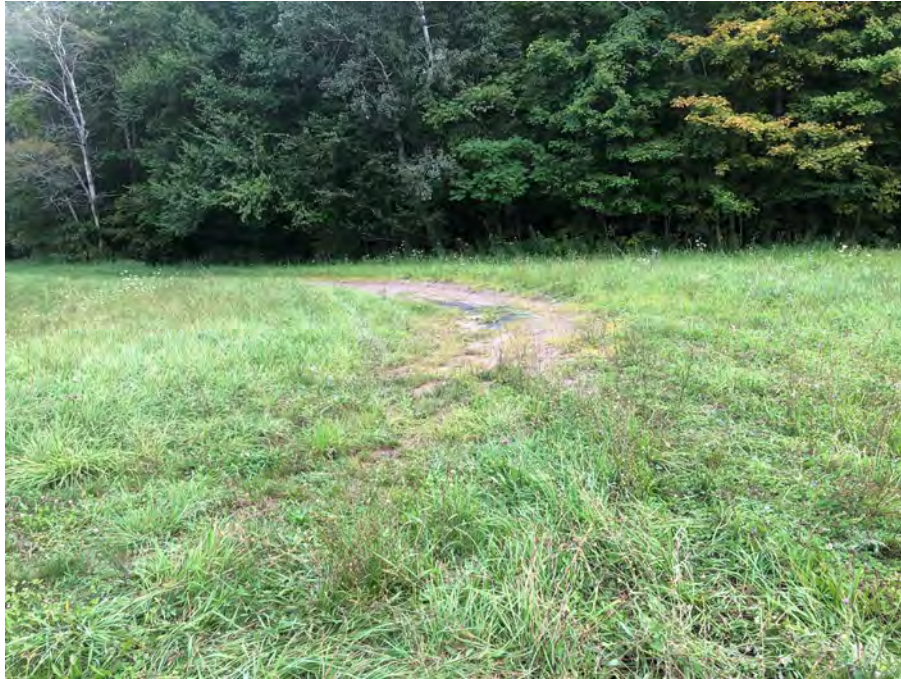
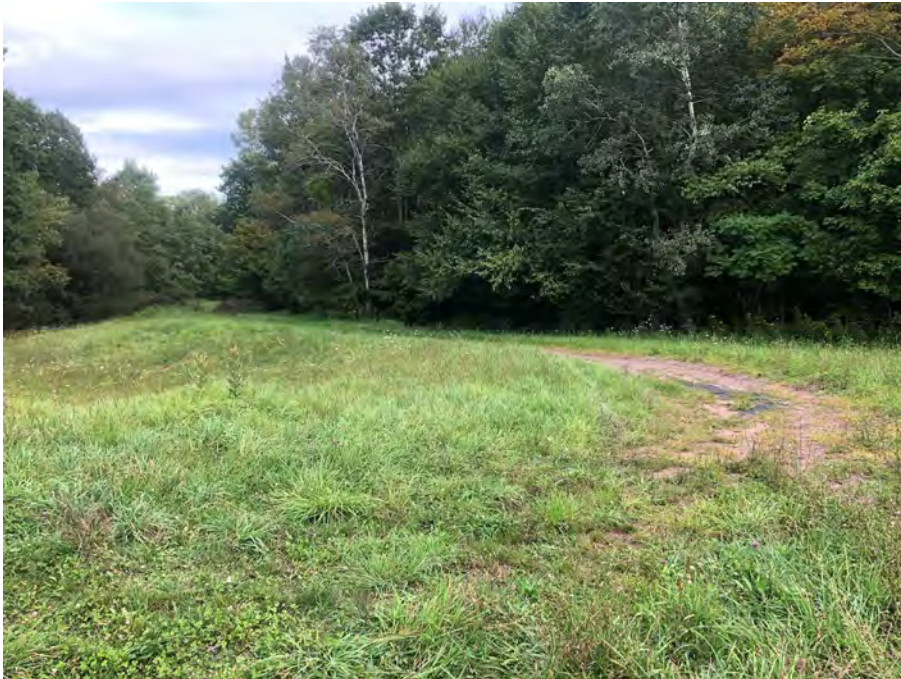
An approximately 20-foot section of geotextile fabric in the landfill access road was exposed. No other areas of damage or erosion were observed during the inspection.

The landfill and site were inspected on September 10, 2019 and appear to be in acceptable condition. Although the landfill cap did not appear to be mowed, no woody vegetation was established on the landfill. A section of geotextile in the landfill access road was exposed.

Exposed road fabric on access road

- Annual O&M should continue to be conducted as described in the Draft SMP.
- The landfill cap should be mowed on an annual basis to prevent the establishment of woody vegetation.
- The exposed area of geotextile in the landfill access road should be repaired and additional road material should be placed over the geotextile. The area should then be regraded to limit further erosion of the roadway.

The landfill access road should be repaired and graded to limit erosion.

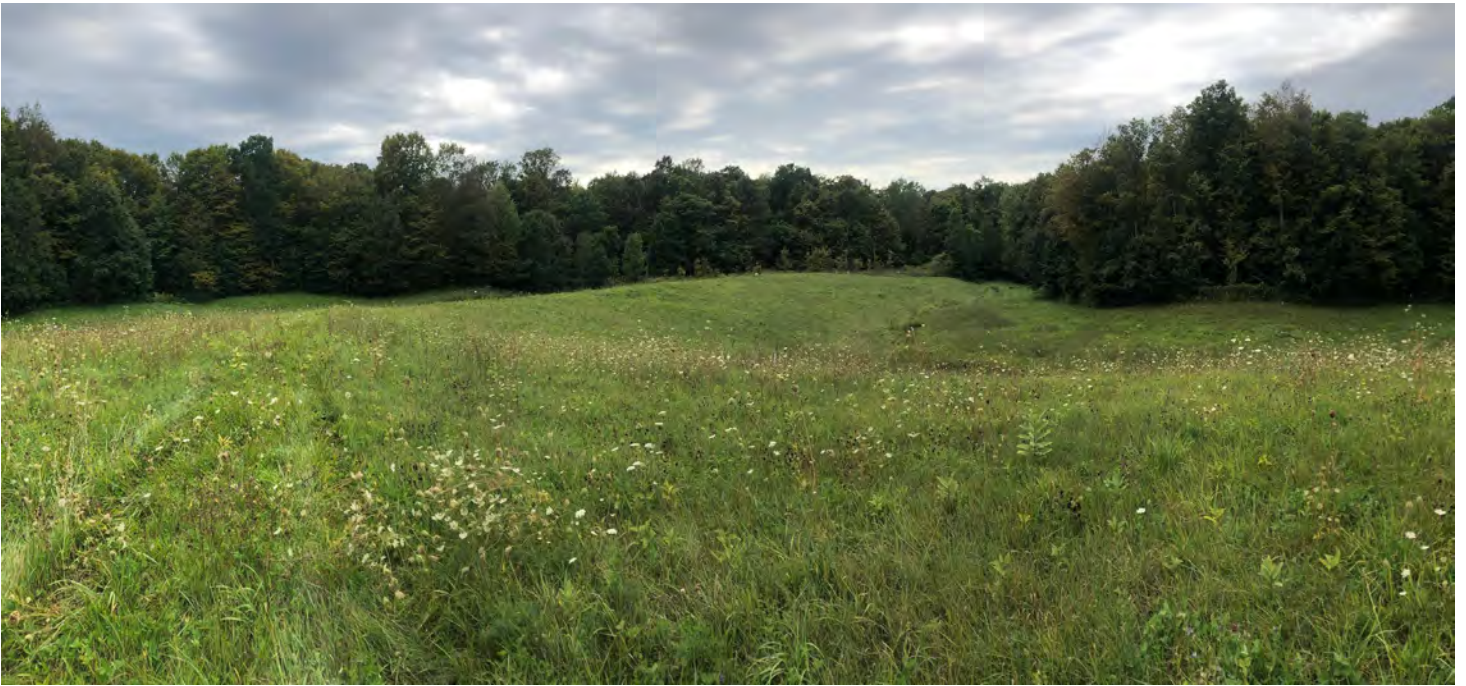
North side of landfill, facing west.

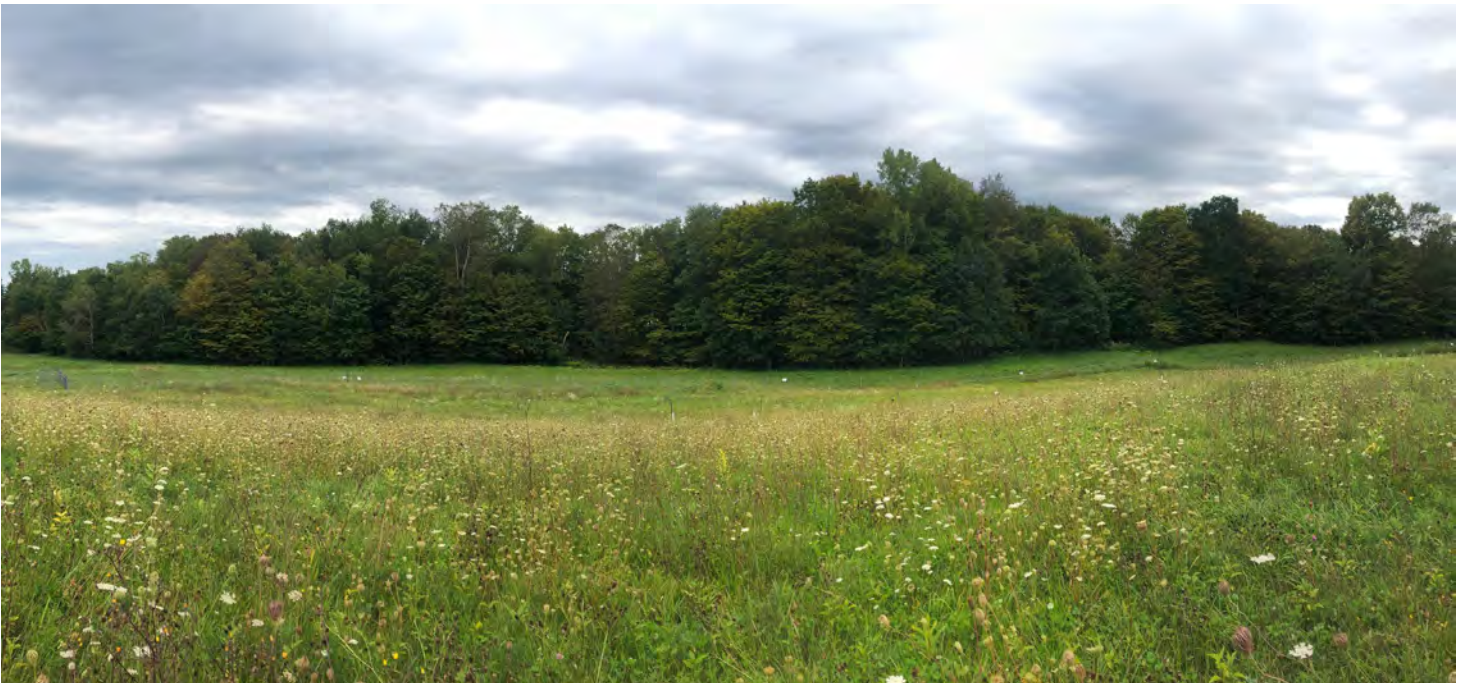
East side of landfill, facing south

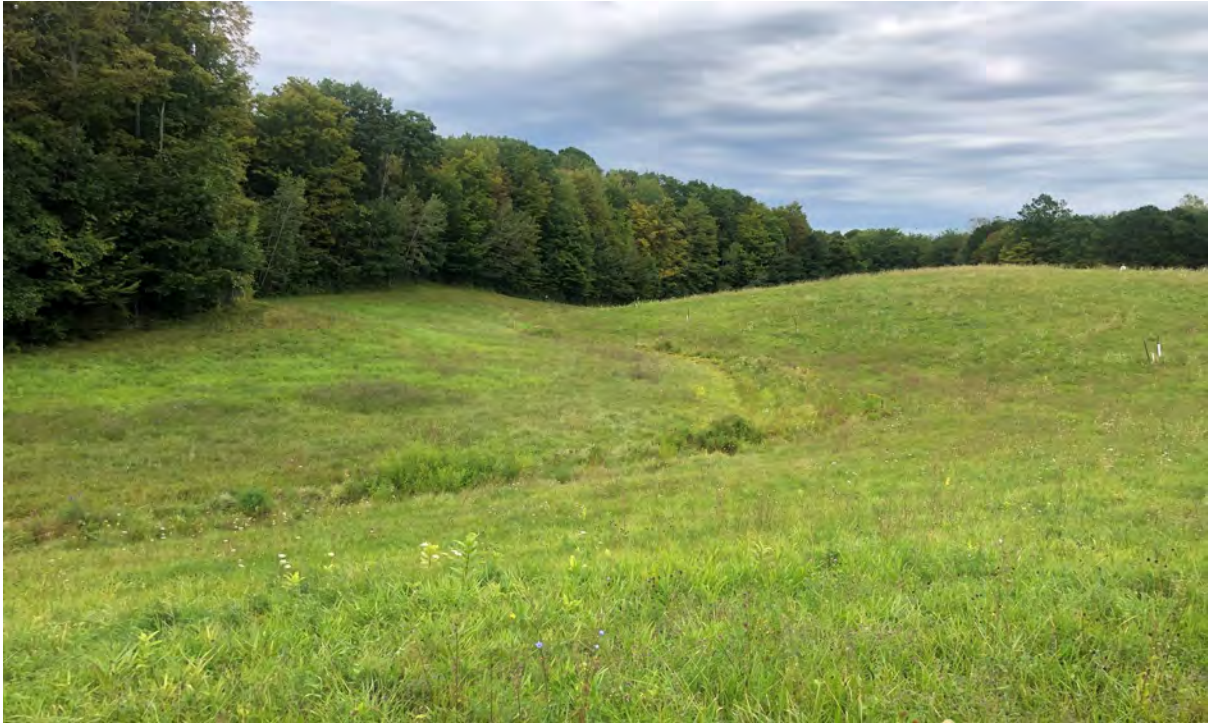
Northwest corner of landfill, facing east

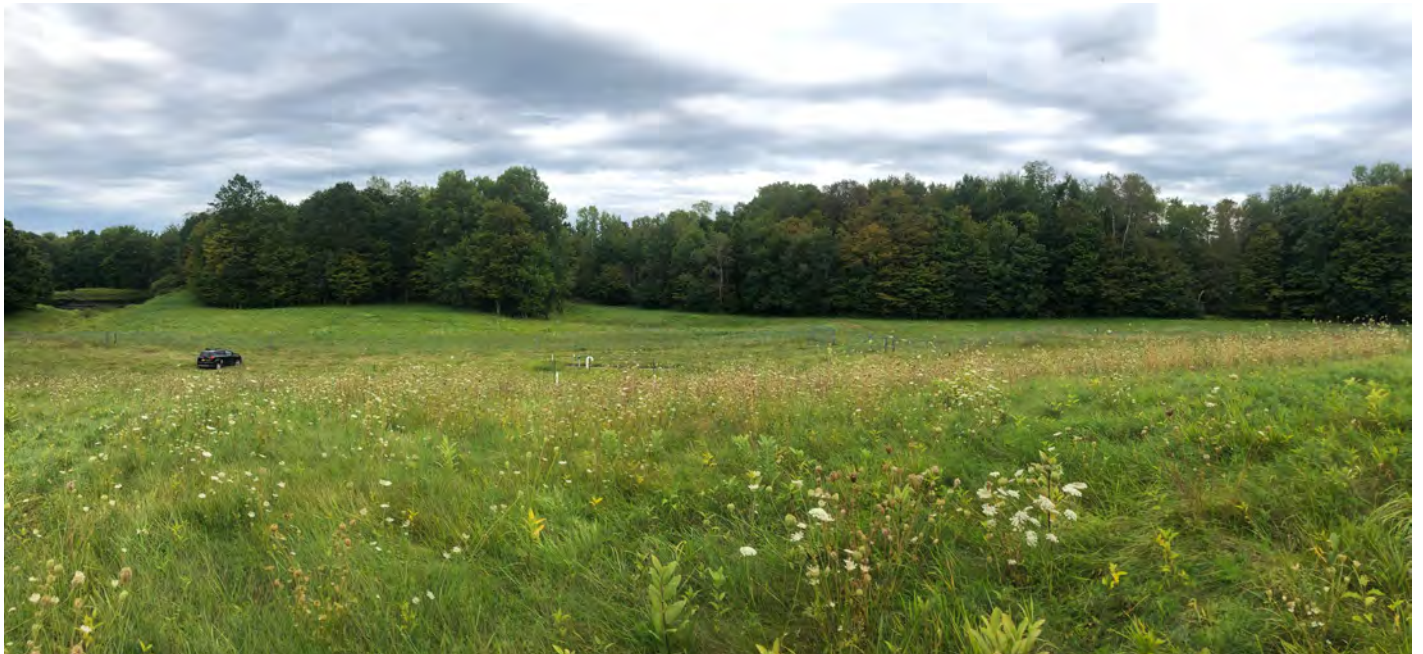
East side of landfill, facing east
