PHASE II INVESTIGATION REPORT
CRYSTEEL MANUFACTURING, INC.
1902 ROUTE 57
FULTON, NEW YORK

PHASE II INVESTIGATION REPORT

**CRYSTEEL MANUFACTURING, INC.
1902 ROUTE 57
FULTON, NEW YORK 13069**

**JUNE 20, 2000
PROJECT #52035.01**

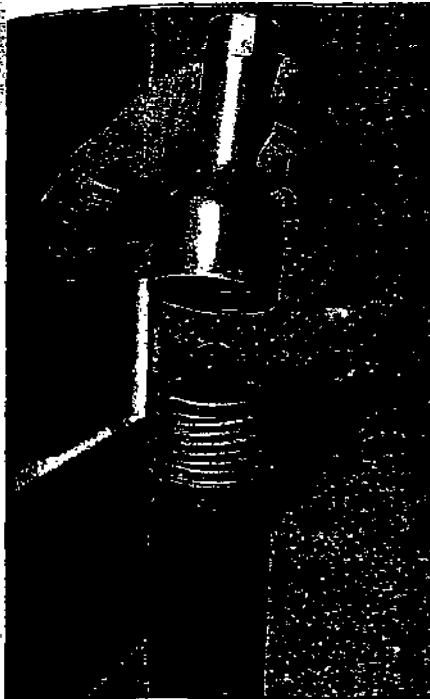
The DT21 System features a drive bumper (DT4010K) which is placed on the top of the 1.0-in. probe rod. This bumper prevents the dynamic hammering forces from being transmitted to the sample liner, thus helping to preserve the liner during the sampling process.

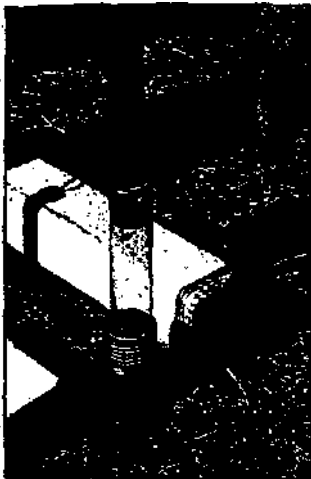
8. Thread the liner/drive head assembly into the female end of a 1.0 in. probe rod.
