# Field Notes

Oswego Castings  
Site ID N° 738033

Mitchell Street  
Oswego, N.Y.

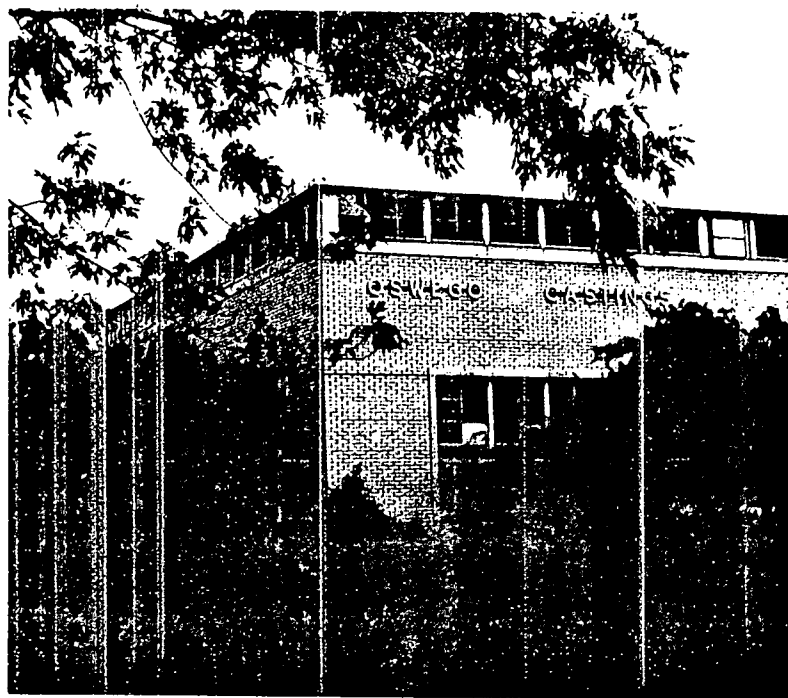
Overview photo of a portion of the main plant building for Oswego Castings.

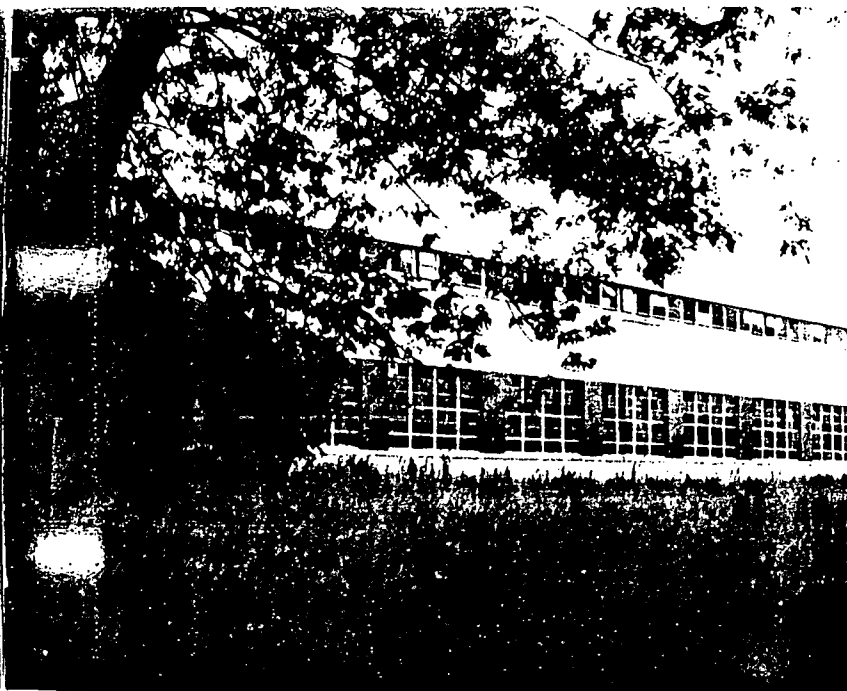
Many of the windows in the building have been shot out, & the inside of the building has been cleaned out.

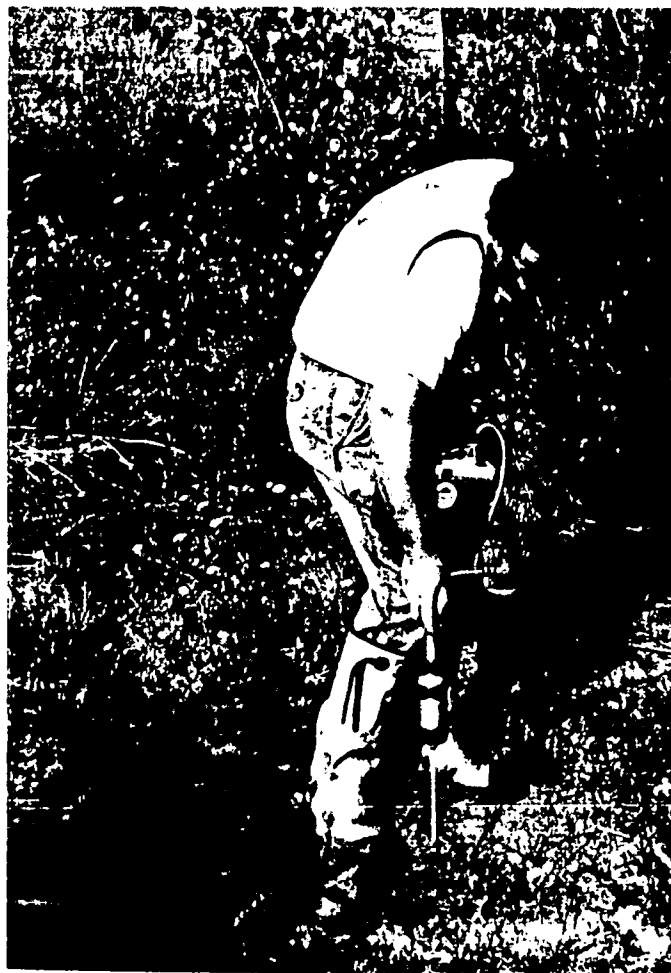
Eric Knapp checking for volatiles in the area of the Core sand disposal section. HNu readings did not go above background.

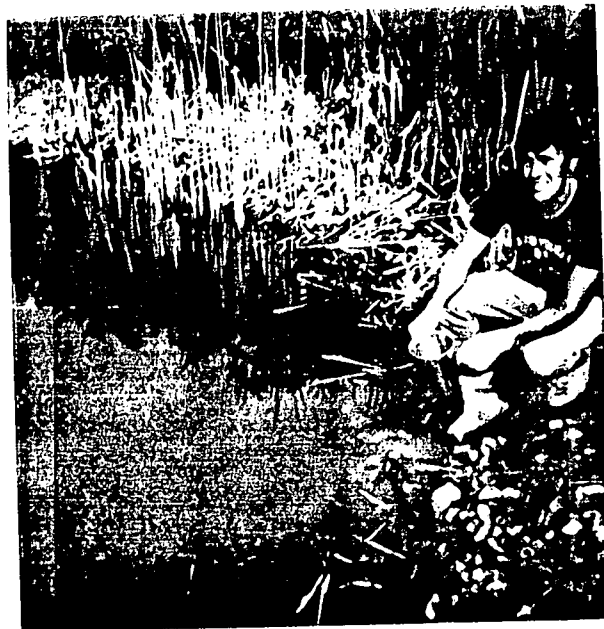
Oswego Castings  
Sampling Point 01801A

SAMPLE TAKEN IN A  
SMALL 60'x60' pond on  
NORTHWEST CORNER OF  
PROPERTY. POND WAS MANMADE,  
PAST USE UNKNOWN. THERE  
WAS NO APPARENT ODORS.

WATER WAS CLEAR. SAMPLE

GREY IN COLOUR, WITH  
DECOMPOSING VEGETATION.

FLORA & FAUNA BOTH WERE  
ABUNDANT. POND WAS ORIGINALLY  
LINED WITH GRAVEL, WHICH IS  
STILL APPARENT.

Samples 01 & 01A taken by  
FM Koch @ about 10:07 AM.
